Report on
Geotechnical Investigation

Proposed Budawang School Relocation
17 Croobyar Road, Milton

Prepared for
School Infrastructure New South Wales (SINSW)

Project 89390.02
April 2021

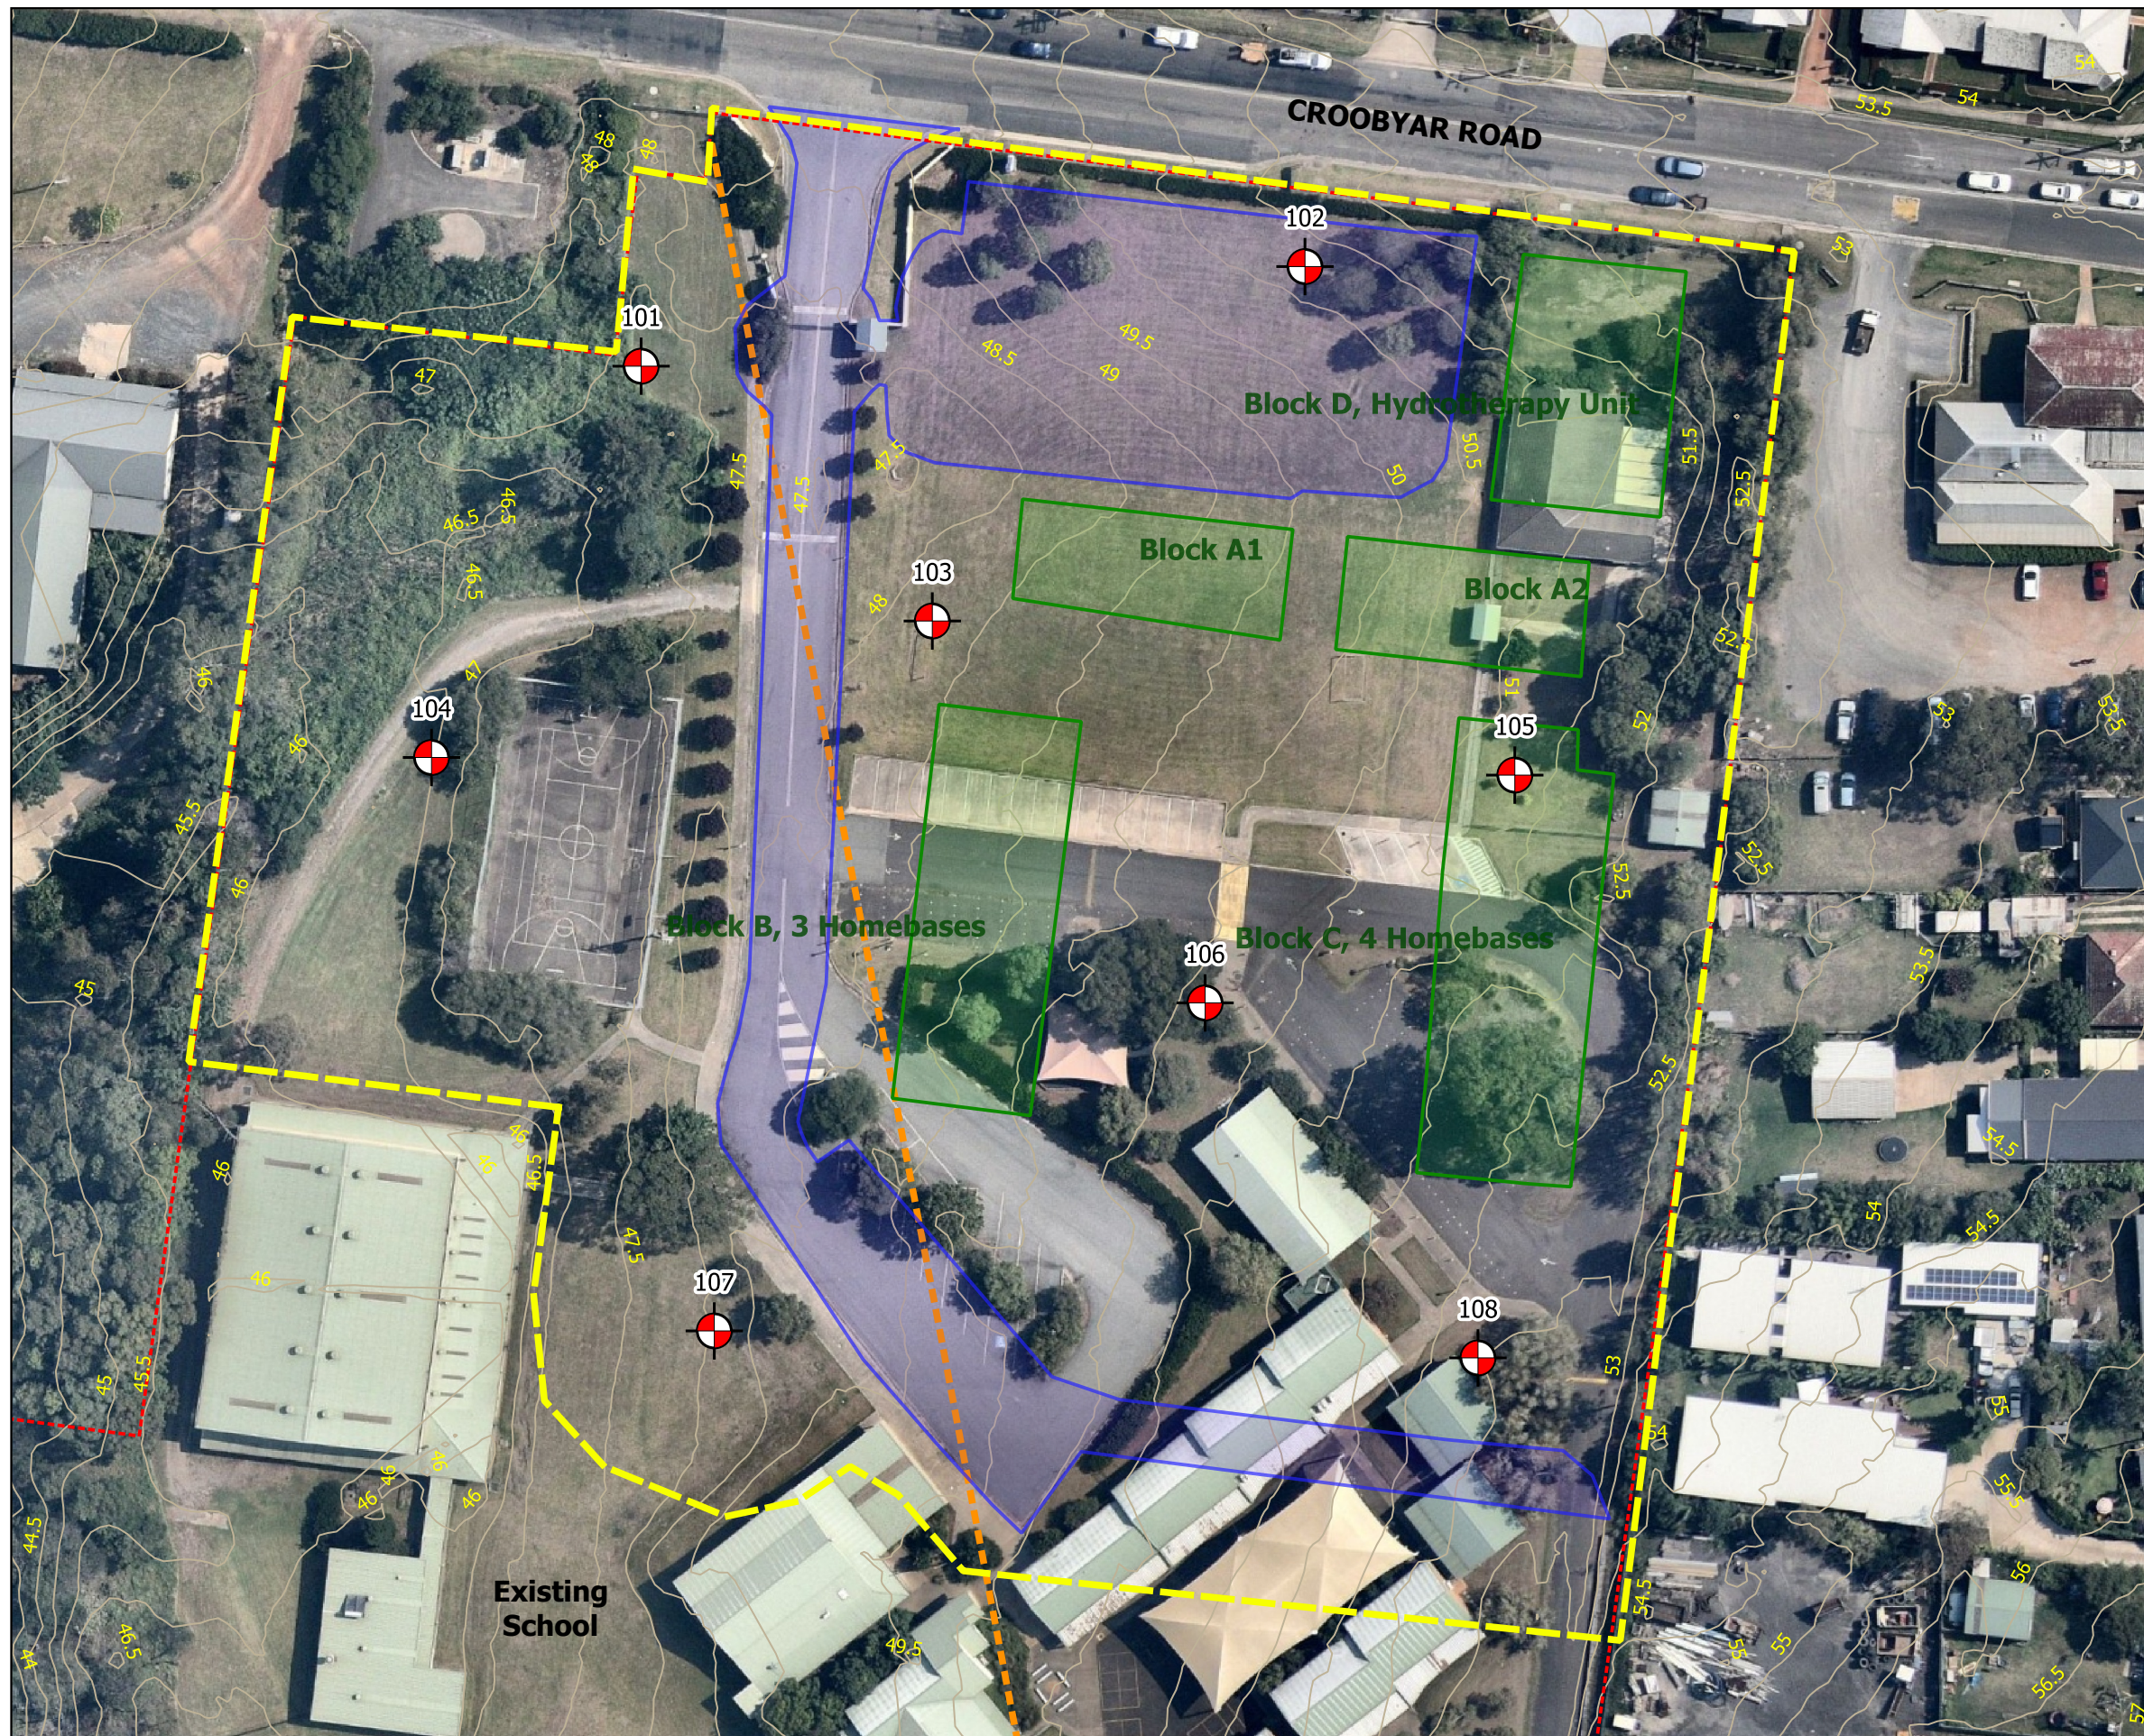
Approximate Location of Existing Sewer Main

At the time of the investigation, single storey buildings associated with the former school were located in the northern and southern sections of the site (refer Drawing 1). A north to south trending drainage depression was located along the western boundary. Stands of trees were noted along the eastern and western boundaries and sporadically throughout the remainder of the site. An existing netball/basketball playing surface was located in the western part of the site. Other parts of the site were typically lightly grassed/landscaped (near existing buildings) or asphalt sealed (car parks and driveways). A sewer main diagonally crosses the site (refer Drawing 1).

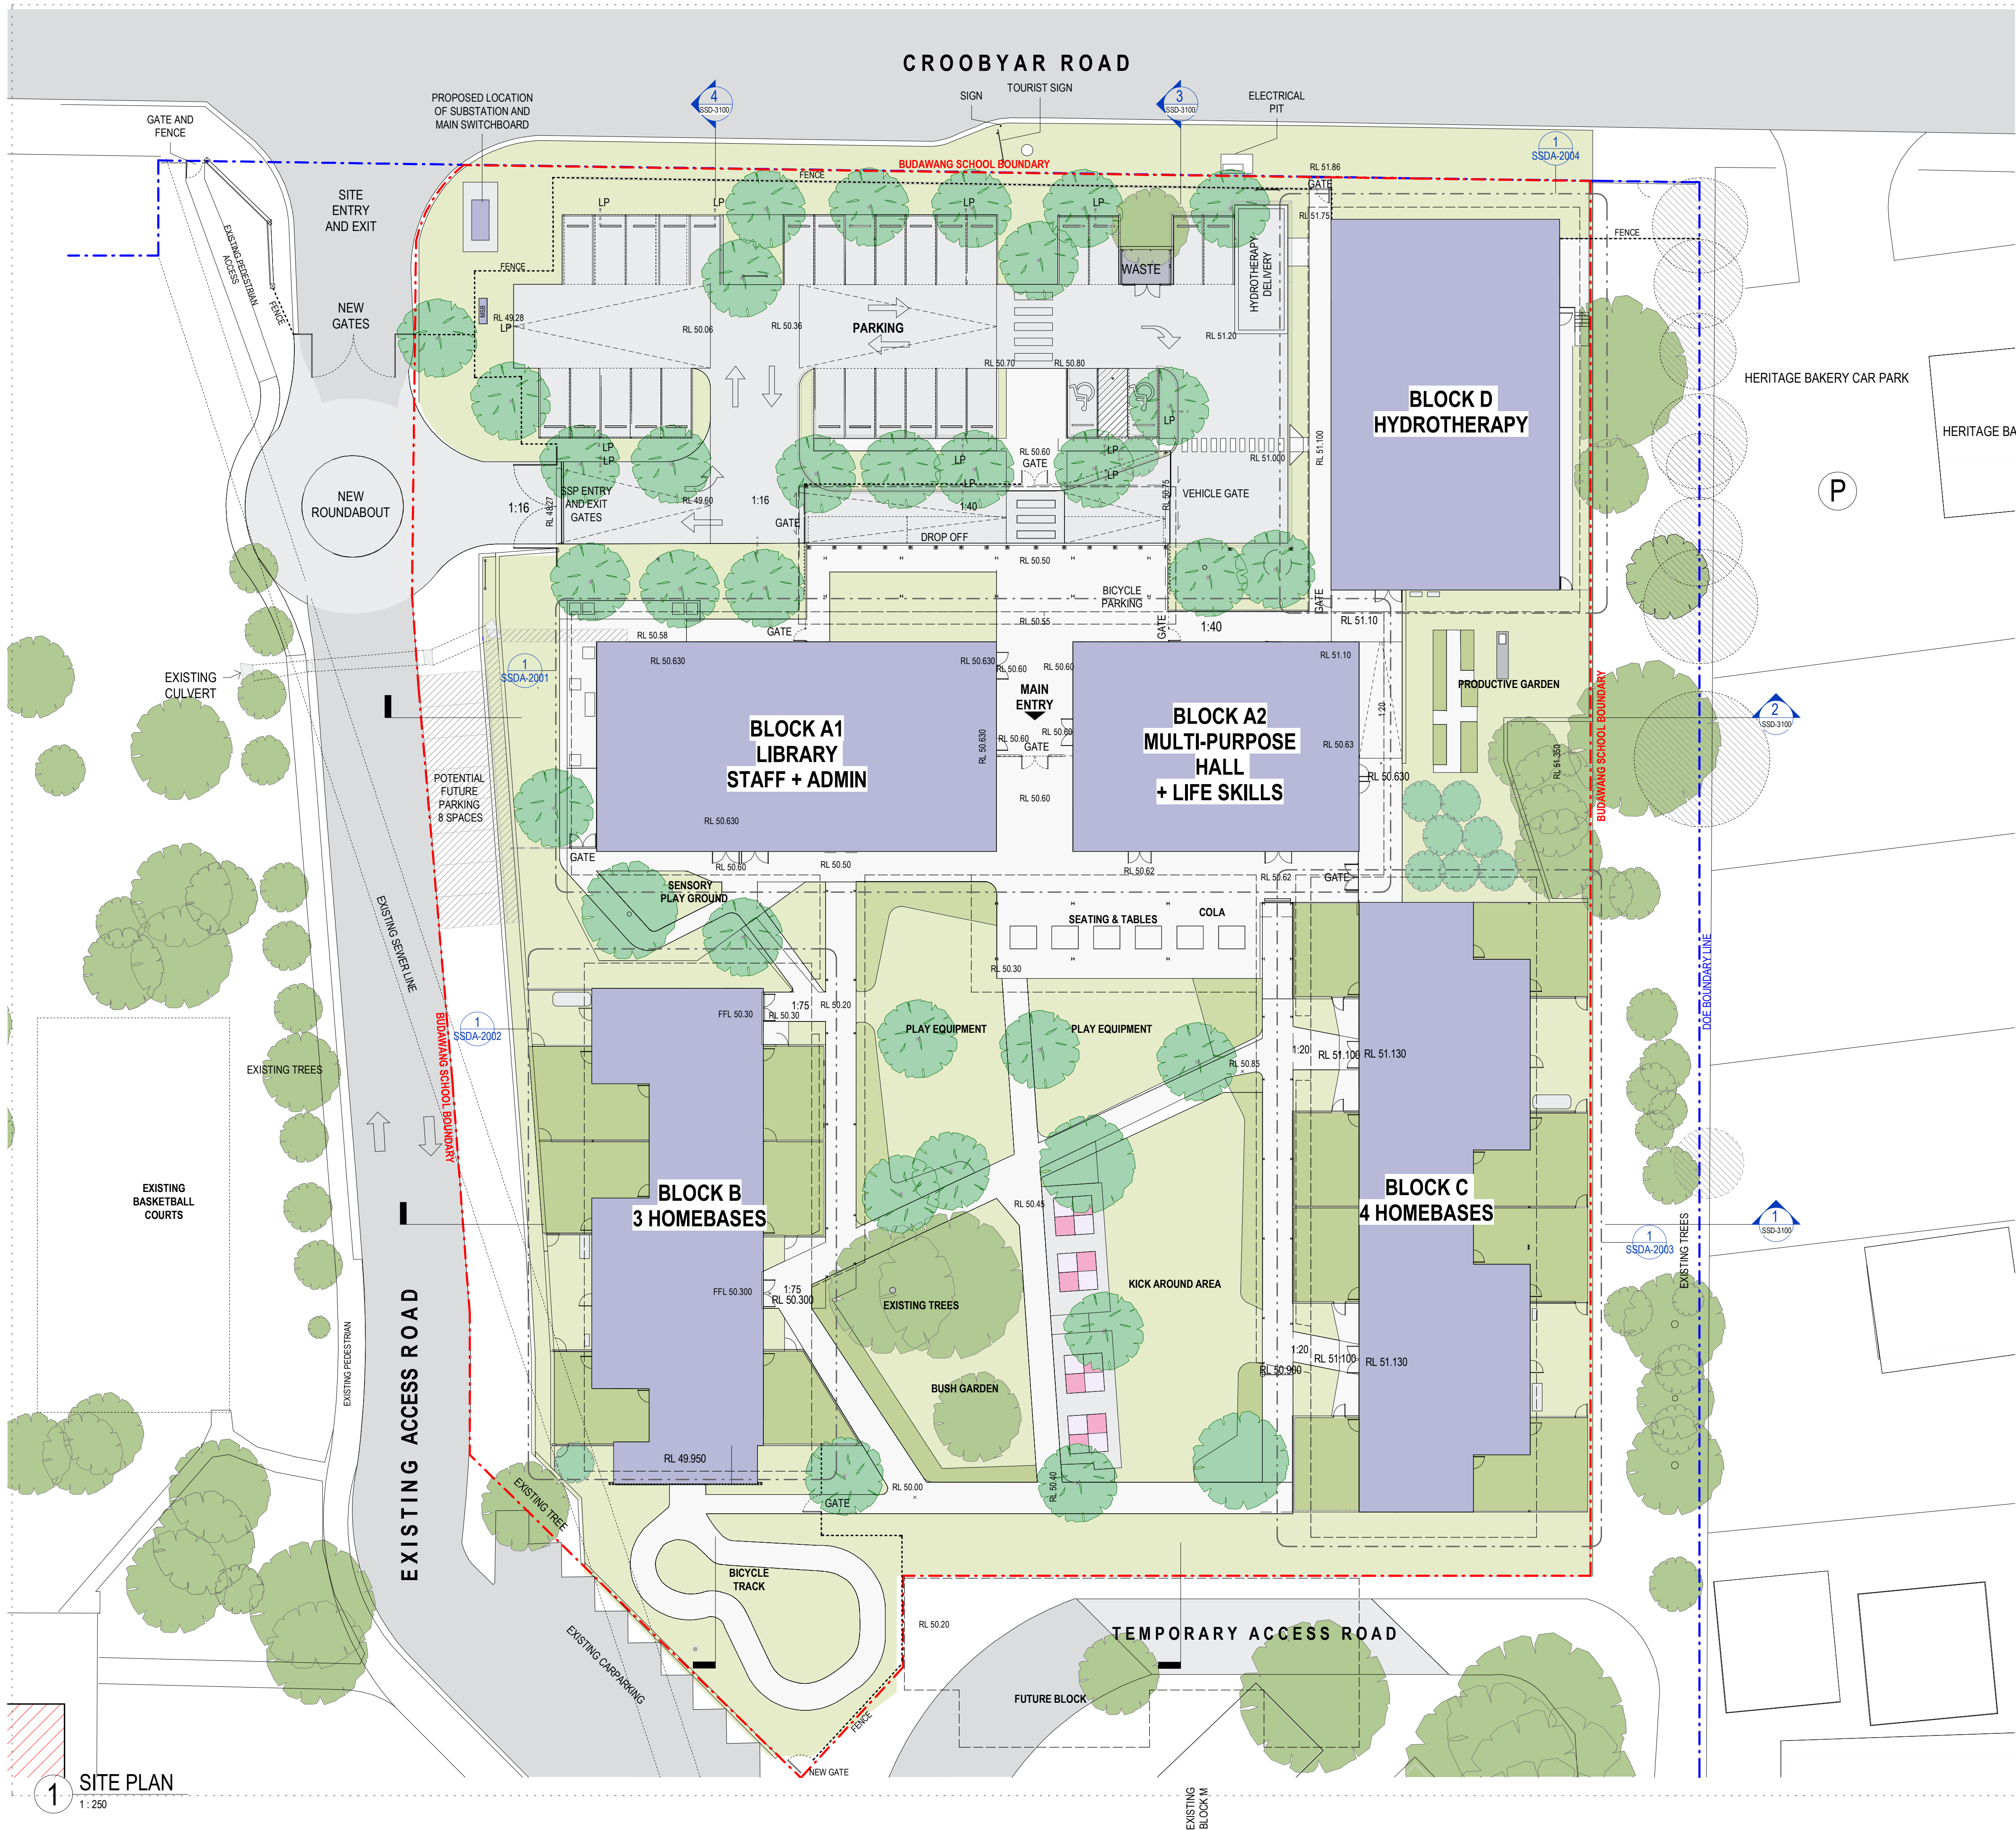
Drawing 1
Master Plan, Project 190941, Drawing No. SSDA-2000 Issue D
Site Photographs
Borehole Logs (Bores 101 – 108)

Notwithstanding the P classification, the natural silty clay subsurface conditions in the vicinity of the proposed buildings (refer Drawing 1 in Appendix B for proposed building locations) are expected to comprise natural silty clays with characteristic surface movements commensurate with Class H2 (highly reactive) conditions from the reactivity viewpoint, when assessed in accordance with the requirements of AS 2870:2011.

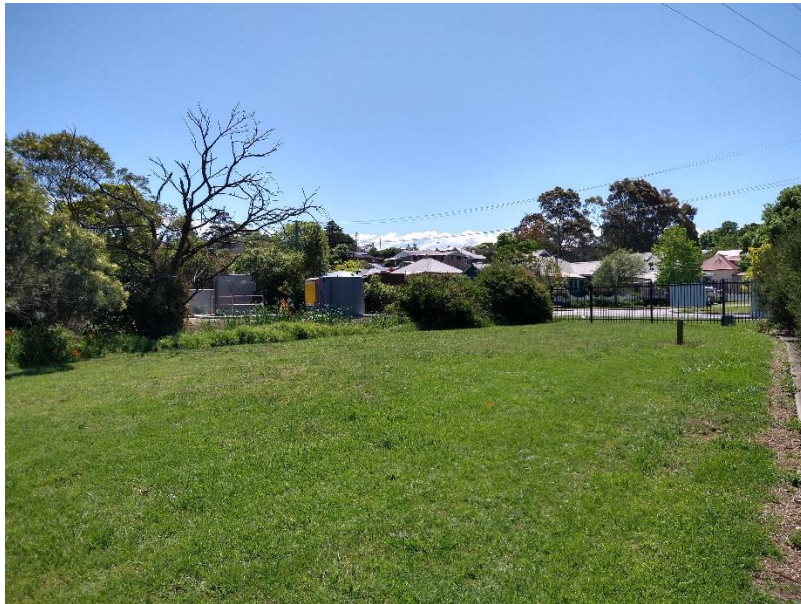
Photo 1 – View across the north eastern section of the site towards a small creek and pump station.

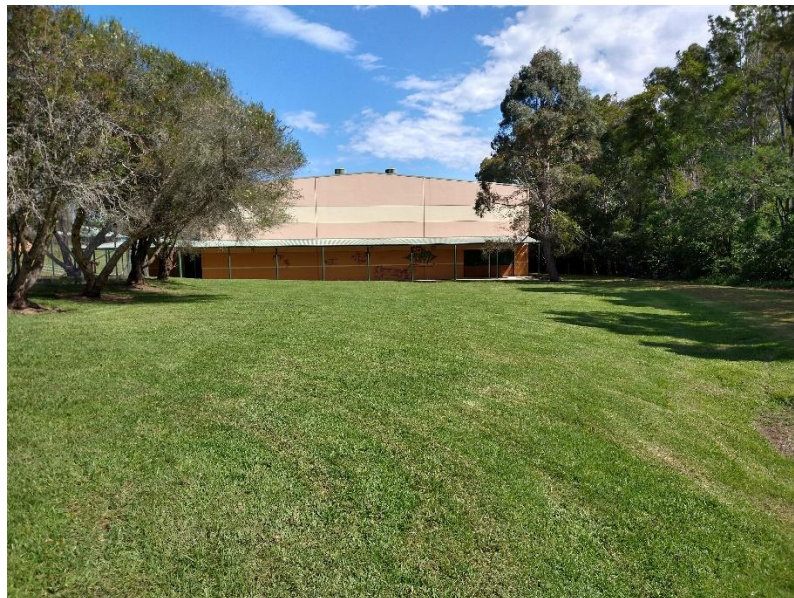
Photo 8 – View south behind existing tennis courts across a grassed fill platform.

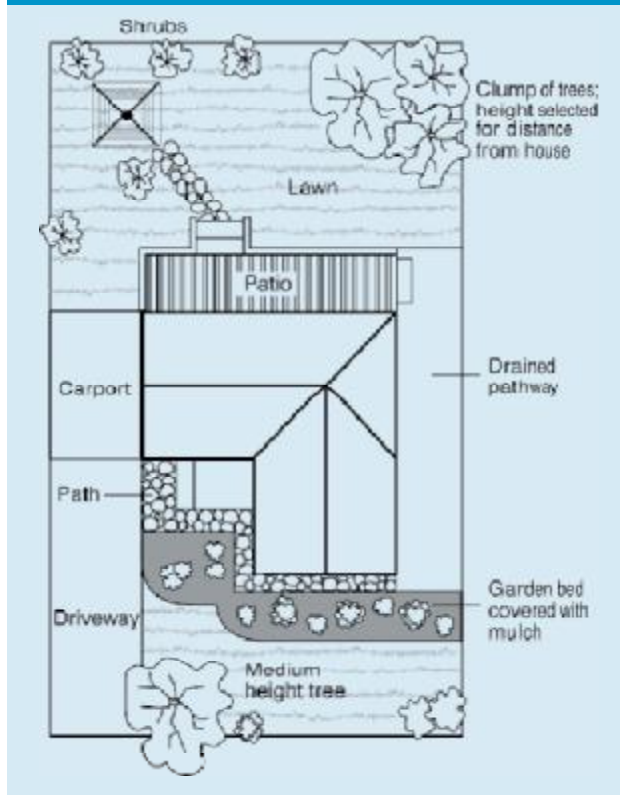
Gardens for a reactive site

should extend outwards a minimum of 900 mm (more in highly reactive soil) and should have a minimum fall away from the building of 1:60. The finished paving should be no less than 100 mm below brick vent bases.
