CLIENT: John Holland Pty Ltd  
 PROJECT: Proposed Maternity (3B2) Building  
 LOCATION: Little Uralba Street, Lismore

Project 90317.00  
September 2016

It is understood that the construction of a seven storey maternity ward building denoted Building 3B2 is proposed. It is further understood that the building is to be 'future proofed' by designing the foundations to allow for an additional five storeys to be constructed in the future if required. All construction will be from approximately existing site levels.

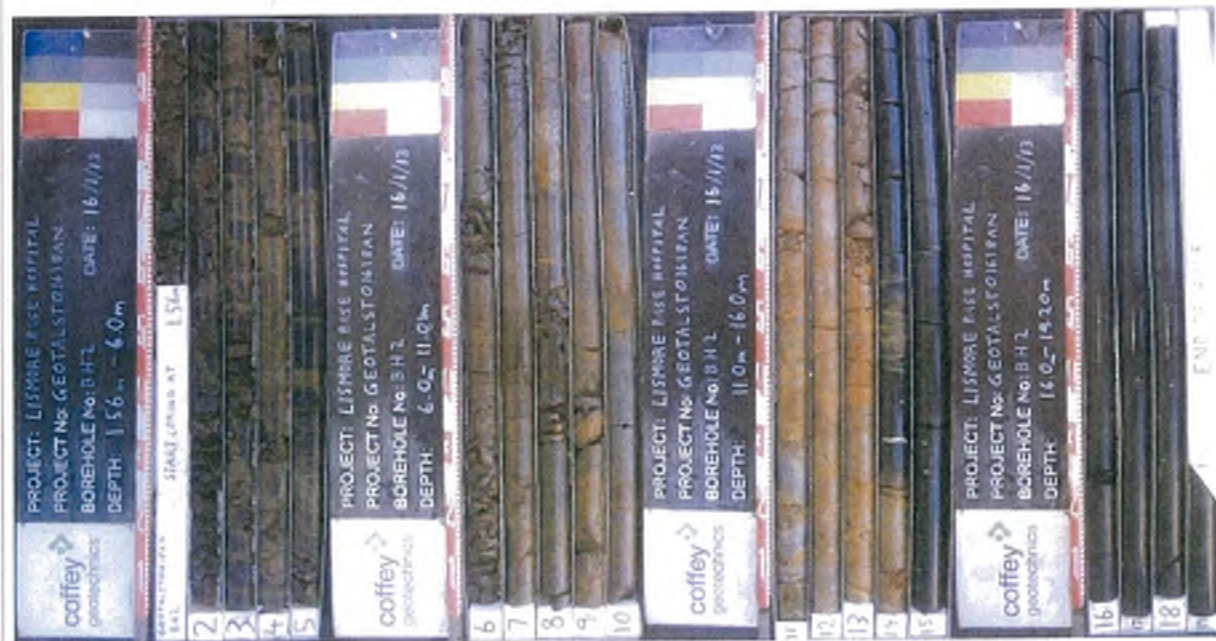
Drawn	BY	Client	NEW SOUTH WALES HEALTH INFRASTRUCTURE
Approved		Project	LISMORE BASE HOSPITAL NEW 11 FLOOR STRUCTURE
Date	2013/01/18	Site	CORE PHOTO - PHAS - B12
Scale	N15	Project No.	GEOTALSTONIAN/AD
Prepared	AS	Sheet No.	FIGURE 5
NO.

JT2= JT, 0-20°, UN, SO, VN-CO clay

END OF CORE
