### Review of the Proposed Balustrades for the new Access Ramp into Bay 4

**TKD**Architects  
Tanner Kibble Denton

**ASN BUILDING BAY 4-5**

**140851**

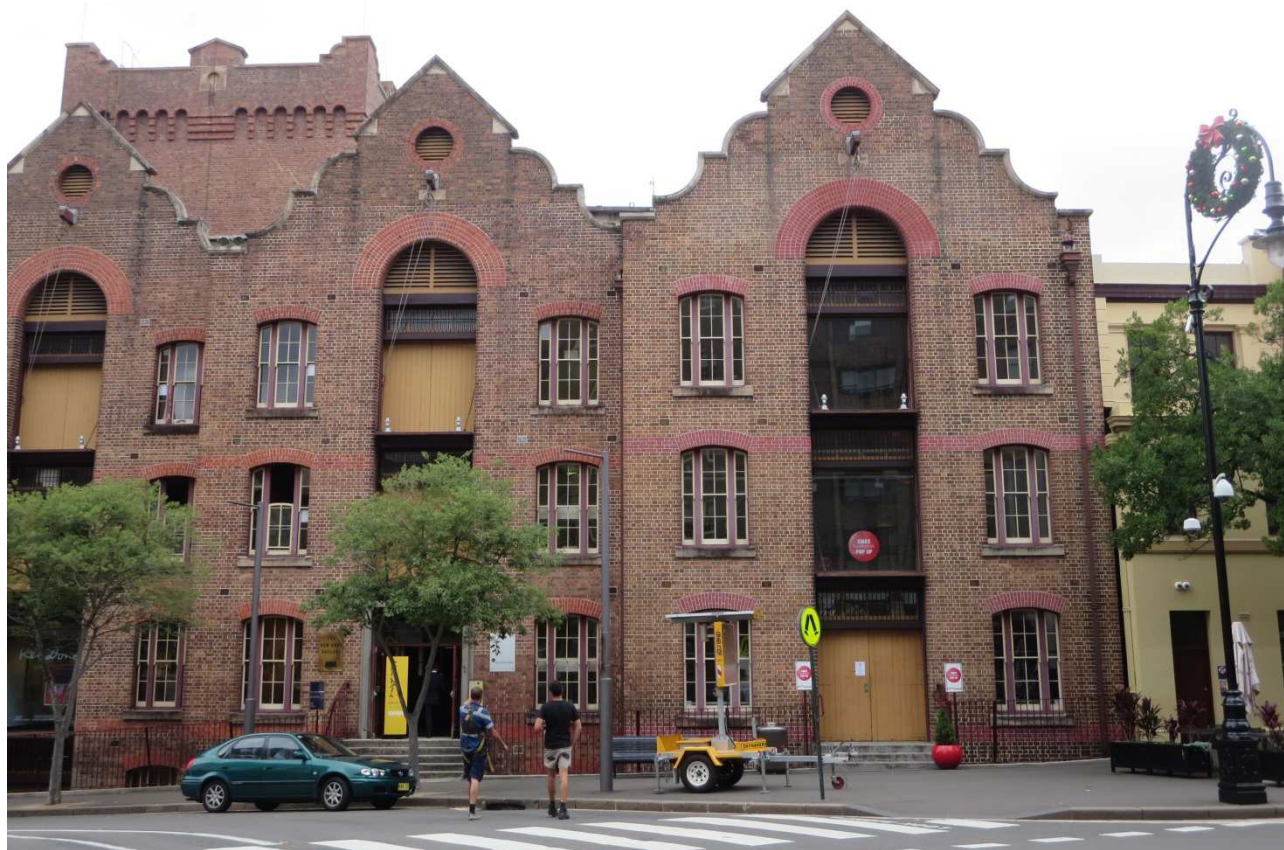
1. Existing view of entry into Bays 4 and 5 from across George Street

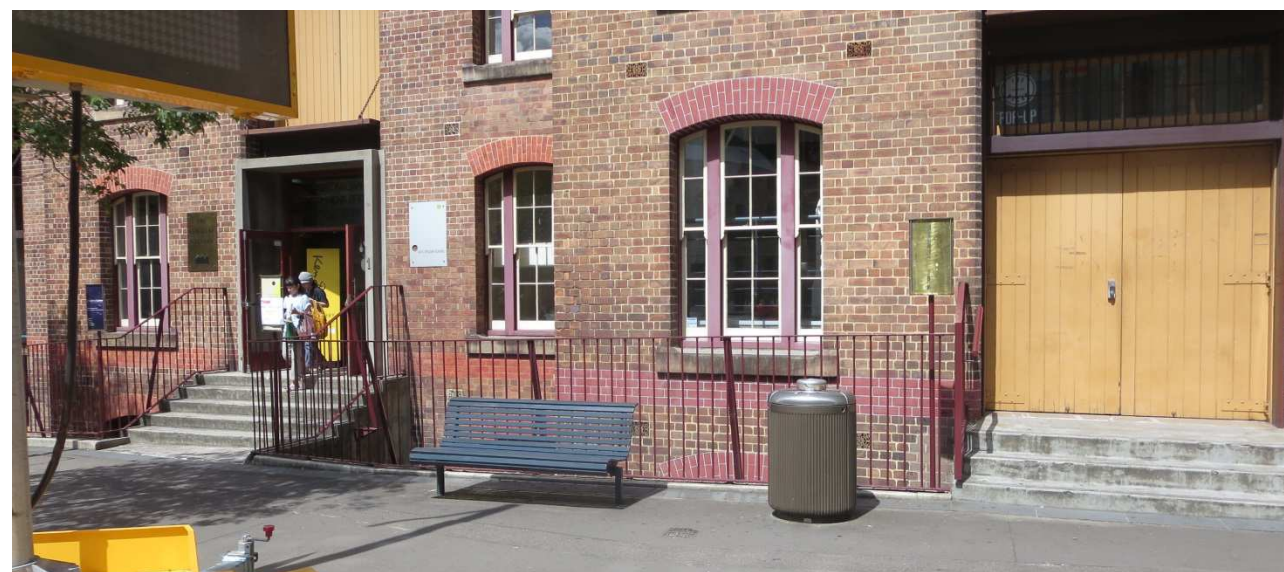
3. Closer view of the balustrade at the entries into Bays 4 and 5

The existing steel balustrades to the voids sit above a concrete capping to the retaining wall with bracket supports on the inner face fixed to the retaining wall. Handrails were required have been welded with brackets to the balustrade and are paint finished to match the balustrade.

Construction: Steel rods with flat plates top and bottom.

Finish: Painted. The colour is now faded but would likely have matched the window frames - ie Pascol 'Venetian Red' or 'Indian Red'.

Appearance: Photos show the existing balustrades are not a strong prominent item on the façade. If repainted, they may be a little more prominent.

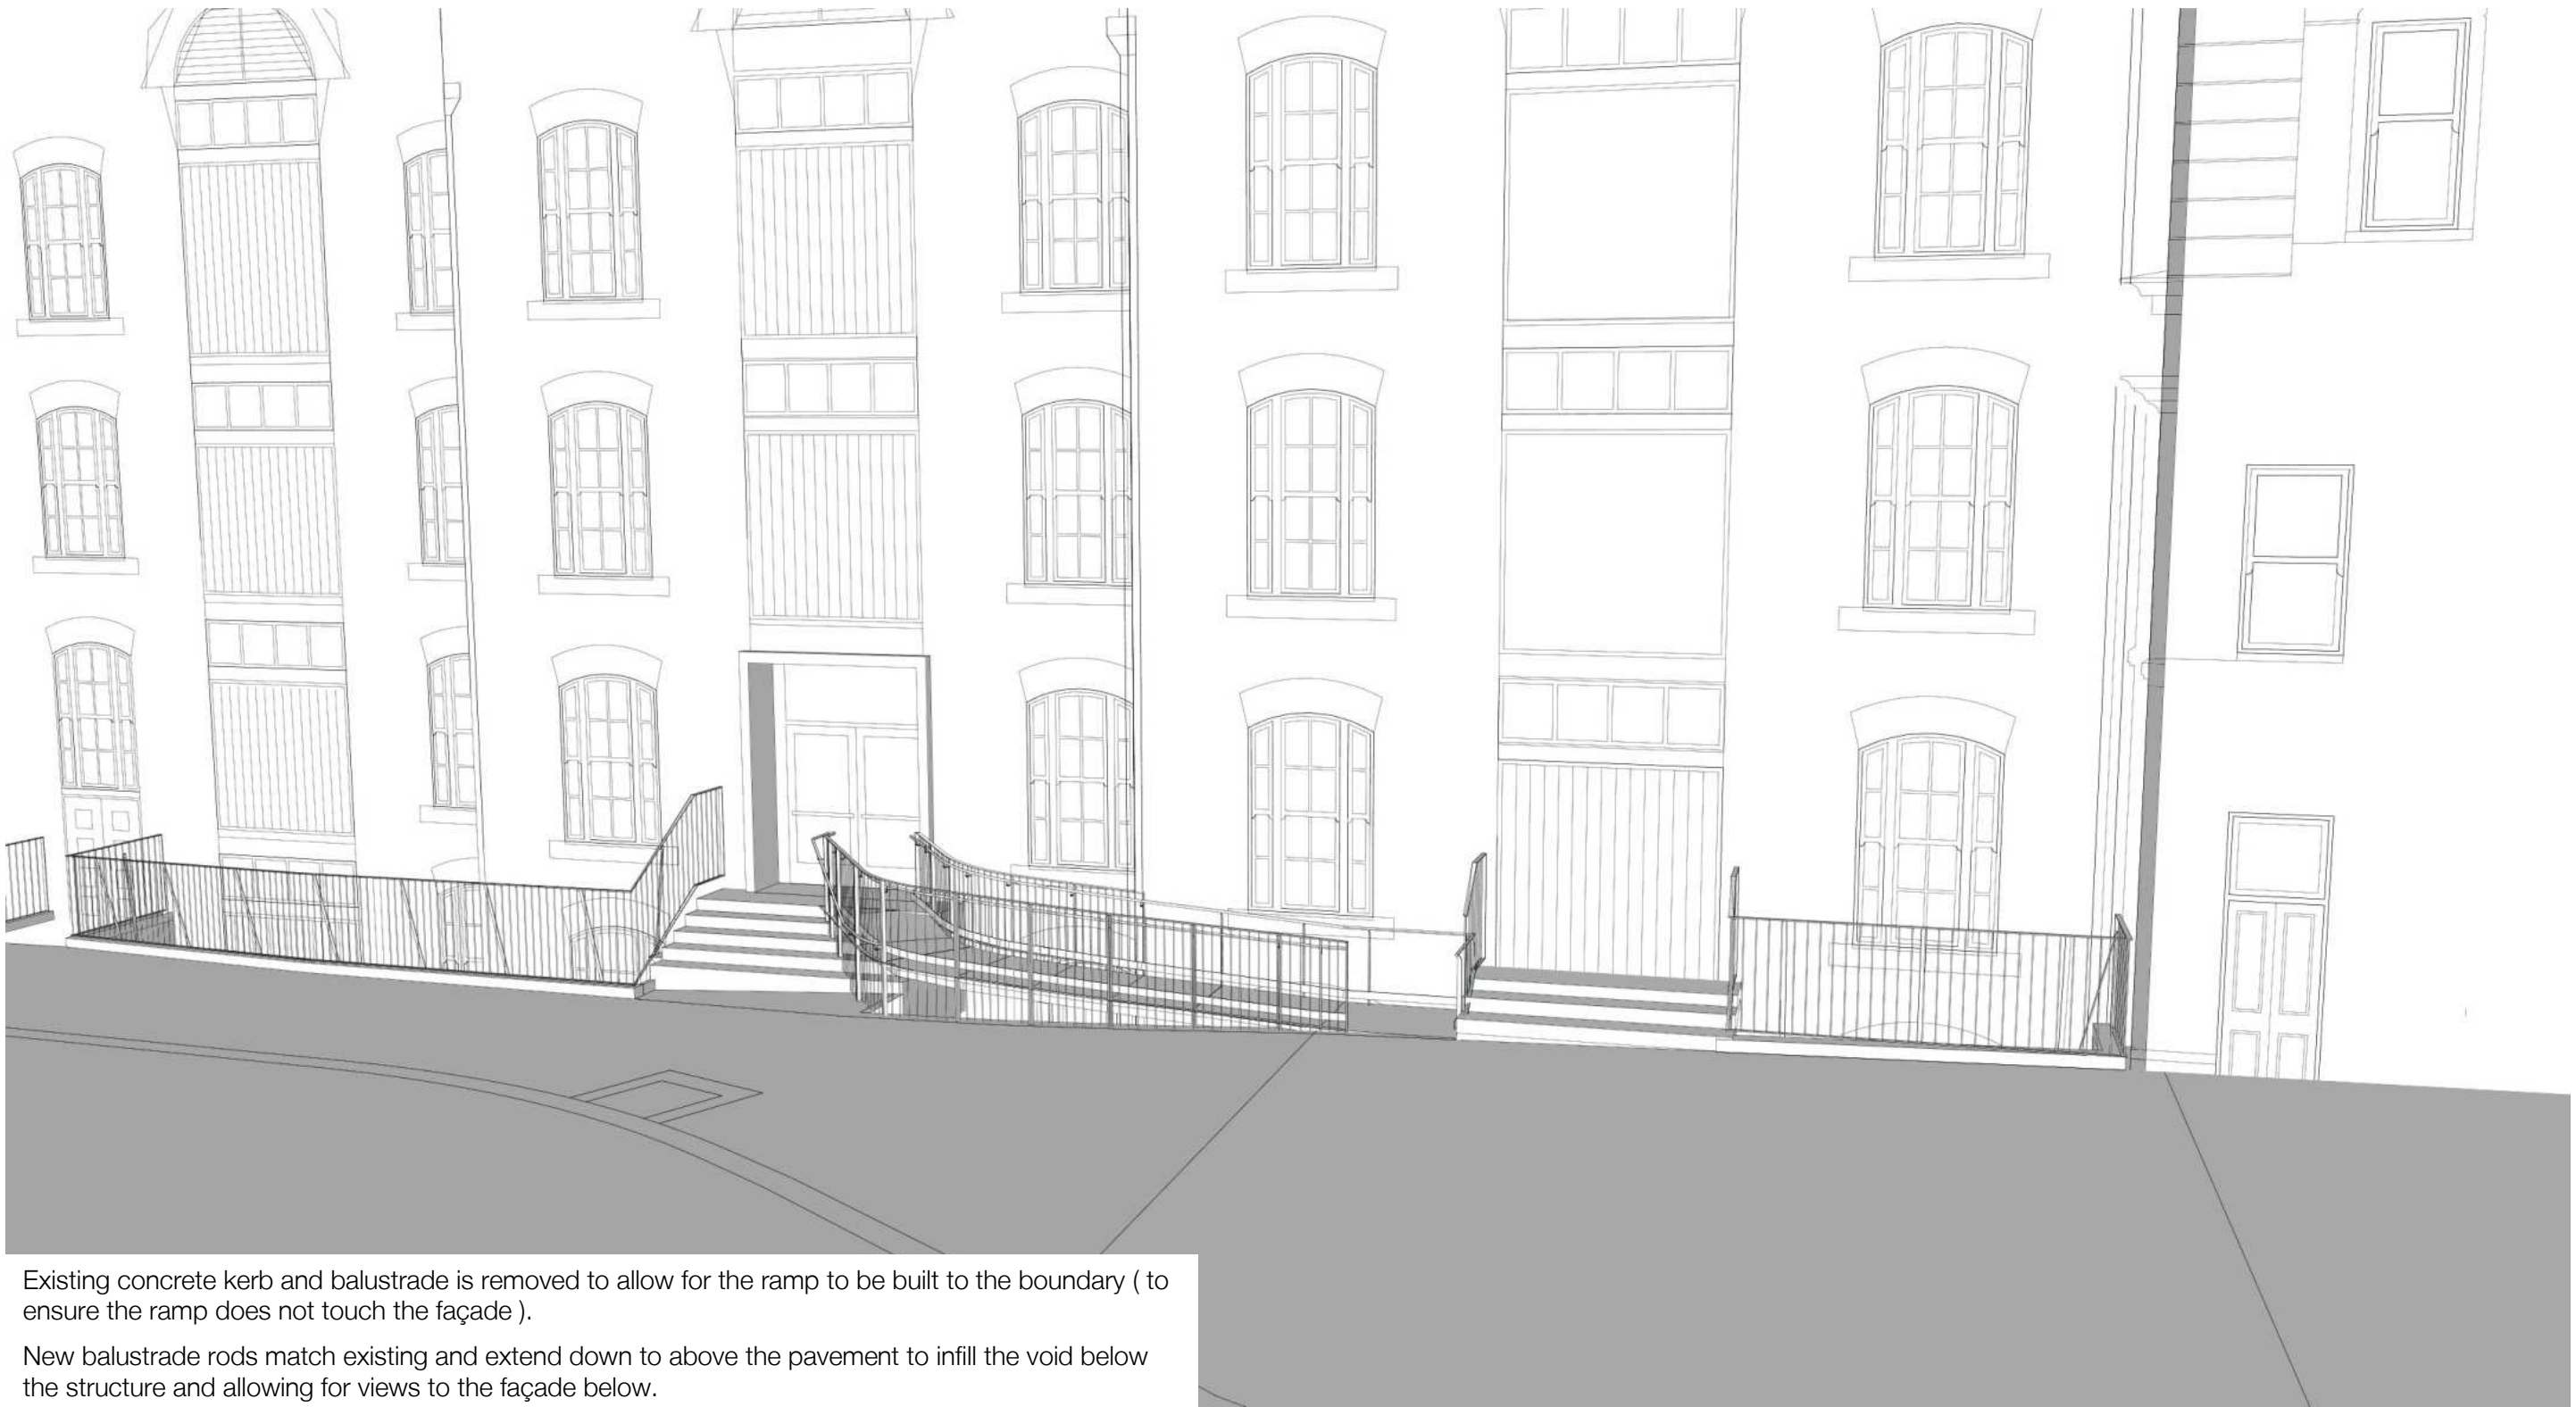
A. PROPOSED RAMP – AS DETAILED AND DOCUMENTED – VIEW 1

Existing concrete kerb and balustrade is removed to allow for the ramp to be built to the boundary ( to ensure the ramp does not touch the façade ).

New balustrade rods match existing and extend down to above the pavement to infill the void below the structure and allowing for views to the façade below.

Posts incorporate LED strip lighting to illuminate the ramp avoiding façade lighting.

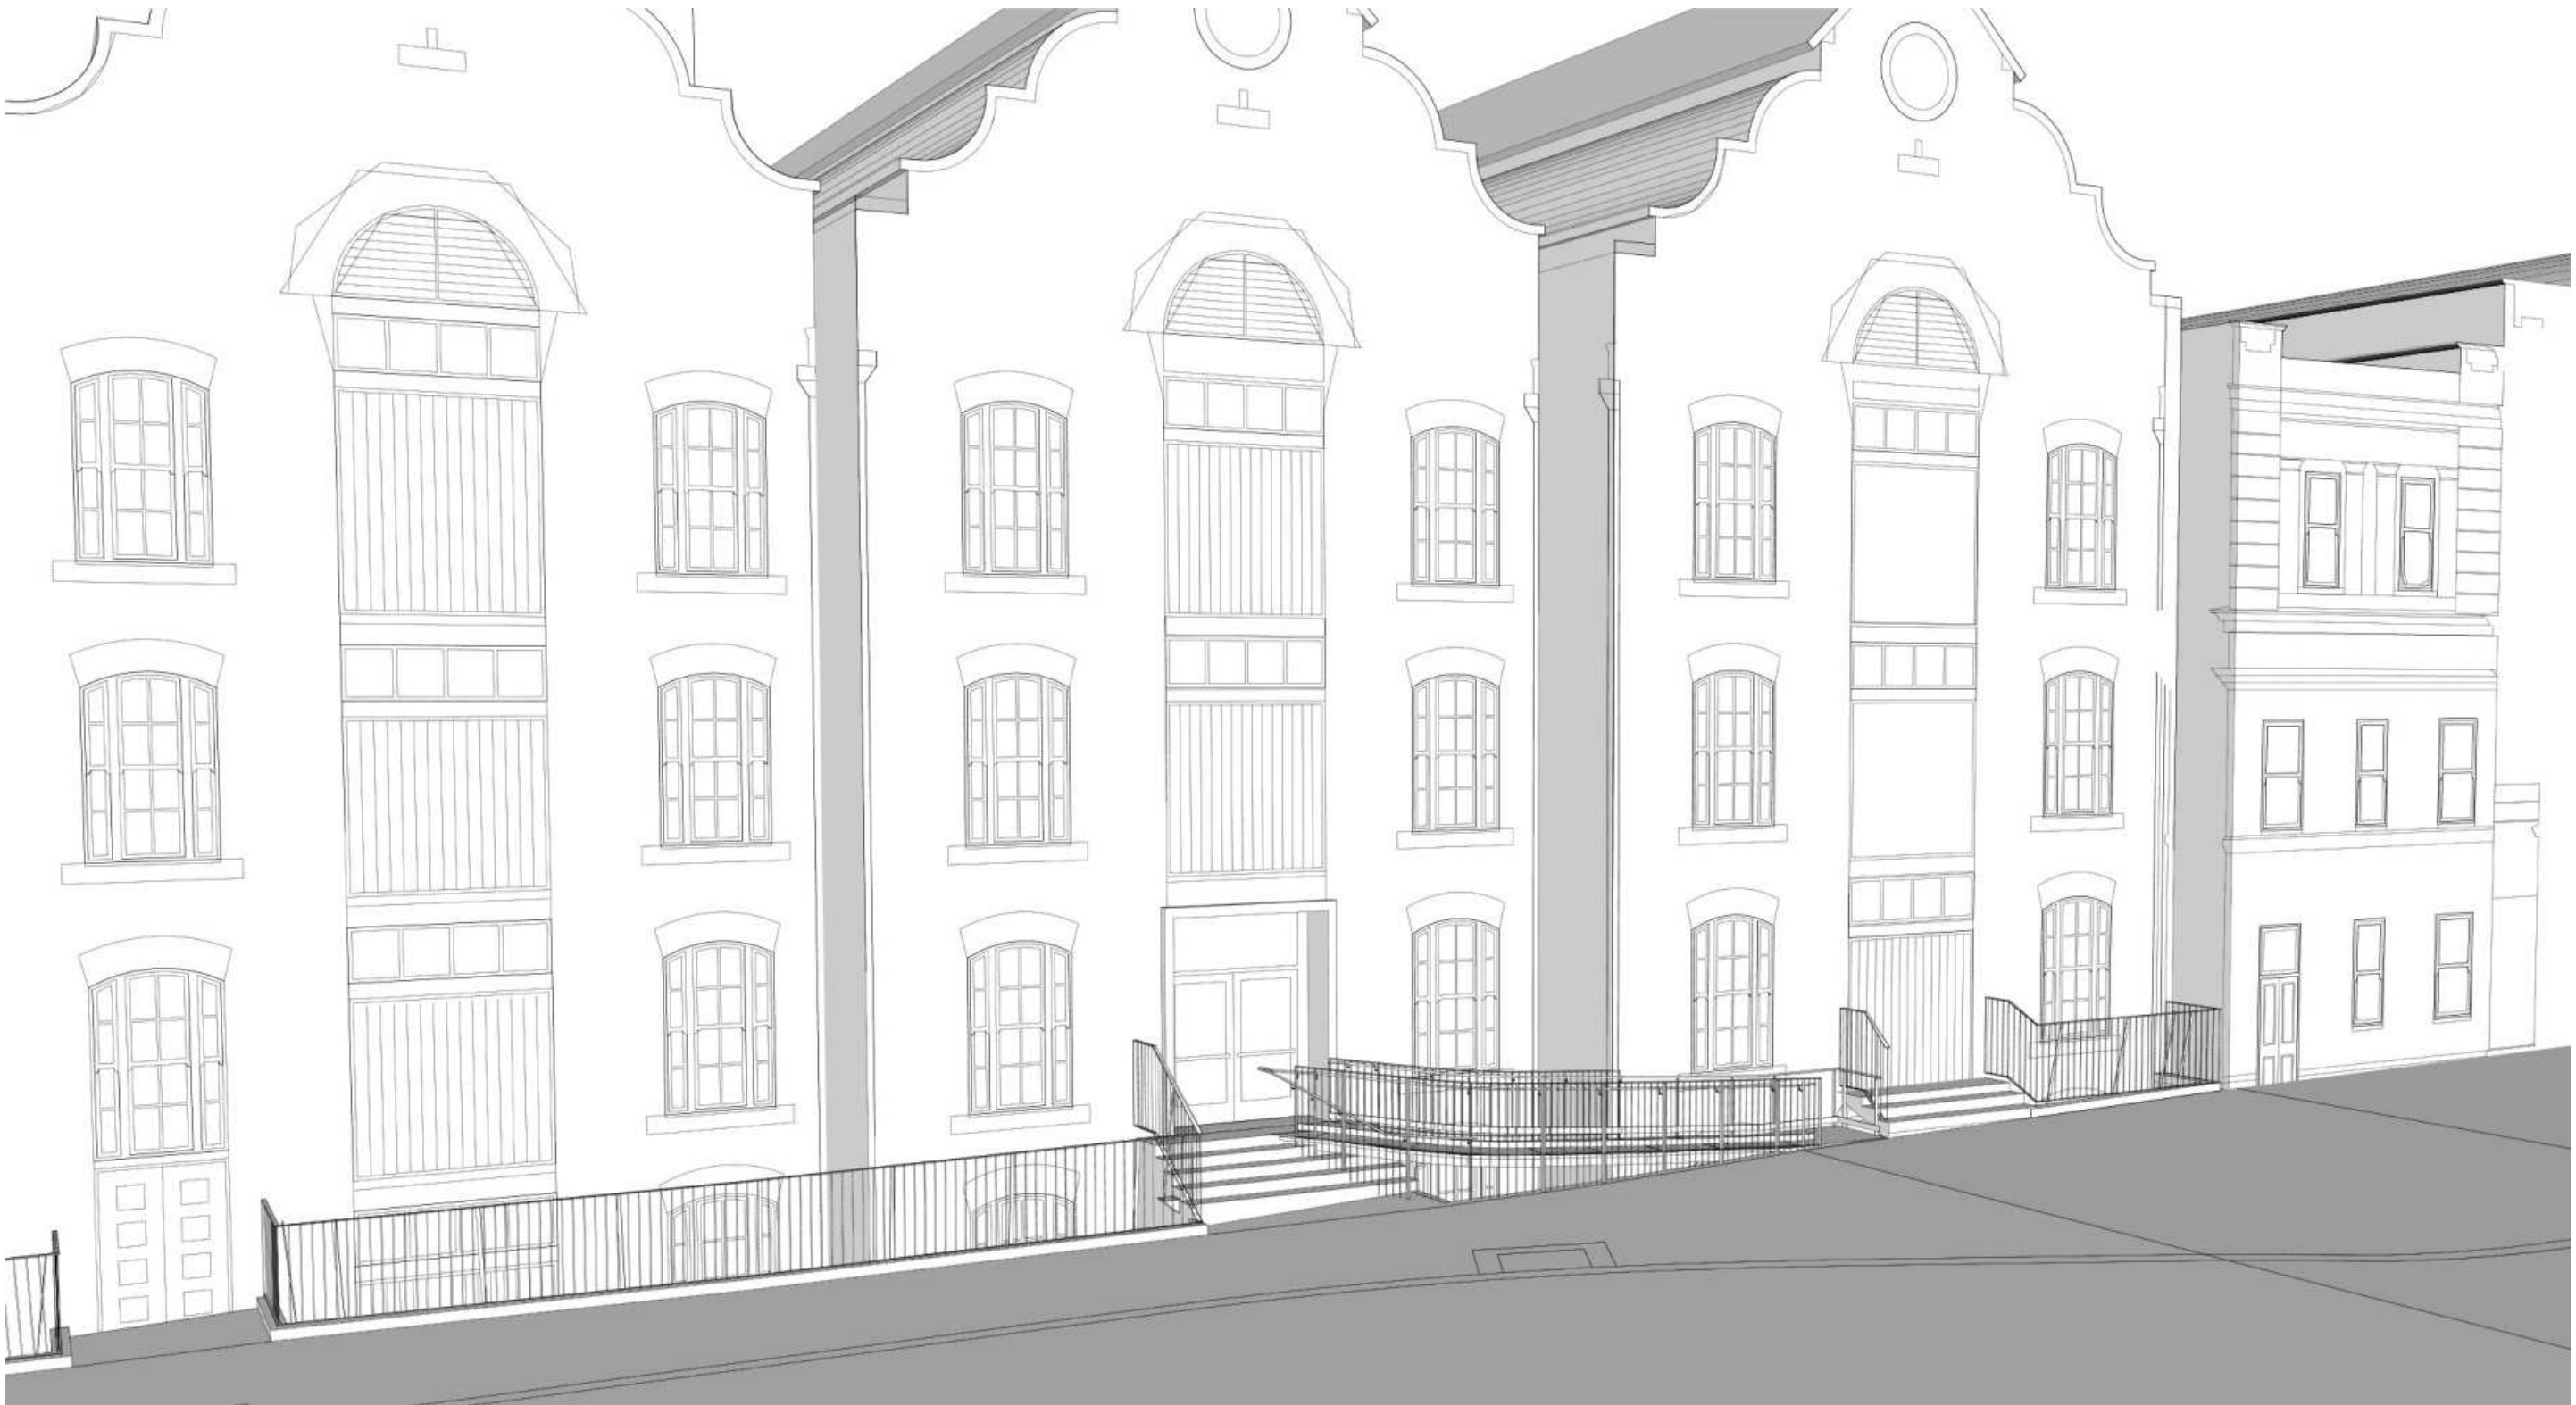
A. PROPOSED RAMP – AS DETAILED AND DOCUMENTED – VIEW 2

View from the street demonstrating the retention of the existing steps into Bay 4 and views to the façade below the ramp.

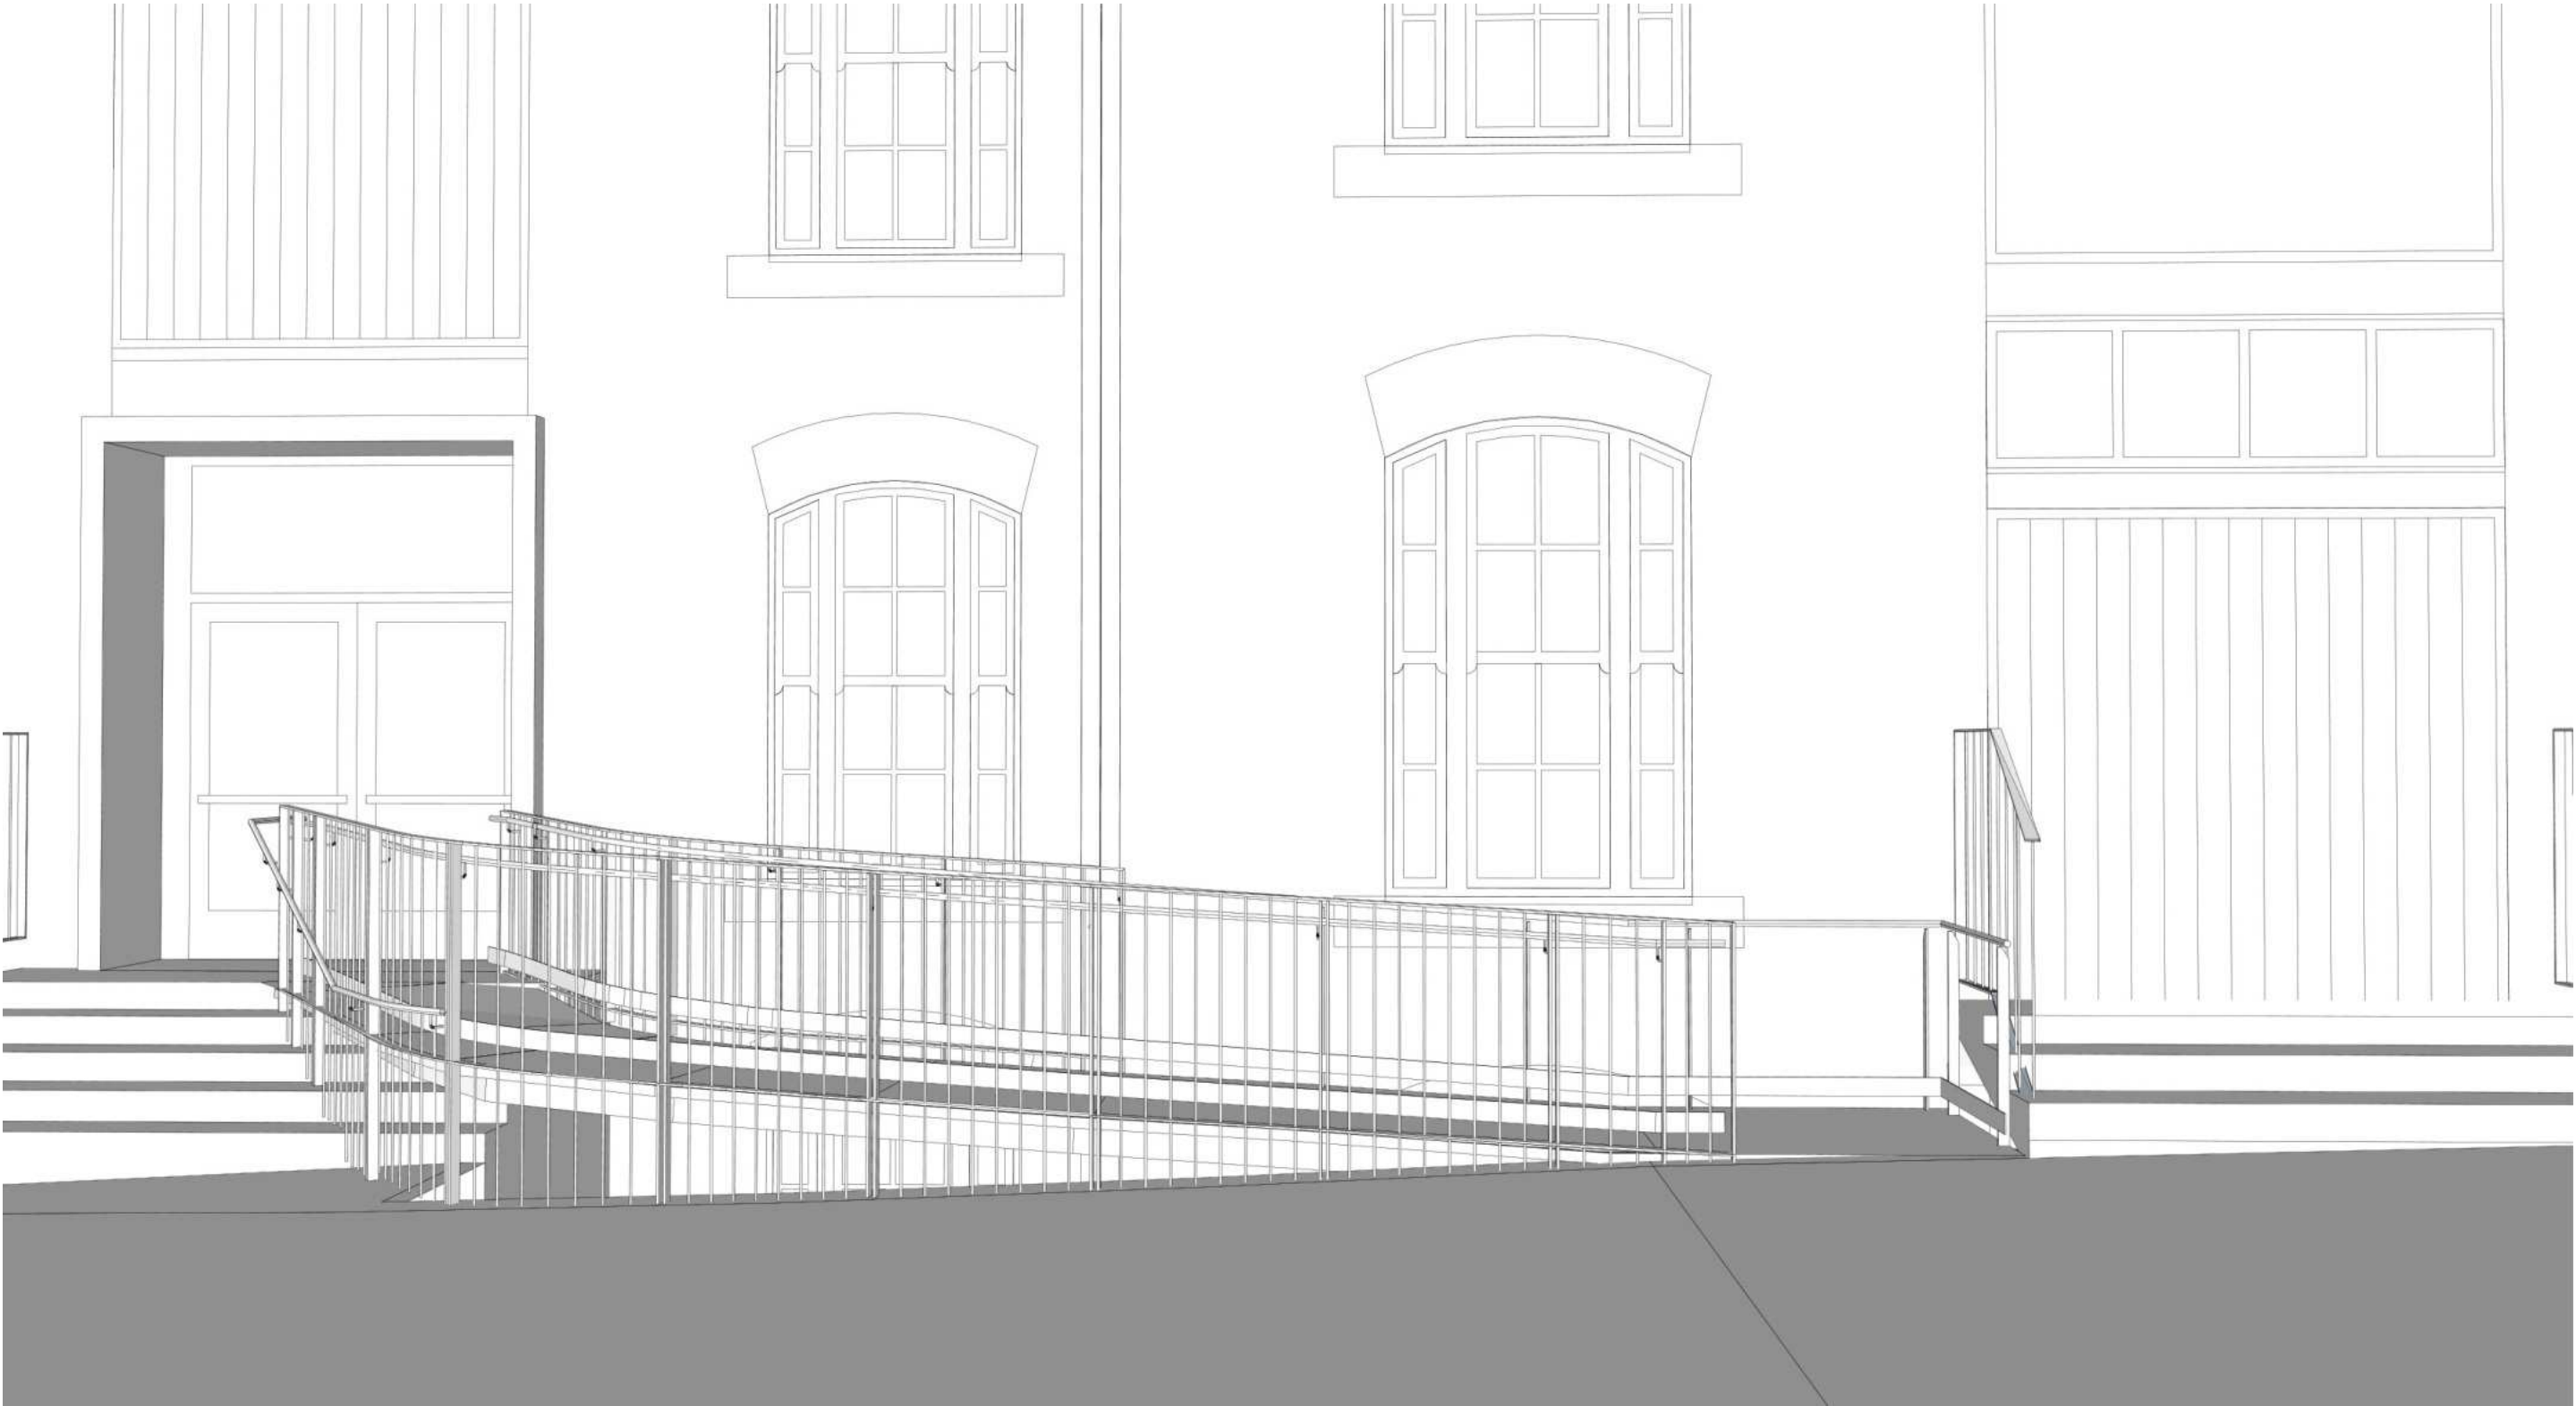
A. PROPOSED RAMP – AS DETAILED AND DOCUMENTED – VIEW 3

Closer view of the proposed new ramp

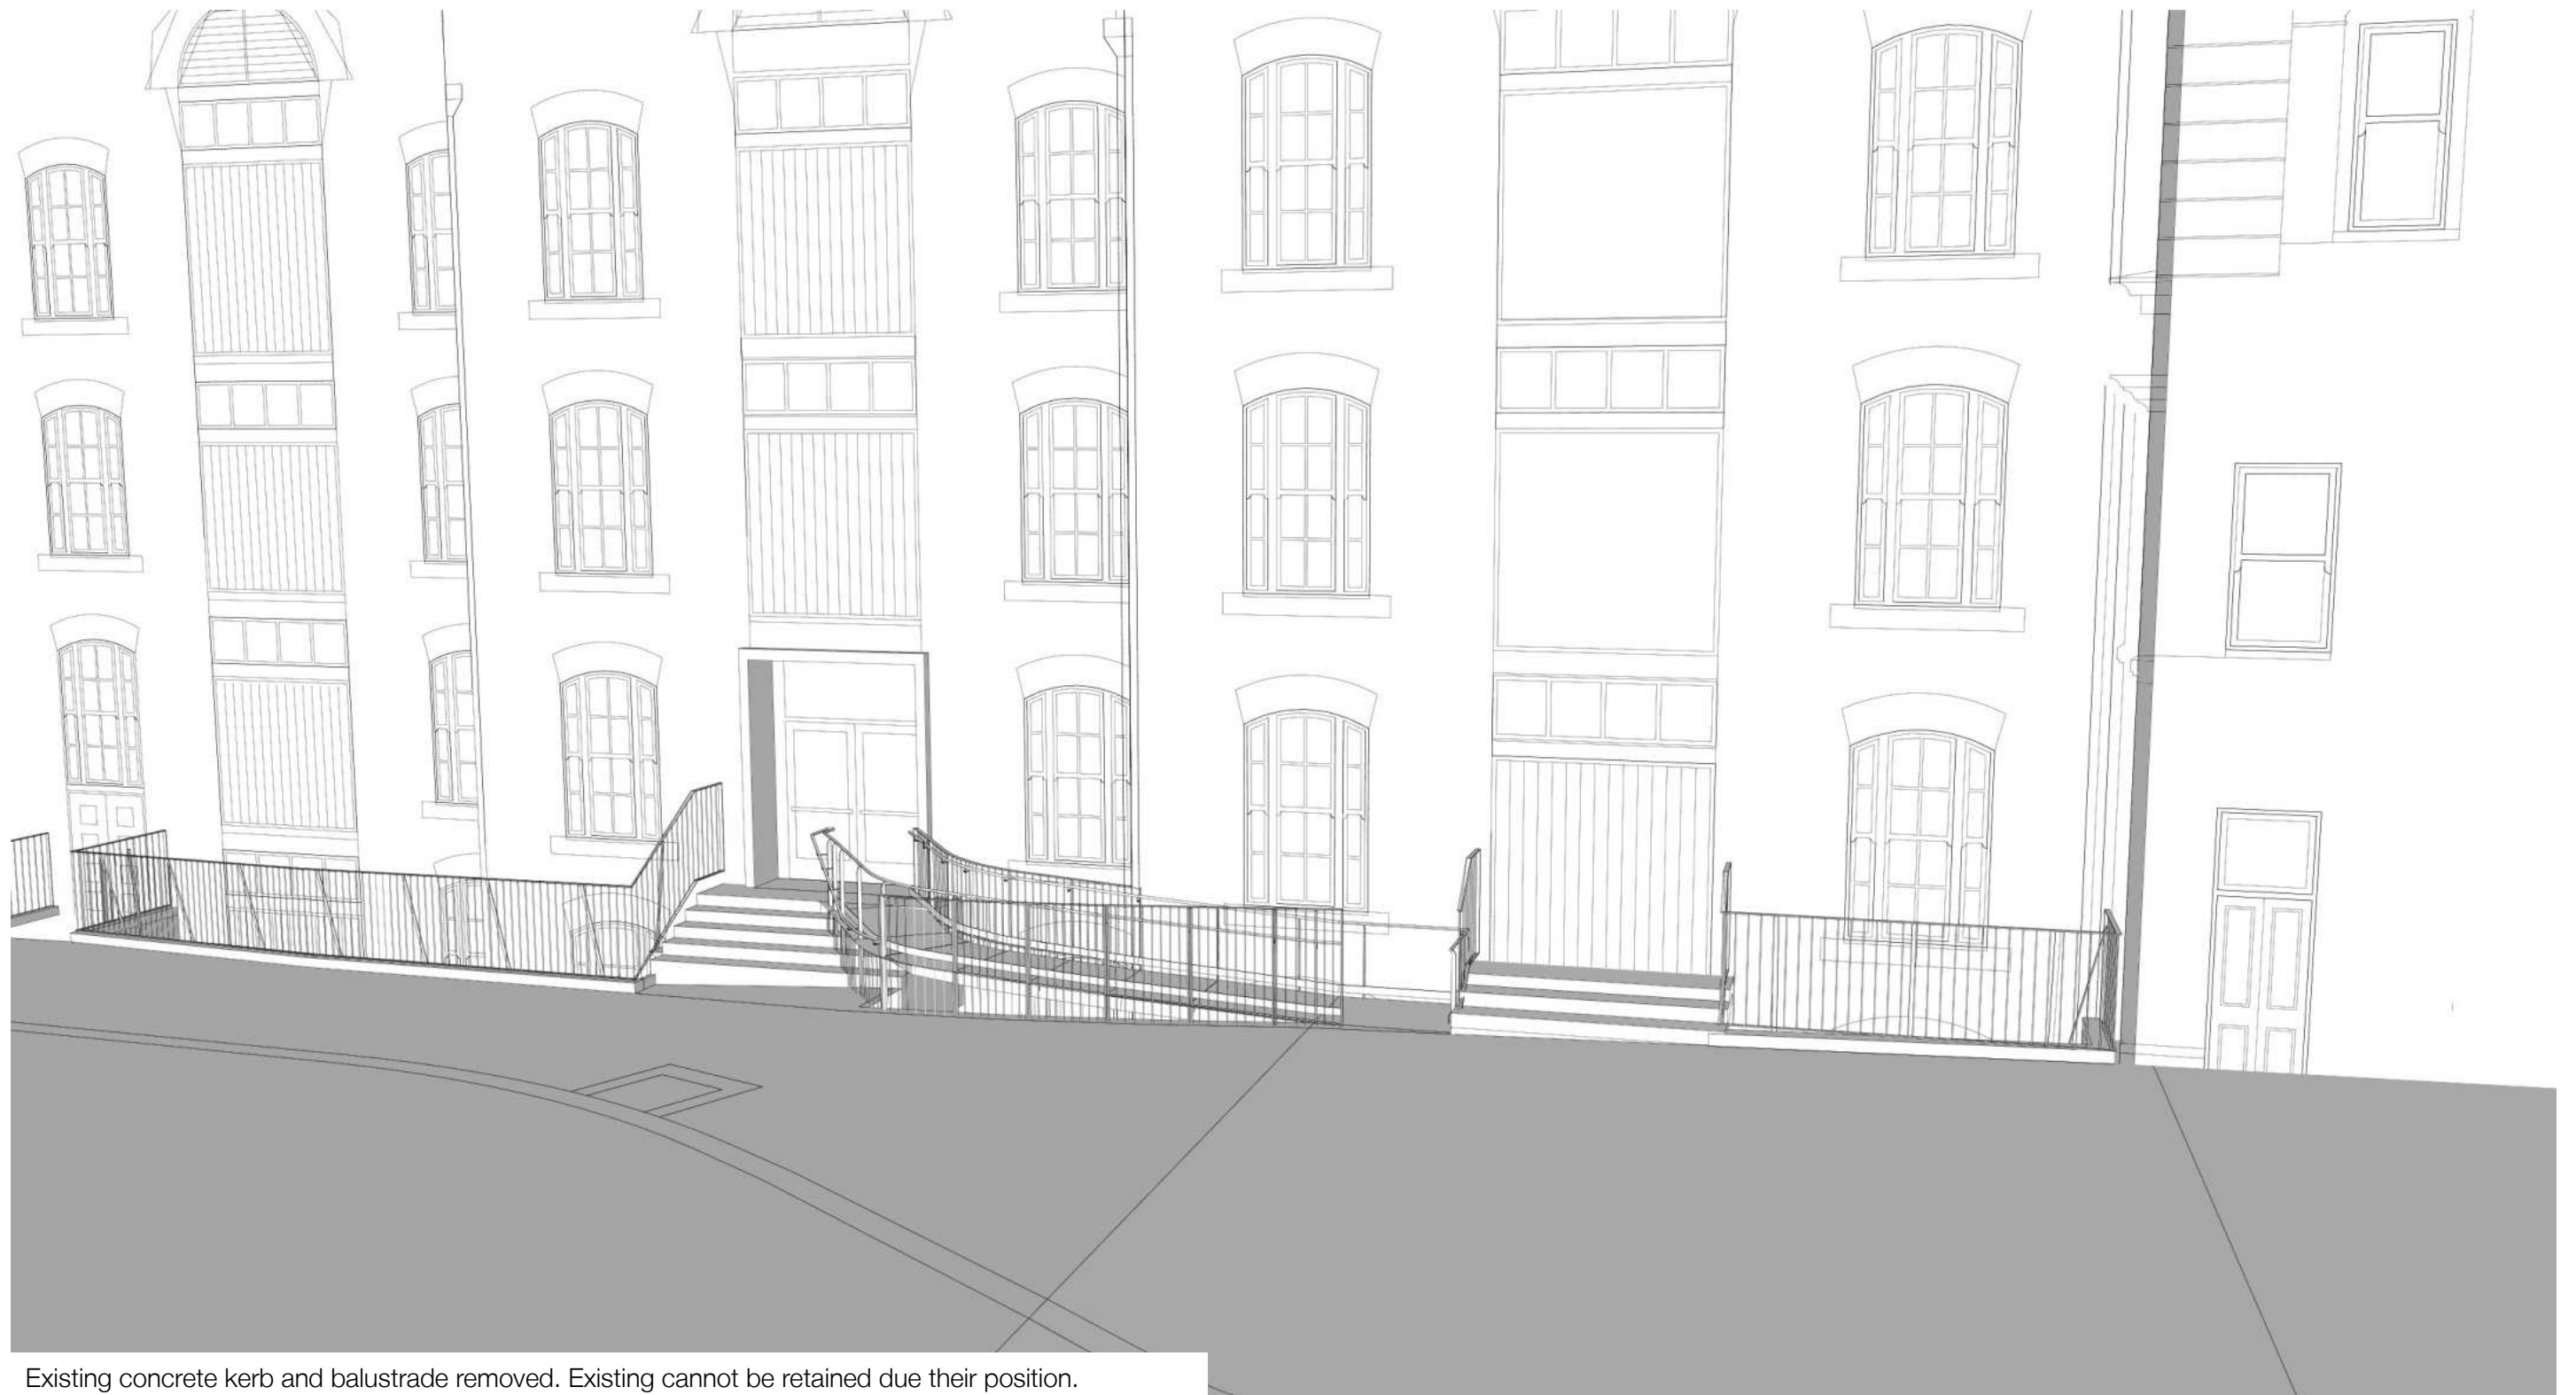
B. RESPONSE TO SHFA HERITAGE – NEW BALUSTRADE IN ALIGNMENT WITH EXISTING – VIEW 1

Existing concrete kerb and balustrade removed. Existing cannot be retained due their position.  
New balustrade to the rake of the existing on a new alignment and incorporating lighting for ramp  
Option B1 - Vertical rods below ramp floor extend to above the step treads to infill the open void

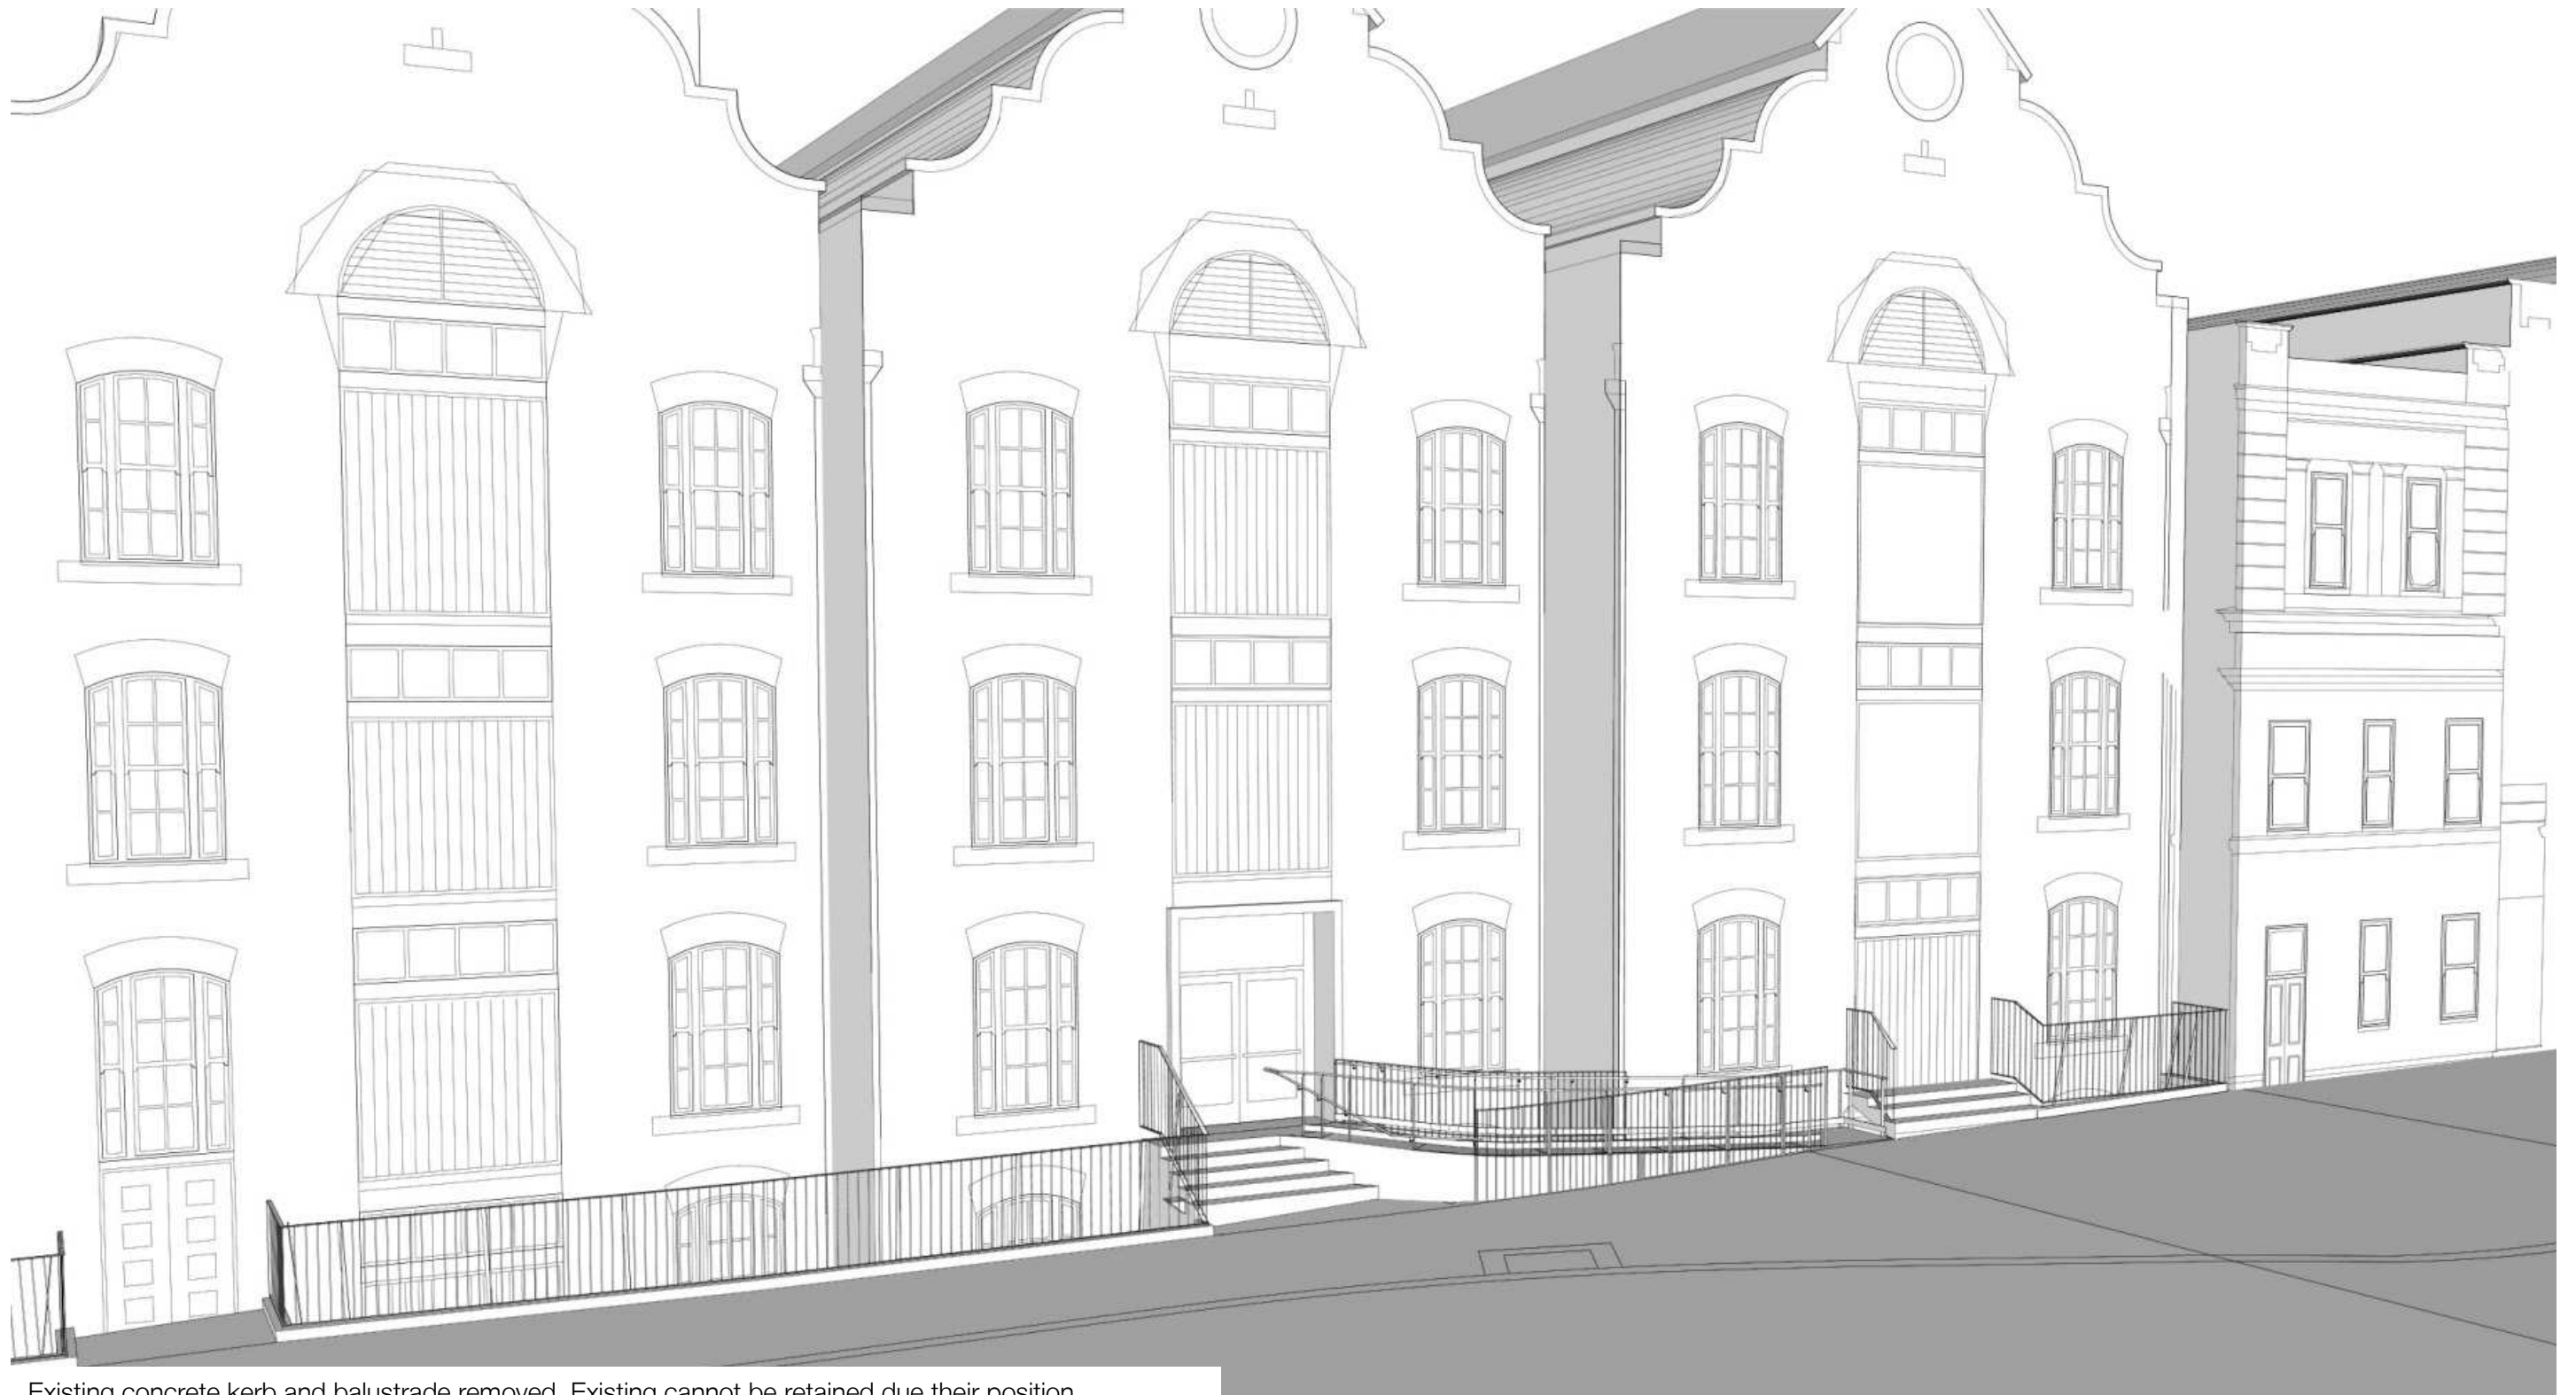
B. RESPONSE TO SHFA HERITAGE – NEW BALUSTRADE IN ALIGNMENT WITH EXISTING – VIEW 2

Existing concrete kerb and balustrade removed. Existing cannot be retained due their position.

New balustrade to the rake of the existing in a new alignment and incorporating lighting for ramp.

Option B2 – Solid infill below ramp to above the step treads and pavement to infill the open void.
