### Review of the Proposed Balustrades for the new Access Ramp into Bay 4

**TKD**Architects  
Tanner Kibble Denton

**ASN BUILDING BAY 4-5**

**140851**

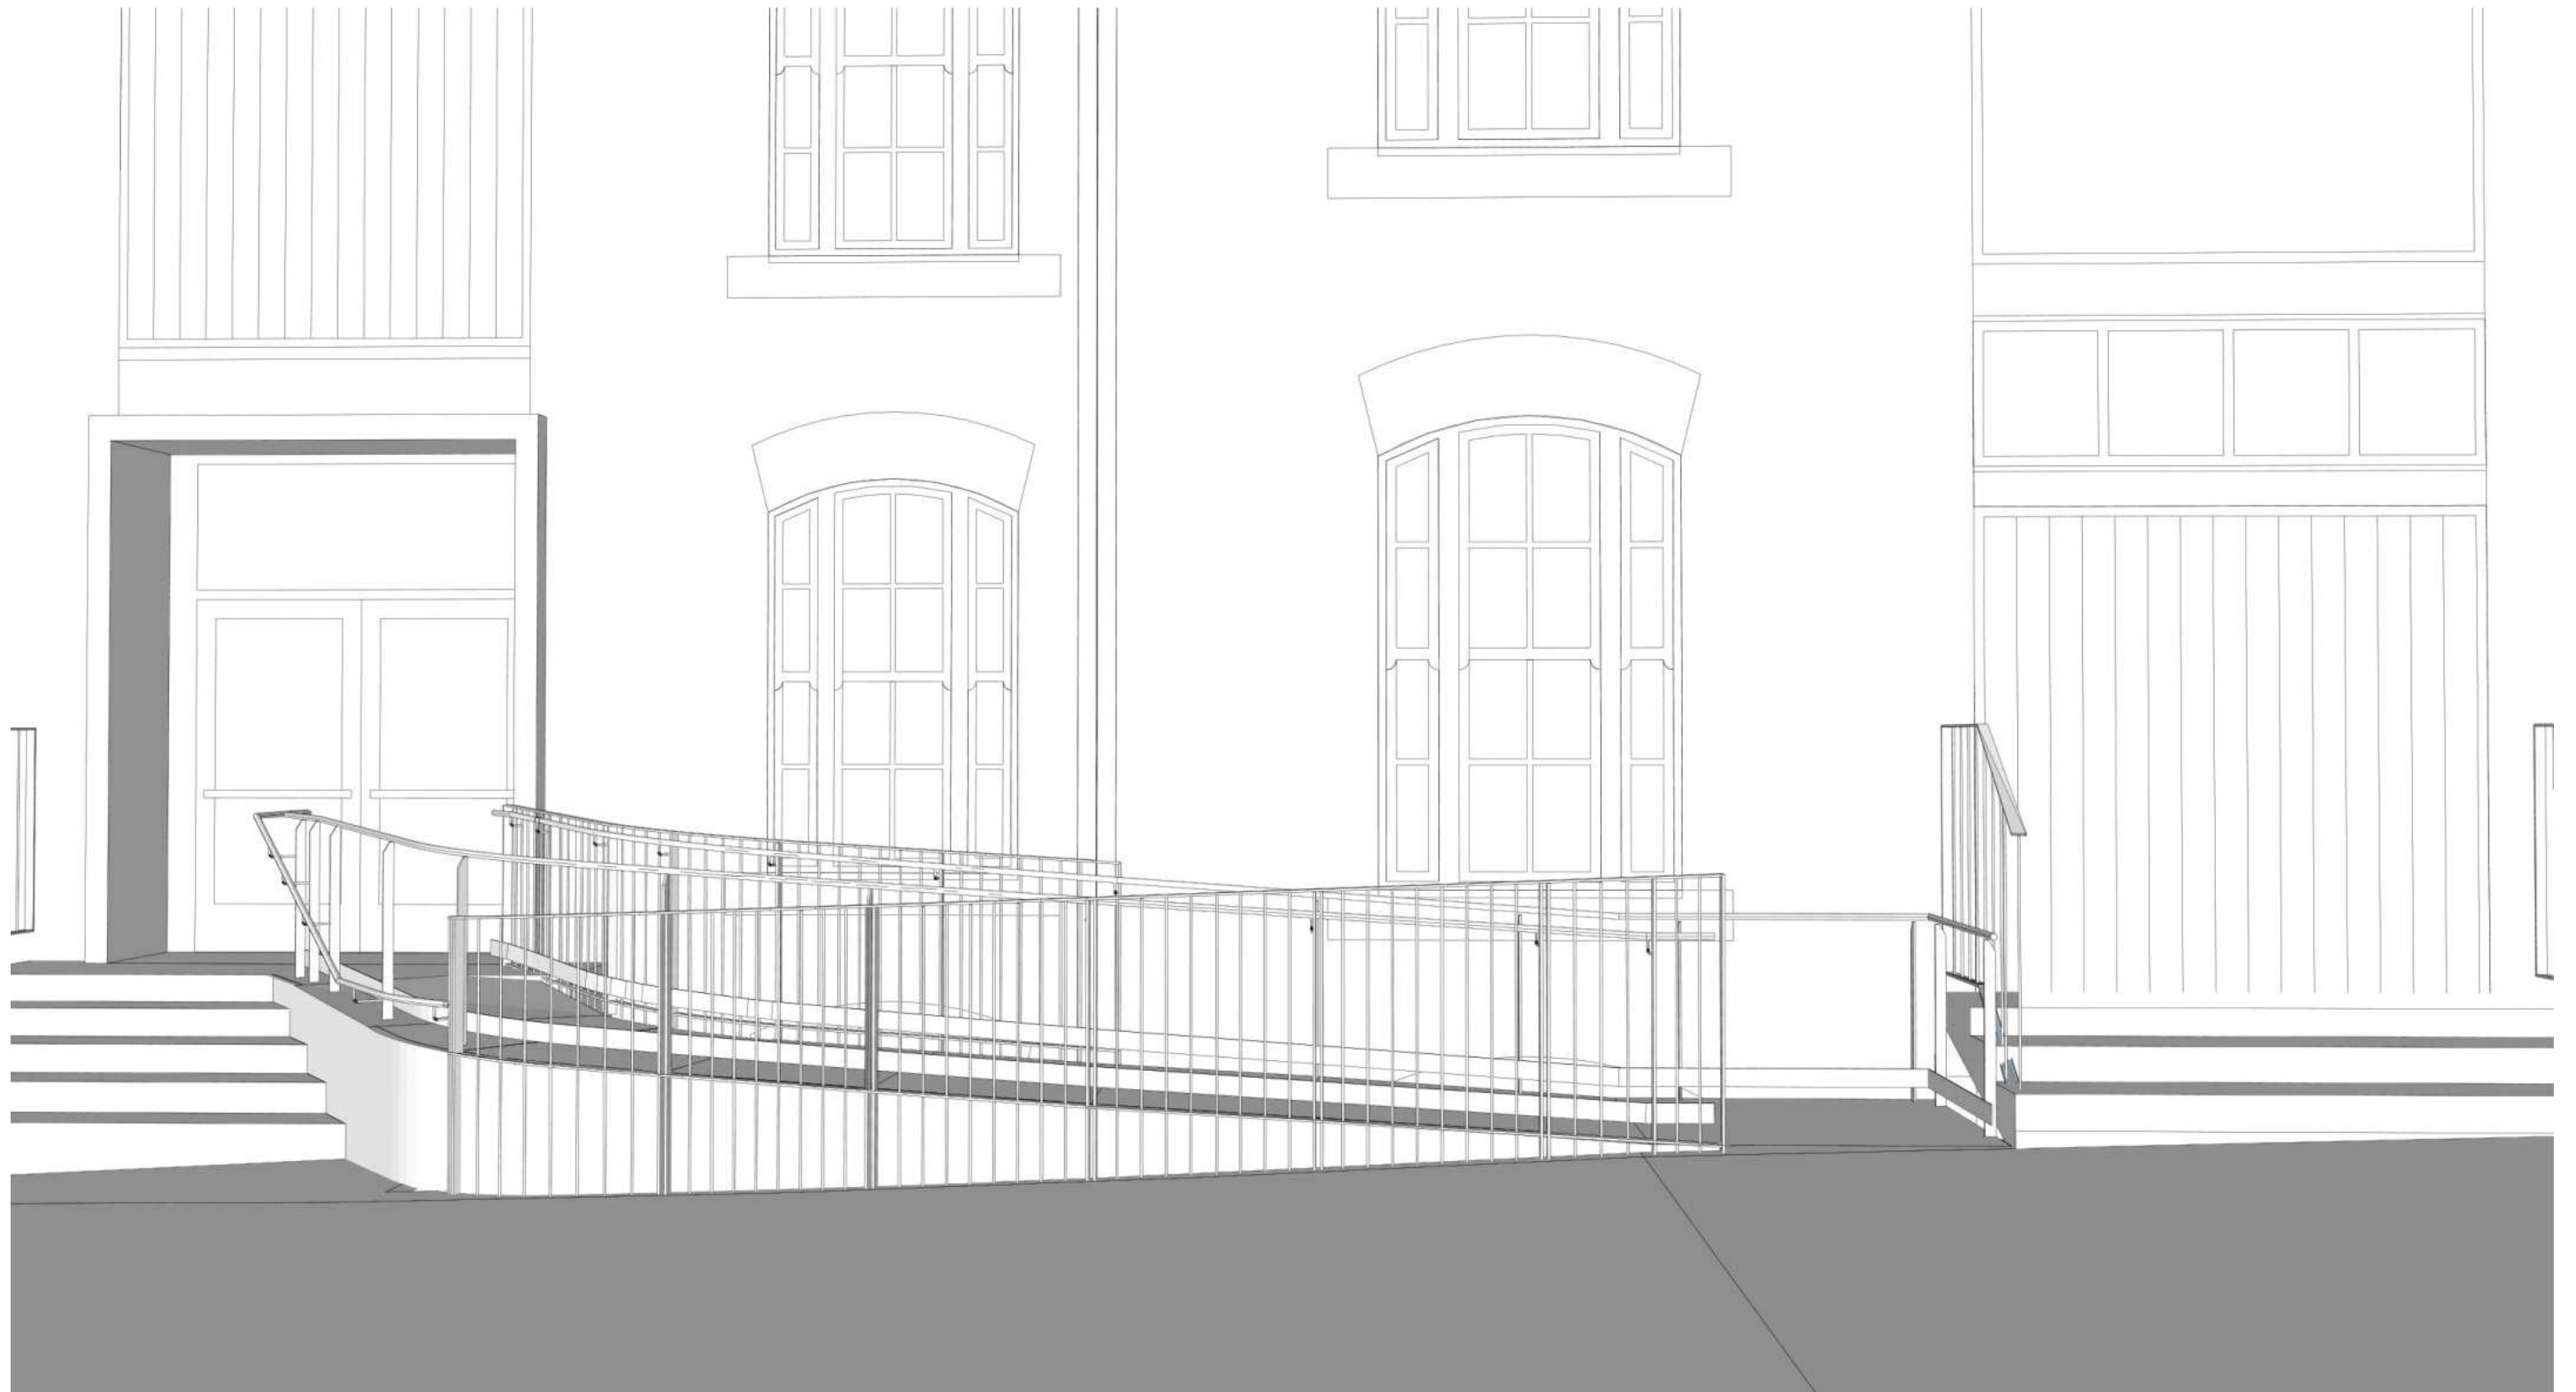
B. RESPONSE TO SHFA HERITAGE – NEW BALUSTRADE IN ALIGNMENT WITH EXISTING – VIEW 3

Option B2 – Closer View. Views of the façade are obscured by the ramp in this proposal.

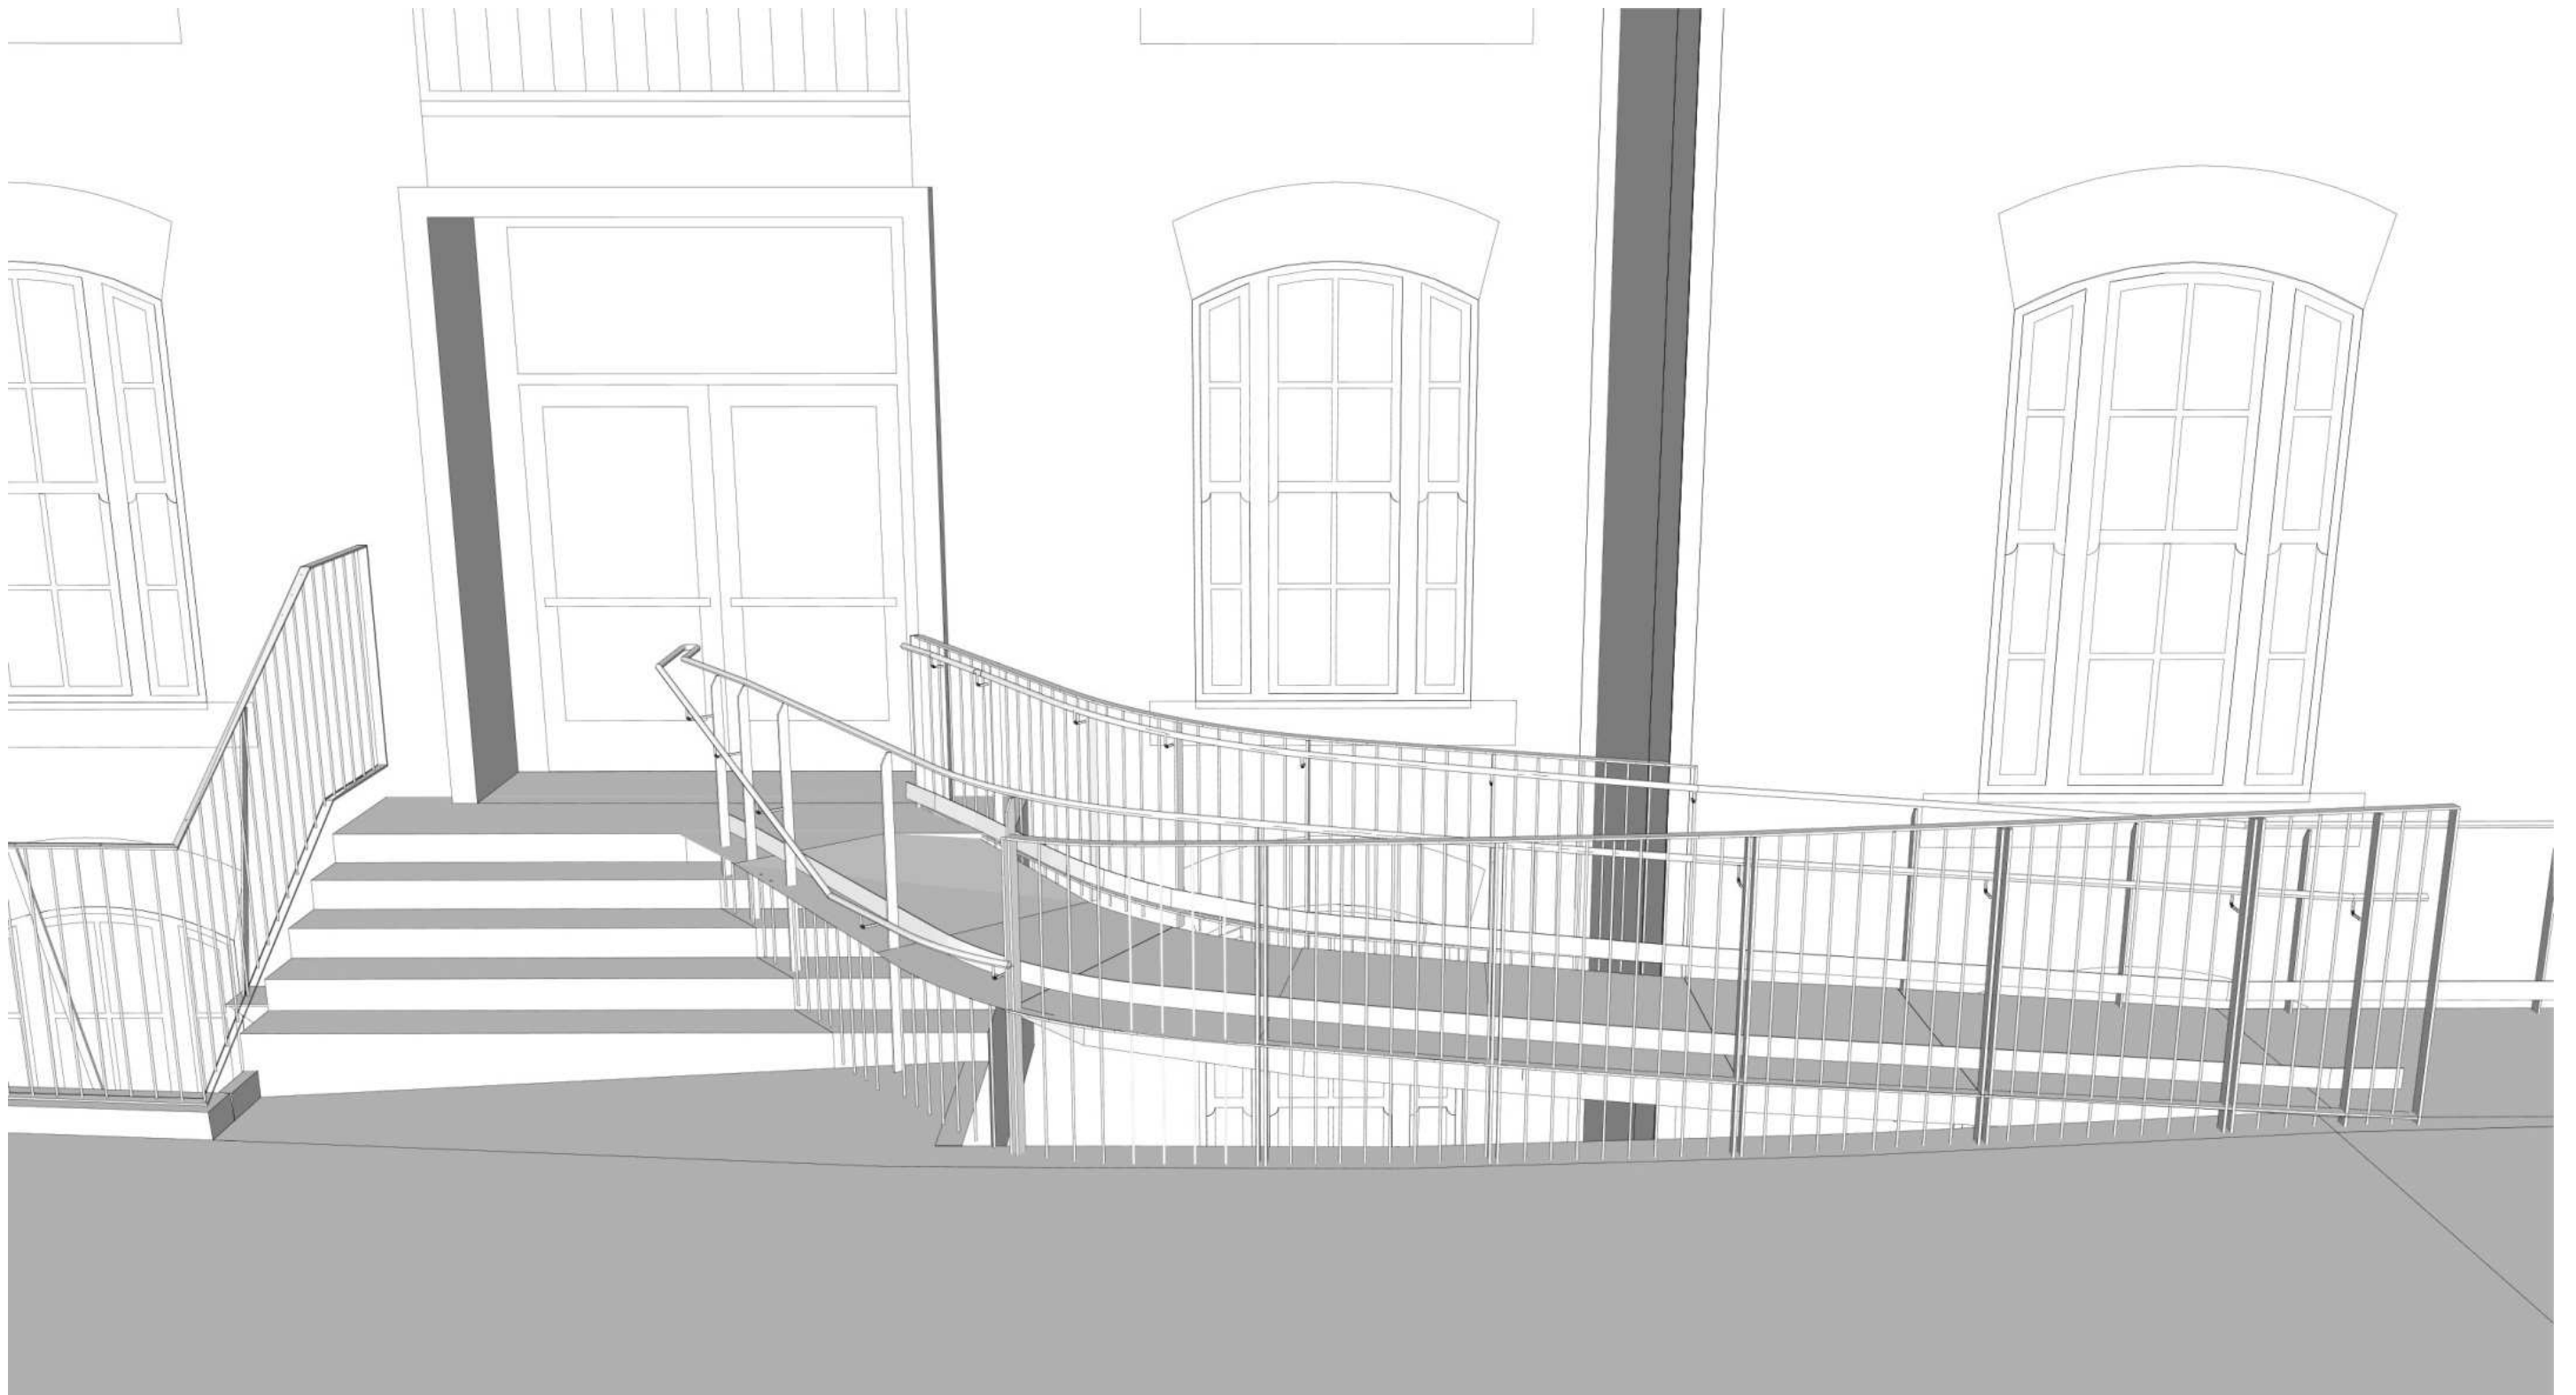
C. RESPONSE TO SHFA HERITAGE – NEW BALUSTRADE IN ALIGNMENT WITH EXISITNG (alternate) – VIEW 1

Option B1 – Closer View. Views of the façade below the ramp are visible in this proposal.
