Former ASN Co. Building  
1-5 Hickson Road, The Rocks  
Conservation Management Plan

2009

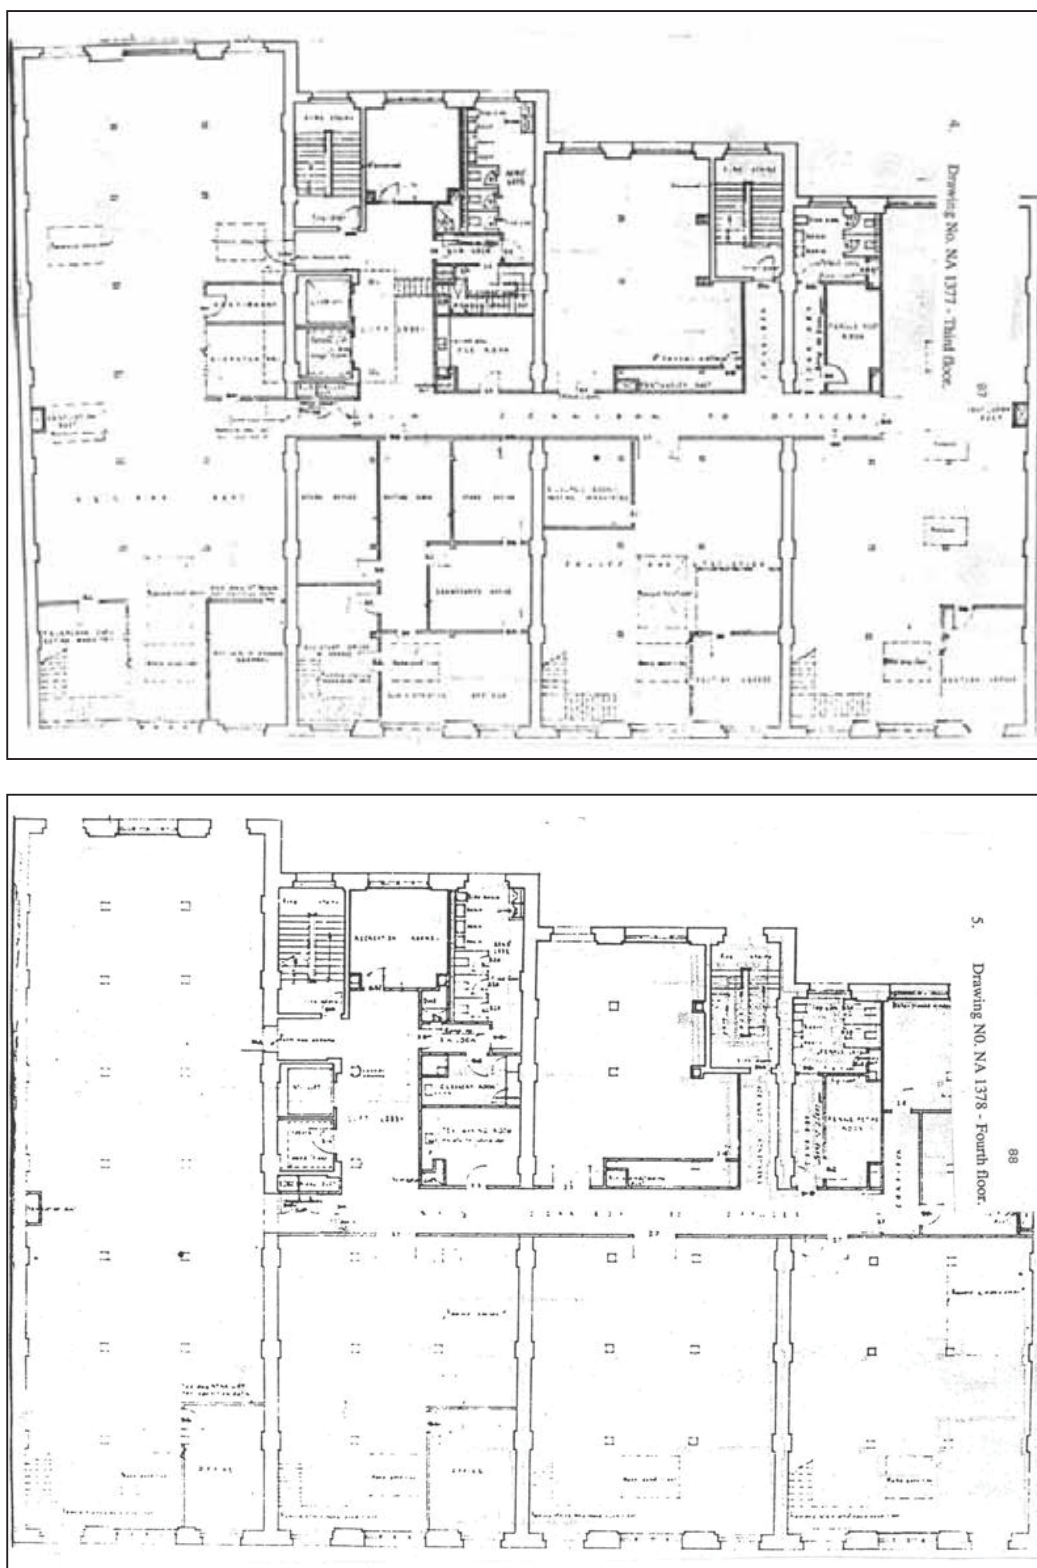
**Figure 22:** Reproduction of 1949 plans of conversion from warehouse to offices. Second & Third Floors, Drawing Nos. NA 1377 & 1378  
(Source: E.Martin & Associates, 1981)

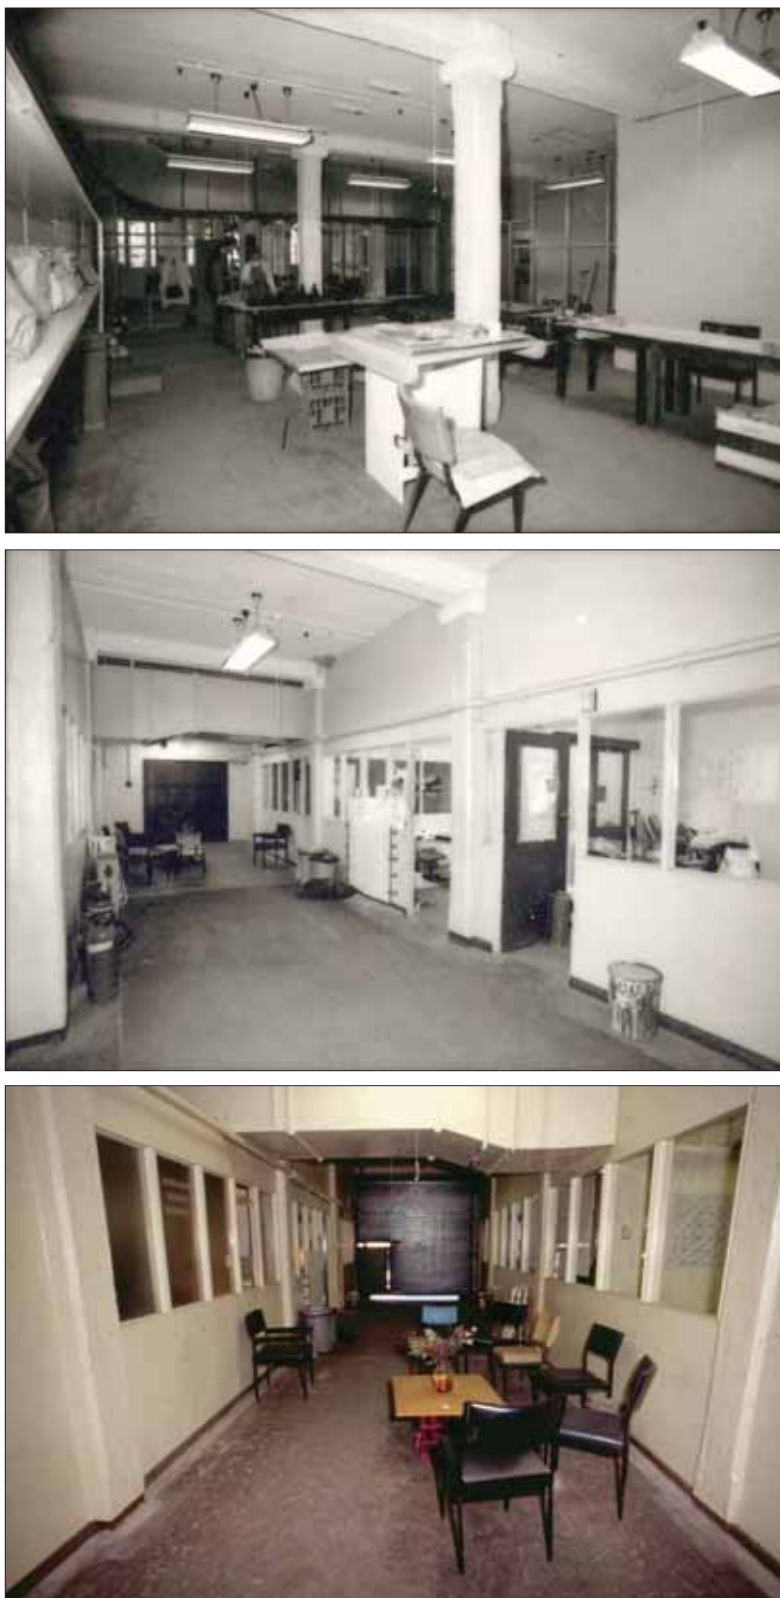
**Figure 29:** Ground floor partition layout of the ASN Co. Building taken during artefact sorting from Lilyvale excavation in 1989.  
(Source: Sydney Harbour Foreshore Authority, 193435\_LE24; 193461\_LE\_36 & 192334\_LVLE\_158 respectively)

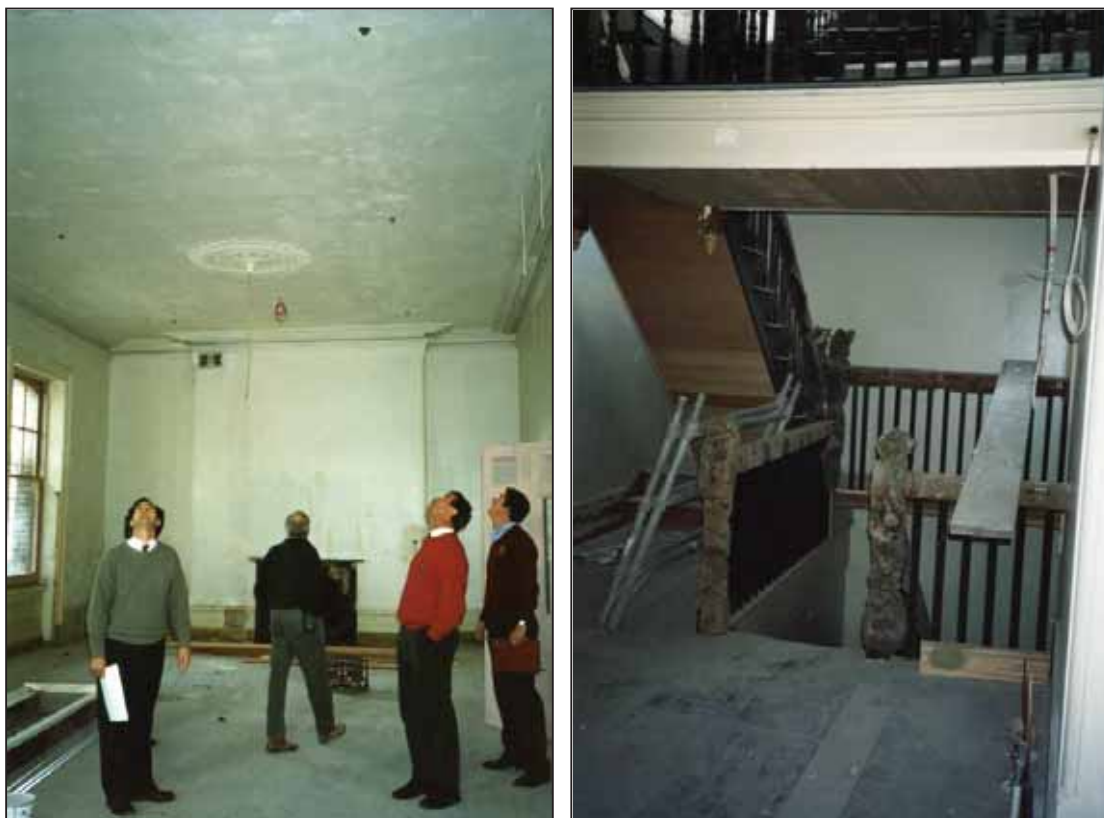
**Figure 31:** 1990s Photographs of the ASN Co. Building showing the refurbishment and conservation works  
(Source: Sydney Harbour Foreshore Authority, 170834, 170826 & 170828)

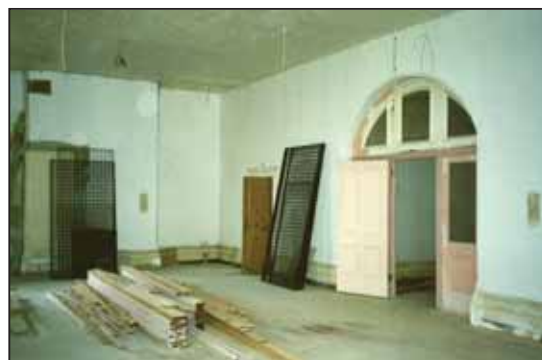
Air-conditioning of the warehouse bays 2-4 was completed in 2003. The works did not cover the areas (Bay 5 and part of Bay 4), which had been altered for *The Story of Sydney* in the early 1990s.

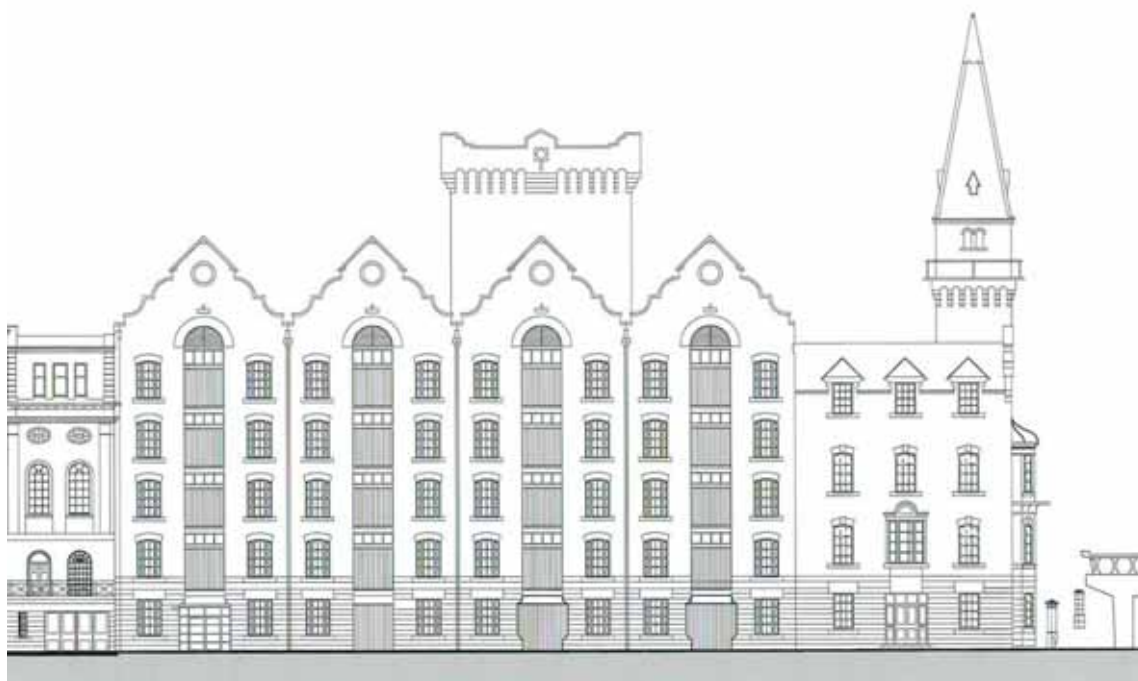
**Figure 35:** East (Circular Quay) elevation of the ASN Co. Building as shown in the measured drawings dated 26/02/04. (Source: Foreshore Authority, ROX-659\_AR-2000-B)

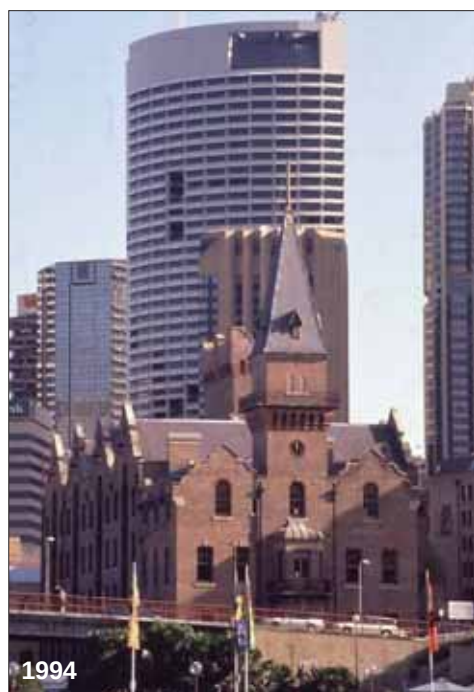
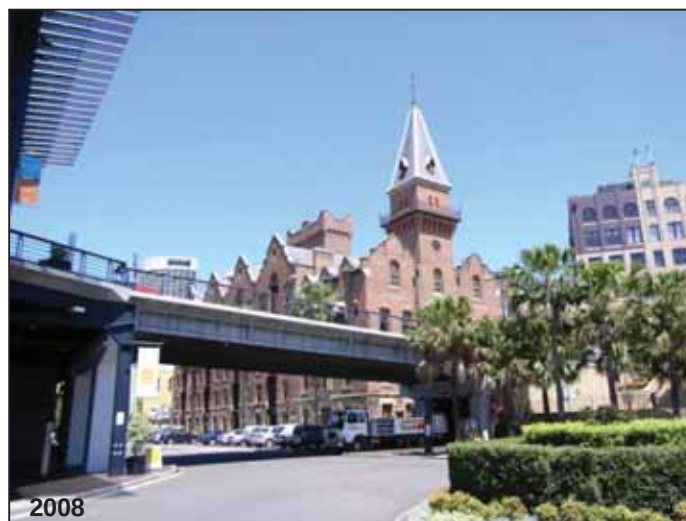
**Figure 42:** Left: 1994 view of the ASN Co. Building northern elevation on Circular Quay West (Source: Foreshore Authority, 193740 AB 9)  
Above: 2008 view of the northern elevation of the ASN Co. Building

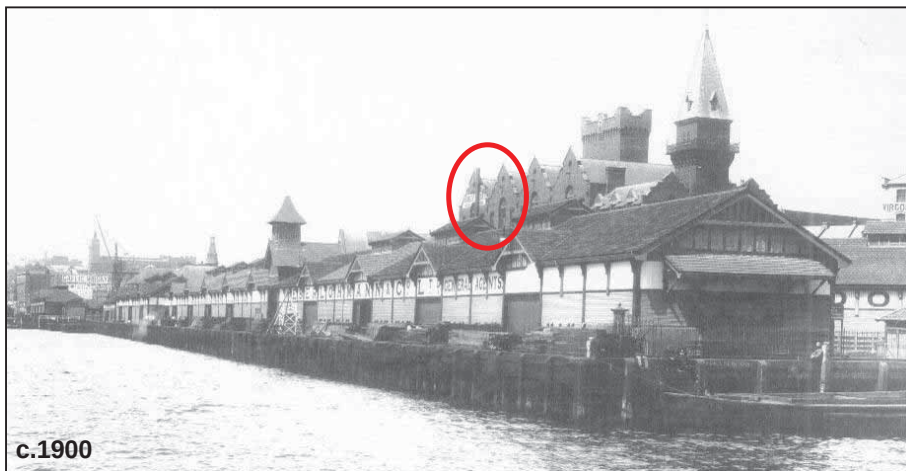
**Figure 67:** Evolution of signage on the building (see also Figure 68).  
(Source: 1976 Photographs Sydney Harbour Foreshore Authority, 38951HIM 28 and 38950; 1900 photo from Mitchell Library Small Picture File – Circular Quay)

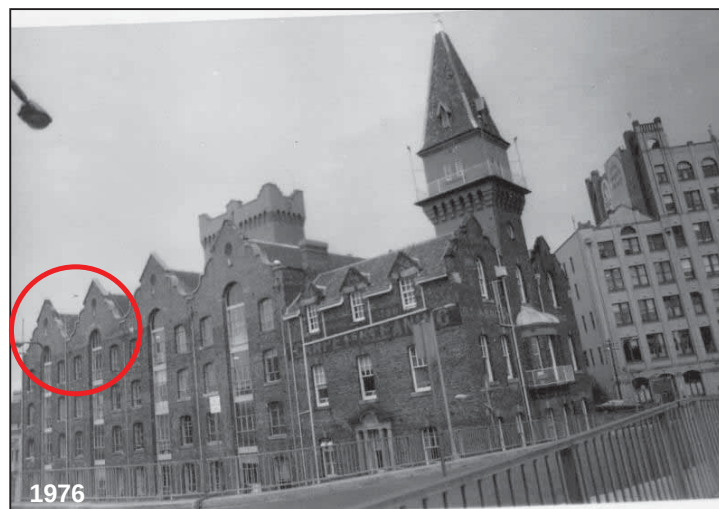
**Figure 68:** These images also show the evolution of signage on the building. Note painting on the towers in 1976, which were removed in the 1990s. (Source: 1976 photograph: Foreshore Authority)

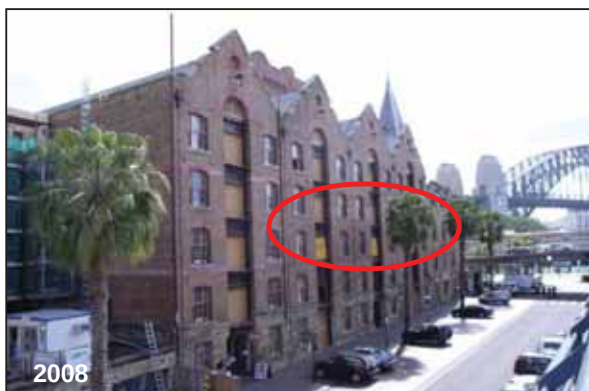
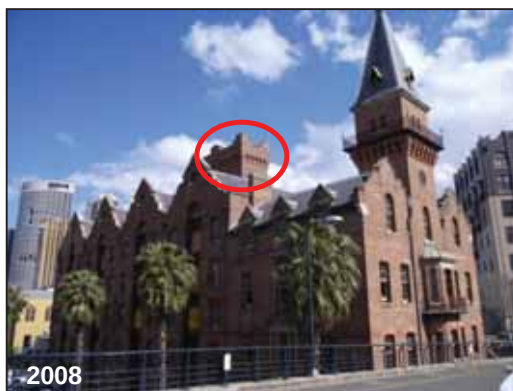
**Figure 70:** The loading bay doors have been restored as part of the 1990s restoration, replacing the glass in most instances. Examples of where glass remains are included in the image to the left. The water tower was painted in 1970. It is clearly absent in the 1890s images. (Source: 1970 image: Foreshore Authority archives 39944\_A742-113 – ASN Building. Remaining historic images: Mitchell Library Small Picture File – Circular Quay.) Below are images of the clearstorey in 2008 and during refurbishment in the 1990s, see also Figure 70 on the next page (Source for 1990s image the Foreshore Authority\_170766.

Externally the large timber windows, loading doorways and swing-down platforms, cat heads and hoist pulleys were reinstated. The balustrades of the clock tower and the balcony, which were replaced at an unknown date with pipe and chain-wire railing, were reconstructed. A new bell was installed in the tower in 1993. The paint was removed from the spire and water tower and other parts of the brick façade and the white ASN Co. lettering to the west, north and east façade were restored. The sprinkler system was updated and the earlier system was retained. The emphasis of the conservation work was to retain and conserve much of the original fabric. Therefore, the original or early above ground industrial archaeological elements identified in the Doring's preliminary study remain. These elements, with the exception of evidence of the Acoustic Laboratory, have been conserved within the building, and they have been observed during the site inspections for the current study.

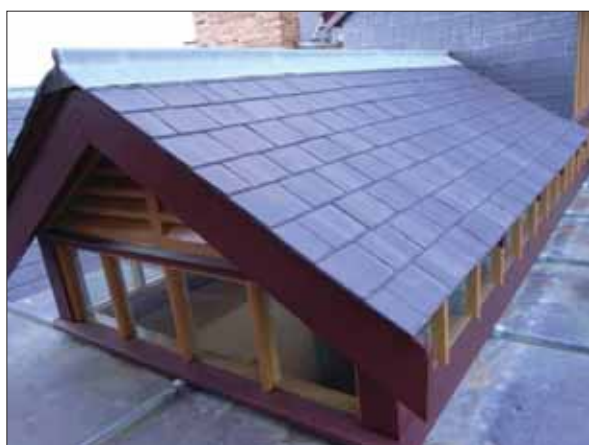
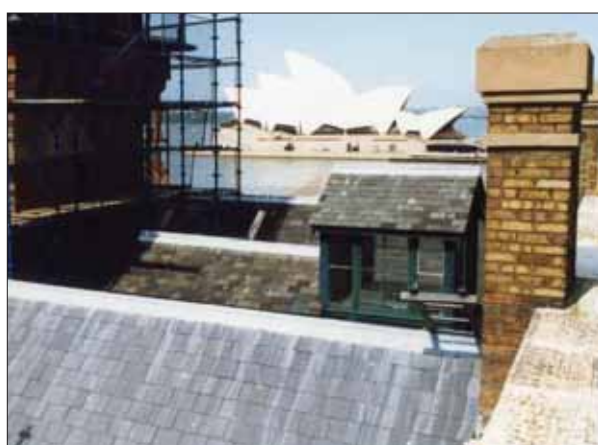
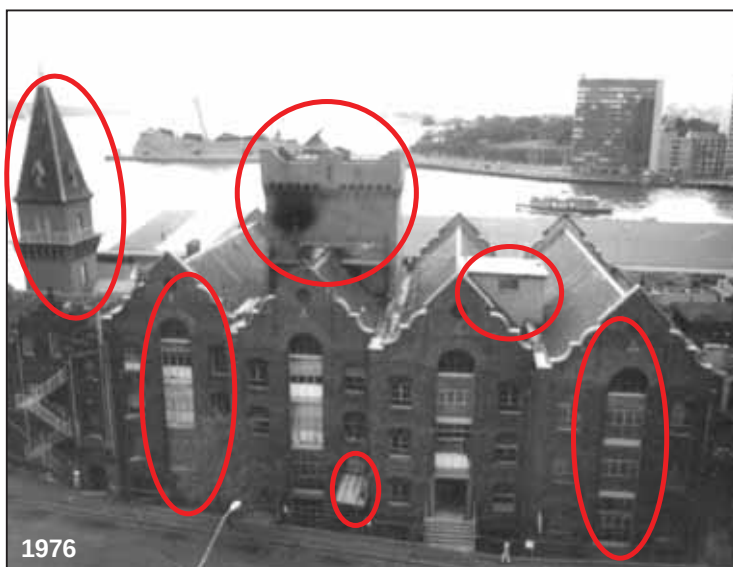
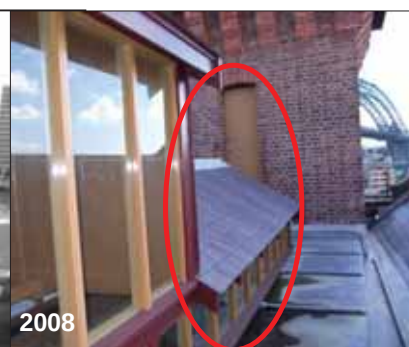
**Figure 71:** Changes to the west elevation included reinstatement of original detailing and finishes in the 1990s. The 1976 photograph shows the painted towers, glazed loading doors and an awning on the third bay. Note the roof access door from the clock tower and colesory after refurbishment in the inset. (Source: 1970 photo: Foreshore Authority, 38948 HIM 25)

Below: Roofscape of ASN Co. Building showing back of the Anglo-Dutch gable detailing with stone capping and decorative accent on the apex of Bay 1 gable, the water tower, slate roofing with lead ridge capping, box guttering and lead flashing.

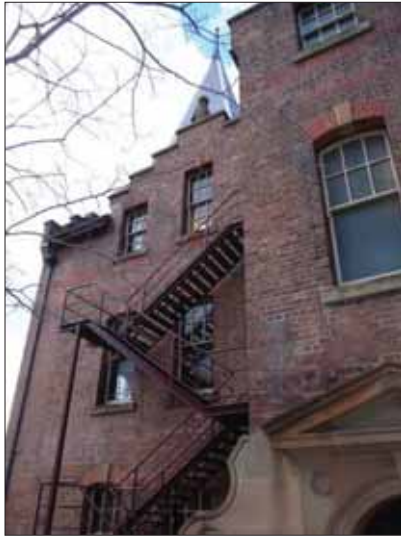
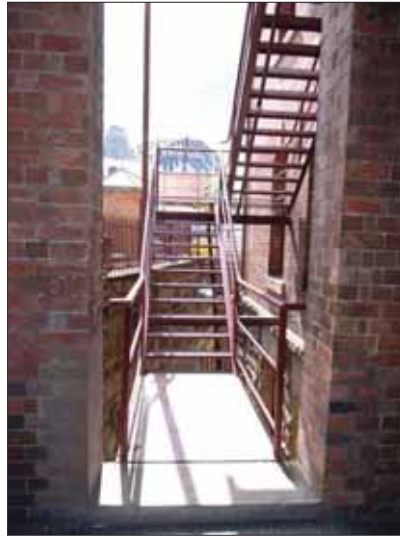
**Figure 72:** 1961 external fire stairs have been refurbished with a new opening from an original window at entry to the office block (Bay 1)

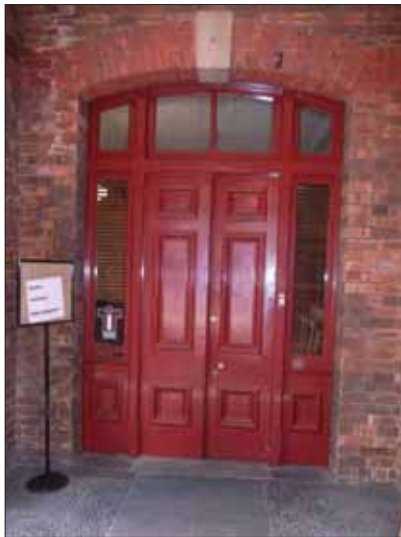
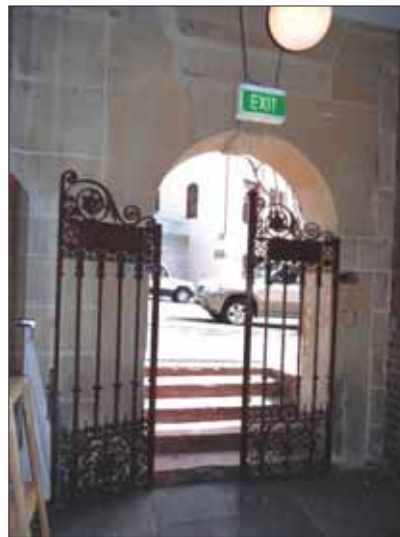
**Figure 73:** (Far left) original panelled timber entrance door with sidelights and transom window, and (Left) decorative wrought iron gates to the office block (Bay 1)

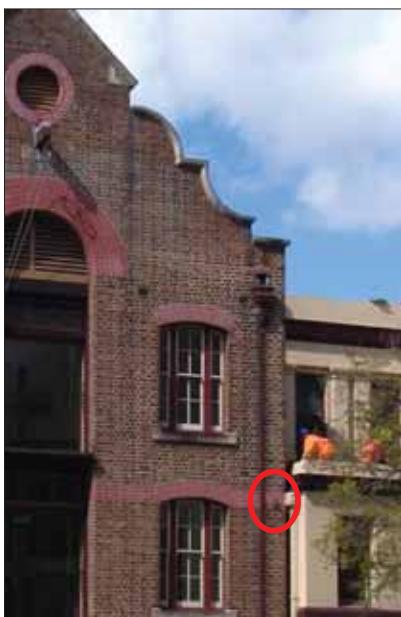
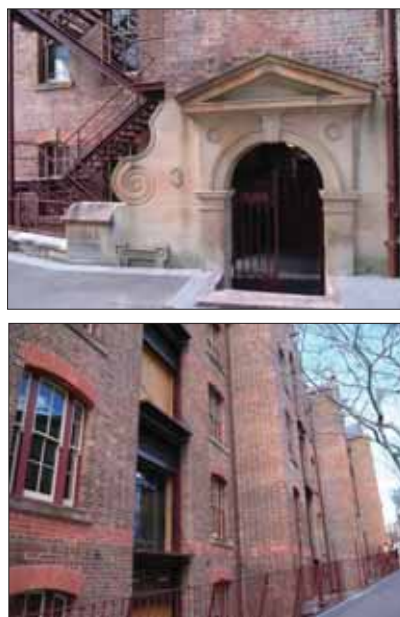
**Figure 74:** (Far left) south most end of Bay 5 showing overall gable detailing including round accent window, arched loading bay with restored pulley and cathead, segmental arched window openings with stone sills, copper rainwater head and downpipe, and original bracket that was used for supporting the overhead wires for trams at 3<sup>rd</sup> floor window lintel level (Left top) decorative dressed stone entrance to office block with classical motifs and scrolls (Left bottom) warehouse bays showing the stepping articulation of the bays from Hickson Road to George Street

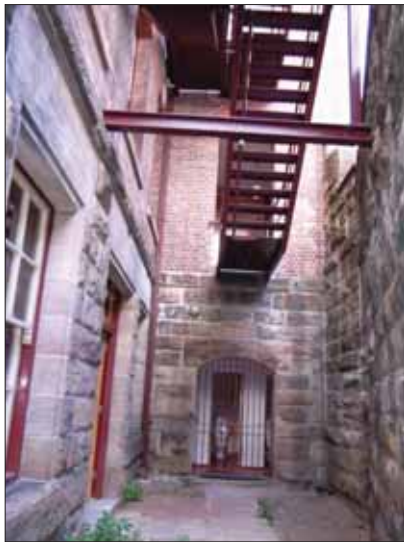
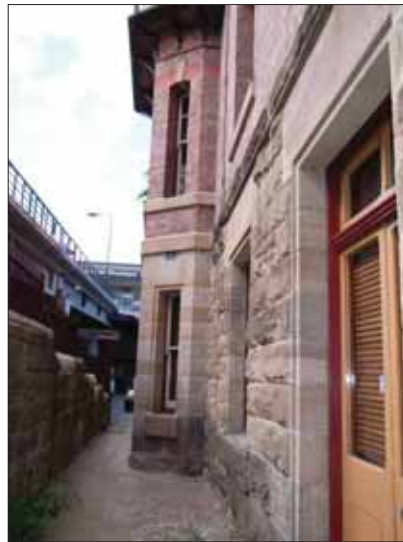
**Figure 75:** (Far left top) Ground floor level of the office block with rockfaced ashlar stone walls and retaining wall below Hickson Road, external toilets are behind the iron grille gate, which appears to have an access door to the warehouse bay beyond, now kept closed. 1961 fire stairs are above.

(Left top) ground and first floor levels of the north façade below the overpass bridge of the OPT. Note the dressed ashlar stone to the bay and the entrance, and facebrick walls and the decorative iron brackets to the bay window below the balcony.

(Far left bottom) entrance to the original shipping office from Circular Quay West with modified entrance on the ground floor.

(Left bottom) general view of eastern elevation of Bay 5 from Circular Quay West. Note restored typical loading bay timber sliding doors with transom light window and swing down platforms, rockfaced ashlar stone walls and original vehicular entrance to the ground floor

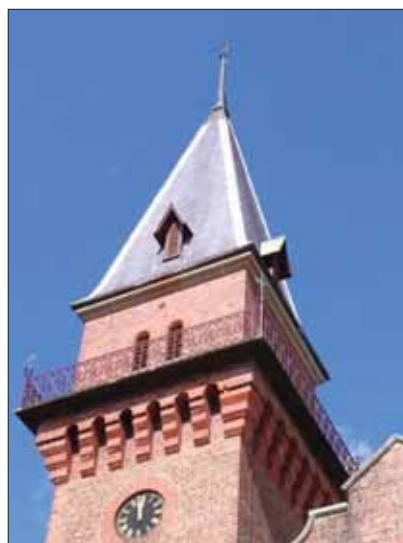
**Figure 76:** (Far left) original 12-pane timber framed windows to the top floor of office block (Bay 1) on eastern elevation, and (Left) clock tower with original louvered windows, and restored spire, iron balustrade and clock

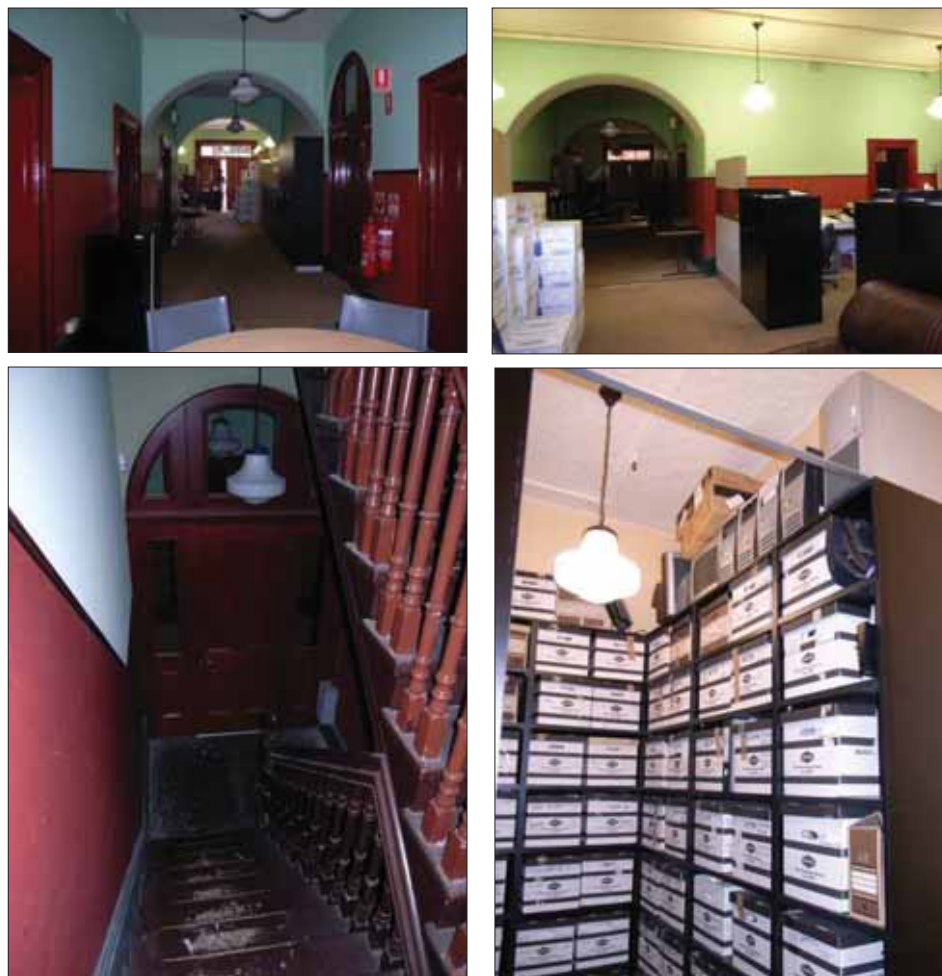
**Figure 77:** General views of Office block ground floor (Bay 1) showing main corridor, eastern office, worn timber stair and pressed metal ceiling

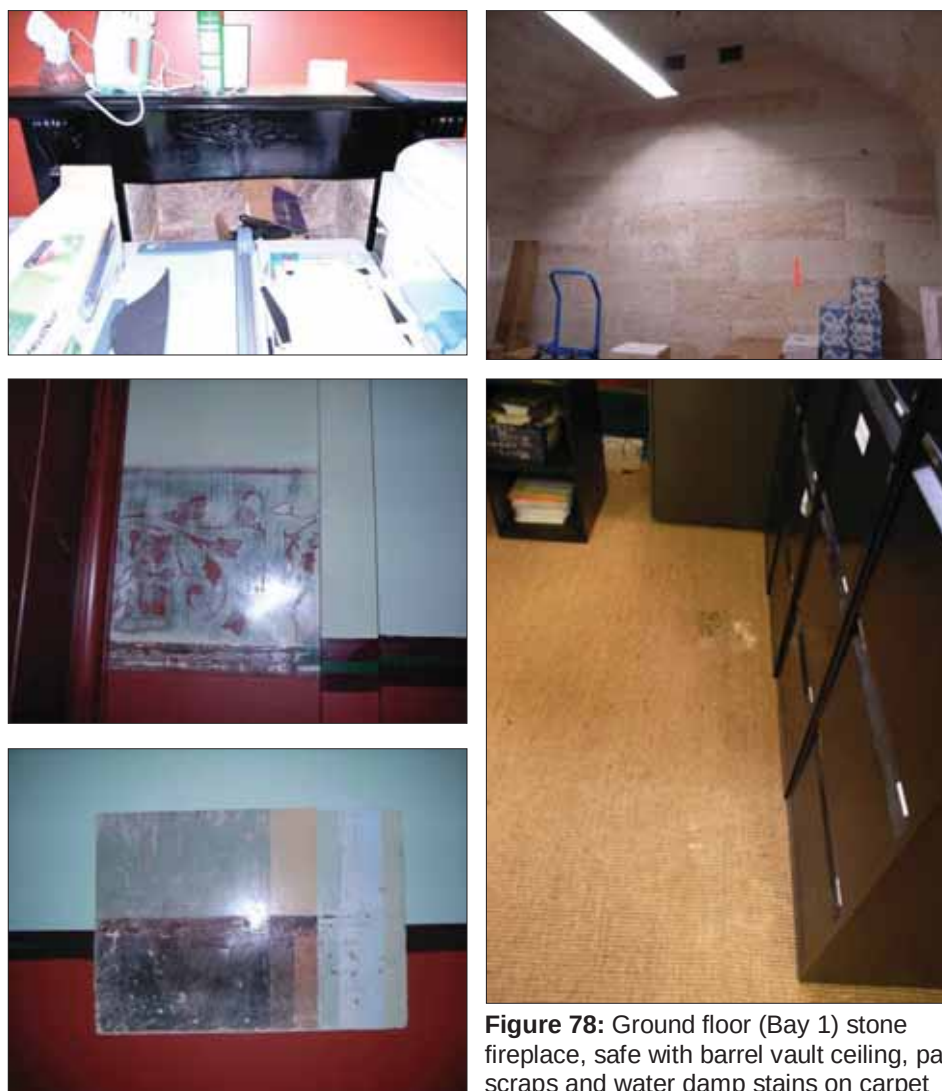
**Figure 78:** Ground floor (Bay 1) stone fireplace, safe with barrel vault ceiling, paint scraps and water damp stains on carpet

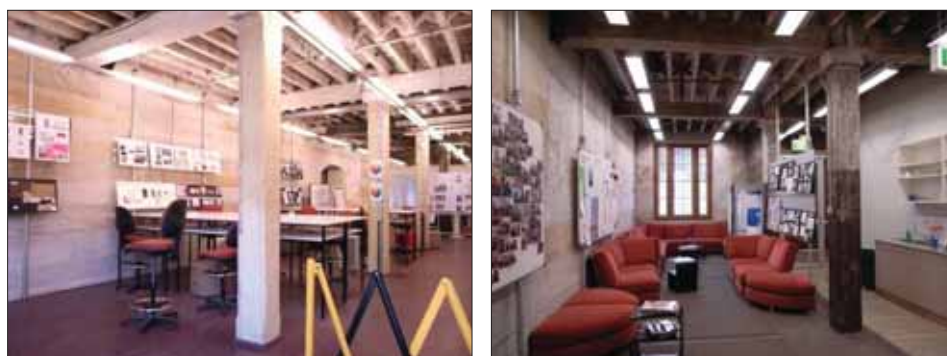
**Figure 79:** General views of Bays 4 and 3 occupied by the CATC Design School

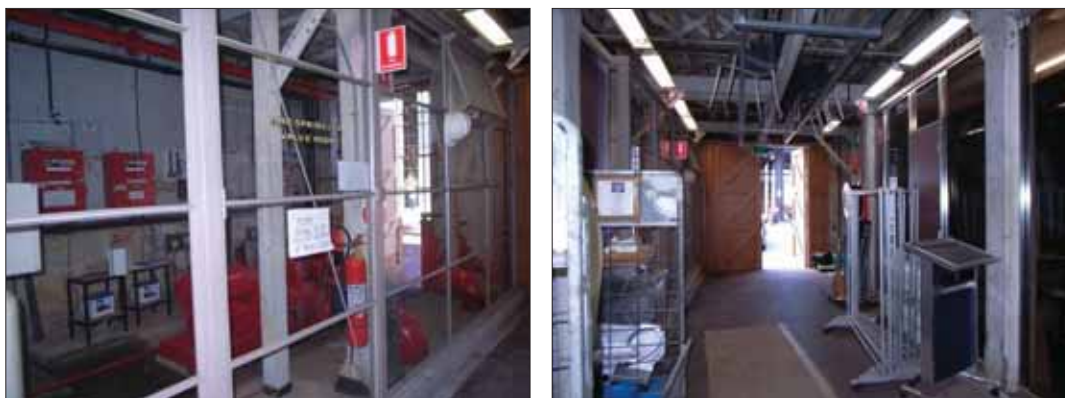
**Figure 81:** Plant room and entrance of Bay 2

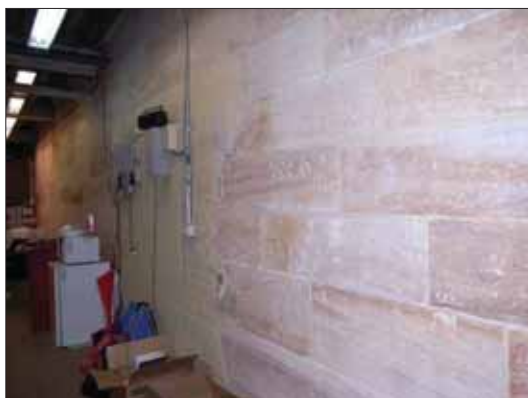
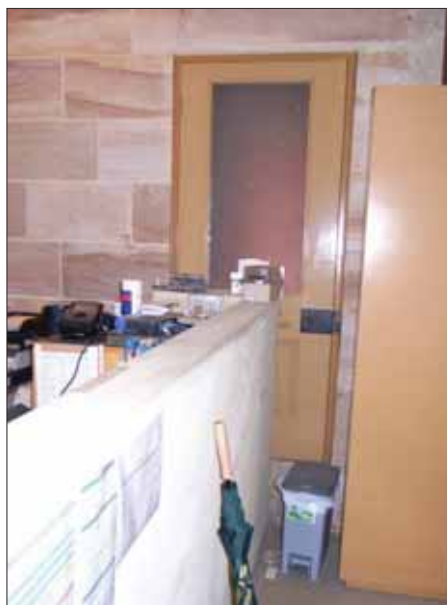
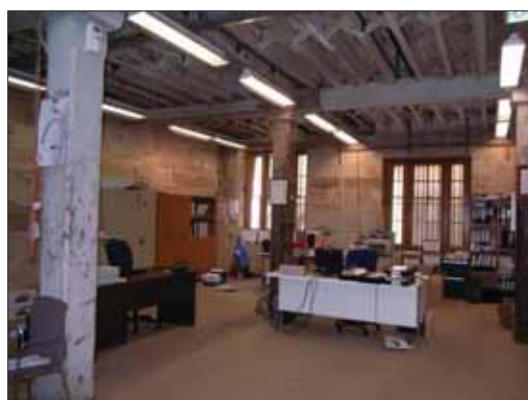
**Figure 82:** Bay 2 office area to the west showing bricked-in opening to Bay 3, original door to external toilet block (kept locked), and general office layout of Bay 2 looking west towards George Street retaining wall

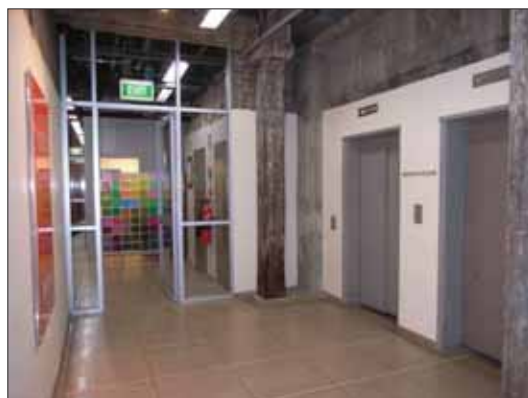
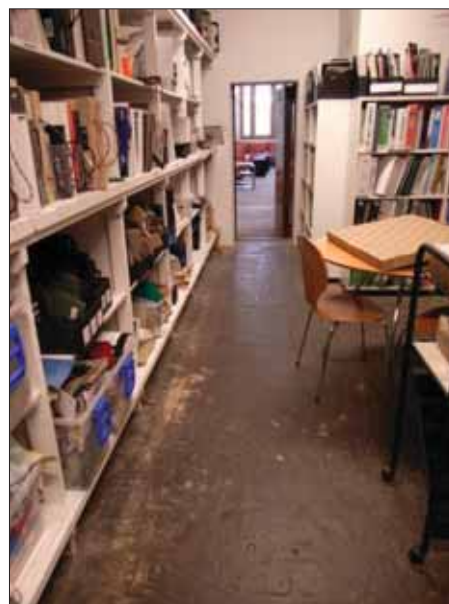
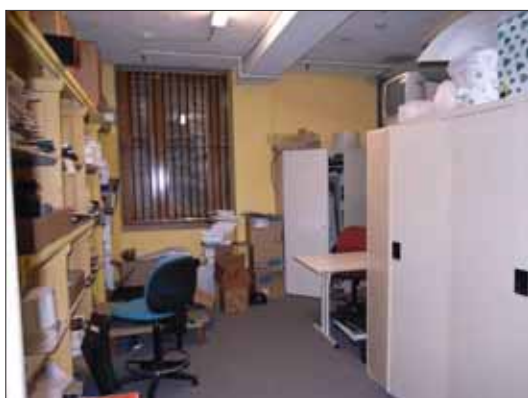
**Figure 83:** Lift foyer in Bay 4 providing access to CATC ground floor classes, part of strong room with concrete/asphalt floor, western storage room for Ken Done Gallery occupies the space behind the strong room

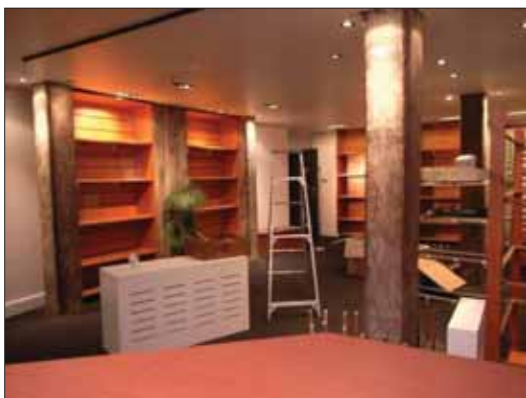
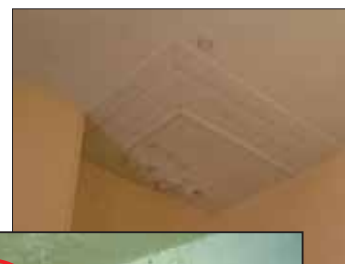
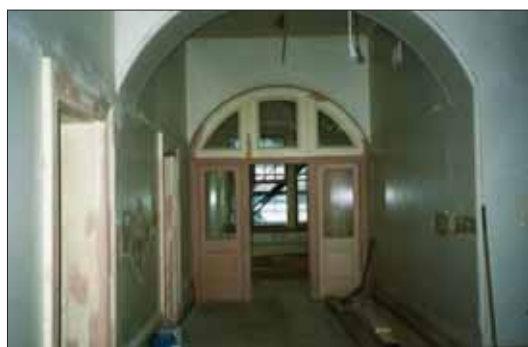
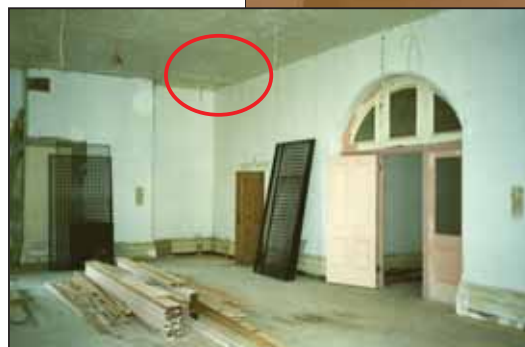
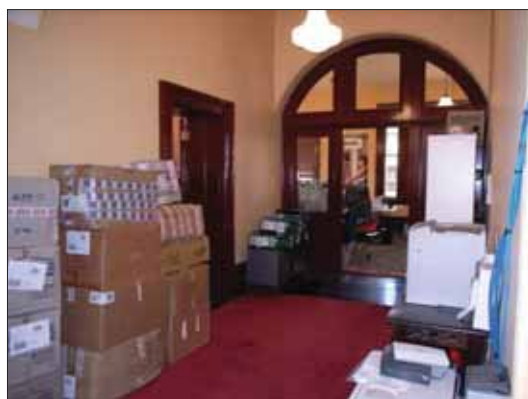
**Figure 85:** Bay 1 office spaces: top images are taken during the restoration works in 1990 provided by the Authority; below images are the same spaces in 2008. The inset shows the damage to corner plasterboard piece that require inspection & repair.

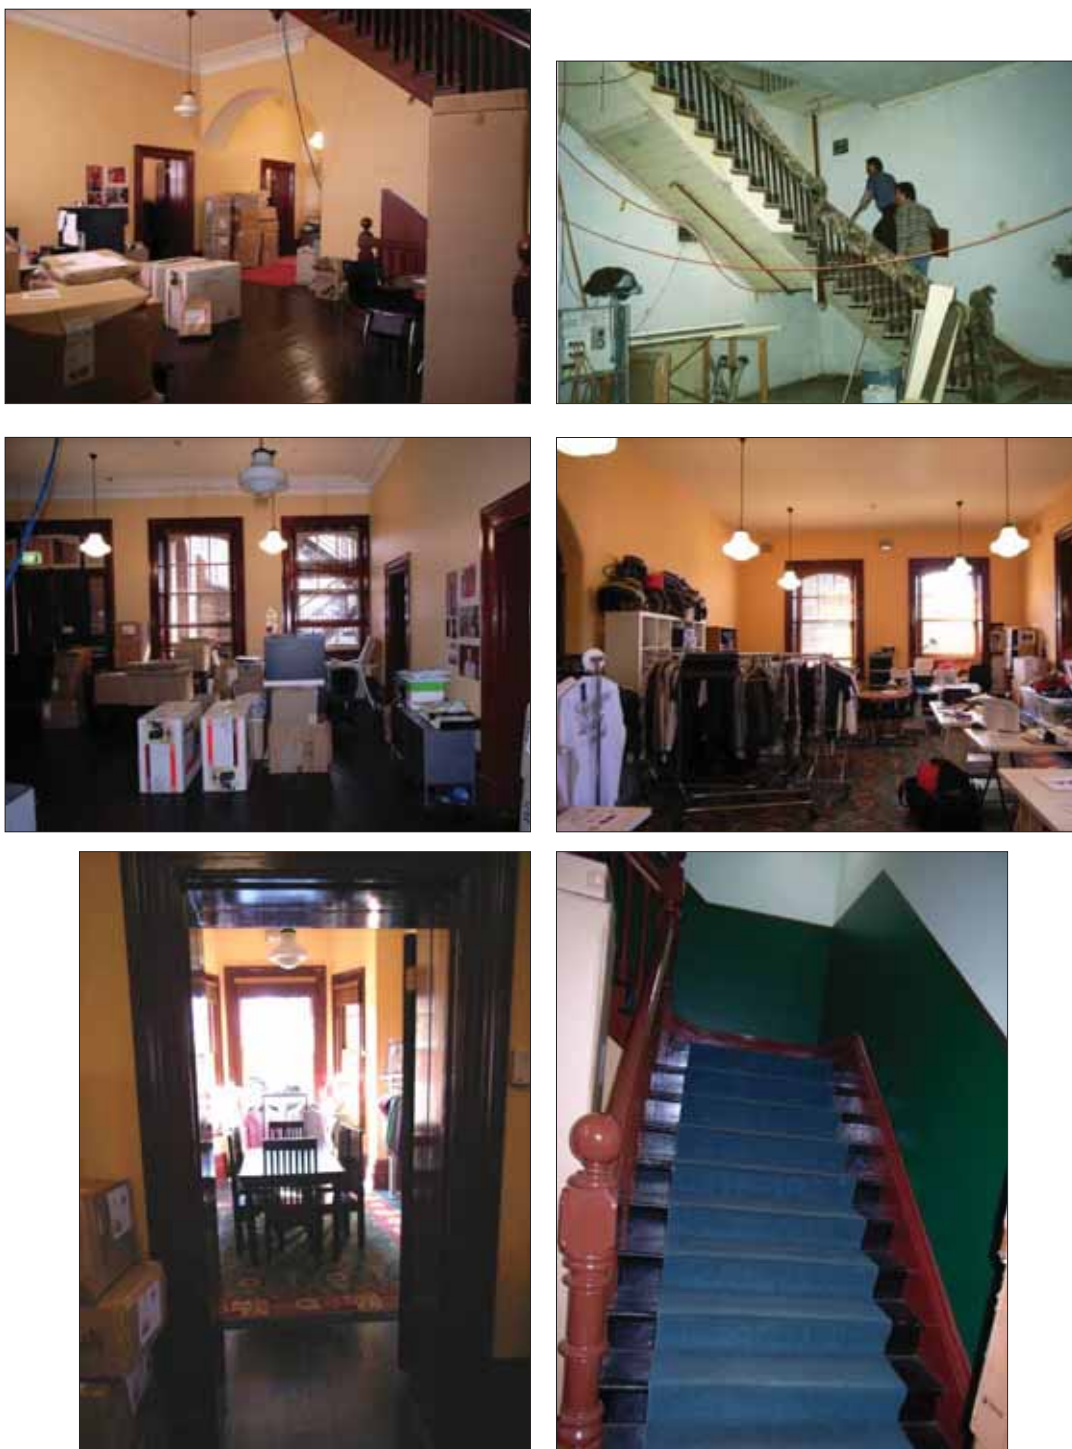
**Figure 86:** Bay 1 office spaces: top right image showing the main timber stair was taken during the restoration works in 1990 provided by the Authority; top left image and the stair show the same space and elements in 2008. Images in the centre and left above provide information on the existing configurations of the Bay 1 western and eastern sides' offices on the first floor.

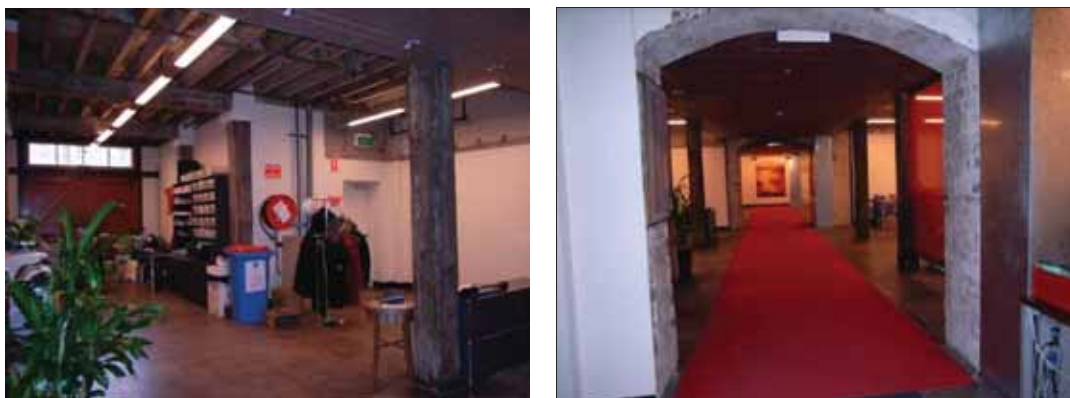
**Figure 87:** Bay 1 Warehouse component where McLachlar Lister Company occupies Bays 2 to 4. Left is the 1950s stairs in Bay 3 looking towards George Street, interconnected character of the bays and warehouse quality of the space are evident on the right image

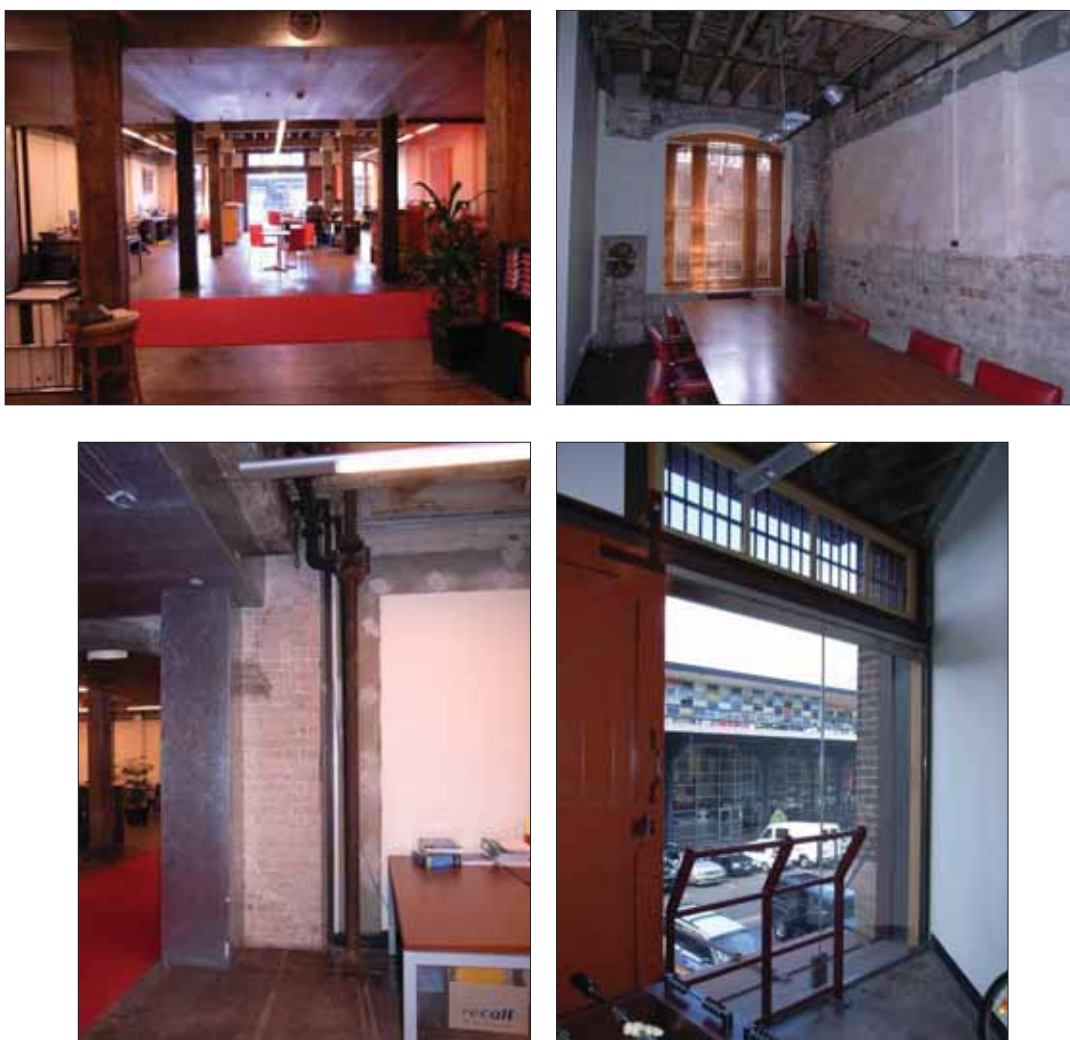
**Figure 88:** General views of Bays 2 to 4 showing air-condition ducts along the centre corridor between the arched openings, remnant rendered and painted wall of the 1950s-1960s alterations with original facebrick walls partially exposed, original fire services downpipe and the new glass insertions to loading doors with metal safety barriers.

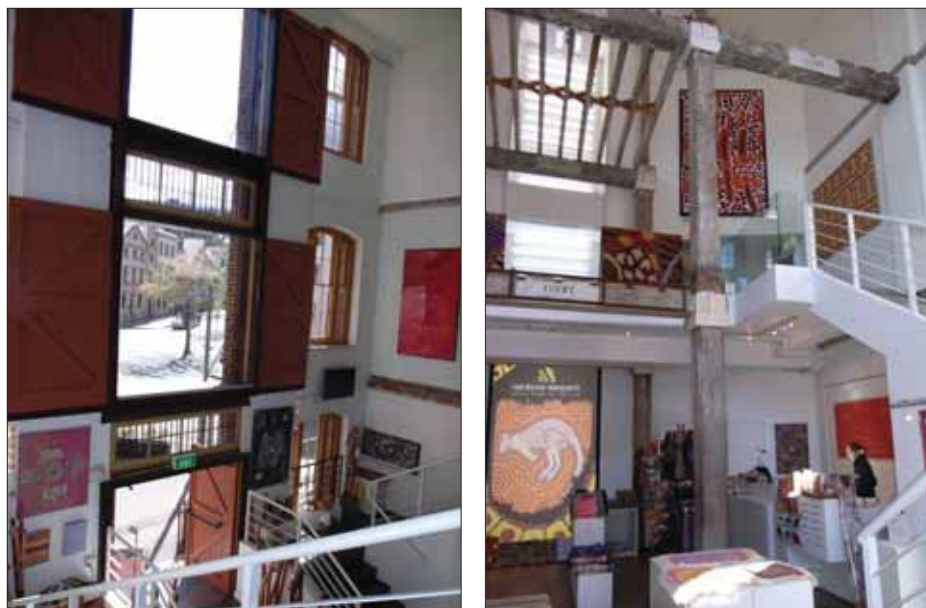
**Figure 89:** General views of western portion of Bay 5, Aboriginal art gallery. Note the retained timber structure with painted numberings, exposed brick floor levels and joist junctions.

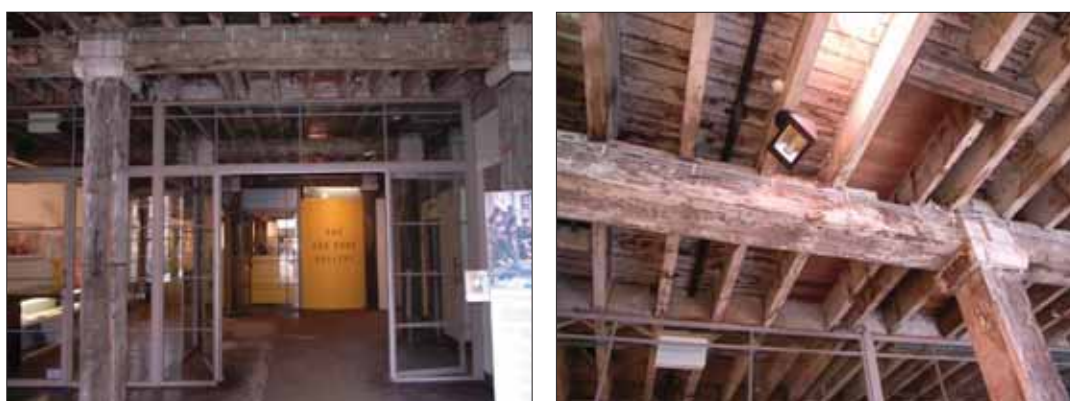
**Figure 90:** Entrance foyer to Bay 4 looking towards Ken Done Gallery and the lift foyer. Note terrazzo flooring to the foreground, and exposed timber ceiling structure (post and beam with cast iron capital) with evidence of repair and new services

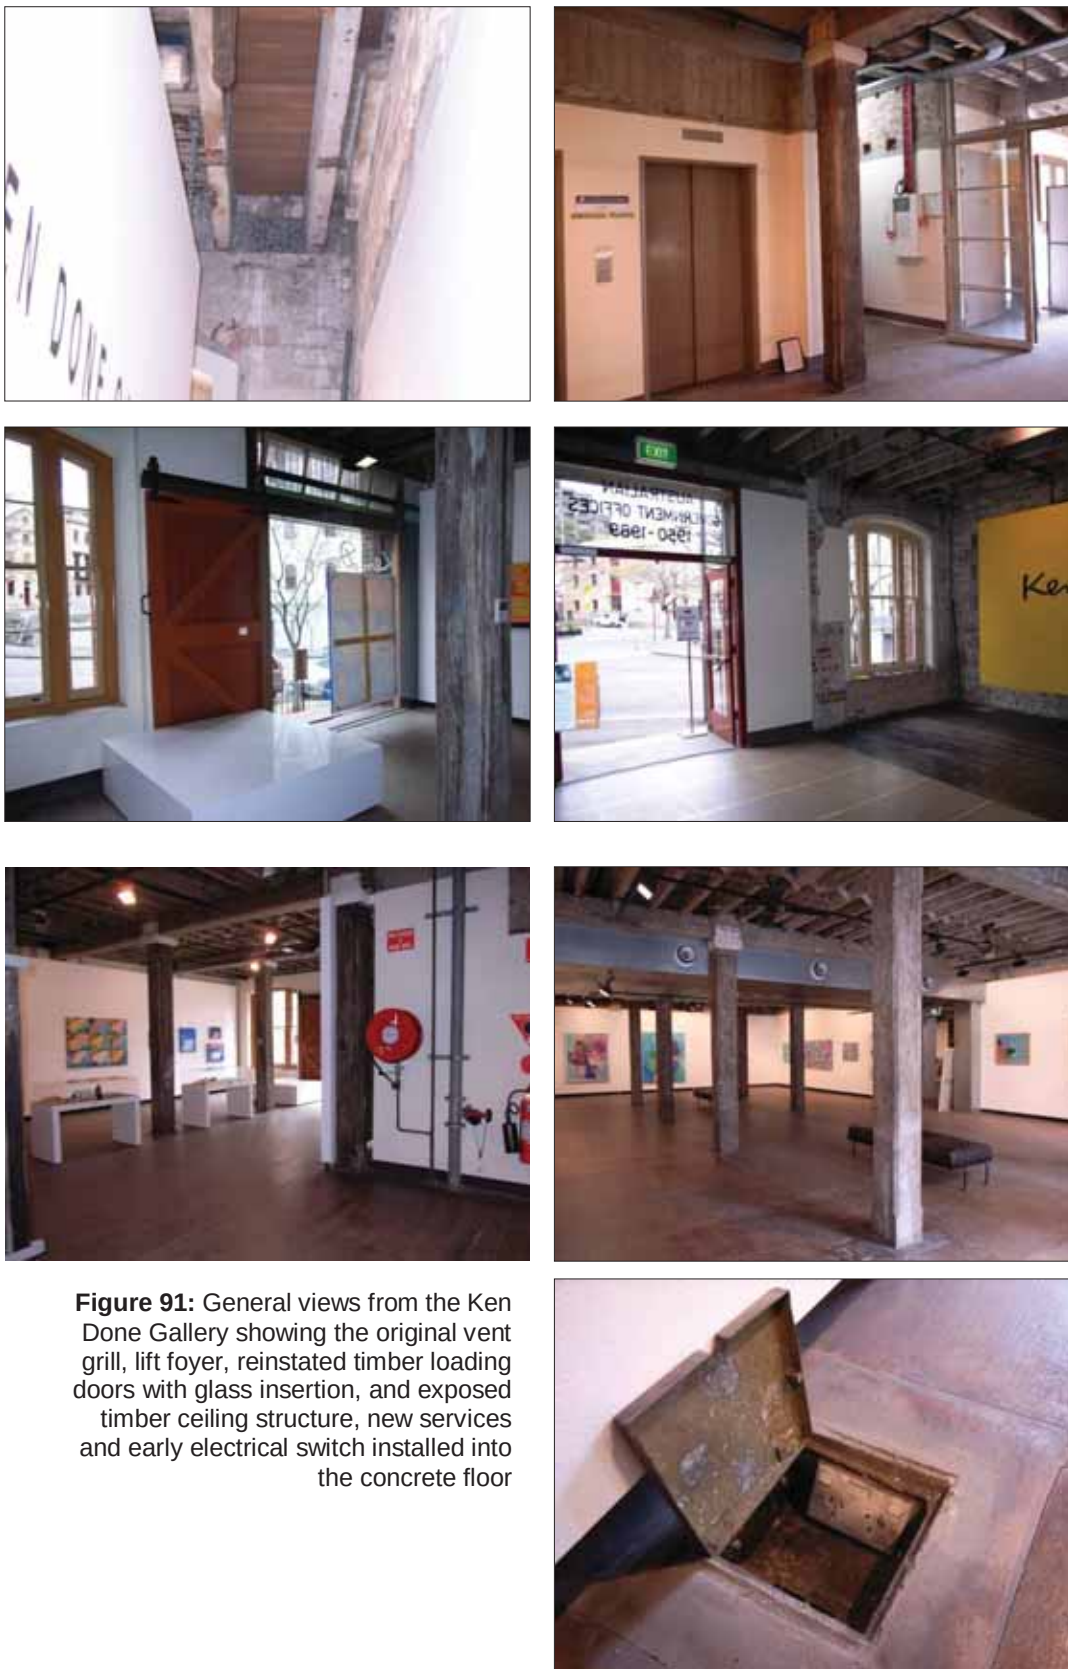
**Figure 91:** General views from the Ken Done Gallery showing the original vent grill, lift foyer, reinstated timber loading doors with glass insertion, and exposed timber ceiling structure, new services and early electrical switch installed into the concrete floor
