Former ASN Co. Building  
1-5 Hickson Road, The Rocks  
Conservation Management Plan

2009

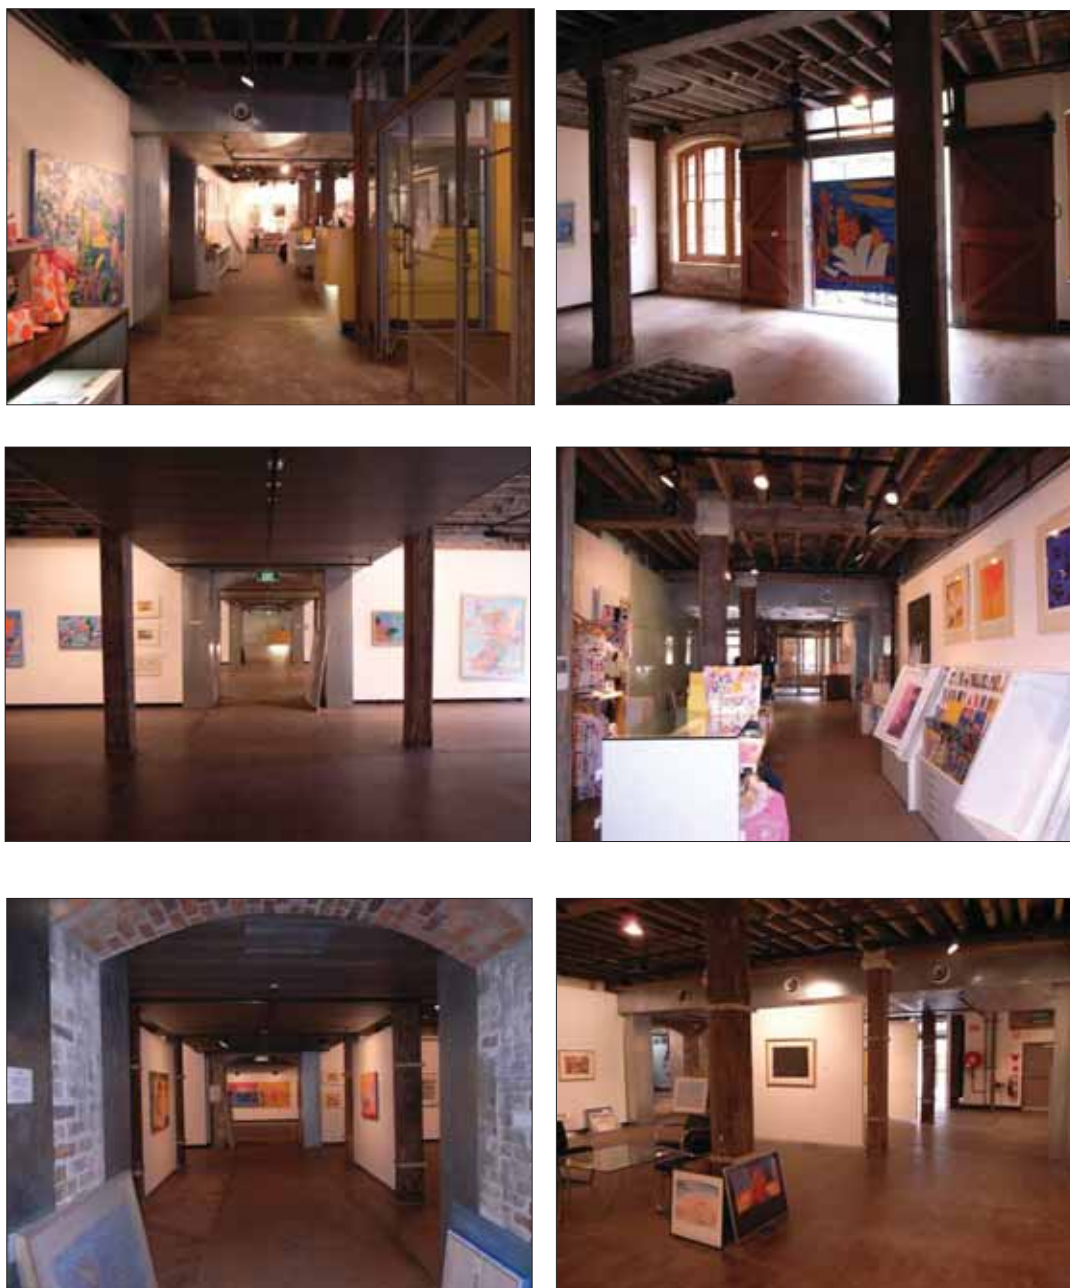
**Figure 92:** General views from the Ken Done Gallery showing the original open plan warehouse character and layout of the Bays 2, 3 and 4. Exposed timber ceiling structure and structural posts, new services including air-conditioning duct in the centre left image, glass and plasterboard partitions, and repaired brick arch opening. Use of the spaces as gallery maintains the opportunity for appreciation of the warehouse qualities of the former ASN Co. Building

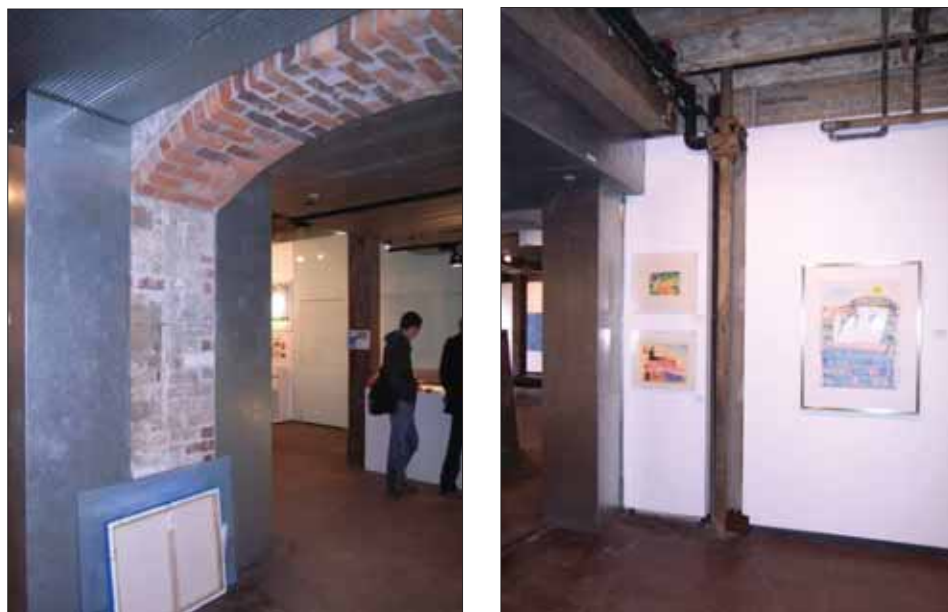
**Figure 93:** The Ken Done Gallery showing the repaired brick arch opening, and original fire services

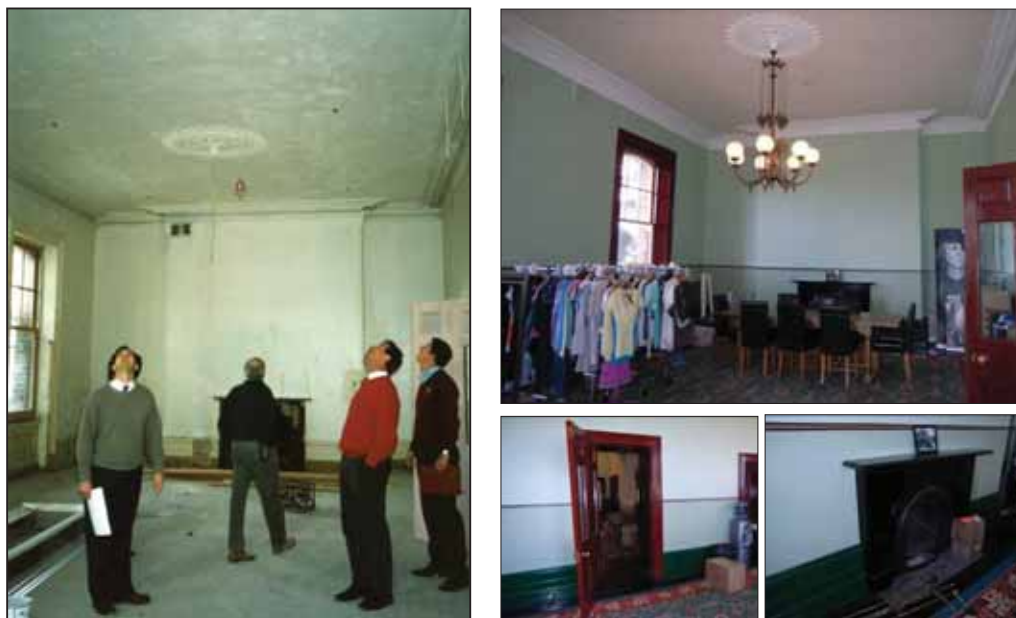
**Figure 94:** The eastern side office on the Second floor of Bay 1 showing the room during the 1990s restoration works and in 2008. Note new Victorian colour scheme, highlighted plaster moulded cornices, ceiling rose and slate fireplace  
(Source for 1990s image the Foreshore Authority)

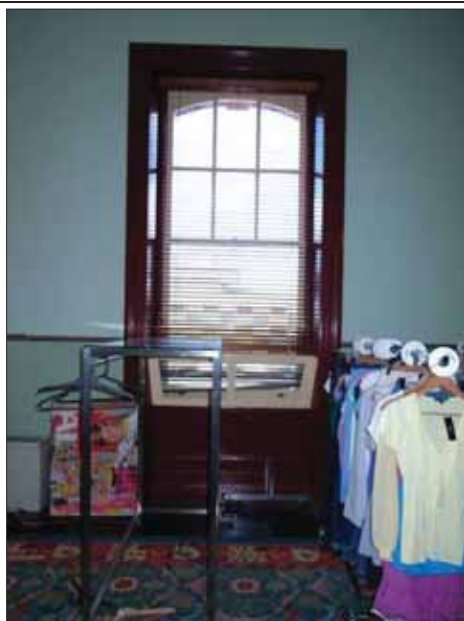
**Figure 95:** Example of reconstructed timber framed sash window with two mullions and other retained and reinstated features of Bay 1: fireplaces and overall office fabric/joinery.

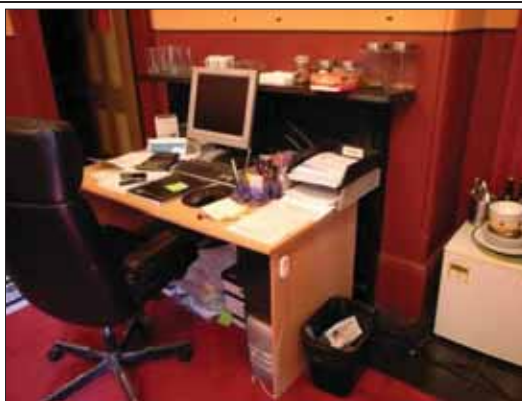
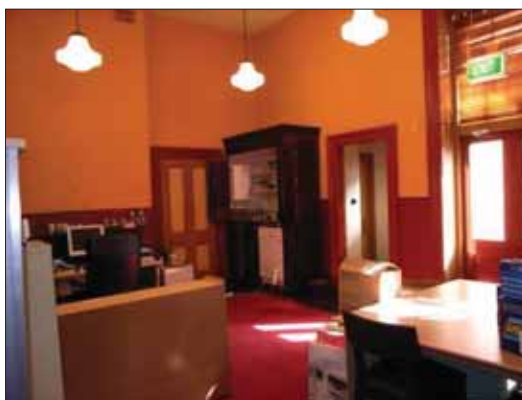
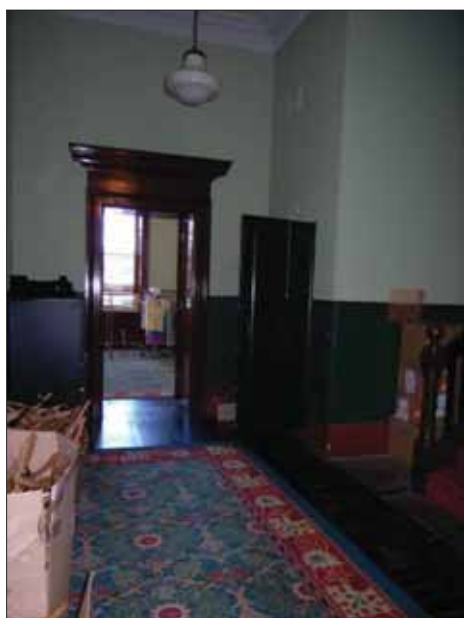
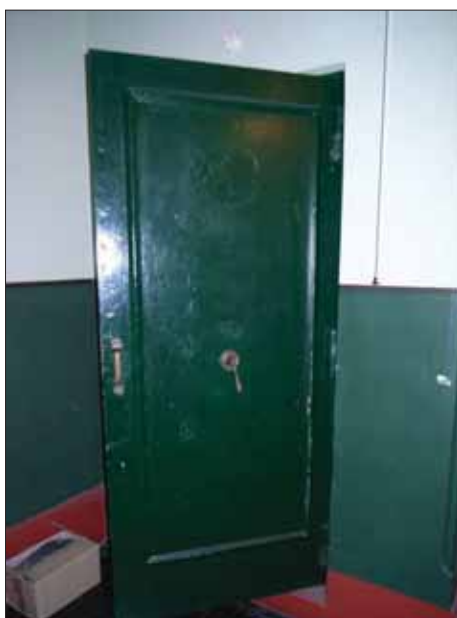
**Figure 96:** Restored and refinished classical timber door to the former boardroom and the safe door. The right image shows the doors prior to restoration.  
(Source for 1990s images: Foreshore Authority)

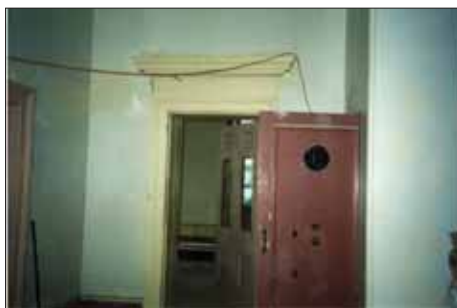
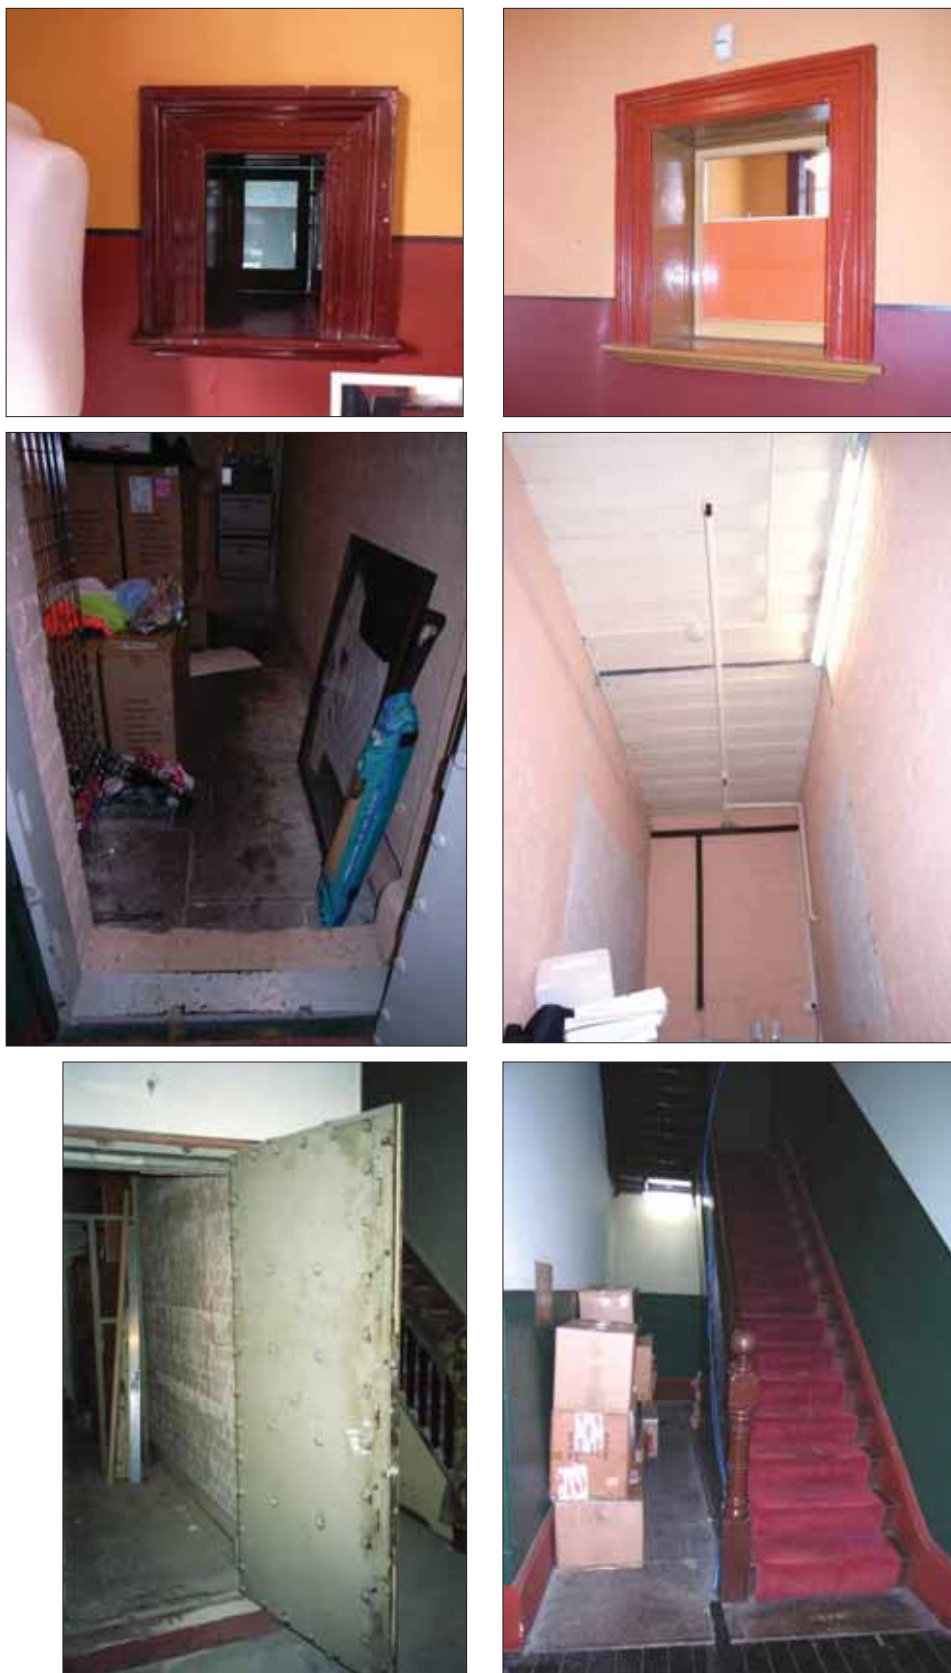
**Figure 97:** Service and communication windows, safe room with flagstone floors and timber board ceiling, safe during restorations, and restored original timber stair  
(Source for 1990s image the Foreshore Authority)

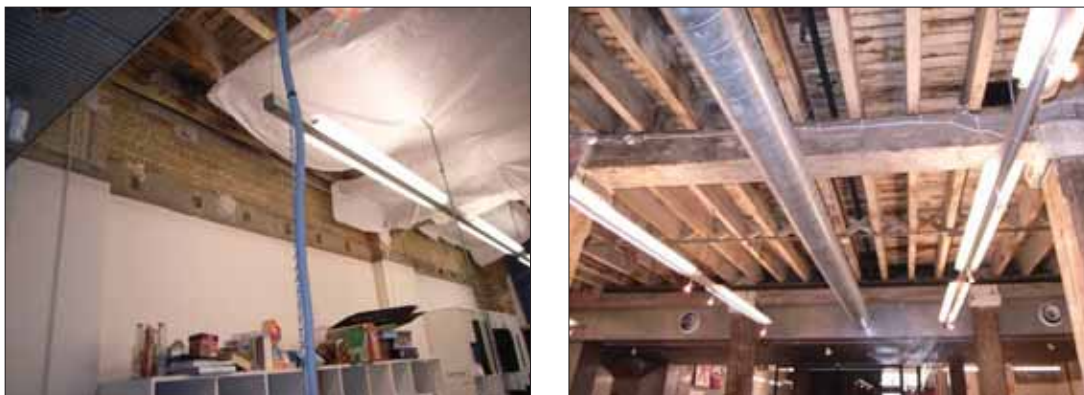
**Figure 98:** Views of the timber joists and underside of timber floor boards in Bay 4 of the third level. The suspended cloth ceiling is for temporary measures to protect from any dust caused due to the refurbishment works on the forth floor above. Note evidence of removed earlier suspended ceiling above the wall render of the left image

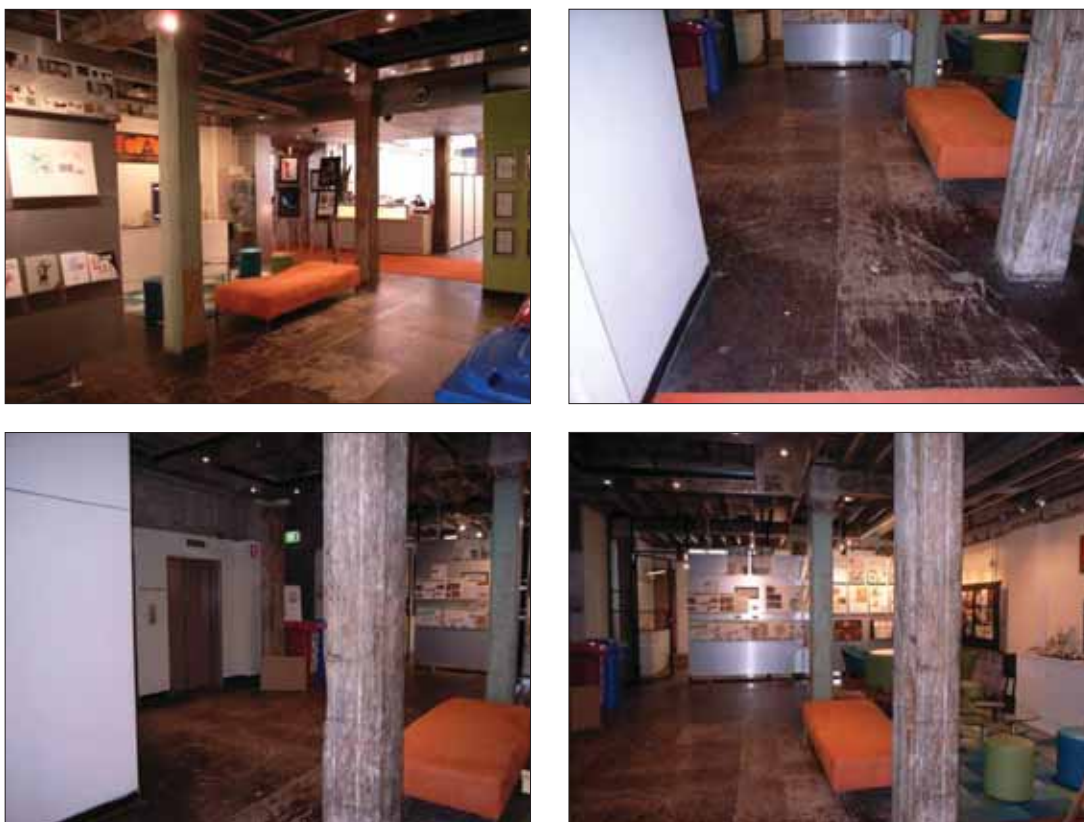
**Figure 99:** General views of warehouse Bays 2, 3 and 4 showing the concrete floor with asphalt finish and evidence of earlier uses trough marks on the floor

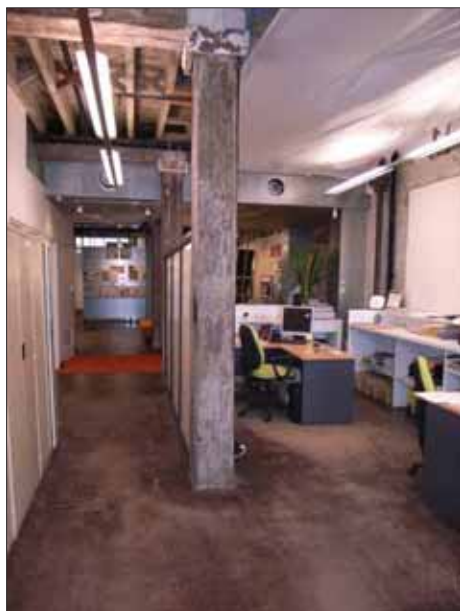
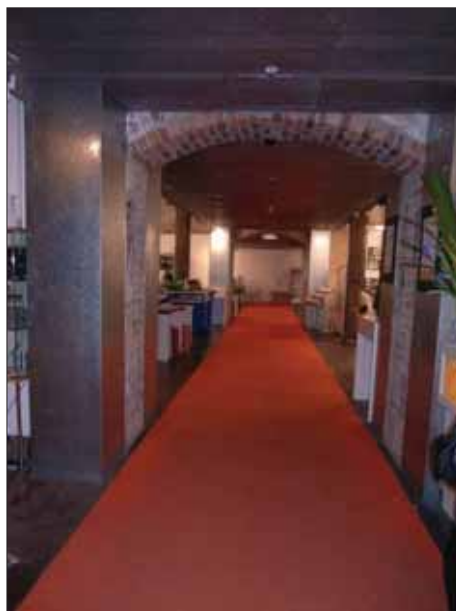
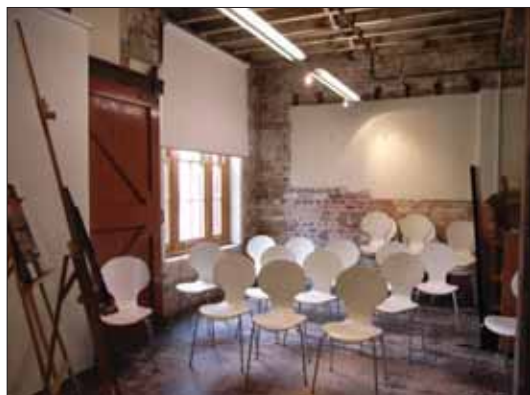
**Figure 99:** Above left is the view of Bay 4 looking west towards the lift foyer, above views through the original arched openings with air-conditioning duct in between, the classroom on the left facing the George Street elevation and features layers of finishes from the original to the 1950s-1960s and reconstructed loading doors. The top sash rail of the timber window seen here is partially broken and requires repair in splicing form.

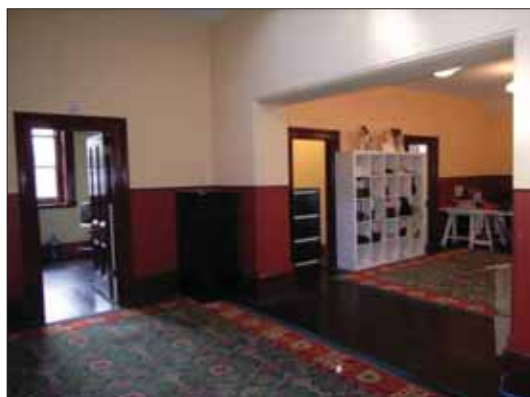
**Figure 100:** General view of Bay 1 office main stair foyer looking towards former caretaker's suit beyond the large opening and the clocktower access room (left door of the above image). Close up view of the clock tower access room door to the right

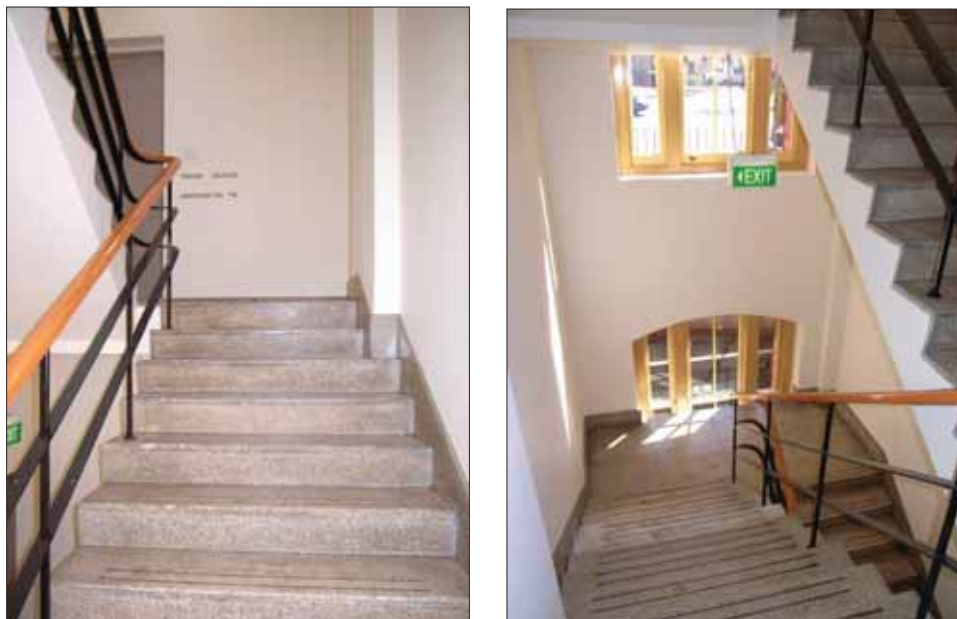
**Figure 102:** The 1950s firestairs on the south-western corner of Bay 4 featuring terrazzo steps, iron balustrade and timber hand railing. Note floor identification signage consistent throughout all building levels

The 1950s fire stairs, located in Bays 3 and 4 were retained and the elevators in Bay 4 were also retained and refurbished. The works did not cover the areas (Bay 5 and part of Bay 4), which had been altered for *The Story of Sydney* in the early 1990s. Air-conditioning of the warehouse Bays 2-4 was completed in 2003.

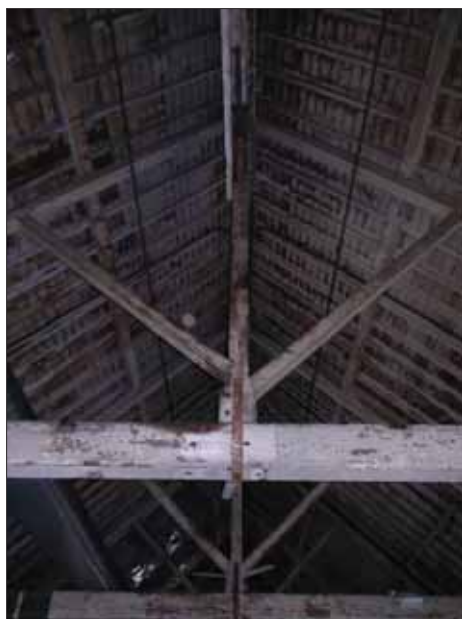
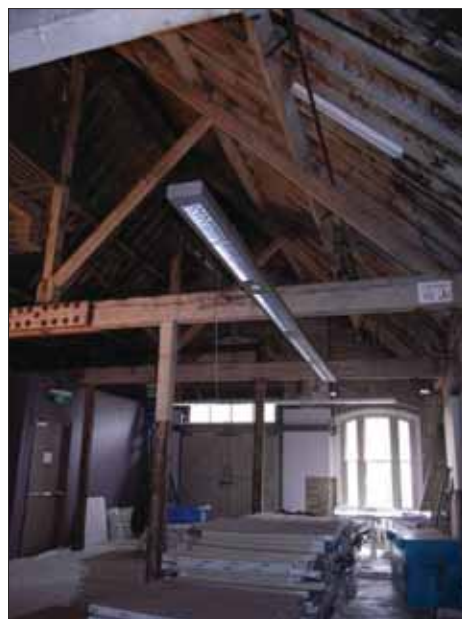
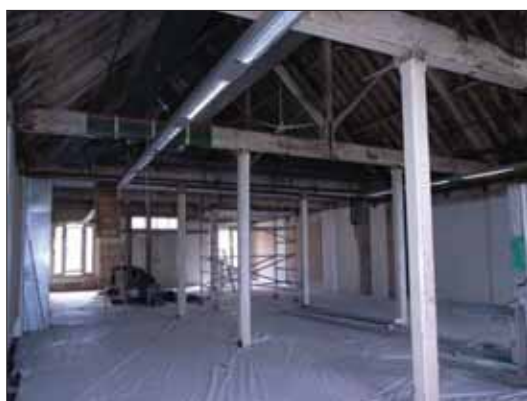
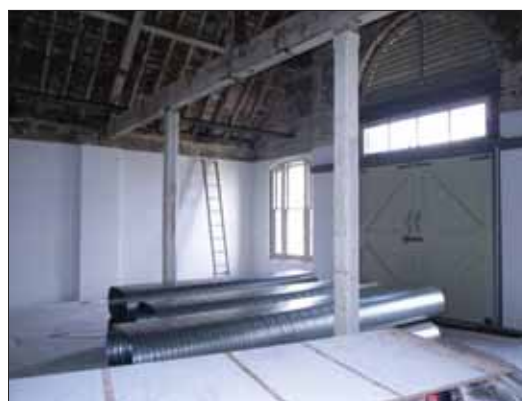
**Figure 103:** The fourth floor warehouse bays with Kingpost trusses and beams, sawtooth gabled roof form, timber rafters, brick gable ends, arched loading doors with louvered tops, glazed transoms and timber board doors. New light fittings and services and carpet flooring are for the new tenancy fit-out. Note original fire sprinklers under the roof lining

The top floor of the warehouse building and clearstorey and roof top of the office block, the forth floor has the most significant structural elements of the building. The Kingpost trusses and sawtooth gabled roof in exposed form exhibit an impressive environment and presentation. The interconnected bays 2 to 4 were under refurbishment works for a new tenancy at the time of the site inspection. The new fit-out follows the similar approach by respecting and maintaining the original spatial qualities and warehouse character of the space. The office block featured by the clearstorey and the clocktower middle level on this floor. The original timber floor boards are visible within the warehouse bays; so are all the structural timber elements including Kingpost trusses, beams and cathead beams. A mezzanine level with pull-down ladder appears to be inserted in the eastern half of Bay 3.

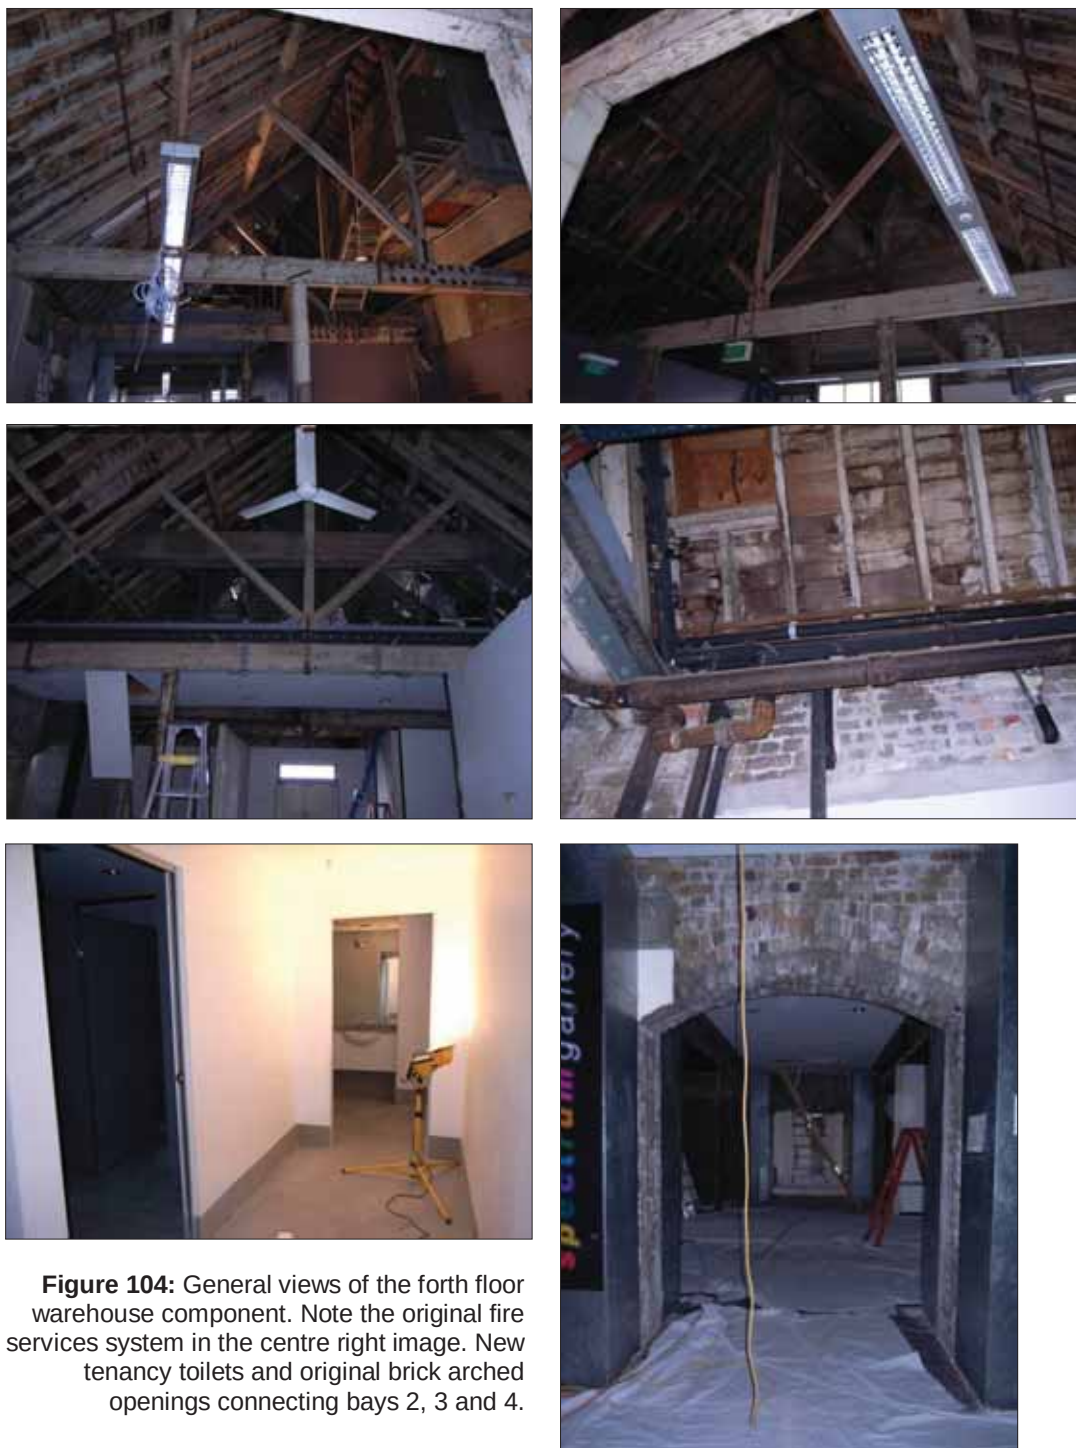
**Figure 104:** General views of the fourth floor warehouse component. Note the original fire services system in the centre right image. New tenancy toilets and original brick arched openings connecting bays 2, 3 and 4.

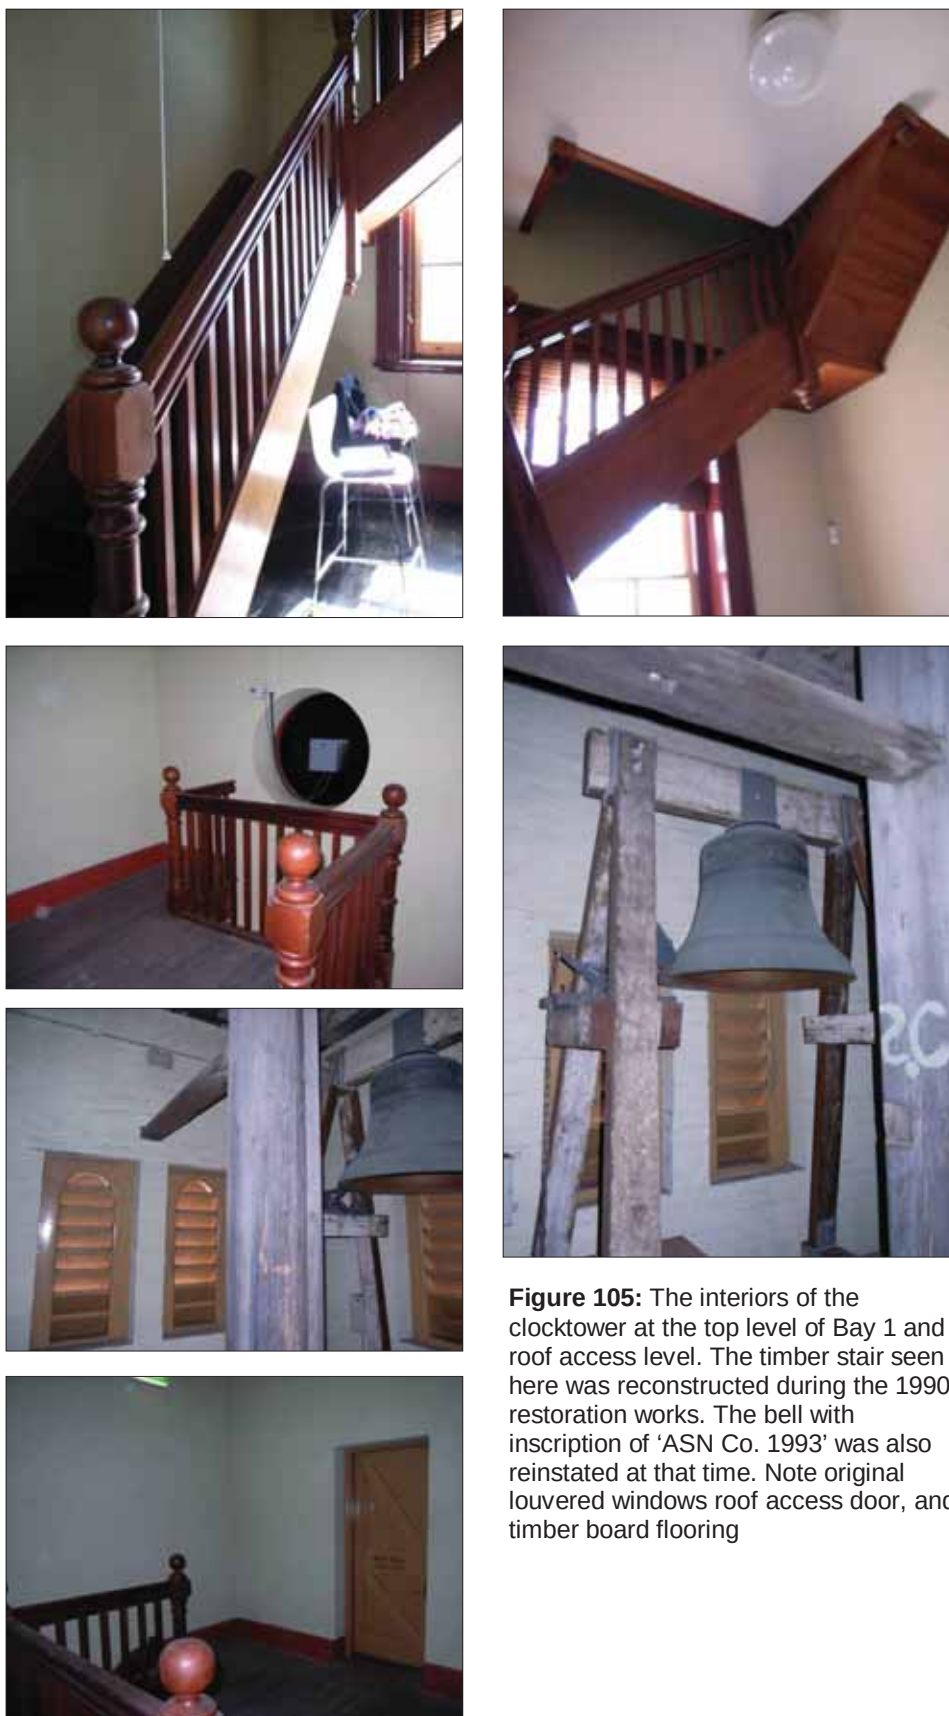
**Figure 105:** The interiors of the clocktower at the top level of Bay 1 and roof access level. The timber stair seen here was reconstructed during the 1990s restoration works. The bell with inscription of 'ASN Co. 1993' was also reinstated at that time. Note original louvered windows roof access door, and timber board flooring

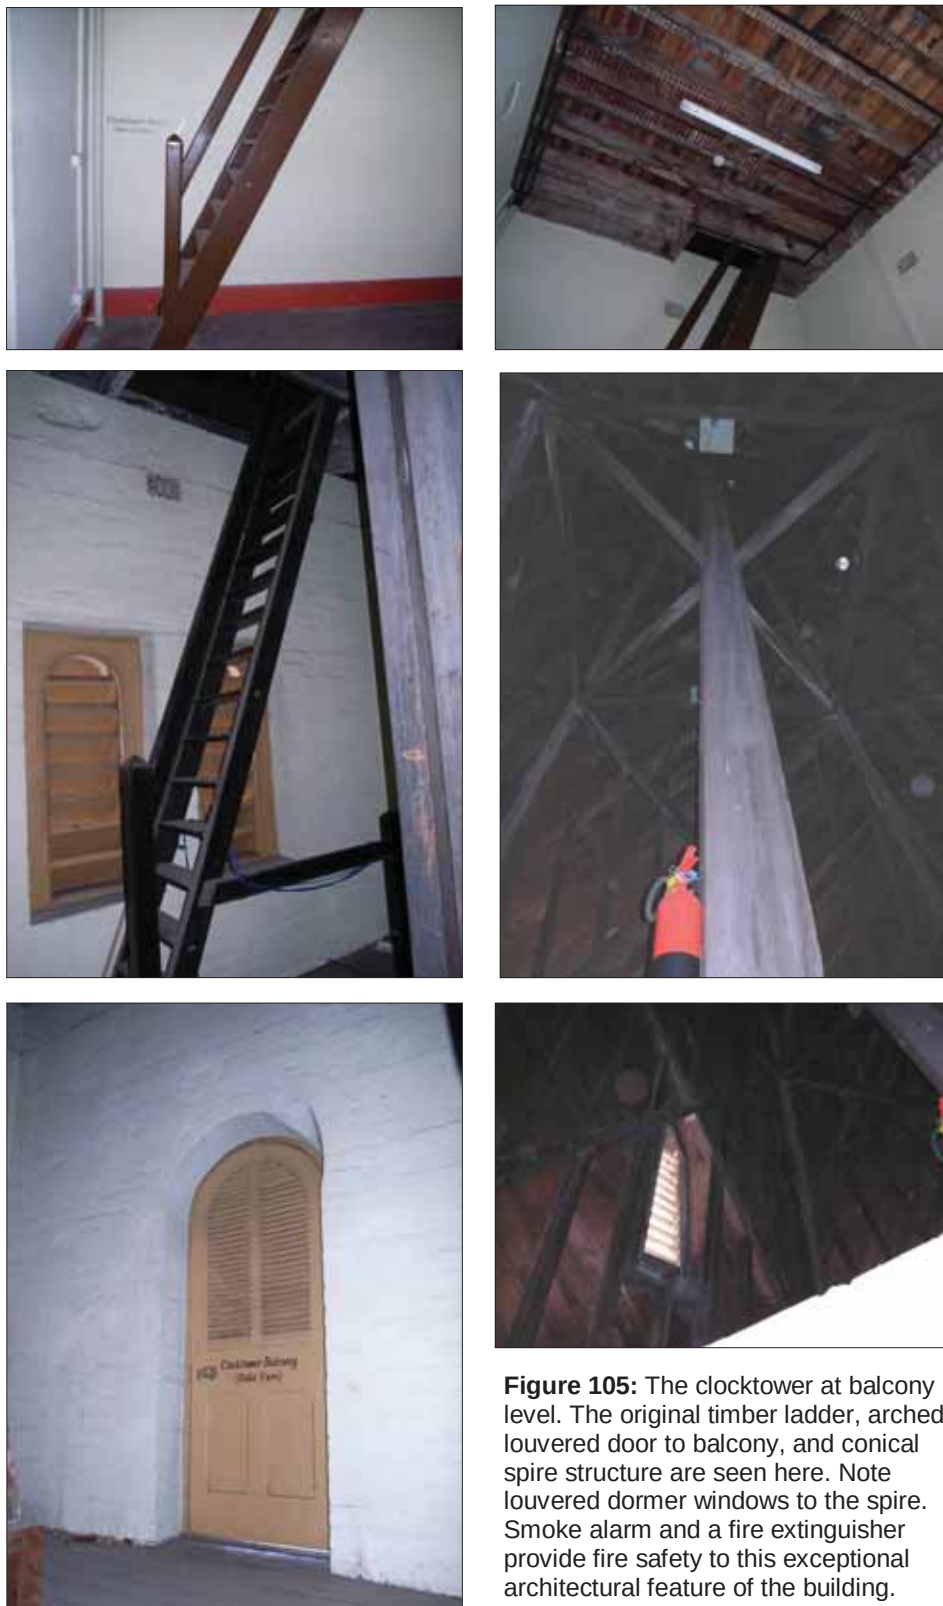
**Figure 105:** The clocktower at balcony level. The original timber ladder, arched louvered door to balcony, and conical spire structure are seen here. Note louvered dormer windows to the spire. Smoke alarm and a fire extinguisher provide fire safety to this exceptional architectural feature of the building.

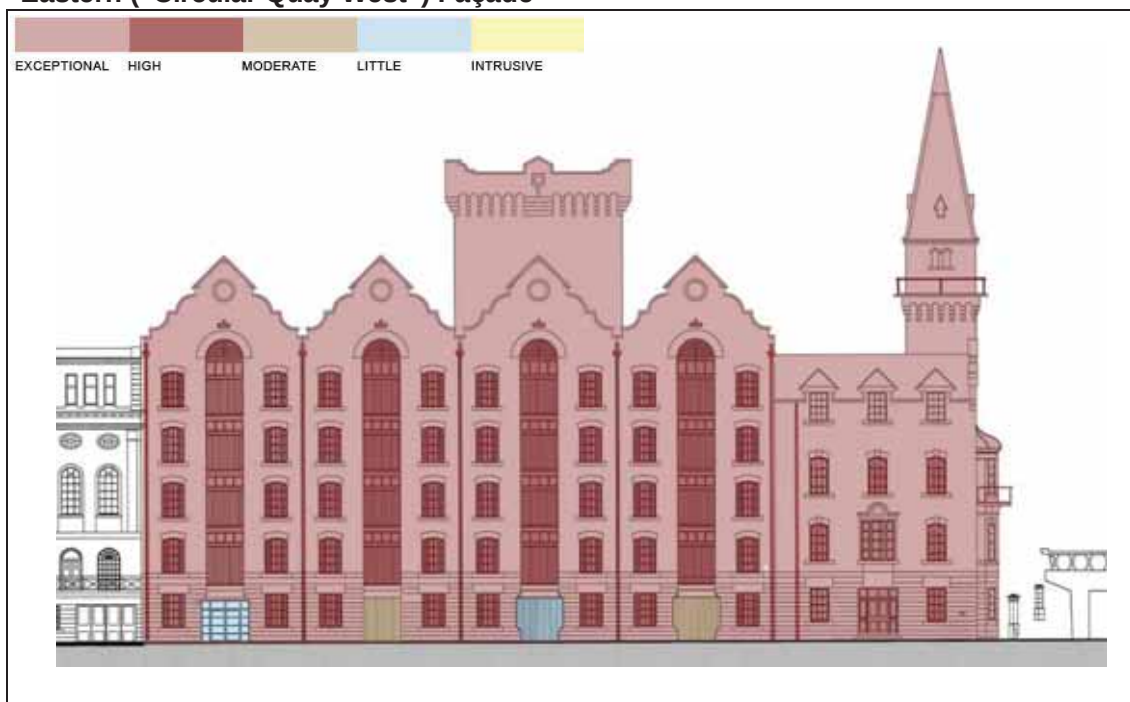
### Eastern ("Circular Quay West") Façade

| <ul style="list-style-type: none"> <li>Overall façade including clock tower (including spire and dormers), water tower, ASN Co. signs</li> <li>Anglo-Dutch architectural elements including curvilinear gables with stone capping and round accent windows, segmental arched window openings, loading bays with arched top, stone window sills</li> <li>Original dormer windows to Bay 1 including timber 12-pane sash windows</li> <li>stone classical window with mullions to Bay 1 on first floor level</li> <li>Polychromatic face brick finish, and rockfaced-ashlar sandstone base</li> </ul> | Exceptional |
| <ul style="list-style-type: none"> <li>Reinstated loading bay doors and pulleys</li> <li>Stairs to George Street Bays 5 and 4</li> <li>Timber multi-paned sash window frames with two mullions form (although the fabric is recent the material and form important)</li> <li>Copper downpipes and rainwater heads including service pipes</li> <li>Wrought iron balustrade to clock tower</li> <li>Slate roofing and lead capping</li> <li>Engraved business sign on stone lintel to No. 35 entry</li> <li>Wall vents and louvered segmented arch ventilation window with stone sill at eastern end on the top floor</li> <li>Remnant painted business signs to loading docks reveals</li> <li>Interpretive plaque</li> </ul> | High |

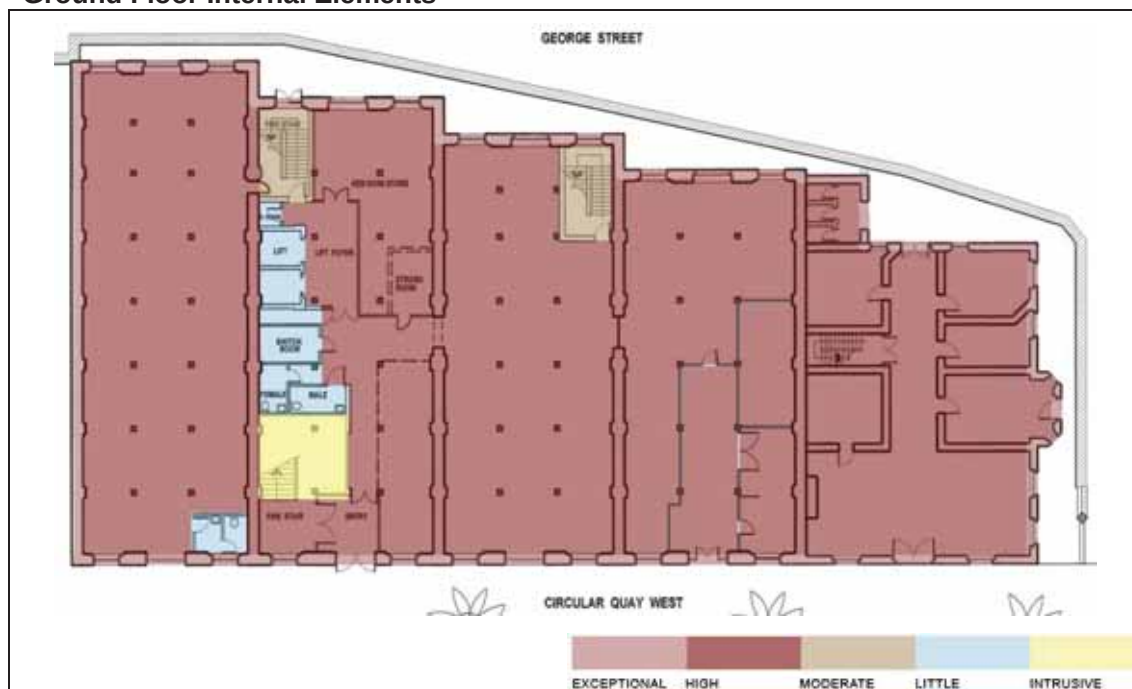
### Ground Floor Internal Elements

| <ul style="list-style-type: none"> <li>– Overall office floor layout to Bay 1, and overall open plan warehouse floor layout to Bays 2, 3, 4</li> <li>– Original toilet block to courtyard on west side of Bay 1</li> <li>– Exposed warehouse structural elements including timber posts, beams, herringbone bracing, stone and face brick walls, Bays 2, 3, 4 and 5</li> <li>– Original arched openings between Bays 2, 3 &amp; 4</li> </ul> | Exceptional |
| <ul style="list-style-type: none"> <li>– 1990s Fire stairs in Bay 4 (Circular Quay West side)</li> </ul> | Intrusive |

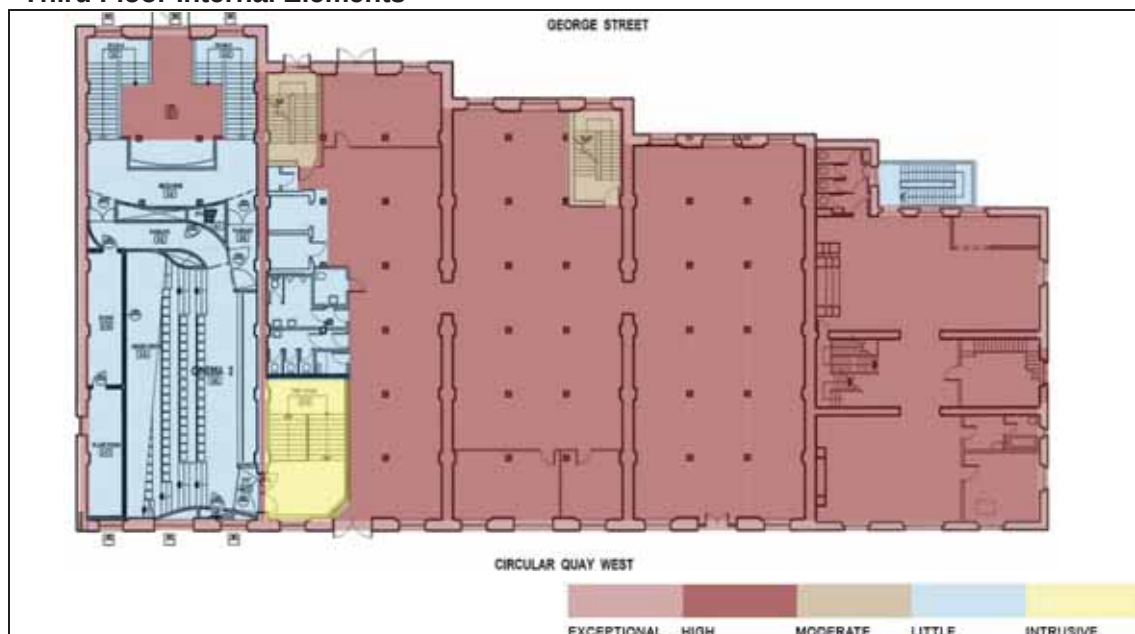
### Third Floor Internal Elements

| <ul style="list-style-type: none"> <li>Overall office floor layout to Bay 1, and overall open plan warehouse floor layout to Bays 2, 3 &amp; 4</li> <li>Load bearing walls and exposed timber post and beam structure with herringbone bracing and cast iron capitals in Bays 2, 3 &amp; 4</li> <li>Brick Arches between Bays 2 &amp; 3, and 3 &amp; 4</li> <li>Brick Arches between Bays 2 &amp; 3, and 3 &amp; 4</li> <li>Remnant original fire sprinkler pipes in Bays 2 &amp; 3</li> <li>Original timber staircases and balustrades, Bay 1</li> <li>Original Clearstory structure and form</li> </ul> | Exceptional |

| <ul style="list-style-type: none"> <li>– Exposed wall and pilaster indicating original floor heights in cinema – Bay 5</li> <li>– Evidence of 1949 rendered finishes Bay 3</li> <li>– Sliding loading doors (form-material except glazing)</li> <li>– Concrete flooring over original timber boards in Bays 2, 3 &amp; 4</li> <li>– Timber skirting in Bay 1</li> <li>– Lath &amp; plaster ceiling with pitch over the windows forming dormers on west, north &amp; east elevations, Bay 1</li> <li>– Moulded timber architrave and door joinery, Bay 1</li> <li>– Original internal door joinery, Bay 1 (except door to office)</li> <li>– Original fireplace to caretaker suit, Bay 1</li> <li>– Original fireplace to office 3, Bay 1 (surrounds new)</li> <li>– Early shower fittings/pipes probably from the 1950s Bay 1 –caretaker's suite</li> </ul> | High |

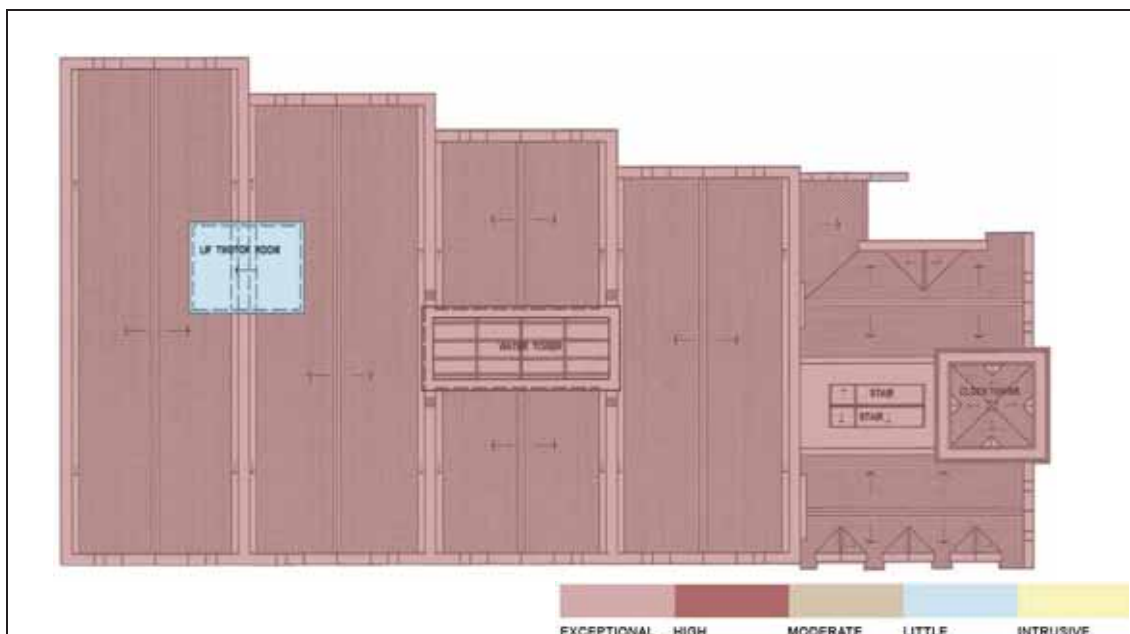
## Roof

| <ul style="list-style-type: none"> <li>Overall sawtooth and gabled form and slate roofing</li> <li>Clearstory, water tower and clock tower</li> </ul> | Exceptional |
| <ul style="list-style-type: none"> <li>Lead capping, flashing and box guttering</li> <li>Face brick chimneys with rendered top</li> </ul> | High |
| <ul style="list-style-type: none"> <li>Lift motor room</li> <li>Air-conditioning condensers</li> <li>Various wiring, light fittings, signage, piping and access ladders</li> </ul> | Little |

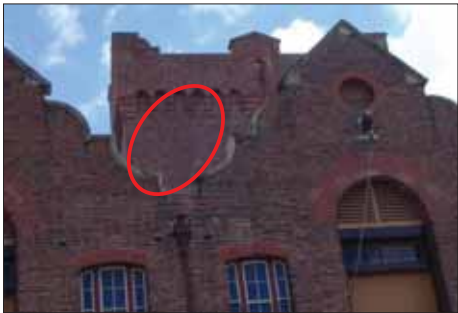
| Schedule of Conservation Works<br>Former Australasian Steam Navigation Company Building | | | |
|---|---|---|---|
| Clock Tower and Water Tower | Excellent | Exceptional to High | <u>Immediate work (0-6 months)</u> <ul style="list-style-type: none"> <li>- Inspect and monitor existing crack at the top section of eastern façade of the Water Tower rectify as required. Consult a structural engineer if necessary.</li> </ul> <u>Conservation works (6 month – 2 years)</u> <ul style="list-style-type: none"> <li>- Inspect regularly for any defect, missing mortar joints or structural movements as part of ongoing maintenance work programme</li> <li>- Clean as part of the overall façade cleaning</li> <li>- Monitor corrosion and defect to wrought iron, and slipped slate, ridge capping.</li> </ul> |

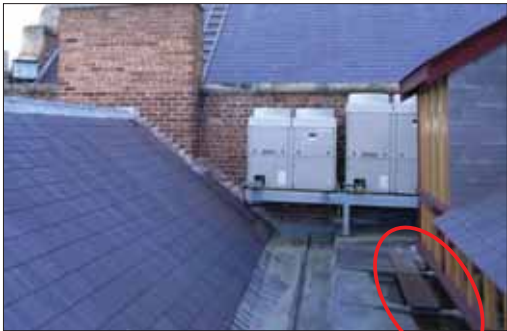
| Schedule of Conservation Works<br>Former Australasian Steam Navigation Company Building | | | |
|---|---|---|---|
| Roof | Fair to Good | Exceptional to High | <p><u>Immediate work (0-6 months)</u></p> <ul style="list-style-type: none"> <li>- Inspect the small puddle east side of the Clearstory. Ensure the slope of the roofing is rectified to redirect the water to the gutter.</li> </ul> <p><u>Conservation works (6 month – 2 years)</u></p> <ul style="list-style-type: none"> <li>- Check over slate roofing, box gutters, flashing and capping throughout, repair as part of the ongoing maintenance programme</li> <li>- Inspect chimneys for missing mortar joints, and slipped flashing at roof joints as part of ongoing maintenance programme</li> </ul> |

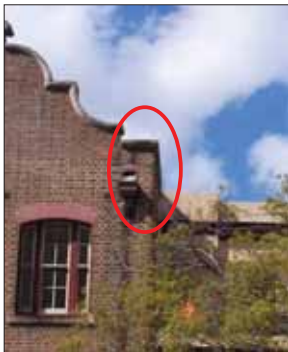
| Schedule of Conservation Works<br>Former Australasian Steam Navigation Company Building | | | |
|---|---|---|---|
| Walls | Good | Exceptional | <p><u>Immediate work (0-6 months)</u></p> <ul style="list-style-type: none"> <li>- Inspect crack at the top gable end of Bay 5 above southern most rainwater head, repair and ensure no structural issue or safety hazard occurs</li> </ul> |
