## **D.4 Hydrology Memorandum**

**To** European Energy  
**From** Corey Pontifex  
**Office location** Adelaide  
**Tracker code** 83000-5289-5-1  
**Date** 25/02/2026  
**Subject** **Mulwala BESS - Existing Water Assessment and Topographic Review**

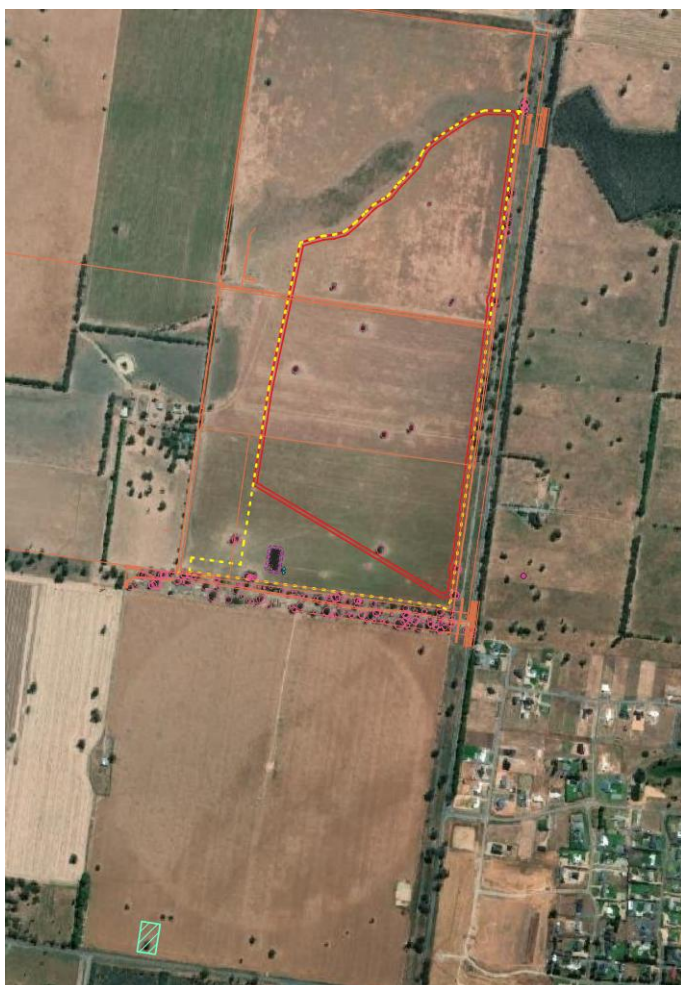
**Figure 1 Proposed BESS locations**

Fyfe has been engaged to review the suitability of the existing flood and water assessment in relation to the proposed relocation of the Battery Energy Storage System (BESS) for the Mulwala Solar Farm (SSD-9039) located north of Mulwala, New South Wales. The purpose of this report is to determine whether the conclusions of the original assessment remain valid for the new site location and to identify any additional considerations that may influence surface water behaviour. The previous and new site locations are shown in blue and purple respectively in Figure 1.
