Report on  
Preliminary Site Investigation

Australian Museum  
1 William Street, Sydney

Prepared for  
Australian Museum

Project 86582.00  
October 2018

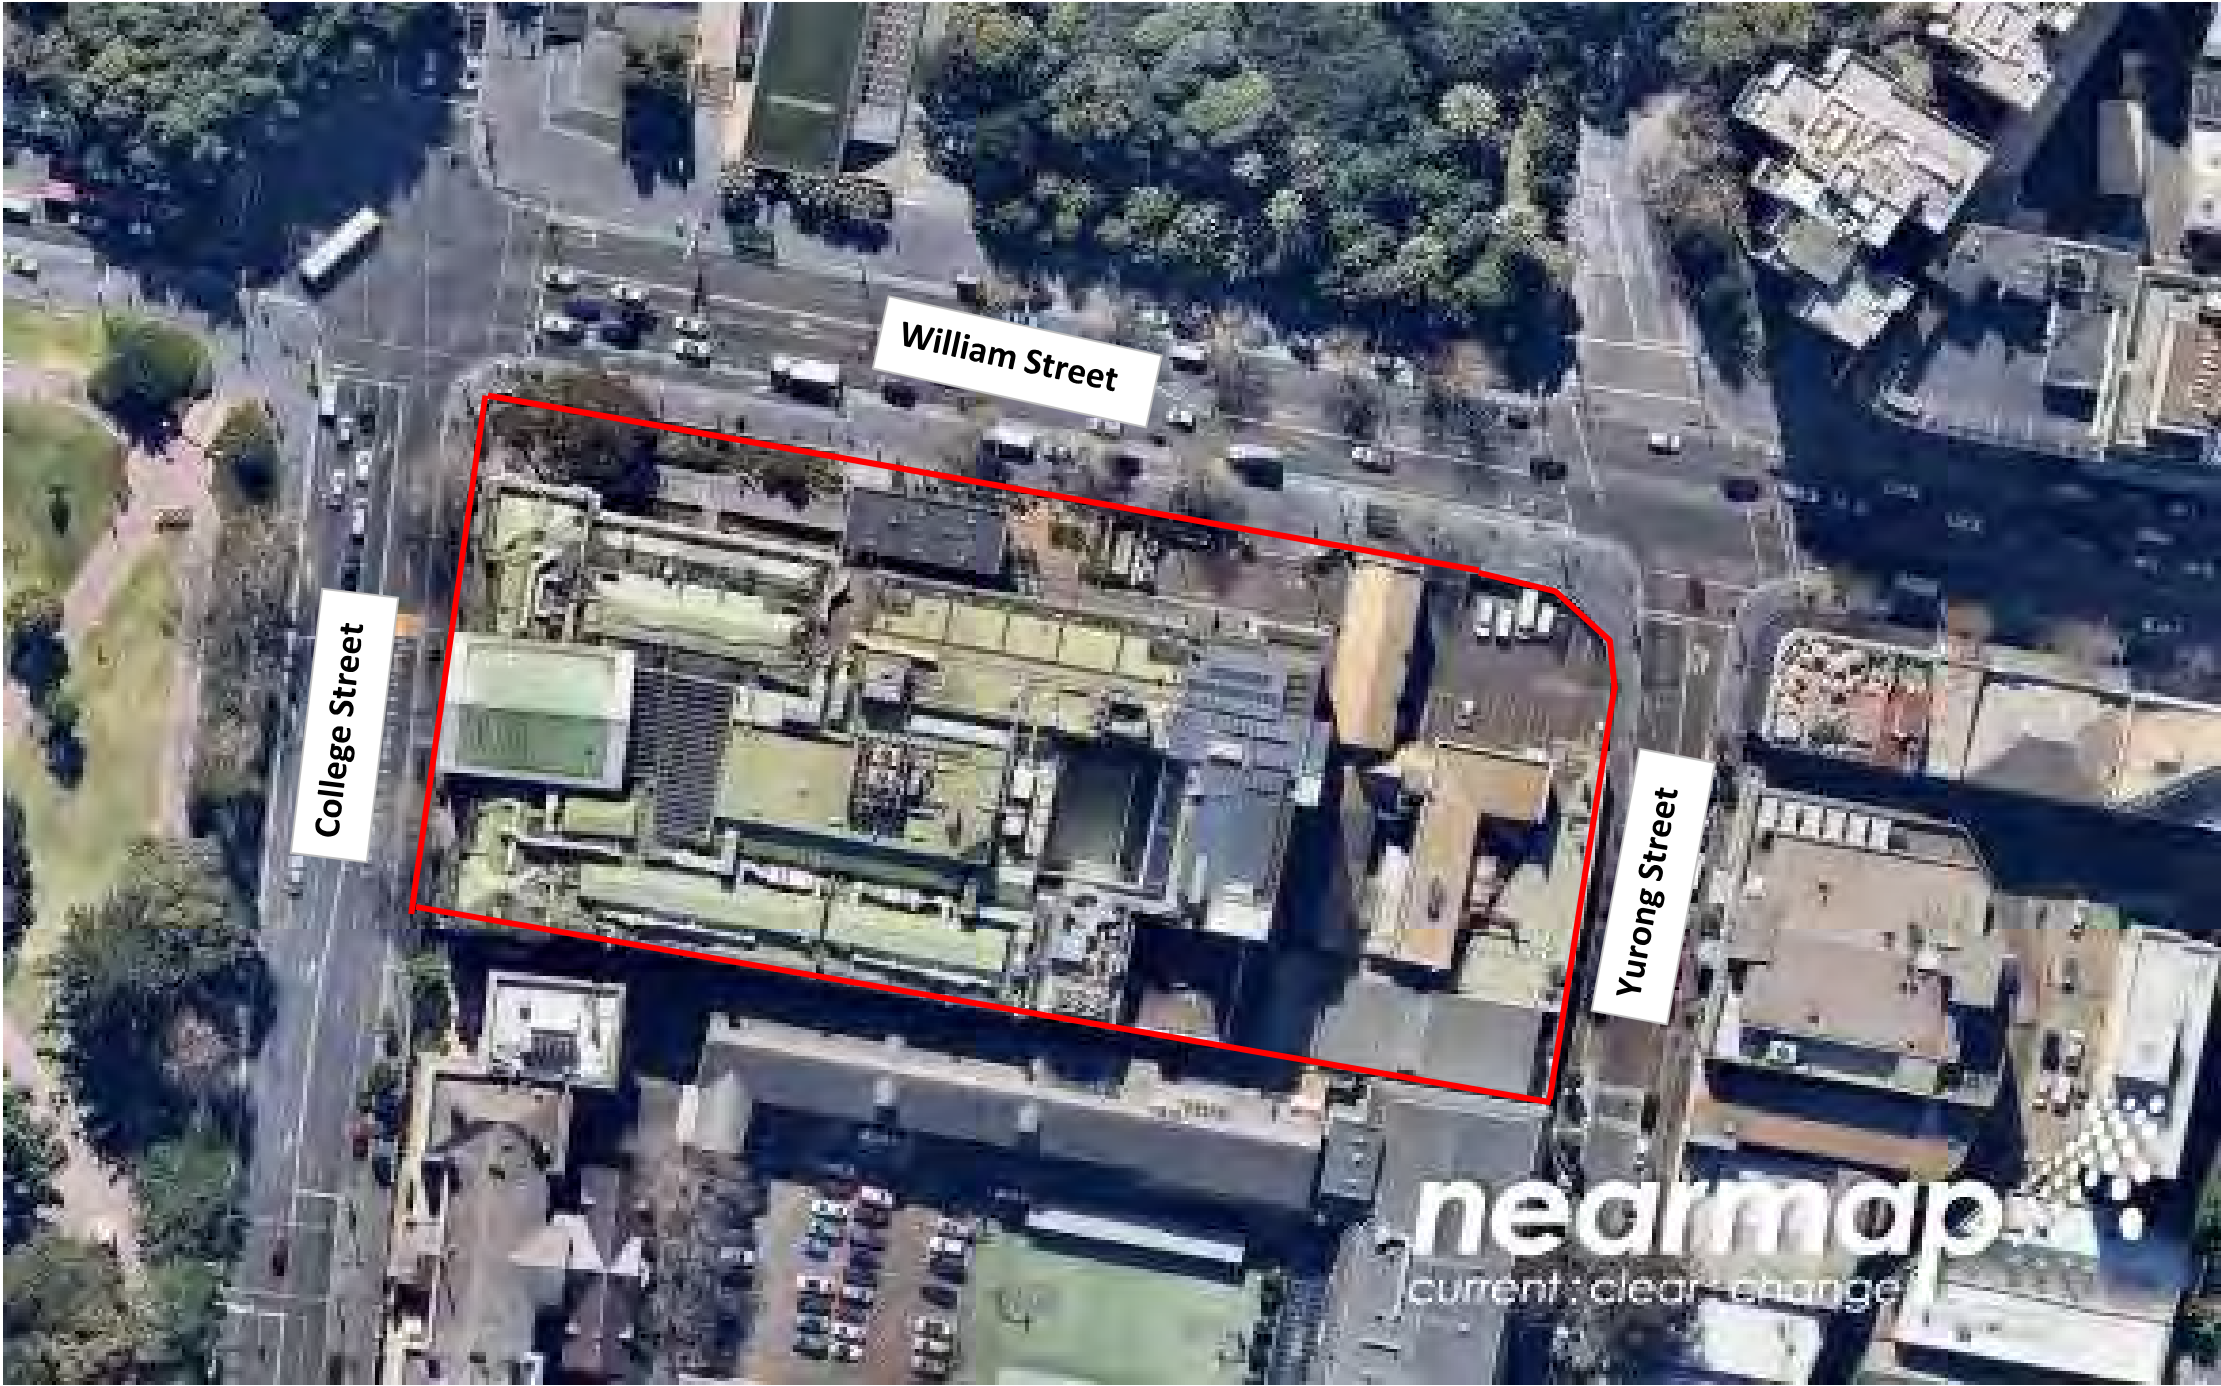
| <b>Douglas Partners</b><br><i>Geotechnics Environment Groundwater</i> | CLIENT: The Australian Museum | | TITLE: <b>Preliminary Site Assessment</b><br><b>Australian Museum</b><br><b>1 William Street Sydney</b> | PROJECT No: 86582.00 |
