McPhillamys Tailings Storage Facility (TSF) Risk Assessment

<i>Prepared for:</i>	LFB Resources NL, McPhillamys Gold Project
<i>Prepared by:</i>	Risk Mentor
<i>Author:</i>	<i>Dr Peter Standish</i>
<i>Date of Team Review:</i>	<i>8th and 12th March 2019</i>
<i>Job Number:</i>	<i>RM1979</i>
<i>Version:</i>	<i>1</i>
<i>Date:</i>	<i>3/07/2019</i>

McPhillamys Gold Project

TSF Risk Assessment

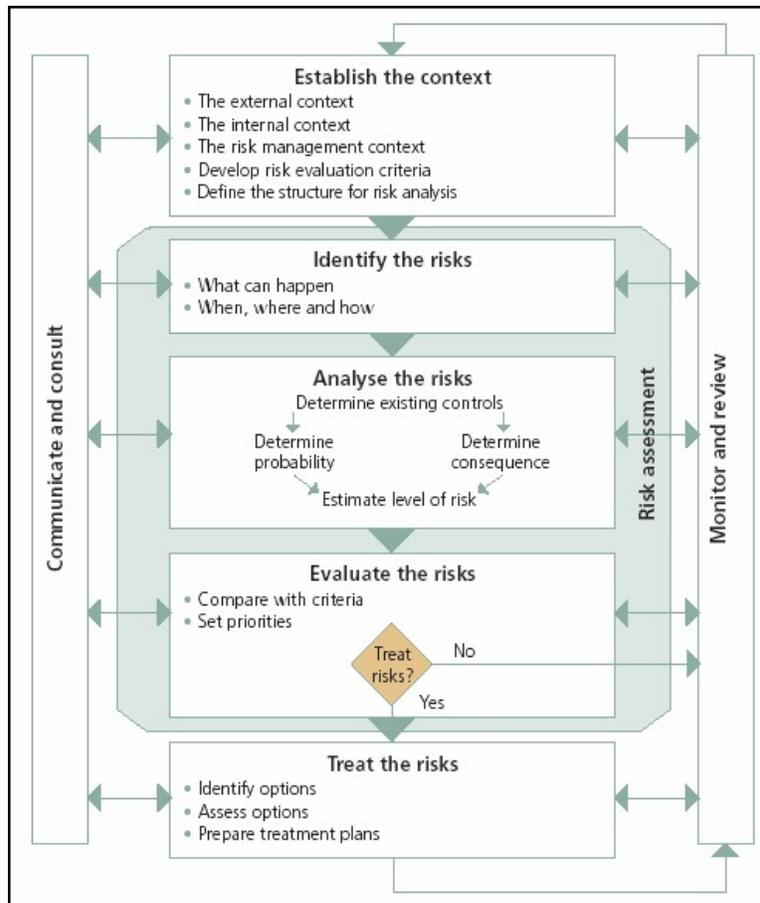
Figure 2 - Risk Management Process (AS/NZS ISO 31000:2018)

Source: after AS/NZS ISO 31000:2018.

The risk assessment process was based on the framework provided on Figure 2 (based on AS/NZS ISO 31000:2018, MDG1010 *Minerals Industry Safety and Health Risk Management Guideline* [NSW Department of Trade and Investment, 2011] and HB 203:2006 *Environmental Risk Management – Principles and Process* [HB 2003:2006]).

Figure 2 outlines the overall framework utilised for the TSF RA.

With respect to the overall framework (Figure 2), steps 1 to 3 above represent the ‘establish the context’ phase and step 4 represents the ‘identify risks’, ‘analyse risks’, ‘evaluate risks’ and ‘treat risks’ phases.

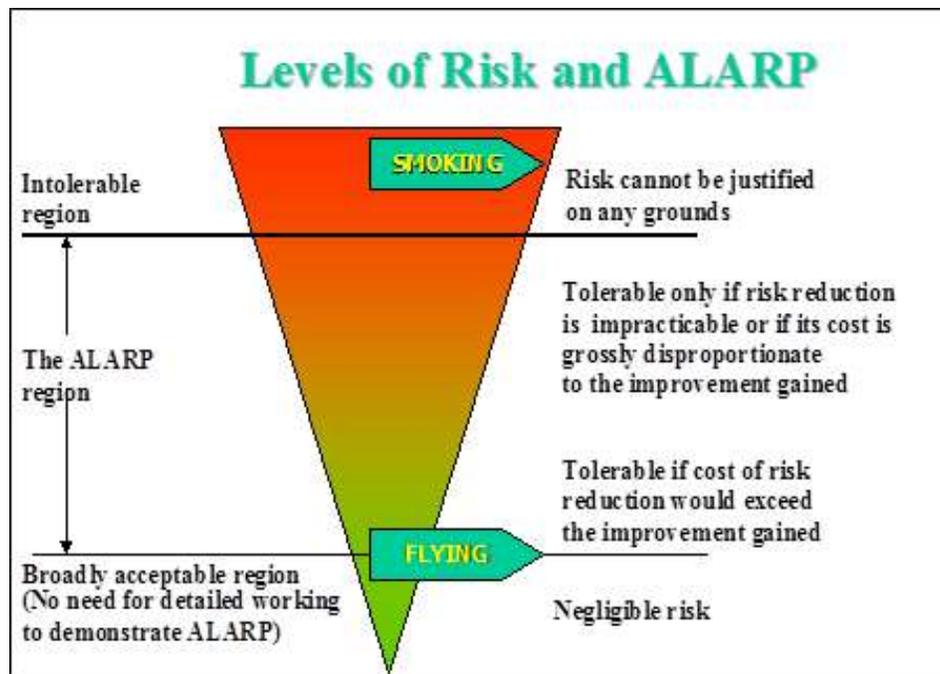
Figure 3 - Risk Criteria "ALARP"

The risk criteria utilised is to reduce the risk to As Low As Reasonably Practicable (ALARP) or lower. Figure 4 schematically shows the three risk management zones viz. intolerable, ALARP and tolerable. The middle zone is referred to as the ALARP zone.

Flying is an example of a risk considered by most people to be a tolerable risk; whilst smoking is generally considered to be an activity which cannot be justified from a risk perspective. This is shown graphically in Figure 4. Intolerable items such as smoking are at the top of the pyramid where much lower risks, such as flying, sit at the lower end of the ALARP zone (close to tolerable).
