# GEOTECHNICAL INVESTIGATION REPORT

Project Title – 166-174 Blaxland Rd, Ryde

Project Type – Proposed Multistorey Residential Flat Building with 4 basements

Description of Services – Geotechnical Investigation Report

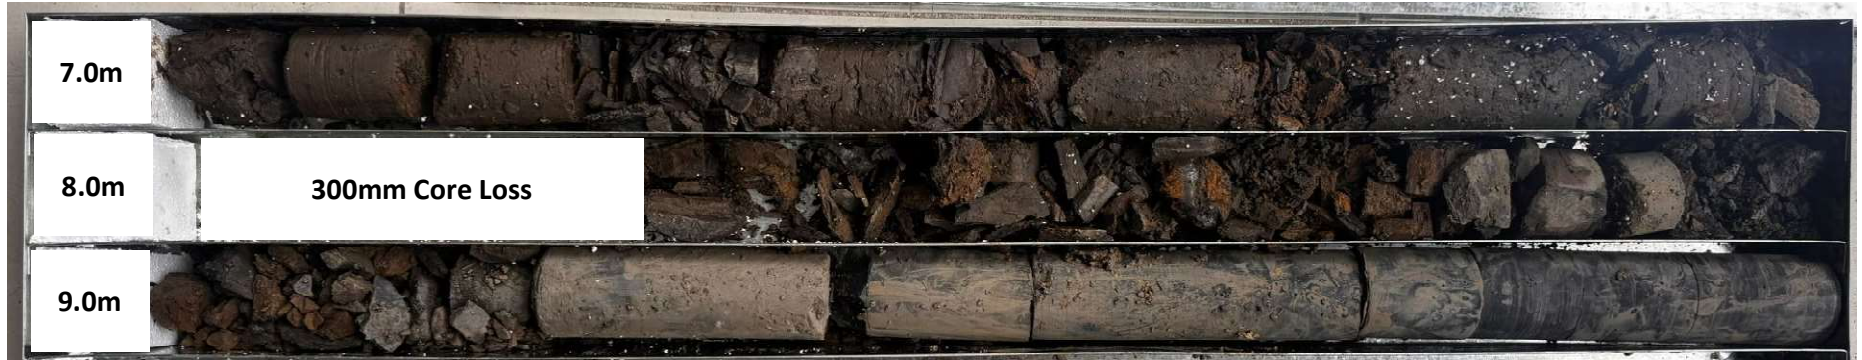
UTM : 56H  
Easting (m) : 324556.41  
Northing (m) : 6257179.99  
Ground Elevation : 48.80 (m)  
Total Depth : 13 m BGL

Excavator : Track Mounted Drilling Machine  
Excavator Supplier : Stratacore Drilling Pty Ltd  
Logged By : CEC Geotechnical  
Reviewed By :  
Date : 10/02/2026

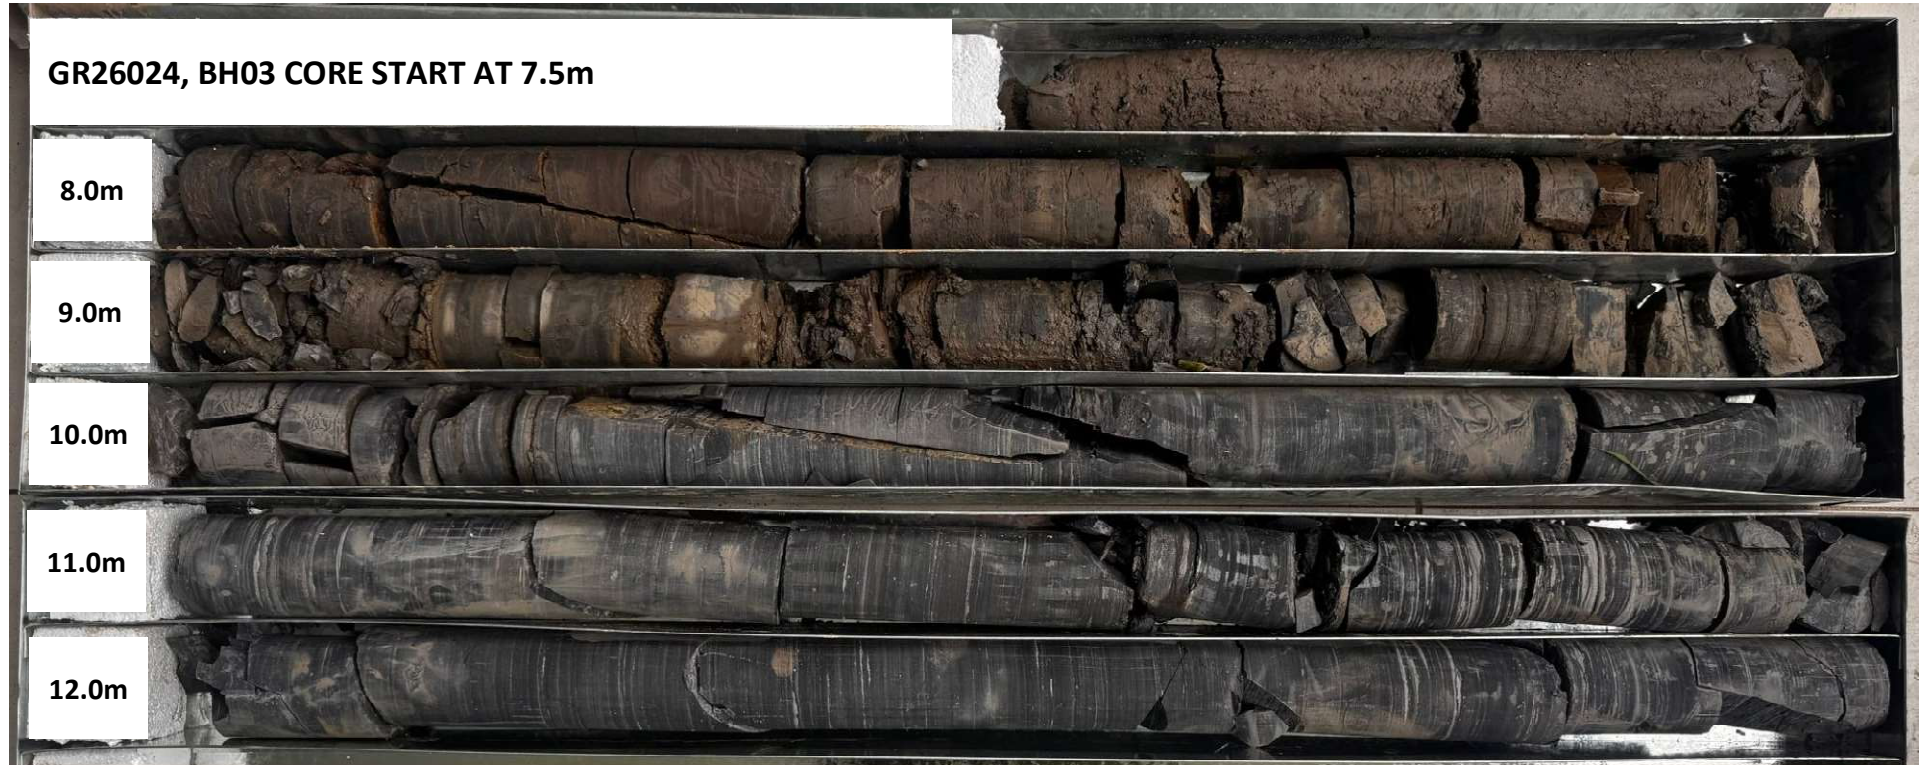
**UTM** : 56H  
**Easting (m)** : 324567.38  
**Northing (m)** : 6257167.65  
**Ground Elevation** : 53.80 (m)  
**Total Depth** : 15 m BGL

**Excavator** : Track Mounted Drilling Machine  
**Excavator Supplier** : Stratacore Drilling Pty Ltd  
**Logged By** : CEC Geotechnical  
**Reviewed By** :  
**Date** : 10/02/2026
