## **APPENDIX K      BLADE THROW REPORT**

# Blade Throw Risk Assessment

## Hills of Gold Wind Farm

Project No.: 0550690

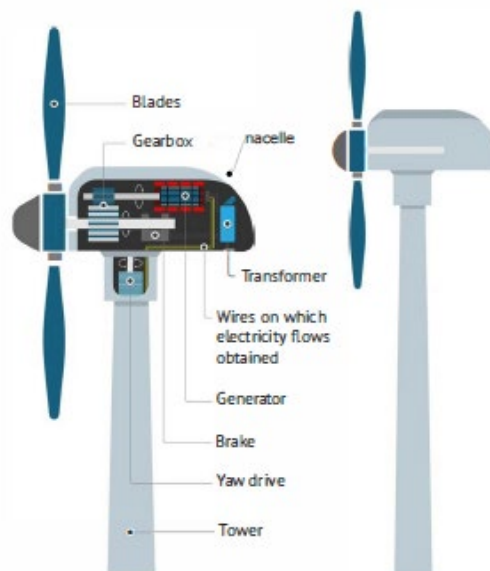
**Figure 3-1 Wind Turbine Components**

Preventing structural failures such as fatigue resistance of wind turbine subassemblies can, in addition, prevent the possibility of a blade throw event (MMI Engineering Ltd, 2013). A diagram of wind turbine subassemblies and components is depicted in Figure 3-1. Data has indicated that subassembly failure frequencies are reducing with time, which has been correlated to improvements in design and manufacturing (Ribrant & Bertling, 2007). The causes for wind turbine blade failures may also include extreme environmental conditions, incorrect design for ultimate or fatigue loads, extremely low strength of the materials, failure of turbine control system, and human error (Carbone & Afferrante, 2013; Rastayesh, et al., 2019).
