Bayswater Power Station - Water and Other Associated Operational Works Project

EIS Response to Submissions - Water

IS353800 Bayswater EIS RTS - Water | v01.01

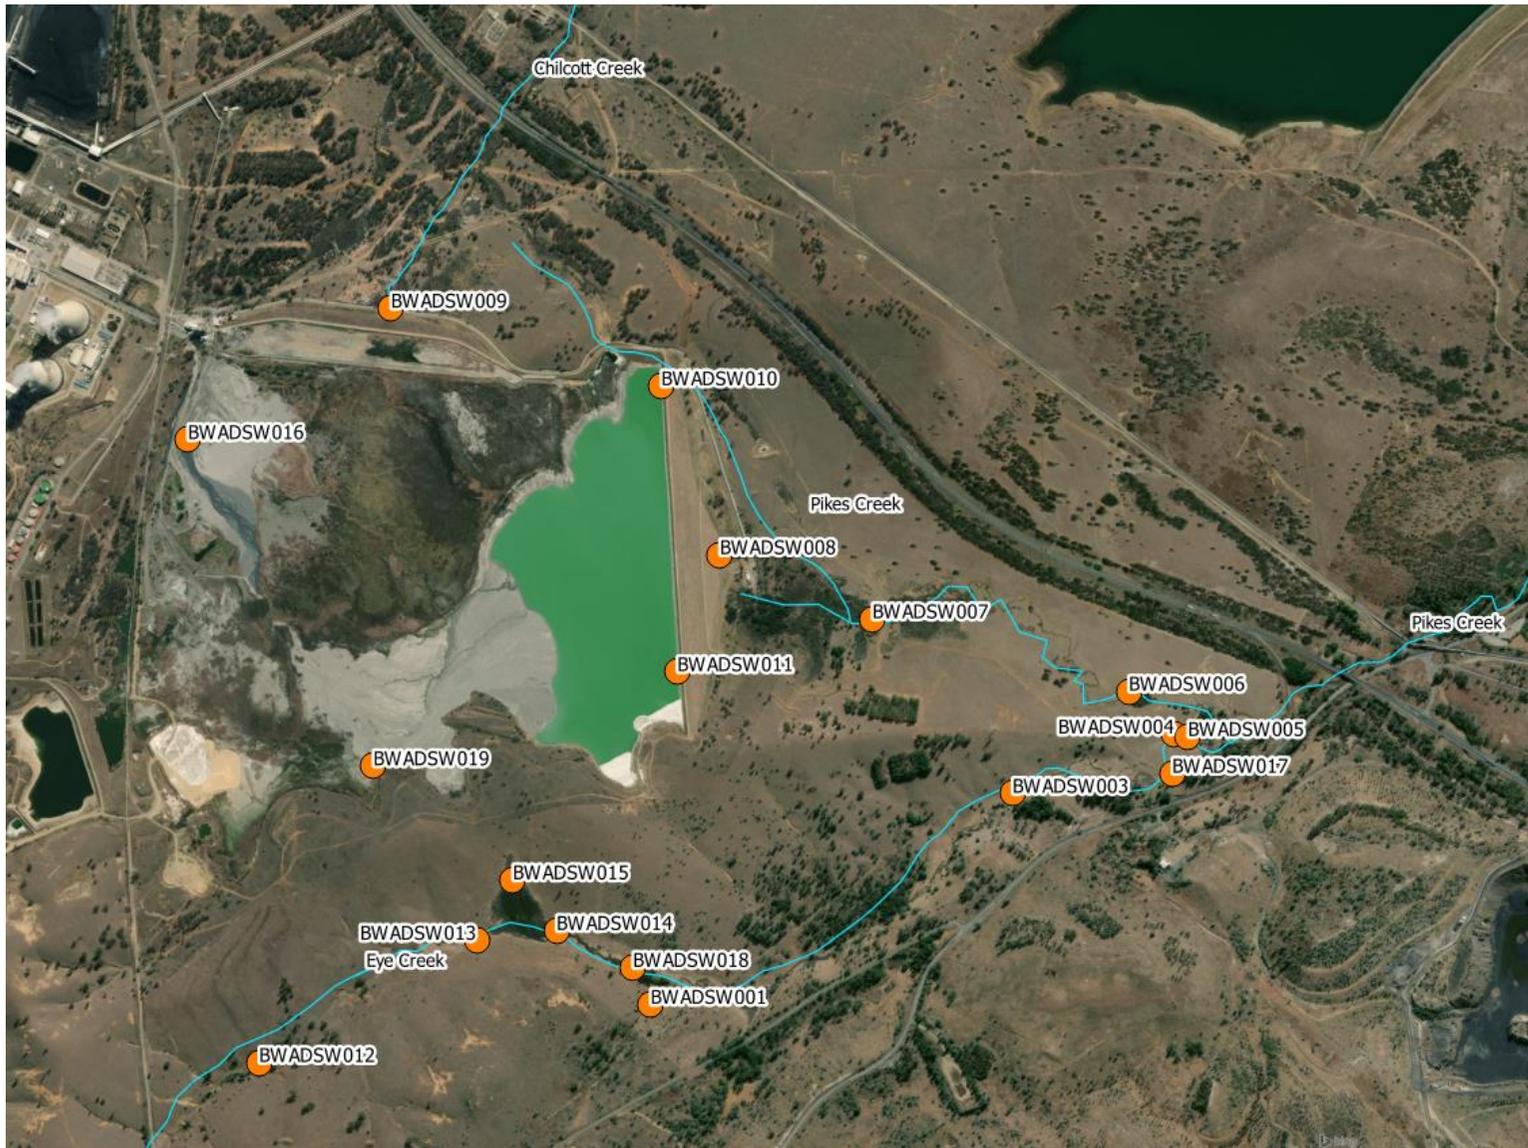
Figure 4.2: Sample locations - 12 October 2020 (Jacobs)

Figure 4.2 shows the locations of the Jacobs 2020 sample points.

Figure 4.2 shows the locations of the Jacobs (2020) sample points.

The water collected from the pools is considered to be groundwater as the creek was dry after a prolonged dry spell and the pools were in particularly deep section of the creek. Therefore, the water is considered daylighting groundwater that is likely representative of the alluvium groundwater quality at those locations. The water quality of the alluvium in Eye Creek is likely to be a combination of surface water runoff, water seepage from the BWAD and discharge from coal seams in the area. Figure 4.2 shows the locations of the Jacobs (2020) sample points.

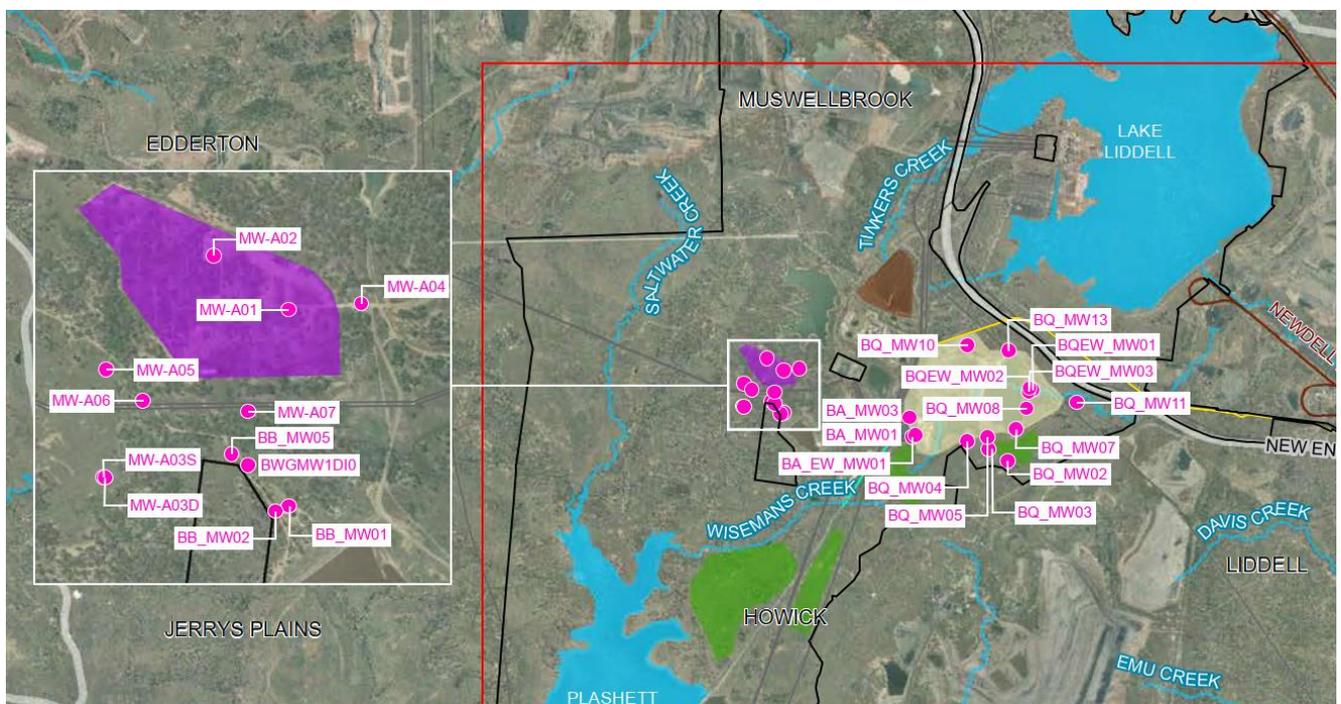
Figure 4.3: AGL Bayswater groundwater monitoring locations (sourced: Jacobs 2020b)

Existing groundwater quality data is available for Project assessment groundwater monitoring bores. The bores were sampled during multiple rounds and field tested (field parameters only) and laboratory tested for the range of analytes. There are 27 groundwater monitoring bores across four key Project elements (refer Figure 4.3), including the ash dam augmentation, salt cake landfill, periphery of the north eastern potential borrow pit area and the Ravensworth Ash Line:

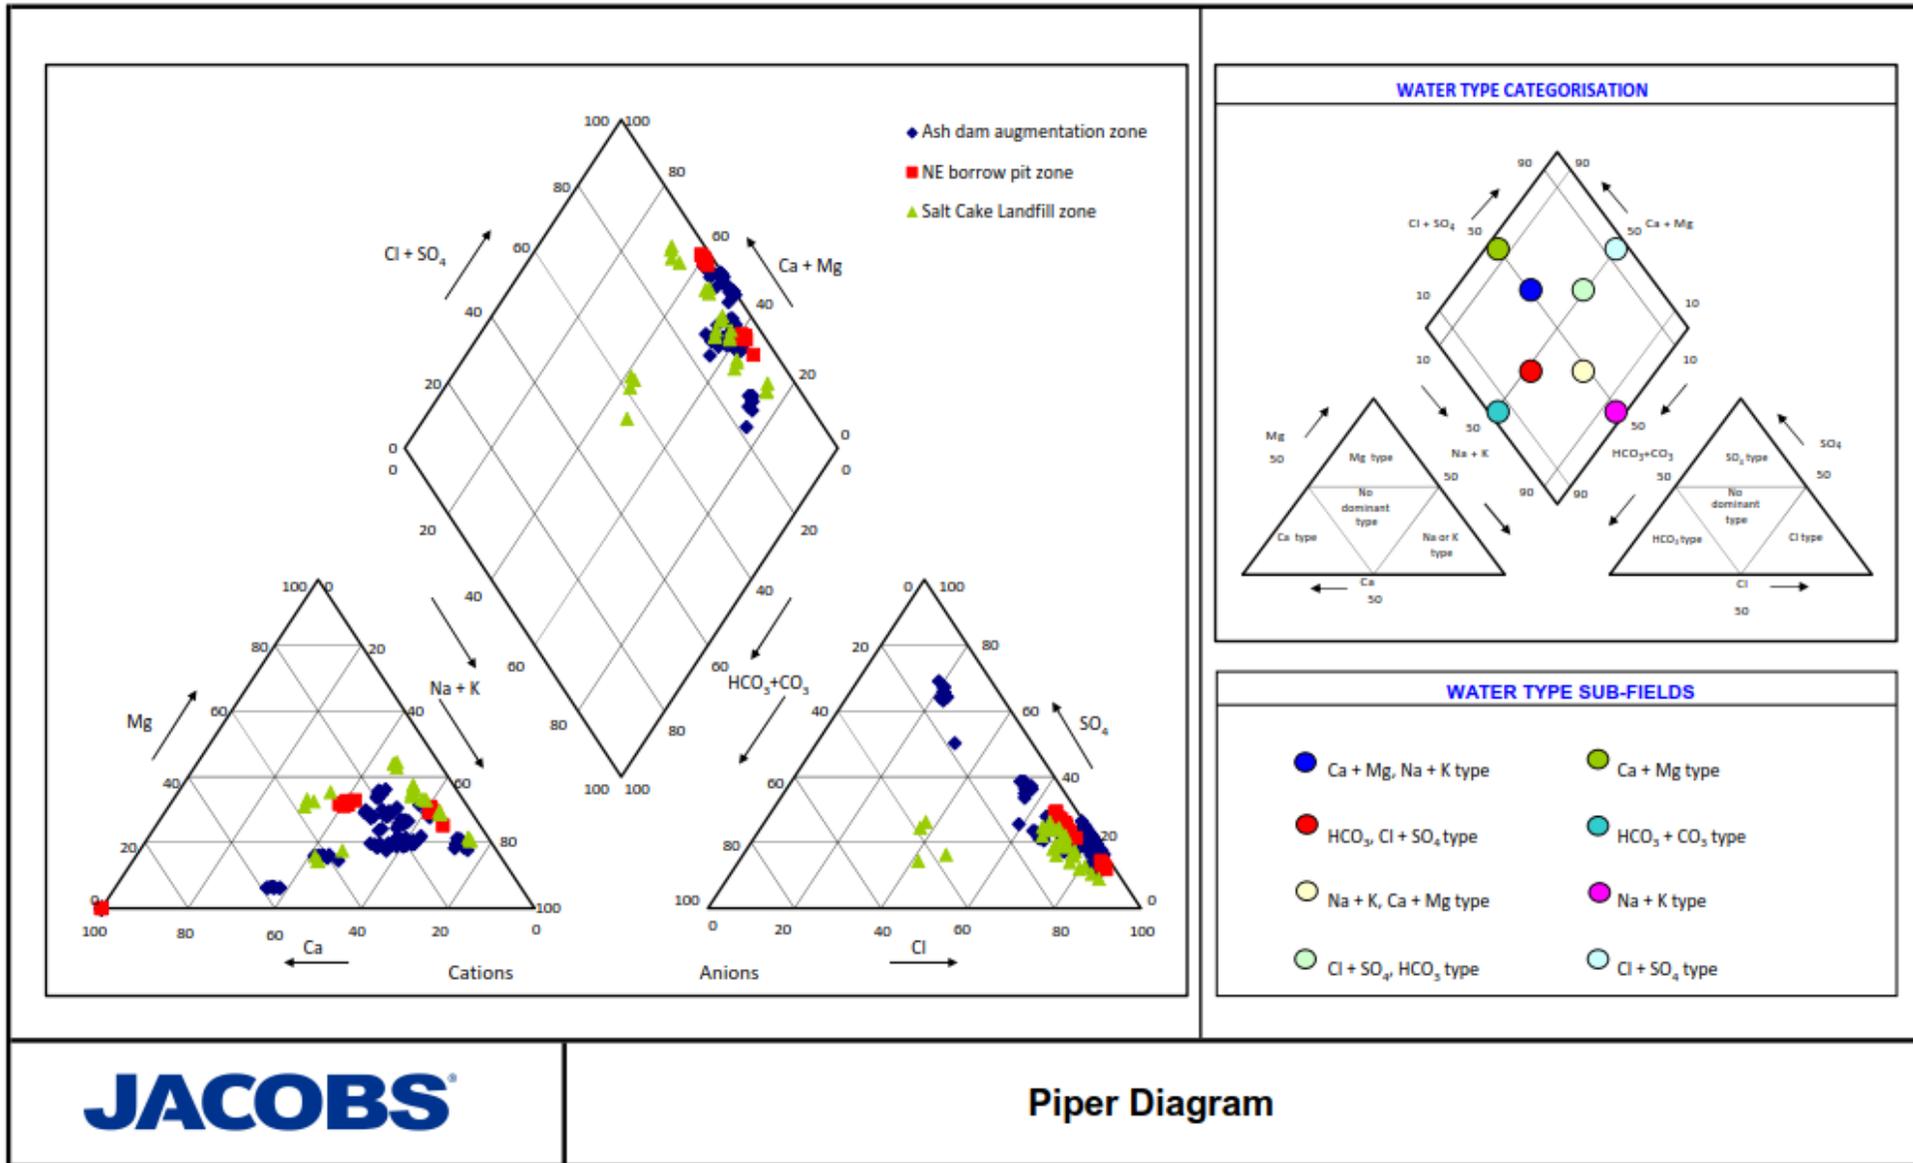
Figure 4.4: Piper plot of major cations and anions - historic data (Jacobs 2020a)

In order to characterise the existing groundwater quality, the major and minor ions are presented in a piper plot in Figure 4.4. The piper plot indicates the groundwater of the Project monitoring bores is generally split between sodium chloride and calcium chloride water types. MW_A04 (middle samples in diamond portion of plot) associated with the Salt cake landfill, has a distinct groundwater quality signature compared to other Project bores (refer Figure 4.4). This location is characterised by no dominant water type (Jacobs 2020b).

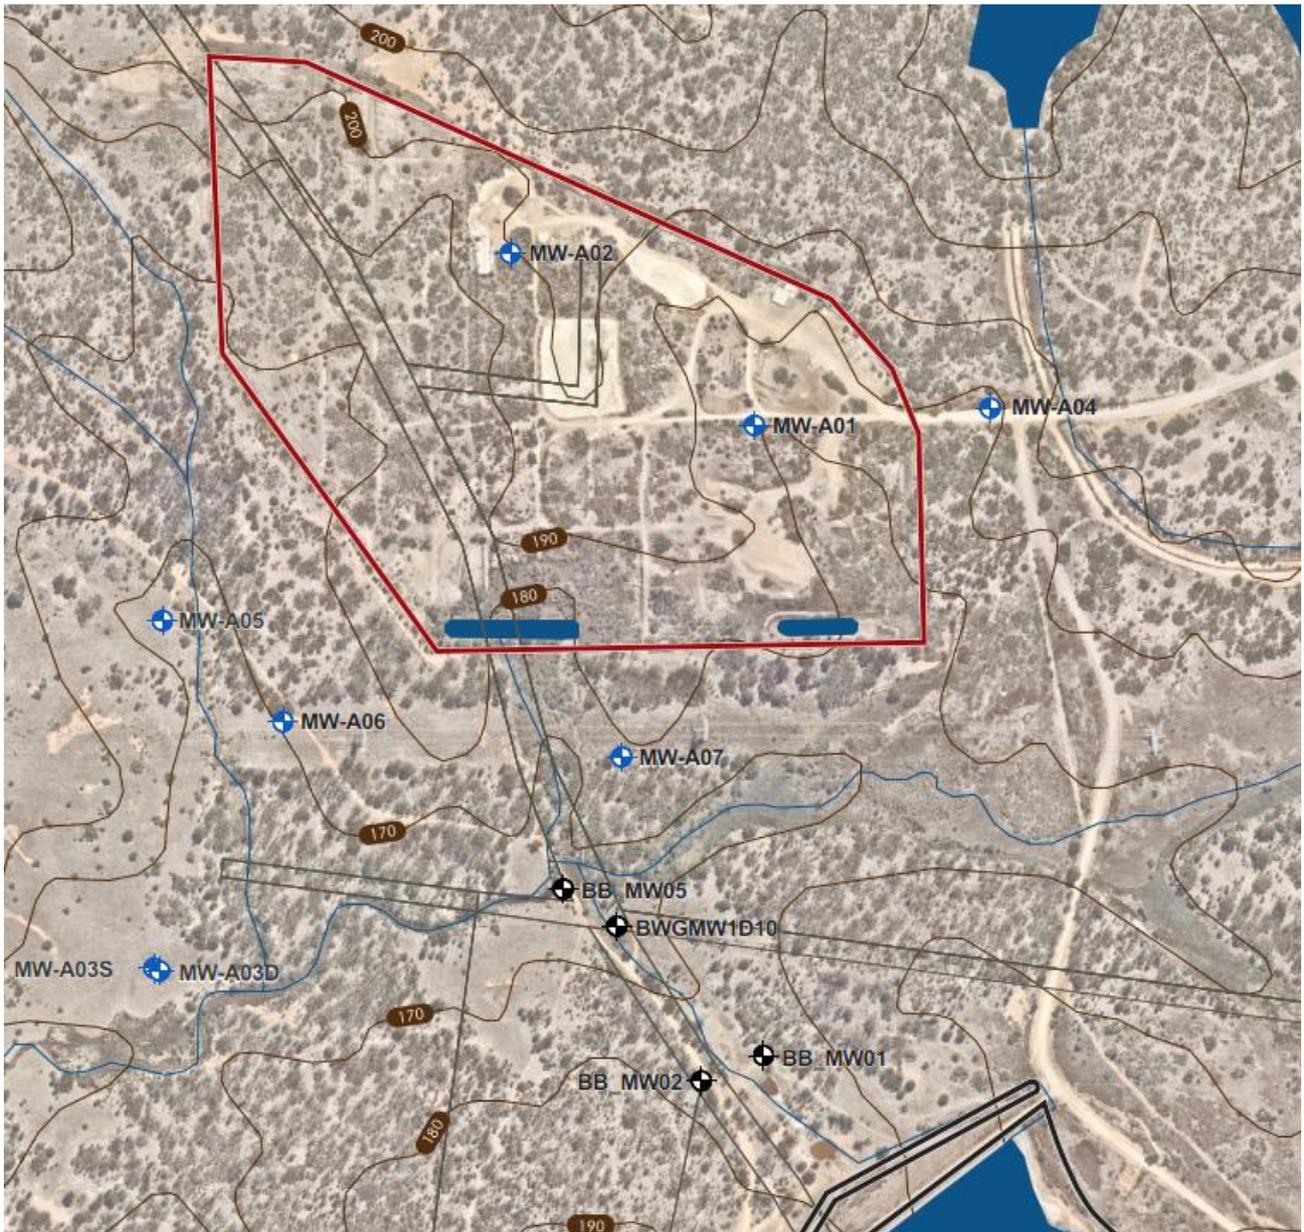
Figure 8.1: Salt cake landfill groundwater monitoring locations (source AECOM 2018)

A groundwater monitoring plan is proposed to be established prior to construction to monitor the construction, operation and closure phases of the landfill. The existing groundwater monitoring locations at the proposed landfill site were sampled by AECOM in 2018 (AECOM 2018). The location details are summarised in Table 8.1 and shown on Figure 8.1. Six of the eight monitoring bores are positioned suitably to undertake pre-construction, construction, operation and post-closure phase monitoring, and will provide a long-term data set that can be used to assess for potential leakage from the landfill. The AECOM (2018) report constitutes the initial data for a baseline.

Well ID	Easting (GDA94z56)	Northing (GDA94z56)	Location	Rationale	Targeted Formation
MW_A01	305816.63	6413458.77	The proposed waste salt cake storage site	Obtain baseline groundwater information within the proposed waste salt cake storage. It is particularly important to know how deep the water table is at this location. These monitoring wells will be destroyed during the construction of the waste salt cake storage.	Siltstone aquifer
MW_A02	305587.76	6413623.26			
MW_A03S	305253.77	6412946.96	Down-gradient of the proposed waste salt cake storage site. Nested with MW_A03D	Obtain baseline groundwater information down-gradient of the proposed waste salt cake storage site. Only down-gradient location where groundwater was evident in the shallow unconsolidated aquifer.	Unconsolidated alluvial aquifer
MW_A03D	305257.63	6412945.30	Down-gradient of the proposed waste salt cake storage site. MW_A03D is nested with MW_A03S.	Obtain baseline groundwater information down-gradient of the proposed waste salt cake storage site, at varying distances and down-gradient directions from the site.	Siltstone aquifer

MW_A05	305261.62	6413275.29	Upgradient of the proposed waste salt cake storage site.	Obtain baseline groundwater information up-gradient (north-east) of the proposed waste salt cake storage site.	Siltstone aquifer
MW_A06	305374.61	6413180.21			
MW_A07	305691.99	6413146.82			
MW_A04	306038.09	6413476.95
