Report on  
Geotechnical Investigation

Proposed Sydney Swans HQ & Community Centre  
Royal Hall of Industries, 1 Driver Avenue, Moore Park

Prepared for  
Sydney Swans Limited  
c/- APP Corporation Pty Ltd

Project 86724.00  
May 2019

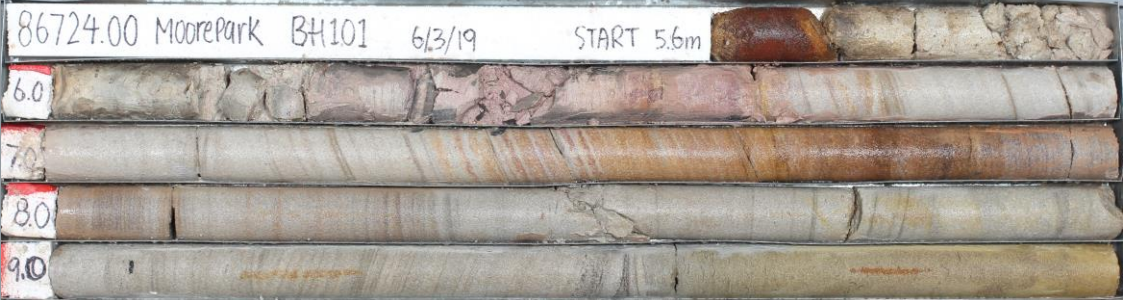
Project No: 86724.00  
BH ID: BH101  
Depth: 5.6-10.0m  
Core Box No.: 1051

5.60 - 10.00m

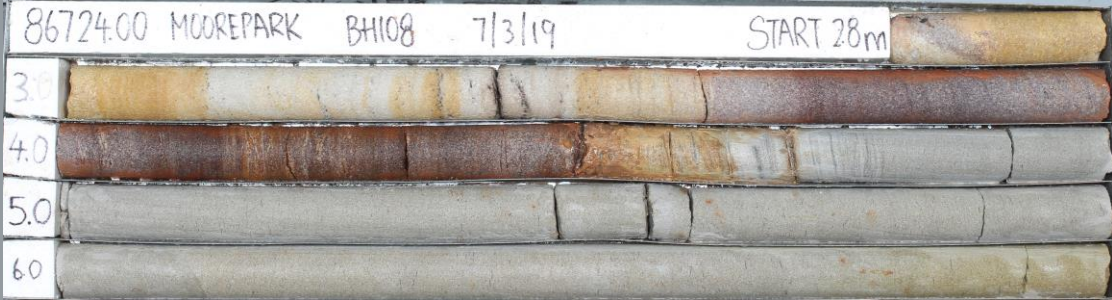
Project No: 86724.00  
BH ID: BH108  
Depth: 2.8-7.0M  
Core Box No.: 2092

2.80 - 7.00m

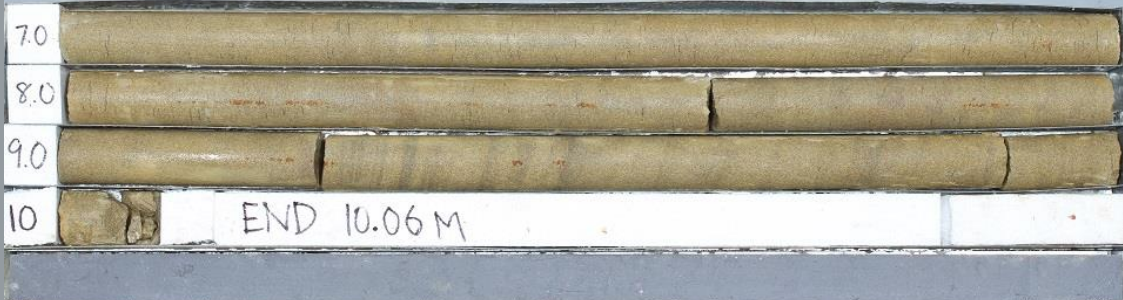
Project No: 86724.00  
BH ID: BH108  
Depth: 7.0-10.06m  
Core Box No.: 2092

7.00 - 10.06m

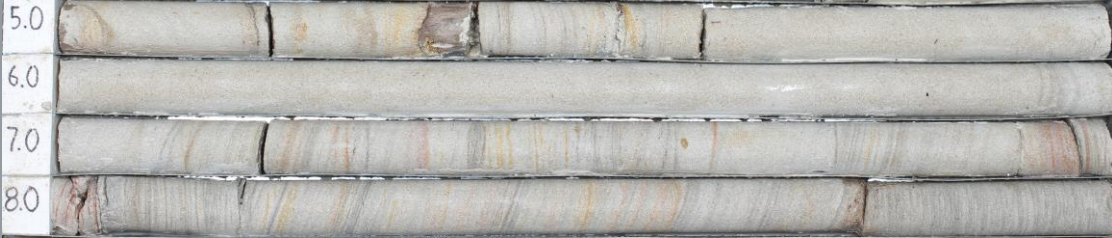
86724.00  
MOORE PARK  
BH109 03/19  
START  
4.3m

4.30 - 9.00m

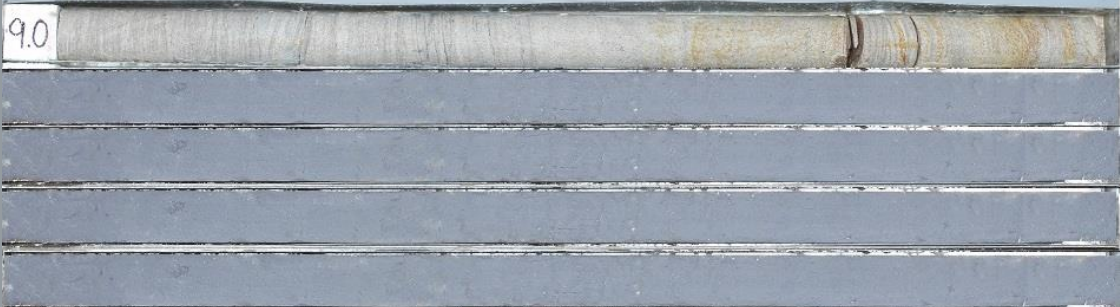
Project No: 86724.00  
BH ID: BH109  
Depth: 9.0 - 10.0  
Core Box No.: 2052

9.00 - 10.00m
