# Site Audit Statement

Site audit statement no. 0088\_IDG

Address        9 Church Street, Newcastle NSW

The objective of the LTEMP is to provide awareness of the contamination managed on site and prevent and manage breaching of the cap. The LTEMP promotes awareness of the contamination management and the requirements to avoid disturbance (where possible) and provides an outline of maintenance requirements. It is noted that only passive management measures are required.

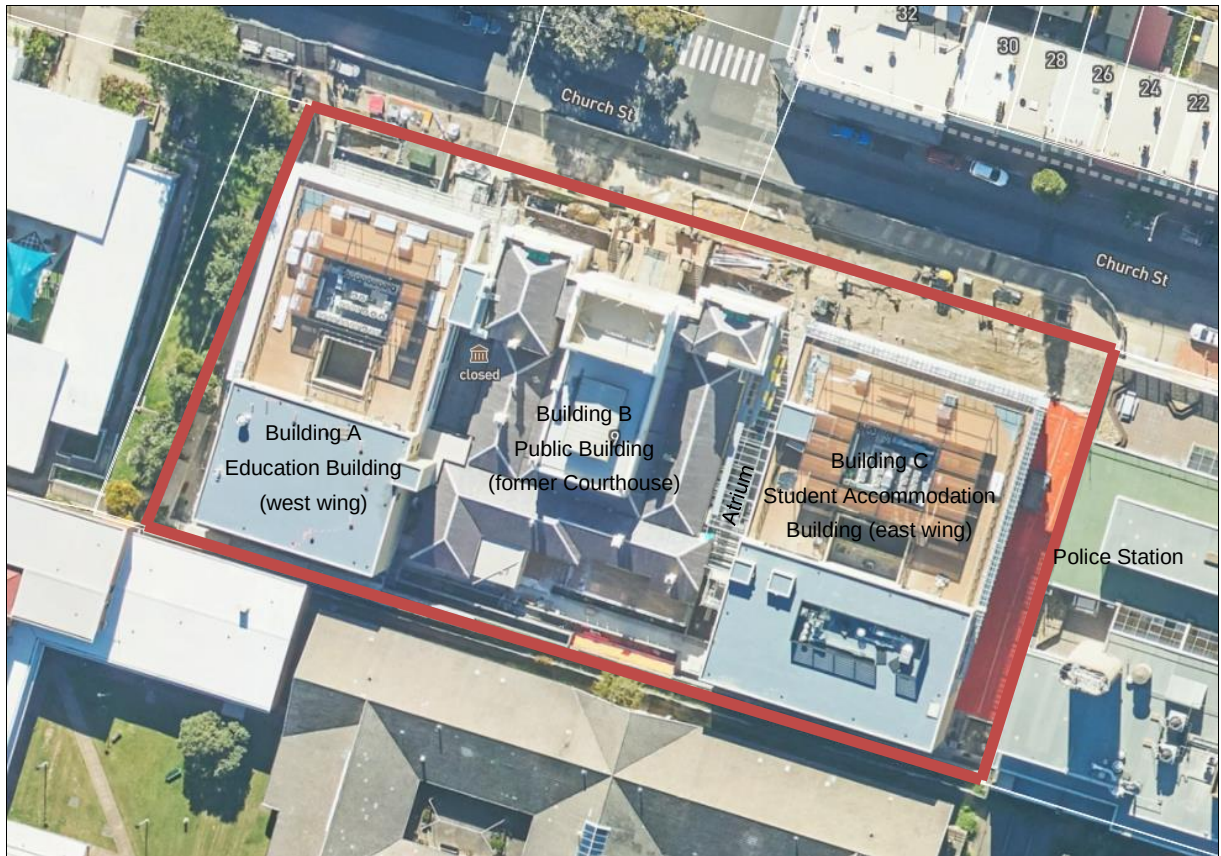
**Figure 1: Approximate extent of development area ('the site') in red, Nihon University (Metromap Image dated 6 June 2021)**

The site is shown on Drawing 1 in Appendix C and Figure 1 below.

Geosurv Asbuilt Remediation Layers Plan and Figure 1 above indicates the location of the areas to be managed under this LTEMP. As a precautionary measure, all materials beneath the marker layers, pavements or buildings across the site as indicated in Geosurv Asbuilt Remediation Layers Plan and Figure 1 must be treated as potentially contaminated in the event that the capping is penetrated. It is noted that the stormwater pipeline trench excavated within the HWC easement located parallel to the eastern side of the former Courthouse (Now central Public Building) was backfilled with 'clean' materials in the event that future maintenance or replacement was required (albeit unlikely). Further details on the management of the HWC easement is provided in DP (2020b).

The site is subject to long-term management (as shown in Figure 1 above and Geosurv Asbuilt Remediation Layers Plan in Appendix C) due to the potential presence of bonded asbestos containing materials (ACM) impacted soils beneath building slabs, pavements or landscape areas.

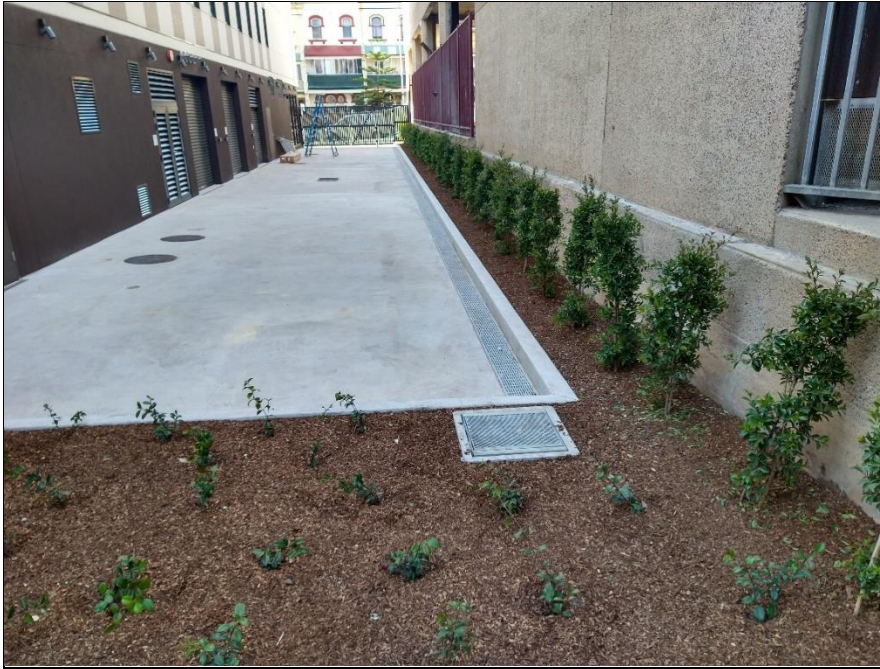
**Figure 10 – Looking north at concrete driveway and adjacent garden bed along the eastern site boundary (20 August 2021). Student Accommodation Building to the left and the Newcastle Police Station to the right.**

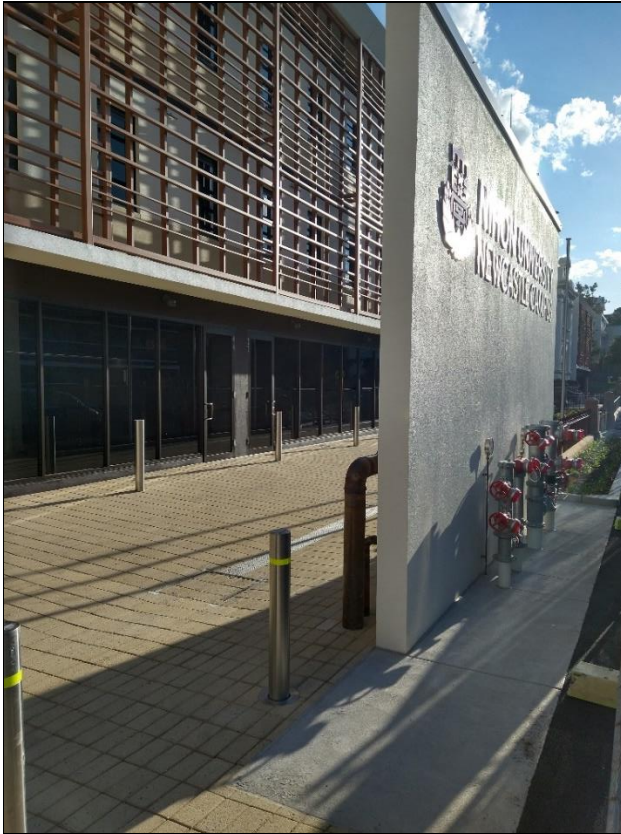
**Figure 12 – Looking west at concrete paved driveway/footpath along the north side (front) of the Student Accommodation Building (20 August 2021)**

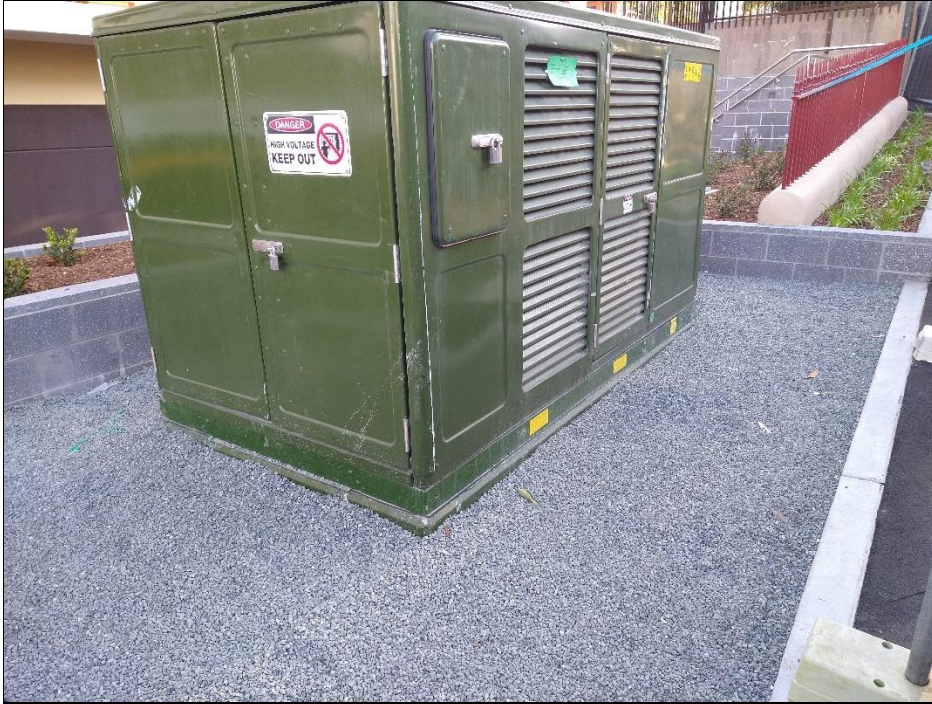
**Figure 18 – Looking west at electrical kiosk along the northern side (front) of the Education Building (20 August 2021)**

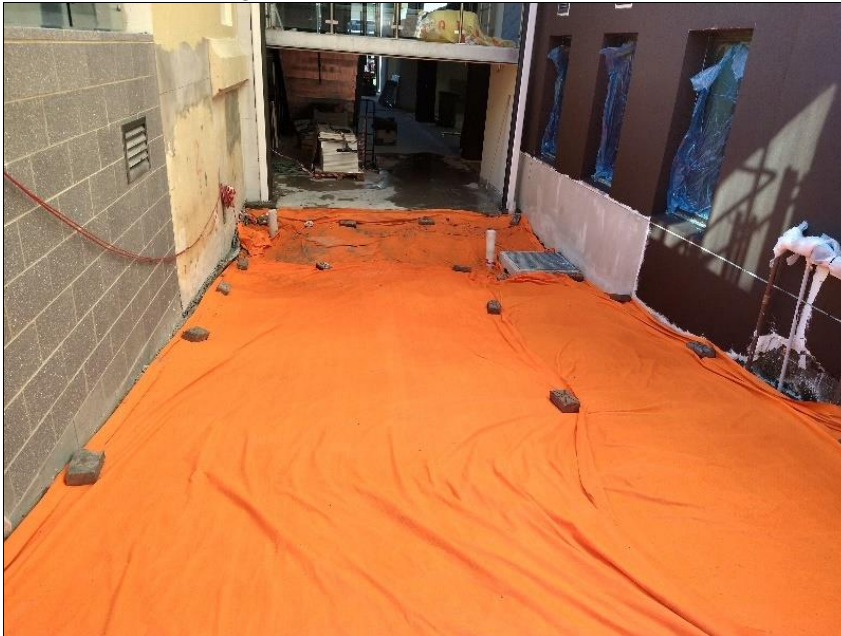
**Figure 23 – Orange geofabric marker layer in garden bed at the rear of the Atrium (16 July 2021)**

Typical placement of the orange geofabric marker layer beneath capping materials within landscape areas is shown in Figures 23 to 24 below.

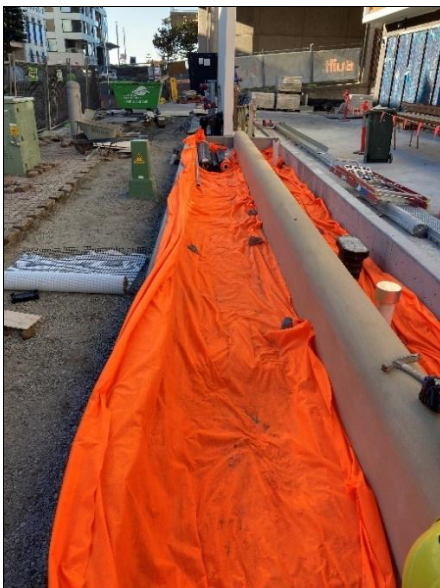
**Figure 24 – Orange geofabric marker layer within garden bed on northern (front) side of the Student Accommodation Building (22 July 2021 – supplied by Built)**

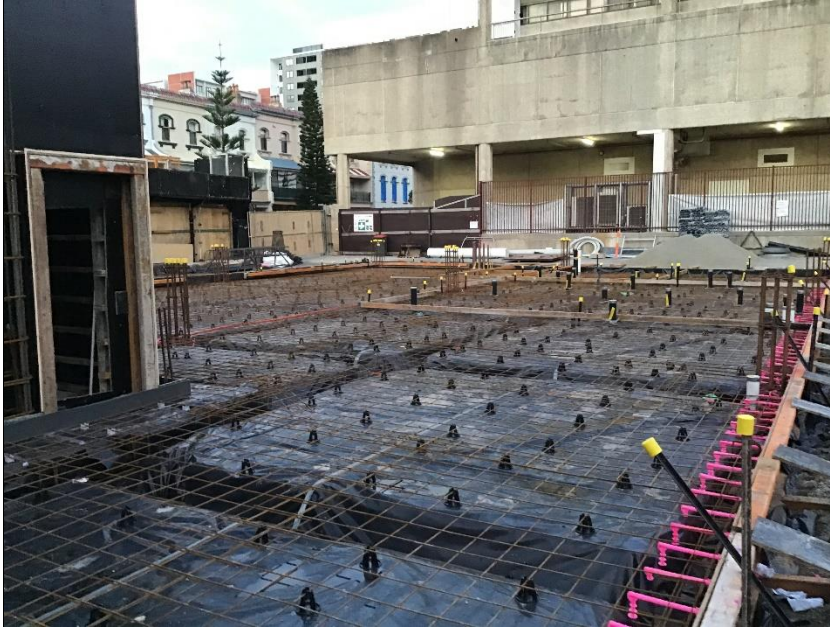
**Figure 25 - Black plastic marker layer beneath Student Accommodation Building concrete slab (30 July 2020 - supplied by Built)**

Typical placement of black plastic marker layer beneath concrete pavements within buildings and driveways is shown in Figures 25 to 27 below.

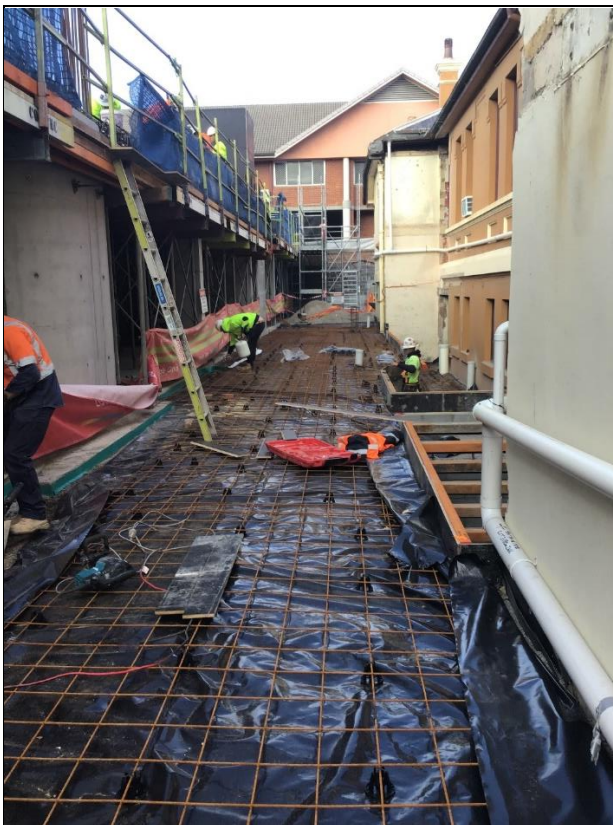
**Figure 26 - Black plastic marker layer beneath Atrium concrete slab (25 August 2020 - supplied by Built)**

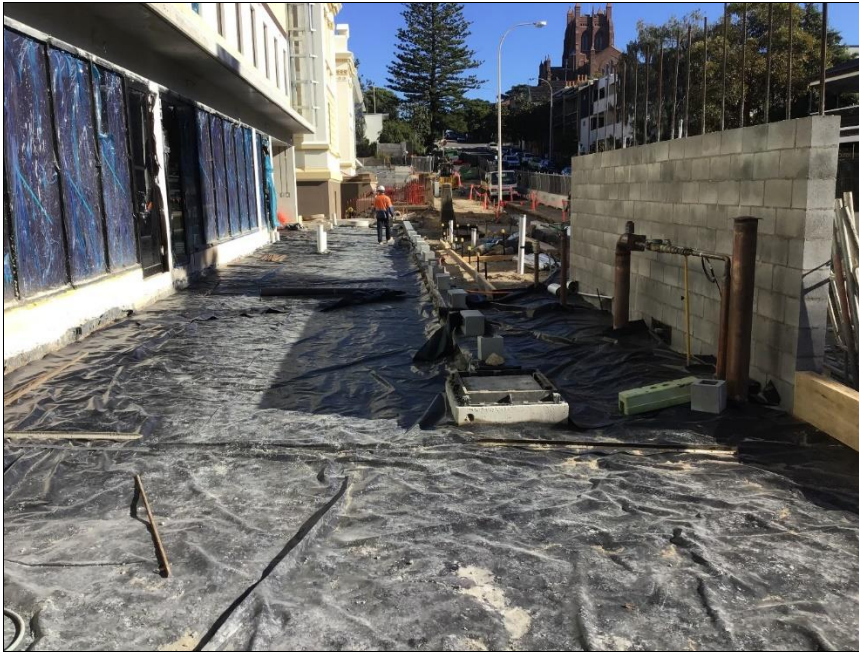
**Figure 27 – Black plastic marker layer beneath concrete pavement on northern (front) side of Student Accommodation Building (26 June 2021 – supplied by Built)**
