Chapter 18

Soils and contamination

Parramatta Light Rail Stage 2

Environmental impact statement

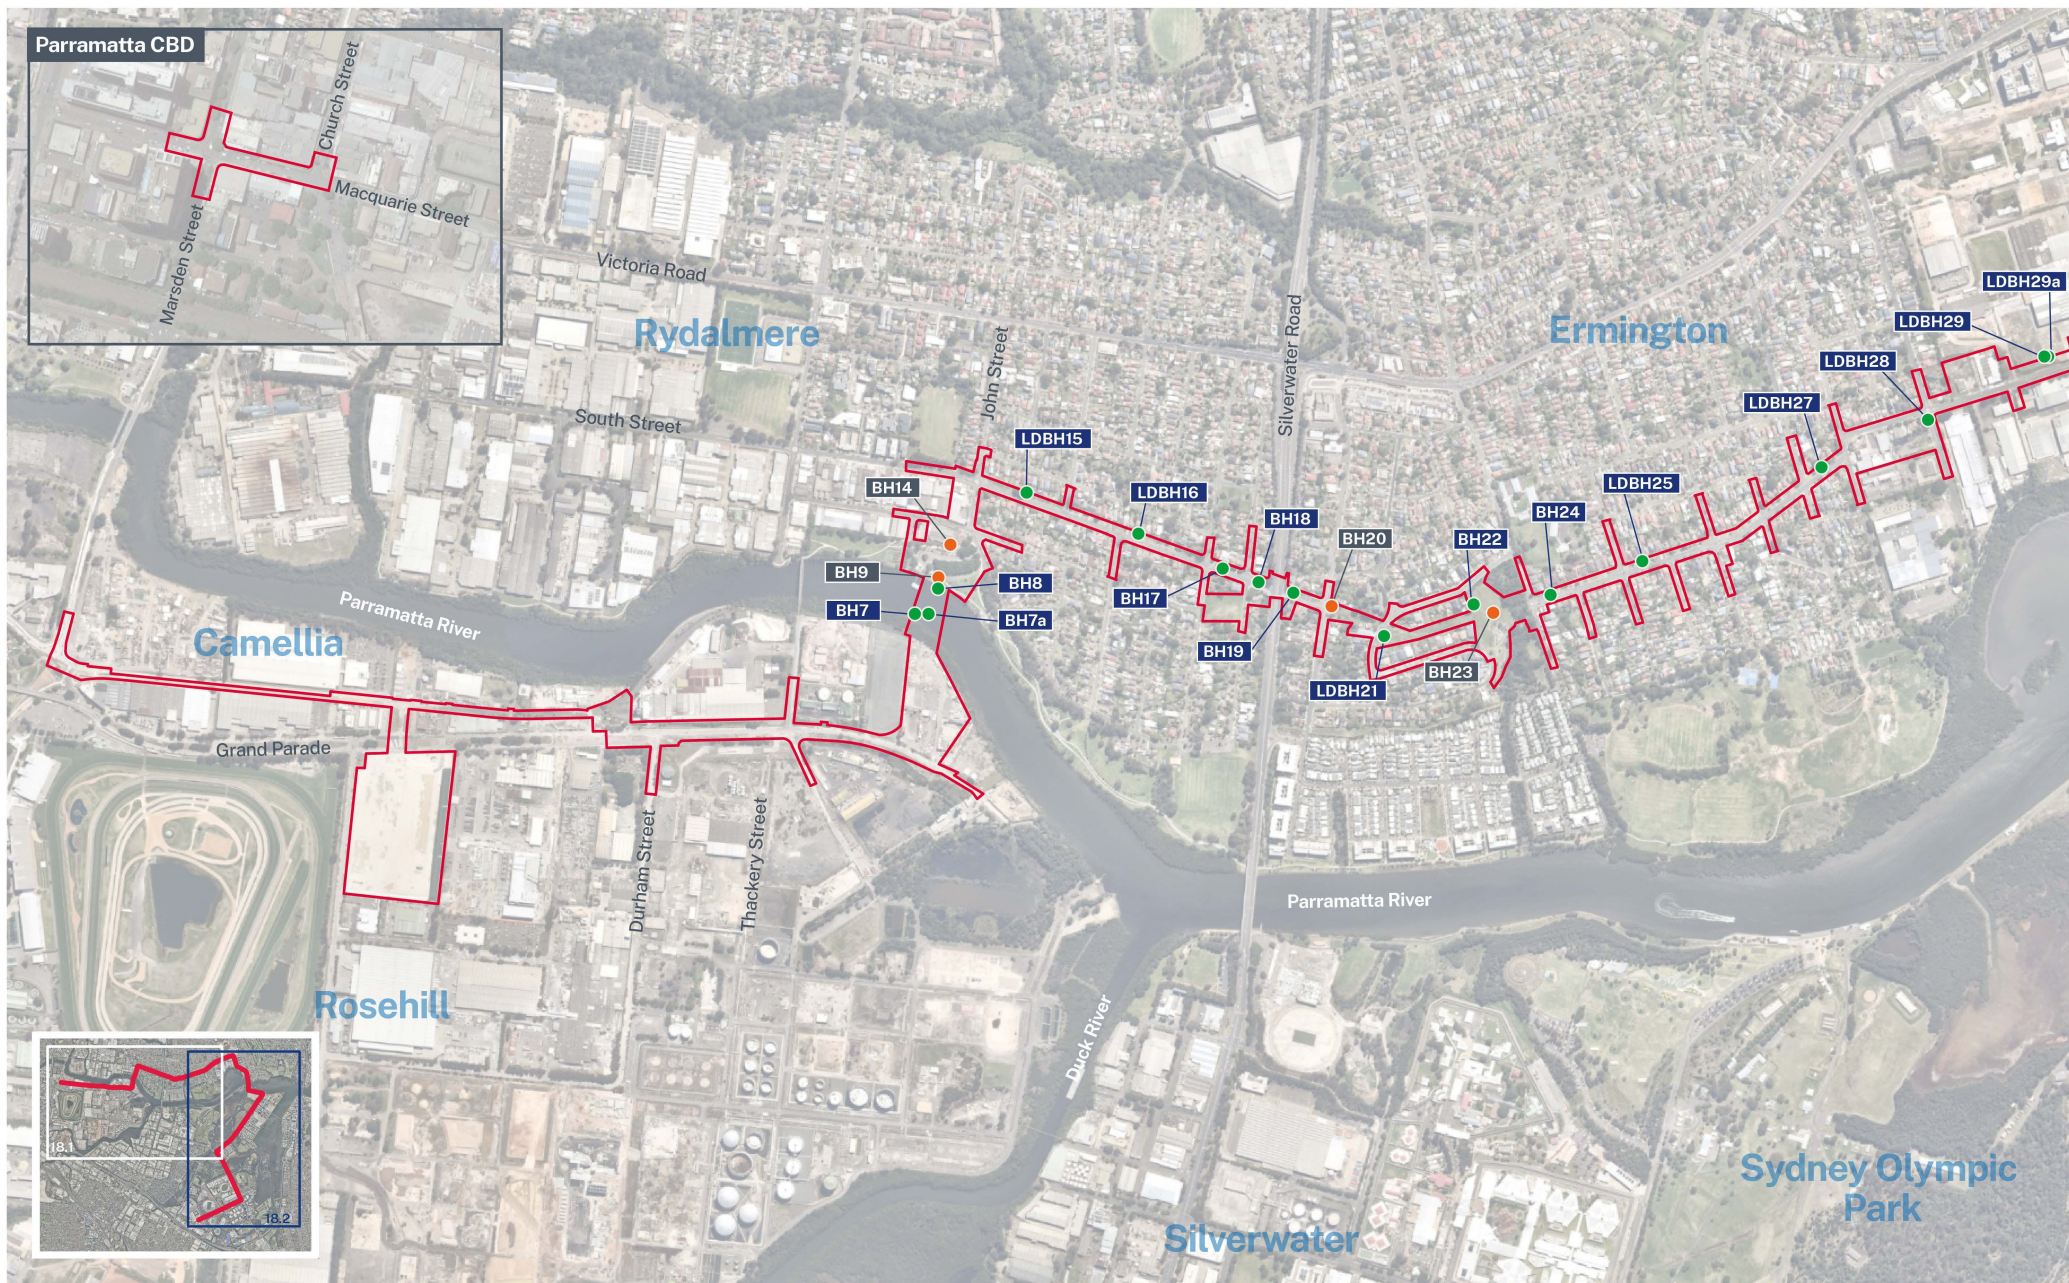
Figure 18.1 Contamination sampling locations - map 1

The locations of the land-based boreholes, over water boreholes and groundwater monitoring wells are shown on Figure 18.1 and Figure 18.2.

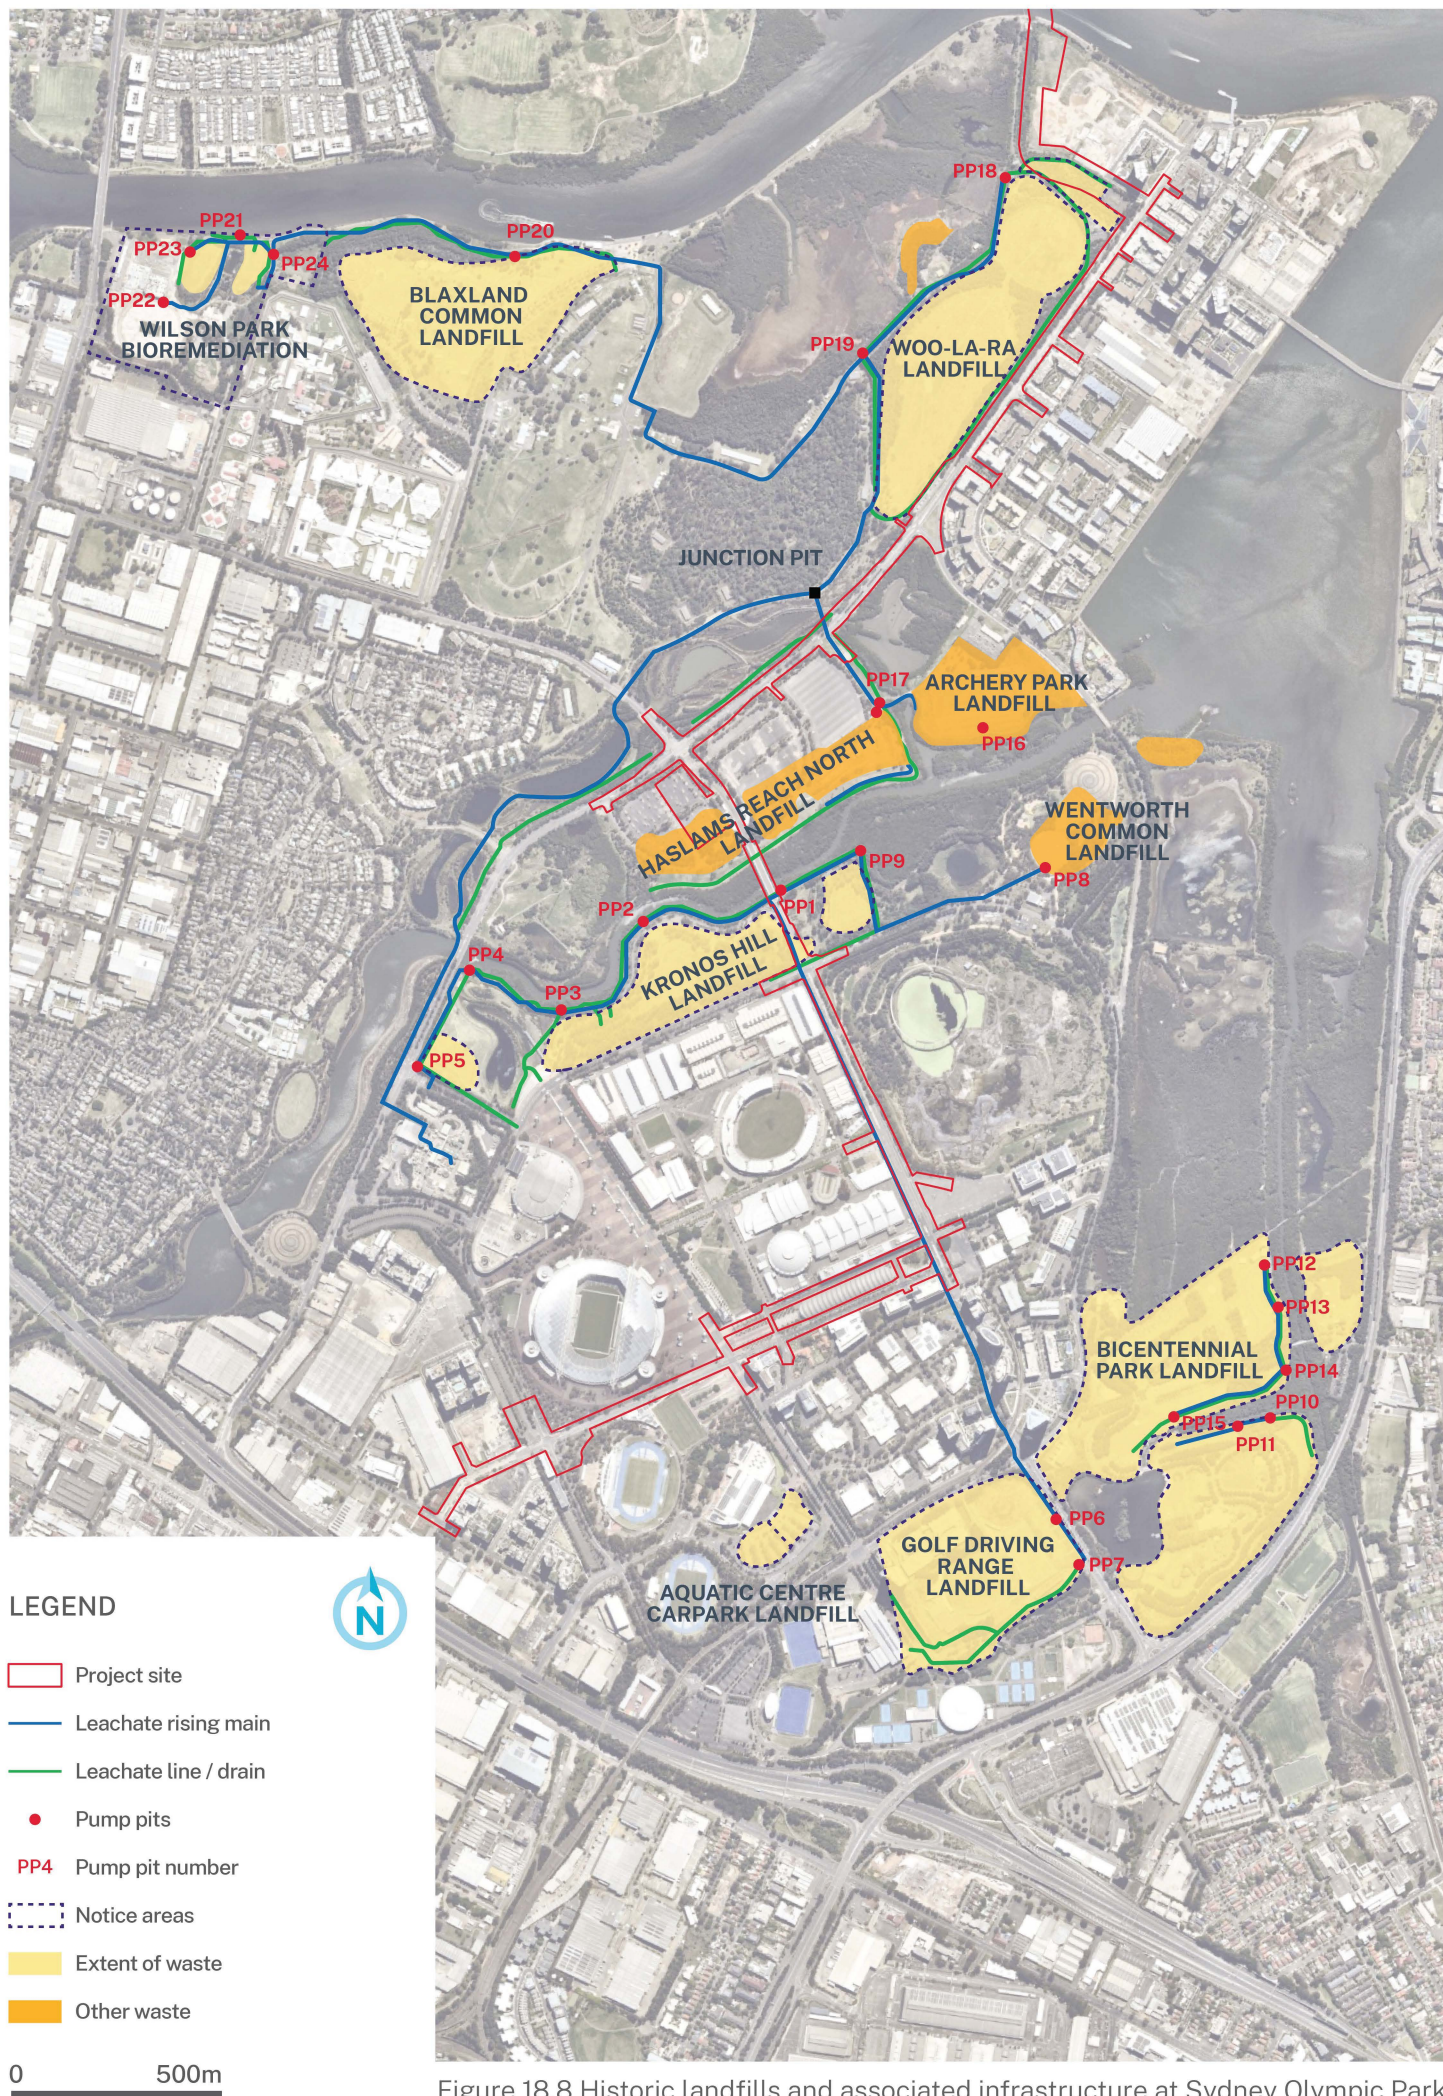
Figure 18.8 Historic landfills and associated infrastructure at Sydney Olympic Park

Listed contamination sites in the vicinity of the project site are summarised in Table 18.12 and shown on Figure 18.7. A number of these sites are the engineered landfills. The location of these landfills and associated leachate management infrastructure is shown on Figure 18.8.

Any groundwater encountered during works within the locations of the engineered landfills in Sydney Olympic Park (see Figure 18.8) would be managed in accordance with the dewatering management strategy (see mitigation measure W16 in section 17.6), which would include options for treatment and disposal of leachate.
