# **Westmead to The Bays and Sydney CBD**

Environmental Impact Statement  
Concept and Stage 1

**Technical Paper 8  
Contamination**

## Sydney Metro West – Stage 1

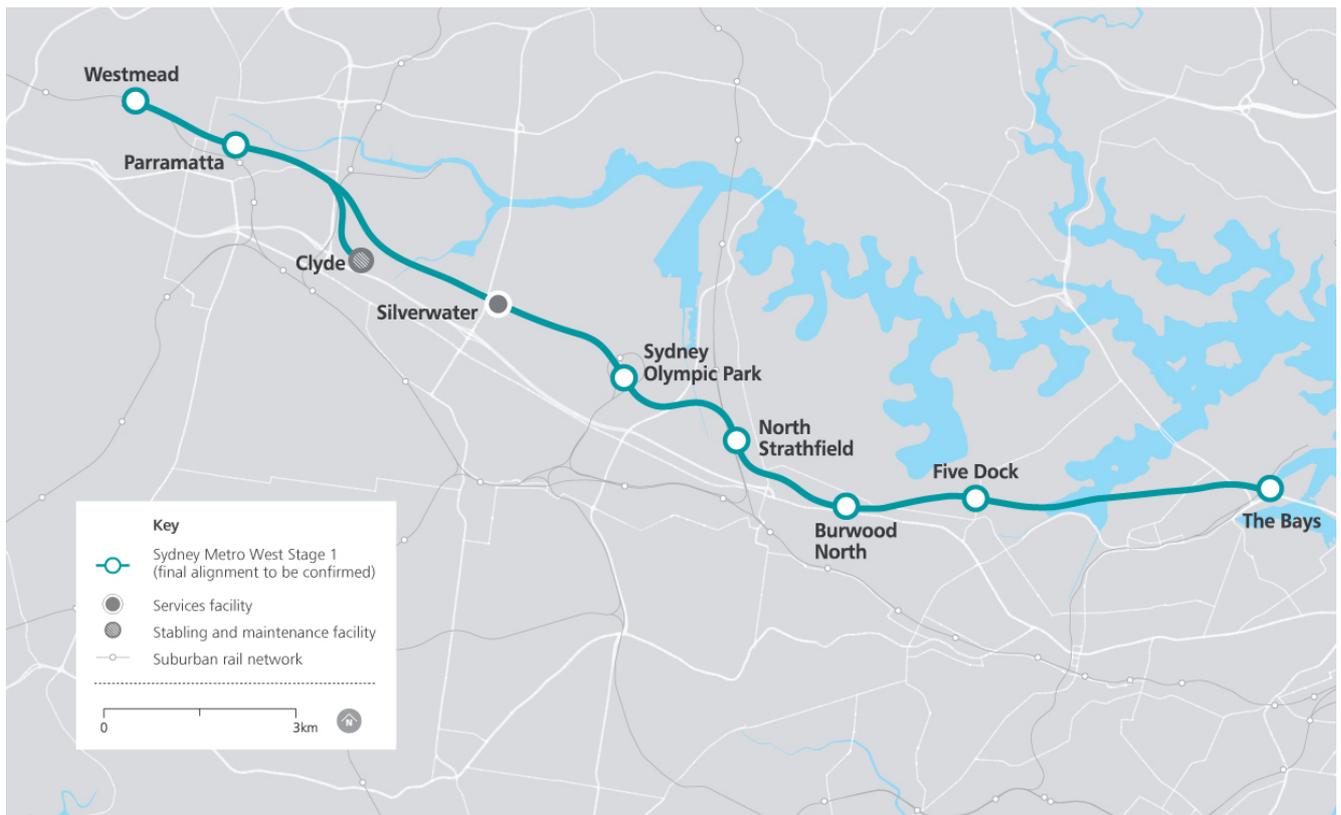
Figure 1-1: Sydney Metro West – Stage 1 overview

Sydney Metro West would mainly be located underground in twin tunnels. Stage 1, which is subject of this assessment, extends from Westmead to The Bays (refer to Figure 1-1).

- Tunnel boring machines would be used to excavate twin tunnels which would be about 21 kilometres long. The tunnel alignment for Stage 1 is shown in Figure 1-1. The depth of the tunnels would vary from about 15 metres to 90 metres deep due to changes in the topography. The shallower tunnel sections would generally be near the tunnel portal at Rosehill and near the cut-and-cover stations. The tunnels would be lined with pre-cast concrete segments to ensure the long term life of the asset and minimise groundwater inflow into the tunnel.

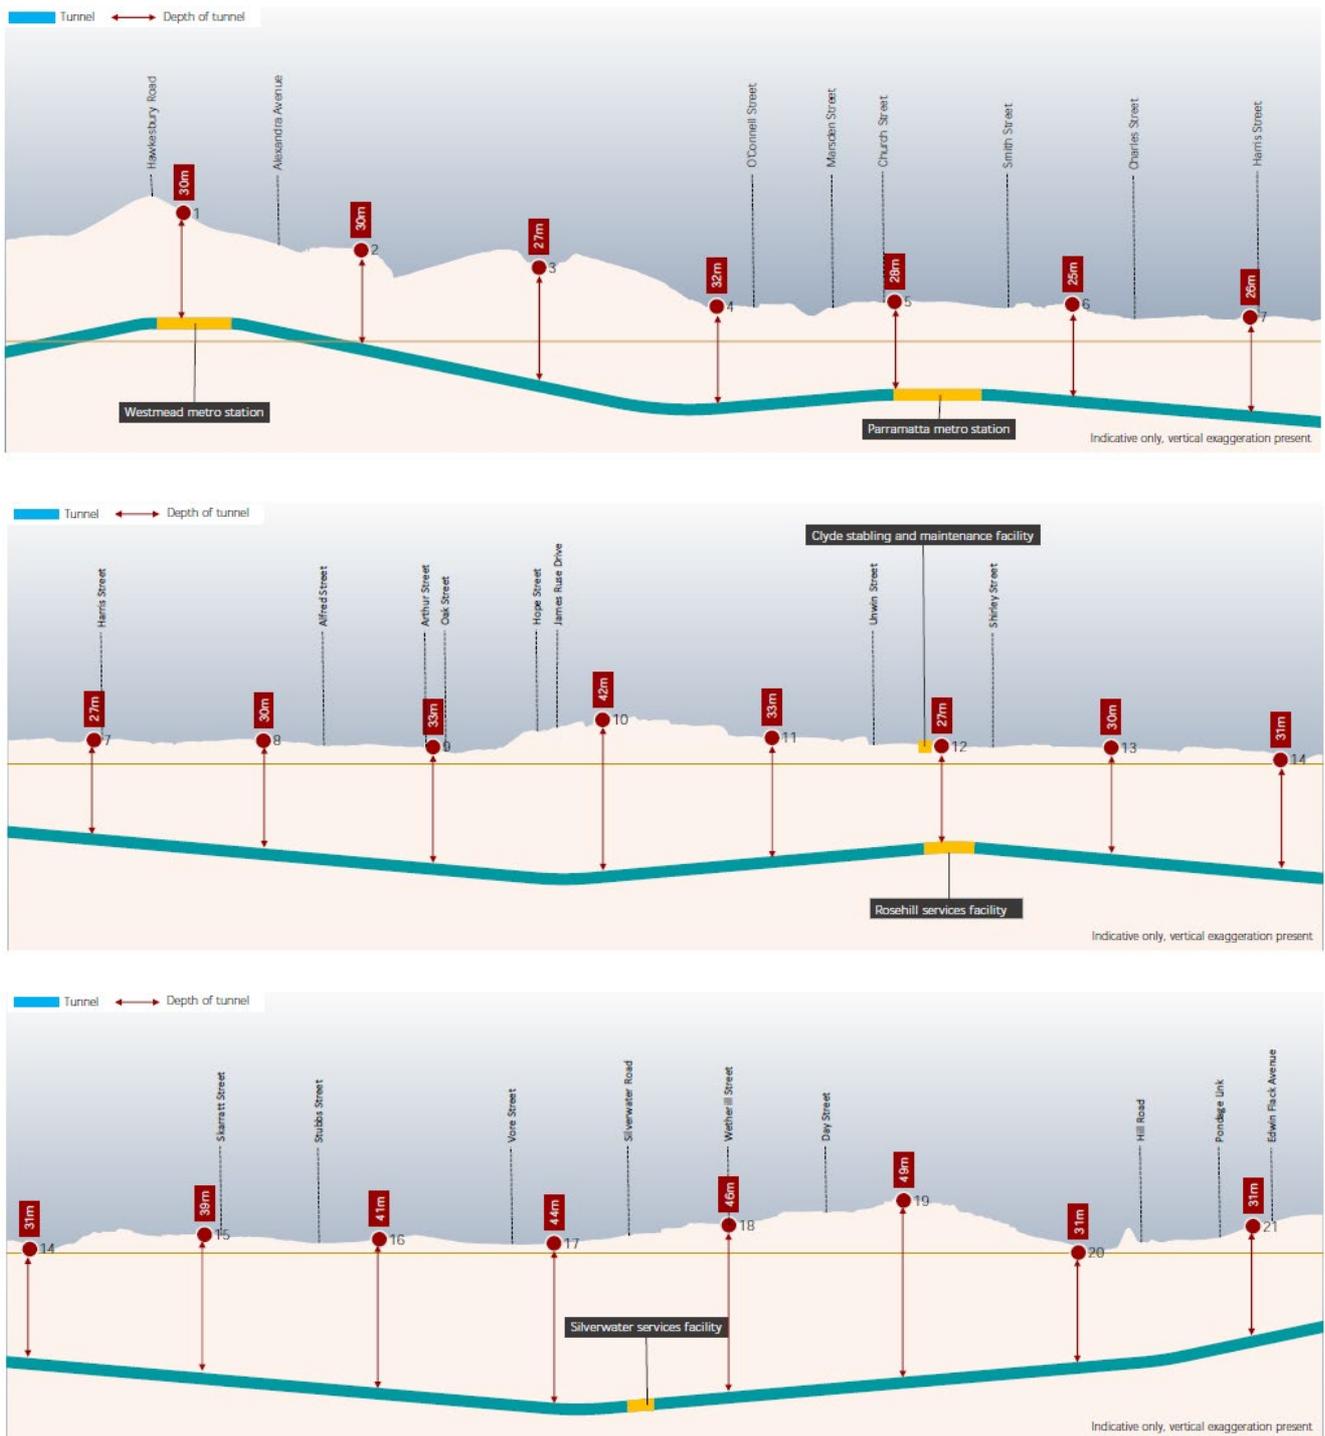
Figure 3-1: Tunnel alignment and depths – Westmead to Sydney Olympic Park

The localised topography at each construction site is detailed in Table 3-2. The alignment and depth of the alignment is provided in Figure 3-1 to Figure 3-3.

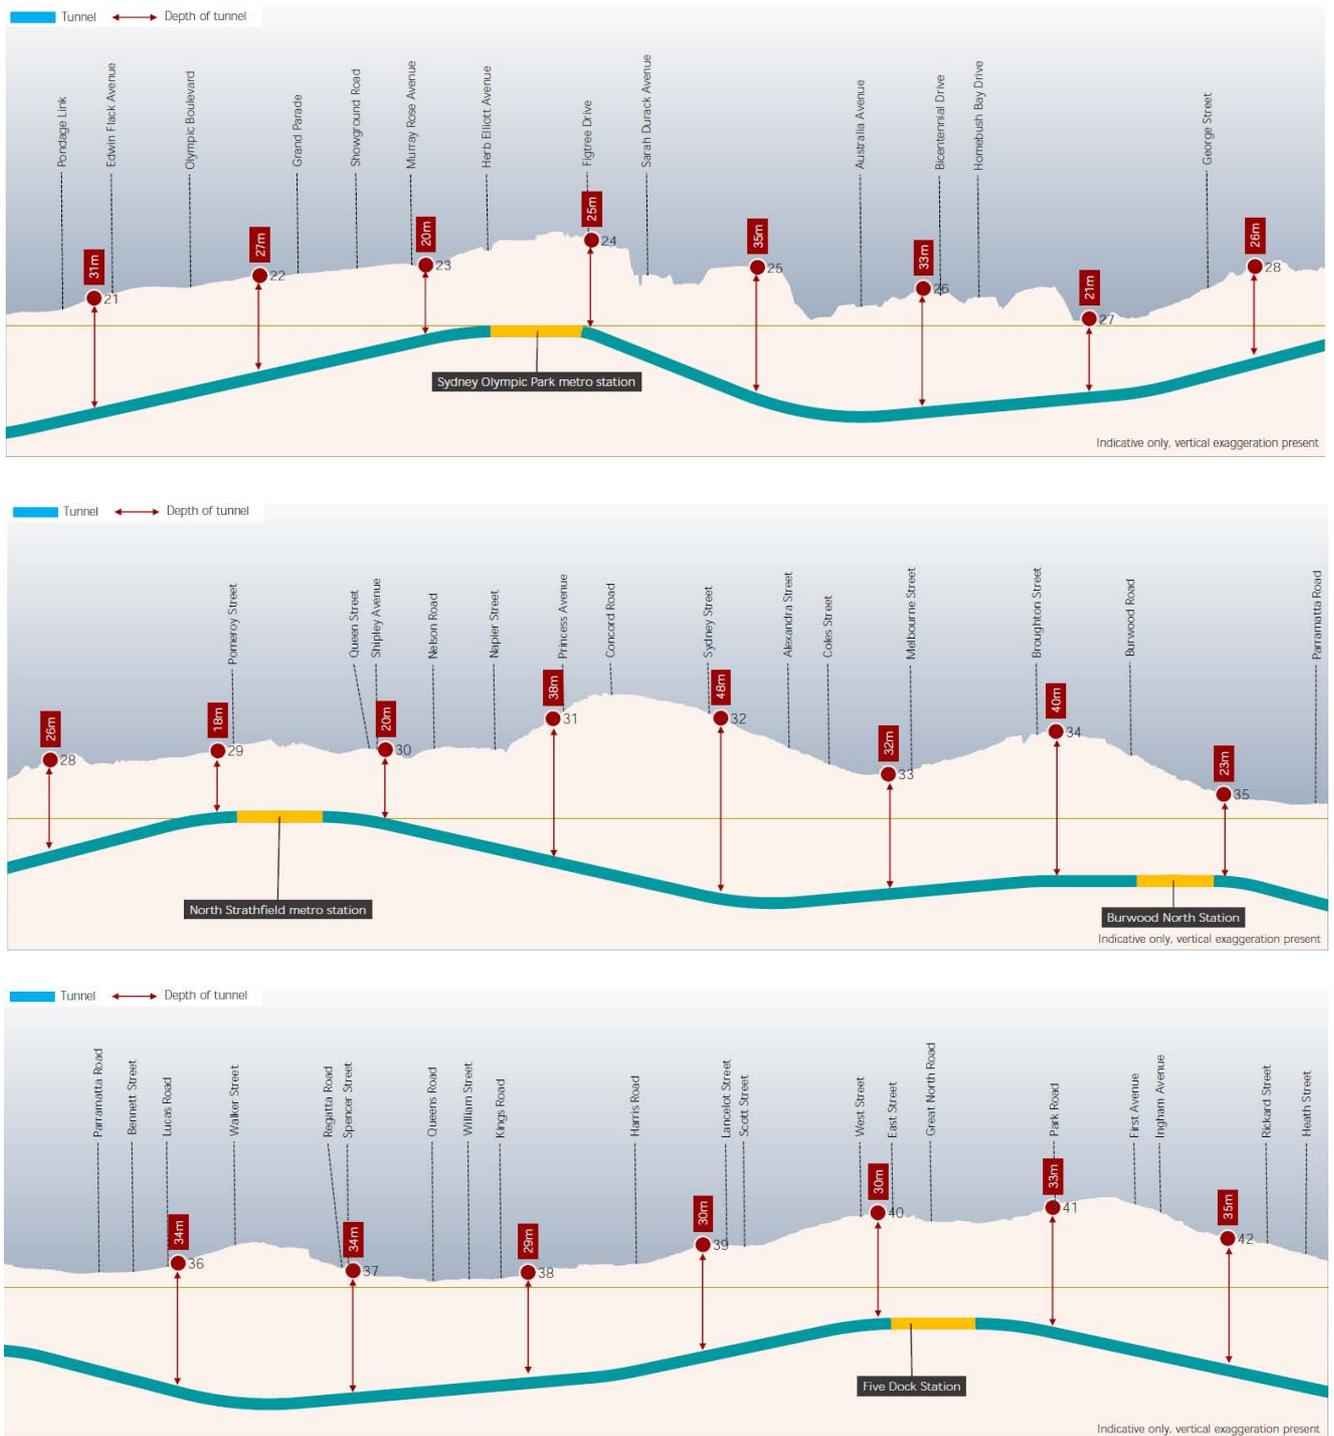
**Figure 3-2: Tunnel alignment and depths – Sydney Olympic Park to Five Dock**

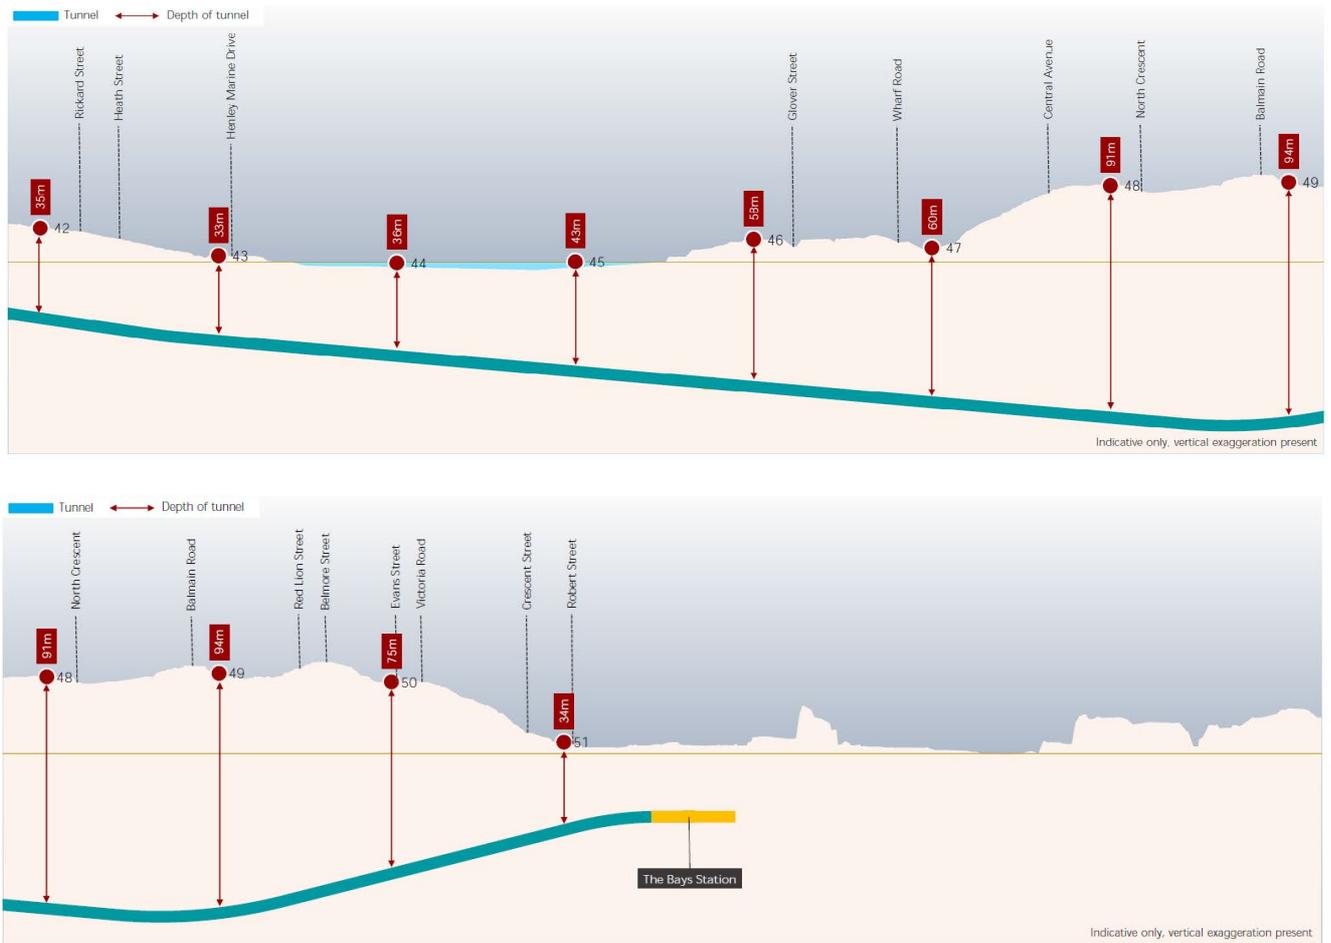
**Figure 3-3: Tunnel alignment and depths – Five Dock to The Bays**

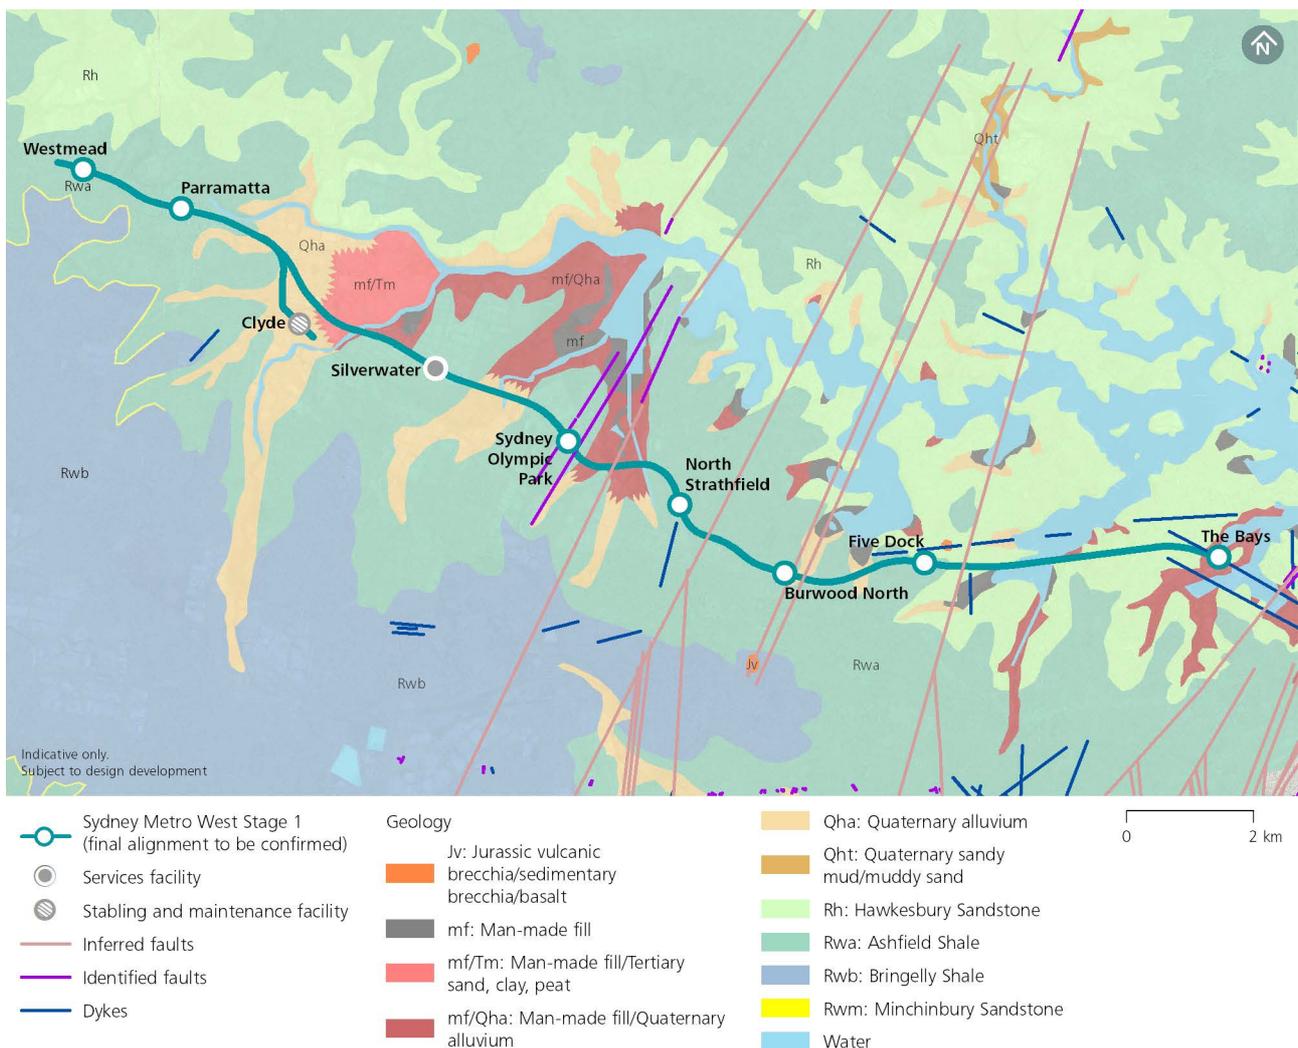
**Figure 3-4: Geology along the Stage 1 alignment**

Both identified and inferred major sub-vertical faults, and identified dykes, are shown in Figure 3-4. Rock permeability may be higher in the vicinity of faults and therefore result in potentially higher groundwater inflows to Stage 1 excavations in their vicinity. Fault zones generally present as joint swarms or brecciated zones. These structural features have been recorded at numerous locations within the Sydney Basin and are generally continuous, mappable and relatively predictable, although not always uniformly linear across the Sydney region.

Identified and inferred faults cross the tunnel alignment to the south and east, respectively, of Sydney Olympic Park metro station construction site. An observed fault is interpreted to intersect the station box for the Sydney Olympic Park metro station. Inferred faults cross the tunnel alignment to the south of North Strathfield metro station and Burwood North Station construction sites, and is interpreted to intersect Burwood North Station construction site. It is possible that unidentified fault and joint swarms could be encountered during excavation. It is also possible that rock permeability in the vicinity of these (potential) faults and joints could be higher than elsewhere.

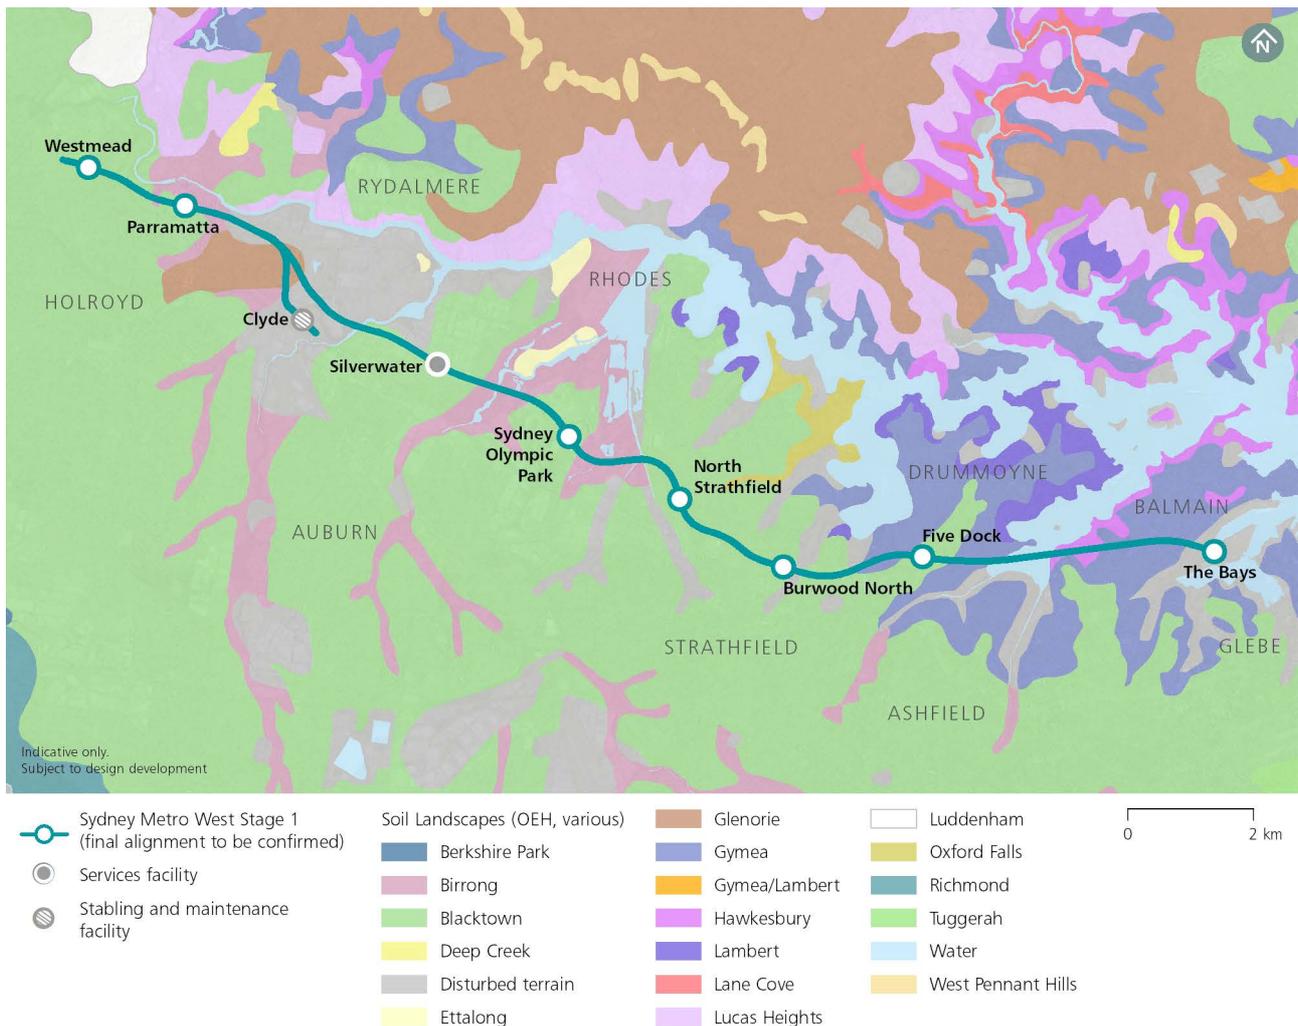
**Figure 3-5: Soil landscapes along the alignment**

Soils within and adjacent to the construction footprint and the alignment have been identified from the NSW Department of Environment, Climate Change and Water's Soil Landscapes of Sydney 1:100,000 Sheet (Tille et al., 2009) and Penrith 1:100,000 Sheet (Hazelton et al., 2010). The characteristics of the major soil types identified along the alignment are summarised in Table 3-5 and depicted in Figure 3-5.

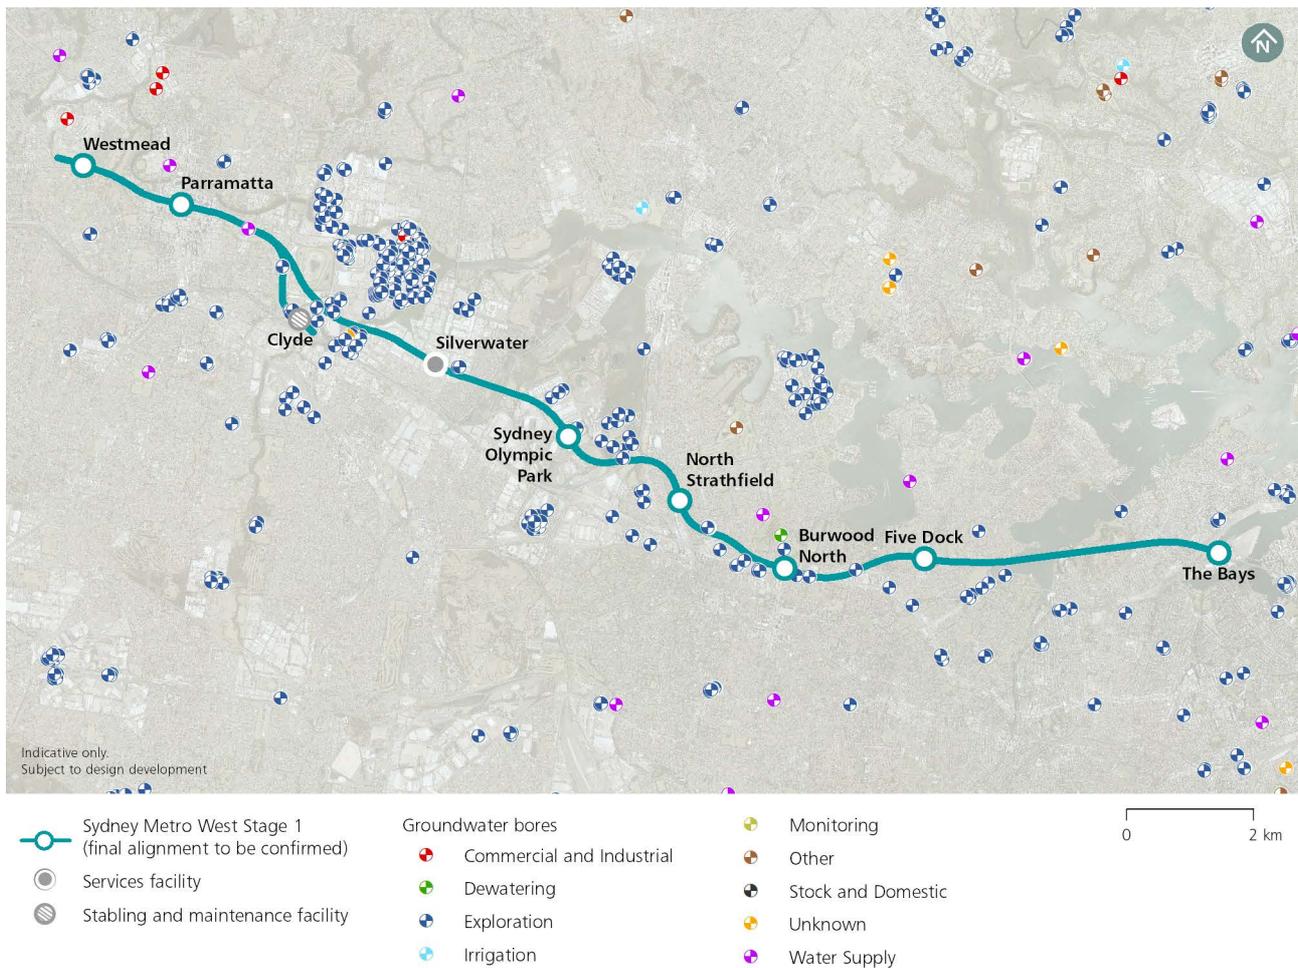
**Figure 3-6: WaterNSW-registered groundwater bores along the Stage 1 alignment**

Groundwater supply bores recorded in WaterNSW's groundwater bore database (WaterNSW, 2019) were reviewed. Groundwater bores registered by WaterNSW along the Stage 1 alignment are shown in Figure 3-6. Further detail on bores located within the predicted groundwater level drawdown zone of influence in Section 4 of Technical Paper 7.

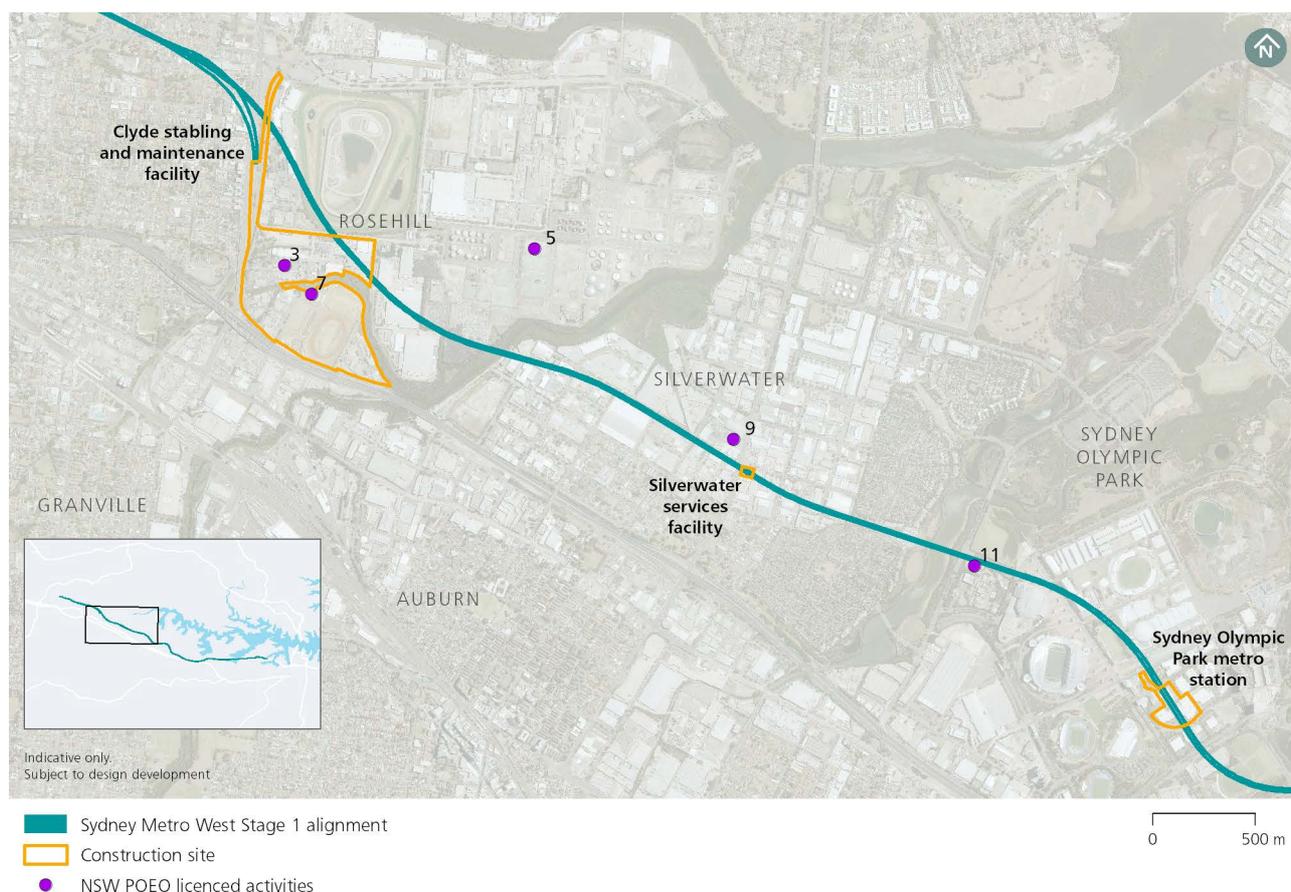
**Figure 3-11: Potential contamination to Stage 1 elements (POEO licenced activities)**

Based on the review of the POEO register, there are a number of Stage 1 elements which could be impacted by contamination (in consideration of contamination type, media, migration pathway potential and lateral/horizontal extent of construction) from licenced activities as detailed in Table 3-23 and shown on Figure 3-11.

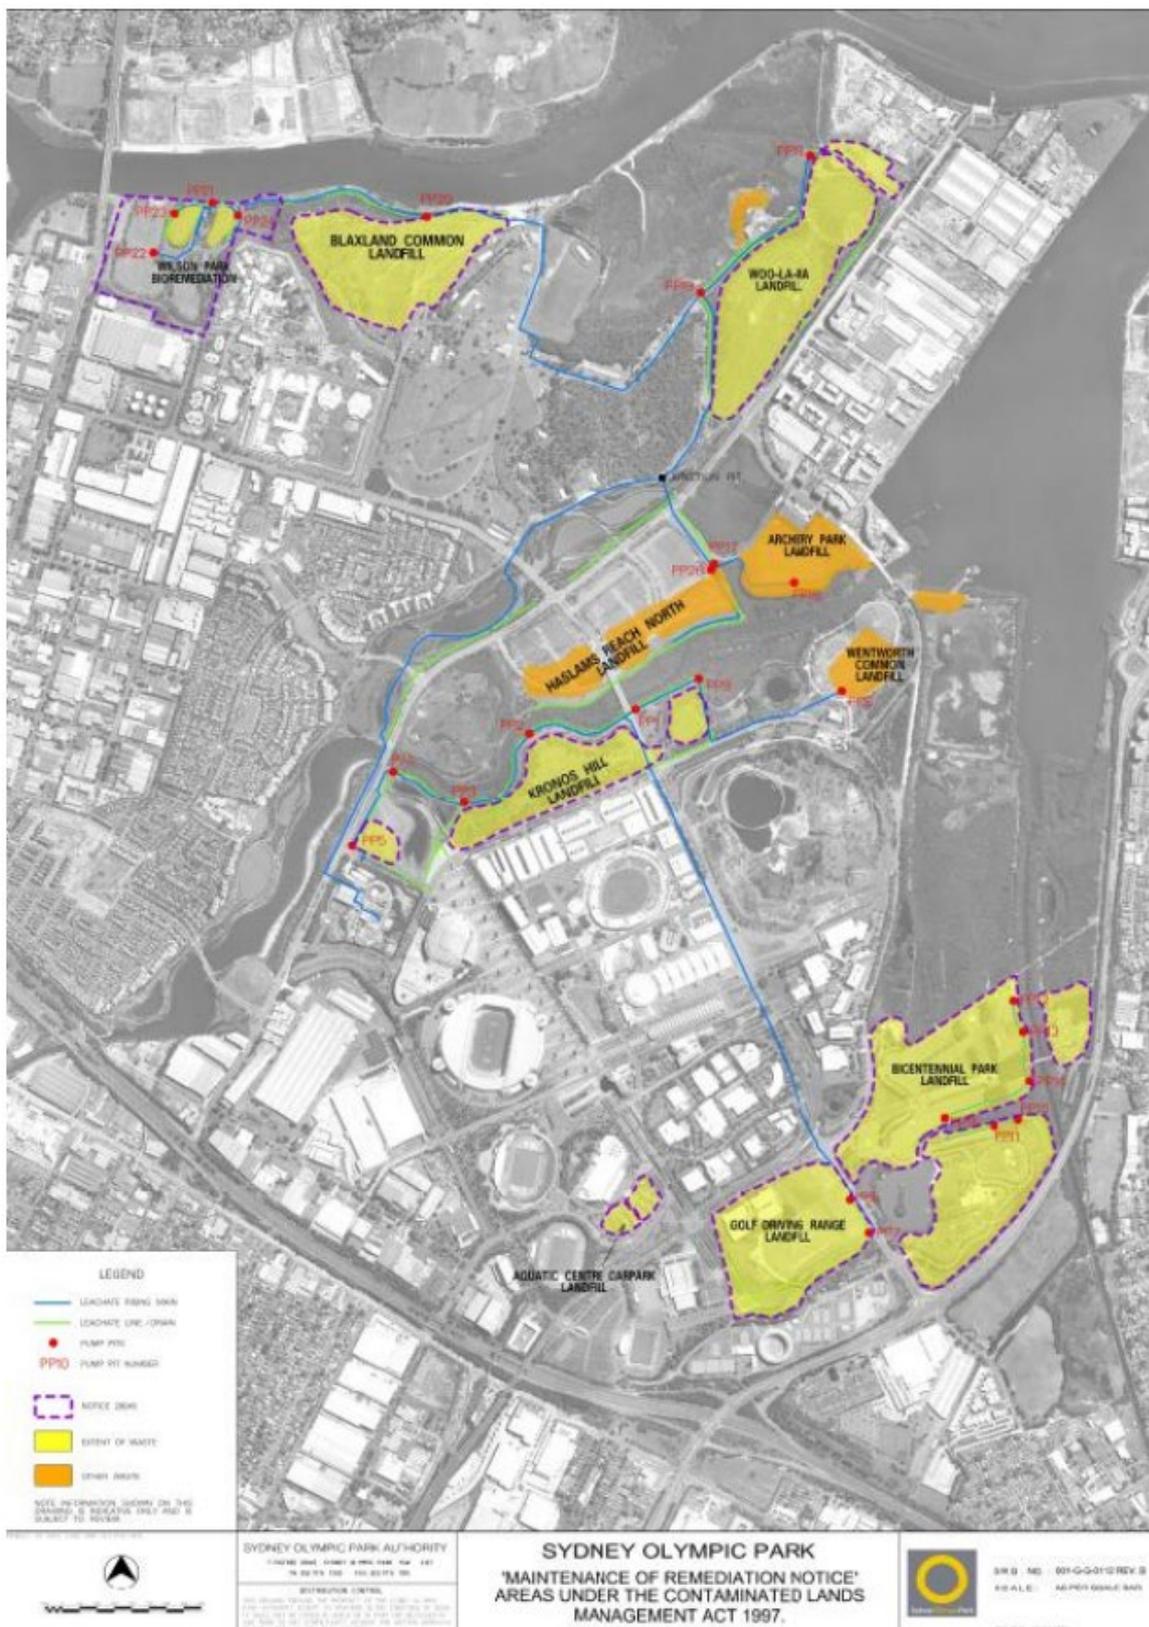
Figure 3-12: Remediation lands (source: Sydney Olympic Park Authority, 2014b)

The landfills (i.e. remediated lands) subject of the policy are detailed in Figure 3-12.

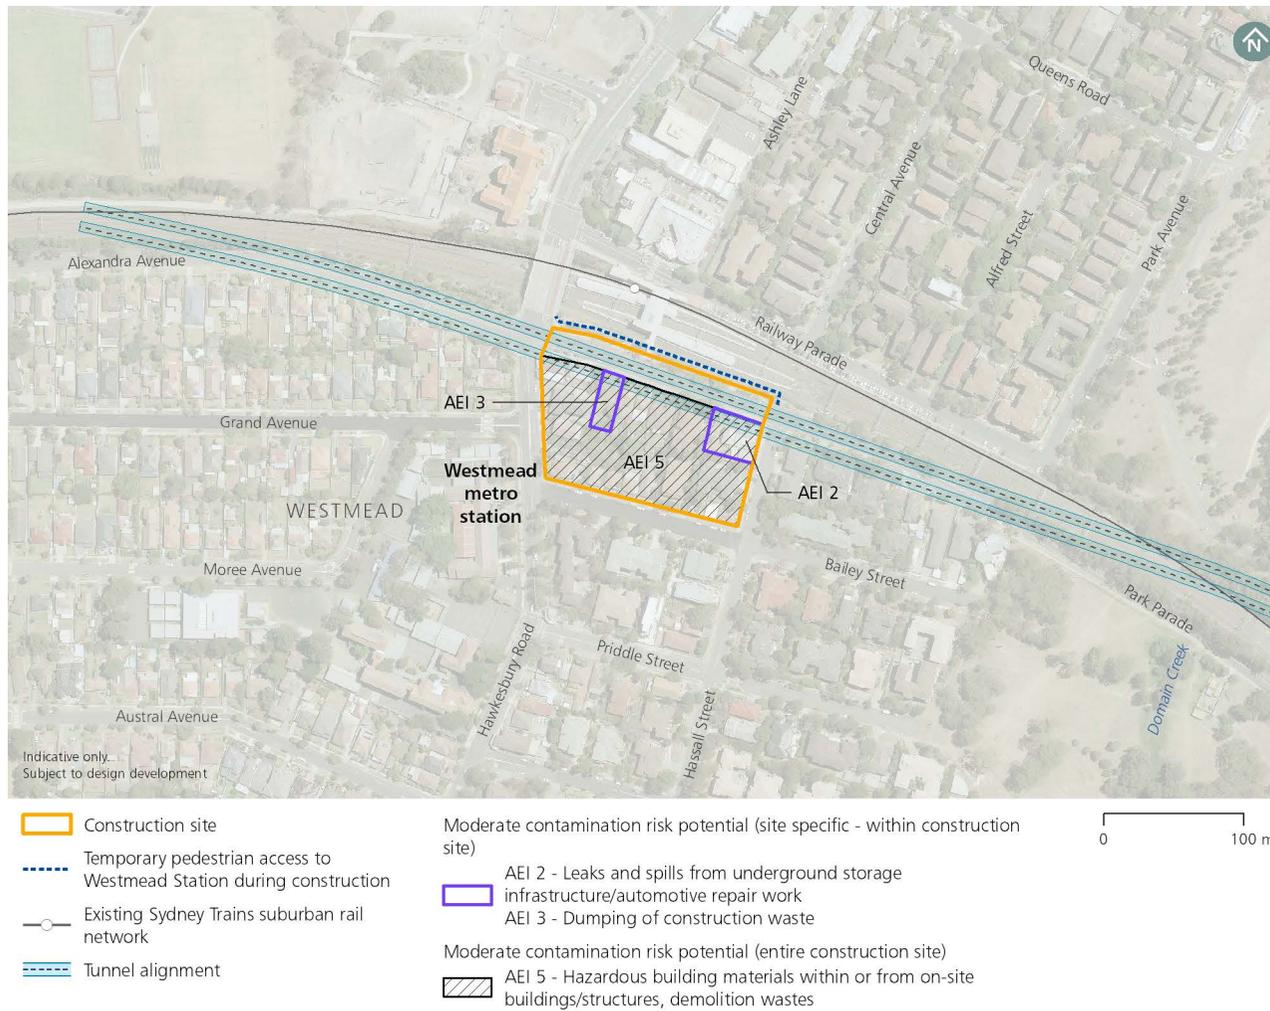
**Figure 4-1: Potential contamination impact – Moderate and above – Westmead metro station construction site and alignment**

- Westmead metro station construction site and tunnel alignment – Soils and groundwater within / beneath the construction site and above the alignment have been assigned a **moderate potential contamination impact** associated with the current and historical activities carried out on and/or adjacent to the site including mechanical workshop activities, dumping of construction wastes and the possible inappropriate management (during demolition) and/or degradation of hazardous building materials within current and former on-site structures

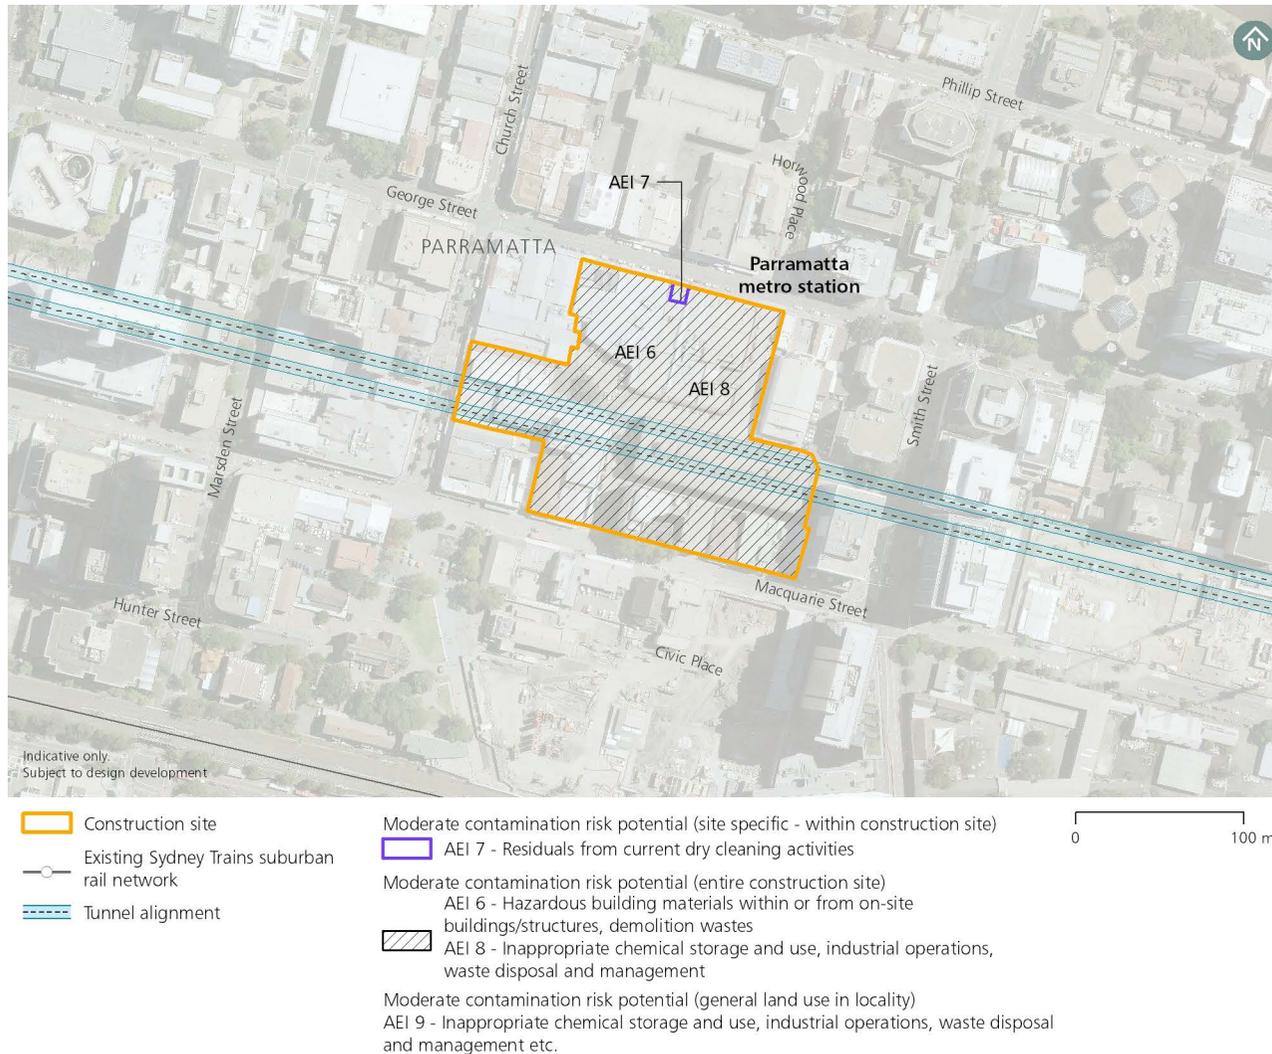
**Figure 4-2: Potential contamination impact – Moderate and above – Parramatta metro station construction site and alignment**

- Parramatta metro station construction site and tunnel alignment – Soils, groundwater and vapour within / beneath the construction site and above the alignment have been assigned a **moderate potential contamination impact** associated with the current and historical activities carried out on and/or adjacent to the site including possible commercial/industrial land use, dry cleaning operation and the possible inappropriate management (during demolition) and/or degradation of hazardous building materials within current and former on-site structures

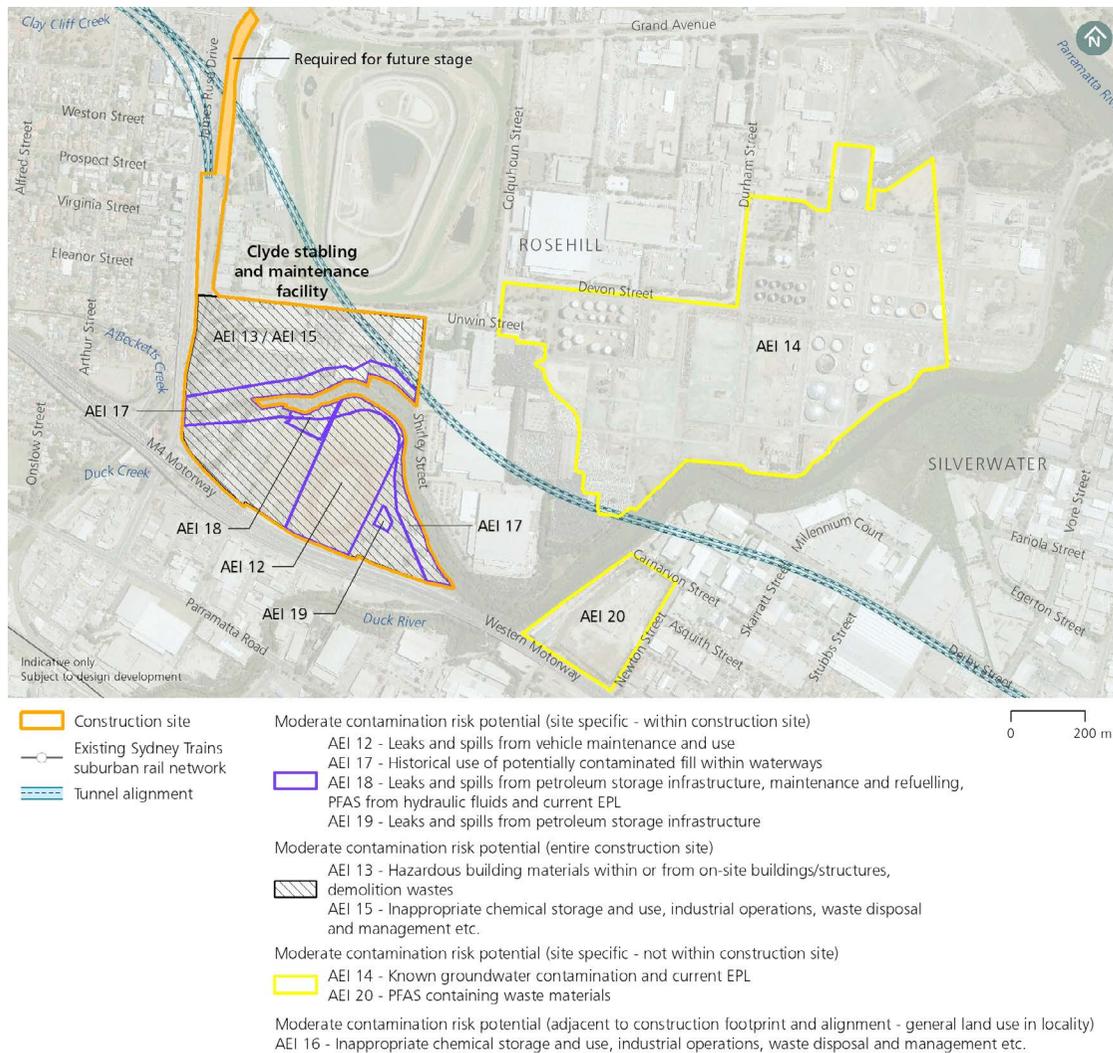
**Figure 4-3: Potential contamination impact – Moderate and above– Clyde stabling and maintenance facility construction site and alignment**

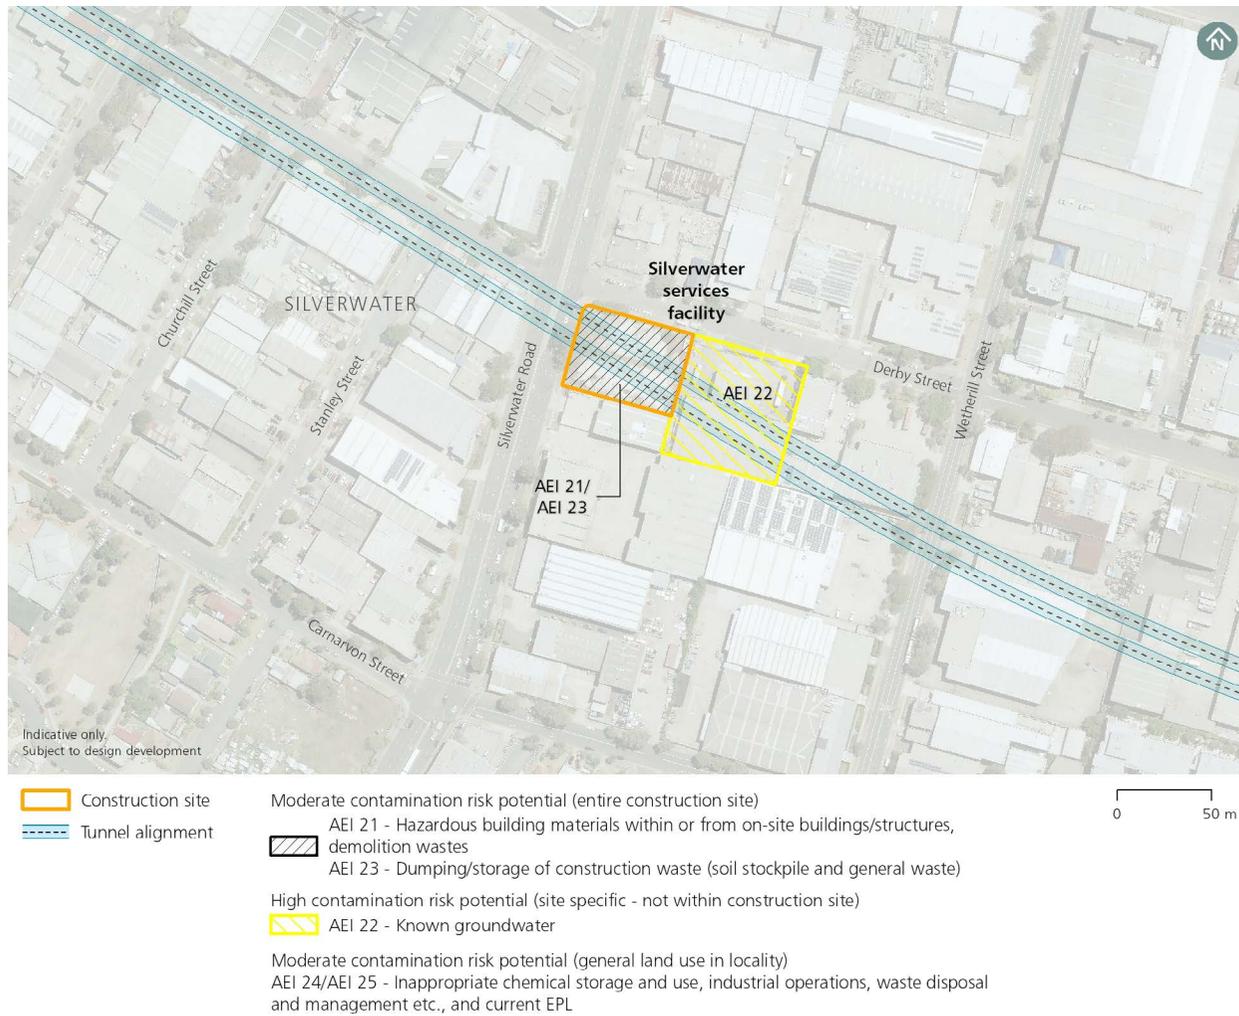
**Figure 4-4: Potential contamination impact – Moderate and above – Silverwater services facility construction site and alignment**

- Silverwater services facility construction site and tunnel alignment – Soils, groundwater and vapour within / beneath the construction site and above the alignment have been assigned a **moderate to high potential contamination impact** associated with the current and historical activities carried out on and/or adjacent to the site including possible commercial/industrial land use, known VOC contamination on-site, dumping of construction wastes and the possible inappropriate management (during demolition) and/or degradation of hazardous building materials within current and former on-site structures

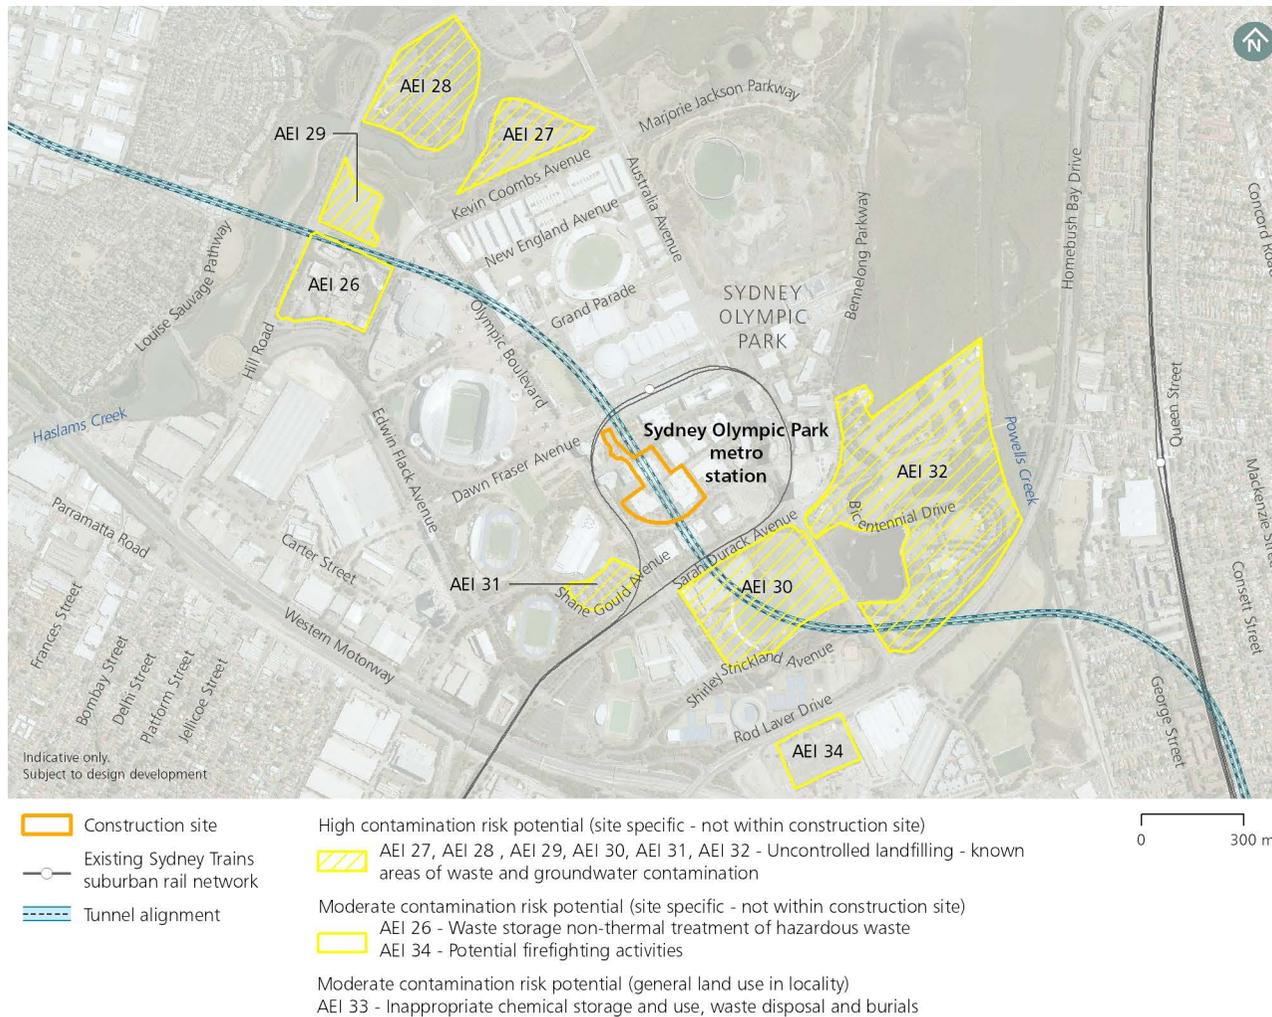
**Figure 4-5: Potential contamination impact – Moderate and above – Sydney Olympic Park metro station construction site and alignment**

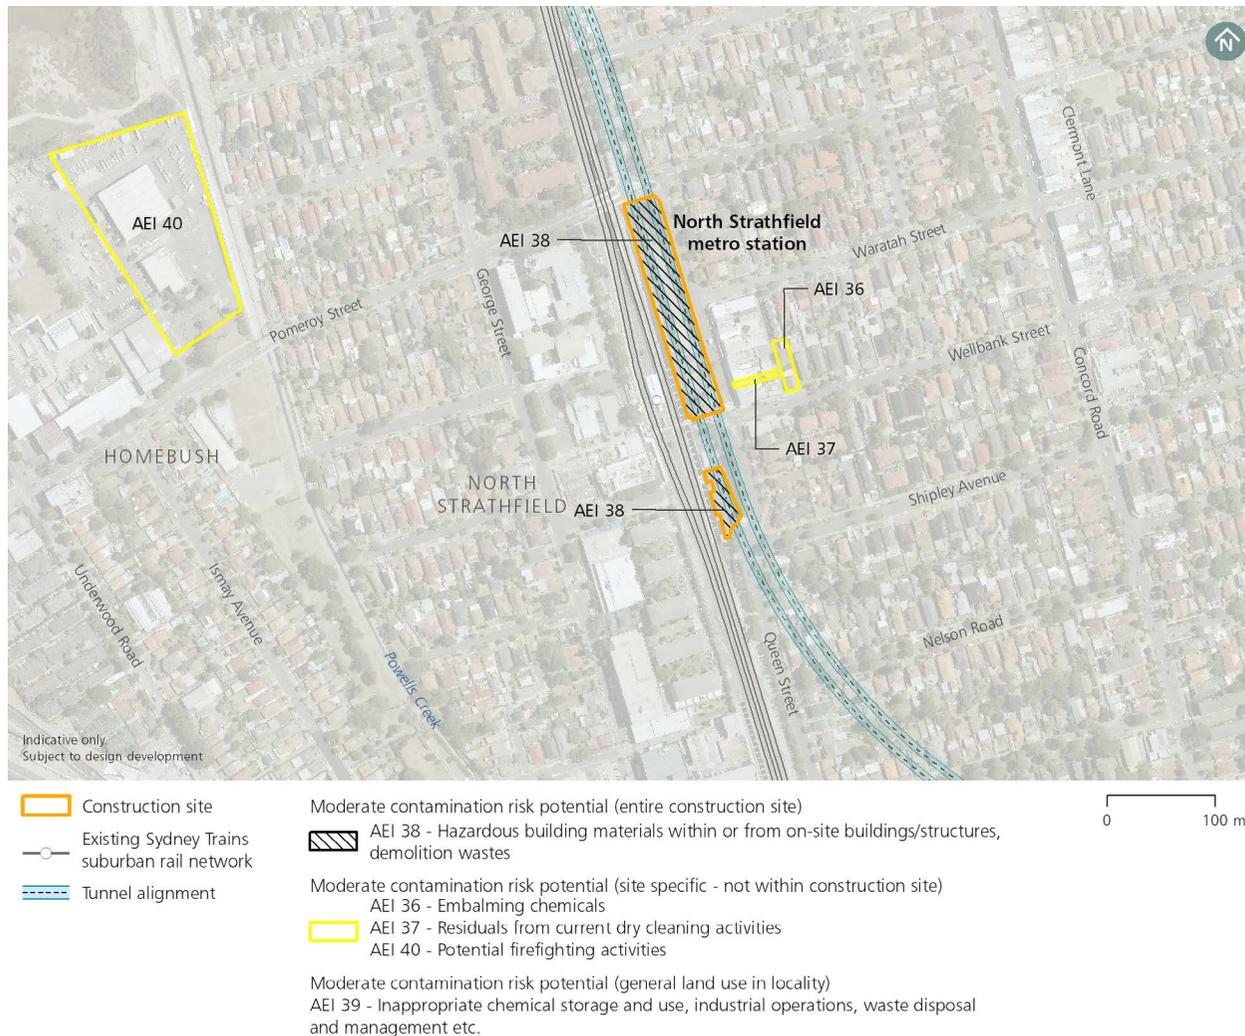
**Figure 4-6: Potential contamination impact – Moderate and above – North Strathfield metro station construction site and alignment**

- North Strathfield metro station construction site and tunnel alignment – Soils within the construction site or above the alignment have been assigned a **moderate potential contamination impact** associated with the current and historical activities carried out on and/or adjacent to the site including the possible inappropriate management (during demolition) and/or degradation of hazardous building materials within current and former on-site structures and potential firefighting activities adjacent to the site
