# **Westmead to The Bays and Sydney CBD**

Environmental Impact Statement  
Concept and Stage 1

**Technical Paper 8  
Contamination**

## Sydney Metro West – Stage 1

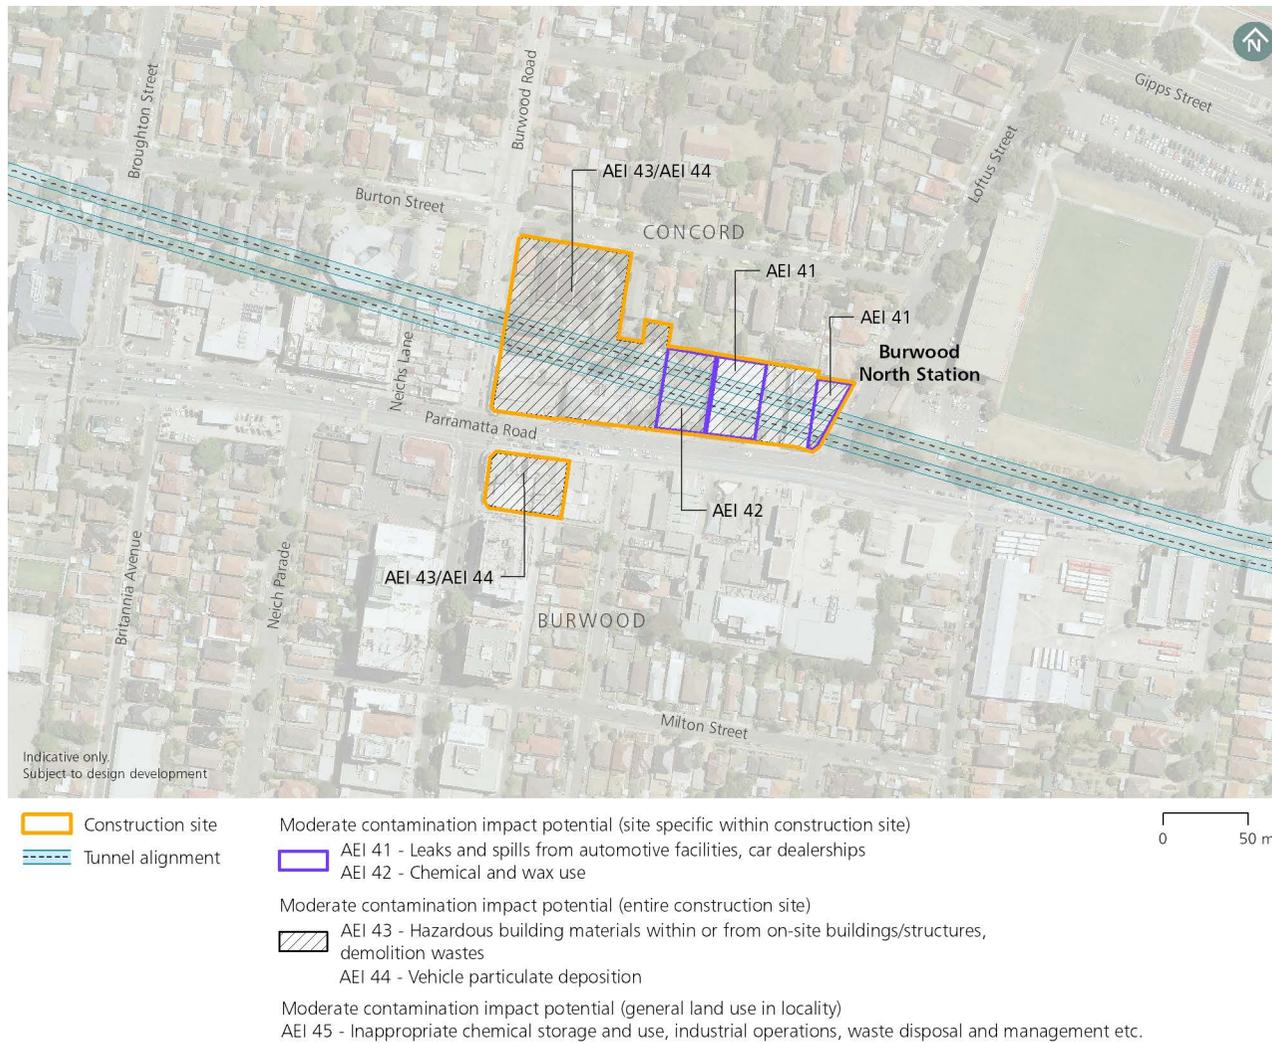
**Figure 4-7: Potential contamination impact – Moderate and above – Burwood North Station construction site and alignment**

Table 4-7: High-level contamination prioritisation – Burwood North Station construction site and alignment

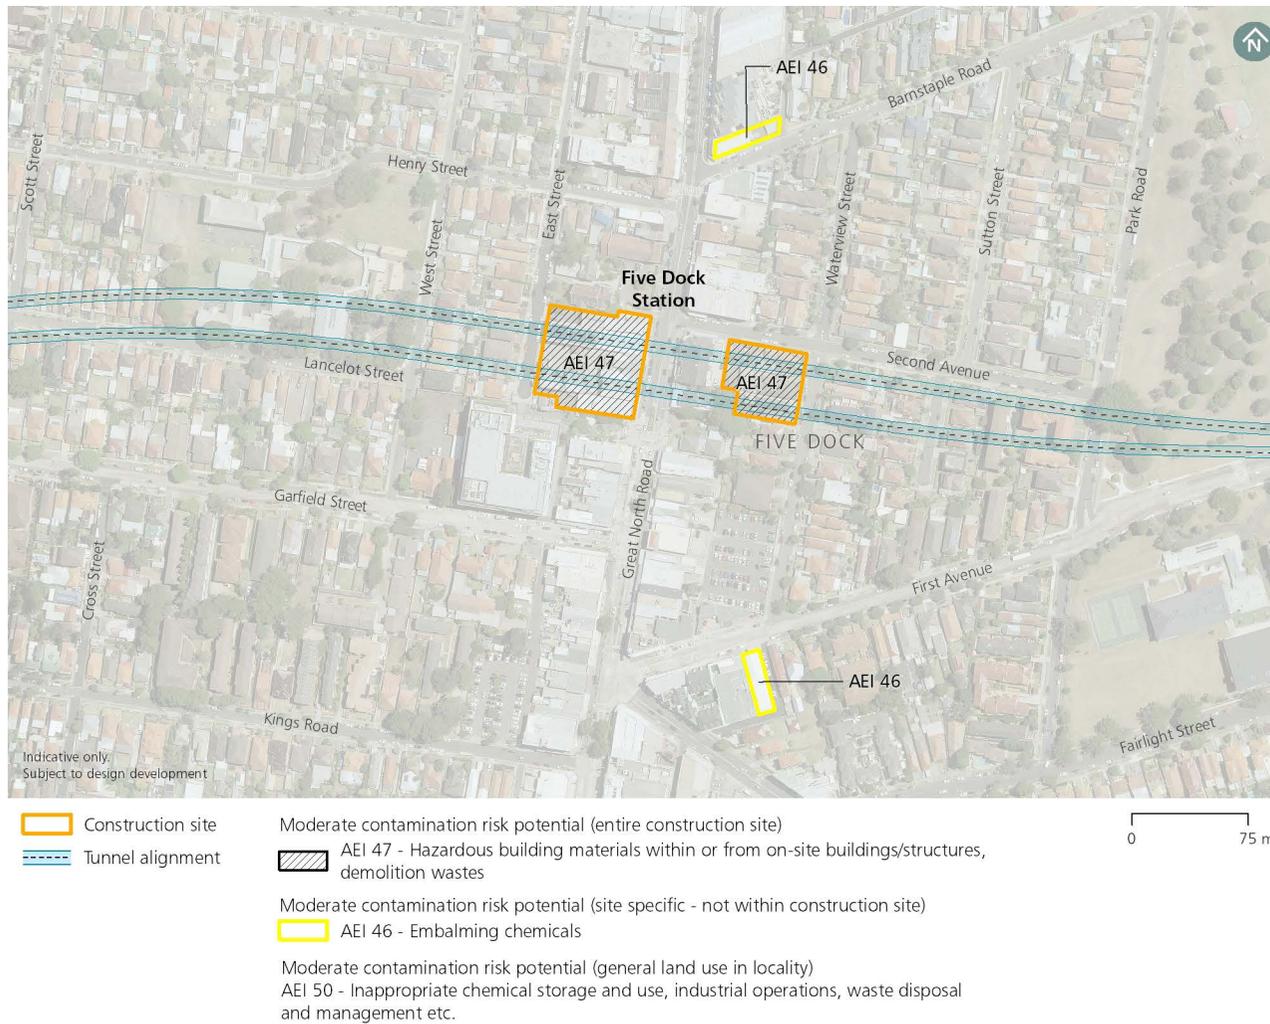
**Figure 4-8: Potential contamination impact – Moderate and above – Five Dock Station construction site and alignment**

Table 4-8: High-level contamination prioritisation –Five Dock Station construction site and alignment

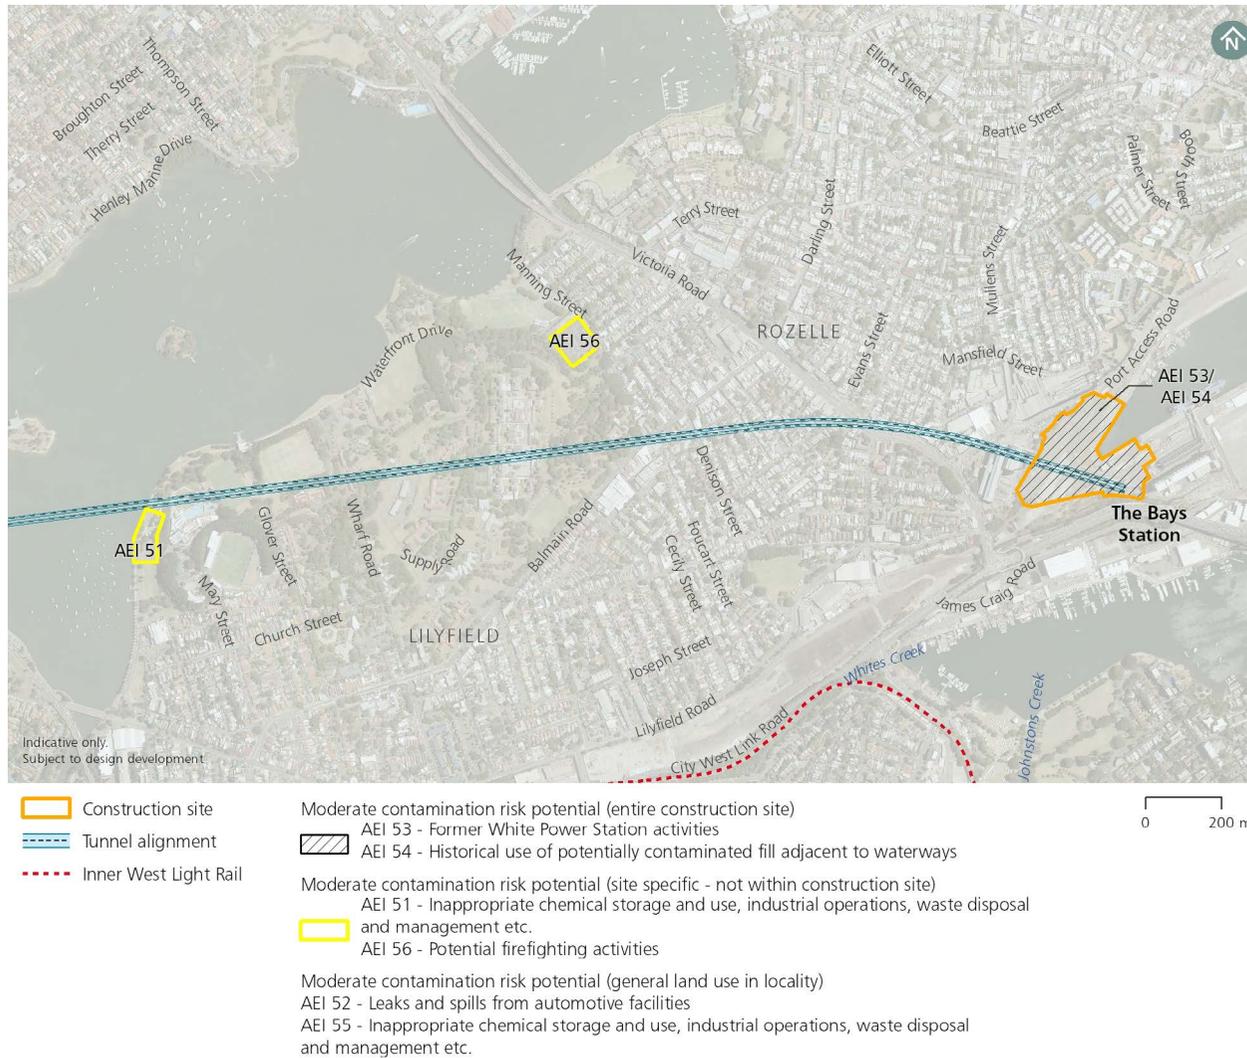
**Figure 4-9: Potential contamination impact – Moderate and above – The Bays Station construction site and alignment**

Table 4-9: High-level contamination prioritisation – The Bays Station construction site and alignment

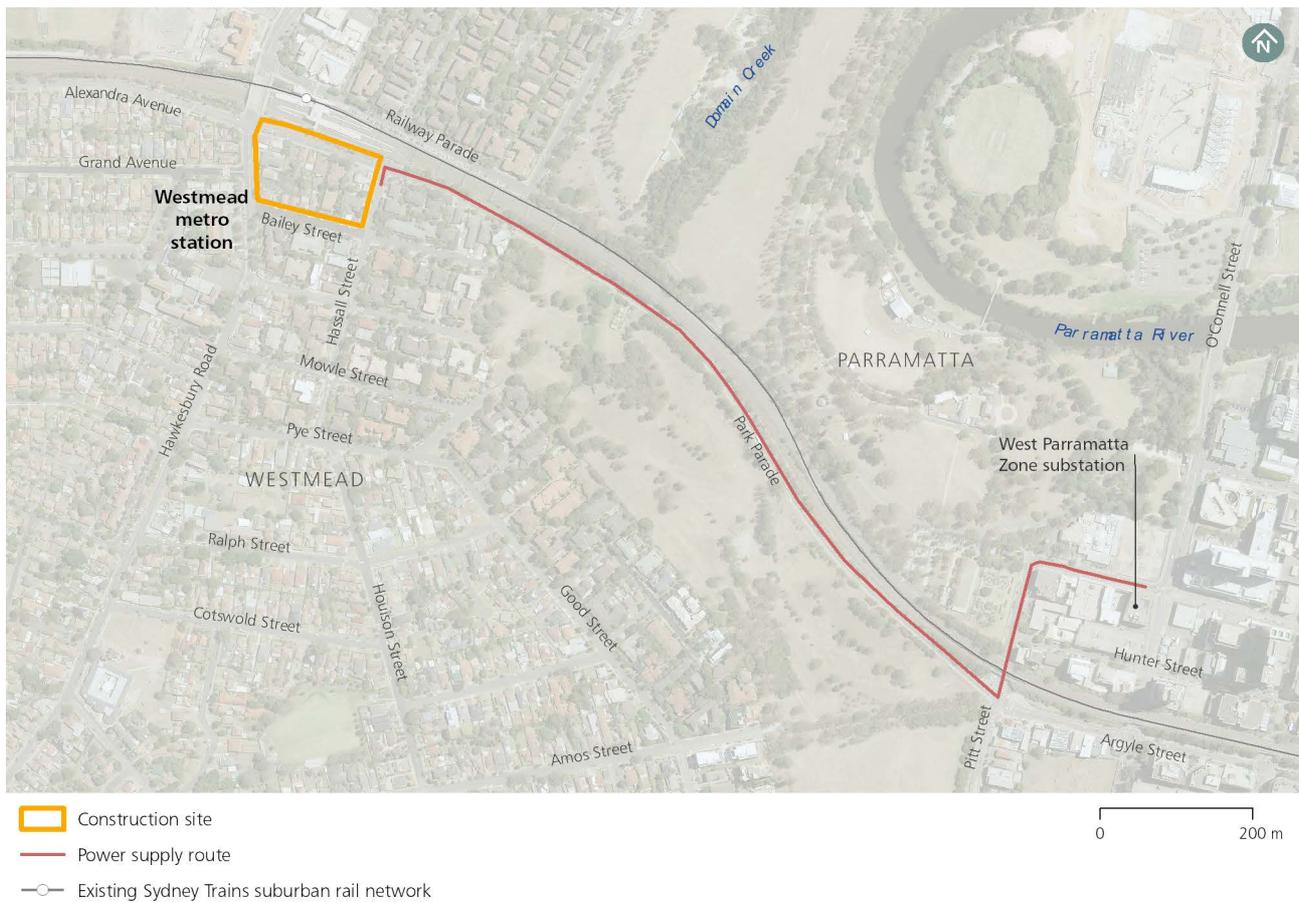
**Figure 5-1: Westmead metro station construction site –power supply route**

The majority of the Westmead power supply route follows Park Parade, with the eastern portion located adjacent to Pitt and Macquarie Streets and the West Parramatta zone substation (refer to Figure 5-1). The majority of the land use (possibly less than 100 years) surrounding the power supply route is likely to have been utilised for agricultural and recreational open space (Parramatta Park and the former Parramatta Golf Club) with residential present within the western portion (Westmead) and residential / commercial present within the eastern portion (Parramatta). The power supply route adjacent to Park Parade is located adjacent to the T1 North Shore and Western Line. Significant industrial land use is unlikely to have occurred in the near vicinity of the power supply route. Park Parade is likely to have been a formalised road for the last 50 years and significant filling beneath the road is unlikely to have occurred. Based on a review of GoogleEarth, the T1 North Shore and Western Line in some locations is raised above Park Parade probably to facilitate the drainage of Domain Creek. It is possible that fill material has been used to raise the rail line at some locations. The open space area to the north and south of Park Parade may have been subject to some filling in the past, potentially associated with reclamation and/or flood mitigation, especially in the vicinity of waterways (i.e. Domain Creek and Parramatta River). Filling in the vicinity of the power supply route may potentially contain material of unknown quality and/or construction wastes.

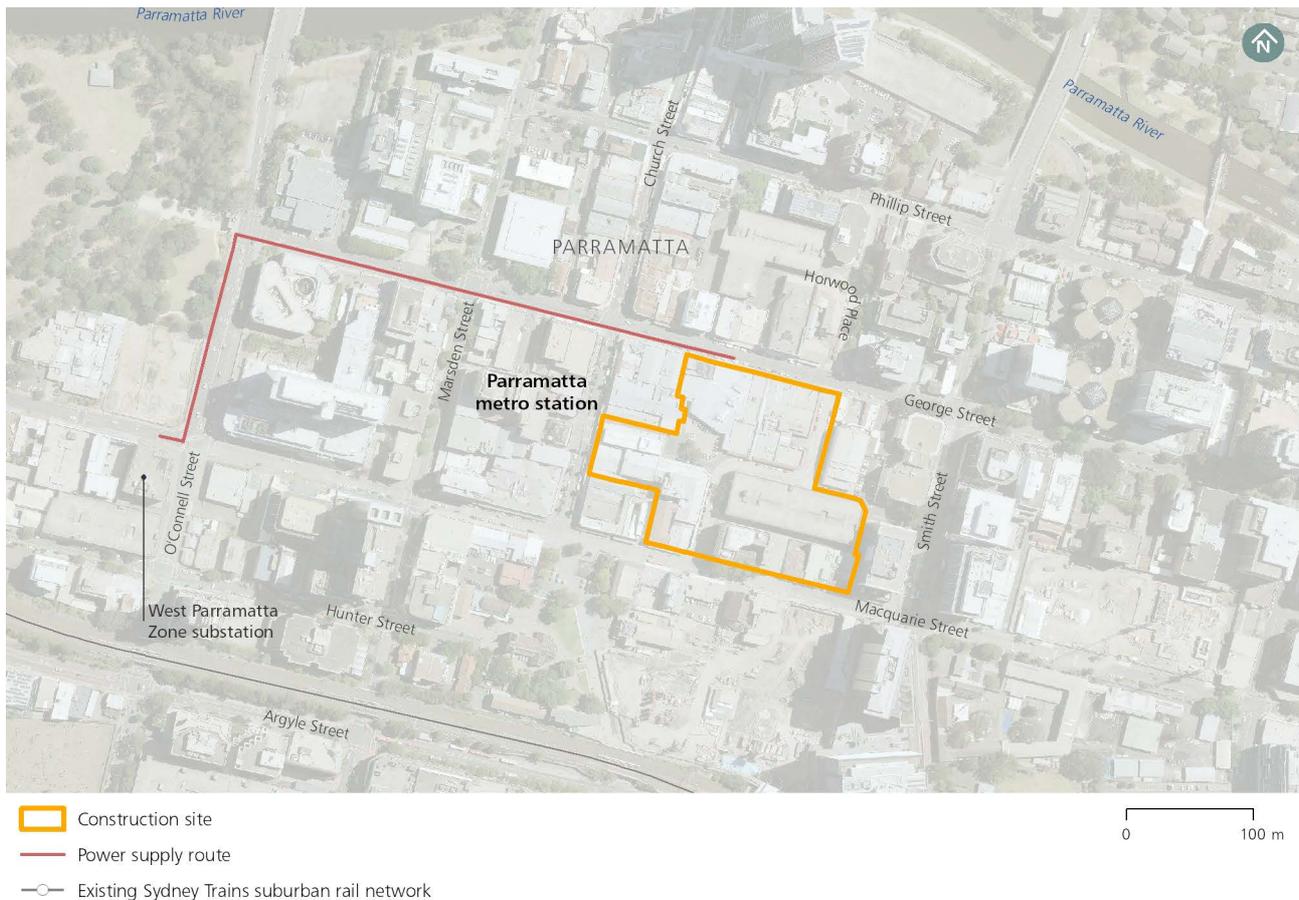
**Figure 5-2: Parramatta metro station construction site – power supply route**

The majority of the power supply route follows George, O'Connell and Macquarie Streets (refer to Figure 5-2). The majority of the land use (possibly less than 100 years) surrounding the power supply route is likely to have been utilised for residential and commercial uses. Significant industrial land use is unlikely to have occurred in the near vicinity of the power supply route. George, O'Connell and Macquarie Streets are likely to have been formalised roads for the last 50 years and significant filling beneath these roadways is unlikely to have occurred.

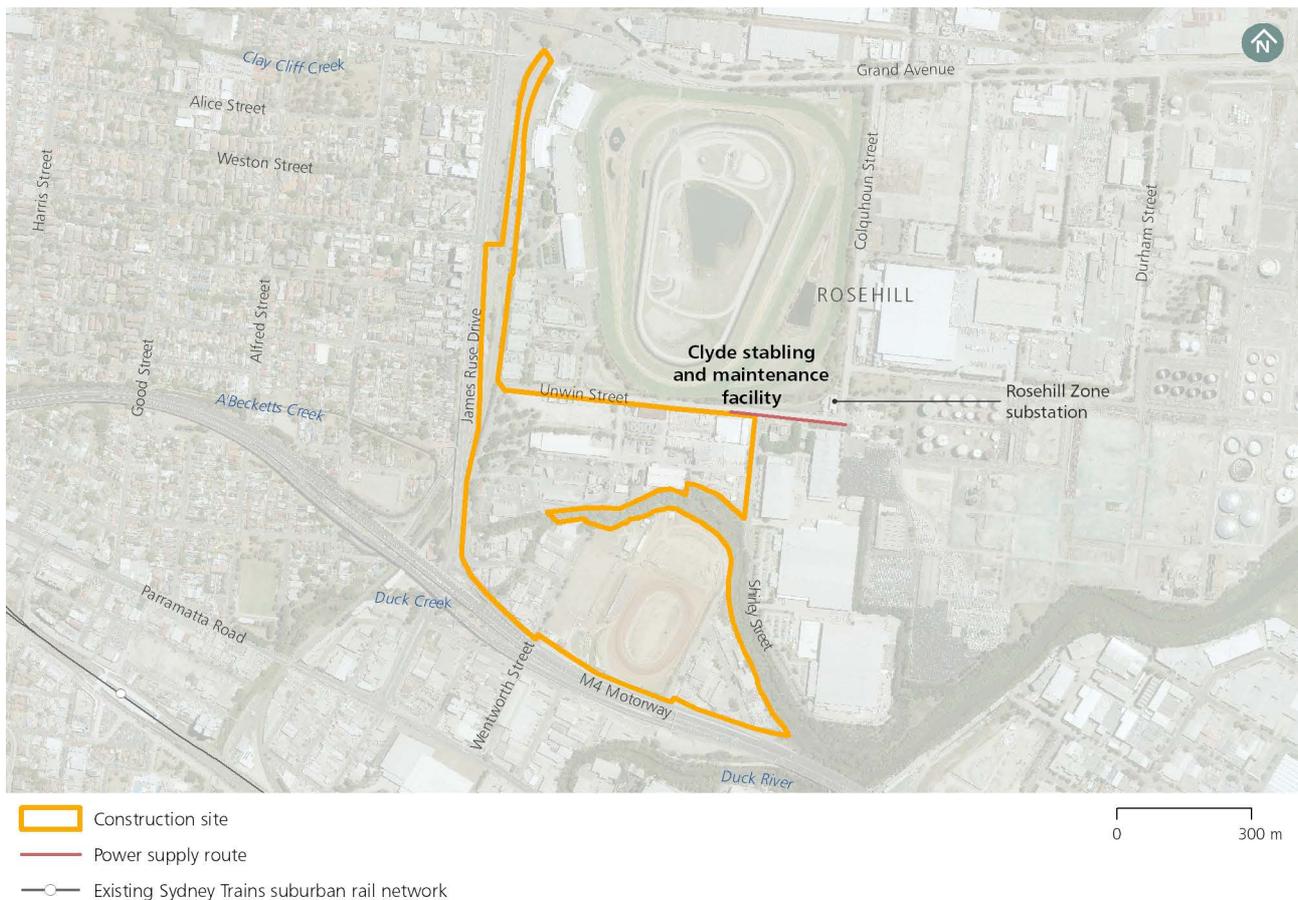
**Figure 5-3: Clyde stabling and maintenance facility construction site – power supply route**

The power supply route follows Unwin Street (refer to Figure 5-3). The majority of the land use (possibly less than 100 years) surrounding the power supply route is likely to have been utilised for industrial purposes. It is possible that industrial wastes (potential asbestos wastes) may have been used in the construction of the roadways and as fill within the local area. Any construction activities for the power supply route which extends into groundwater could expose contamination known to be present in this general locality. It is anticipated that the groundwater inflow to excavations for power supply route would generally be relatively minor (if at all). Minor short-term dewatering may potentially be required for the construction of the power supply route.

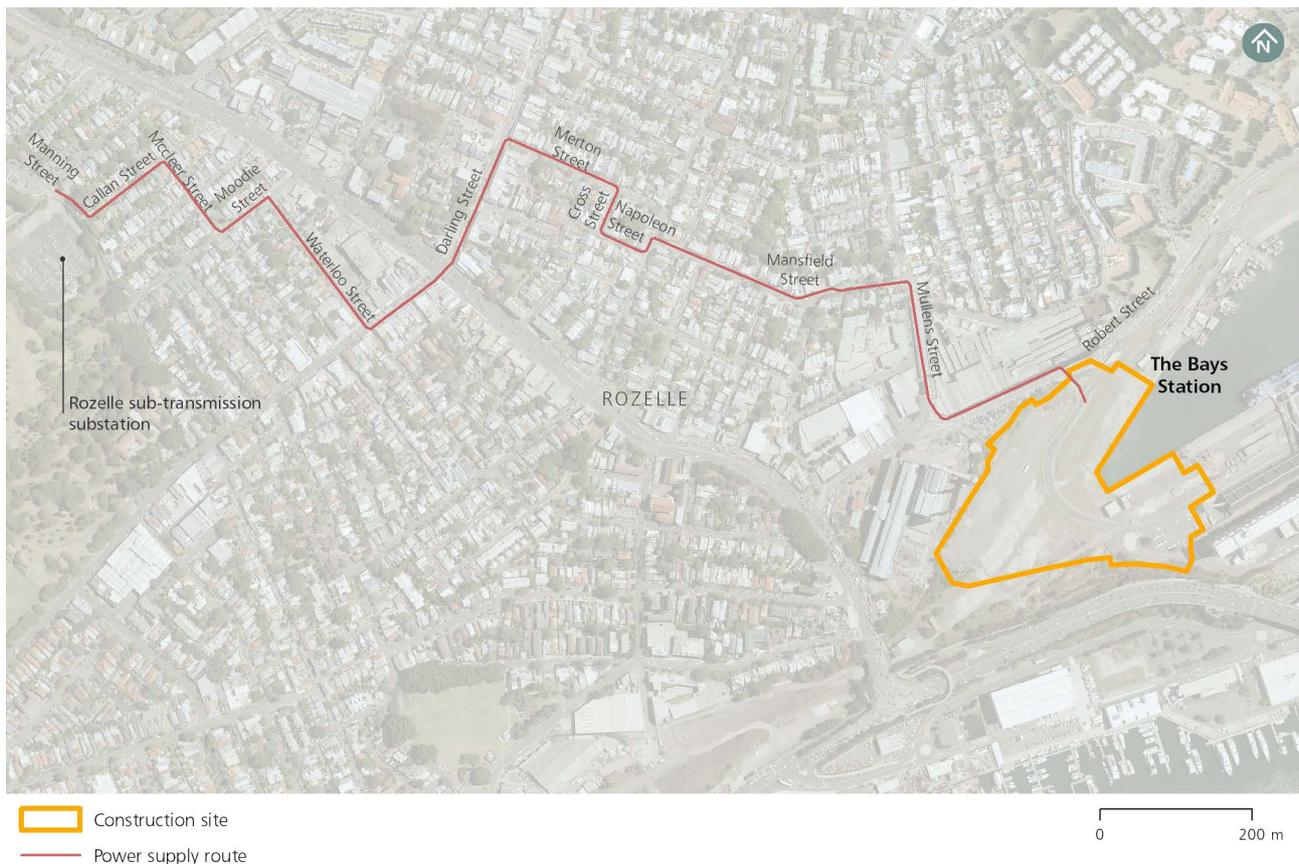
Figure 5-4: The Bays metro station construction site – power supply route

The majority of the power supply route follows Robert, Mullens, Mansfield, Cross, Merton, Darling, Waterloo, Moodie, McCleer, Callan and Manning Streets (refer to Figure 5-4). The majority of the land use (possibly less than 100 years) surrounding the power supply route is likely to have been utilised for residential, commercial and industrial uses. Industrial activities are likely to be concentrated within the eastern end of the power supply route. It is possible that wastes associated with historical industry within the general locality or from harbour side industry (potential coal/coke wastes, ash and slag) may have been used in the construction of the roadways and as fill within the local area.
