## 17 Soils, geology, groundwater and contamination

This chapter assesses the potential impacts on soils, geology, groundwater and of contamination associated with the Project.

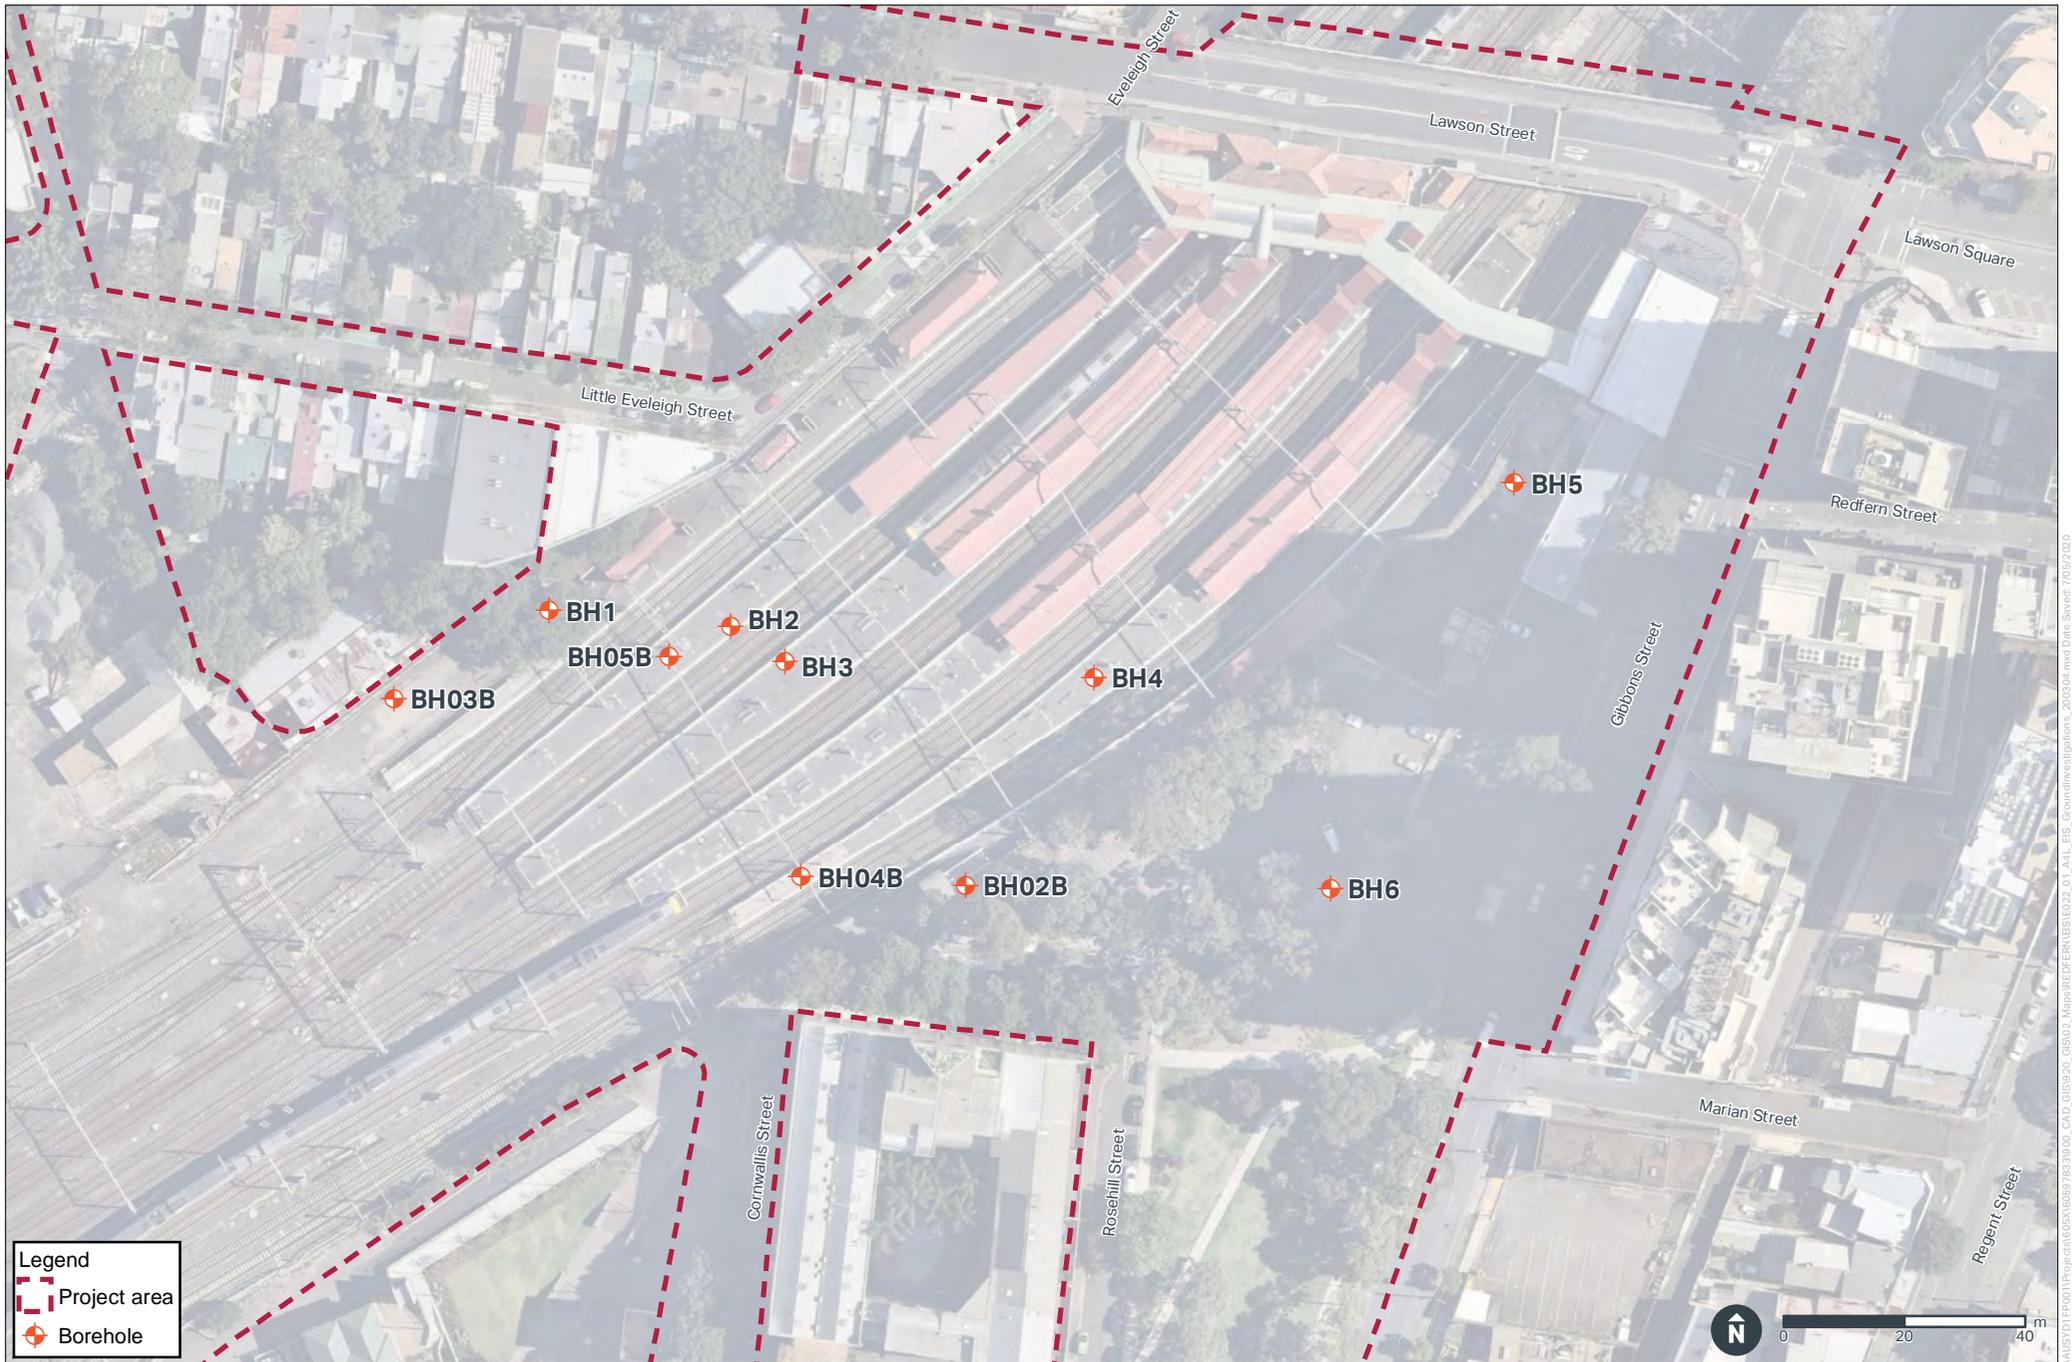
**FIGURE 17-1: LOCATION OF THE BOREHOLES BH1 – BH6 (SOURCE: JACOBS, 2018A) AND BH02B – BH05B (SOURCE: AURECON, 2020)**

As a part of the contamination investigation (Jacobs, 2018a) and geotechnical investigation (Jacobs, 2018b), six boreholes (Boreholes BH1 to BH6 as shown in **Figure 17-1**) were drilled to depths of between 8.5 metres and 10.4 metres below ground level. An additional four boreholes were also drilled to depths of between 13.61 and 18.72 metres as part of further geotechnical investigations (Aurecon, 2020). The borehole investigations performed across the Project area provide clarity on the underlying subsurface profile. **Table 17-2** specifies the five geotechnical units encountered, in order of increasing depth.

Soil samples were collected from each of the boreholes shown in **Figure 17-1** until contact with natural soils and/or bedrock was made, or where there was evidence of potential contamination. Borehole depths for soil samples varied from 0.0 metres to 3.0 metres below ground level. Borehole BH1 was drilled near the end of Platform 1, behind 125-127 Little Eveleigh Street. Boreholes BH2, BH3 and BH4 were drilled within the south west extents of Platforms 3, 4 and 9, respectively. Borehole BH5 was drilled to around five metres to the west of the existing entrance stairs at the northern end of Platform 10. Borehole BH6 was drilled to around 40 metres south east of the Platform 10 building. BH02B was drilled adjacent to the southern side of the tracks (near the proposed Marian Street entrance), and BH03B was drilled adjacent to the northern side of the tracks. BH04B was drilled within the south west extent of Platforms 8 and 9, and BH05 was drilled within the south west extent of Platforms 2 and 3 (both of these were drilled near the proposed alignment of the concourse).
