## 3.2 Test Trench 2: Car Park, Thompson Square

| Windsor Bridge Replacement Project 14020 | | |
| European Test Excavation | Test Trench 2 | |

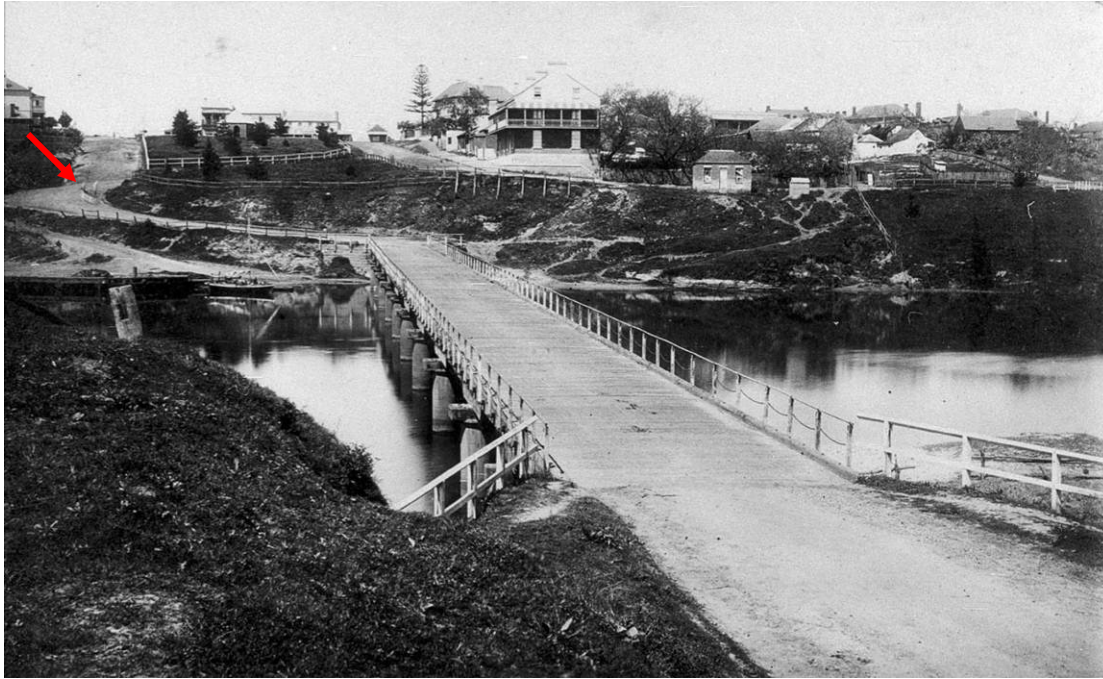
*Plate 25: View of Thompson Square that shows the c. 1855 road extension to Bridge Street and the point where it met the 1876 road to the wharf (source: NSW State Library).*

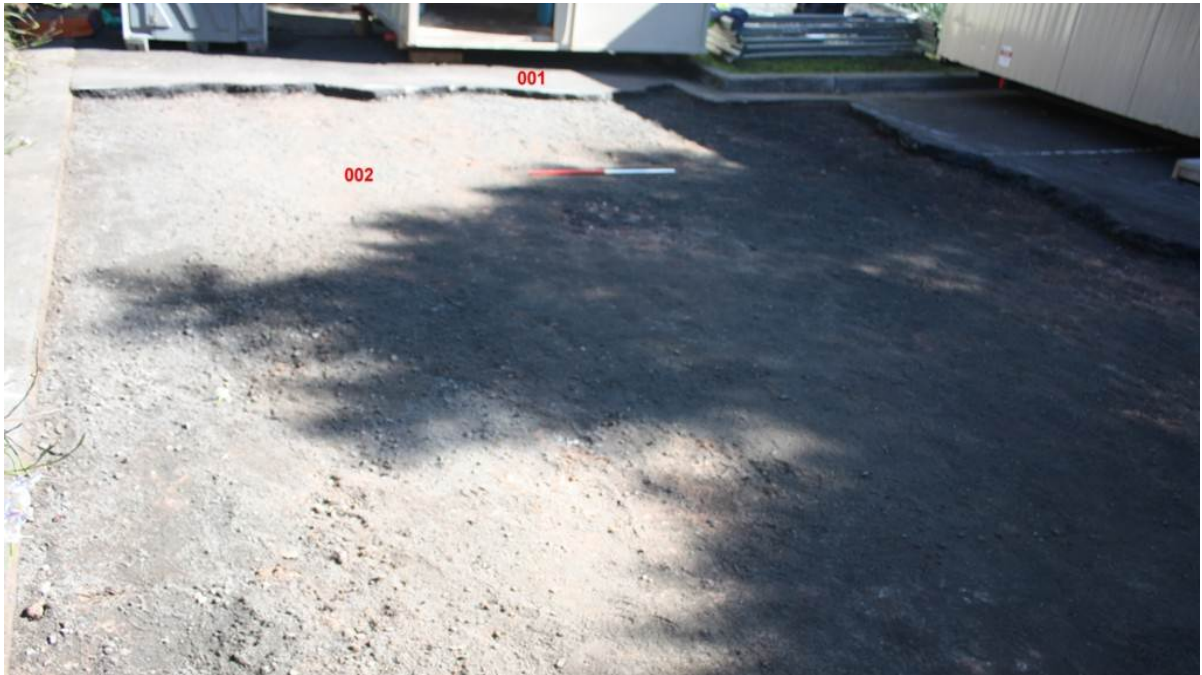
Plate 28: Test Trench 2, removal of the present car park surface revealing the underlying blue metal; scale one metre.

The upper portion of Test Trench 2 was similar to that found in Test Trench 1. The entire excavation area was covered with bitumen up to 50 mm deep [001]; this is the present surface in use. It was laid over a thin deposit of blue metal [002] and below the blue metal was up to 300 mm of compacted sandstone rubble [005]. This was the same deposit found under the present road in Test Trench 1 [051]. A cement kerb and gutter ran along the southern side of the trench at the edge of the reserve [004, 005]. The presence of the blue metal [002] here across the surface of the trench, similar to that found under the kerb and gutter in Test Trench 1 [054] suggests that the car park is later than the last surfacing of Old Bridge Road and comparable in date to the kerbing and guttering found around the reserve, probably from the mid-1970s onwards.

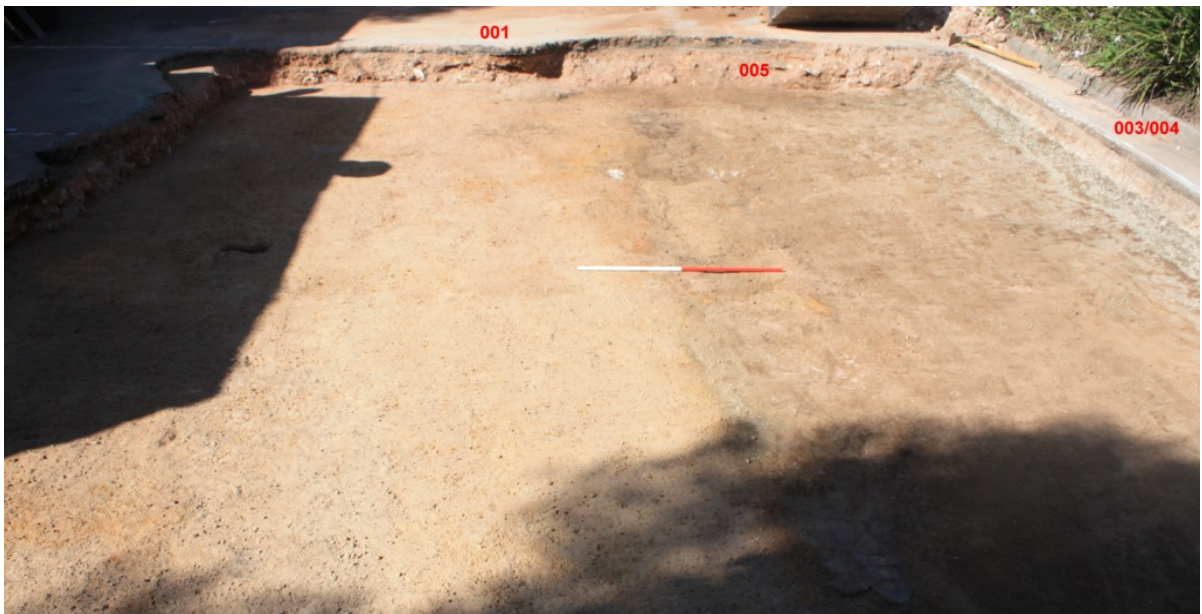
Plate 29: Test Trench 2, view east showing the depth of sandstone rubble lying under the road in the section; scale one metre

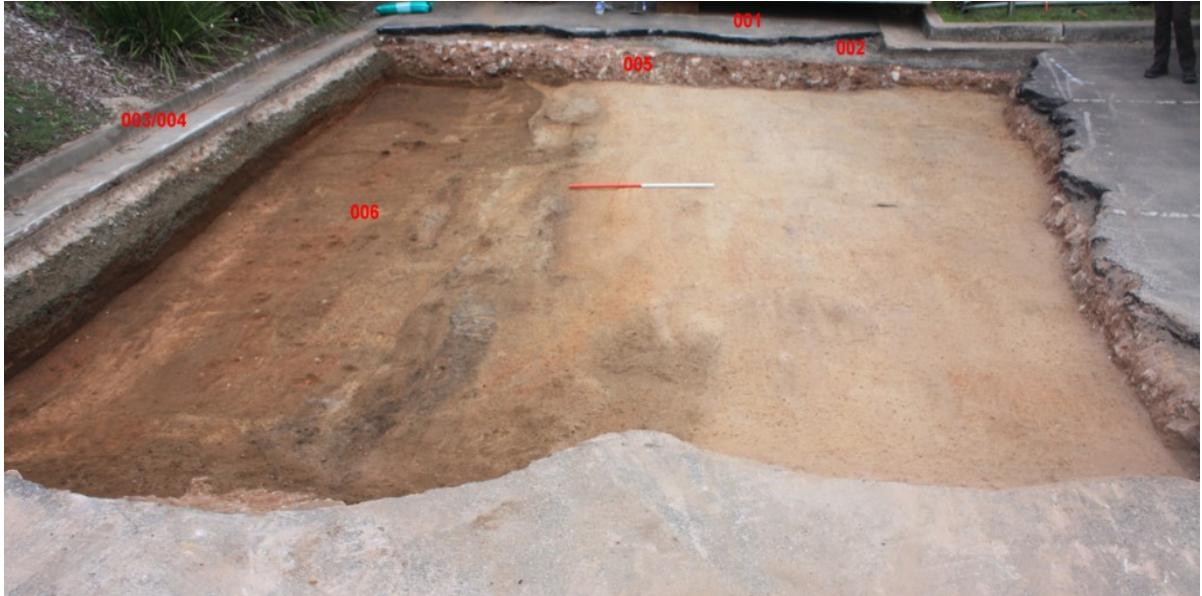
Plate 30: Test Trench 2, view west showing the cut [006] along the southern side of the trench; scale one metre.

Removing the sandstone rubble revealed a flat surface across the entire trench and along the southern side a wide cut up to 2.8 metres wide (Plate 30). This cut ran the full east-west length of the trench [006]. It narrowed slightly at the western end of the trench.

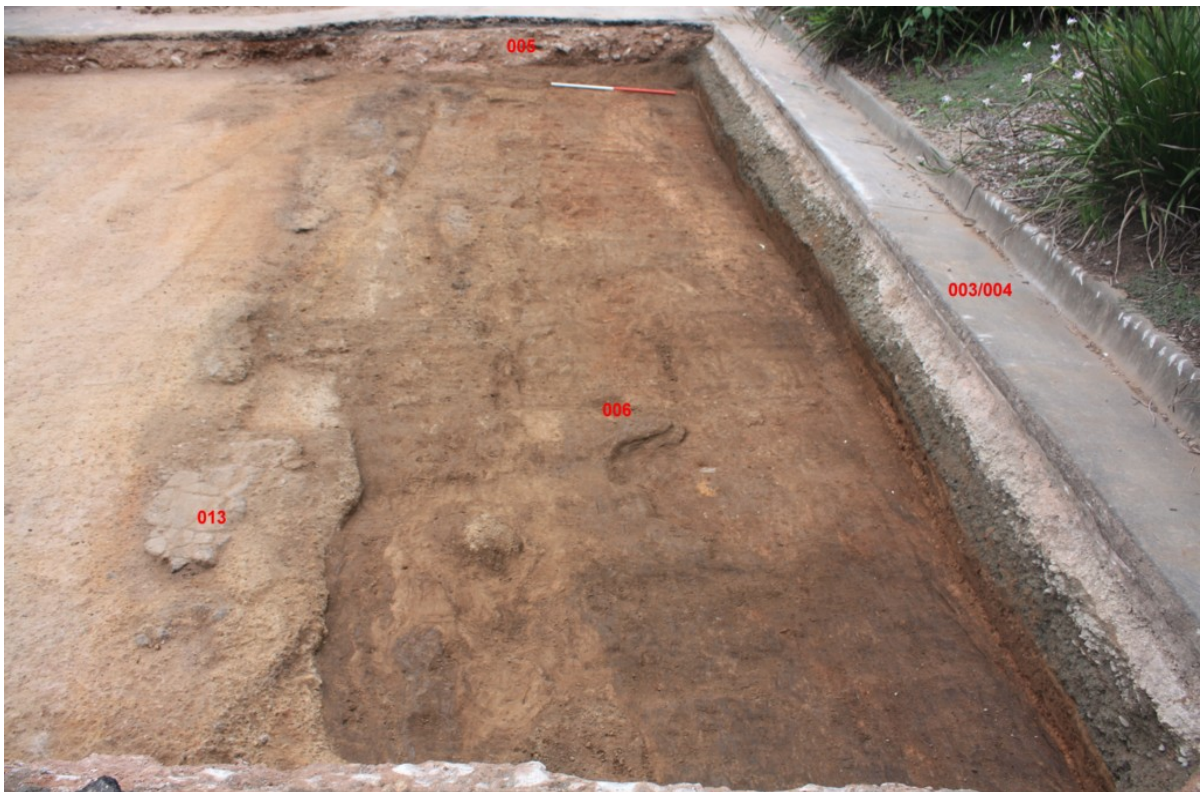
Plate 31: Test Trench 2, view east showing the cut [006]; scale one metre.

The long, straight cut [006] had been made into an existing surface [008]. The cut appears to have been a paved path or road; remnants of bitumen surfacing survived along the northern side of the cut and at the western end in a shallow depression [013]. Some of this bitumen was mixed with the loam and compacted clay that had been used to fill the cut [007]. In the section at the eastern end of the trench there appears to have been a post-hole cut into the filling material [036].

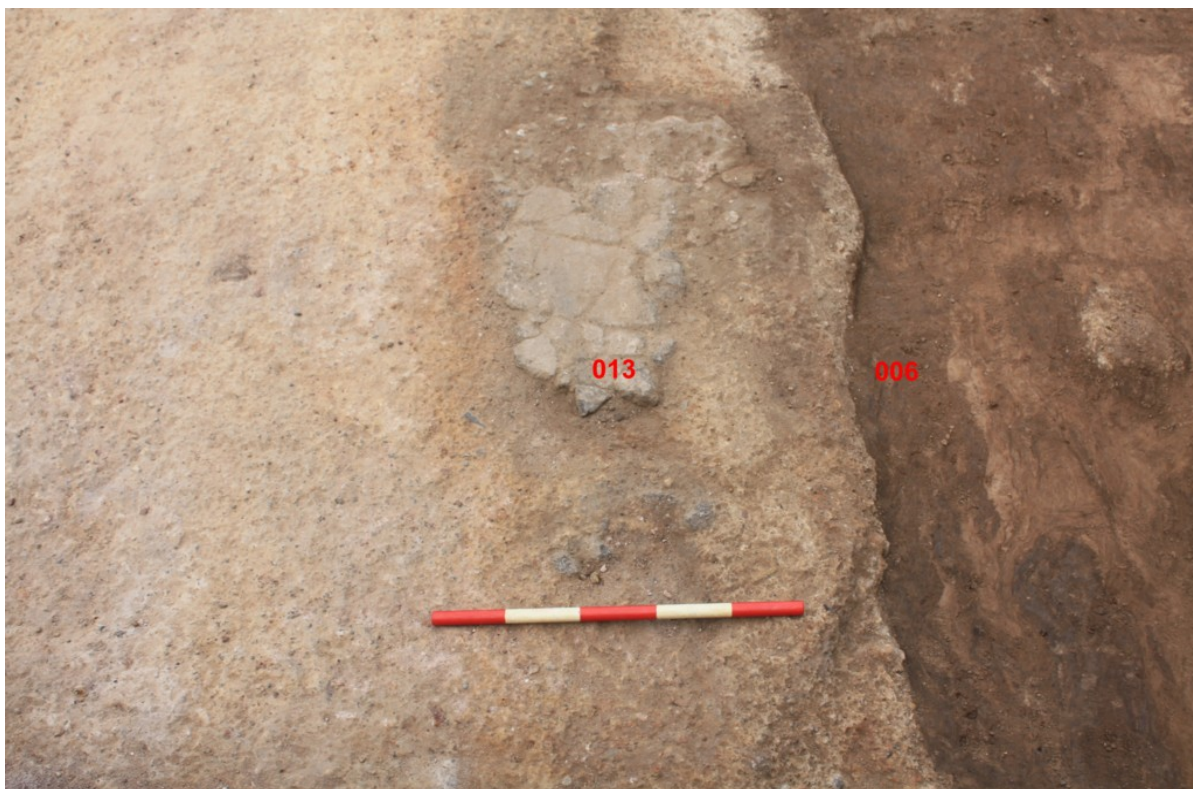
Plate 32: Test Trench 2, remnant bitumen surface on the northern side of the cut for a path [006], view east; scale 500 millimetres.

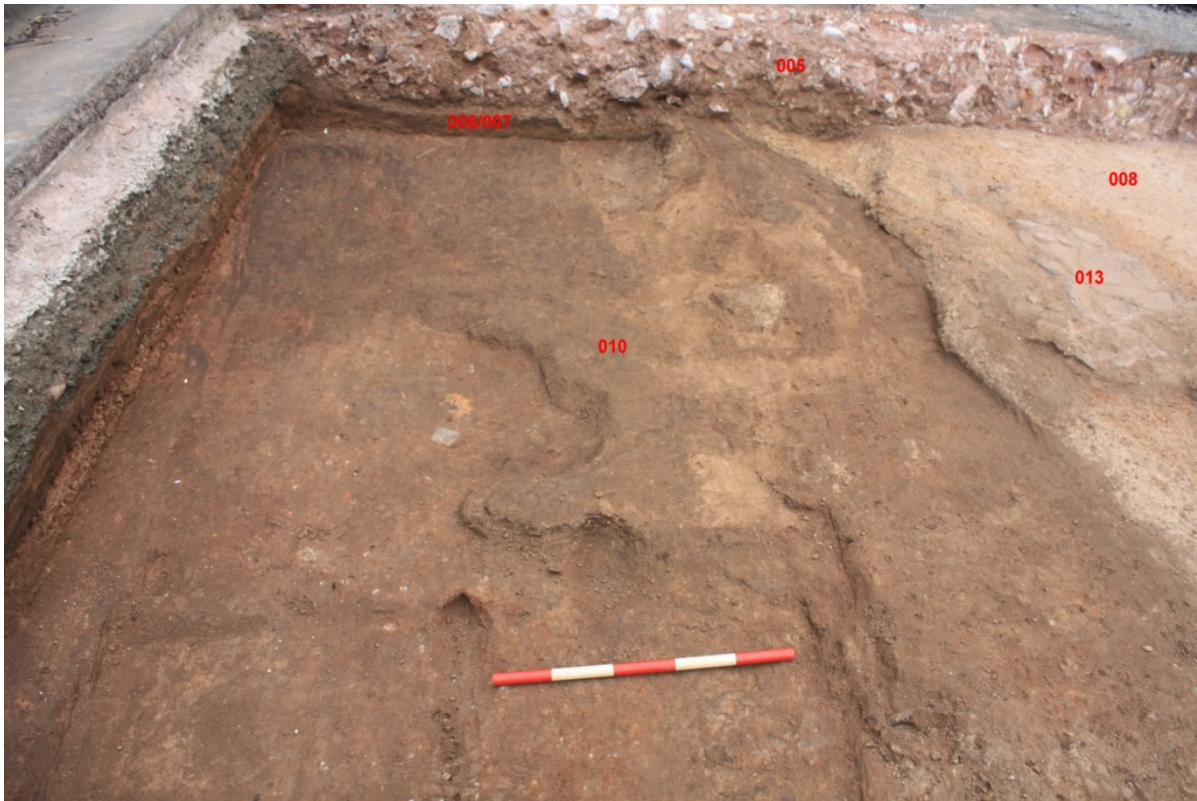
*Plate 35: Test Trench 2, view west showing remnants of the compacted silty soil [013] that was used to support the hard paved surface [008] here exposed in the cut [006/007] along the southern side of the trench; scale 500 mm.*

The hard surface [008] was founded on a deposit of fill or bedding material [010] that extended across the entire trench. The cut on the southern side of the trench [006] had been excavated into this material removing some and leaving portions of the compacted material intact. This flat compacted bedding was made with silt, red and orange sand, some gravel, small pieces of both early and later nineteenth century brick and some blue metal [010]. The inclusions appear to have been to create a textured surface that would grip the new hard surface.

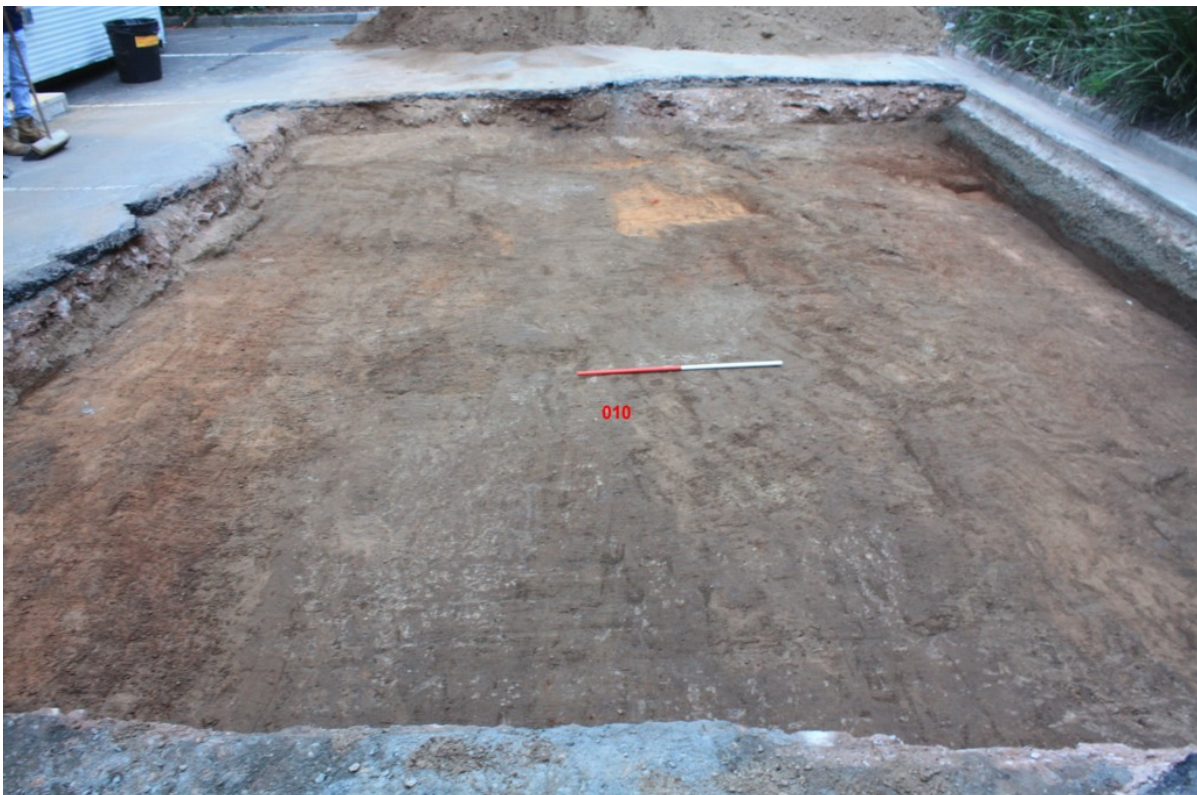
*Plate 36: Test Trench 2, view east showing the compacted silty soil [010] that formed the base for the hard paved surface [008]; scale one metre*

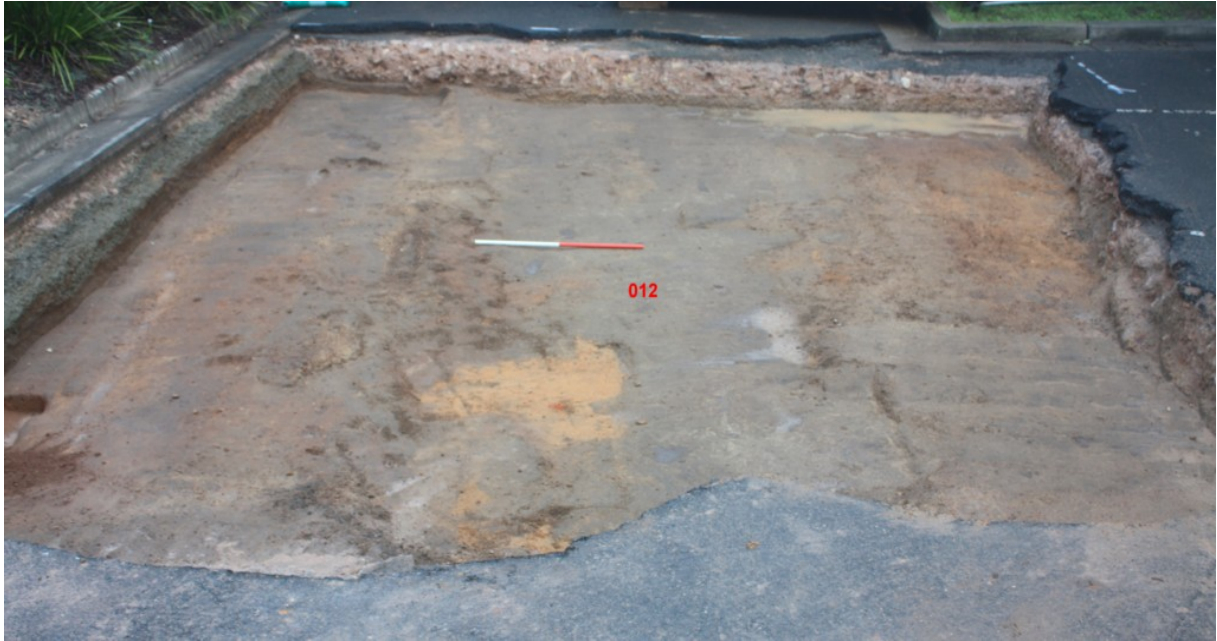
*Plate 37: Test Trench 2, view west showing the sandy silt [012] that lay under the bedding material [010] for the hard paved surface [008]; scale one metre*

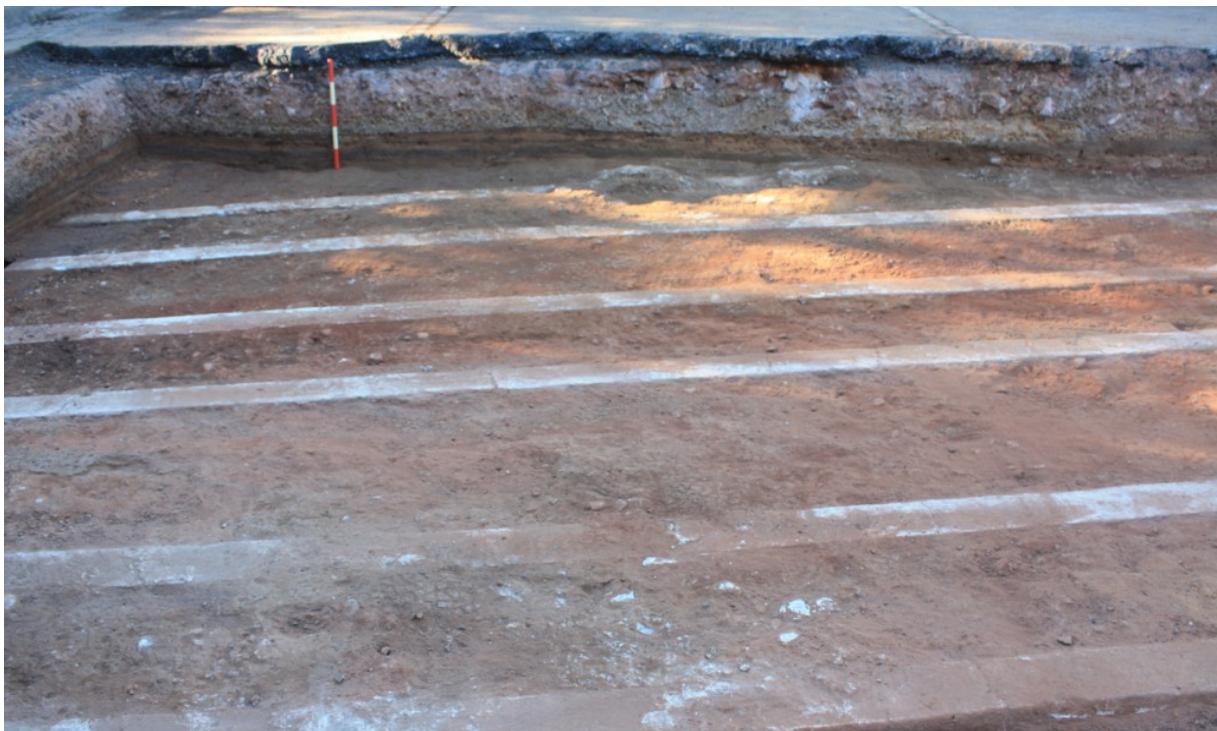
*Plate 38: Test Trench 2, view north showing in section the layers of fill that produced a hard flat and slightly sloping surface; scale 500 millimetres.*

The layering of these two principal deposits with some lensing produced a clean flat surface that sloped gradually to the west best seen in the sections.

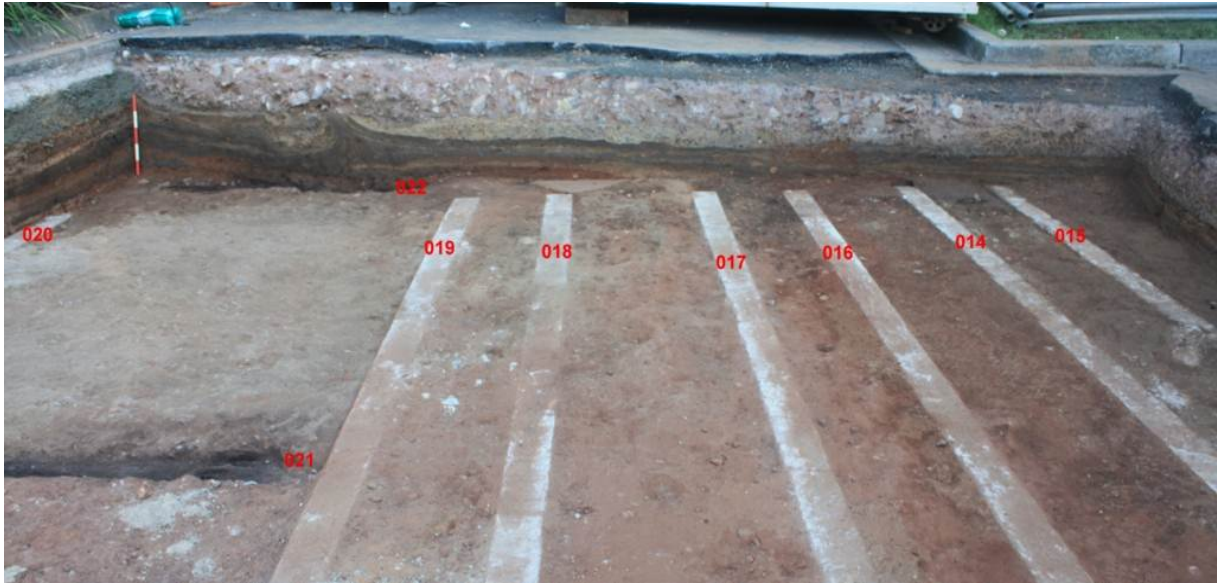
*Plate 42: Test Trench 2, view west showing all the concrete beams and one of the timber plates, the second [024] is in the shade at the end of the trench; scale one metre.*

On the southern side of the trench was another concrete beam [020]; this was separated from the main group by 2.1 metres. The reason for the separation is unknown but two timber beams or plates were found spanning the gap in the space between this beam and the larger group, but not touching the concrete beams on either side; they were separated by approximately 200 mm. As well, the two timber plates [021, 022] were separated from each other by a space of approximately three metres.

One particular feature of all the concrete beams and the timber plates is that they were placed on a slight angle from north-east to south-west.

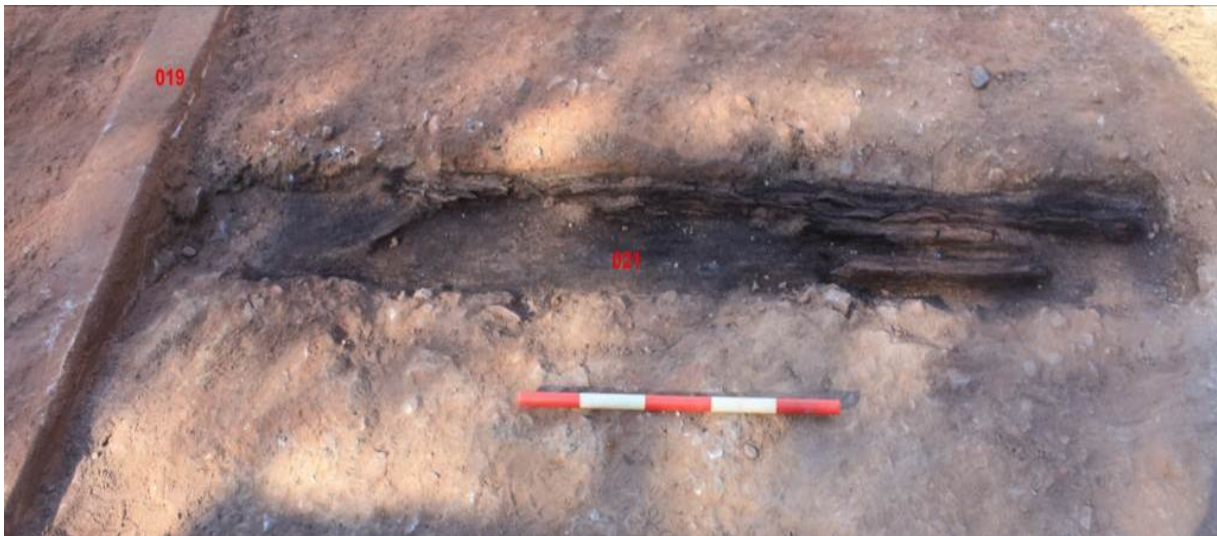
*Plate 43: Test Trench 2, view east (above) showing the timber plate in the body of the trench [021] and at the western end (below); scale 500 millimetres*

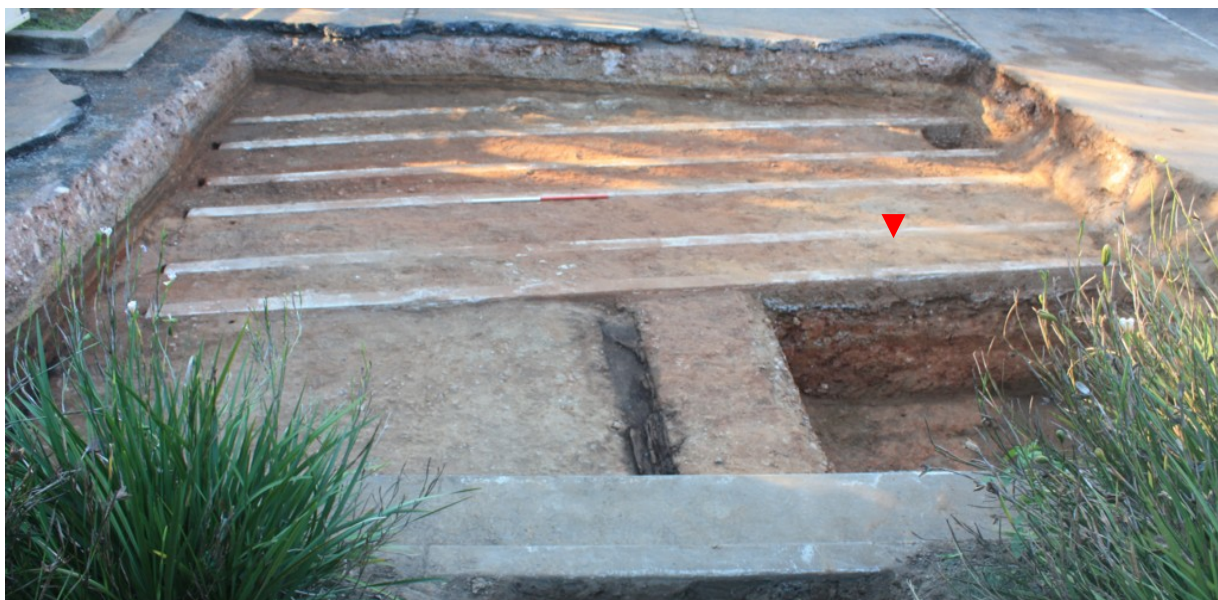
*Plate 47: Test Trench 2, view north showing the position of the test pit (indicated by arrow) used to take the excavation to the required depth while preserving the features uncovered in the body of the excavation; scale one metre.*

In order to preserve these features the excavation was limited from this point to a test pit in the south-eastern corner between the two concrete beams [019, 020] and beyond the timber plate [021]. In this pit measuring approximately 2.0 x 2.5 metres the excavation was taken to the depth of 1.5 metres, the depth required for the proposed bridge construction.

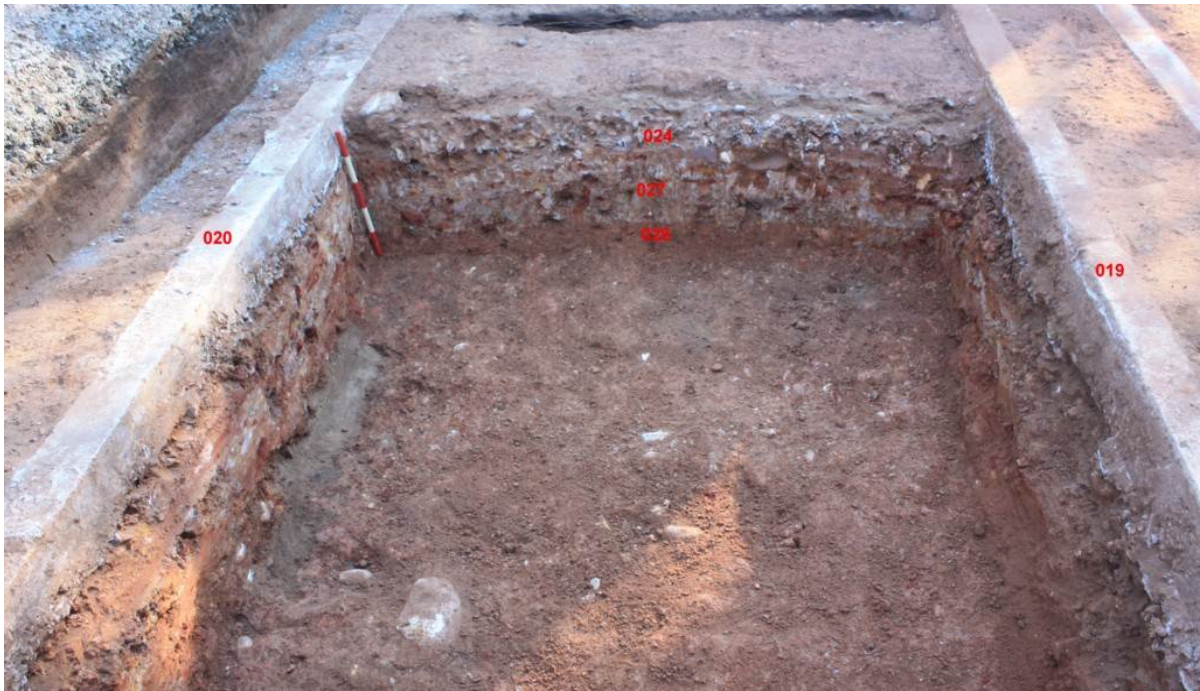
Plate 48: Test Trench 2, view west showing the section in the small test pit with the fill layers [027, 028] below the packing for the beams [024]; scale 500 millimetres

Immediately below the hard packing [024] used to stabilise the concrete beams were several layers of fill used to raise and level the site prior to the introduction of the beams. The first of these layers, below the packing fill, was a deposit of mixed white and orange clay up to a

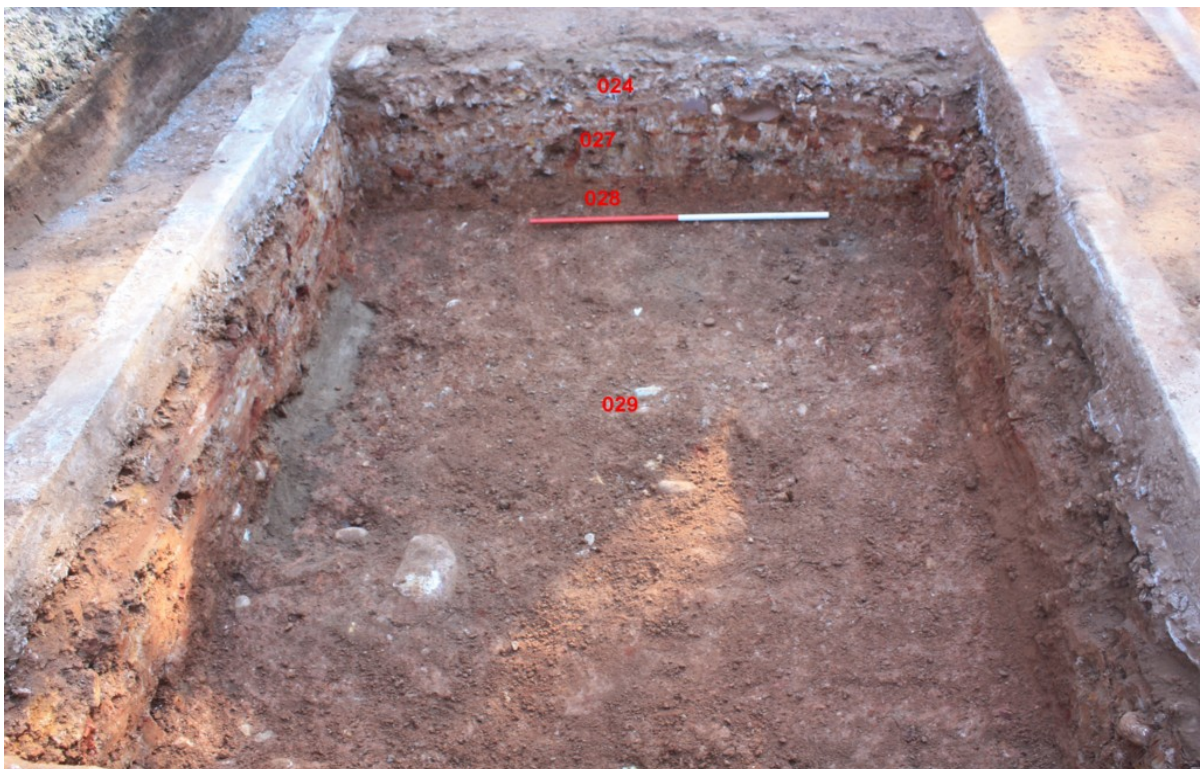
Plate 49: Test Trench 2, view west showing the compacted stone and soil layer [029]; scale one metre.

Below the two fill layers [027, 028] was a compacted deposit that comprised loam, some red clay, and a large quantity of rounded stones and small gravel [029]; it was up to 250 mm in depth but this was at its deepest point. It filled a sloping cut below and so the middle section was considerably deeper than the sides (south and north). It was impossible to determine from the small excavation area whether this was a fill deposit or an older road surface.

What is more difficult to interpret are the layers found at the base of the smaller test pit excavated in the south-eastern corner of the large trench. The deposit with numerous rounded pebbles and gravel [029] could be the surface of the older road to the bridge or a deposit common to Thompson Square. The survey plan of the early 1870s for the proposed bridge records that the surface of the square close to the river was composed of earth with rounded pebbles. Whether this surface is a contained feature or common to the square is impossible to determine from the area available. Similarly, the deposit below [030] is also impossible to interpret other than it appears to be introduced soil and that it has been cut and shaped, possibly for the surface above it or for a purpose no longer evident because of the excavation made into it. It is also impossible to determine if it is a unique feature or a widely spread surface.

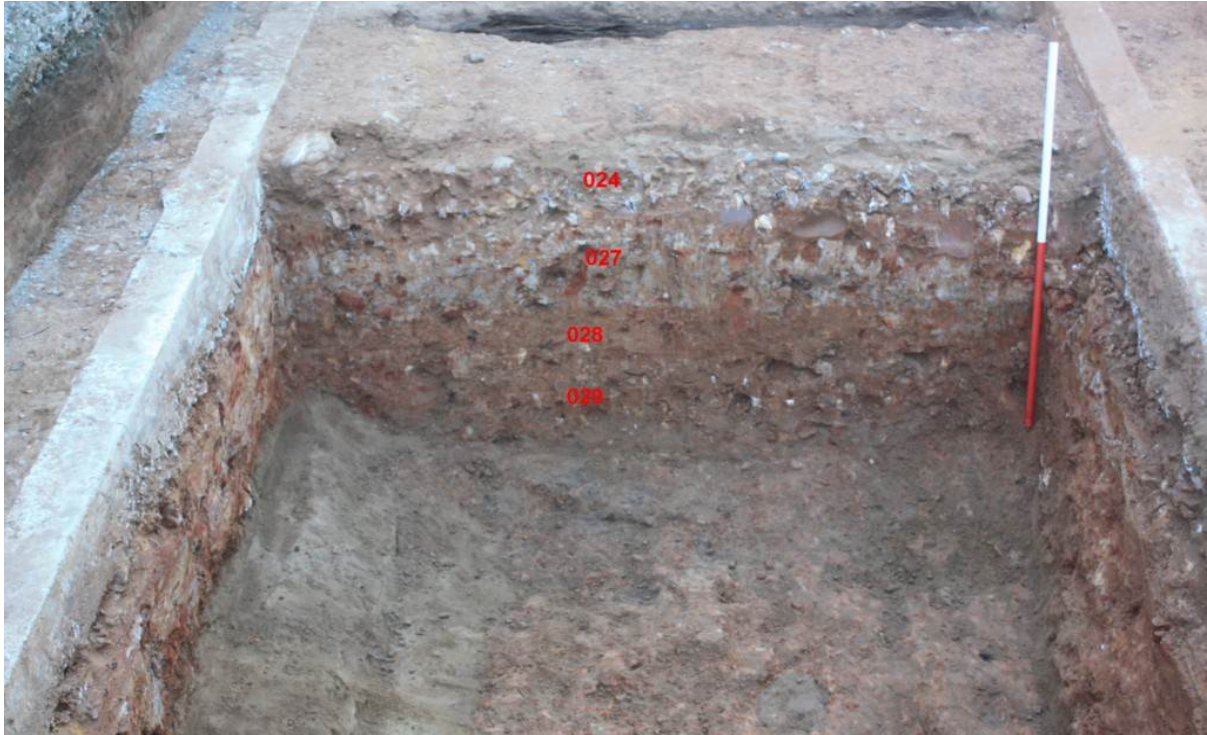
*Plate 50: Test Trench 2, view west showing the stone and clay fill in section filling in the sloping cut below it; scale one metre.*

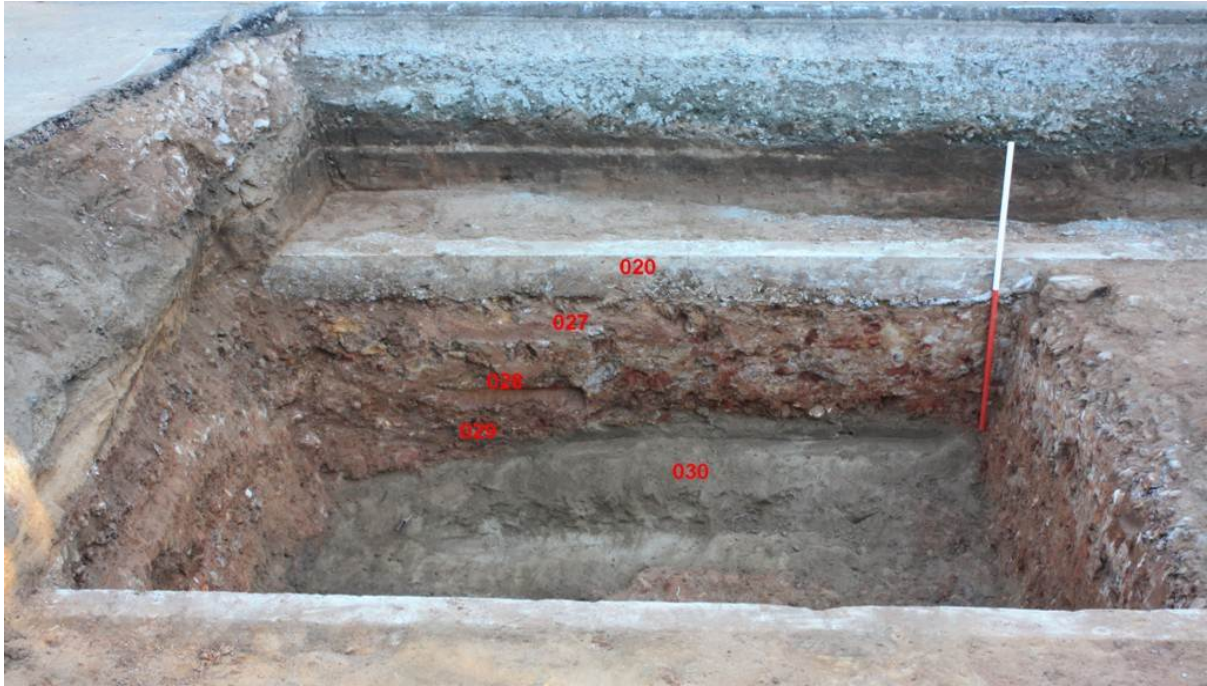
Plate 51: Test Trench 2, view south showing the sloping silty soil [030] cut into a step at the base of the test pit; the slope to the east is evident here: scale one metre.

Below this deposit was a distinctive fine, silty green/grey coloured loam. It was completely sterile of inclusions or artefacts. It may originally have been a level deposit but appears to have been cut in a step on the southern side of the trench leaving a thin deposit across the base of the trench that was missing in parts [030]. It also substantially sloped down to the east. There was insufficient evidence to determine what this material had been used for or when it was deposited here. Below it could be seen the top of a new deposit [037] apparently red clay. At this point the excavation had reached the 1.5 metre depth that is proposed for excavation of the new bridge and the investigation was terminated here.
