Windsor Bridge replacement project

Submissions report
Incorporating preferred infrastructure report

APRIL 2013

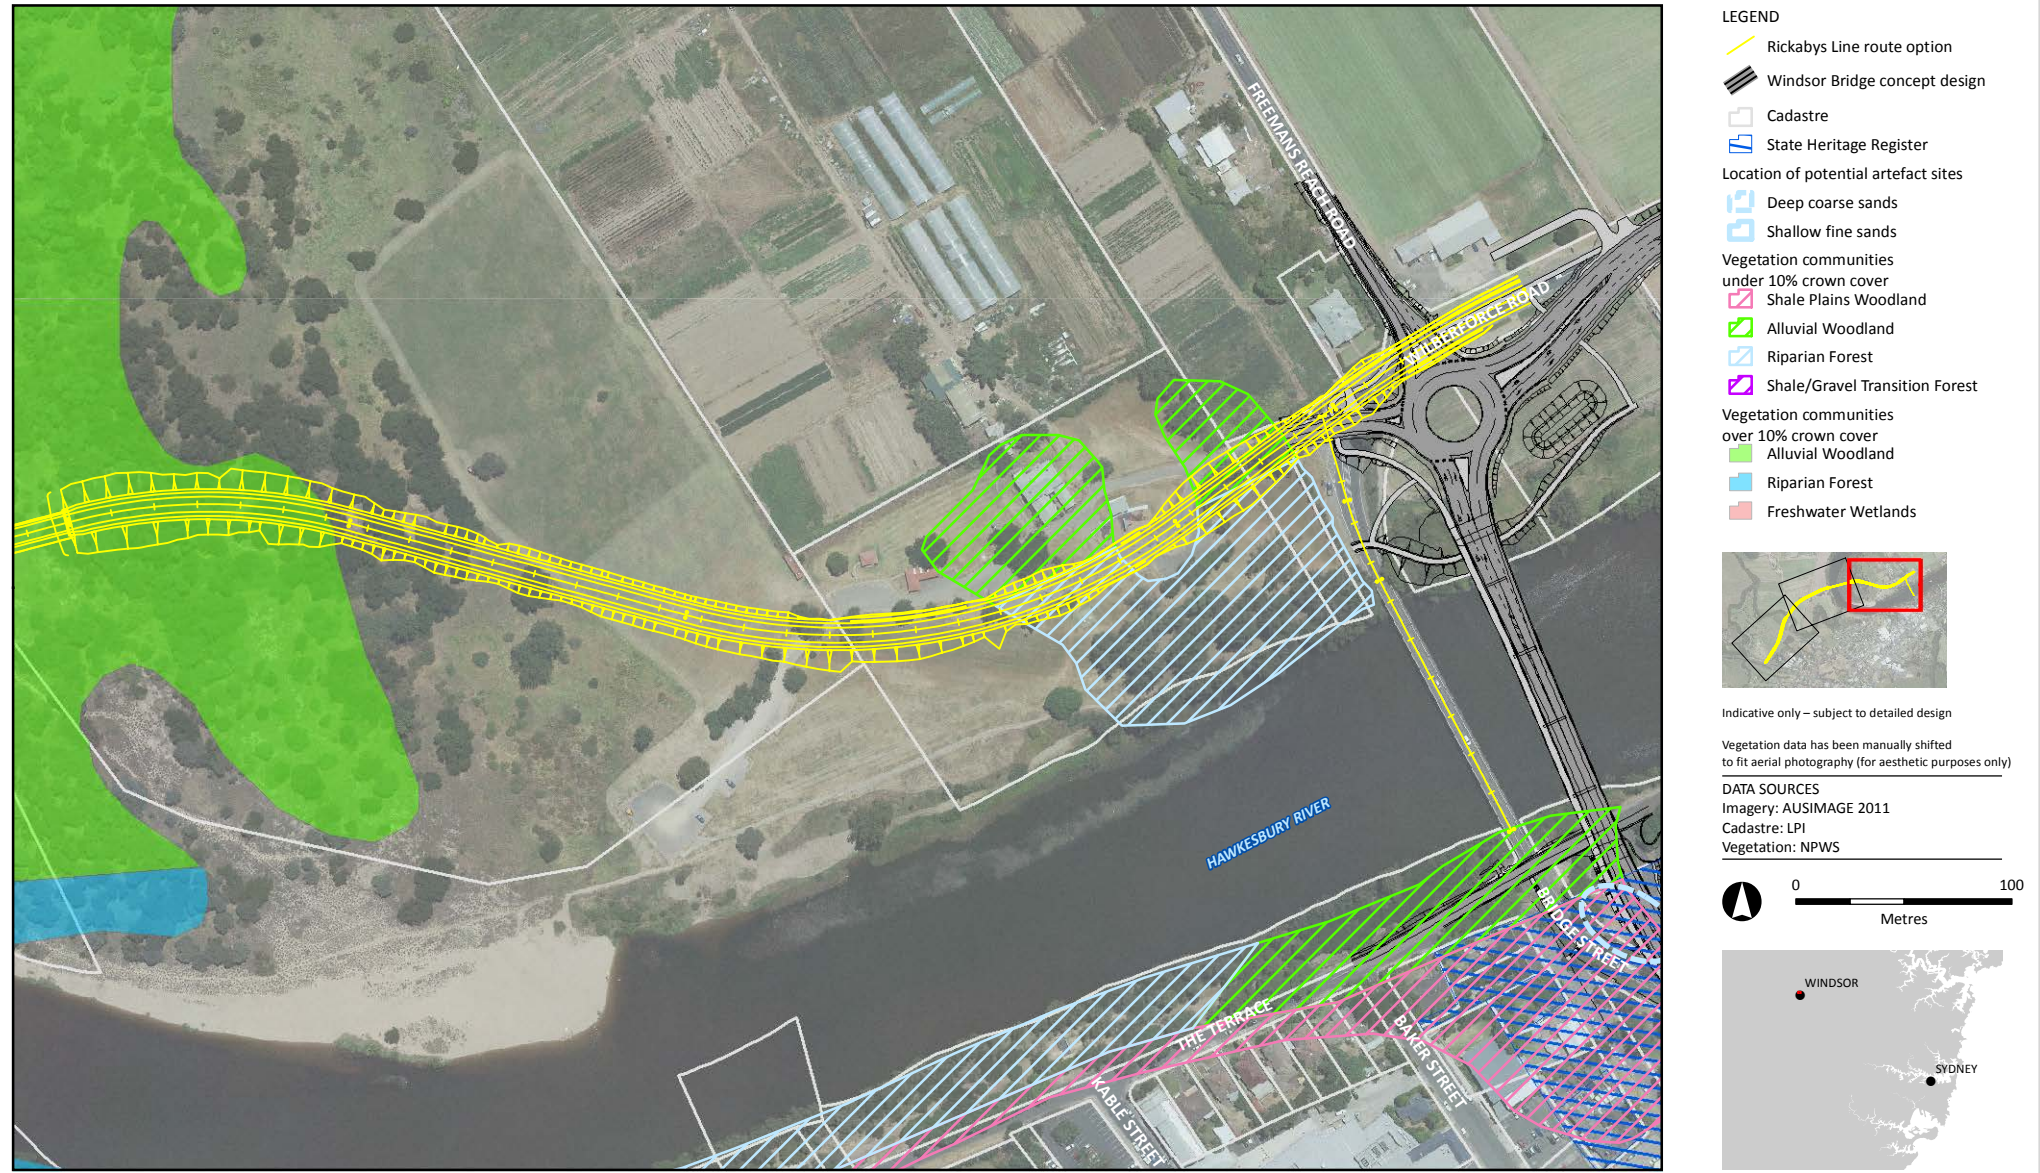
Figure 4-1 | Rickabys Line route option

Windsor Bridge replacement site layout plan

To enable a more comprehensive environmental, cost and engineering assessment of the Rickabys Line option, a preliminary design of the alternative route was prepared based upon the description provided in the submission. In reviewing the description of the option as provided in the submission, a number of issues were identified as needing refinement to meet relevant design standards and mitigate significant impacts. These issues are outlined in the following sections. Based upon the refinements made to the proposed alternative a preliminary concept design was developed which is presented in **Figure 4-1** to **Figure 4-3**.

The route alignment of the bypass component of the Rickabys Line option is shown in **Figure 4-1** to **Figure 4-3**. As discussed above, the route could be modified within this corridor, however the route was identified to minimise potential impacts and reduce the cost of the option. While the environmental assessment included in the following sections is based on this alignment, it should be noted that the impacts identified would be broadly consistent with alternative alignments through this corridor.

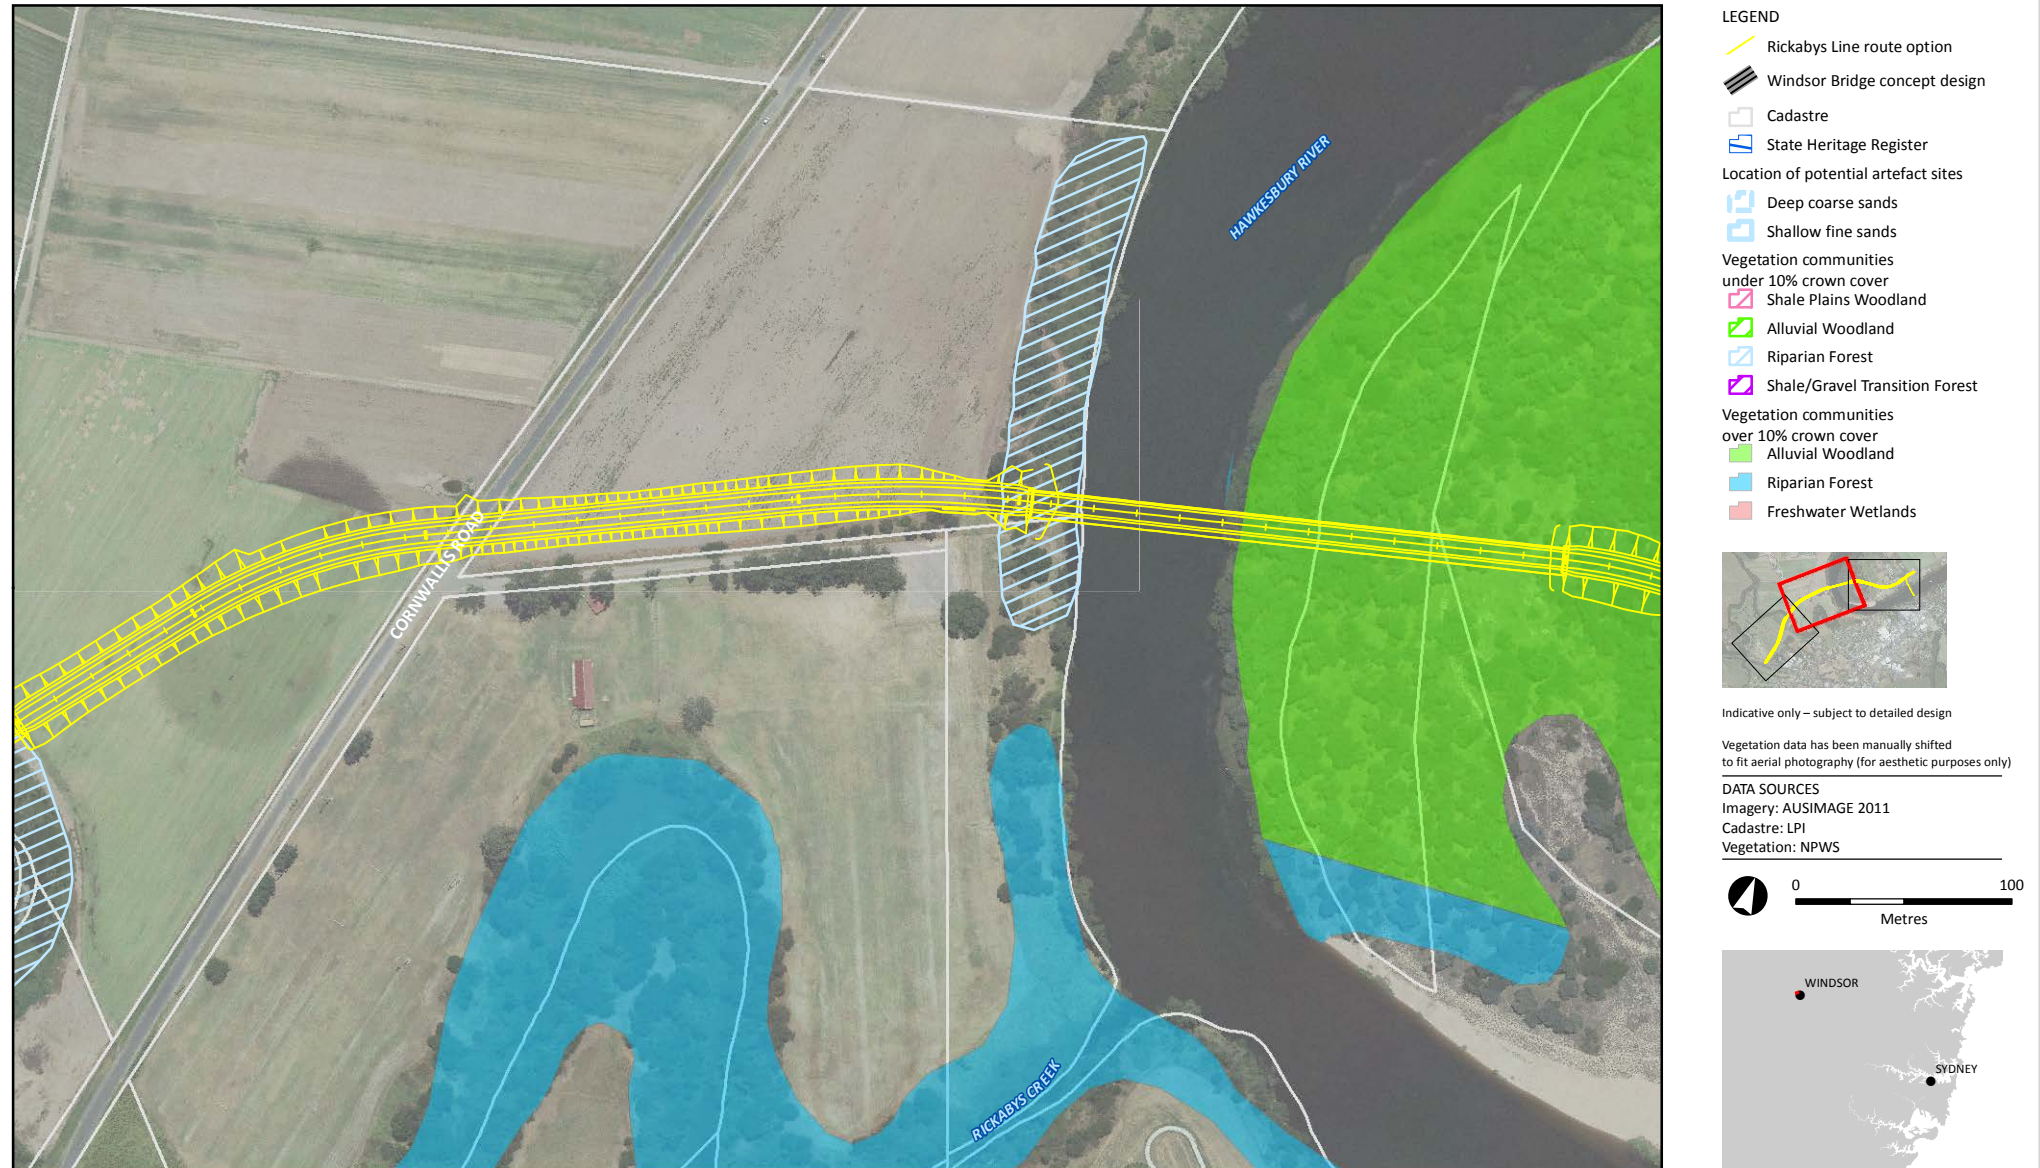
Figure 4-2 | Rickabys Line route option

Windsor Bridge replacement site layout plan

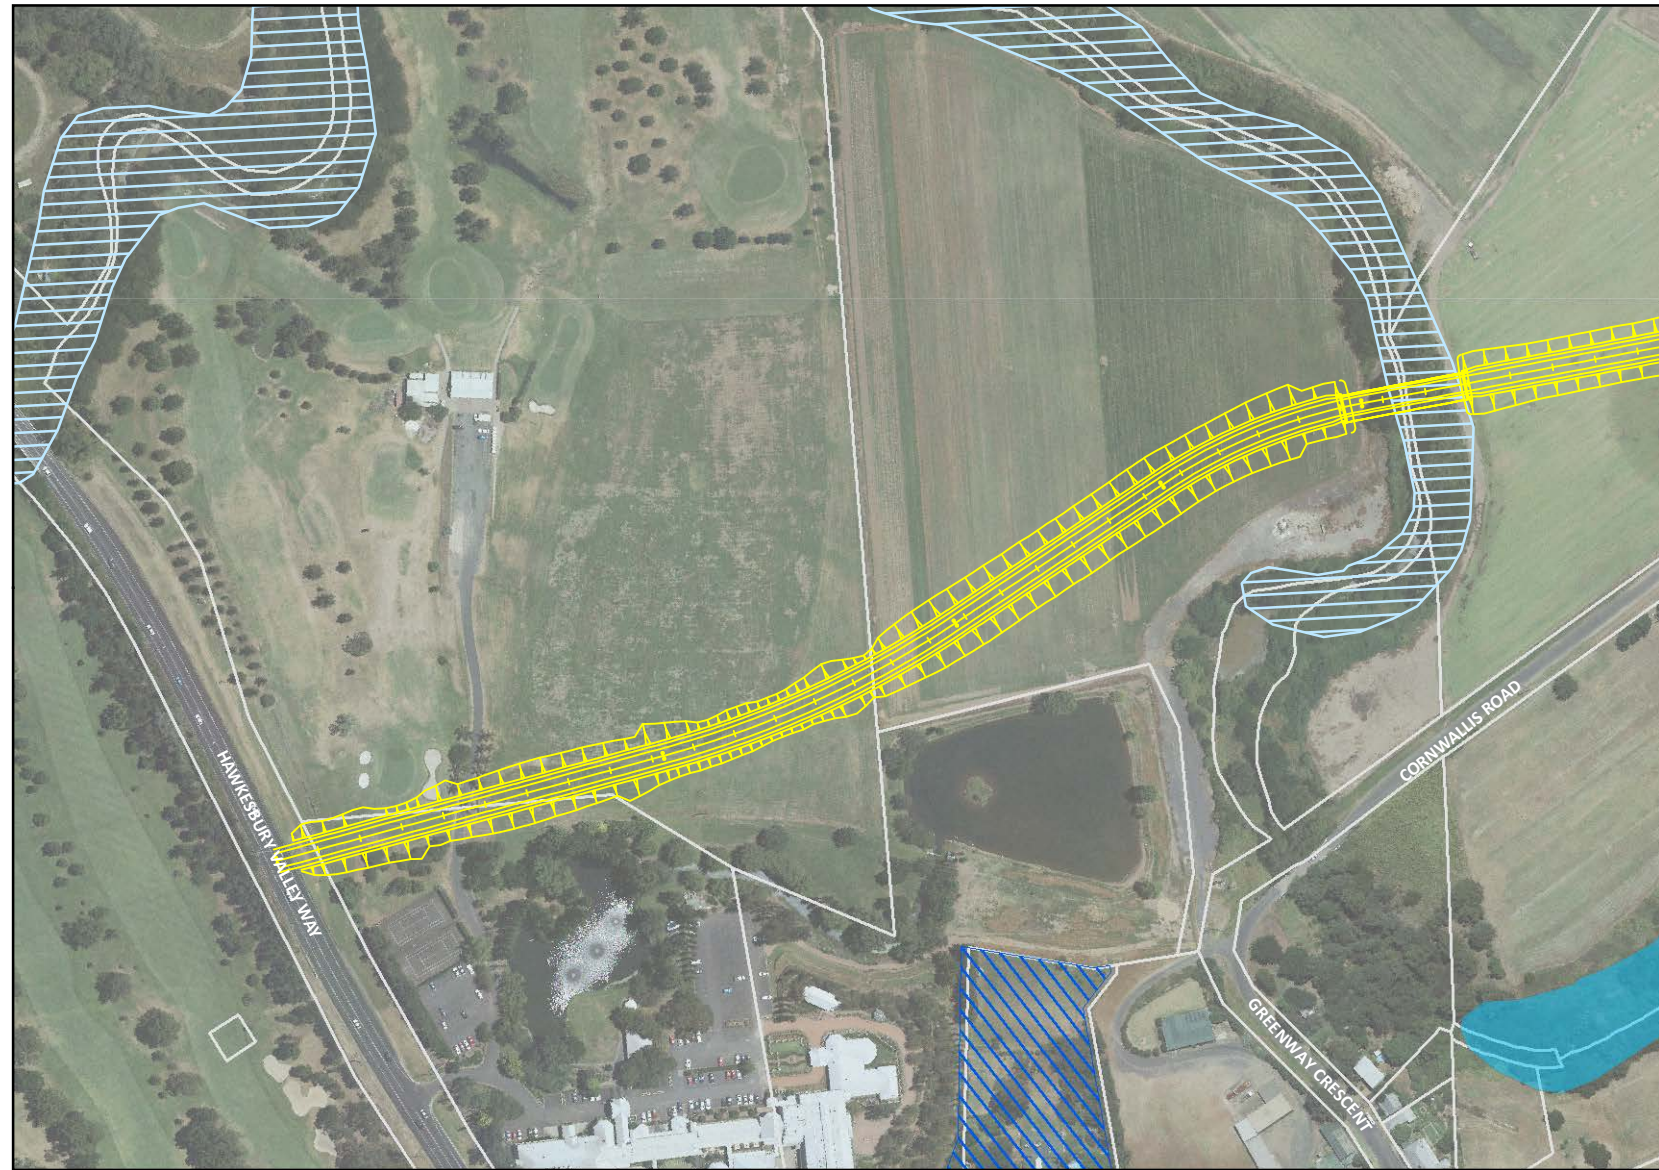
Figure 4-3 | Rickabys Line route option

- LEGEND**
- Rickabys Line route option
 - Windsor Bridge concept design
 - Cadastre
 - State Heritage Register
- Location of potential artefact sites**
- Deep coarse sands
 - Shallow fine sands
- Vegetation communities under 10% crown cover**
- Shale Plains Woodland
 - Alluvial Woodland
 - Riparian Forest
 - Shale/Gravel Transition Forest
- Vegetation communities over 10% crown cover**
- Alluvial Woodland
 - Riparian Forest
 - Freshwater Wetlands

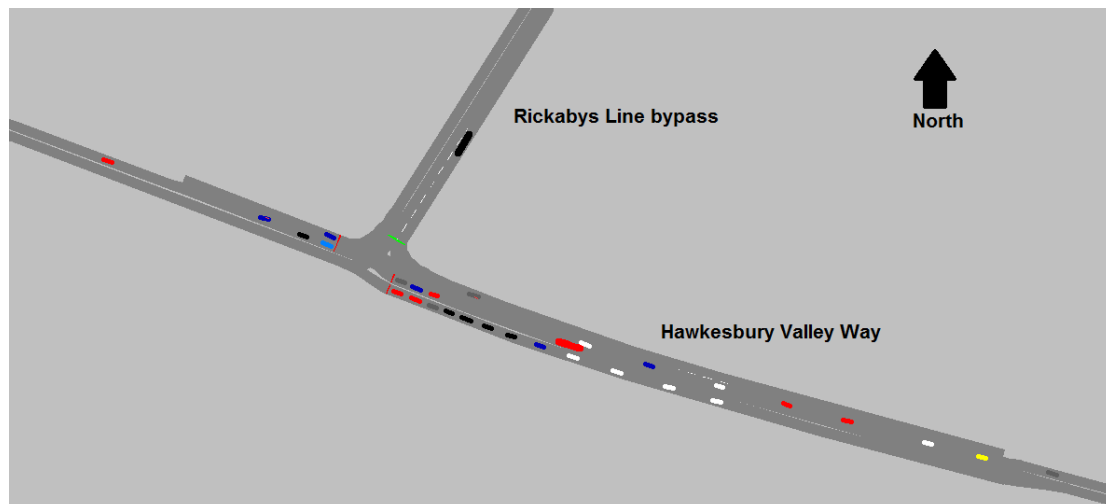
Figure 4-4 Hawkesbury Valley Way / Rickabys Line option intersection – traffic control signals

A preliminary concept design was prepared for the intersections of the Rickabys Line option with Hawkesbury Valley Way (see **Figure 4-4**) and the existing bridge/Freemans Reach Road/ Wilberforce Road intersection (see **Figure 4-5**). At Hawkesbury Valley Way, a traffic light controlled intersection would be required and Hawkesbury Valley Way would need to be widened to provide turning and merge lanes for traffic travelling to and from the Rickabys Line option. The intersection on the northern bank of the Hawkesbury River would be more complicated because it would not be possible to build a roundabout or four legged intersection that complied with road design and safety standards due to the low level and location of the existing bridge approach road in relation to the other roads. Instead, two traffic light controlled T-intersections would be required. A less complicated and better performing intersection could be built if the heritage listed Bridgeview property was acquired and demolished but this was not considered to be feasible. Cornwallis Road would require a minor realignment near its intersection with the Rickabys Line option to meet road safety design codes. The intersection of Cornwallis Road and the Rickabys Line option would be controlled by stop signs for traffic on Cornwallis Road.

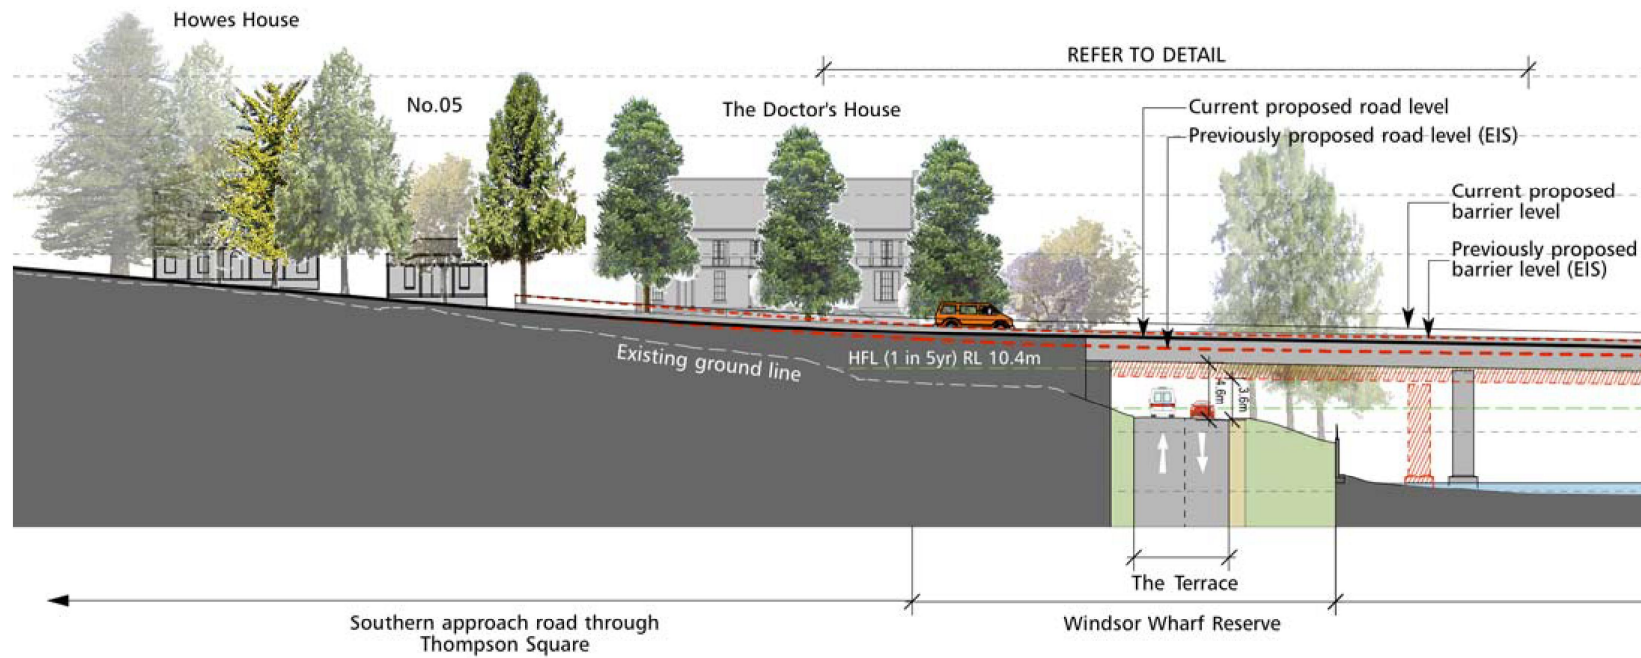
Figure 5-1 Change in height of bridge and approach road – southern bank

Figure 5-1 and **Figure 5-2** presents the difference in heights of the modified project in comparison to the project presented in the EIS.

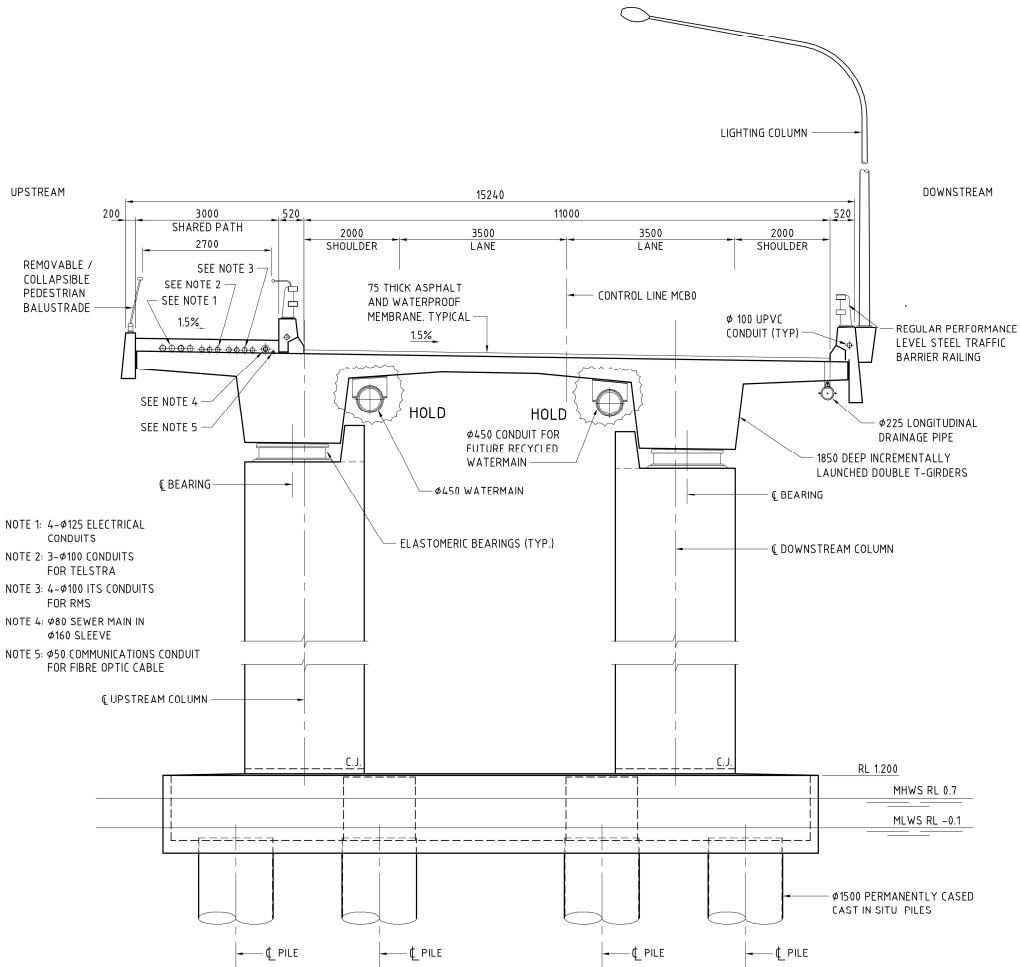
Figure 5-3 Cross-section of double T bridge

- Instead of a double box girder bridge as shown in Figure 5-4 of the EIS, a double T bridge would be constructed. A double T bridge would have a slightly shallower superstructure than a double box girder bridge but would otherwise have similar features to those described in the EIS. It would be incrementally launched as described in the EIS. **Figure 5-3** shows a cross section of the double T bridge.
- To accommodate the double T bridge, the location of the bridge piers in the Hawkesbury River would change slightly from those presented in the EIS. The changes in pier locations are presented in **Figure 5-4**. The southern and northern piers closest to the respective river banks would be located further from the banks and there would be a minor change in location for one of the central piers.

As a double T bridge would have a slightly shallower superstructure than a box girder bridge, it would have less visual impact and less impacts on upstream flood levels in comparison to the bridge described in the EIS. The reduction in impacts would, however, be minor. All other impacts would remain as described in the EIS.

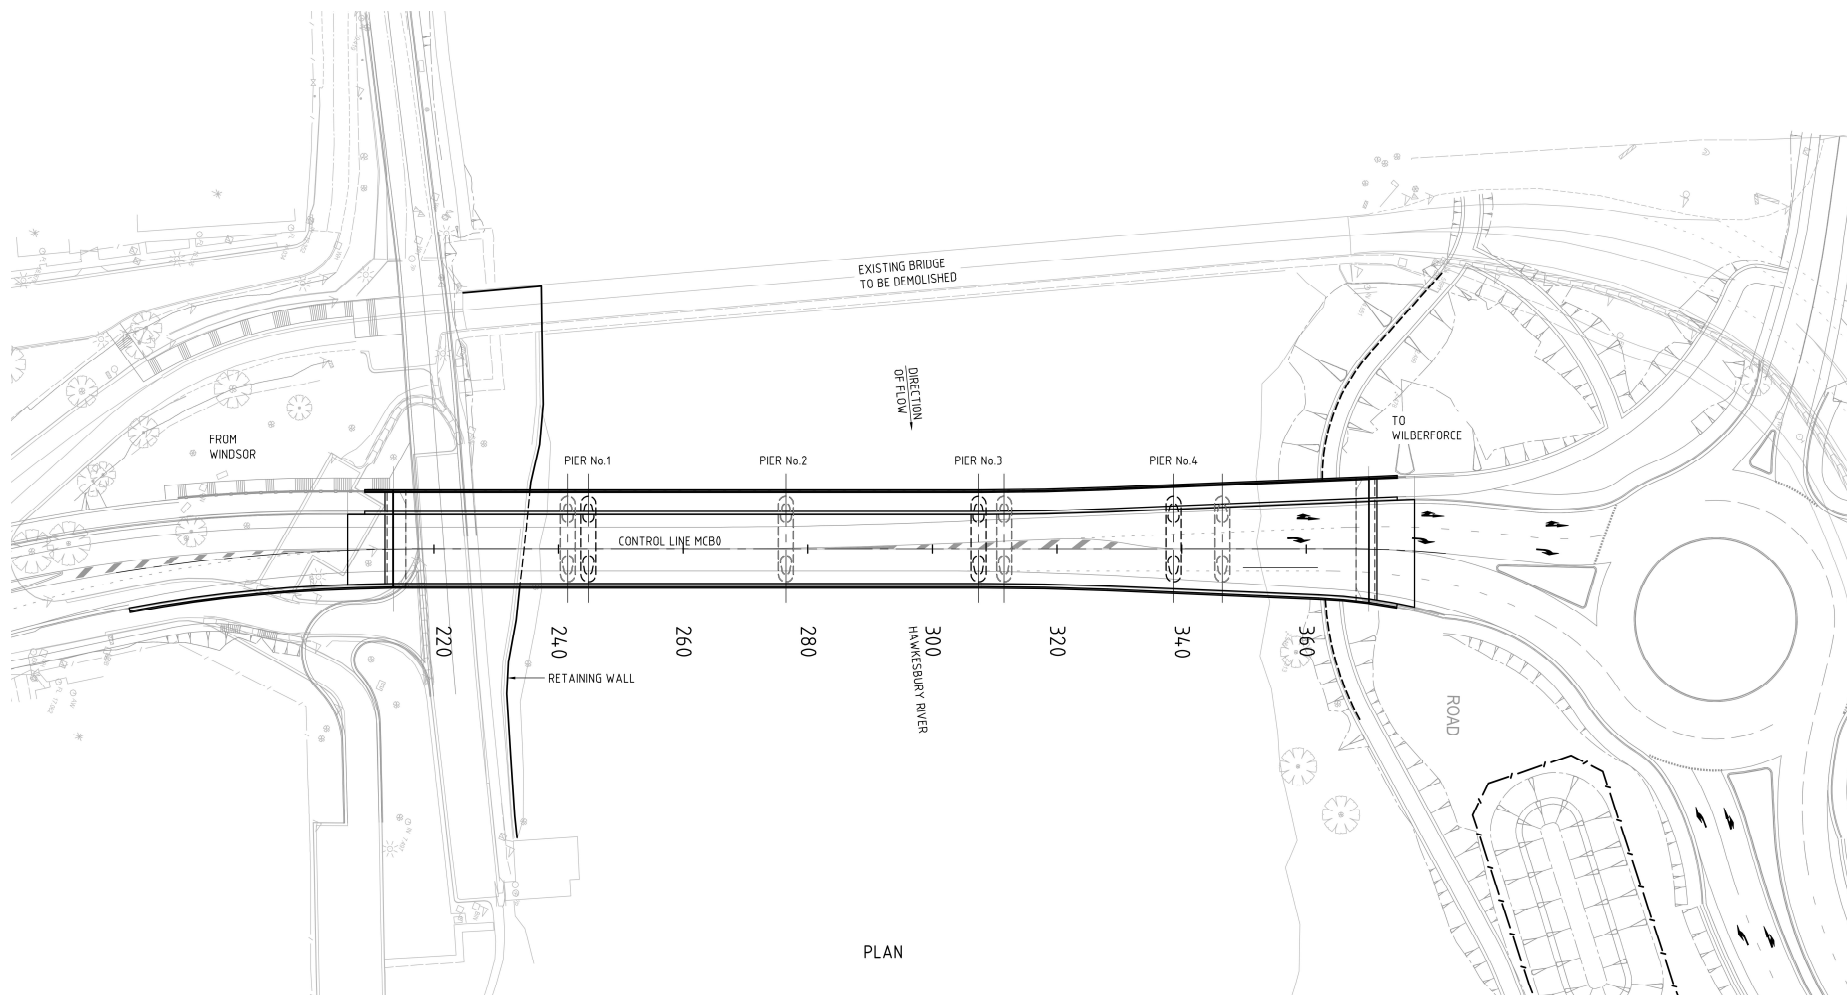
Figure 5-4 Changed pier locations – Note grey indicates original pier location and black indicates new pier location

The change in the location of the bridge pier closest to the southern river bank would result in a minor reduction in direct impacts on maritime archaeological remains and may reduce the scour of the southern bank during flood events. Additionally, the proposed location and spacing of the piers away from the river bank, combined with the proposed increase in the clearance of the bridge over The Terrace, would enhance the perception of space along the foreshore and under the bridge and open up the views from The Terrace. This is explained further in the Landscape Character and Visual Impact Assessment Addendum in **Appendix D**.

There would be no significant changes to other environmental impacts as a result of the proposed change in pier location, with all other impacts and associated management measures remaining as described in the EIS. The new pier locations have been assessed for potential maritime heritage impacts and would not result in any impacts on maritime heritage.

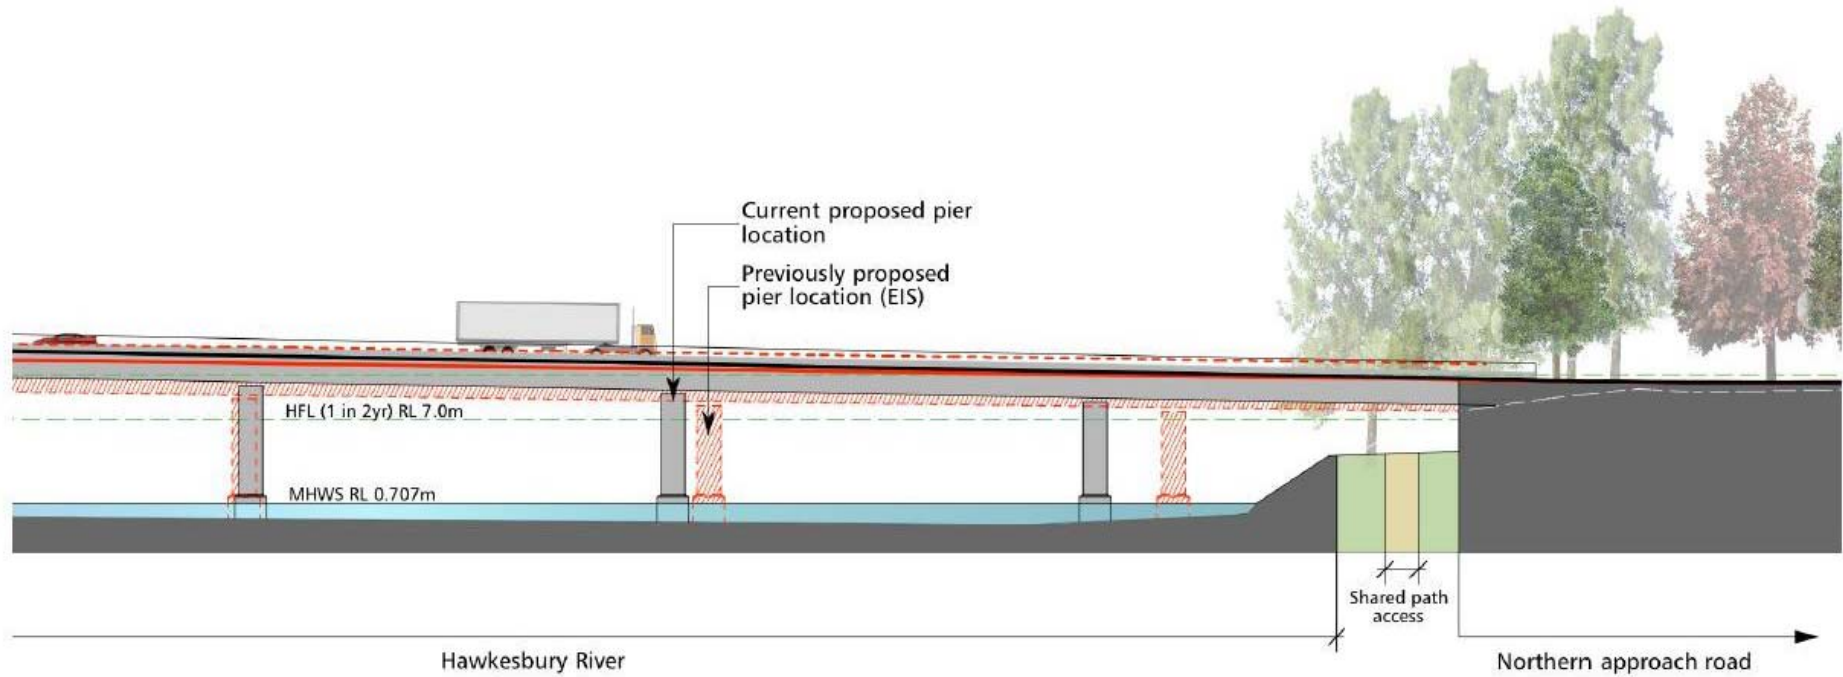
Plate 4: Longitudinal section of the replacement bridge showing the elements that have been redesigned. The level of the replacement bridge and barriers is minor on this side of the bridge. The amended locations of the proposed piers are shown in grey.

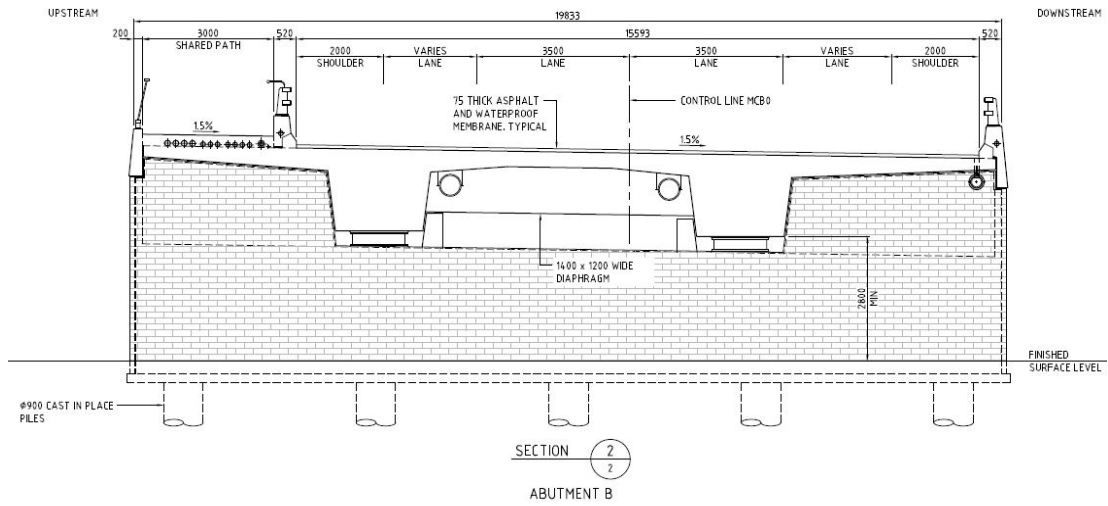
Plate 5: Cross section of the replacement bridge in Thompson Square with the Land Bridge option showing the piles across the structure. An additional six piles along each side also formed part of this design. Source: SKM Plan DS2012/000155 Sheet 3.

| Plate 2: Cross section of the replacement bridge in Thompson Square with the Land Bridge Option showing the piles across the structure. An additional 6 piles on each long side also formed part of this particular design. Source: SKM Plan DS2012/000155 Sheet 3. | 19 |

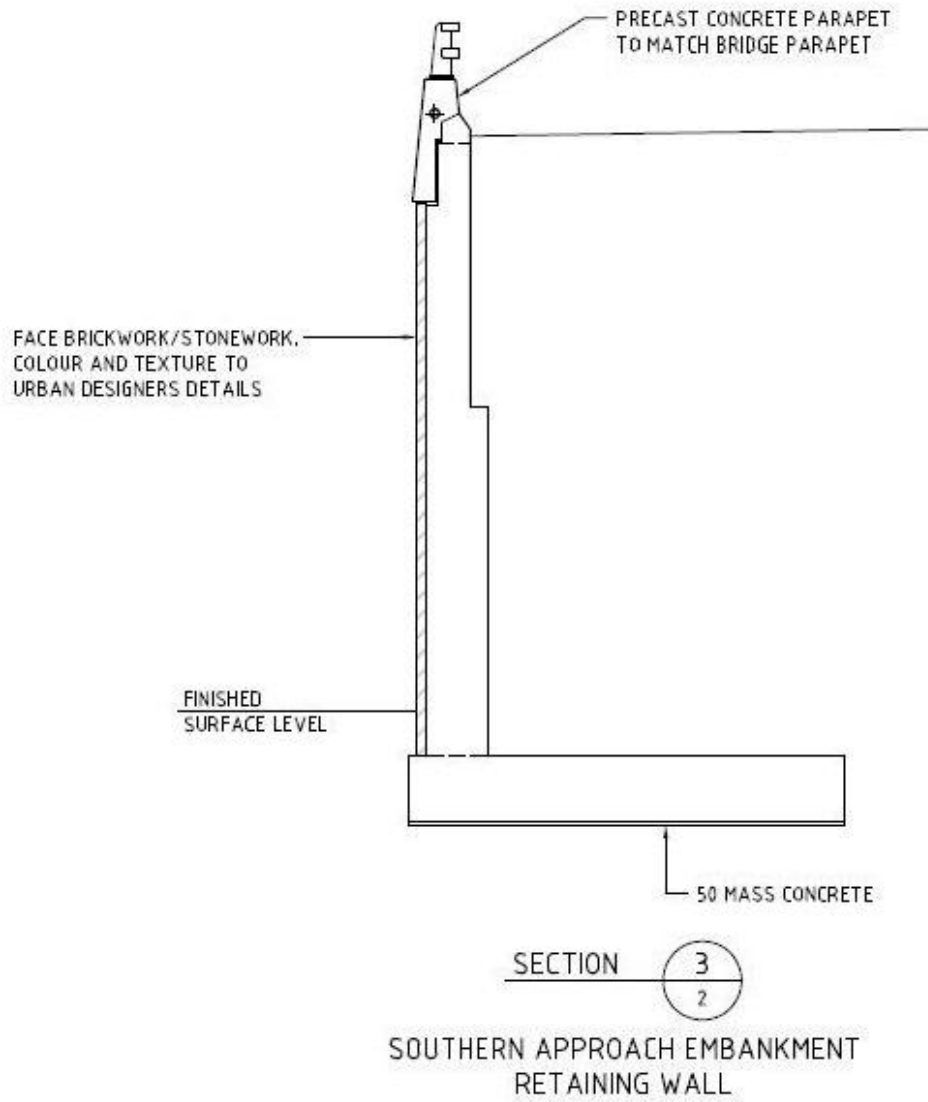
Plate 6: Diagram of one side of the L-shaped retaining walls proposed for the bridge abutments in Thompson Square. This design will be constructed if the project is approved. Source SKM Plan DS2012/000155 Sheet 3.

| Plate 3: Diagram of one side of the L-shaped retaining walls proposed for the bridge abutment in Thompson Square. Source: SKM Plan DS2012/000155 Sheet 3. | 20 |

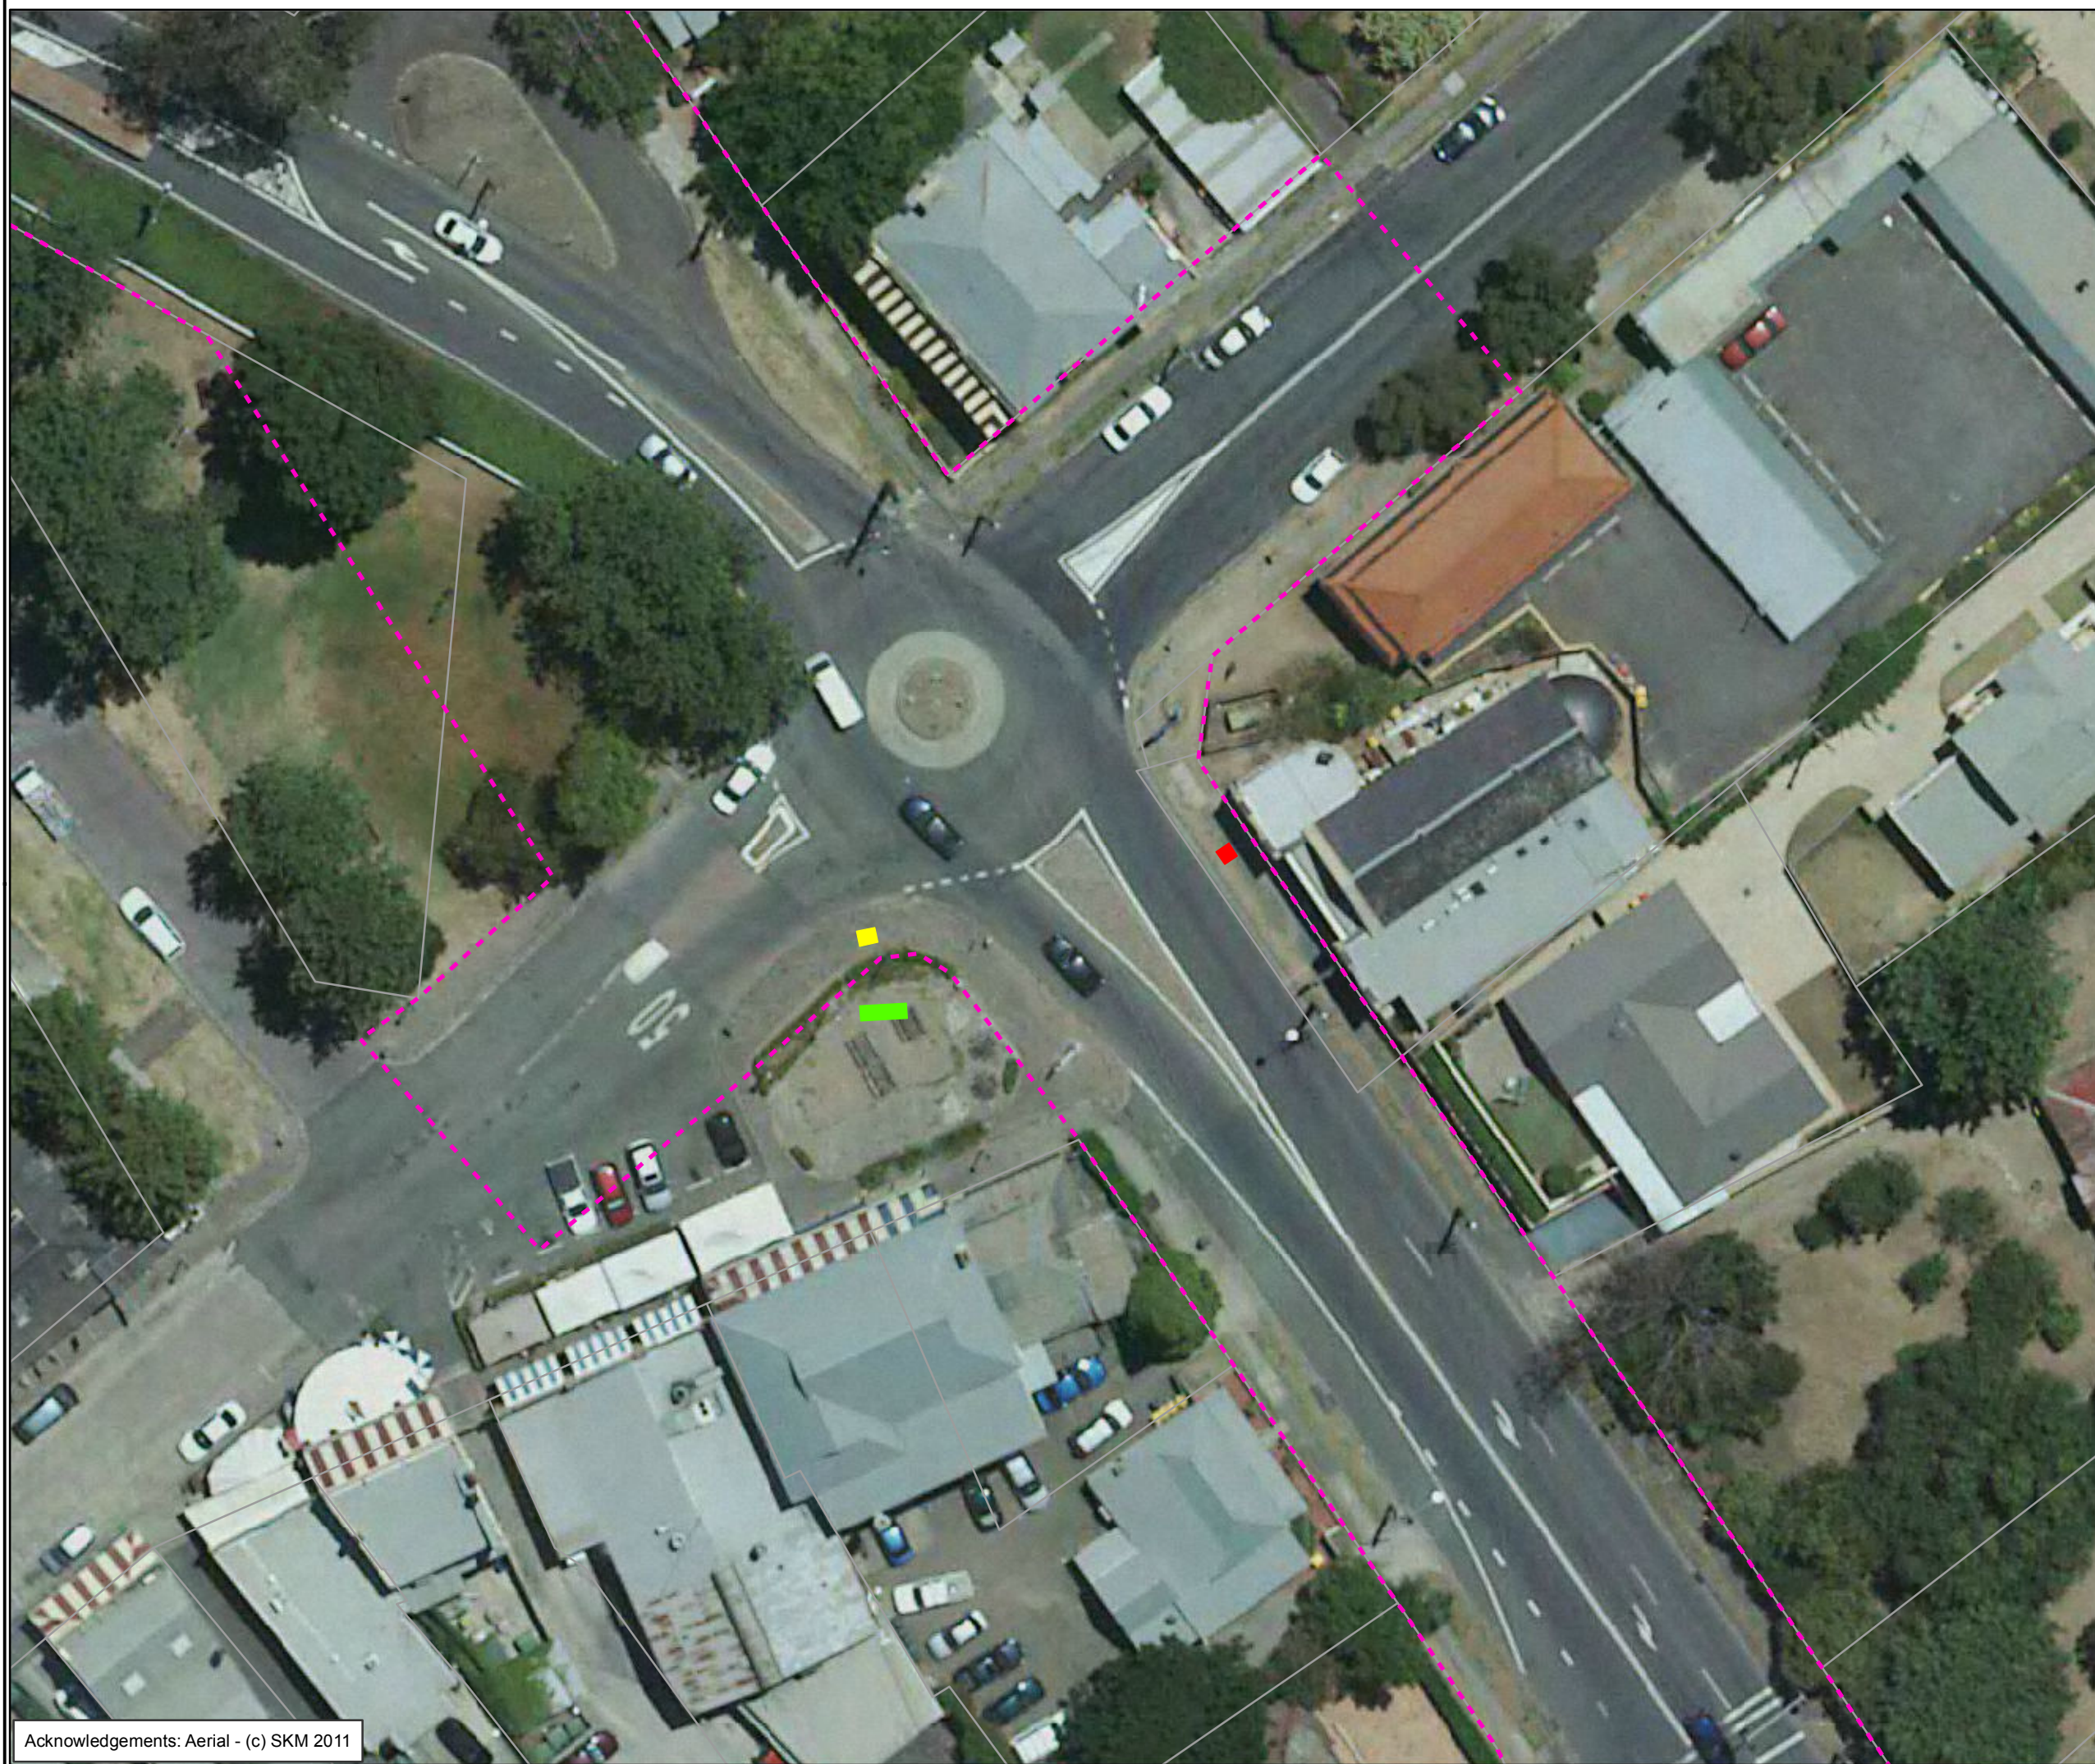
- Test Trench 10 - 1m x 1m
- Test Trench 11 - 1m x 1.2m
- Test Trench 12 - 1m x 3m
- Construction Work Zone

Figure 2: Location of test trenches during the current archaeological program

It was known before work commenced that there were services within those footpaths that further narrowed the areas for investigation. The services identified prior to the work commencing are shown on the accompanying diagram. Figure 2 is a plan showing the location of the trenches.

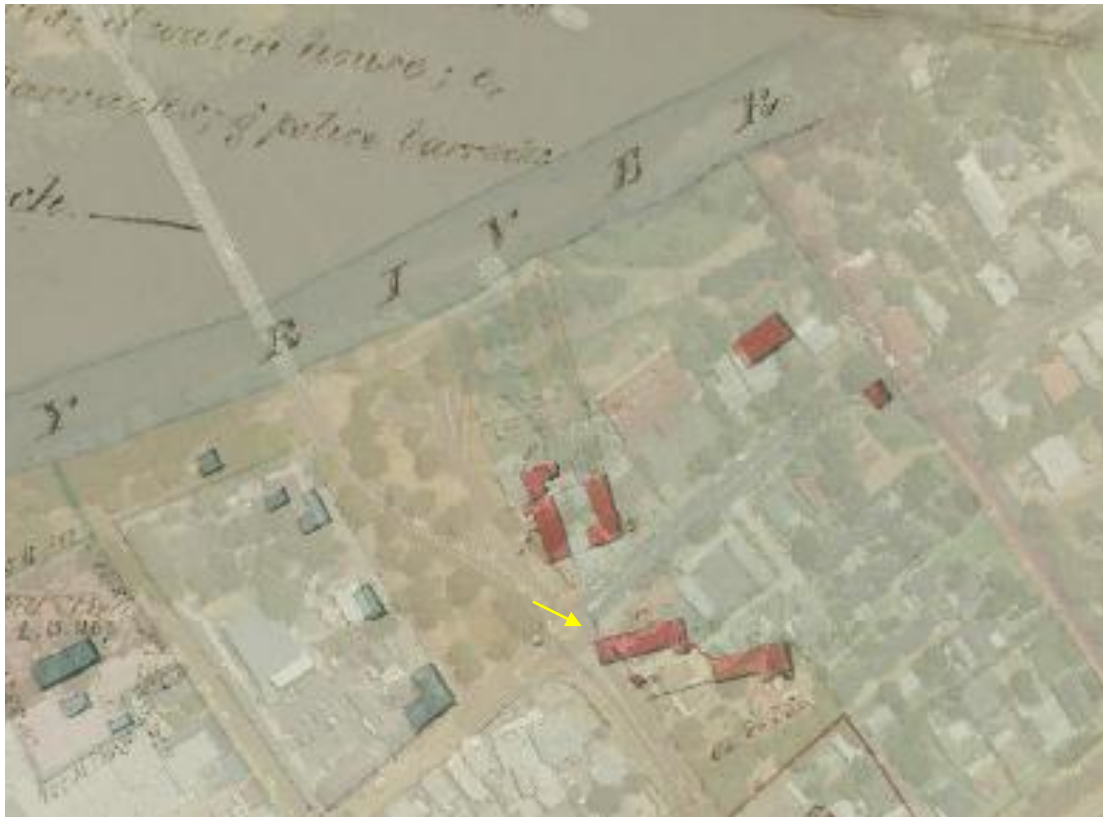
Plate 3: Overlay of 1831 survey onto contemporary aerial image showing the relationship of the Commissariat Store of 1803 to the present School of Arts building and Bridge Street

Overlays of historic period surveys from the first half of the nineteenth century in relation to the present roads and buildings demonstrate that the site of the former Commissariat building of 1803 is likely to lie under the School of Arts building. The older building appears to have projected beyond the western façade of the School of Arts into the present footpath and Bridge Street.

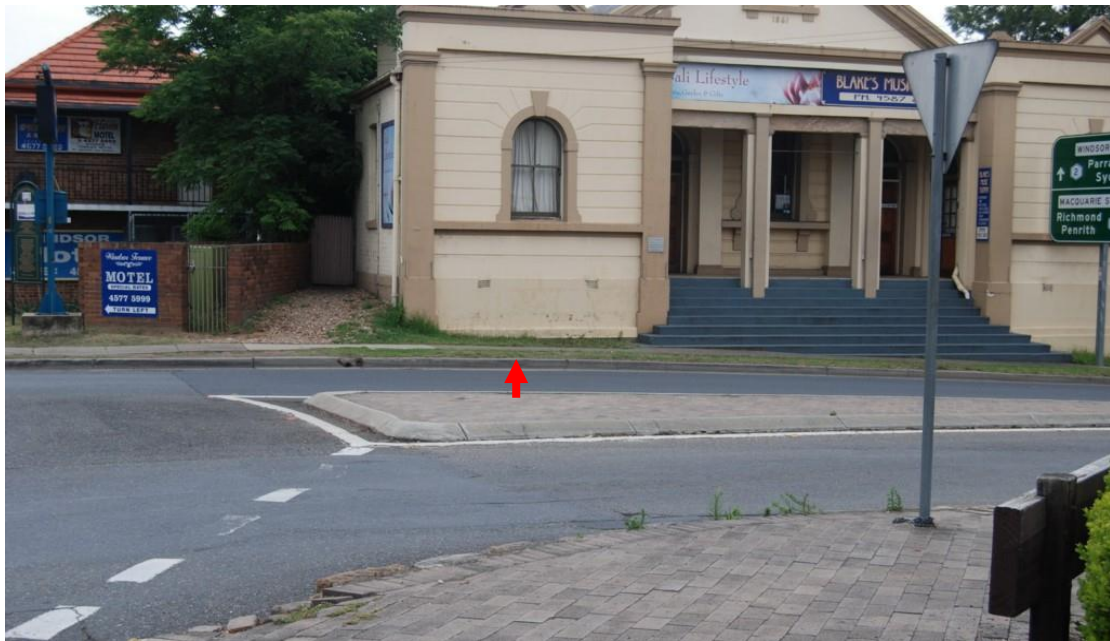
Plate 4: View east showing Bridge Street and the School of Arts building; the position of the test trench is indicated by the arrow

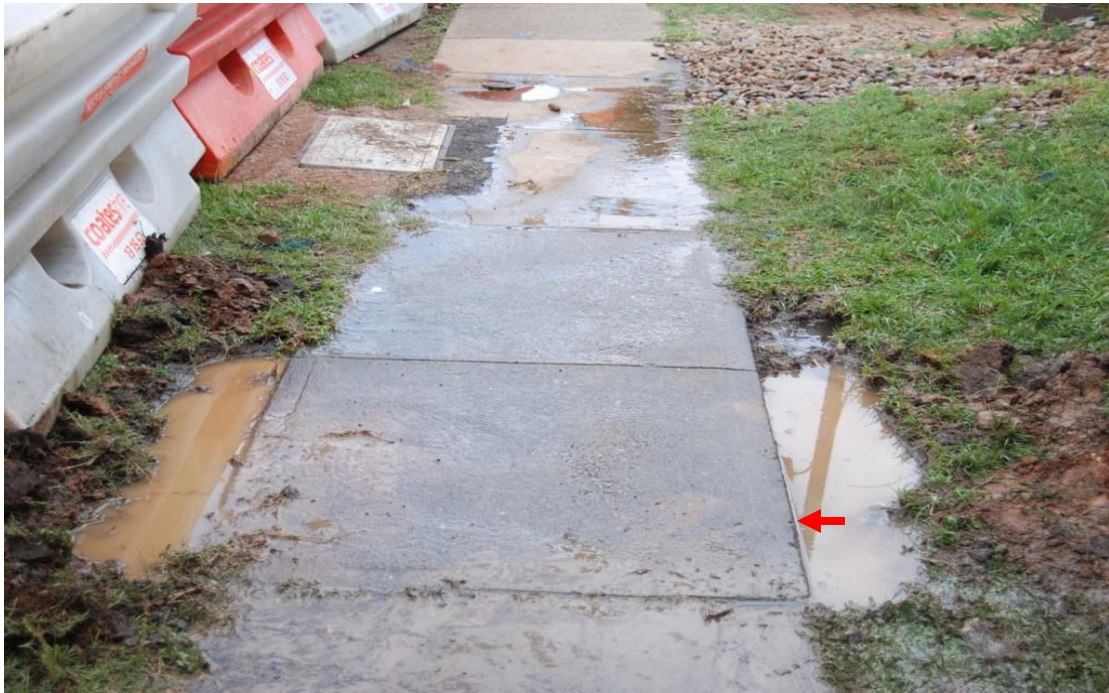
Plate 5: View north showing the slab to be removed (indicated by the arrow) for the test trench with the recent disturbance just to the north of this site caused by enlarging a service pit also visible
