Windsor Bridge replacement project

Submissions report
Incorporating preferred infrastructure report

APRIL 2013

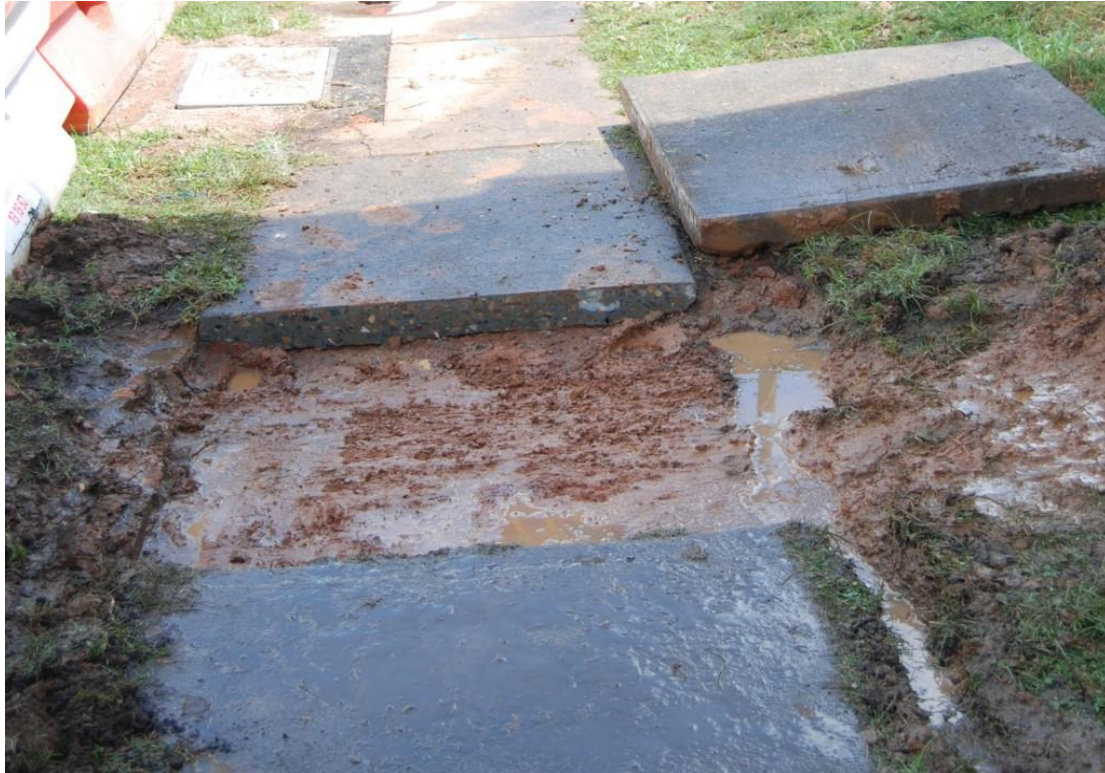
Plate 6: View north showing the footpath slab [001] removed from the trench revealing the surface of the underlying deposit [002]

The surface slab from the footpath **[001]** was lifted in one piece. It is made from cement with bluestone inclusions poured into formwork. It is approximately 60 mm thick and was laid directly over the underlying deposit of clay **[002]**.

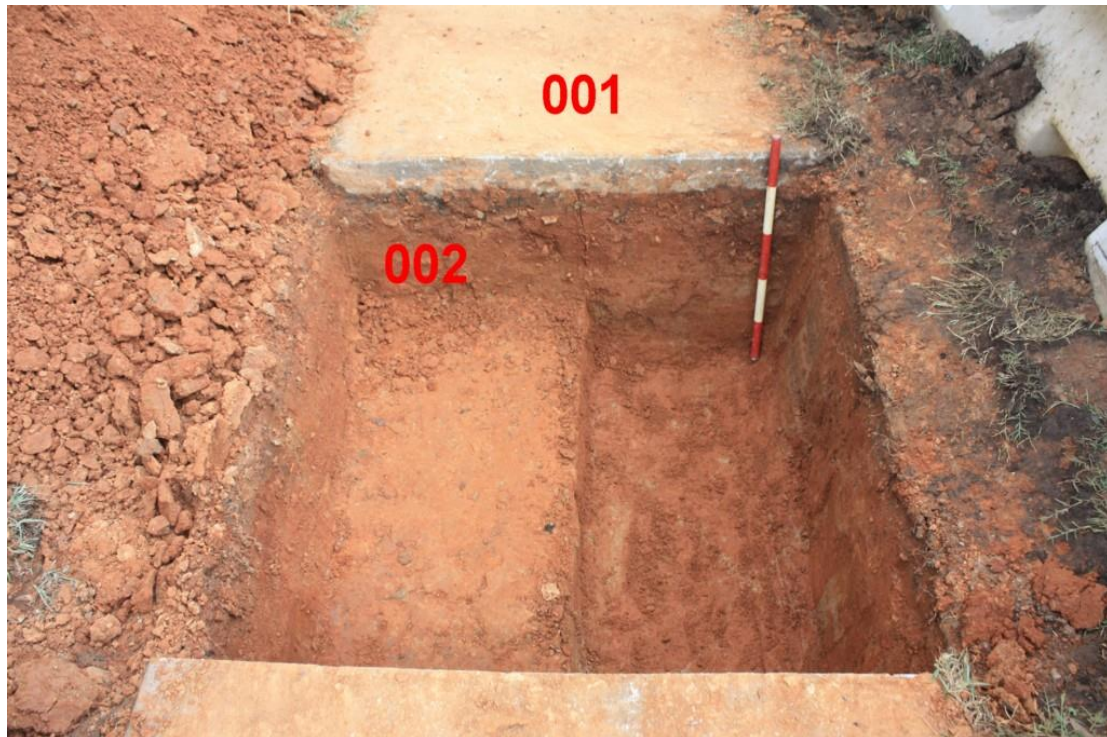
Plate 7: View south of Trench 10 showing the clay with sand lenses underlying the footpath on the eastern side of Bridge Street; scale 500mm

The deposit **[002]** below the footpath comprised red clay with minor lenses of sandy soil and some lighter coloured clay distributed unevenly throughout the matrix. The top 100-200 mm was more disturbed and less regular in composition than the lower portion but it was a consistent matrix for the full depth. The mixed red clay **[002]** was excavated to its full depth of 400 mm. This deposit filled the entire trench and extended beyond it.

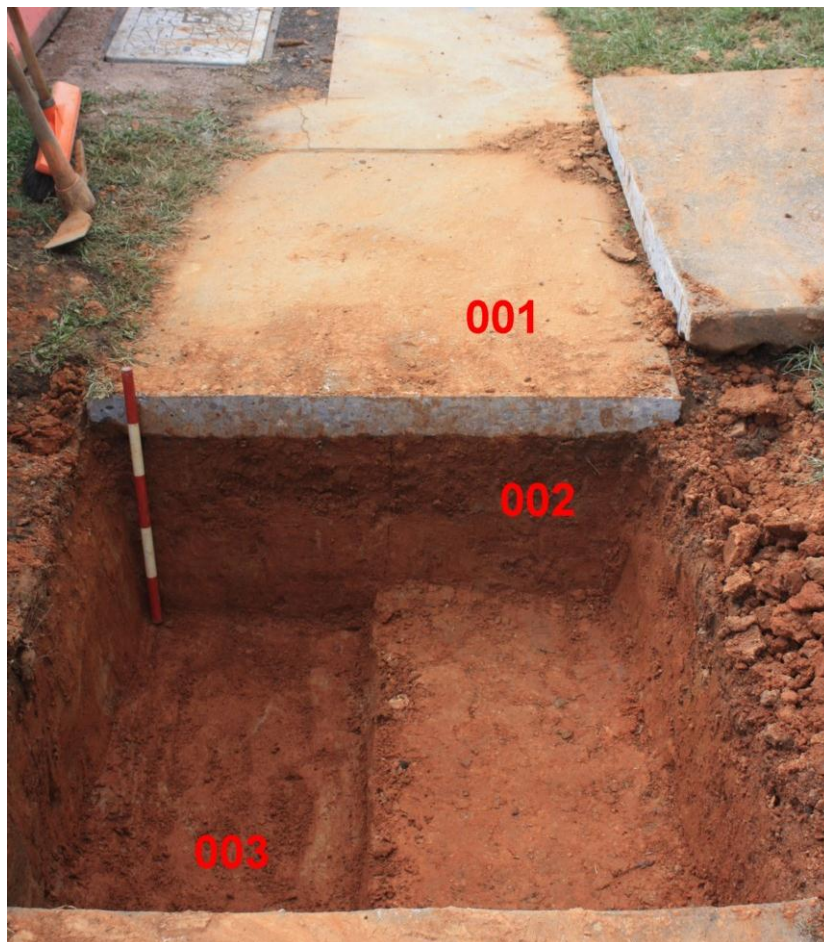
Plate 8: View north of Trench 10 showing sandstone bedrock at the base of the trench and its immediate relationship to the clay above it. This image also highlights the more disturbed nature of the upper part of the clay visible here in the shadow as a darker and slightly more textured material; scale 500 mm

Immediately below the red clay was the upper surface of naturally occurring sandstone bedrock **[003]**. There were no deposits between the two and no evidence of change to the bedrock.

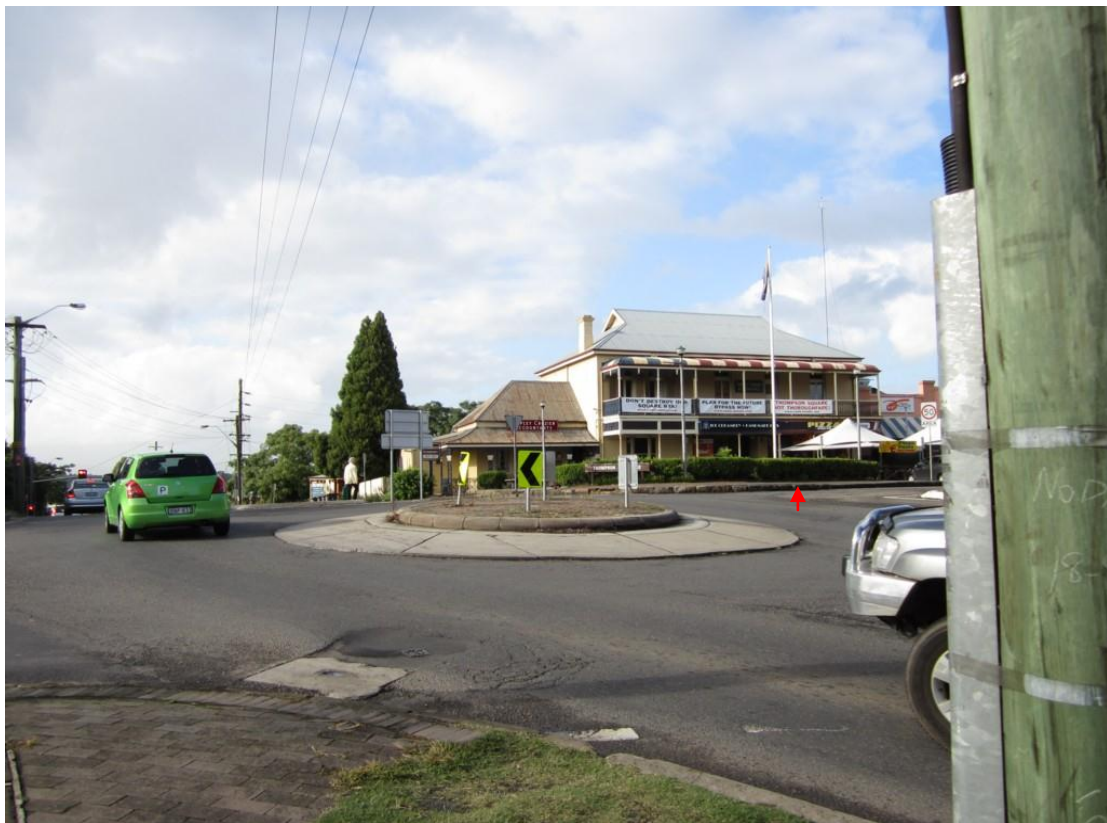
Plate 9: View south at the intersection of George and Bridge Streets showing the investigation area along George Street indicated by the arrow

The location of this test trench on George Street has been discussed in Section 2.6.1; it was the only viable location free of services, which could accommodate the width of the excavator bucket between the safety barrier and the garden bed, very close to the proposed test trench site and with the same archaeological potential in the project area. The sample provided from this area was expected to provide evidence of road development and possibly accumulated deposits that would characterise the use of this area as a public thoroughfare from early in the nineteenth century. The excavated trench measured 1000 x 1200 mm.

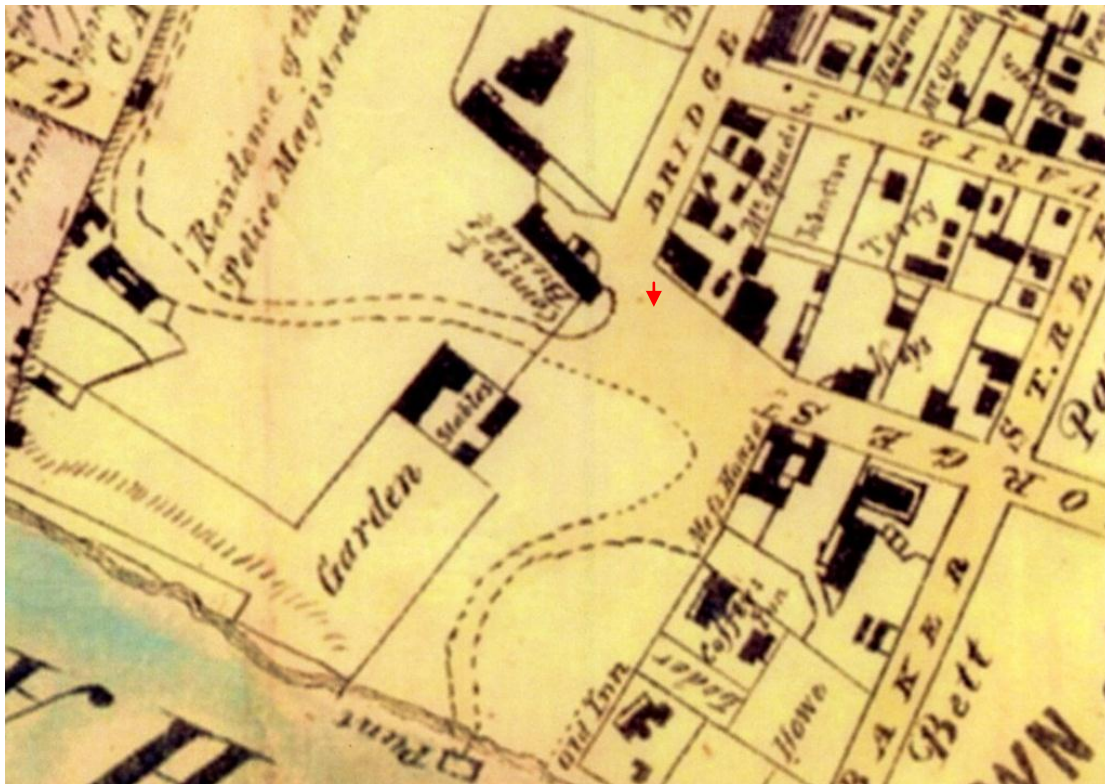
Plate 10: Survey of 1842 showing the position of Trench 11 in open ground, part of the earlier configuration of George Street (detail of Peninsula Farm Auction 5 February 1842, plan prepared by Surveyor Armstrong: source nla map f187 on line)

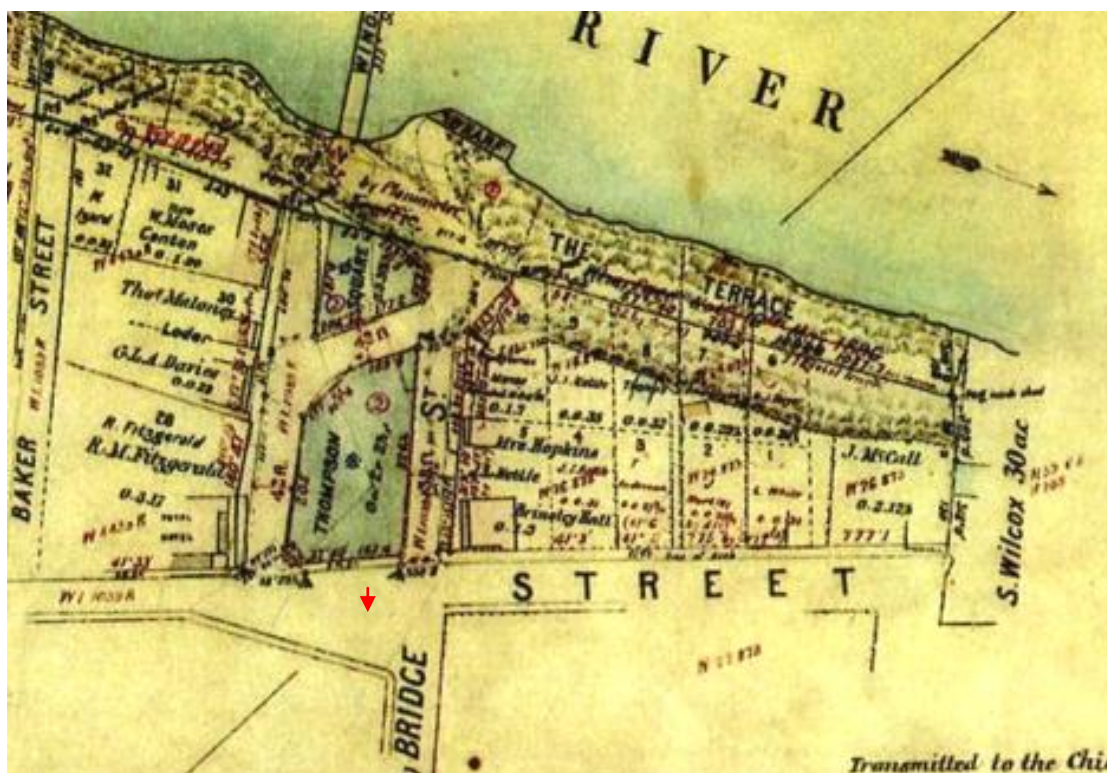
Plate 11: Survey of 1894 showing the wider area of George Street with the approximate position of the test trench (Source LPI 1009-3000)

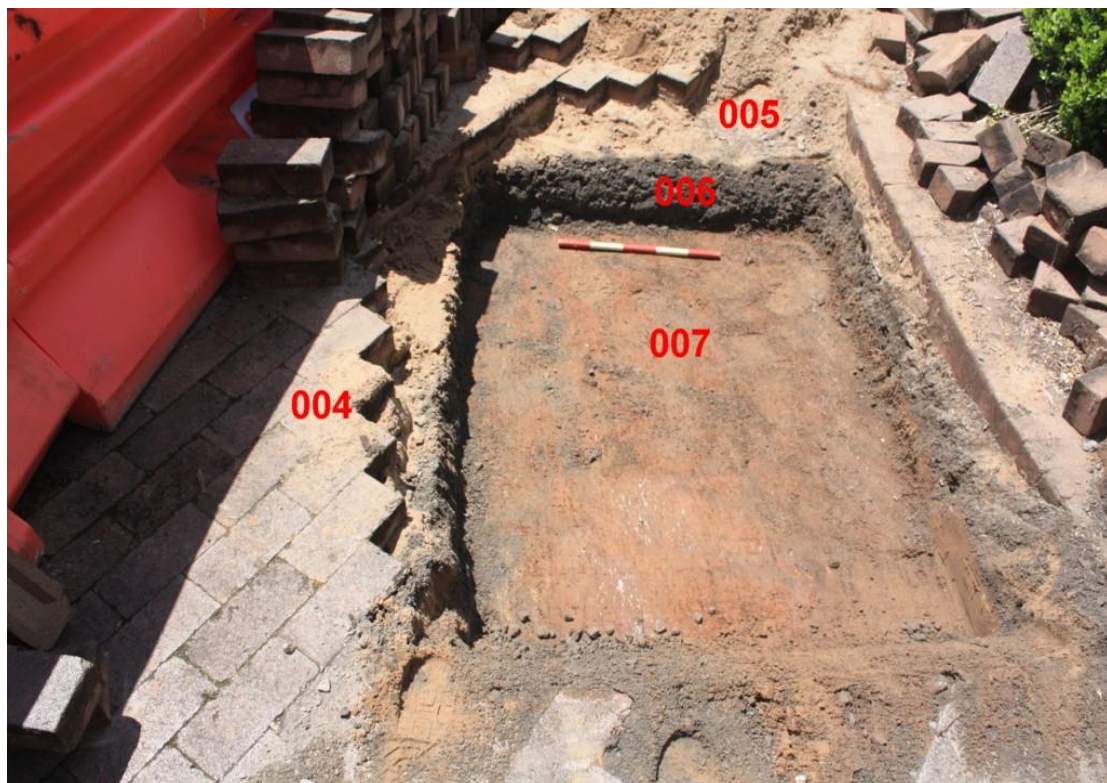
Plate 12: View east of Trench 11 showing the surface pavers and bedding sand and the George Street road surface [006] in section. The base of the trench is covered with a silty soil deposit [007]; scale 500mm

The surface of the test trench was covered with fired brick pavers [004]. These were laid over a bedding deposit of sand [005] to a maximum depth of 100 mm. These deposits were lying over compacted road surface [006]. This road surface of blue metal and bitumen and cement is an extension of the present road surface in George Street covered by the extension of the pedestrian area on this southern side of the road. It is possible that there are two layers of road represented by this surface; if so one is completely bonded to the other and this makes it impossible to determine if this represents two phases of work at different times or two components of one phase of work completed at the same time.

Below this road was a thin deposit, a maximum of 50 mm, of silty soil [007]. This covered an underlying surface or feature [008].

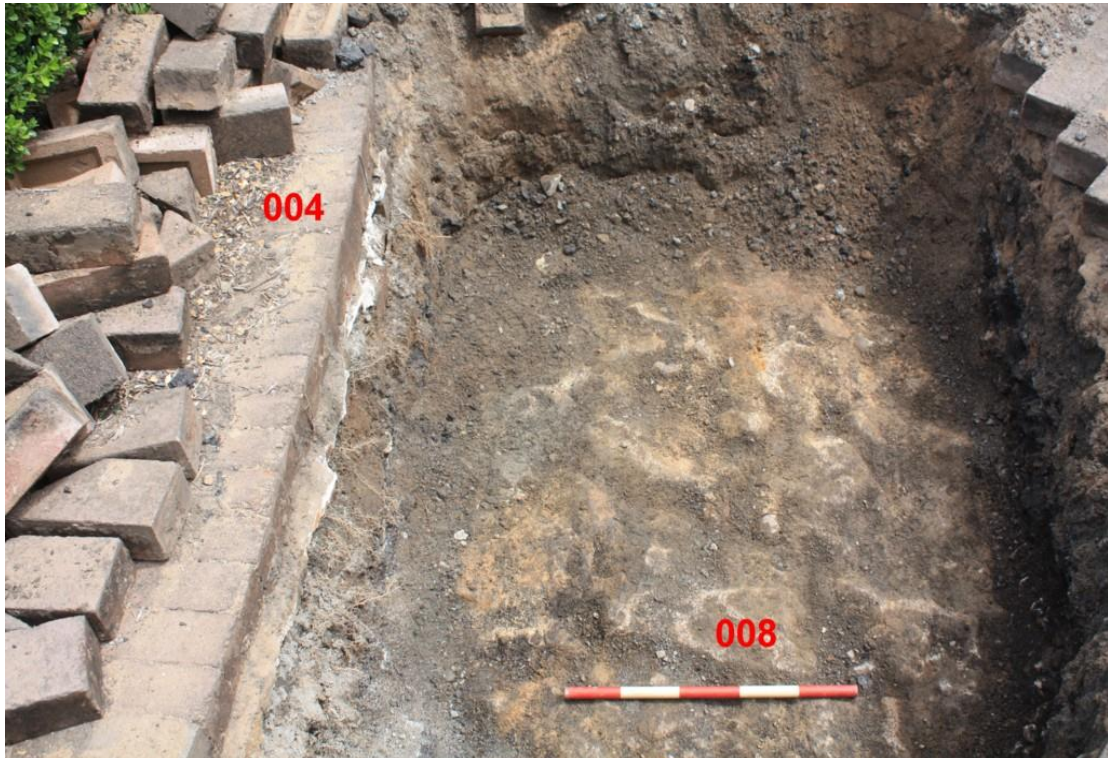
Plate 13: View west showing the surface of the sandstone feature exposed; on the left is the band of paving that provides an edge to the garden at the side of the path; scale 500 mm

This earlier feature [008] was made using irregularly shaped sandstone rubble and some shaped pieces, packed together without bonding to form a hard and impervious surface. It was approximately 250 mm in depth. It extended beyond the area of the test trench.

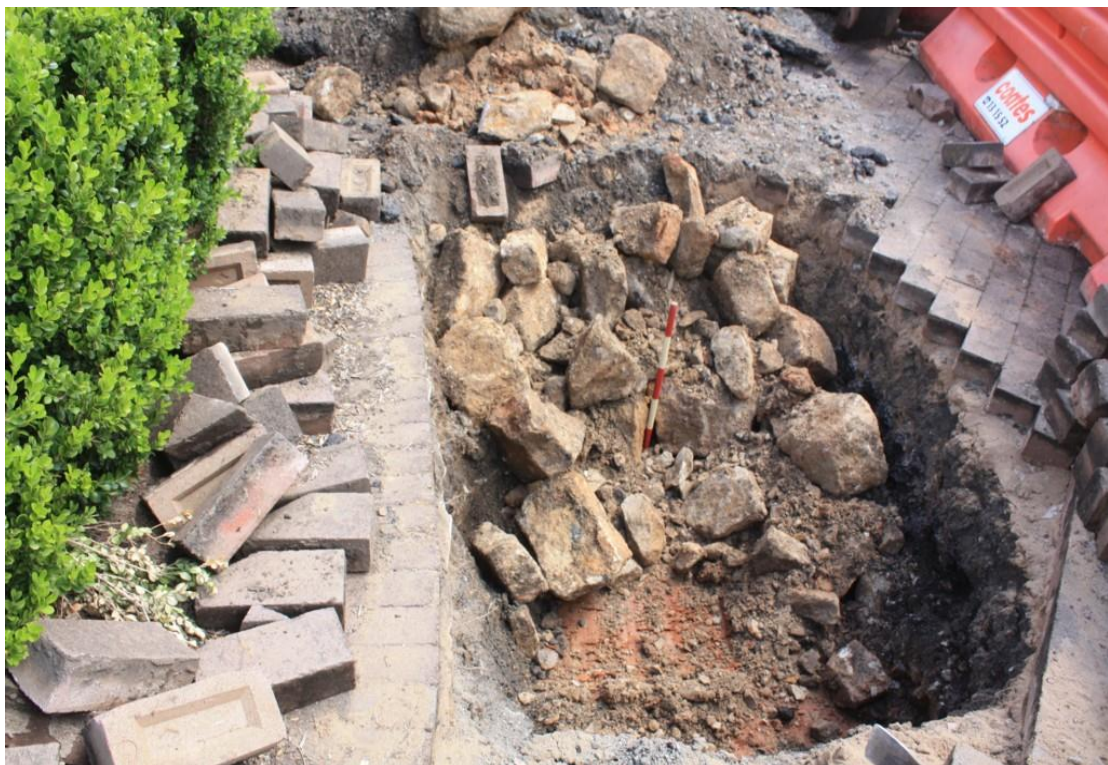
Plate 14: View west during the removal of the sandstone feature showing the variation in the cobbles; scale 500 mm

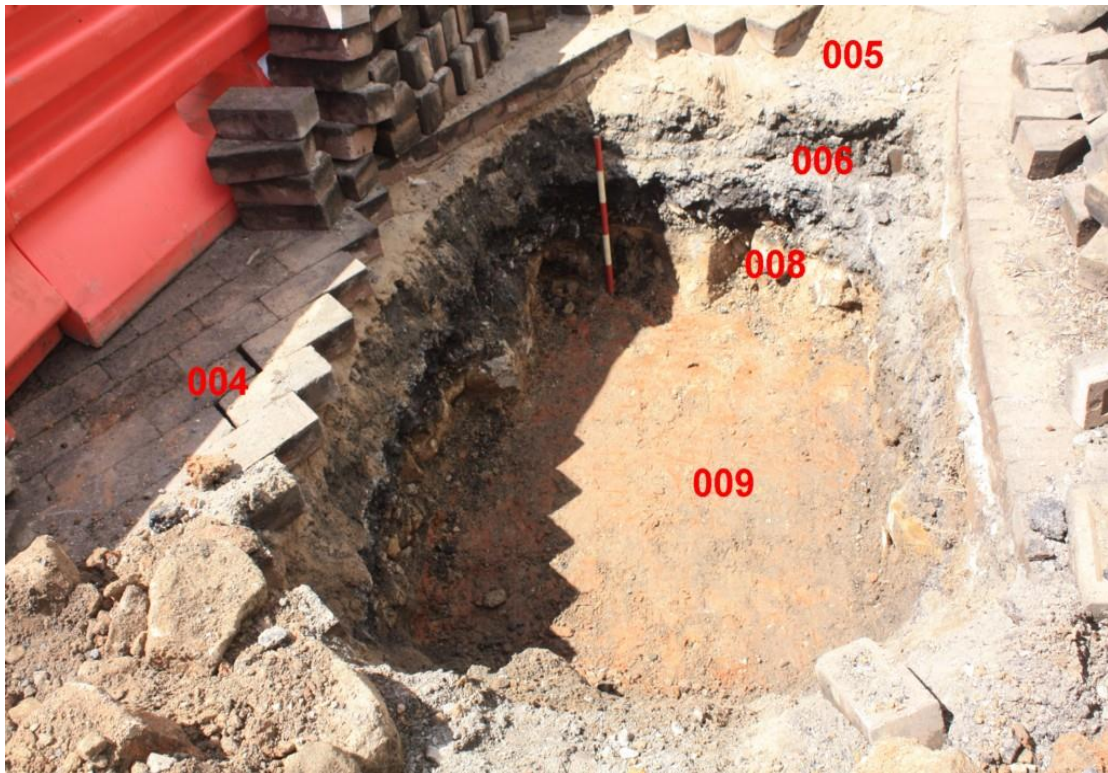
Plate 15: View east showing the surface of the red clay [009] that lies under the sandstone feature; the latter can be seen in the section [008]; scale 500 mm

The sandstone **[008]** had been laid on a compacted deposit of red clay **[009]**. The clay was between 150 mm and 200 mm deep. It had no inclusions.

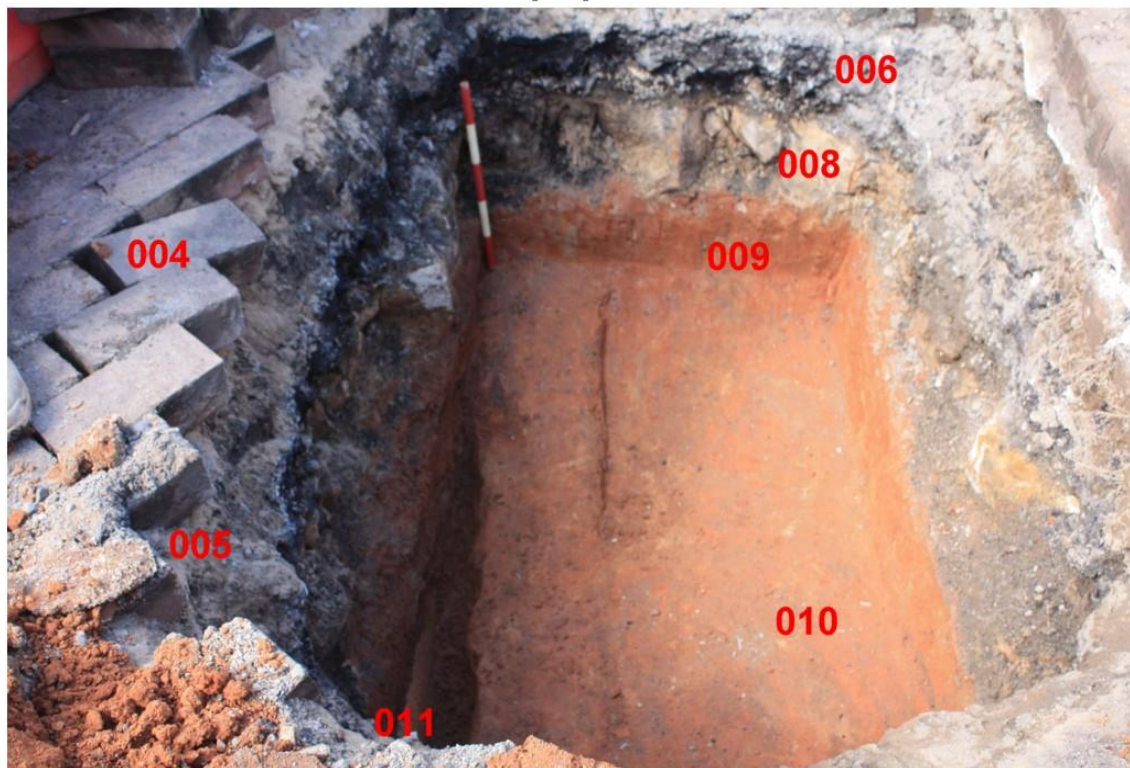
Plate 16: View east showing the sandstone bedrock [010] under the red clay [009]; this image clearly shows the straight edge of the shaped sandstone on the left side of the trench. As well, the trench cut at the base of the section [011] is evident; scale 500 mm

Below the clay **[009]** was the surface of the underlying sandstone bedrock **[010]**. The bedrock was very smooth and flat except for a raised section on the northern side of the trench. It had a straight edge and was between 20-30mm higher than the lower smooth surface. The edge was caused by it being shaped and the smooth surface adjoining it of the bedrock might also have been polished or levelled. This action or actions demonstrates that the red clay above it was introduced; it had not been cut through and backfilled to allow for the work to be undertaken on the rock. Further it lies over the top of a service trench visible in the section.

This service trench was at the extreme northern edge of the test trench, at the base of the section or edge of the trench. It had been made by excavating a diagonal cut into the bedrock **[011]**. It is only visible in the base of the trench for a maximum of 70 mm but it certainly extends beyond the limits of this excavation into the road. Within this trench only partly visible was a terracotta or stoneware service pipe **[012]**. At the base of this service trench was a loose deposit of soil **[013]**; it contained some clay but it was impossible to investigate due to the danger of destabilising the section of soil above it.

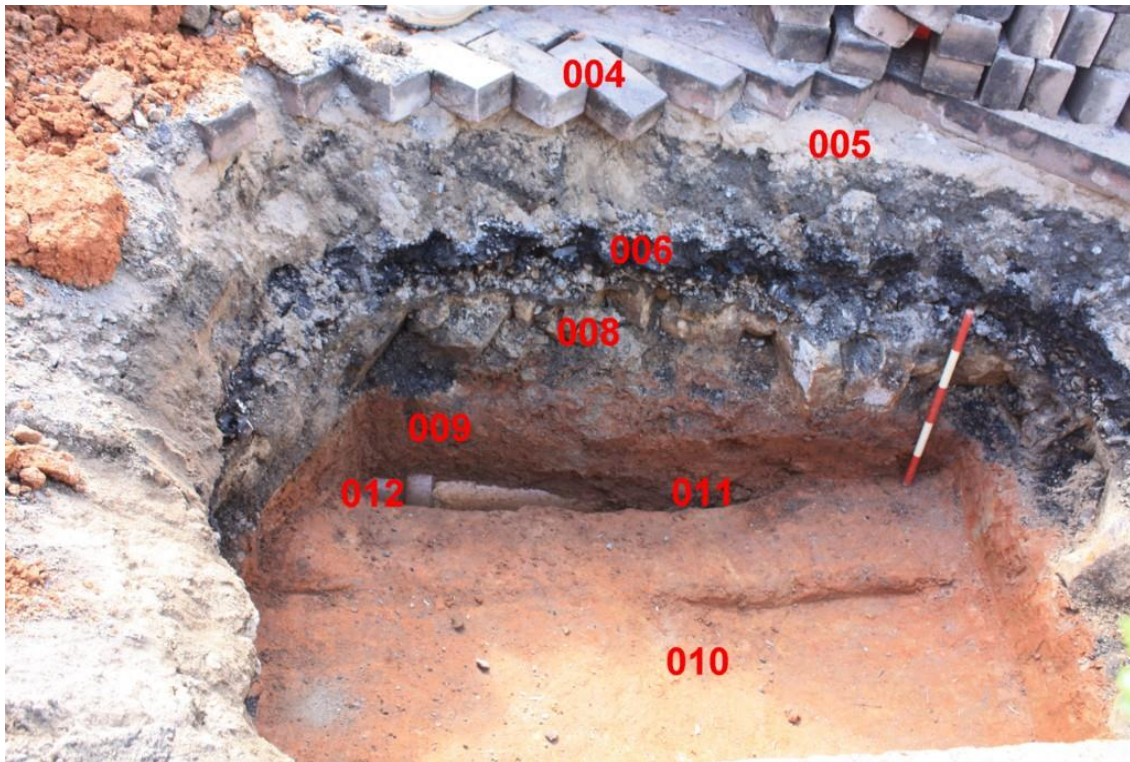
Plate 17: Northern section of Trench 11 highlighting the shaped edge of the sandstone bedrock; the red clay capping the service trench is also visible in this image (scale 500 mm)

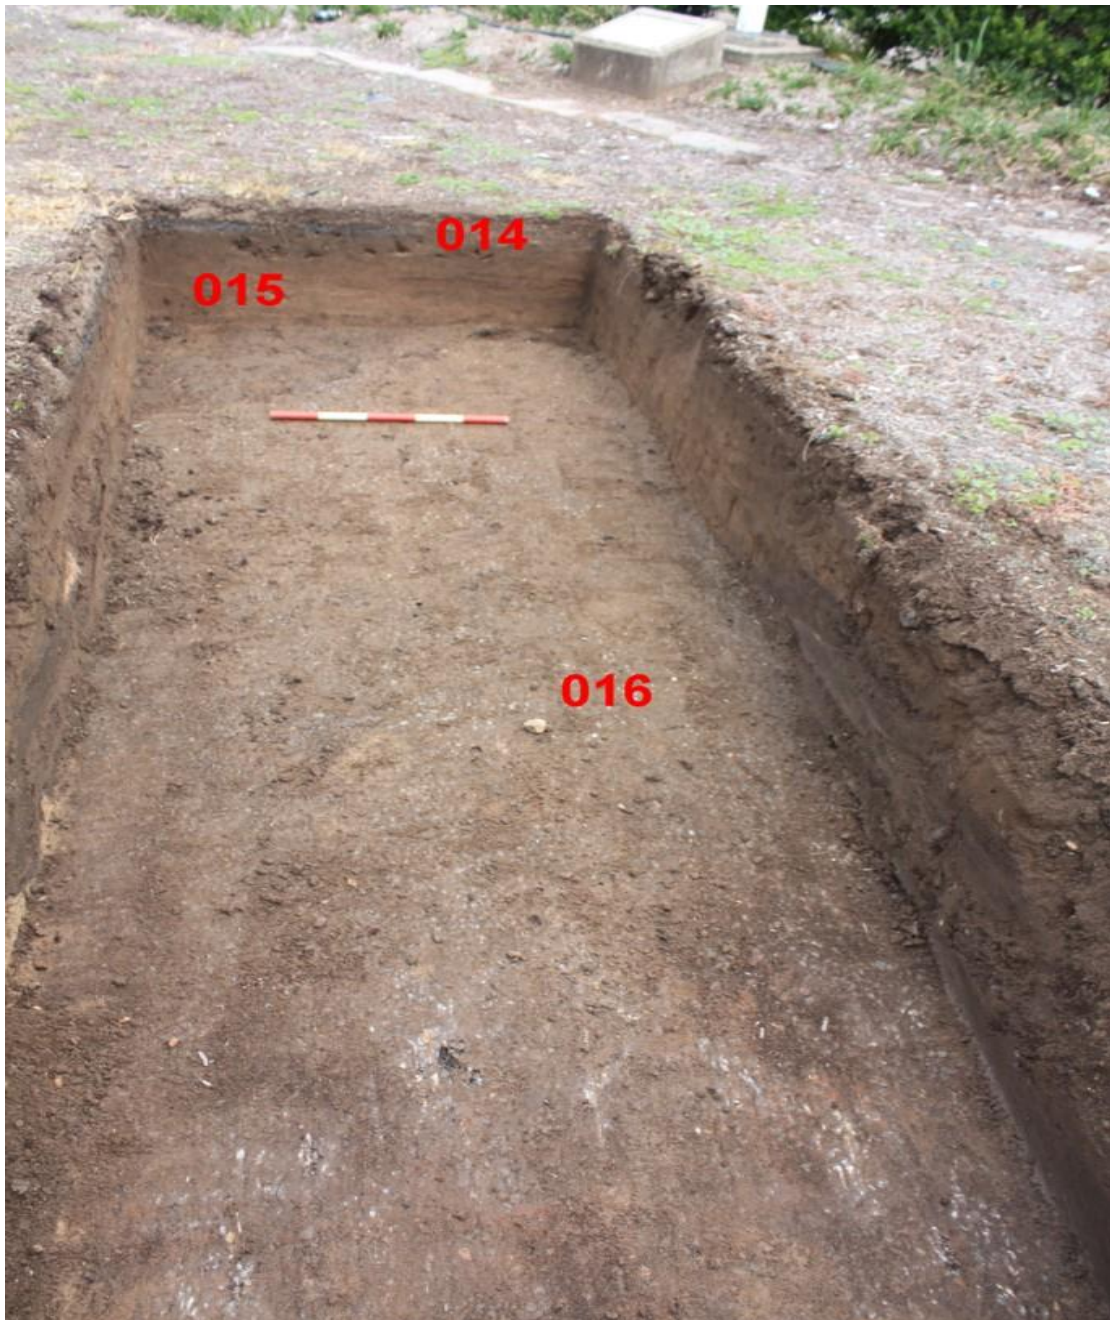
Plate 19: View west showing the topsoil [014, 015] above the bitumen surface [016]; scale 500 mm.

The surface of the trench was covered with compacted introduced sterile topsoil [014] to a maximum depth of 100 mm. Below this was 400 mm of sterile introduced topsoil [015]. Immediately below this soil was a hard compacted surface of bitumen and blue metal to a maximum depth of 20 mm [016]. Under this was a bedding deposit for the surface comprised of larger blue metal gravel and clay [017]. This deposit was not removed; the trench was backfilled with the soil removed from it. There were no artefacts recovered from this trench.

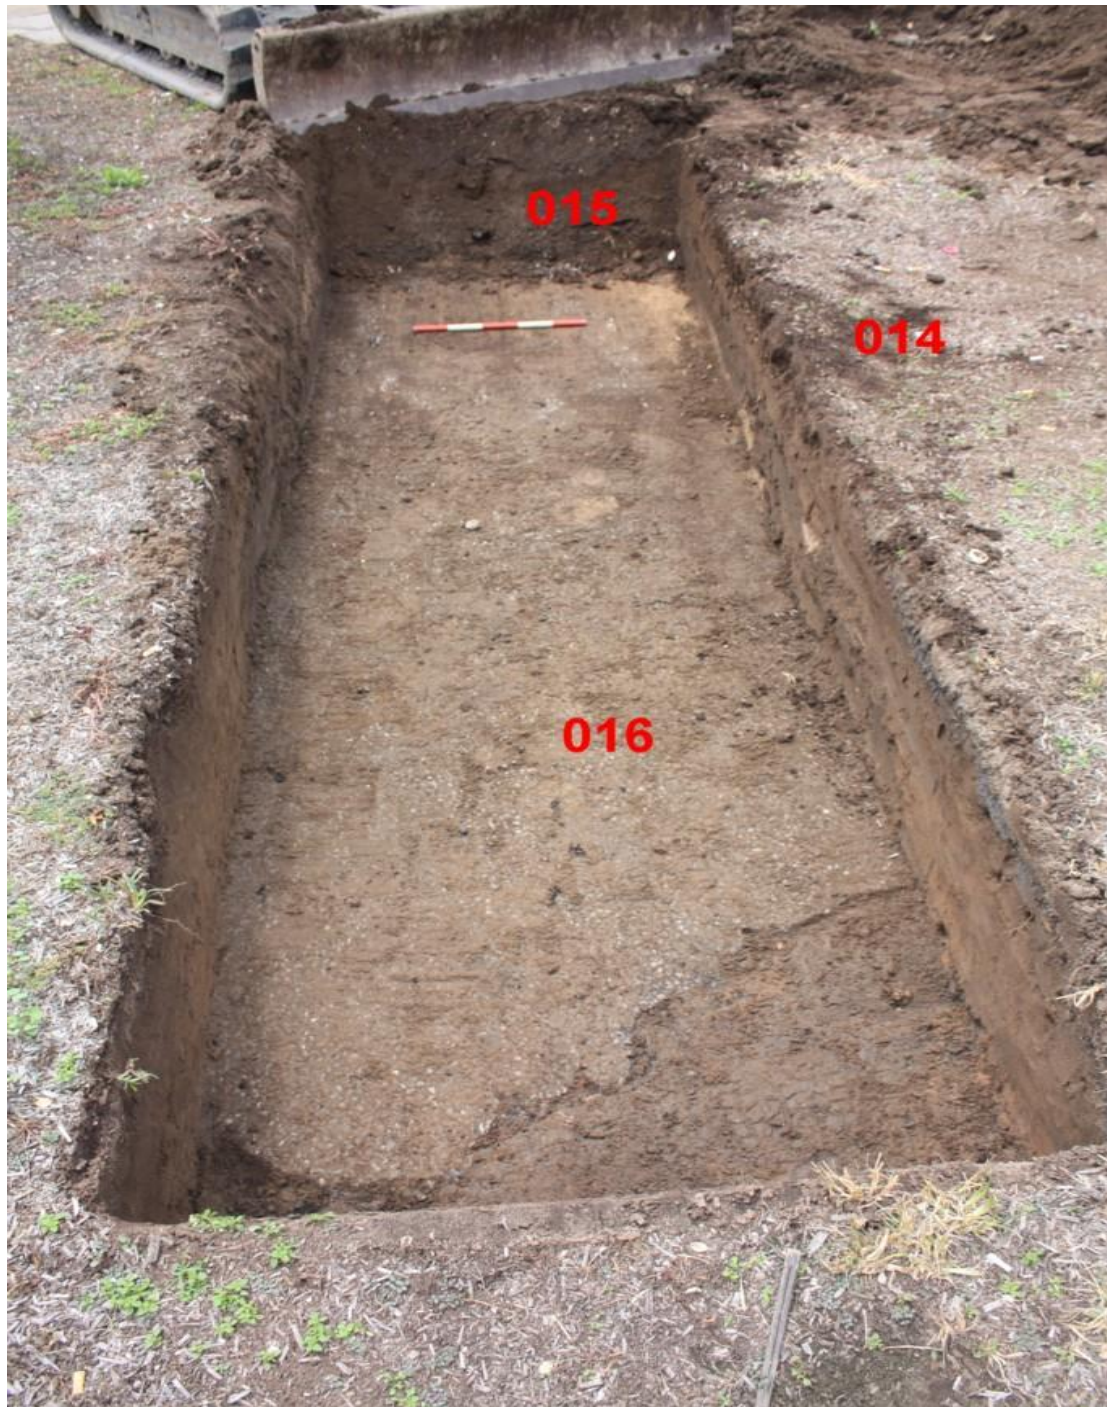
Plate 20: View east showing the bitumen surface [016]; the cut in the surface in the foreground was made in the past prior to the introduction of the garden soil above it; scale 500 mm.

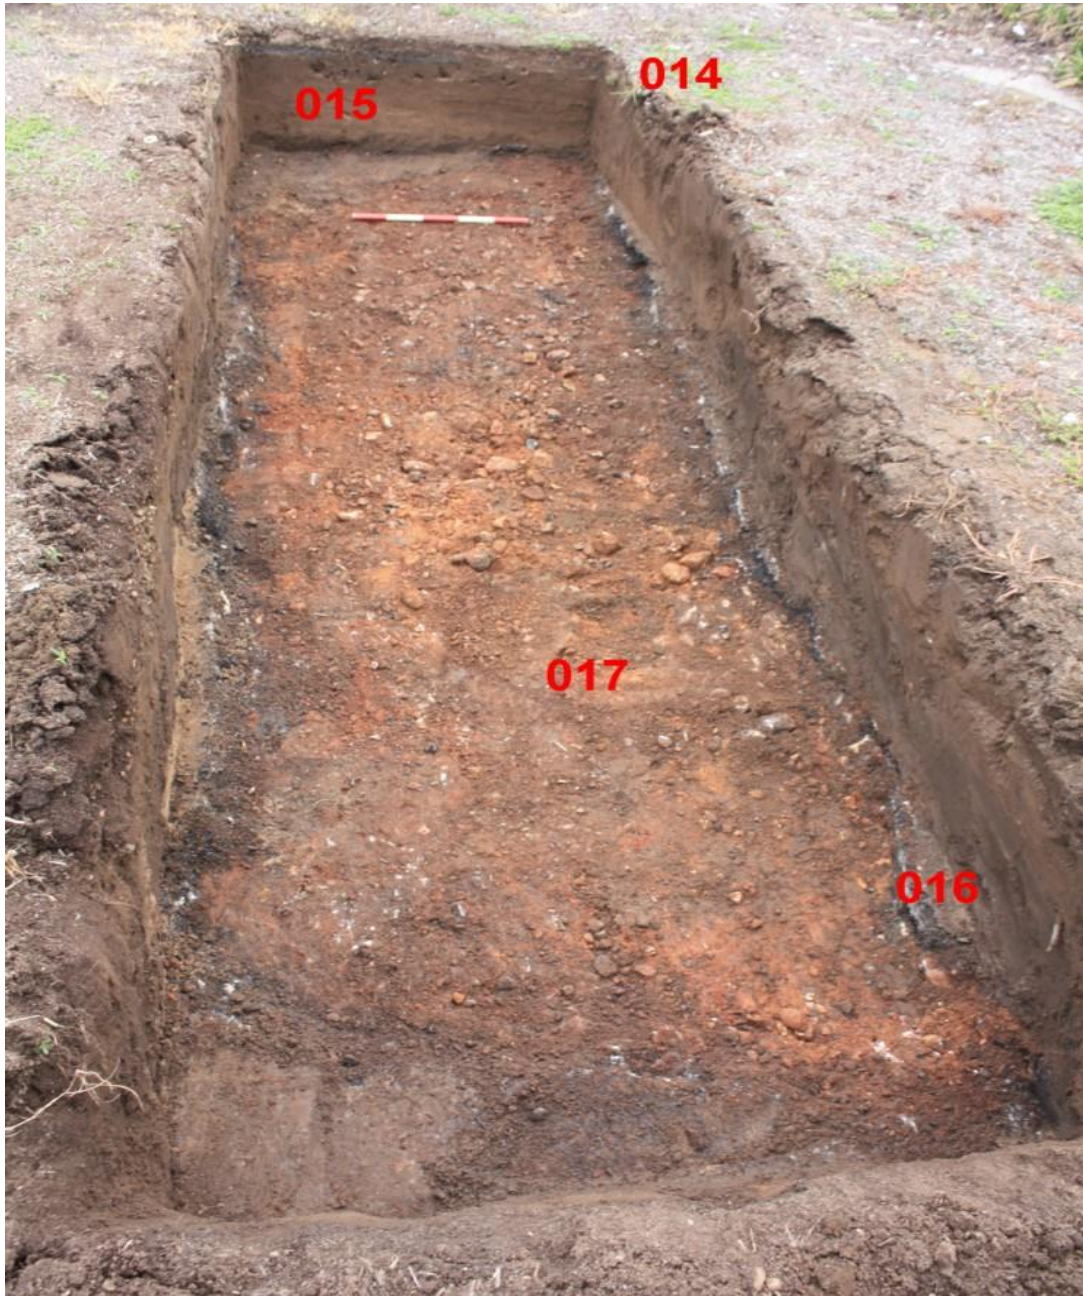
Plate 21: View west showing the bitumen surface [016] removed to reveal the bedding deposit [017] below it.

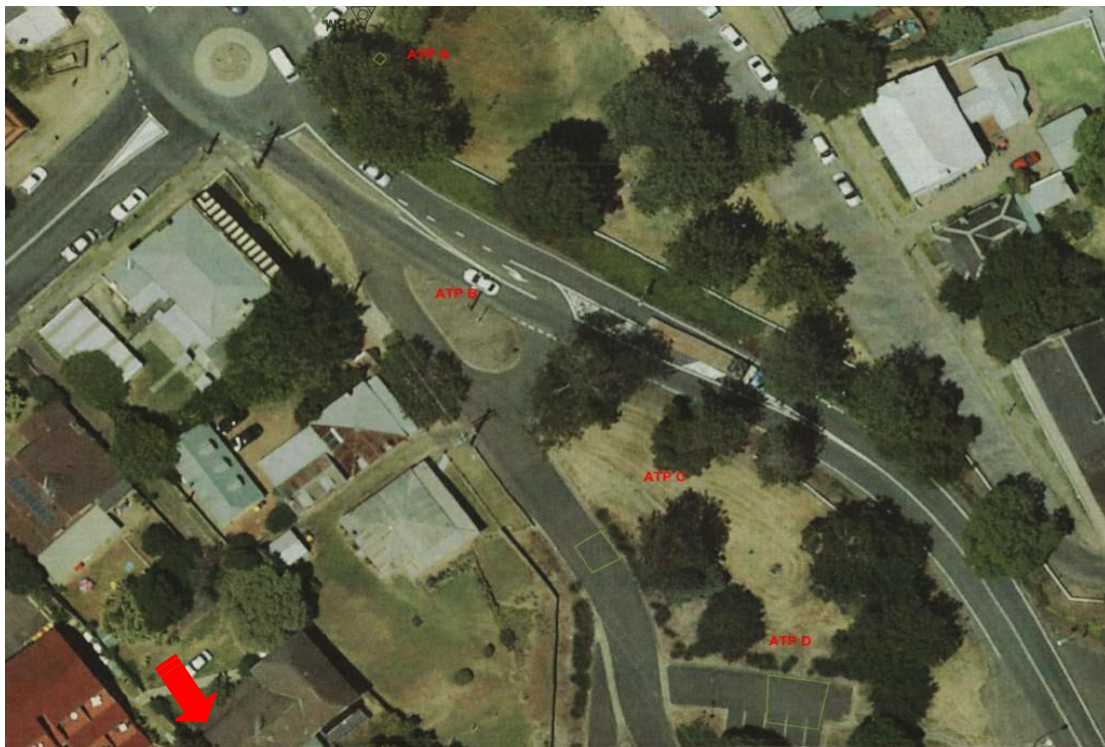
Plate 22: Location of indigenous test pits; Test Pits A and B are closest to the Bridge Street and George Street intersection.

The most relevant pit and closest to the north-western corner of the intersection was a test pit dug to evaluate the profile for indigenous archaeology (ATP A or Indigenous Test Pit 057E 560N). A second test pit further north in Bridge Street was also used to inform the present investigation (ATP B or Indigenous Test Pit 050E 591N). Some evidence has also been used to interpret results from historic period trenches 1 and 2; this evidence is discussed in Section 9.

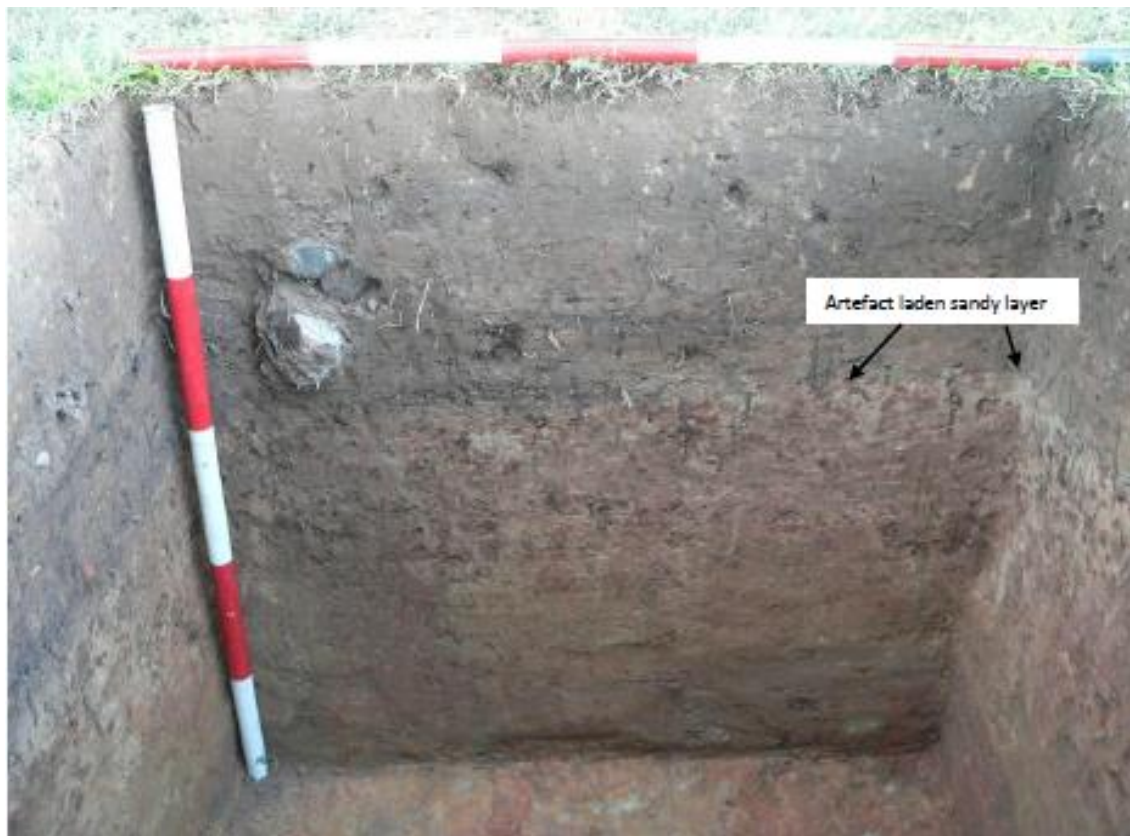
Plate 23: North section of ATP A showing the small European horizon above the remnant sand dune; the top of the red clay is at the base of the pit (scale one metre)¹.

This test excavation revealed that the top 300 mm of the deposit in the parkland is comprised of dark grey-brown humic loam considerably disturbed by tree roots and including a small sample of European artefacts. The latter have a wide chronological spread including a fragment of a later nineteenth century clay smoking pipe and c. 1950s tiles. Below this material from 300 mm downwards was the upper portion of an ancient sand body including substantial quantities of Aboriginal artefacts. The pit was excavated to a depth of one metre; at this point naturally occurring red clay was exposed.

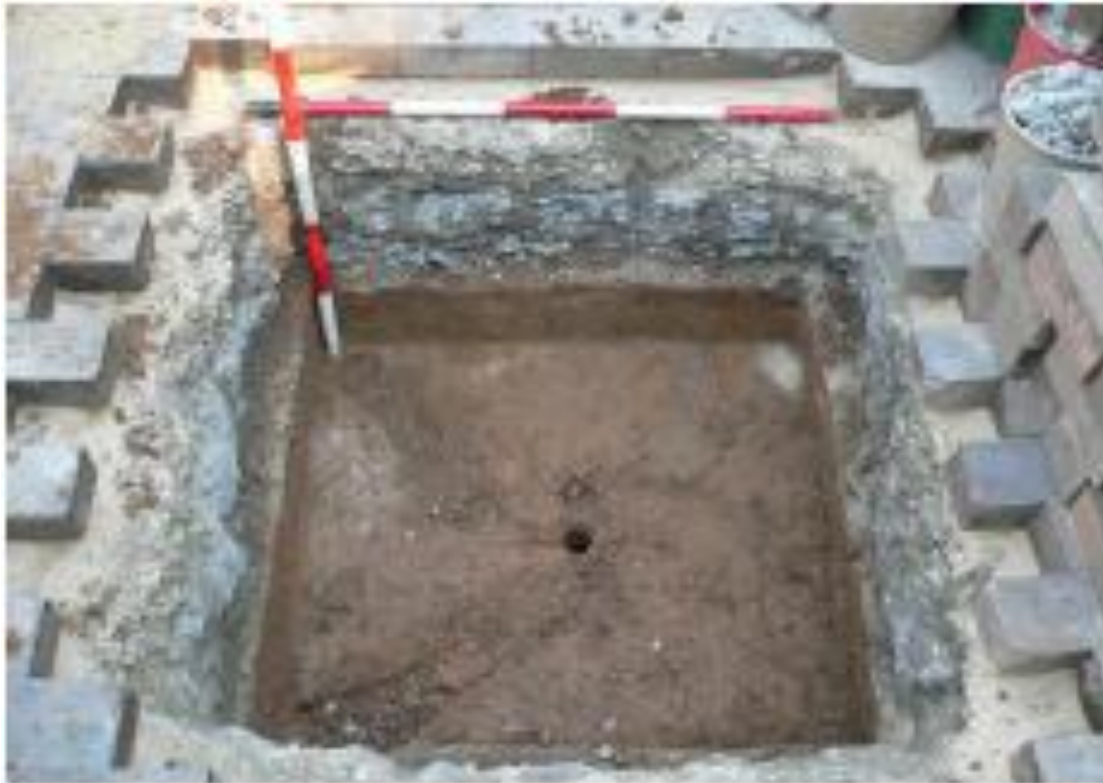
Plate 24: Section in ATP B; scale 1 metre

This pit was located in the traffic island between Old Bridge Street and Bridge Street. The surface was covered with paving bricks to reveal 80mm of bedding sand, above 230mm of blue metal. Below this was 250mm of concrete and at the base of the excavation was sticky red clay.

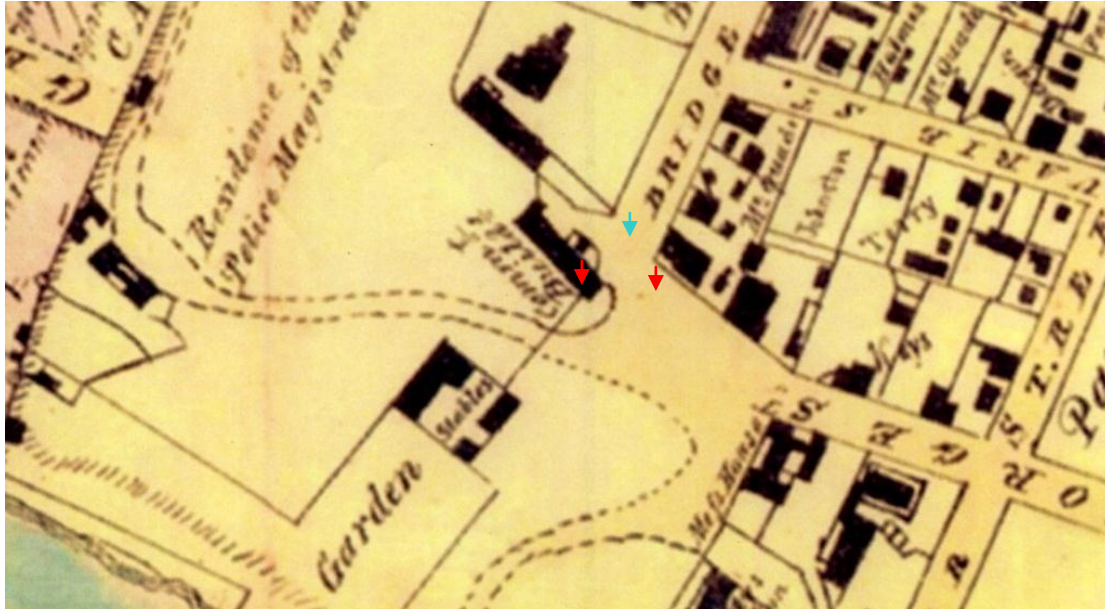
Plate 25: 1842 survey with the red arrows indicating the presence of bedrock close to the surface (archaeological test trenches) and deep deposits of fill and clay shown by the blue arrow recorded in a geo-technical core (detail of Peninsula Farm Auction 5 February 1842, Plan prepared by Surveyor Armstrong: source nla map f187 on line)

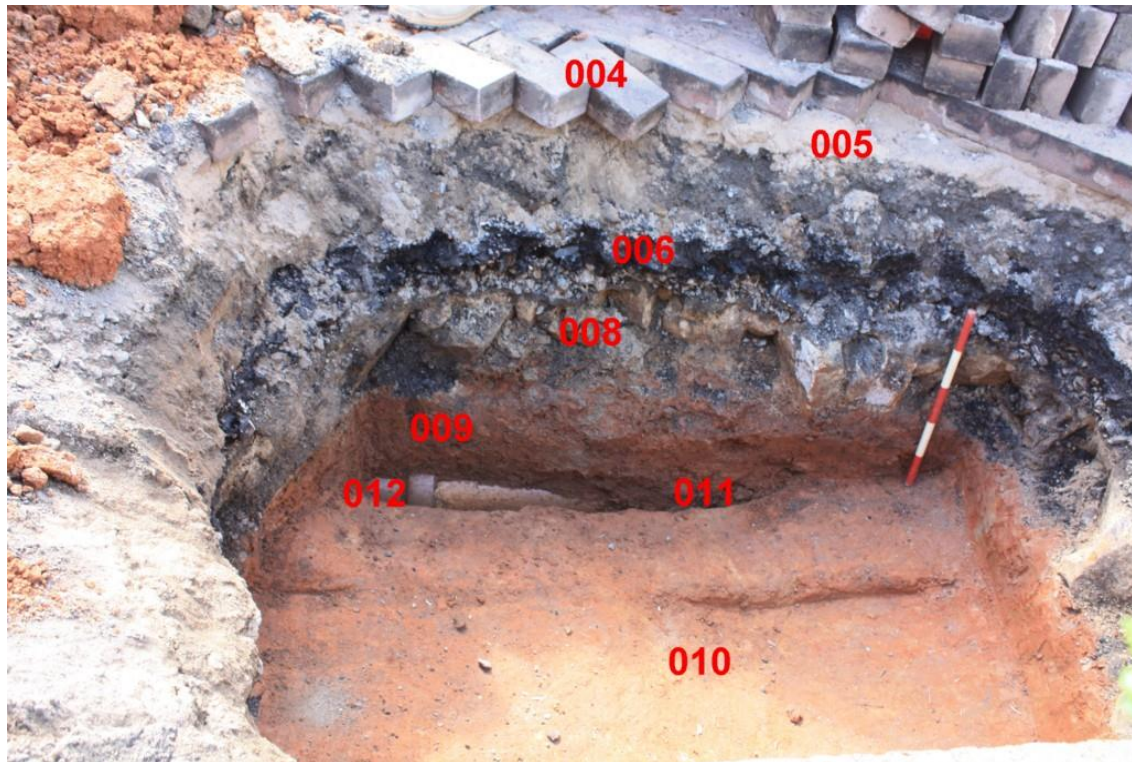
Plate 27: View north showing the shaped sandstone bedrock [010] in Test Trench 11; scale 500 mm.

There is some evidence exposed in the current excavations to suggest that the geology was put to use to assist the earliest settlement. There is the apparent relationship between the western end of the Commissariat building and the extent of shallow bedrock at the same point. Test Trench 11 revealed that the bedrock had been shaped; there is a deliberate straight line formed by apparently slightly cutting and smoothing the sandstone **[010]**. This feature extends both east and west beyond the boundaries of the trench. The feature is also likely to extend north into the road.

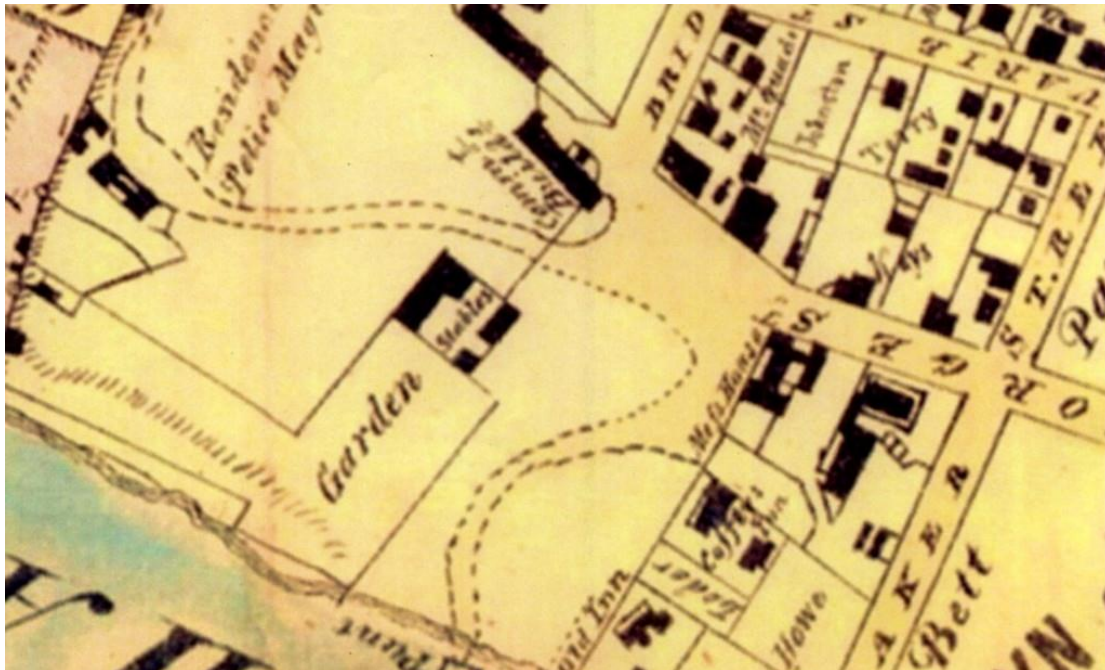
Plate 28: Detail of Armstrong's plan of the town in 1842 showing the large open area on the ridge top with the Commissariat building providing a visual curtailment to the end of George Street. The distinct splayed corner at the Bridge Street intersection is also recorded here detail of Peninsula Farm Auction 5 February 1842, plan prepared by Surveyor Armstrong: source nla map f187 on line).
