Windsor Bridge replacement project

Submissions report
Incorporating preferred infrastructure report

APRIL 2013

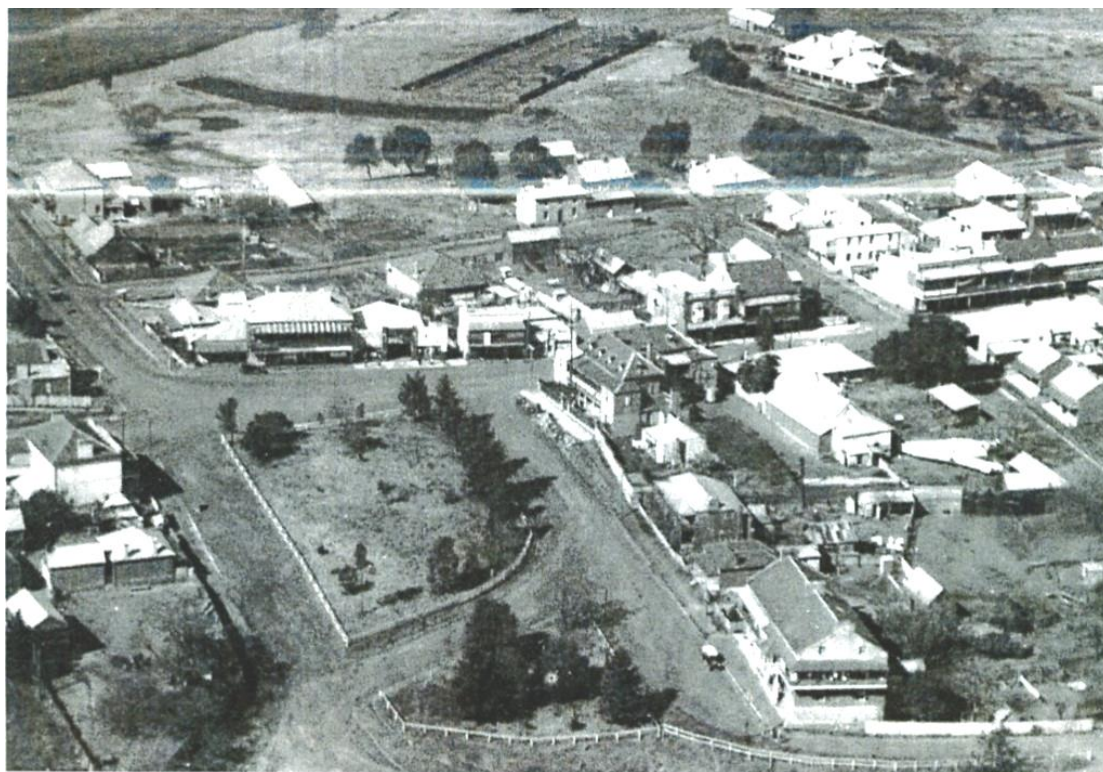
Plate 31: Thompson Square in 1929 showing what appears to be a compacted soil surface along George Street (JHHS 2011 No 2: 21).

It raises the question of how long this possible surface may have remained in use. It certainly does not appear to have been evident in the later 1920s. There is an aerial view of Thompson Square in 1929 and George Street in that image appears to be earth-covered. This could coincide with the deposit of silty soil [007] found in Test Trench 11 lying directly over the stone-built feature.

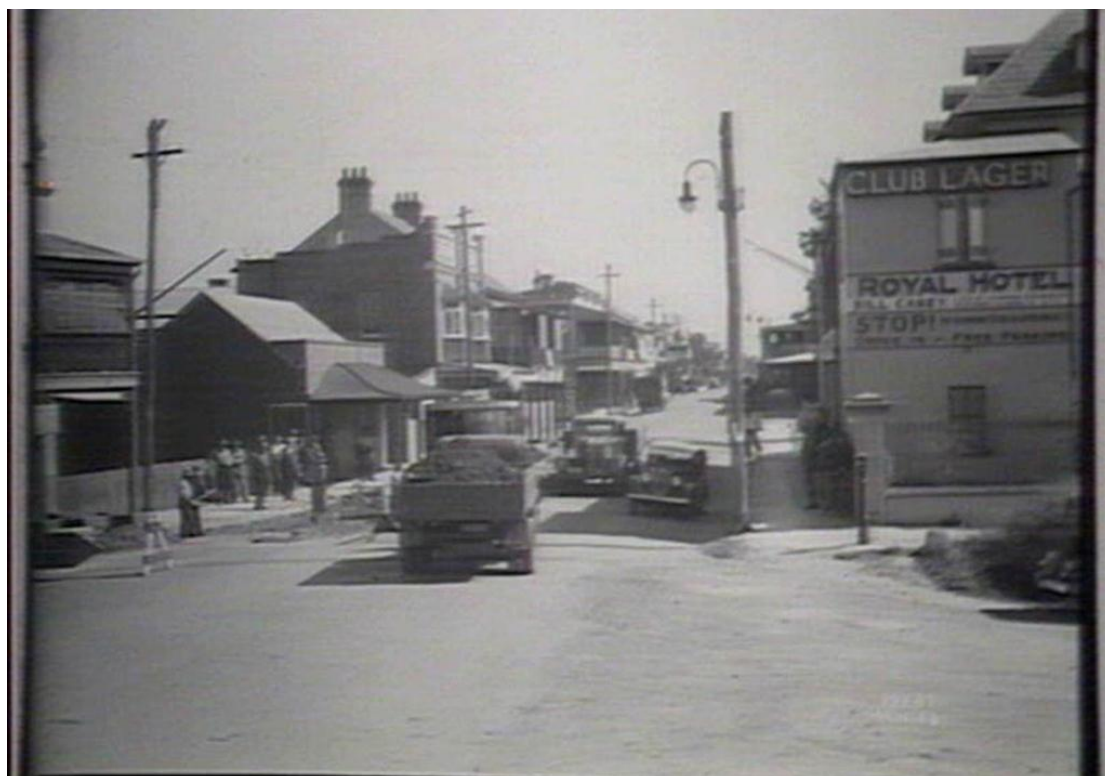
Plate 32: View of street works in 1938 looking west down George Street from the Bridge Street intersection (ML GPO 1-32538).

The 1938 image on the preceding page shows what appears to be a cement paved footpath along the southern side of George Street. It is very similar in appearance to the pavement that presently exists on the eastern side of Bridge Street. This was the slab moved aside at the top of trench 10 **[001]**. The footpath on Bridge Street could date to that time or be a later replacement.

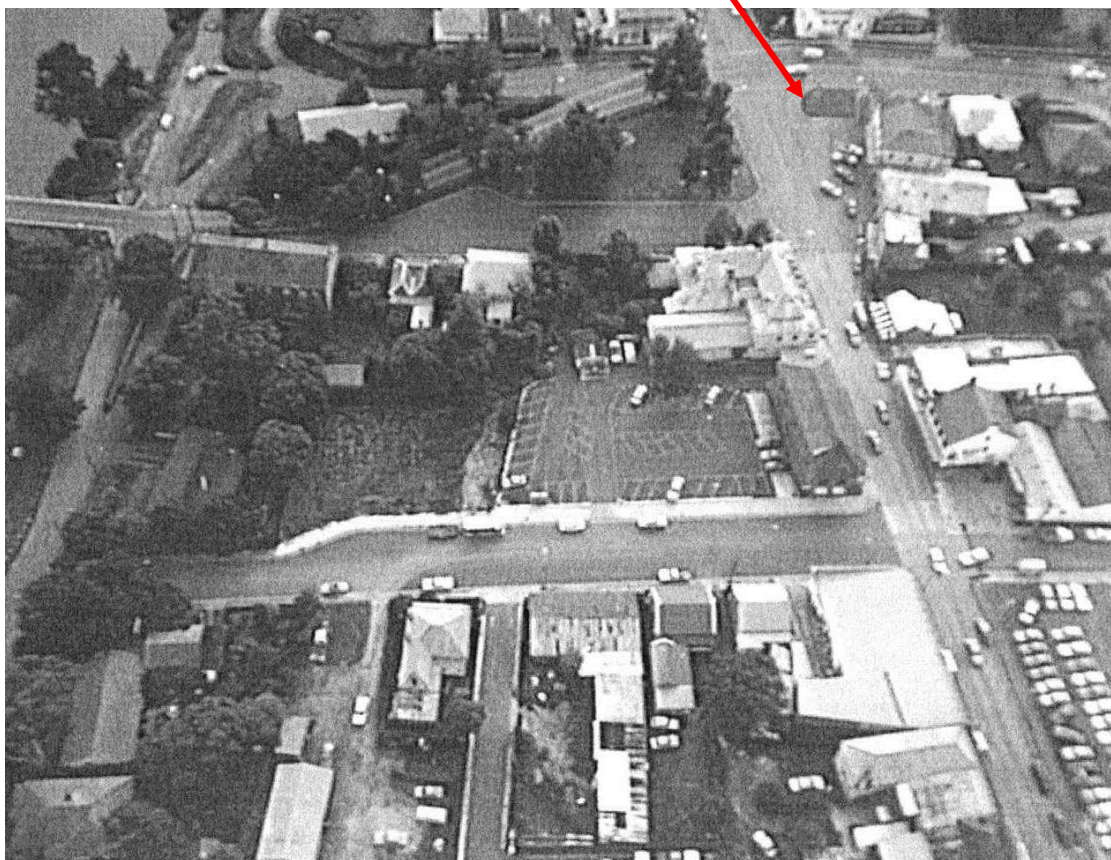
Plate 34: Oblique aerial view of Thompson Square. What appears to be a grassy area in front of the former Hawkesbury Stores in indicated by the red arrow. Source: Hawkesbury Images Local Studies Library Photographic Collection "Aerial view of North Richmond Bridge during floods, March 1978 [sic]. This is clearly an aerial photograph of Windsor with Thompson Square visible at the top of the image.

The alternative date for this feature in Test Trench 12 is that it is a late twentieth century surface developed after 1978 and before the creation of the pedestrian area as it now exists. The evidence for this is a view along George Street in 1978. This shows at the corner of George and Bridge Streets a grass covered strip that runs from the footpath to George Street encompassing the area of the test trench at its northern end. There was no evidence of this feature in the test trench. That strip of grass was still present in 1981 so if the paved surface revealed in the test strip has replaced this grassed area then it must have done so in the later 1980s. At this time there is insufficient archival and physical evidence to more accurately date this feature.

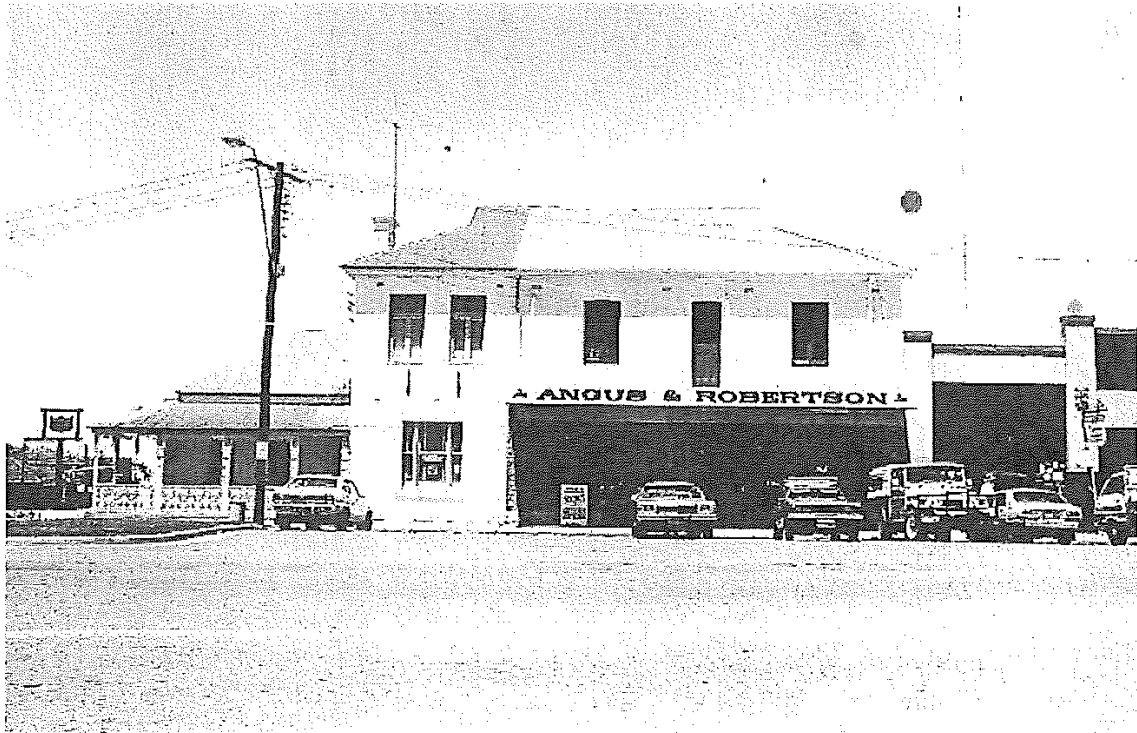
Plate 35: A view of the former Hawkesbury Stores in 1981; view of the grassy verge in front of the single storey building. Source: Fisher Lucas 1981.

The 400 mm of topsoil at the surface of test trench 12 **[014, 015]** extends beyond the area of the grass strip recorded in the images of 1978 and 1981. It has been introduced as part of the present configuration of this corner created in the last twenty years.

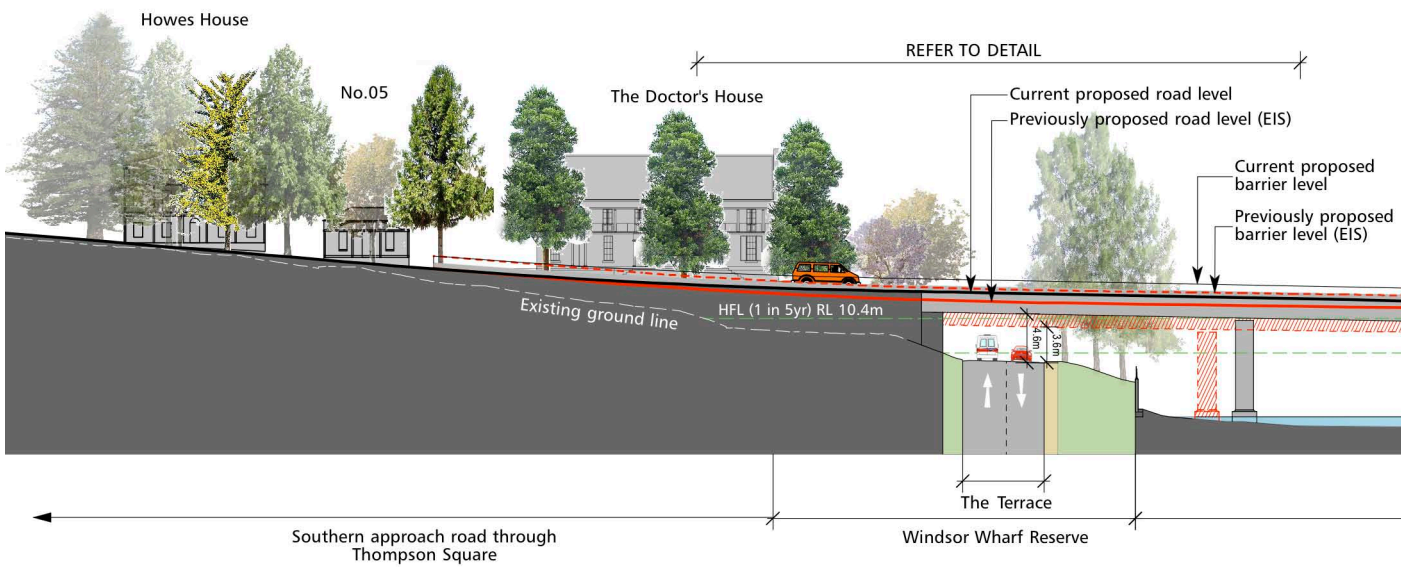
Figure 1.1: Proposed changes to the project. The previous design presented in the EIS is shown in red.

Figure 1.1 and Figure 1.2 presents the difference in heights of the modified project in comparison to the project presented in the EIS.

The location of the piers would be slightly changed so that they are evenly spaced across the river, supporting equal spans of 31.32 metres along the length of the bridge. The proposed location of the piers are also shown in Figure 1.1. No changes to the abutments are proposed.

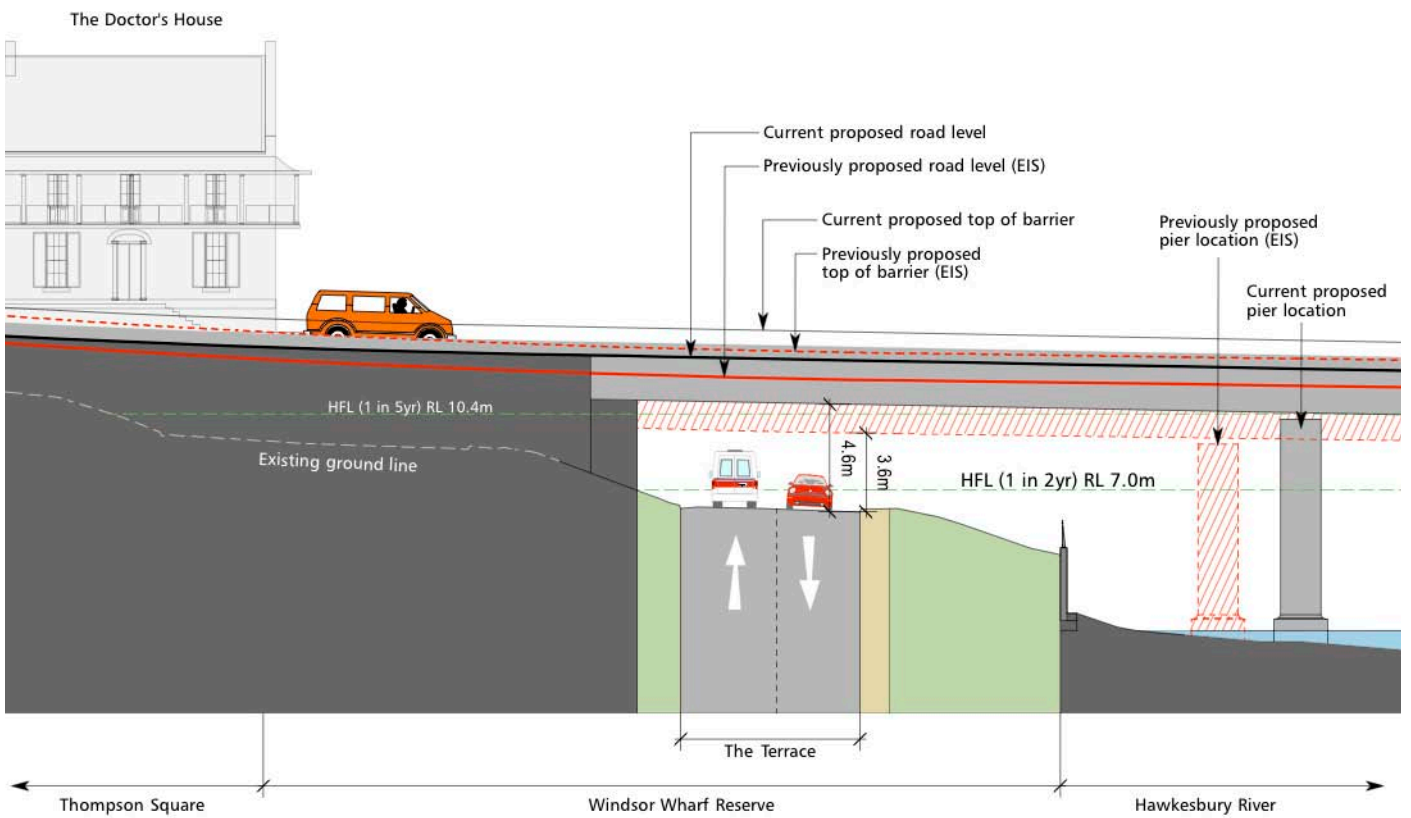
Figure 1.2: Detail section at The Terrace.

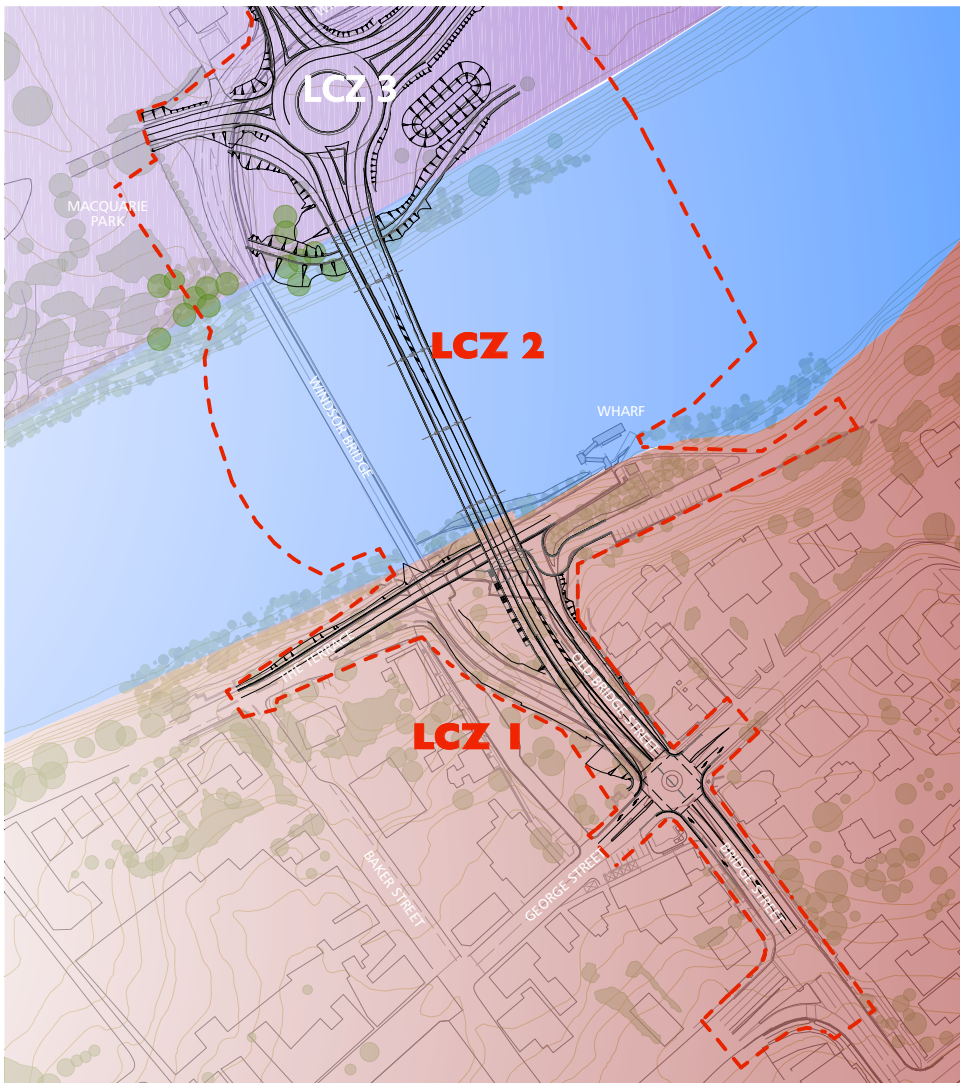
Figure 1.4: Landscape Character Zones, showing those affected in red

The proposed design changes described previously would affect two of the landscape character zones (LCZ) and eight viewpoints previously assessed in the Urban Design and Landscape Concept Report, presented as part of the EIS. The affected LCZ's and viewpoints are highlighted in red on Figure 1.3 and Figure 1.4 and described in more detail below.

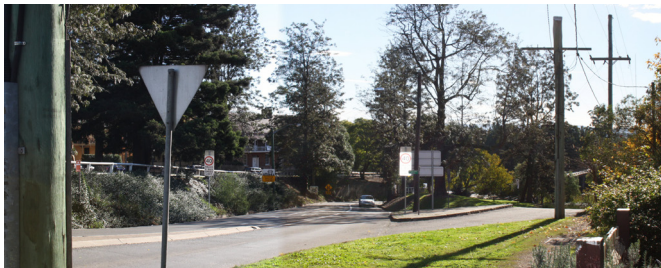
Location: Foreground view from Bridge Street, looking north west.

Description: The viewpoint overlooks the southern approach road to the bridge, which would be only slightly higher than that previously proposed.

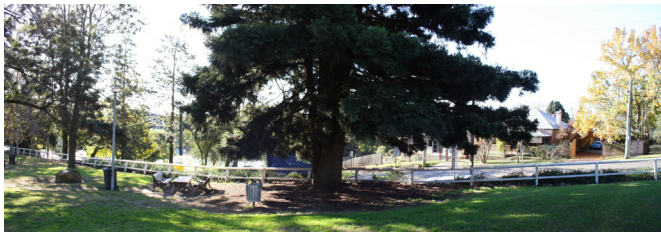
Location: Foreground view from Thompson Square, looking north.

Description: The viewpoint overlooks the southern approach road to the bridge and the bridge itself. The marginally increased height of the bridge abutments would be slightly more prominent from this viewpoint, and may obscure mid distance views to the water marginally more than the proposal presented in the EIS.

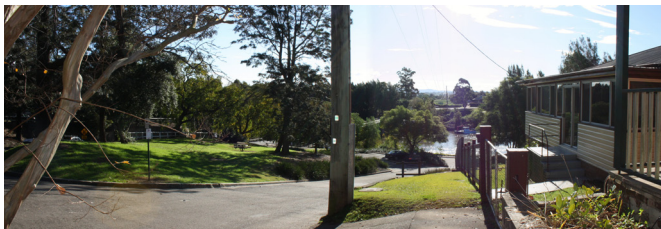
Location: Foreground and mid distance view from Bridge Street, looking north west.

Description: The slightly raised southern approach road and raised bridge abutments and deck would slightly increase the visual dominance of the structure from this location and may obscure views of the river marginally more than the proposal presented in the EIS.

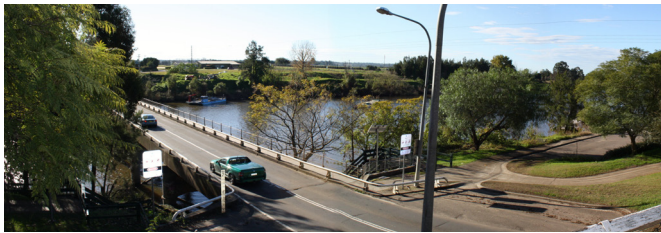
Location: This is a foreground and mid distance view from Thompson Square, adjacent to the Doctor's House, looking north.

Description: This viewpoint overlooks the river and the changes to the proposal presented in the EIS would be noticeable from this location.

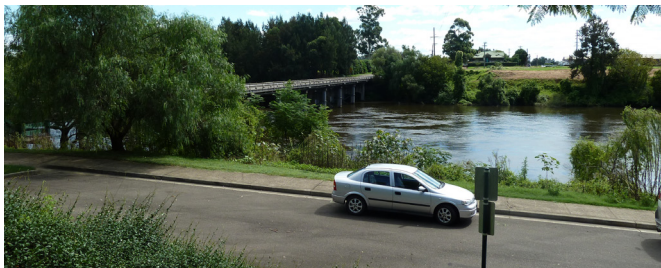
Location: Foreground view from the small carpark near The Terrace, looking north west.

Description: This viewpoint is located under the replacement bridge. The increased height of the bridge would reduce the sense of enclosure under the bridge along this section of The Terrace, and would slightly open the view over the river.

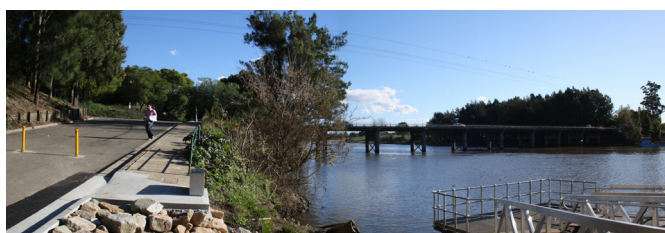
Location: Foreground view from Windsor Wharf, looking south west.

Description: This viewpoint provides extensive views along the river towards the existing bridge. The increased height of the bridge and abutments would be noticeable on the already prominent structure.

Viewpoint 12 was previously assessed to have High sensitivity and a High magnitude, giving a High visual impact. The proposed works would not change the sensitivity rating, which would remain High. The increased height of the bridge would be noticeable from this viewpoint, which looks directly across to, and is in close proximity to, the proposed works, and may be sufficient to increase the magnitude rating. However, the magnitude rating is already High. Therefore, the visual impact rating would remain High.

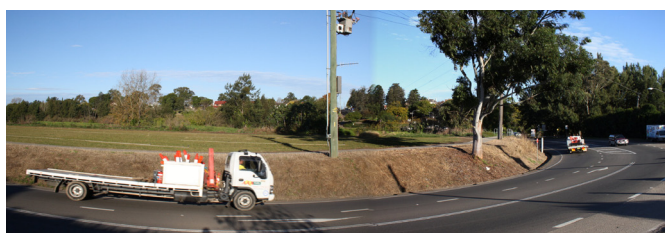
Location: Foreground view from Wilberforce Road, west of Freemans Reach Road, looking south.

Description: This viewpoint looks towards Windsor and the bridge replacement works. The increased height of the bridge would be visible from this location, although not substantially different to the previous proposal.

Viewpoint 17 was previously assessed to have High to Moderate sensitivity and a High to Moderate magnitude, giving a High to Moderate visual impact. The proposed works would not change the sensitivity rating, which would remain High to Moderate. The changes would not be sufficient to increase the High to Moderate magnitude rating as they would be minor from this view due to the distance from the proposed works and the direction of the view along the roadway reducing the perceptible difference. Therefore, the visual impact rating would remain High to Moderate.

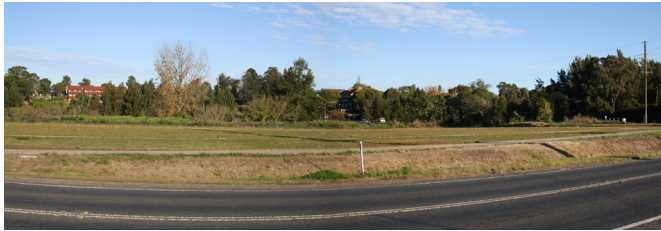
Location: Foreground view from Wilberforce Road, east of Freemans Reach Road, looking south.

Description: This viewpoint looks towards Windsor and the bridge replacement works. The increased height of the bridge would be visible from this location.

Viewpoint 18 was previously assessed to have Moderate sensitivity and a High to Moderate magnitude, giving a High to Moderate visual impact. The proposed works would not change the sensitivity rating, which would remain Moderate. The changes would not be sufficient to increase the High to Moderate magnitude rating as they would be minor from this view due to the distance from the proposed works and the direction of the view along the roadway reducing the perceptible difference. Therefore, the visual impact rating would remain High to Moderate.

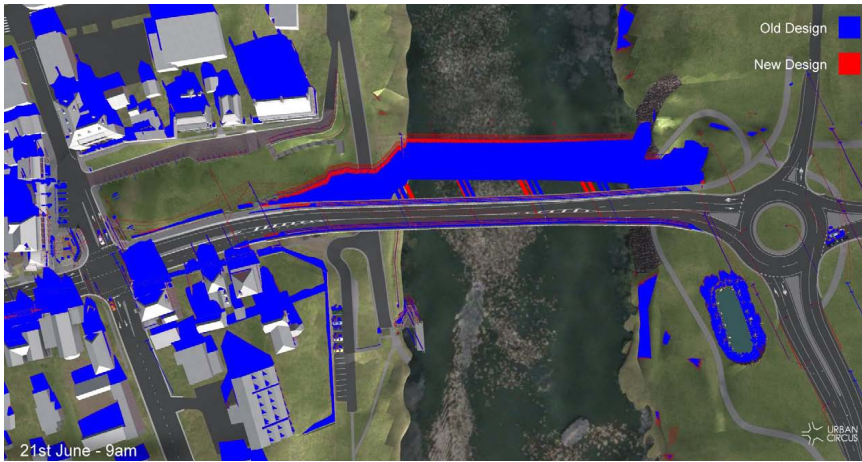
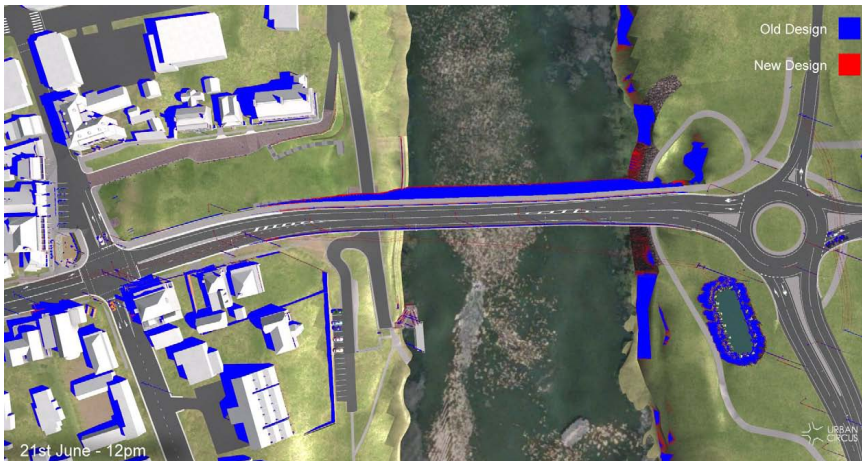
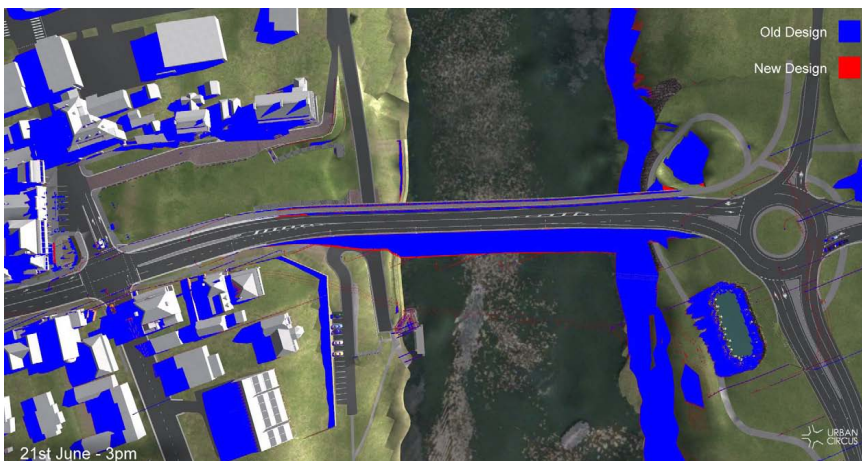
Figure 1.6: Shadow cast by the replacement bridge on 21st June.

21st JUNE

9am

12pm

3pm

The changes to the design would not greatly add to the existing overshadowing effects of the bridge. Generally, the shadow extent would remain similar; its footprint would move south. The most noticeable change would be in the early morning in winter to the lower section of Thompson Square, where the approach road on the alignment of Old Bridge Street becomes elevated on a fill embankment as it approaches the abutment, the river foreshore and the river itself. The section of The Terrace directly beneath the replacement bridge would receive slightly more sunlight due to the increased height of the bridge and the location of the piers further away from the foreshore.

The additional overshadowing caused by the increase in height of the southern approach road embankment and bridge would only slightly further affect user's experiences within the lower section of Thompson Square, and would continue to be unlikely to impact on activities occurring on the river.

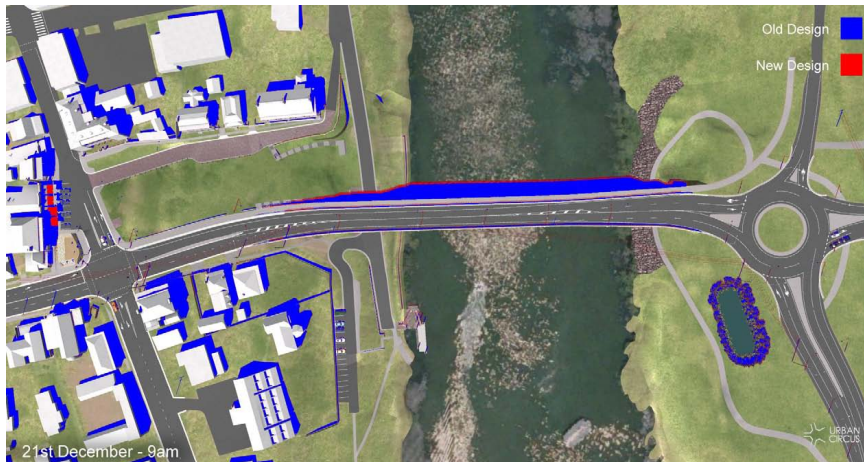
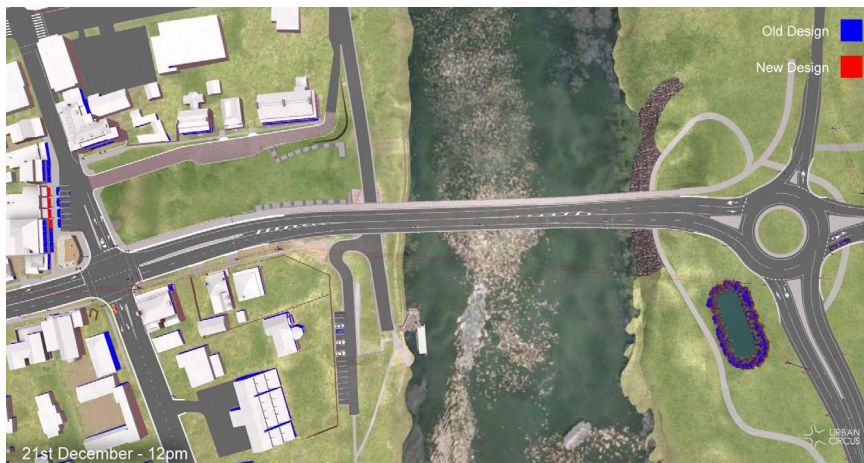
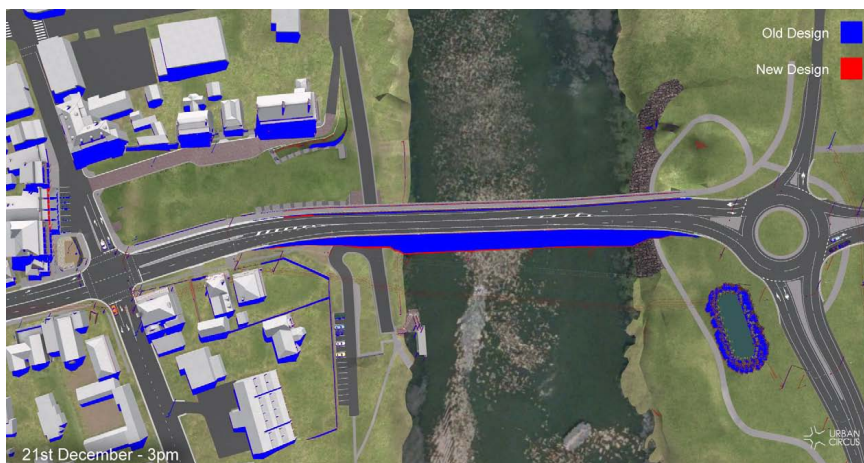
Figure 1.7: Shadow cast by the replacement bridge on 21st December.

21st December

9am

12pm

3pm

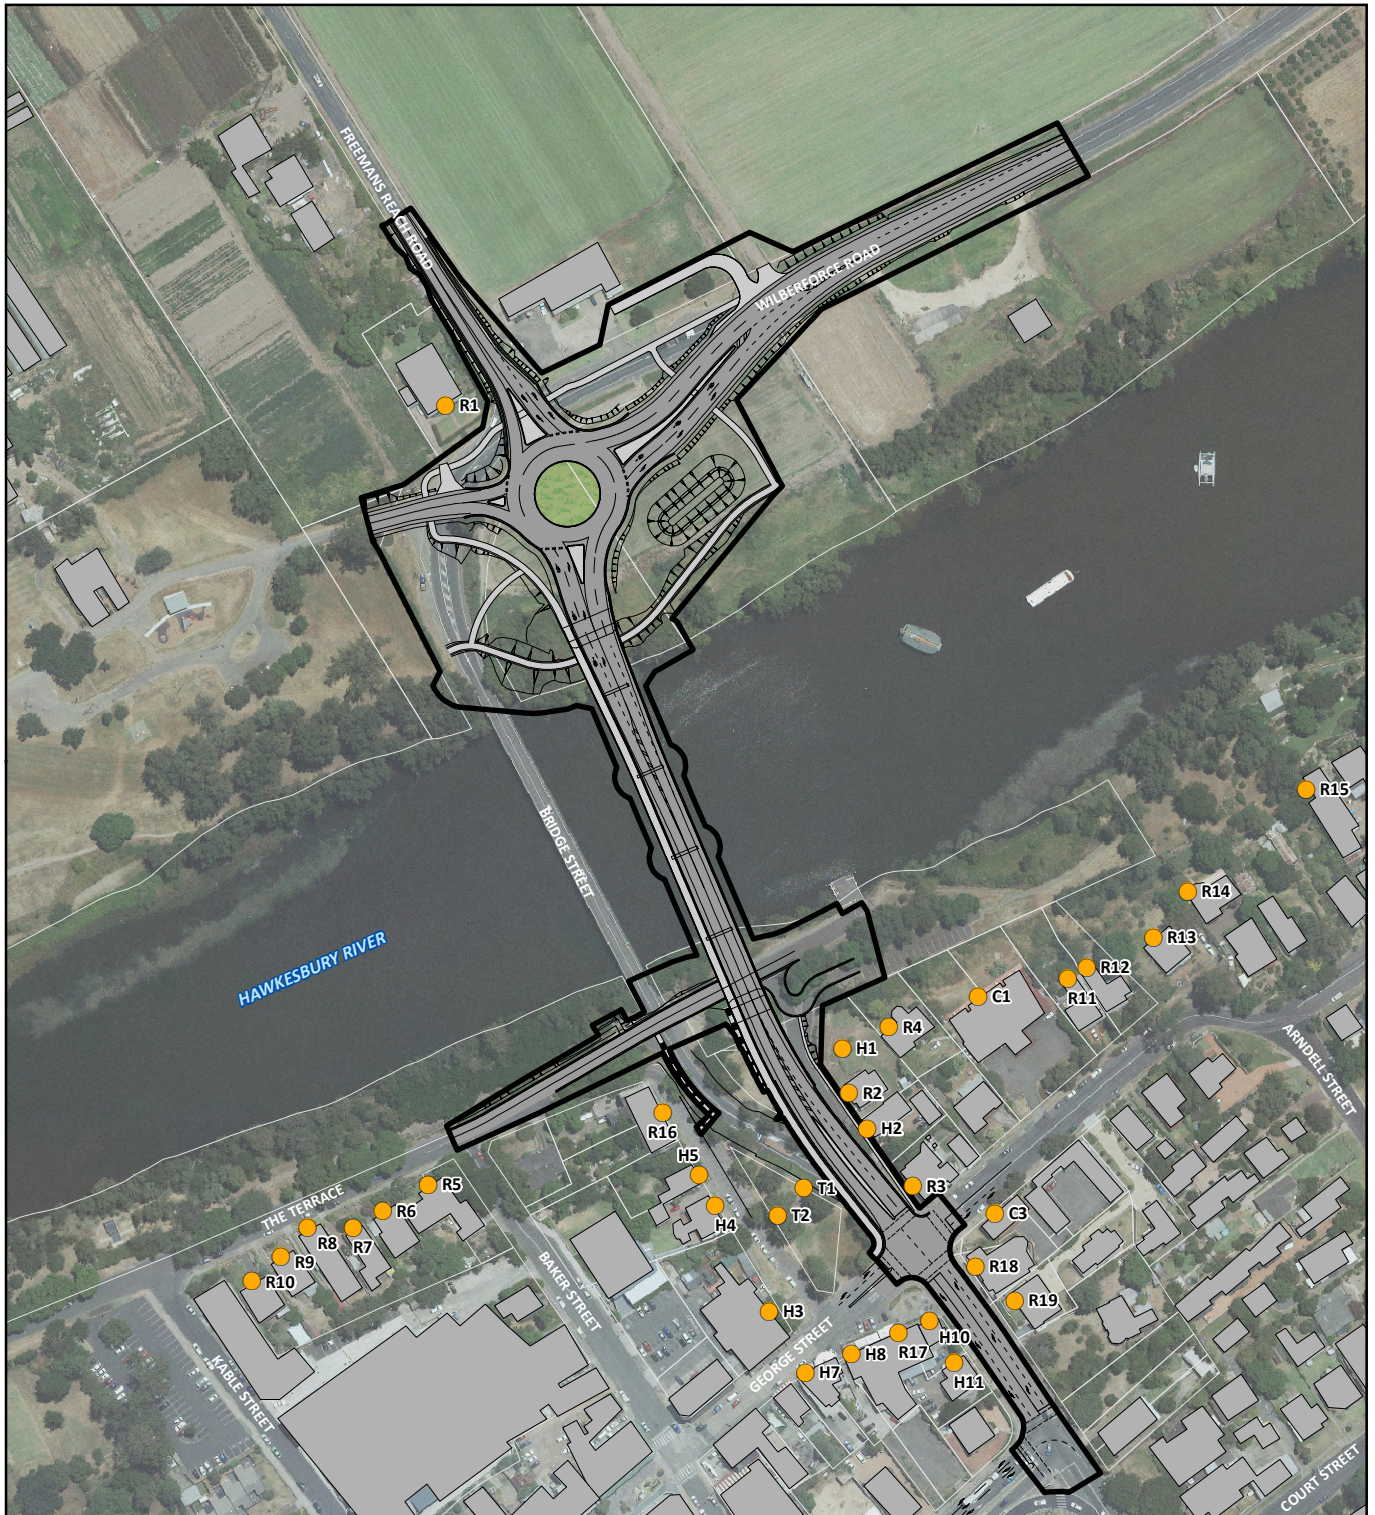
Figure 1-1 | Receivers

The study area comprises a mixture of residential and commercial receivers, many of which are buildings or items with local and/or State heritage significance. The closest residential receivers identified for the project are shown in **Table 1-1**. Additional properties were identified during the exhibition and submission phase of the EIS and have been included in the assessment of noise sensitive receivers for the revised proposal. These properties were previously identified in the EIS Noise and Vibration Working paper as commercial premises and are listed in **Table 1-1** as R16, R17, R18, and R19. **Table 1-2** presents the detail of the revised list of commercial and non residential receivers for the project. The receiver locations revised are shown in **Figure 1-1**.

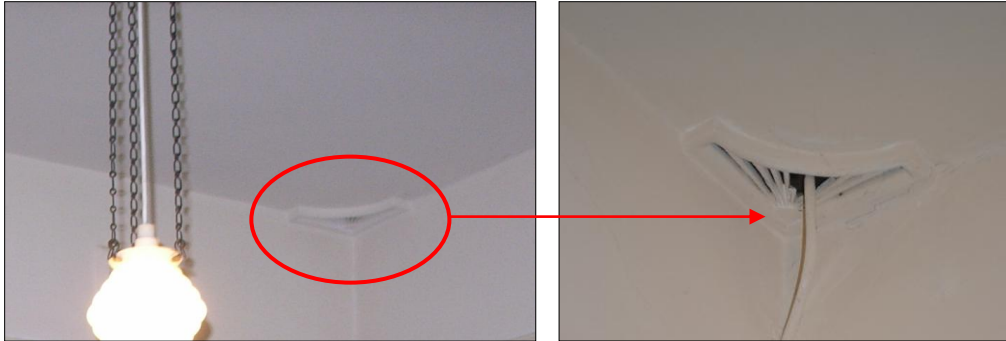
The ventilation system ducts / cabling can be placed within the roof cavity with only minimum required opening for the ducting registers in the ceilings. Consultation should be undertaken

with an appropriately qualified Heritage Architect in order to establish the locations for ducting registers. Images of an example of traditional corner ceiling vent from a house in Alexandria have been provided below for reference. New detailing should not imitate this example but be a simple version of the traditional ceiling vent.

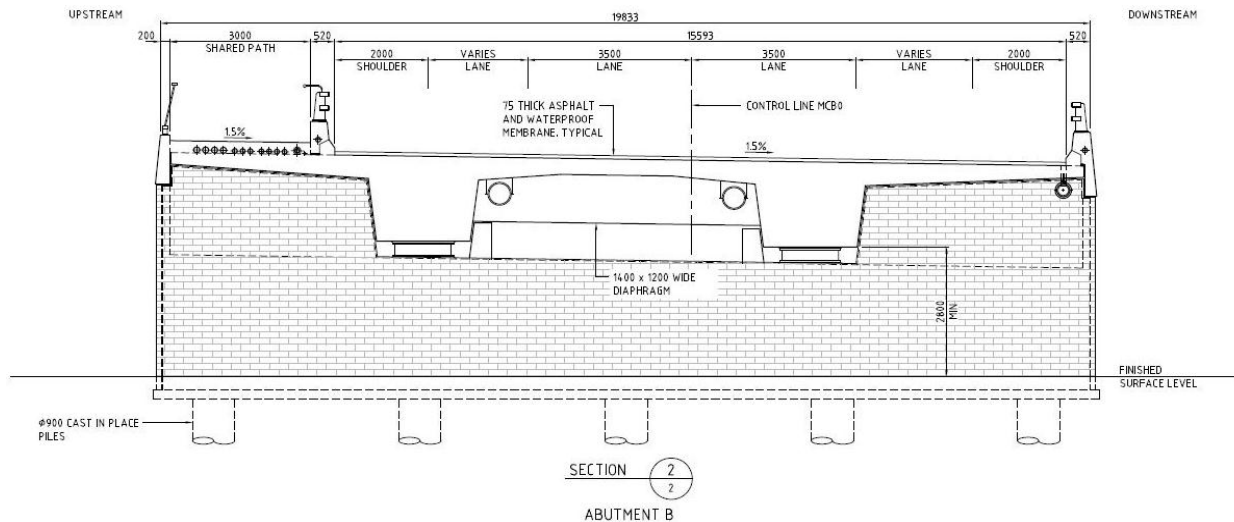
Plate 2: Cross section of the replacement bridge in Thompson Square with the Land Bridge Option showing the piles across the structure. An additional 6 piles on each long side also formed part of this particular design. Source: SKM Plan DS2012/000155 Sheet 3.

Plate 5: Cross section of the replacement bridge in Thompson Square with the Land Bridge option showing the piles across the structure. An additional six piles along each side also formed part of this design. Source: SKM Plan DS2012/000155 Sheet 3.

The land bridge design would have five 900 mm piles across the abutment and six 900 mm piles on each side for a total of 17 piles on the southern approach (refer to Plate 2). The land bridge was initially proposed as it has what appears to be a lesser impact on the site. Construction of a land bridge on the southern approach would avoid disturbing or excavation for construction purposes, the area between the walls and would only require drilling 900 mm diameter holes at 8 metre centres along the sides and five closely spaced piles in the front of the abutment structure. The design would however, impact relics within the footprint of the 17 piles without giving the opportunity to extract the archaeological data in the southern abutment further fragmenting and isolating the resource. Moreover, for health and safety reasons it is not feasible to undertake local archaeological excavation at each of the pile locations. Excavation at this depth would require substantial stepped benching around each pier location, resulting in a larger excavation footprint that would negate any advantage that this approach had to localising impact.

This proposal reduces the extent of excavation although seventeen approximately one metre-wide holes along the eastern side of Thomson Square in an area demonstrated to have an intact and significant archaeological profile would completely fragment the integrity of this resource. Only a portion of intact profile would be retained between the piles.

The impact of this option is compounded by the inability to acquire any meaningful data from the drilling areas either through inspection of the cores or creating wider but still small excavations in each location. This issue of interpreting isolated fragments of information, particularly small samples, has been discussed in the preceding section. For these reasons this approach results in a major impact, with little or no opportunity to mitigate or redress those impacts.

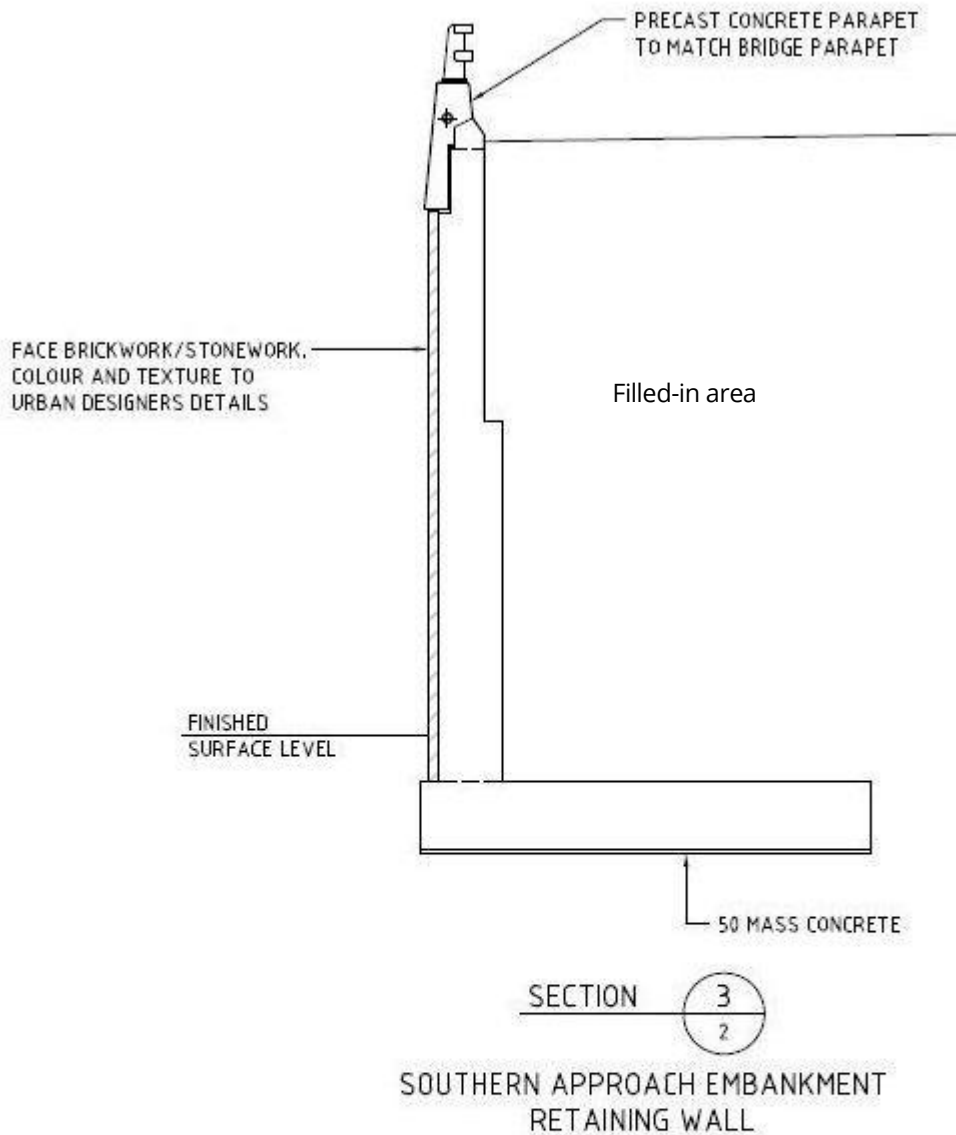
Construction of this option will remove the entire archaeological profile to bedrock (within the footprints of the abutments) and damage archaeological resources close to the surface. Excavation in this area is required from between two to six metres depth in an area equivalent in size to two Olympic-sized pools (approximately 3600 cubic metres).

Additional impacts are possible due to compression produced by machinery and stockpiling during the construction works. The scale of the work enables a large sample of archaeological evidence to be recorded during the construction program.

Plate 6: Diagram of one side of the L-shaped retaining walls proposed for the bridge abutments in Thompson Square. This design will be constructed if the project is approved. Source SKM Plan DS2012/000155 Sheet 3.

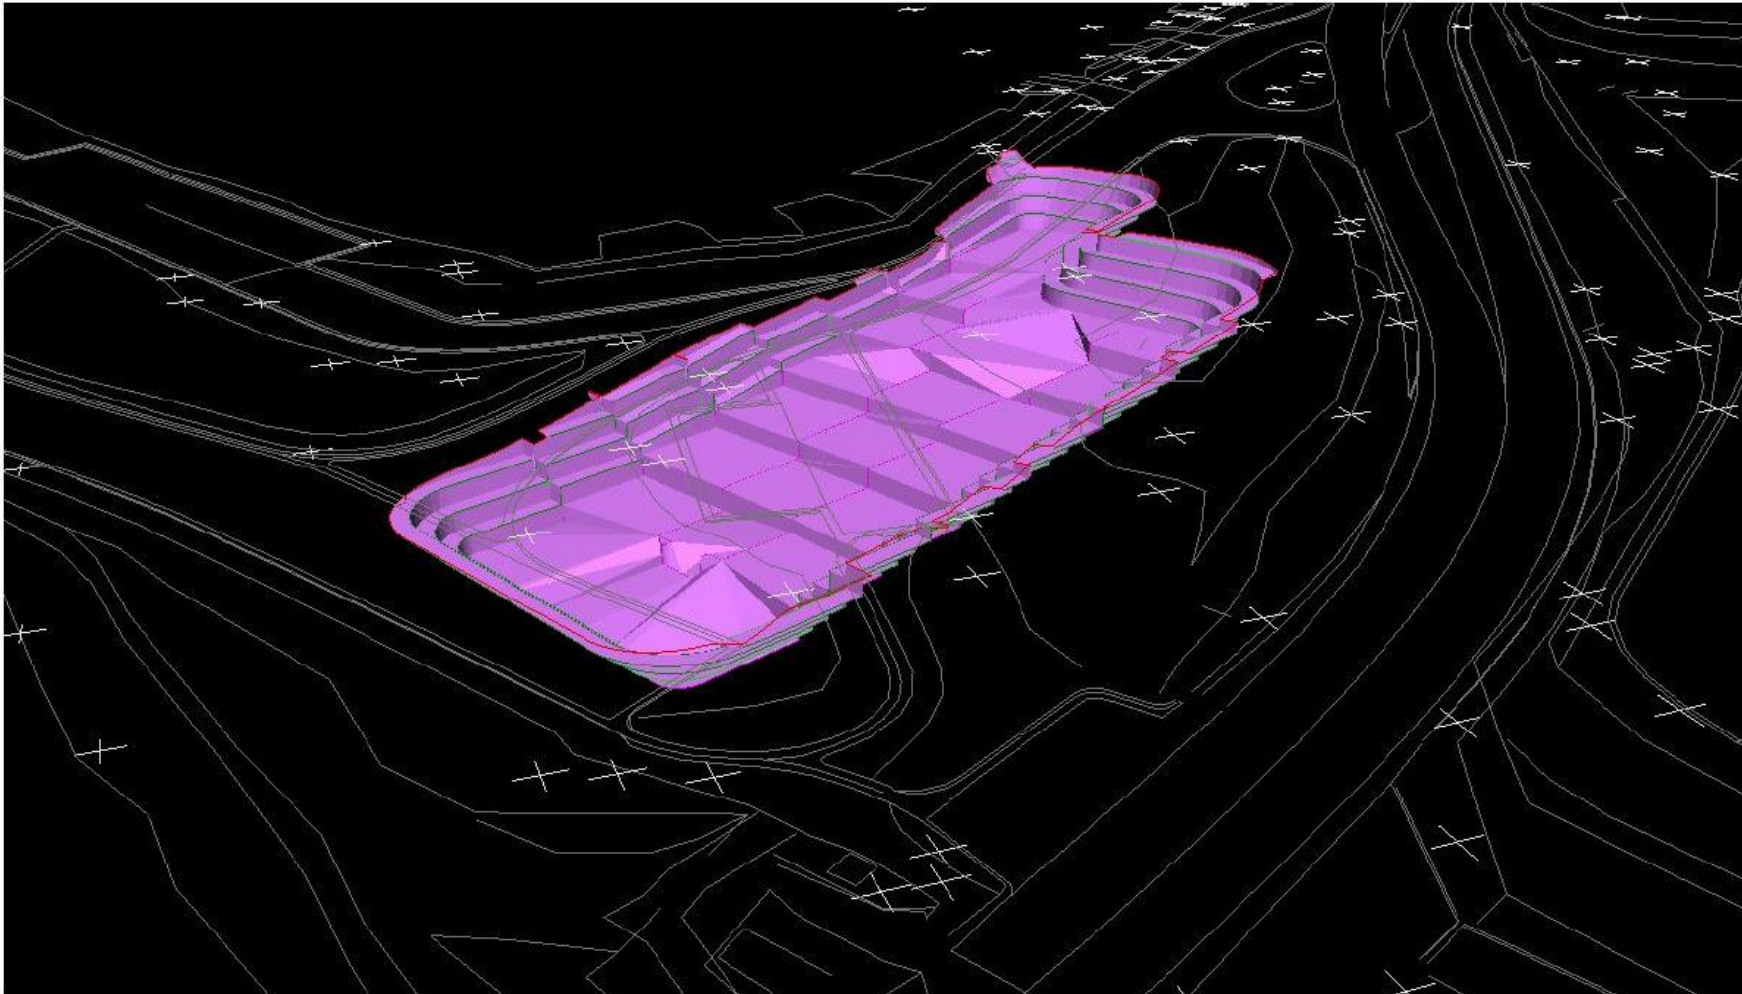
Volume of main excavation = 3645m³

Plate 7: 12D model showing construction impacts

Refer to the sections and 12D model (Plate 7) and cut and fill diagrams (Plate 4, Plate 5 and Plate 6).
