Windsor Bridge replacement project

Submissions report
Incorporating preferred infrastructure report

APRIL 2013

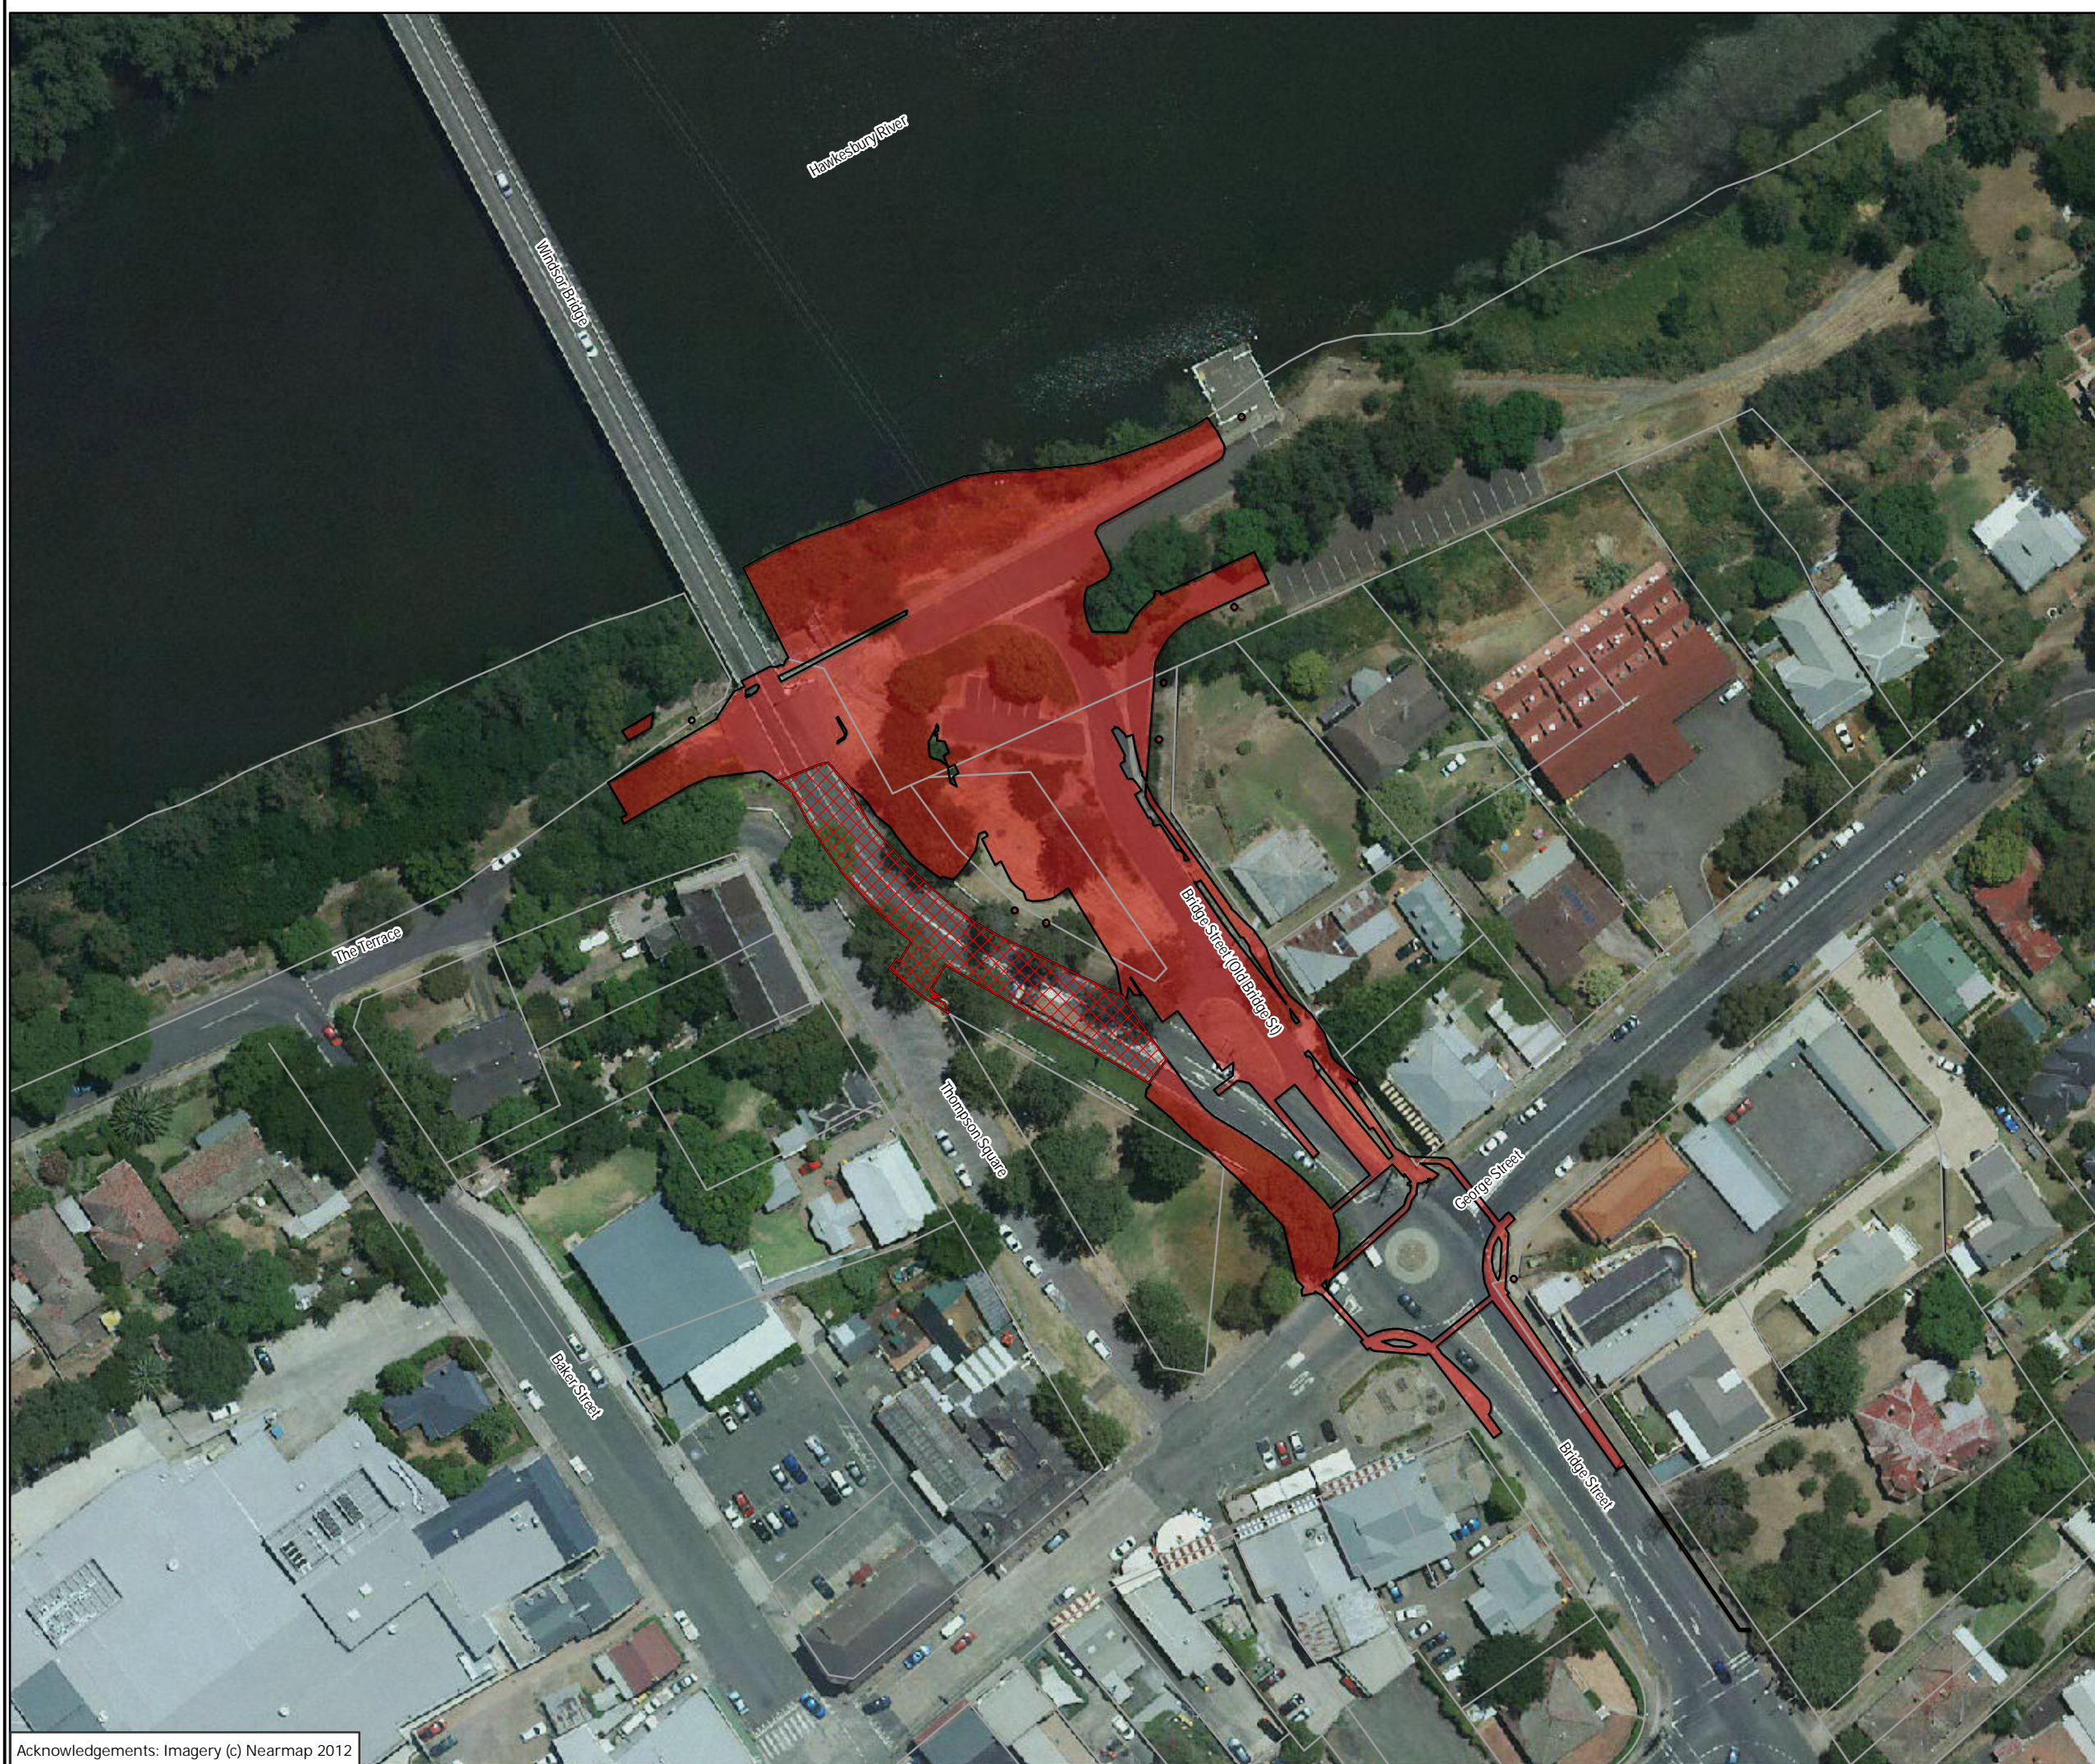
- Area of archaeological excavation
- Subject to further discussion to include in archaeological excavation

Figure 2: Option 1 - Boundary of the construction footprint

The definition of Thompson Square in this document, as in the Historic Period Heritage Working Paper, includes the SHR bound entity as well as the majority of the historical entity. The two are not consistent as the SHR boundary follows modern property boundaries, excludes Bridge Street and does not extend to the river bank, which has remnants from the early town. For the purposes of this document, "the excavation of Thompson Square" refers to the upper and lower parkland, Bridge Street and The Terrace to include the river bank and sites within the river. The area of land that is specific to the discussion of archaeological options is essentially the area of the historical Thompson Square but does not include the surrounding buildings and the eastern and western extents of George Street (refer to Plate 1 for the SHR legal plan; refer to Figures 2, 3 and 4 for the areas of excavation described in the archaeological options in this document).

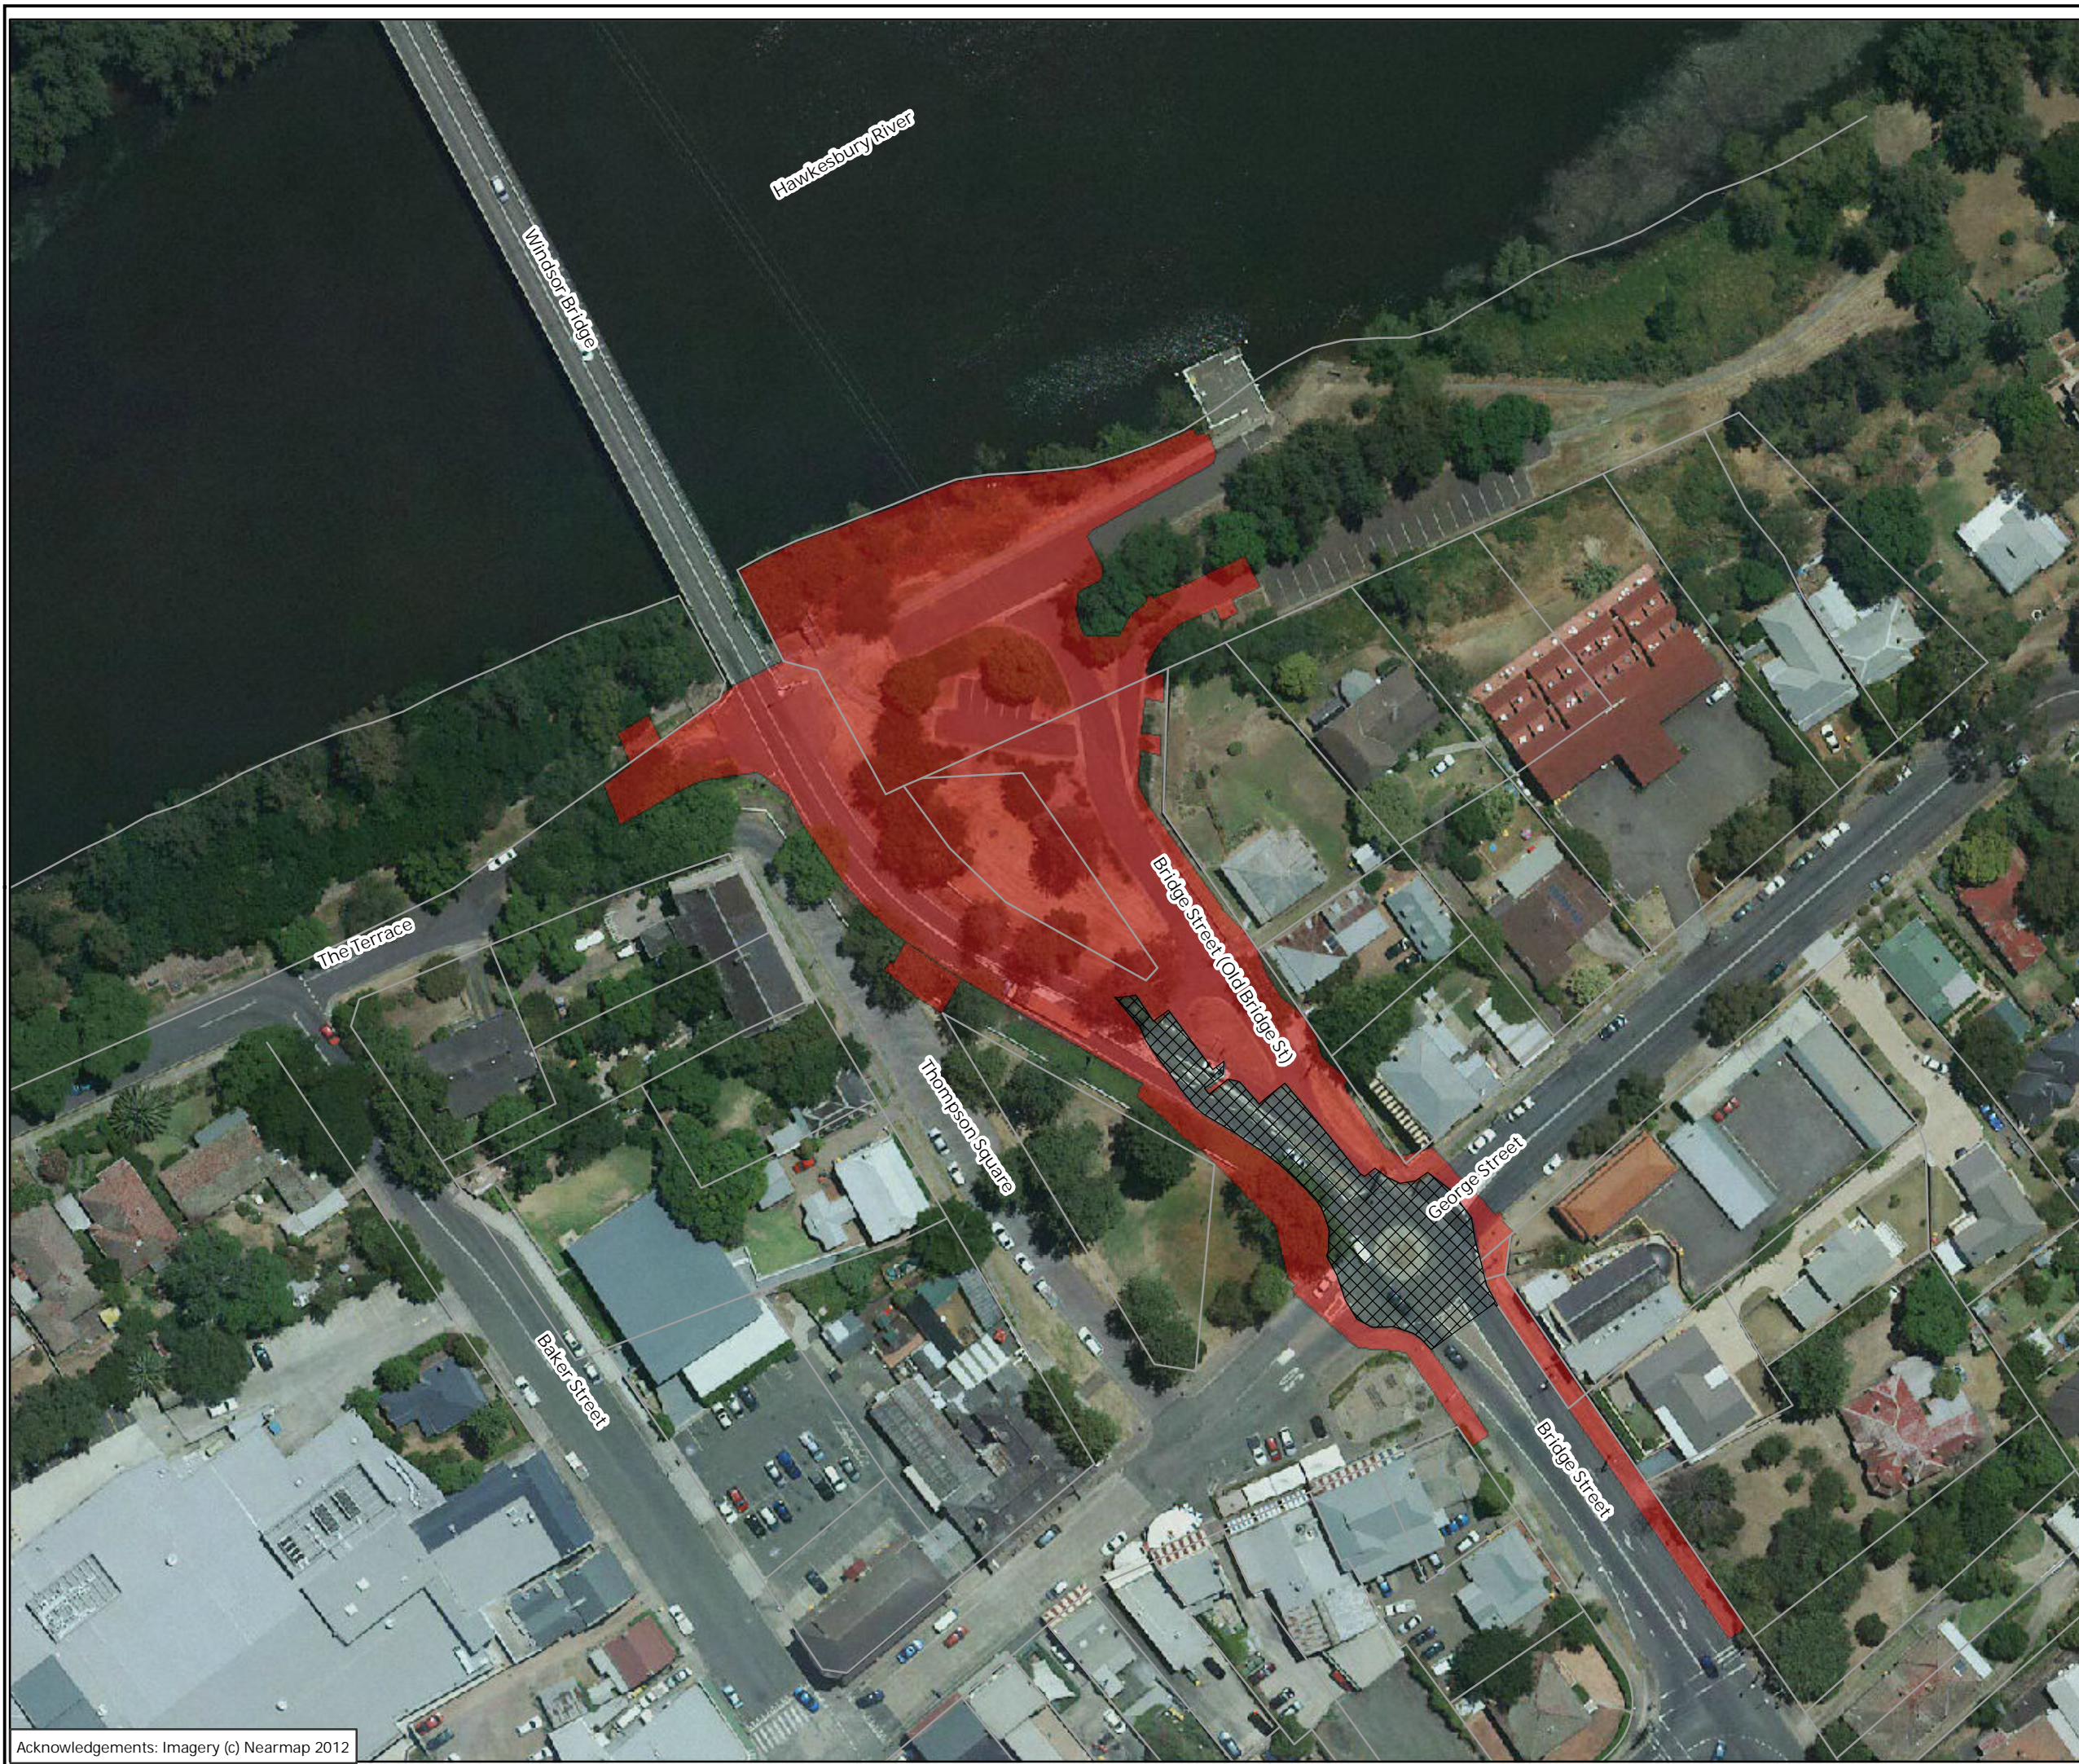
- Area of archaeological excavation
- Subject to further discussion to include in archaeological excavation

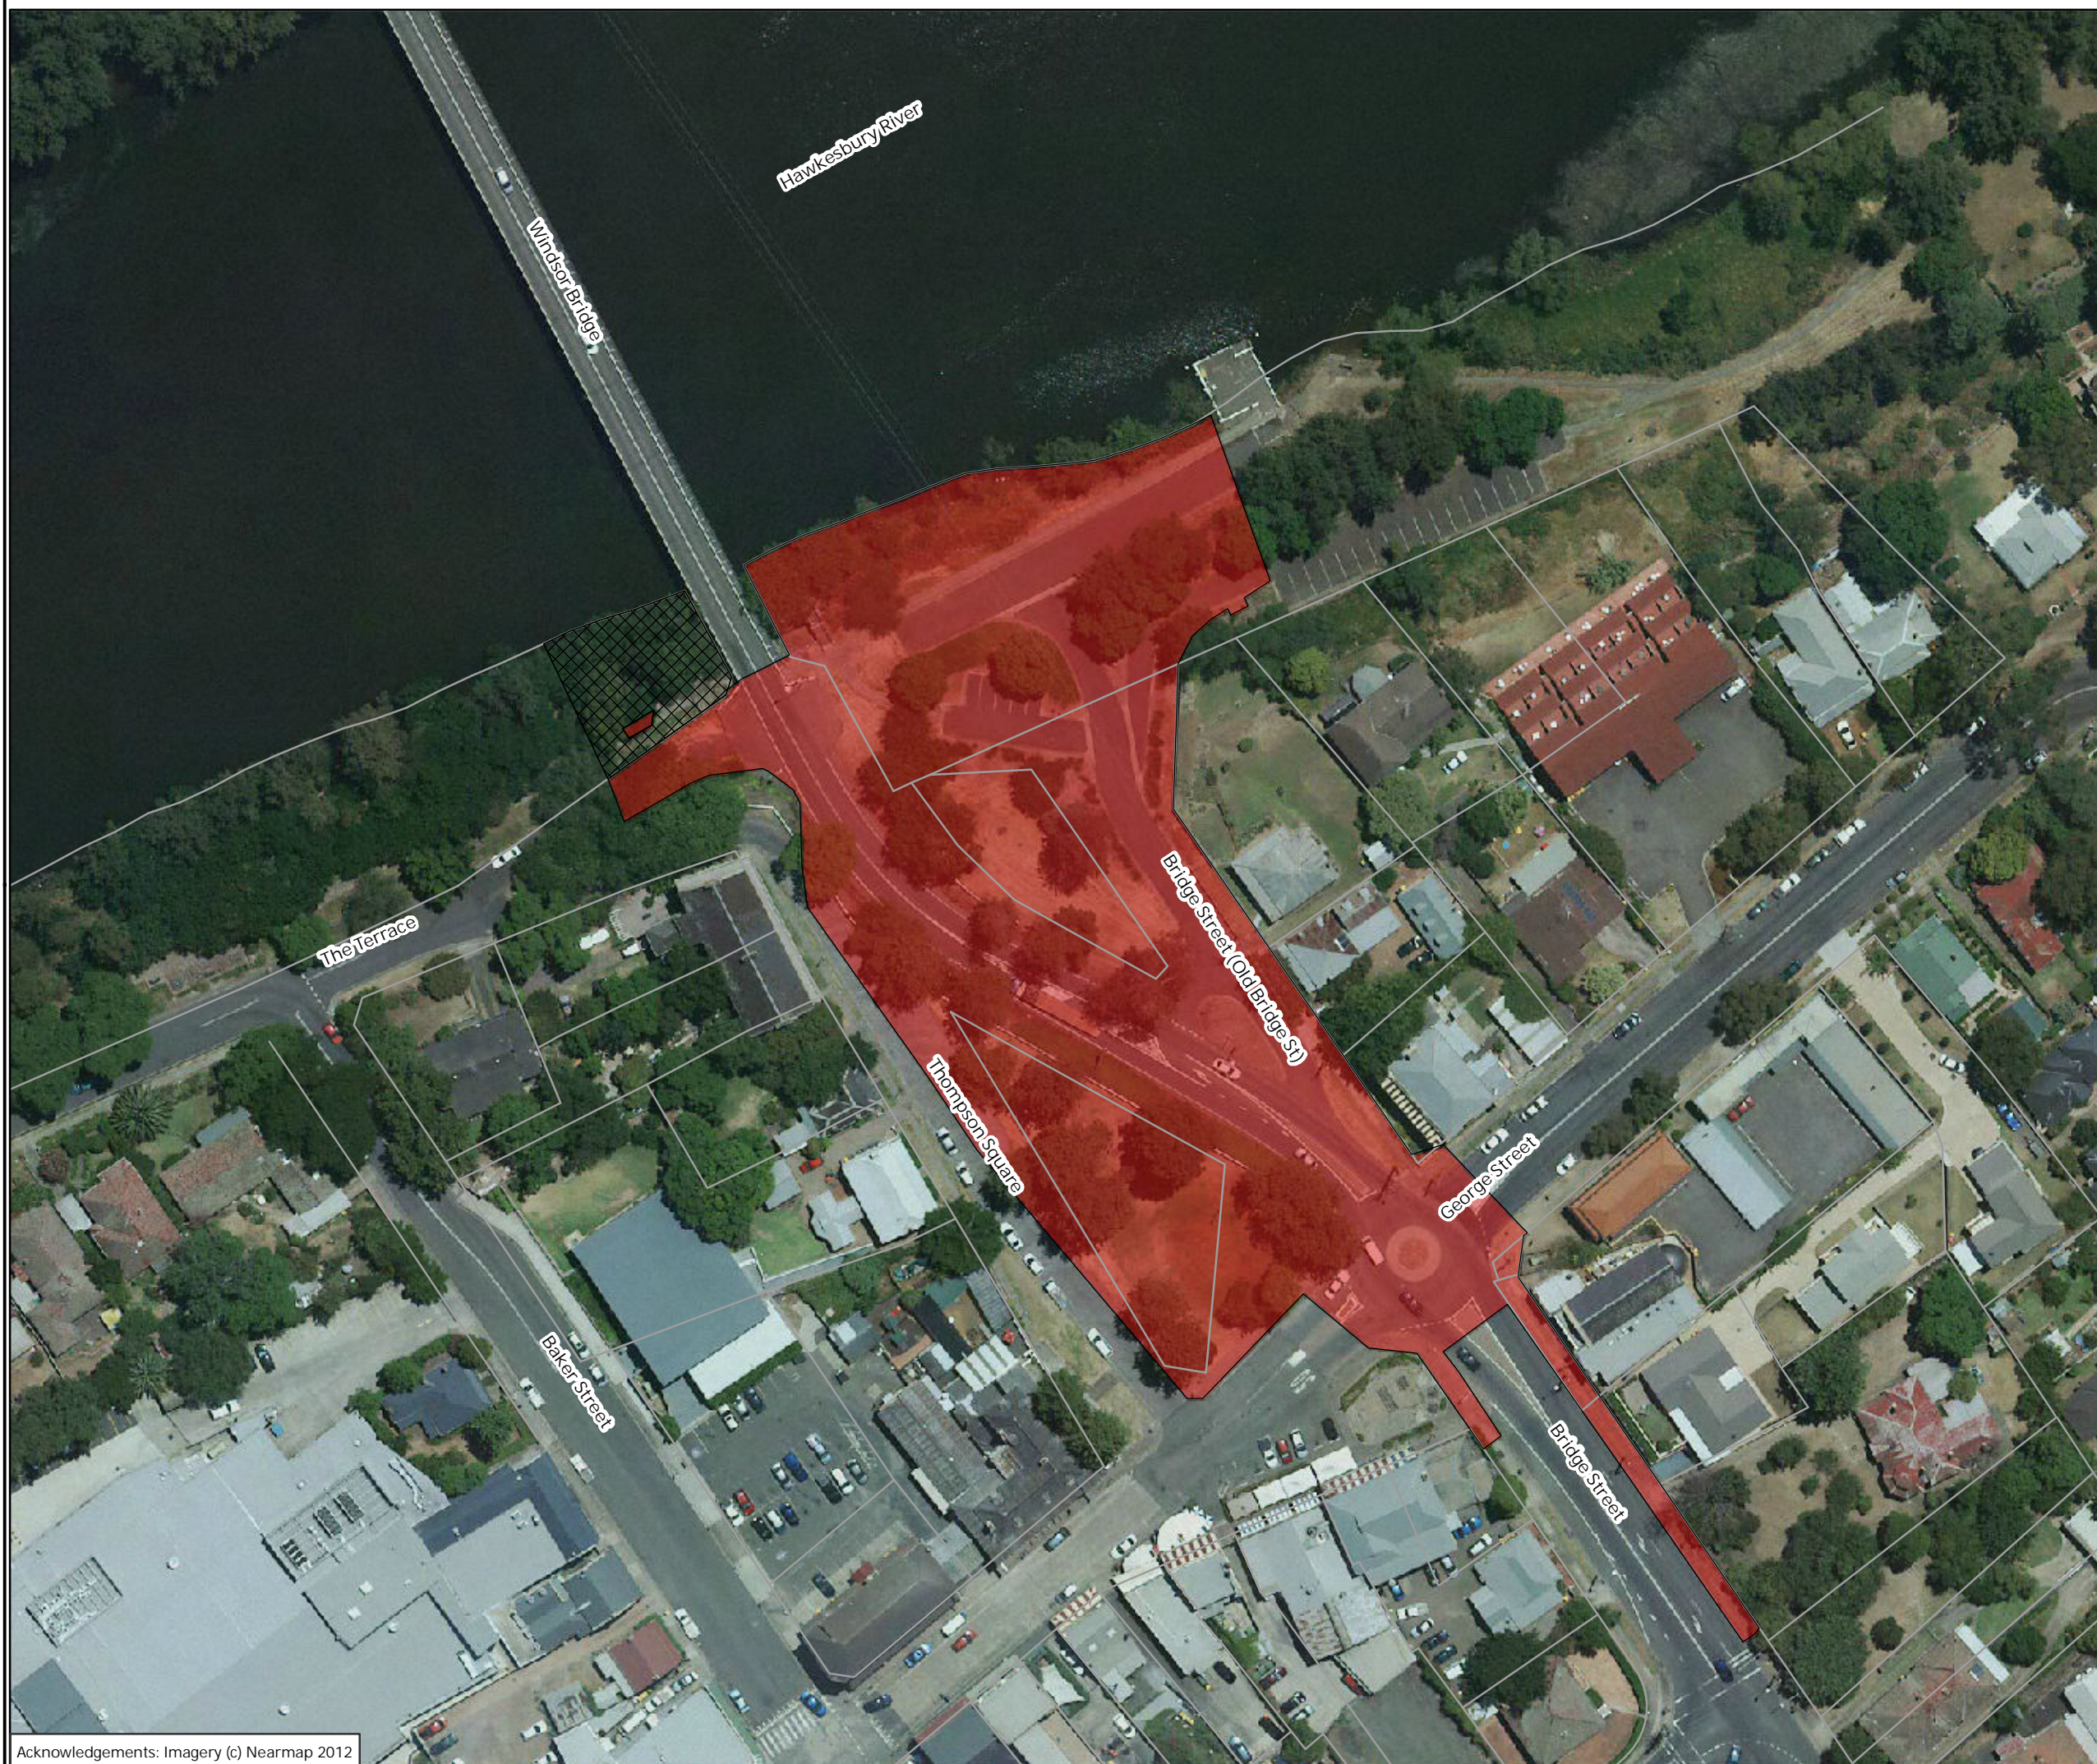
- Area of archaeological excavation
- Subject to further discussion to include in archaeological excavation

Figure 4: Option 3 - Boundary of the comprehensive salvage excavation

| Figure 4: Option 3 - Salvage excavation of the entirety of Thompson Square parkland and roads..... | 36 |
