Construction Monitoring Report 5 – September 2020 to February 2021

SMCSWSSJ-JHL-WSS-EM-REP-000009

Document Details	
Title	Construction Monitoring Report 05
Client	Sydney Metro City & Southwest
Client reference no.	
JHLOR JV contract no.	K44

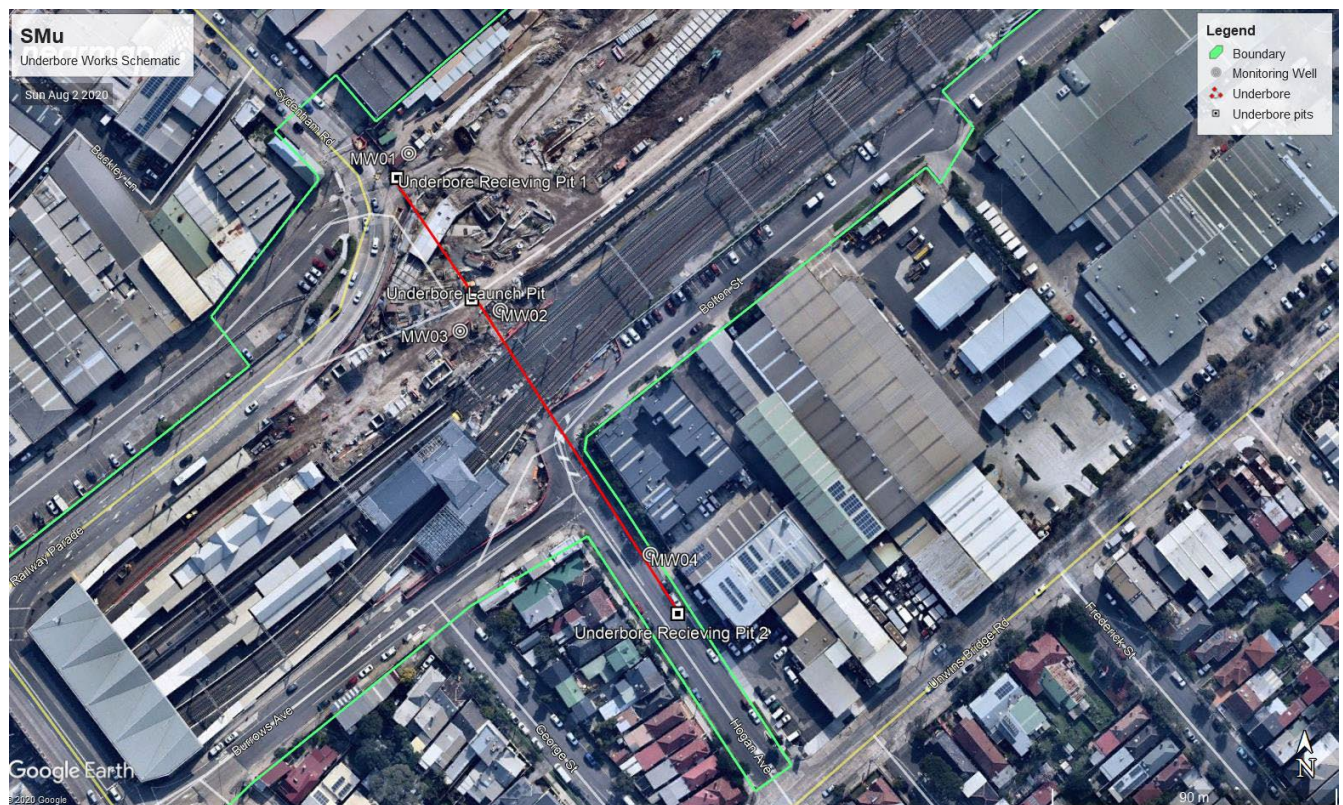
As part of an update to the SMu Construction Soil and Water Management Plan and Groundwater ERAP in the Construction Environmental Management Plan, the requirement to conduct limited groundwater monitoring was added specifically for limited interaction with groundwater during underbore works for a 132kv Ausgrid reroute. The underbore included excavations to approximately 6m bgl. Previous geotechnical investigations had indicated that groundwater was observed within the underbore location at 5.4m bgl. The works involved the excavation of two adjacent central launch pits within the existing construction site at 11 Sydenham rd Marrickville, one receiving pit located on Hogan Avenue and one receiving pit located adjacent to Sydenham Road. A schematic of the works can be seen in Figure 1.

Figure 1 – Underbore excavations and monitoring well locations

Initial investigations found that the underbore will extend into clayey sediment above the Ashfield Shale aquitard. Water was observed within the clay at depth of approximately 5.4mbgl. This clayey sediment is not an aquifer but a water bearing zone with low transmissivity. Groundwater in the perched water-bearing zone is unconfined and varies in depth across the Site from 2 to almost 6 meters BGL. Groundwater in the perched zone is generally trapped in the clayey sediments above the shales which are encountered at a depth of about 9 meters BGL (RL of -4m to -5m AHD) on site at locations.

ADE undertook analysis of groundwater samples taken from the wells on site for a wide range of Contaminants of Potential Concern (CoPC). Groundwater quality testing indicated that elevated levels of ammonia, cyanide, copper and zinc were present. Initial testing at MW02, within the 11 Sydenham rd site (see figure 1), indicated an elevated level of total cyanide. Additional testing was undertaken to confirm the result and to test for a specific compound within the cyanide group, cyanogen chloride, as this related to the Groundwater Investigation levels under the National Environmental Protection (Assessment of Site Contamination) Measure. Secondary testing confirmed the presence of cyanide (total cyanide was 40 µg/L). Cyanogen Chloride was detected at low levels below the Human Health criteria (>0.004mg/L). Due to the industrial nature of land use in Marrickville and Sydenham areas, land and groundwater contamination is known to have occurred over the wider area, consist with results. The project monitored for levels of total cyanide and cyanogen chloride during interaction with groundwater during these underbore works. The methodology and results are included in Section 2.2 and 3.2.

Based on the groundwater results from the preliminary monitoring well MW02 (see section 1.3), it was agreed JHLOR will monitor water within the launch pit locations (see figure 1) for total cyanide on a fortnightly basis and after rainfall of greater than 3mm in 24 hours. The monitoring would test for levels of total Cyanide and Cyanogen Chlorine as contaminants of concern to confirm levels found occurring within the works area. Noting that groundwater levels can fluctuate within the area, sampling will only be undertaken where access to water

Groundwater samples were taken during 8 monitoring events between 21st October and 10th December 2020; from the first round of sampling began following the excavation of first underbore launch pit until the backfill of these excavations. The samples were taken from the launch pit of Underbore 1 and 2, which are approximately in the same location as MW2 (see figure 1). A total of 10 water samples were taken, 7 samples from Underbore 1 and 3 samples from Underbore 2 – see results in table 4.

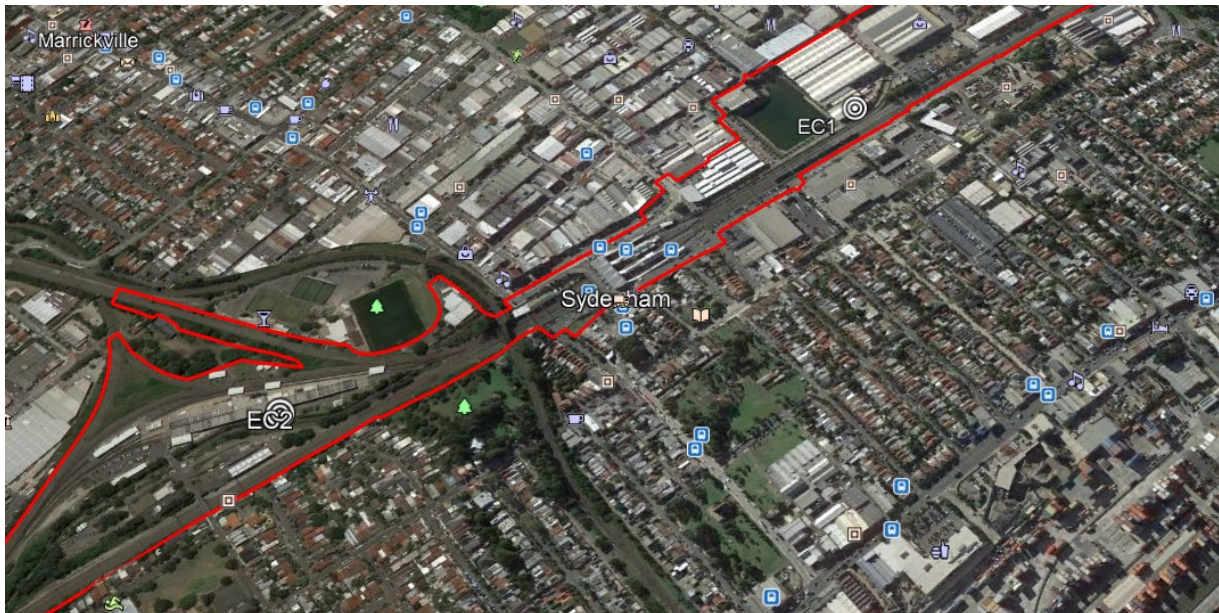
Surface water monitoring is undertaken at two points, one upstream (EC1) and one downstream (EC 2) of the construction footprint. Both are located in the man-made eastern channel running alongside the rail corridor – See Figure 2. The channel is covered for the majority of its length along the east-side of the project following the completion of the new aqueduct across Sydenham pit. The canal remains uncovered west of Sydenham station. The water level in the channel is generally fairly shallow outside of significant rain events (less than 20mm), with limited vegetation. Water sources are diverse urban run-off from collected stormwater.

The two locations identified for surface water monitoring are the only locations that offer safe access. There are several other drainage outlets along the length of the Eastern Channel that may convey water into the channel between the upstream and downstream monitoring locations, however gaining access to the channel at these points is not possible due to obstructions and safety reasons.

Figure 1 - Surface Water Monitoring Locations

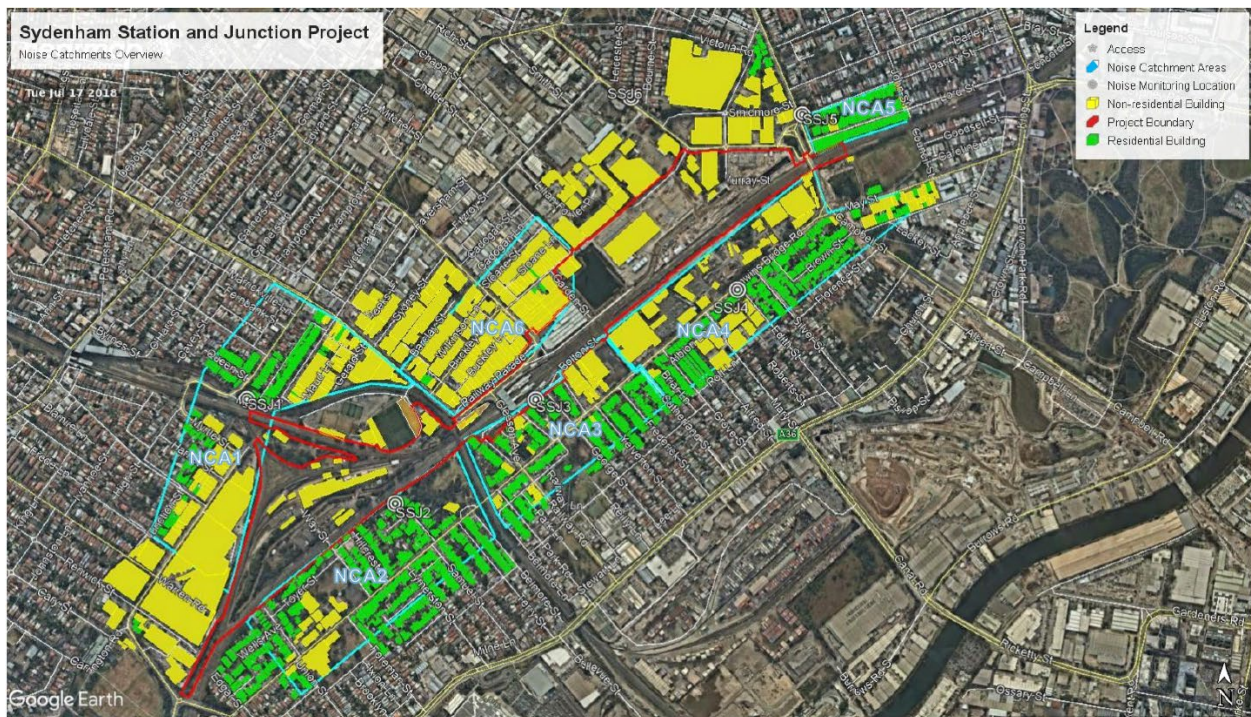
Based on planned work in the construction phase, the areas most regularly impacted by construction noise and vibration are expected to be NCA1 and NCA3. These two catchments contain a number of residential properties – See Figure 3 below.

Figure 2 - NCAs and identified residential and non-residential receivers
