# Beaches Link and Gore Hill Freeway Connection

Beaches Link and Gore Hill Freeway Connection  
Technical working paper: Contamination

December 2020

*Jacobs Group (Australia) Pty Ltd*

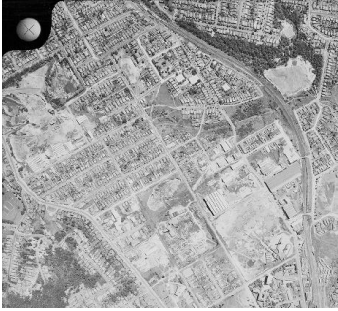
<p>The Gore Hill Freeway Connection surface work site is located within an area comprising residential and commercial developments, open space and a quarry.</p>	<p>The surrounding area comprises established low density residential with increased commercial/industrial use to the south. Main visible industry comprises quarries and brick work.</p>
1961	No image available		
1970	No image available		
1975

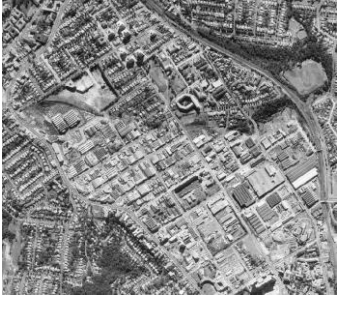
<p>Quarry identified with the north-western corner of the Gore Hill Freeway Connection surface work site in the 1955 imagery has been filled/developed for commercial/industrial. Increased commercial/industrial development has occurred.</p>	<p>Increased commercial/industrial land use is present to the south of the Gore Hill Freeway Connection surface work.</p>
1983/84

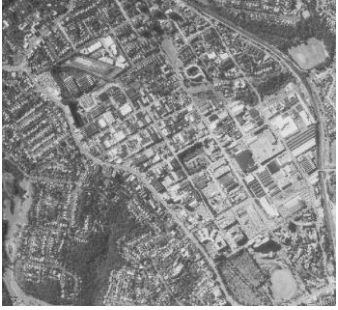
<p>Further commercial/industrial development has occurred in the north-western corner of the Gore Hill Freeway Connection surface work. Other areas are generally unchanged from the 1975 imagery.</p>	<p>Surrounding area is generally unchanged from the 1975 imagery.</p>

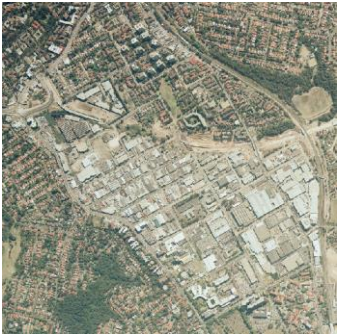
<p>The majority of the Gore Hill Freeway Connection surface work site is highly modified associated with the construction of the Gore Hill Freeway.</p>	<p>Surrounding area is generally unchanged from the 1986 imagery with the exception of the demolition of residential and commercial premises and clearing of areas of bushland to assist construction of the Gore Hill Freeway Connection.</p>
1994	No image available		
1998

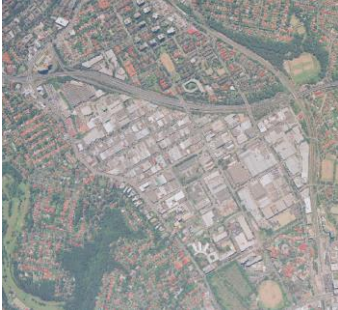
<p>The majority of the Gore Hill Freeway Connection surface work site is occupied by the Gore Hill Freeway. Areas to the north of the freeway are generally residential and to the south commercial/industrial.</p>	<p>Surrounding area is generally unchanged from the 1991 imagery.</p>
2002

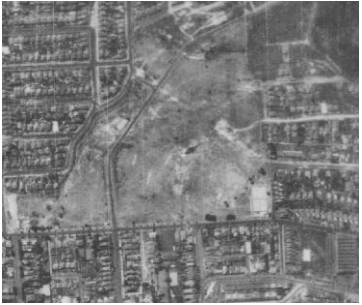
<p>Cammeray Golf Course (BL1) appears to be a vacant parcel of land (golf course and associated facilities not yet constructed). The Warringah Freeway has not been constructed. Possible tennis courts present within the south-eastern corner of the site.</p>	<p>The surrounding area comprises established low density residential. Residential dwellings are present within the current footprint of the Warringah Freeway.</p>
1955	<p>Not visible</p>		
1961

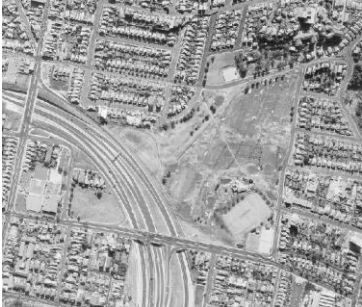
<p>The majority of Cammeray Golf Course (BL1) is occupied by the Cammeray golf course. The Warringah Freeway is constructed/being constructed in areas to the south-west of the site.</p>	<p>The surrounding area comprises established low density residential. Some areas of open space and residential land use identified in the 1961 imagery have been resumed by the construction of the Warringah Freeway.</p>

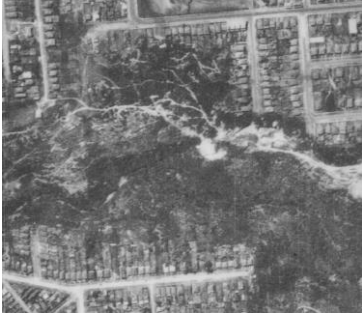
<p>Flat Rock Drive (BL2) is occupied by vacant land (bushland) next to a creek.</p>	<p>Area is predominantly established low density residential. Halstrom Park, Willoughby Leisure Centre and Bicentennial Reserve are occupied vacant bushland next to a creek. A potential industrial facility is located on the corner of Willoughby and Artarmon Roads. A large cleared area is located to the south of Artarmon Road (current location of Channel 9 studios). The Warringah Freeway and Flat Rock Drive have not been constructed.</p>
1955

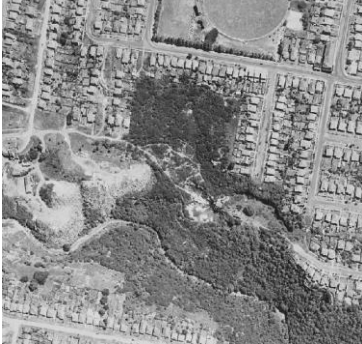
<p>Flat Rock Drive (BL2) is generally unchanged from the 1930 imagery. Infilling of Flat Rock Drive (BL2) has started. The incinerator building is visible along the northern boundary of the site.</p>	<p>Area is predominantly established low density residential. Infilling of Halstrom Park, Willoughby Leisure Centre and Bicentennial Reserve has commenced. The incinerator building is visible along Small Street. An area of industrial premises is located on the corner of Willoughby and Artarmon Roads. A large cleared area is located to the south of Artarmon Road (current location of Channel 9 studios). The Warringah Freeway and Flat Rock Drive have not been constructed.</p>

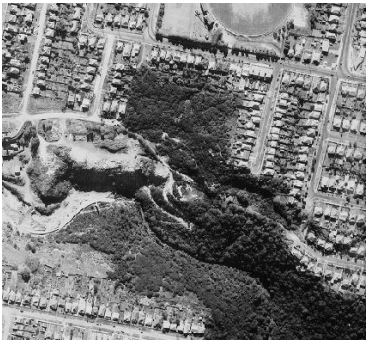
<p>Flat Rock Drive (BL2) is generally unchanged from the 1955 imagery. Infilling activities encroaching on the western boundary of BL2.</p> <p>Infilling of Flat Rock Drive (BL2) has started. The incinerator building is visible along the northern boundary of the site.</p>	<p>Area is predominantly established low density residential. Infilling of Willoughby Leisure Centre and Bicentennial Reserve continues. Incinerator still visible. Halstrom Park appears to be a rectangular sports field. A stack is visible in the south-eastern corner of the infilling operations. An area of industrial premises is located on the corner of Willoughby and Artarmon Roads. Channel 9 studios have been constructed. The Warringah Freeway and Flat Rock Drive have not been constructed.</p>
1970

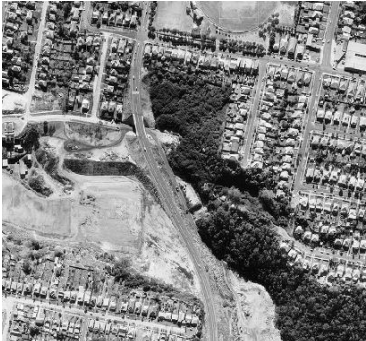
<p>BL2 has been subject to ground disturbance likely to have been associated with the construction of Flat Rock Drive.</p>	<p>Surrounding area is generally unchanged from the 1961 imagery with the exception of continued infilling to the east of the site extending to Tunks Park.</p> <p>Infilling of Willoughby Leisure Centre and Bicentennial Reserve. Incinerator still visible. Flat Rock Drive has been constructed. The stack identified in the 1961 imagery within the south-eastern corner has been demolished.</p>

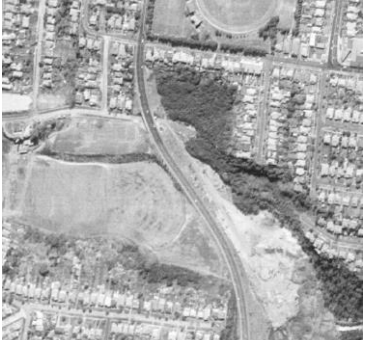
1975

<p>BL2 has been subject to continued ground disturbance (potentially large scale filling and removal of bushland).</p>	<p>Surrounding area is generally unchanged from the 1970 imagery with the exception of the demolition of the industrial facility located on the corner of Willoughby and Artarmon Roads. The TV transmitter tower on the Channel 9 site is visible.</p>

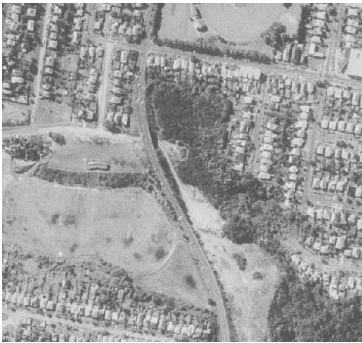
Date of aerial photography		Site	Surrounding area
1983/84

<p>Ground disturbance at BL2 appears to have been completed.</p> <p>Flat Rock Drive (BL2) is generally unchanged from the 1975 imagery with the exception of some ancillary buildings next to the incinerator that have been demolished. Carpark and building constructed within the northern portion of the site.</p>	<p>Surrounding area is generally unchanged from the 1975 imagery with the exception of the construction of medium to high density residential buildings on the corner of Willoughby and Artarmon roads. Some ancillary buildings next to the incinerator have been demolished. A carpark and building have been constructed within the footprint of the Willoughby Leisure Centre site.</p>
1986

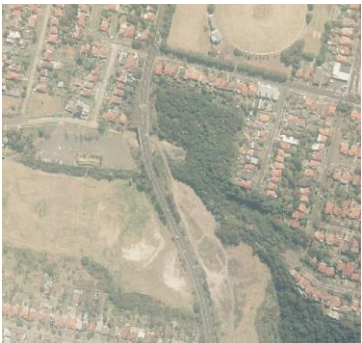
<p>Flat Rock Drive (BL2) is generally unchanged from the 1983/84 imagery.</p>	<p>Surrounding area is generally unchanged from the 1983/84 imagery.</p>

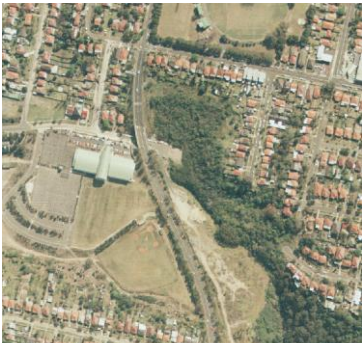
1991

<p>A carpark has been constructed within the northern portion of Flat Rock Drive (BL2). Remainder of BL2 is generally unchanged from the 1986 imagery.</p>	<p>Surrounding area is generally unchanged from the 1986 imagery with the exception of ongoing substantial changes including new sporting fields, sealed netball courts, baseball diamond, aquatic centre and car parking for the Willoughby Leisure Centre and Bicentennial Reserve. Incinerator building is still present to the west of the Willoughby Leisure Centre.</p> <p>The Gore Hill Freeway has been constructed to the south-west of the site.</p>

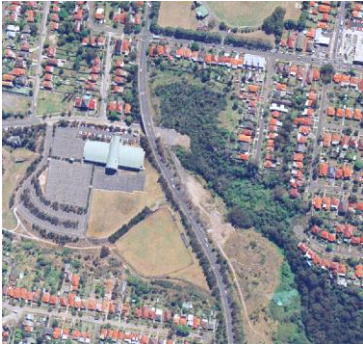
Date of aerial photography		Site	Surrounding area
1994

<p>Flat Rock Drive (BL2) is generally unchanged from the 1991 imagery.</p>	<p>Surrounding area is generally unchanged from the 1991 imagery with the exception of the Gore Hill Freeway located to the south-west of the site.</p>
1998

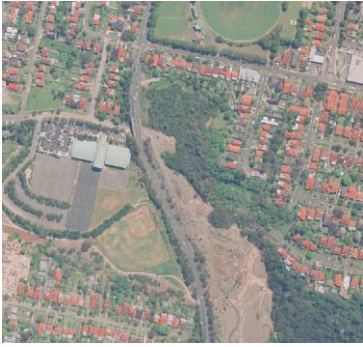
<p>Flat Rock Drive (BL2) is generally unchanged from the 1994 imagery with the exception of minor disturbance works across the majority of the site (potential construction of Flat Rock Gully Reserve).</p>	<p>Surrounding area is generally unchanged from the 1994 imagery with the exception of development (possibly residential) to the south of the site. Additional netball courts have been constructed to the south of the Willoughby Centre.</p>
2002

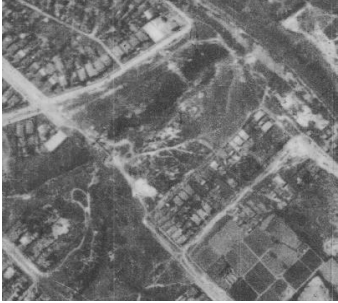
Date of aerial photography		Site	Surrounding area
1930

<p>Punch Street (BL3) appears to be a vacant parcel of land next to a creek. Low density residential premises are located across Punch Street (to the south-east). A bridge structure is observable to the west of the site. Access tracks are visible across the site.</p>	<p>The surrounding area comprises established low density residential to the north of the railway line) with increased commercial/industrial use to the south of the railway line. Main visible industry comprises quarries, brick work and market gardens.</p>
1955

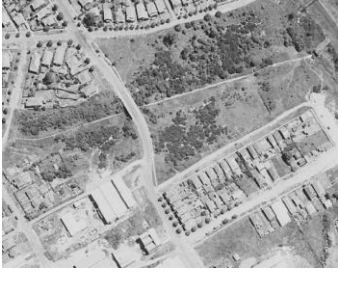
<p>Punch Street (BL3) remains a vacant parcel of land. The nearby creek has been realigned. Low density residential premises are located across Punch Street (to the south-east). The Hampden Road/Herbert Street bridge has been constructed.</p>	<p>The surrounding area comprises established low density residential to the north of the railway line) with increased commercial/industrial use to the south of the railway line. Main visible industry comprises quarries and brick work. Artarmon Reserve has been formalised as open space.</p>

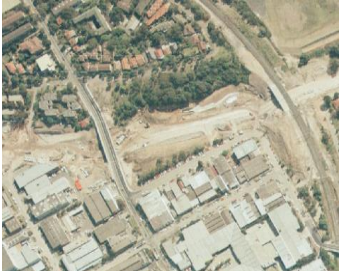
<p>Punch Street (BL3) is highly modified associated with the construction of the Gore Hill Freeway.</p>	<p>Surrounding area is generally unchanged from the 1986 imagery with the exception of demolition of residential and commercial premises and clearing of areas of bushland to assist construction of the Gore Hill Freeway.</p>
1994

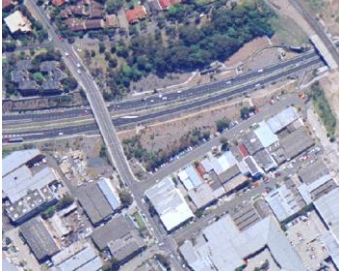
<p>Punch Street (BL3) is a vacant portion of land next to the constructed and operational Gore Hill Freeway.</p>	<p>Surrounding area is generally unchanged from the 1991 imagery with the exception of the presence of the Gore Hill Freeway.</p>

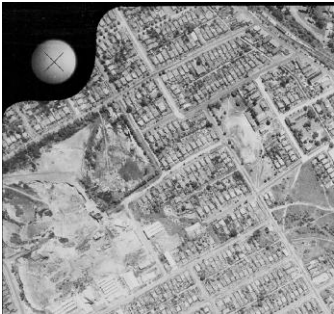
Date of aerial photography		Site	Surrounding area
1930	No image available		
1955

<p>Gore Hill Freeway median (BL6) is located within a quarry. Dickson Avenue (BL4) and Barton Road (BL5) are located on sites occupied by residential buildings.</p>	<p>The surrounding area comprises established low density residential with increased commercial/industrial use to the south. Main visible industry comprises quarries and brick work.</p>
1961	No image available		
1970	No image available		
1975

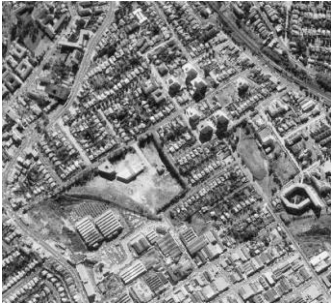
<p>Quarry identified at Gore Hill Freeway median (BL6) in the 1955 imagery has been filled/developed for commercial/industrial. Barton Road (BL5) appears to be occupied by residential buildings. Dickson Avenue (BL4) appears to be occupied by commercial/industrial operations (small workshops).</p>	<p>Increased commercial/industrial land use is present to the south of the sites.</p>
1983/84

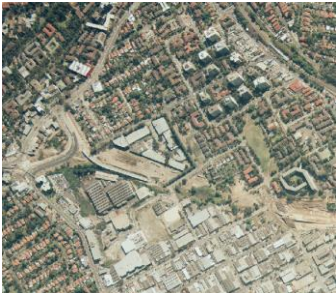
Date of aerial photography		Site	Surrounding area
1991

<p>Barton Road (BL5) and Gore Hill Freeway median (BL6) are highly modified associated with the construction of the Gore Hill Freeway. Both sites appear to be within the construction footprint of the freeway. Dickson Avenue (BL4) is generally unchanged from the 1986 imagery.</p>	<p>Surrounding area is generally unchanged from the 1986 imagery with the exception of the demolition of residential and commercial premises and clearing of areas of bushland to assist construction of the Gore Hill Freeway.</p>
1994	No image available		
1998

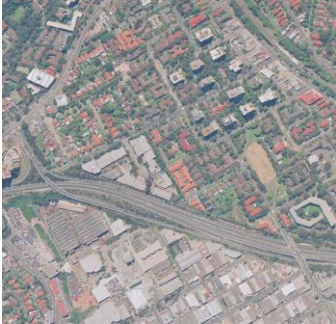
<p>Gore Hill Freeway median (BL6) is part of the Gore Hill Freeway footprint. Barton Road (BL5) appears to be a vacant parcel of land between residential buildings and the freeway. Dickson Avenue (BL4) is generally unchanged from the 1991 imagery.</p>	<p>Surrounding area is generally unchanged from the 1991 imagery.</p>

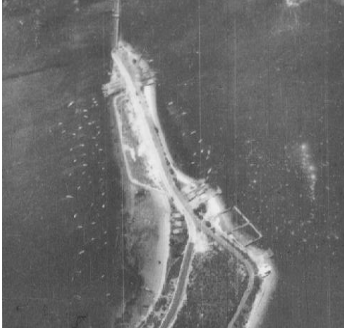
Date of aerial photography		Site	Surrounding area
1930

<p>Spit West Reserve (BL9) is occupied by possible area of land reclamation on the southern side of the Spit bridge and to the west of Spit Road.</p>	<p>Area has generally scattered and isolated low density residential dwellings with increased low density residential dwellings to the south. The majority of the surrounding area appears to be vacant bushland. A bridge structure is present connecting the Spit to Seaforth.</p>
1955

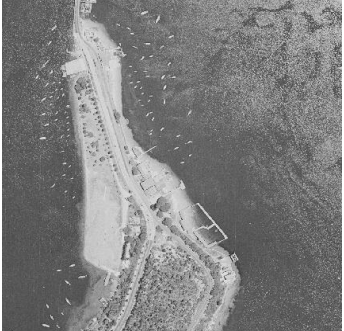
<p>Spit West Reserve (BL9) is a vacant portion of land (possible reserve). Reclamation work observed in 1930 appears to have been completed.</p>	<p>The surrounding area has established low density residential premises.</p>
1961

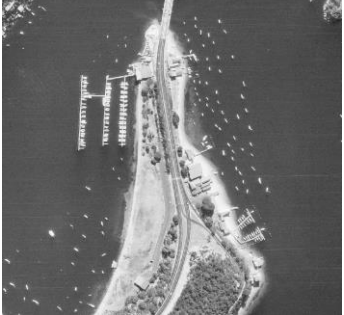
1970

<p>Spit West Reserve (BL9) is generally unchanged from the 1961 imagery with the exception of the construction of a marina to the north of the site.</p>	<p>Surrounding area is generally unchanged from the 1961 imagery with the exception of marina construction on the eastern side of the Spit.</p>

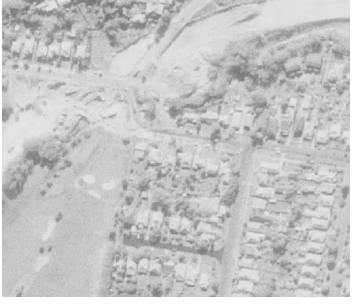
<p>Balgowlah Golf Course (BL10) has undergone substantial change associated with the construction of the Burnt Bridge Creek Deviation.</p>	<p>Surrounding area is generally unchanged from the 1975 imagery with the exception of demolition of residential premises and clearing of areas of bushland to assist construction of the Burnt Bridge Creek Deviation.</p>
1986

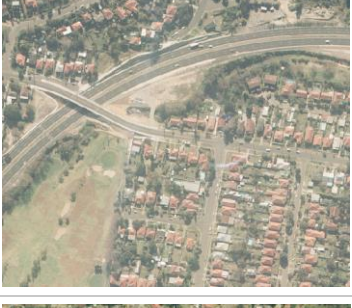
<p>Balgowlah Golf Course (BL10) is a cleared portion of land next to the Burnt Bridge Creek Deviation and the Kitchener Street overpass.</p>	<p>Surrounding area is generally unchanged from the 1983/84 imagery with the exception of construction and operation of the Burnt Bridge Creek Deviation.</p>
1991

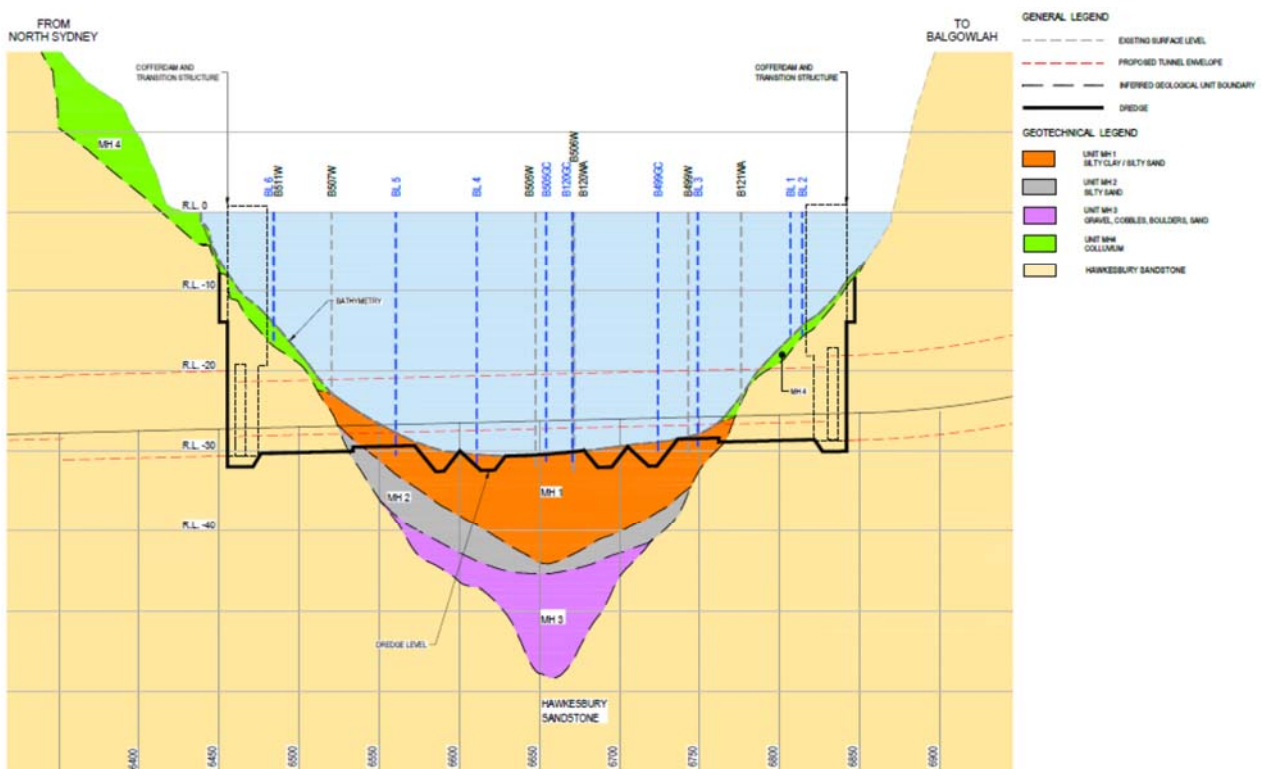
Figure 3 View looking upstream showing the main types of material to be dredged

The material that will be encountered during dredging of the crossing is shown in **Figure 3** and comprises:

- gravelly, muddy sand near the shoreline (shaded green and referenced in the legend to **Figure 3** as colluvium)
- grey green coloured muds<sup>1</sup> (shaded orange)
- sandstone (shaded grey).
