DOUGLAS PARTNERS PTY LTD
 NEW MAITLAND HOSPITAL, METFORD
 BORE 601 PROJECT 81719.01 2015

Client :	Health Infrastructure	Project No. :	81719.01
Project :	Proposed Maitland Hospital	Report No. :	N15-223_1
Location :	Metford Road, Metford	Report Date :	20.11.2015
		Date of Test:	04.11.2015
		Page:	1 of 1

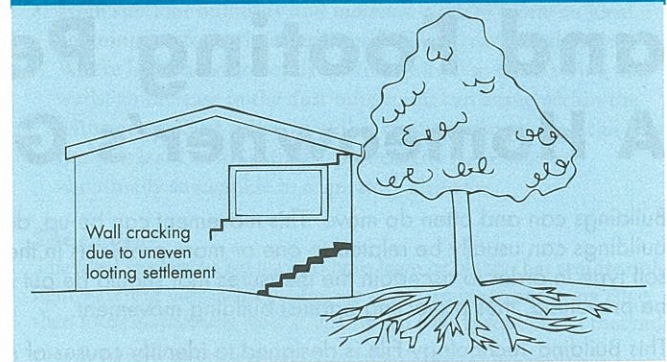
Trees can cause shrinkage and damage

As the weather pattern changes and the soil begins to dry out, the external footings will be first affected, beginning with the locations where the sun's effect is strongest. This has the effect of lowering the

external footings. The doming is accentuated and cracking reduces or disappears where it occurred because of dishing, but other cracks open up. The roof lines may become convex.

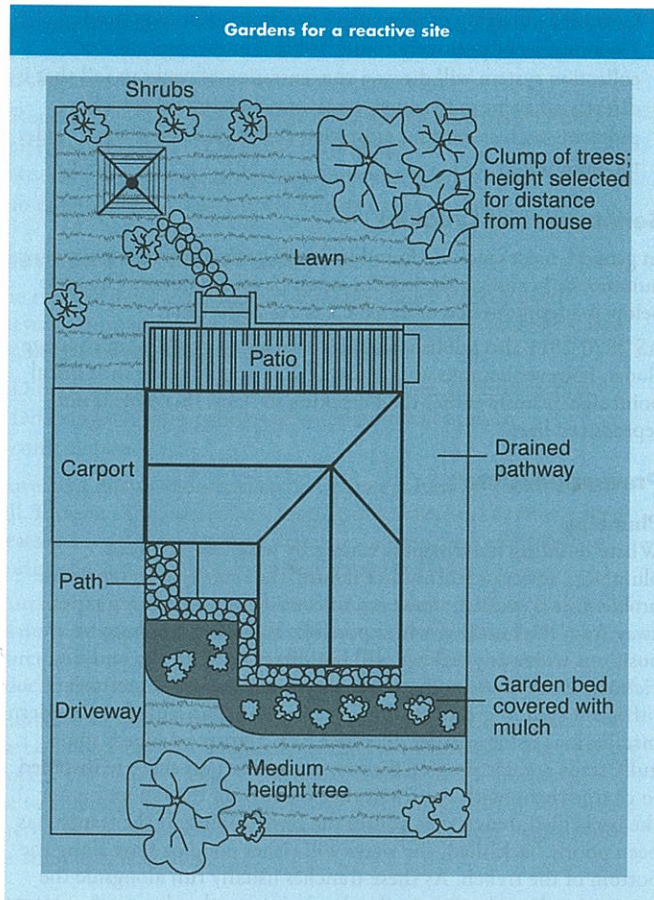
Gardens for a reactive site

For this reason, particularly where problems exist or are likely to occur, it is recommended that an apron of paving be installed around as much of the building perimeter as necessary. This paving should

extend outwards a minimum of 900 mm (more in highly reactive soil) and should have a minimum fall away from the building of 1:60. The finished paving should be no less than 100 mm below brick vent bases.

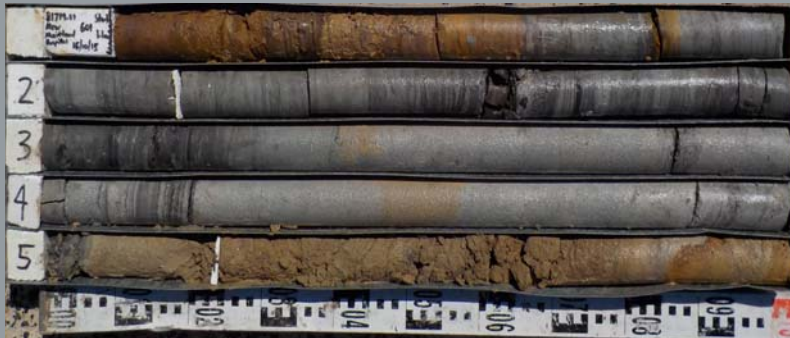
1.10 m – 6.00 m

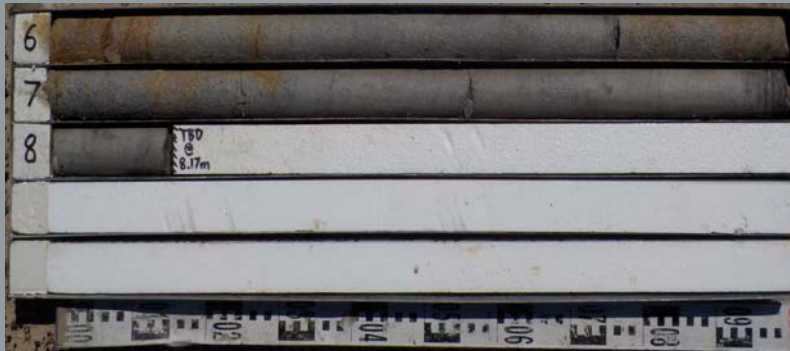
DOUGLAS PARTNERS PTY LTD
 NEW MAITLAND HOSPITAL, METFORD
 BORE 601 PROJECT 81719.01 2015

6.00 m – 8.17 m

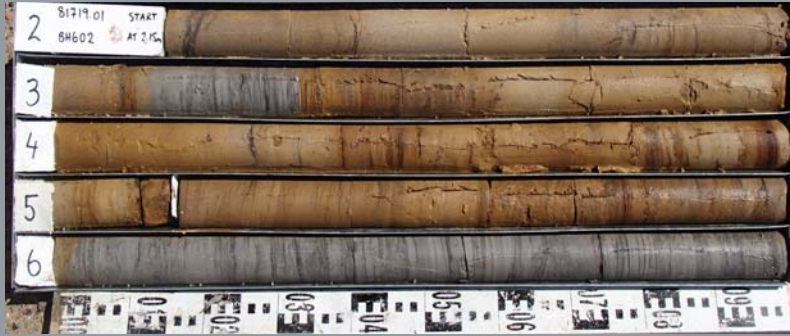
DOUGLAS PARTNERS PTY LTD
NEW MAITLAND HOSPITAL, METFORD
BORE 602 PROJECT 81719.01 2015

2.15 m – 7.00 m

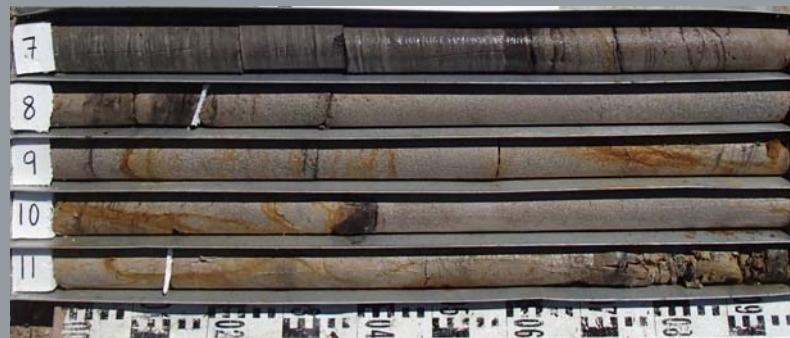
DOUGLAS PARTNERS PTY LTD
NEW MAITLAND HOSPITAL, METFORD
BORE 602 PROJECT 81719.01 2015

7.00 m – 12.00 m

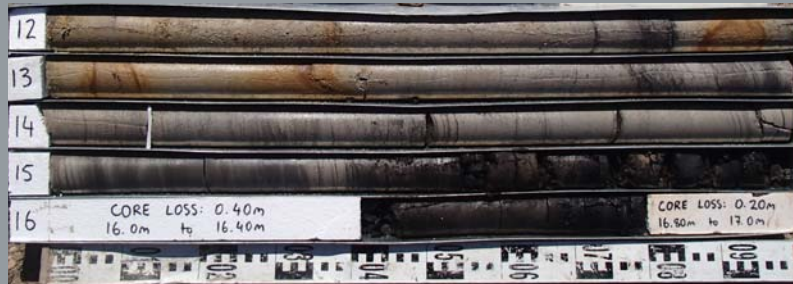
BORE 602 PROJECT 81719.01 2015

12.00 m – 17.00m

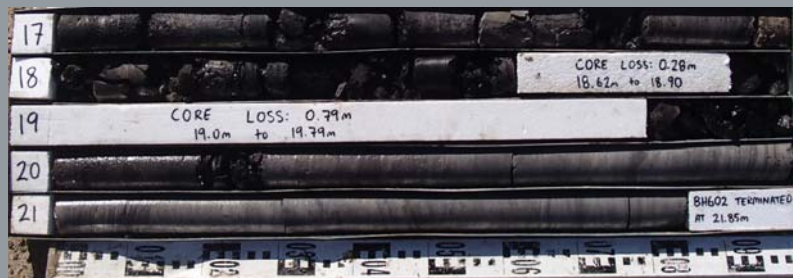
BORE 602 PROJECT 81719.01 2015

17.00 m – 21.85 m

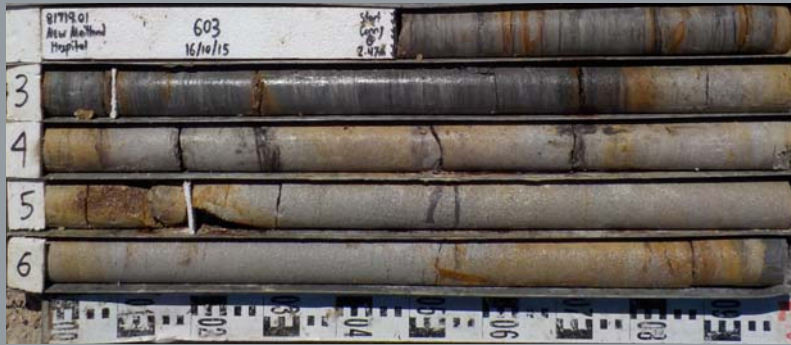
DOUGLAS PARTNERS PTY LTD
NEW MAITLAND HOSPITAL, METFORD
BORE 603 PROJECT 81719.01 2015

2.47 m – 7.00 m

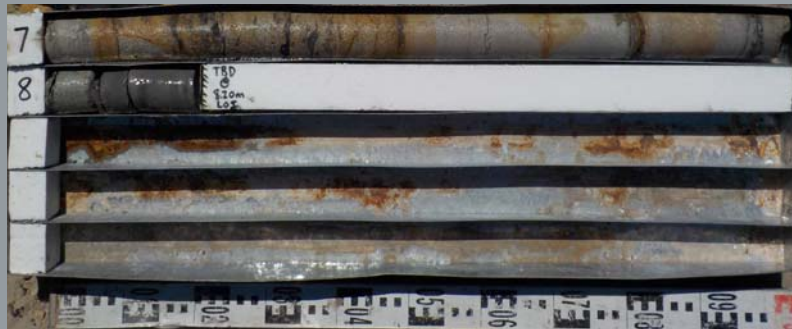
DOUGLAS PARTNERS PTY LTD
NEW MAITLAND HOSPITAL, METFORD
BORE 603 PROJECT 81719.01 2015

7.00 m – 8.20 m

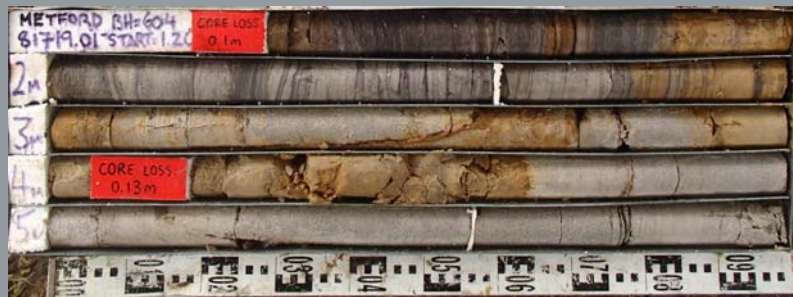
DOUGLAS PARTNERS PTY LTD
NEW MAITLAND HOSPITAL, METFORD
BORE 604 PROJECT 81719.01 2015

1.20 m – 6.00 m

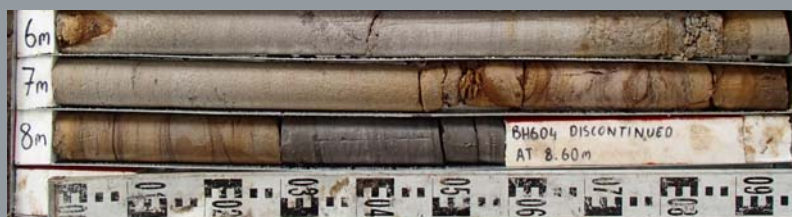
DOUGLAS PARTNERS PTY LTD
NEW MAITLAND HOSPITAL, METFORD
BORE 604 PROJECT 81719.01 2015

6.00 m – 8.60 m

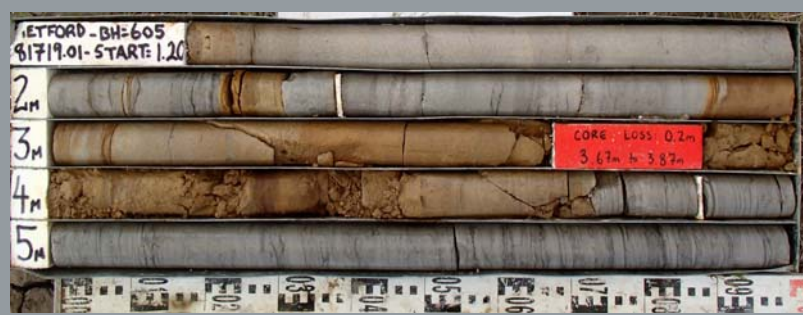
DOUGLAS PARTNERS PTY LTD
NEW MAITLAND HOSPITAL, METFORD
BORE 605 PROJECT 81719.01 2015

1.20 m – 6.00 m

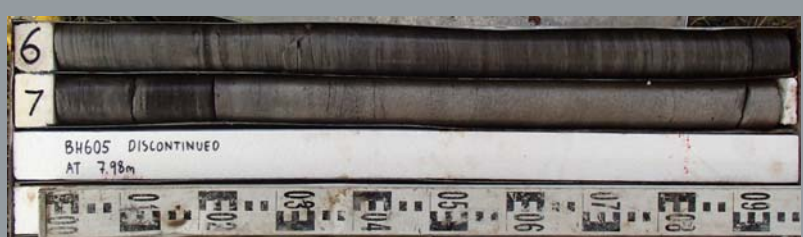
DOUGLAS PARTNERS PTY LTD
NEW MAITLAND HOSPITAL, METFORD
BORE 605 PROJECT 81719.01 2015

6.00 m – 7.98 m

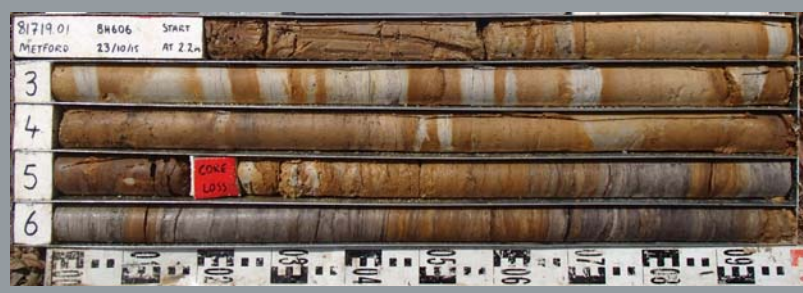
DOUGLAS PARTNERS PTY LTD
NEW MAITLAND HOSPITAL, METFORD
BORE 606 PROJECT 81719.01 2015

2.20 m – 7.00 m

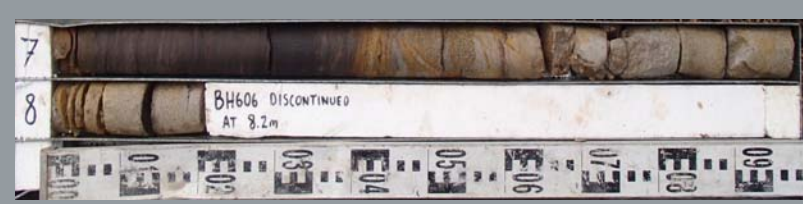
DOUGLAS PARTNERS PTY LTD
NEW MAITLAND HOSPITAL, METFORD
BORE 606 PROJECT 81719.01 2015

7.00 m – 8.20 m

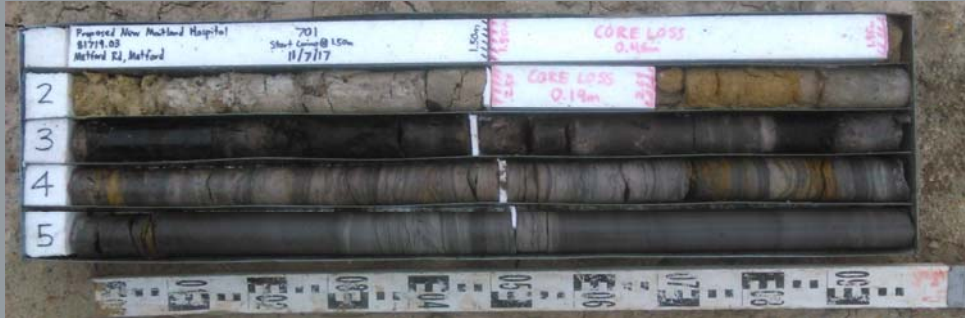
DOULGAS PARTNERS PTY LTD...
NEW MAITLAND HOSPITAL METFORD
Bore 701 PROJECT 81719.01 2017

1.50 m to 6.0 m

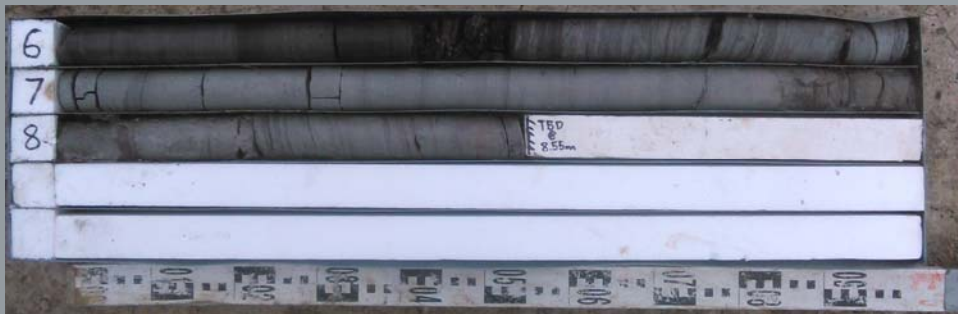
DOULGAS PARTNERS PTY LTD...
NEW MAITLAND HOSPITAL METFORD
Bore 701 PROJECT 81719.01 2017

6.0 m to 8.55 m

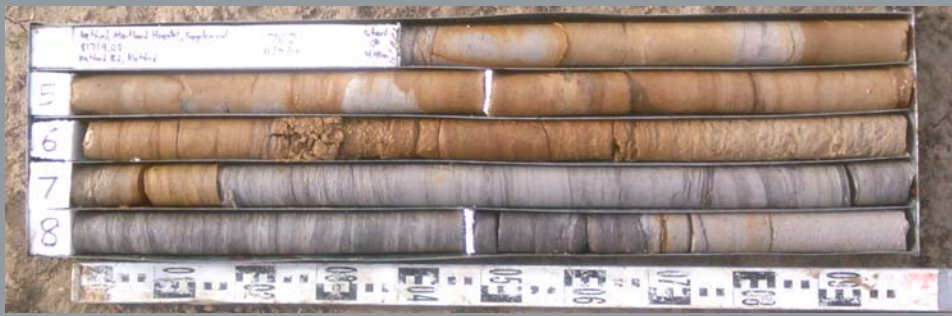
DOULGAS PARTNERS PTY LTD...
NEW MAITLAND HOSPITAL METFORD
Bore 702 PROJECT 81719.01 2017

4.40 m to 9.0 m

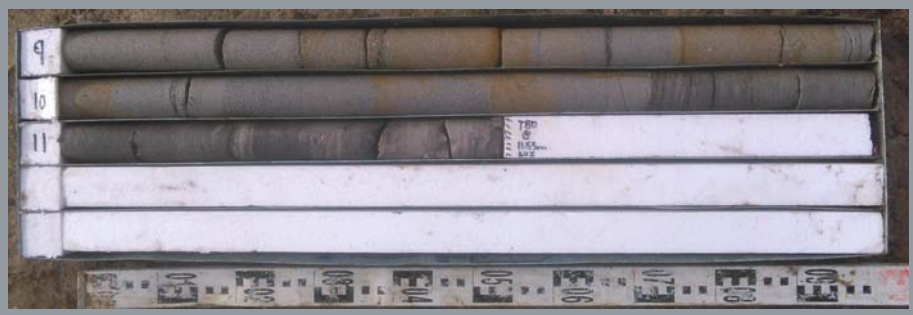
DOULGAS PARTNERS PTY LTD...
NEW MAITLAND HOSPITAL METFORD
Bore 702 PROJECT 81719.01 2017

9.0 m to 11.55 m

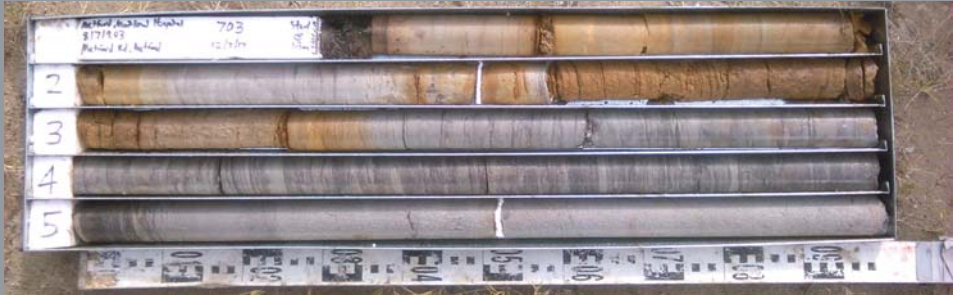
DOULGAS PARTNERS PTY LTD...
NEW MAITLAND HOSPITAL METFORD
Bore 703 PROJECT 81719.01 2017

1.30 m to 6.0 m

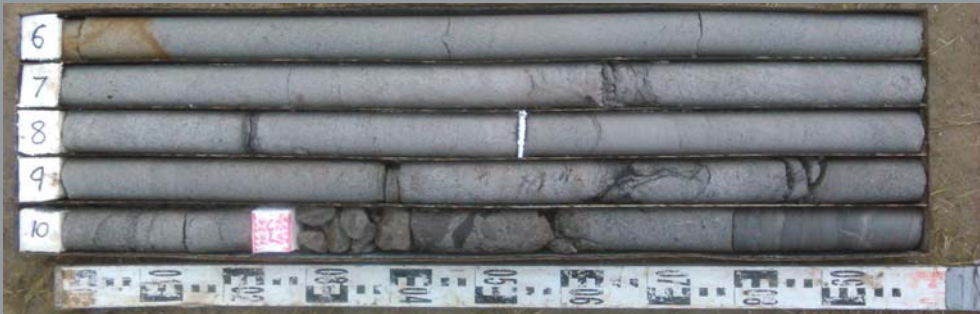
DOULGAS PARTNERS PTY LTD...
NEW MAITLAND HOSPITAL METFORD
Bore 703 PROJECT 81719.01 2017

6.0 m to 11. m

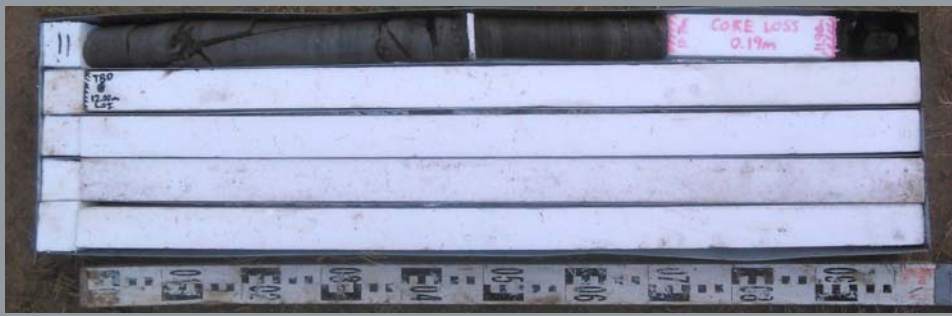
DOULGAS PARTNERS PTY LTD...
NEW MAITLAND HOSPITAL METFORD
Bore 703 PROJECT 81719.01 2017

11.0 m to 12.0 m

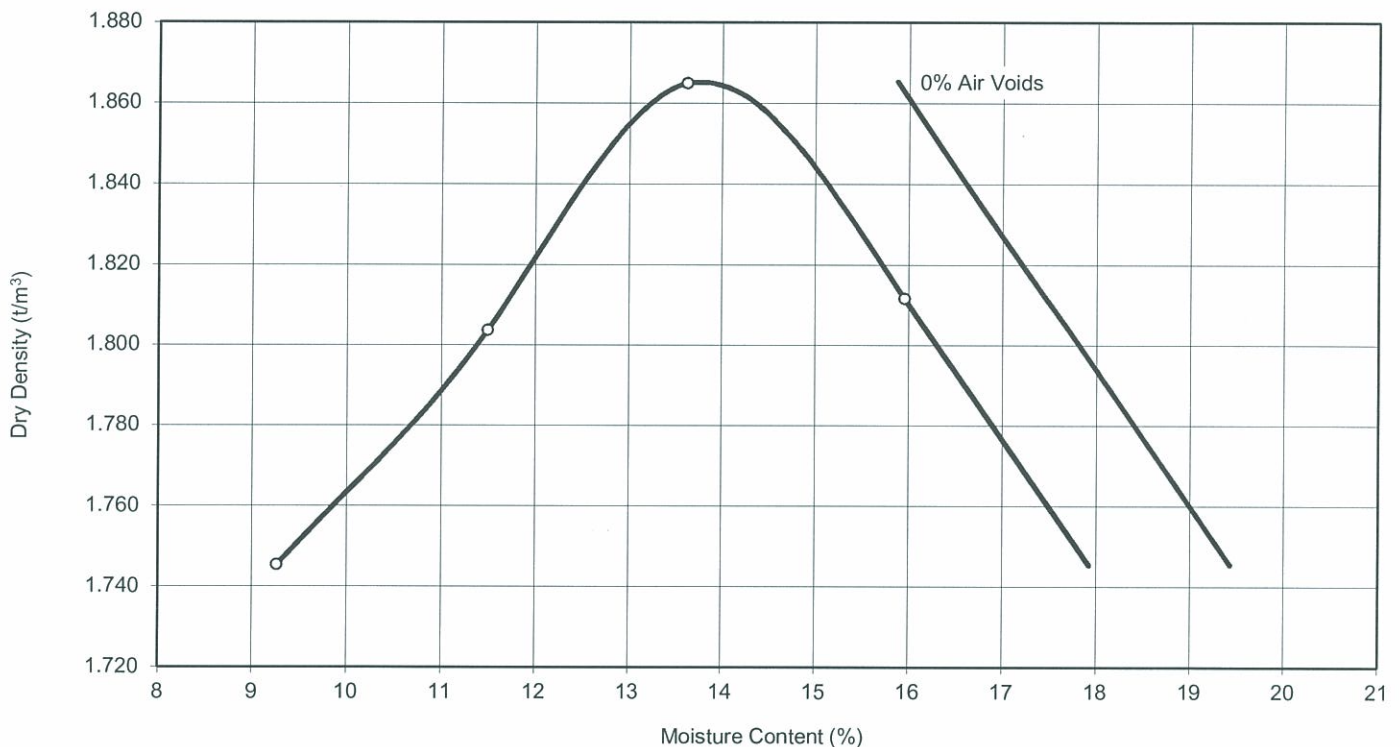
Results of Compaction Test

Sample Details: Location: 301
Depth: 1.0 - 1.3m

Particles > 19mm: 0%

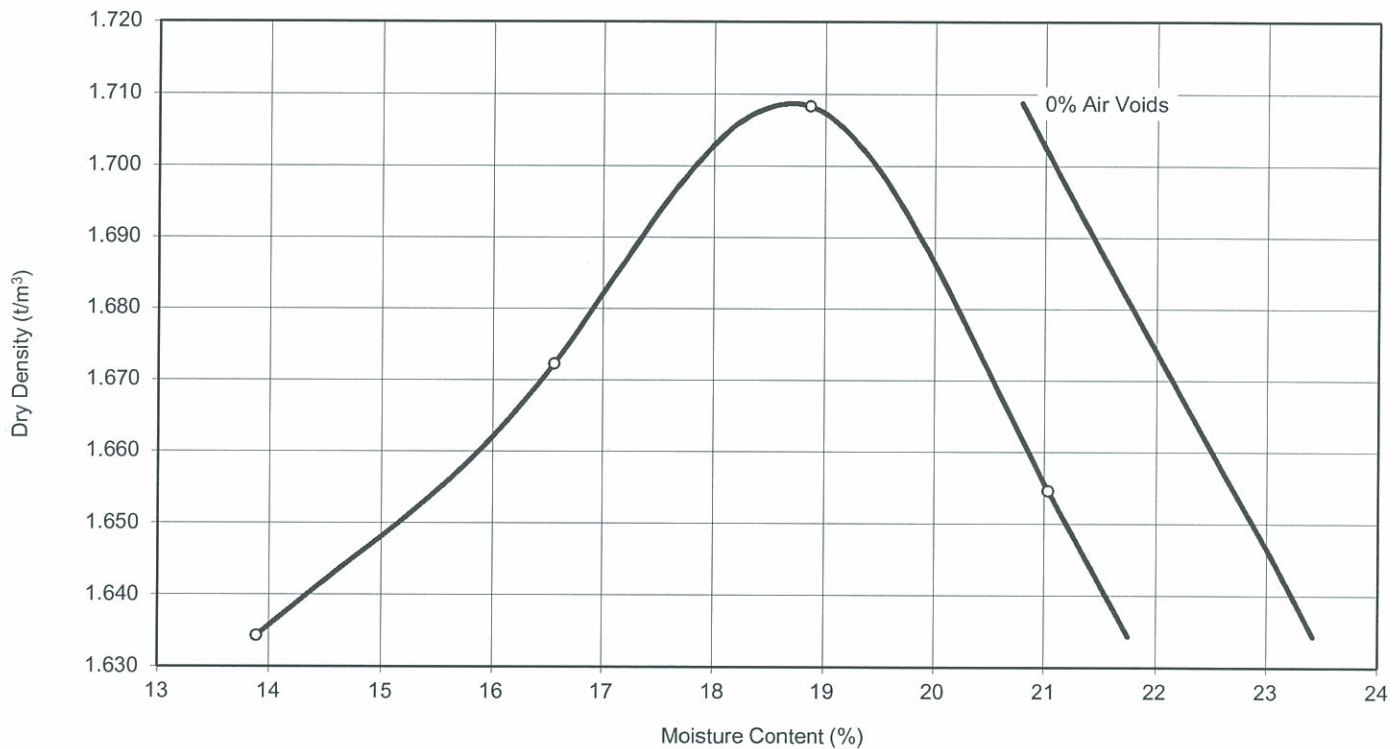
Results of Compaction Test

Sample Details: Location: 301A
Depth: 0.5 - 0.7m

Particles > 19mm: 0%

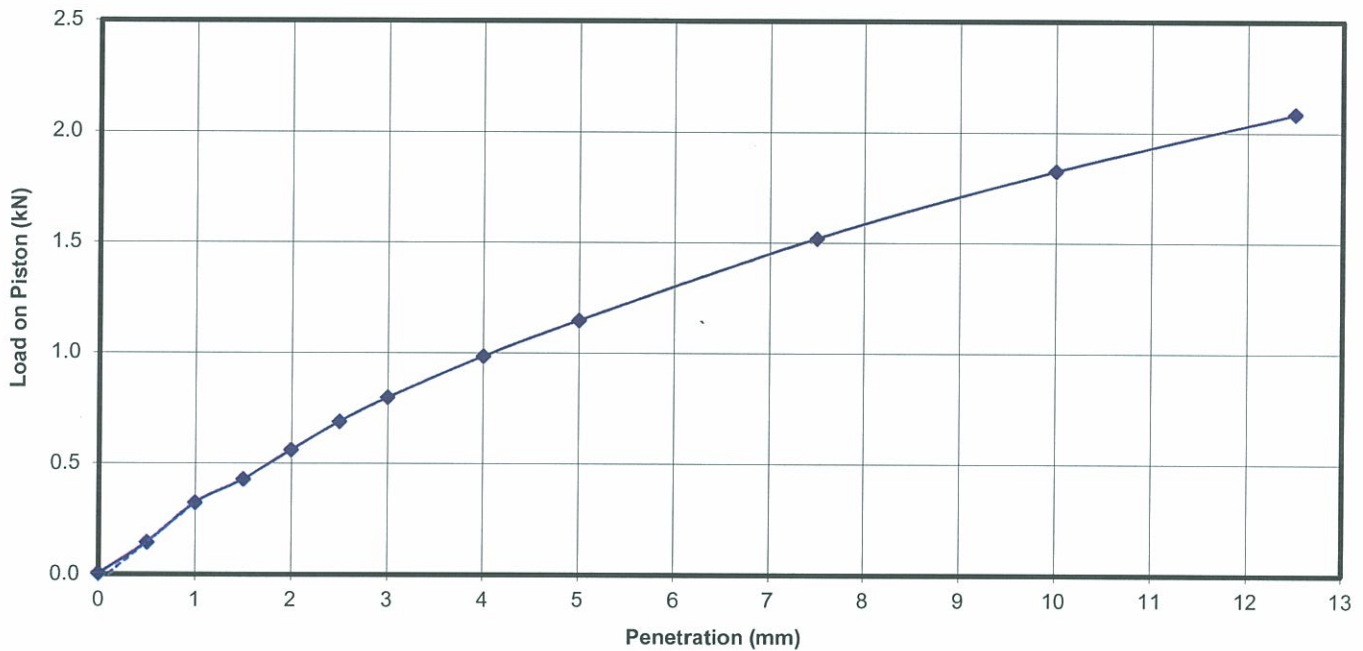
Result of California Bearing Ratio Test

Description: FILLING: Clayey SAND - Brown (Ripped Sandstone)

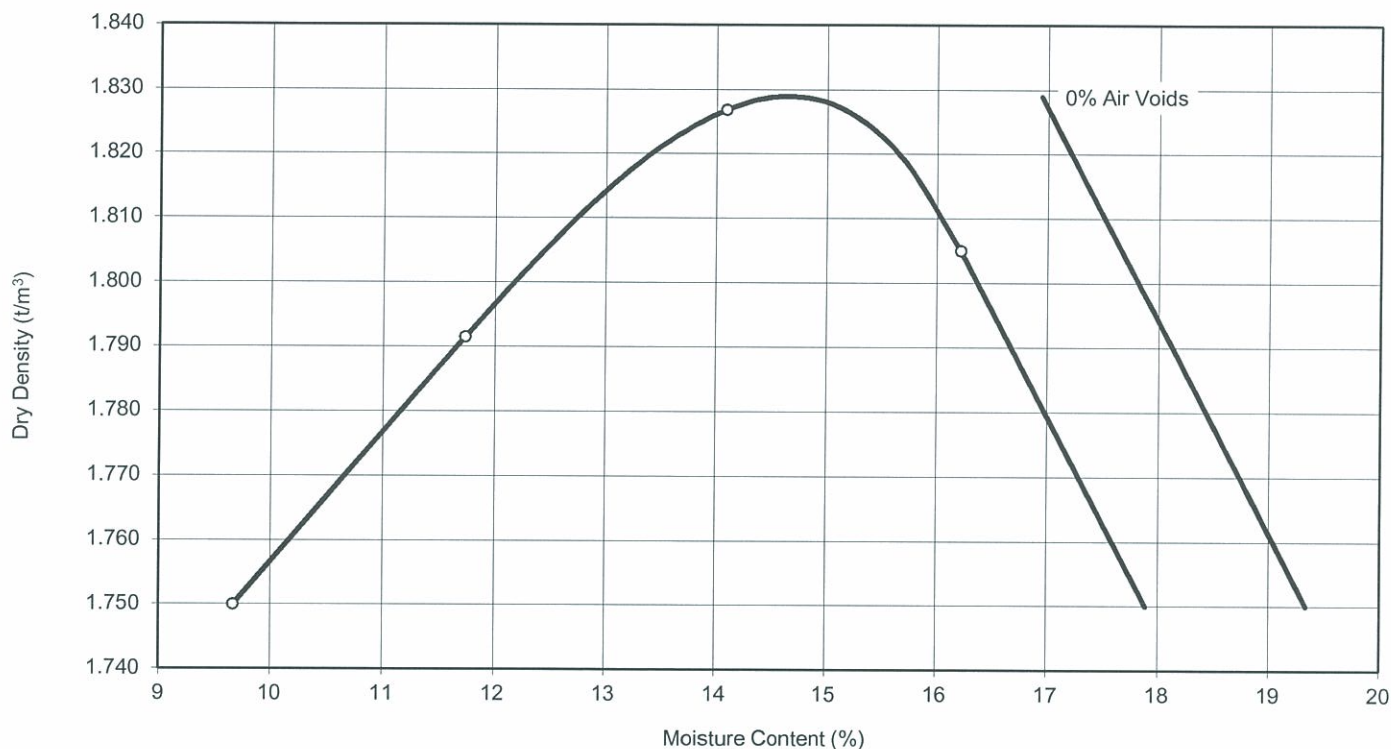
Results of Compaction Test

Sample Details: Location: 303
 Depth: 0.9 - 1.1m

Particles > 19mm: 0%

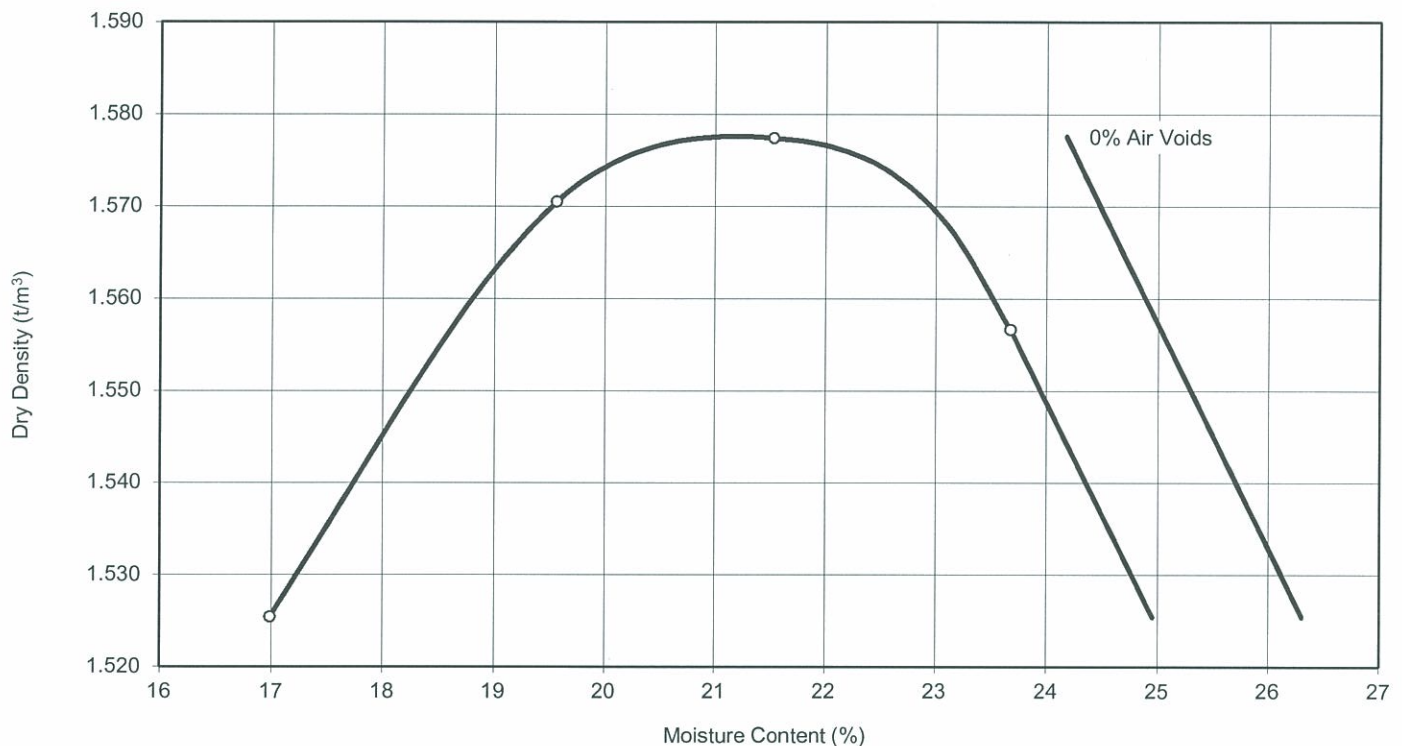
Results of Compaction Test

Sample Details: Location: 306
Depth: 0.9 - 1.1m

Particles > 19mm: 0%

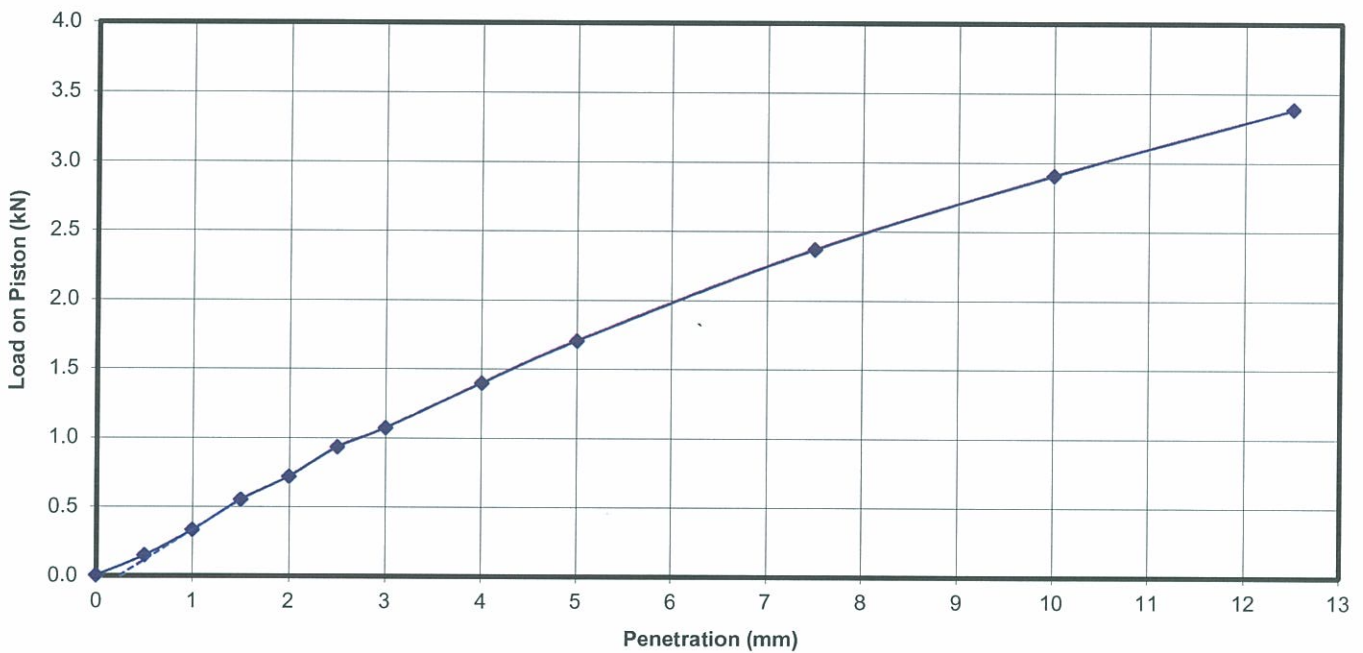
Result of California Bearing Ratio Test

Description: Sandy CLAY - Brown
Sampling Method(s): Sampled by DP Engineering Department
Test Method(s): AS 1289.6.1.1, AS 1289.2.1.1

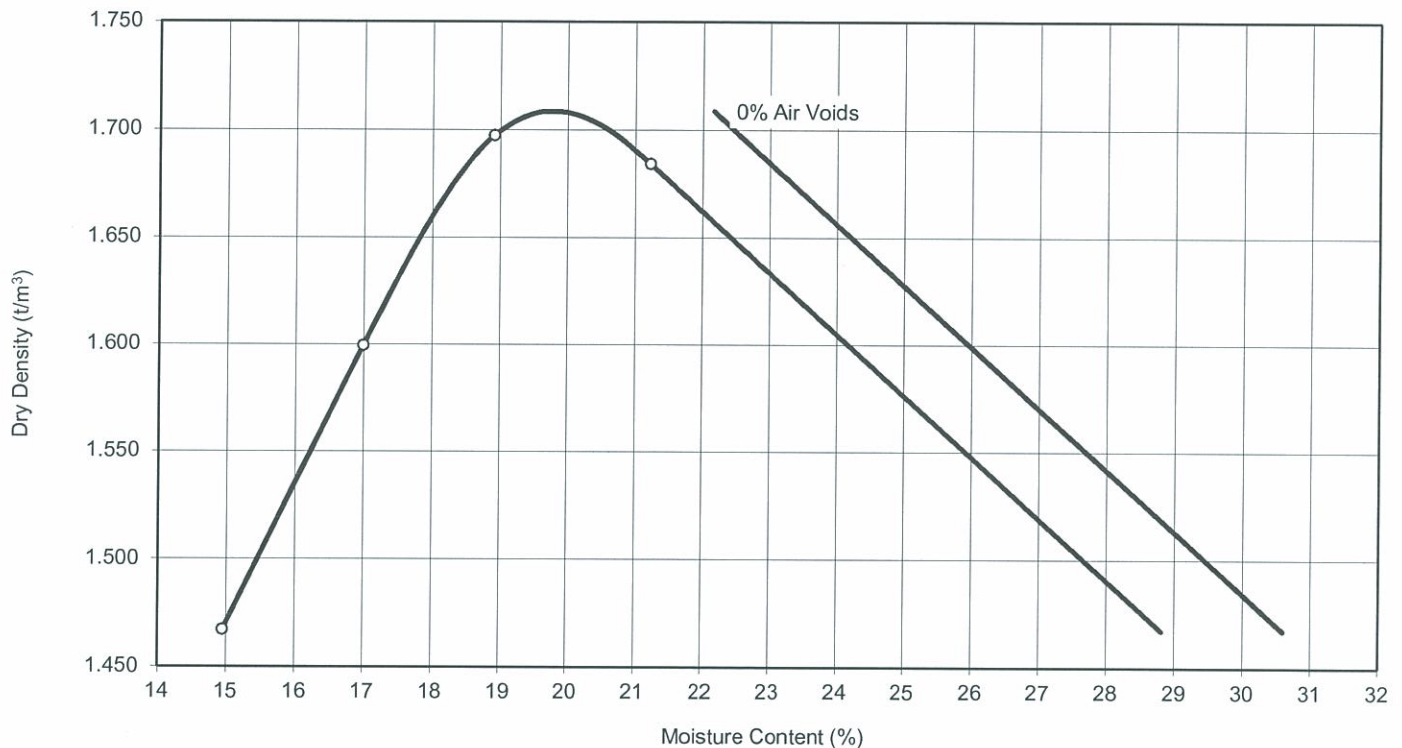
Results of Compaction Test

Sample Details: Location: 311
 Depth: 0.3 - 0.7m

Particles > 19mm: 0%

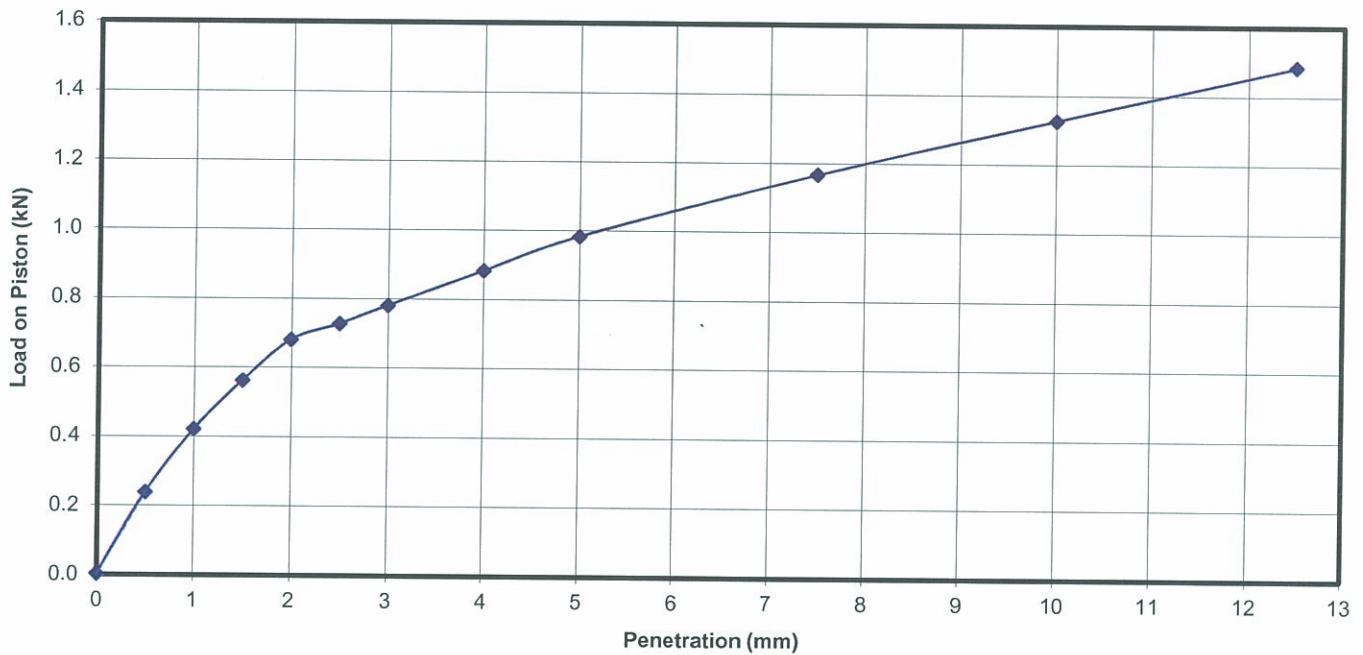
Result of California Bearing Ratio Test

Description: Silty CLAY - Red brown / grey
Sampling Method(s): Sampled by DP Engineering Department
Test Method(s): AS 1289.6.1.1, AS 1289.2.1.1

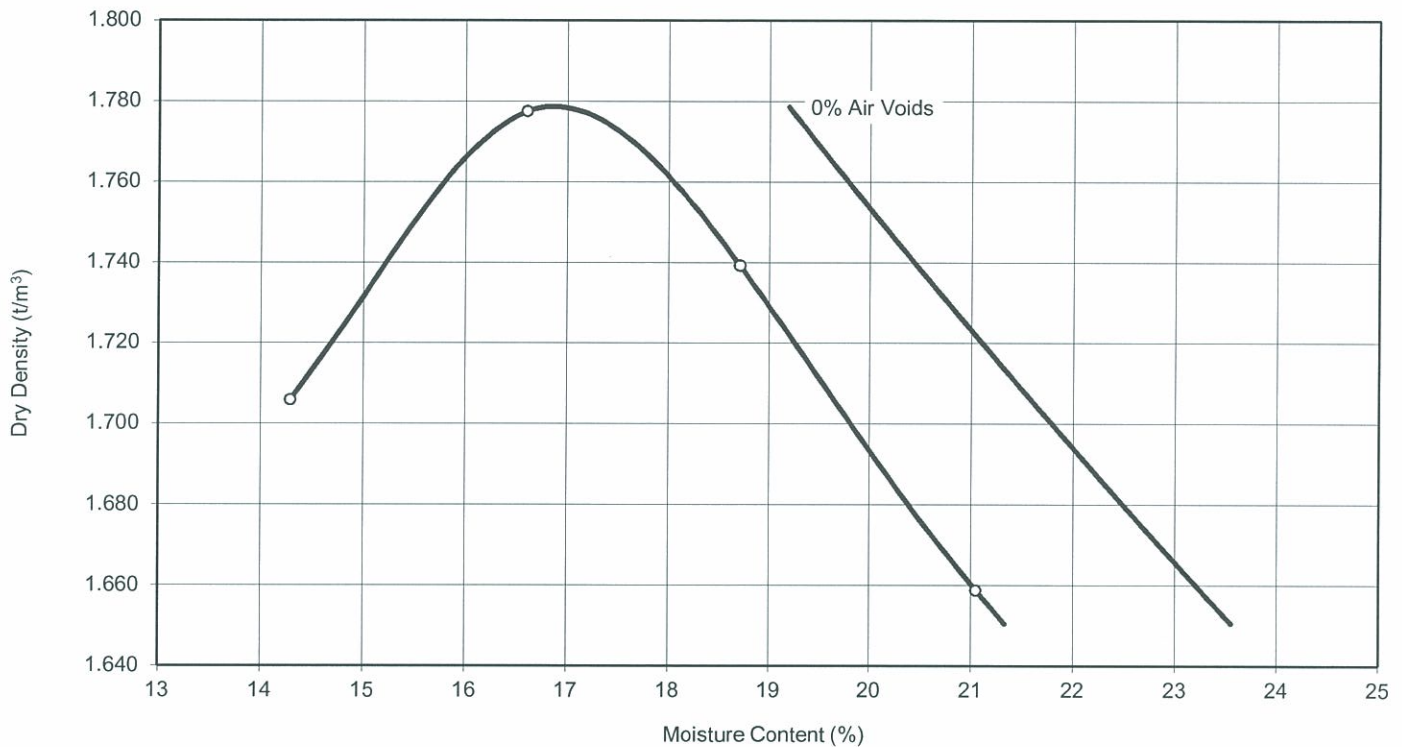
Results of Compaction Test

Sample Details: Location: 313
Depth: 0.9 - 1.2m

Particles > 19mm: 0%

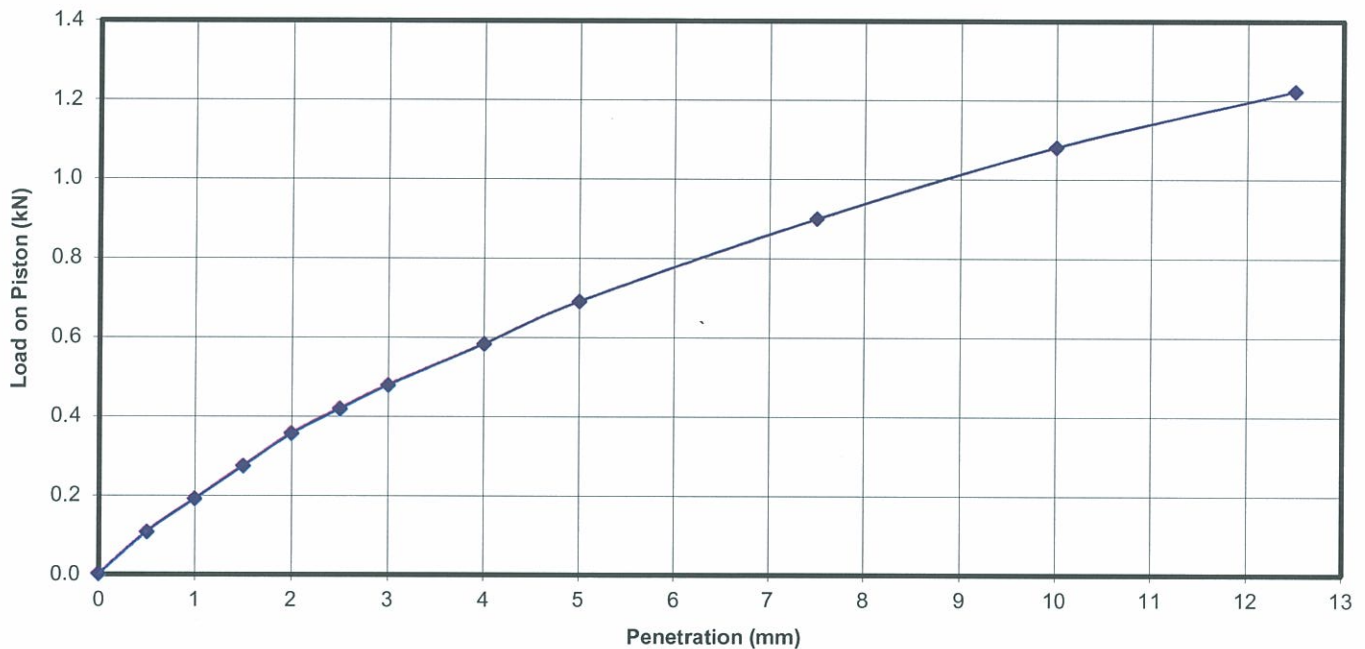
Result of California Bearing Ratio Test

Description: Gravelly Silty CLAY - Brown (Siltstone)

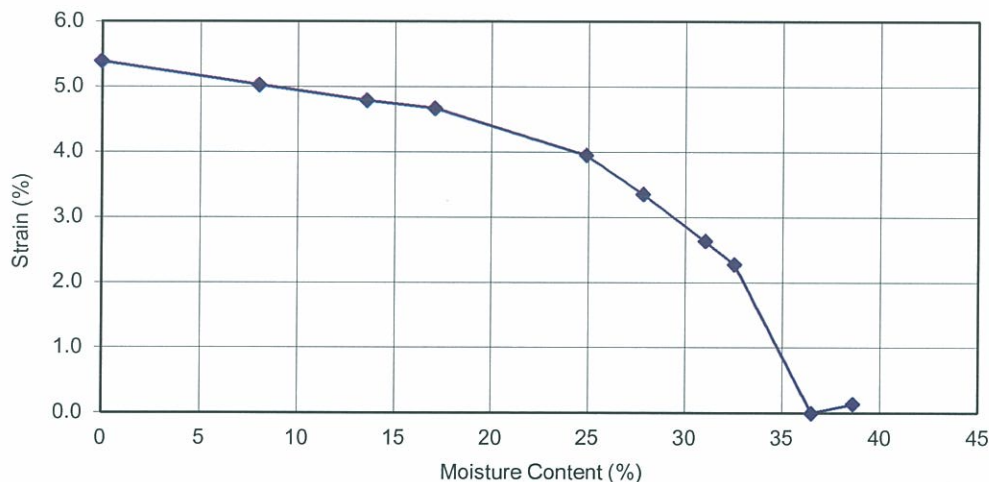
SWELL TEST

Pocket penetrometer reading at initial moisture content	150 kPa
Pocket penetrometer reading at final moisture content	130 kPa
Initial Moisture Content	34.8 %
Final Moisture Content	38.6 %
Swell under 25kPa	-0.1 %

SHRINK-SWELL INDEX I_{ss} 3.0% per Δ pF

Description:	Carbonaceous Sandy CLAY - Dark grey	
Test Method(s):	AS 1289.7.1.1, AS 1289.2.1.1	
Sampling Method(s):	Sampled by Newcastle Engineering Department	
Extent of Cracking:	UC - Uncracked SC - Slightly cracked MC - Moderately cracked	HC - Highly cracked FR - Fractured
Remarks:	Slight consolidation

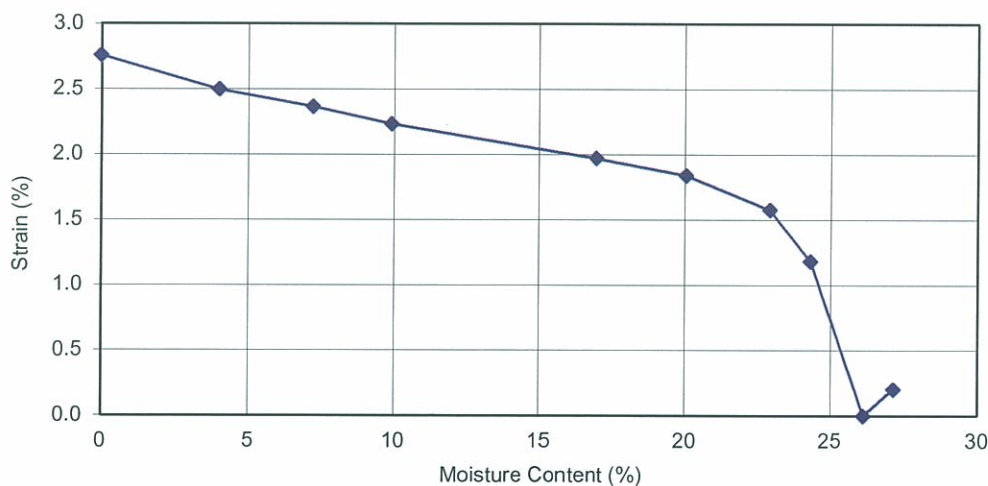
SWELL TEST

Pocket penetrometer reading at initial moisture content	150 kPa
Pocket penetrometer reading at final moisture content	130 kPa
Initial Moisture Content	24.2 %
Final Moisture Content	27.1 %
Swell under 25kPa	-0.2 %

SHRINK-SWELL INDEX I_{ss} 1.5% per ΔpF

Description:	Sandy CLAY - Grey brown	
Test Method(s):	AS 1289.7.1.1, AS 1289.2.1.1	
Sampling Method(s):	Sampled by Newcastle Engineering Department	
Extent of Cracking:	UC - Uncracked SC - Slightly cracked MC - Moderately cracked	HC - Highly cracked FR - Fractured
Remarks:	Slight consolidation

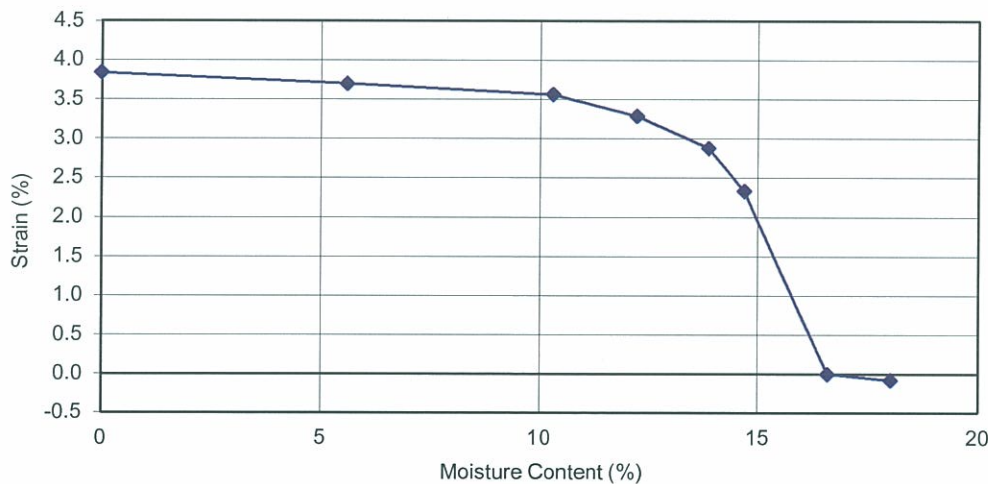
SWELL TEST

Pocket penetrometer reading at initial moisture content	450 kPa
Pocket penetrometer reading at final moisture content	380 kPa
Initial Moisture Content	15.4 %
Final Moisture Content	18.0 %
Swell under 25kPa	0.1 %

SHRINK-SWELL INDEX I_{ss} 2.2% per ΔpF

Description:	CLAY - Orange brown	
Test Method(s):	AS 1289.7.1.1, AS 1289.2.1.1	
Sampling Method(s):	Sampled by Newcastle Engineering Department	
Extent of Cracking:	UC - Uncracked SC - Slightly cracked MC - Moderately cracked	HC - Highly cracked FR - Fractured
Remarks:	Slight consolidation
