Re: Response to DPIE RFI - 2 April 2020 -on-land emplacement areas

This letter provides a response to a request for further information received via email on 2 April 2020 from the NSW Department of Planning, Industry and Environment's (DPIE) regarding the proposed on-land emplacement areas for Snowy 2.0 Main Works. The information requested was regarding:

GF01 drainage concept design

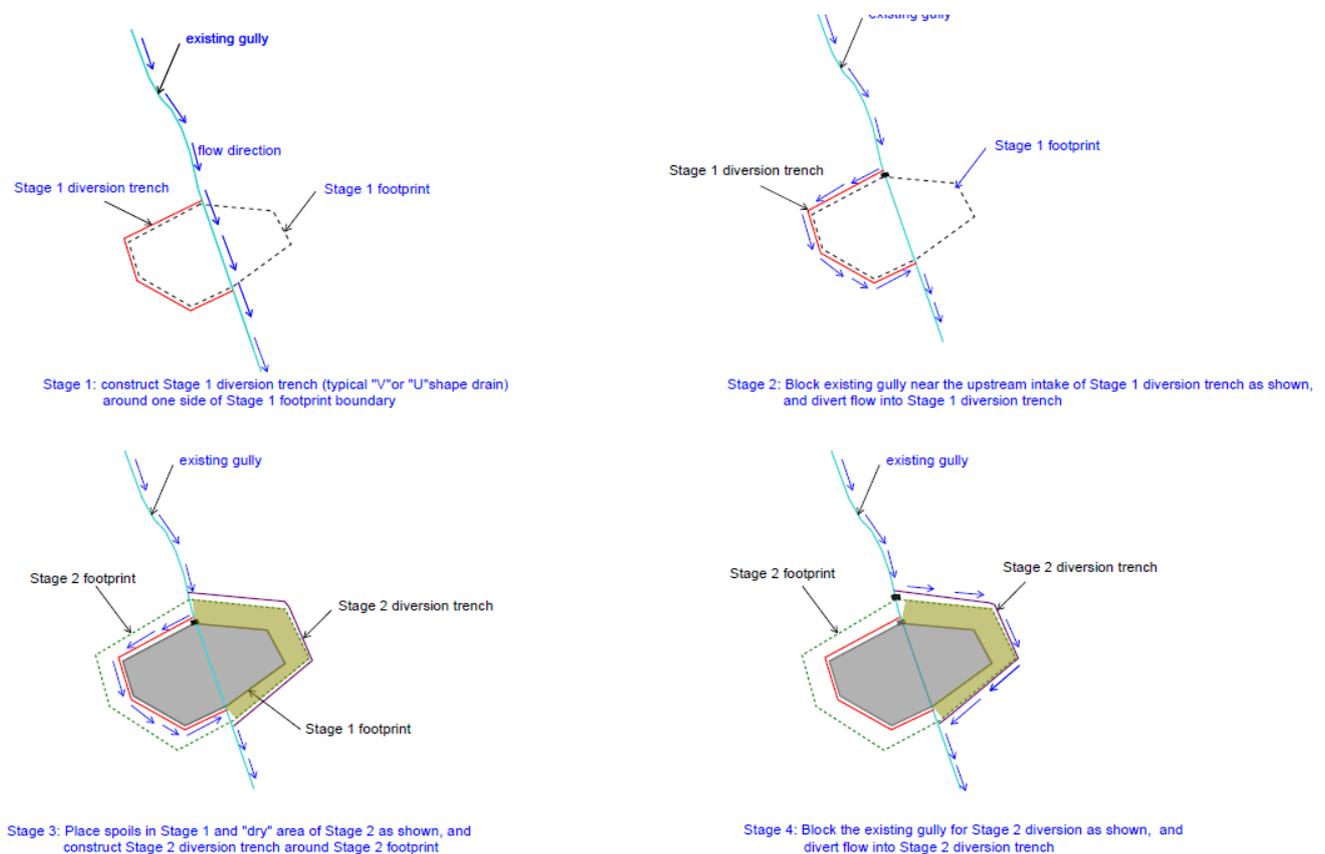
Figure 3.1 Conceptual staging of water flows for construction phase excavated rock emplacement

- Stage 1: Prior to any placement of material, a diversion trench (typically an armoured V channel) will be constructed around the perimeter of the emplacement footprint.
- Stage 2: Once stage one is complete, the natural gully a temporary diversion structure will be constructed, diverting the flows into the newly constructed diversion trench.
- Stage 3: Placement of material can begin within the emplacement footprint, with flow being diverted through the temporary drainage channel around the perimeter of the footprint.
- Stage 4: Whilst placement is occurring and if required, a second diversion trench can be constructed to allow for expansion of the emplacement area, with a new diversion constructed to divert flows.

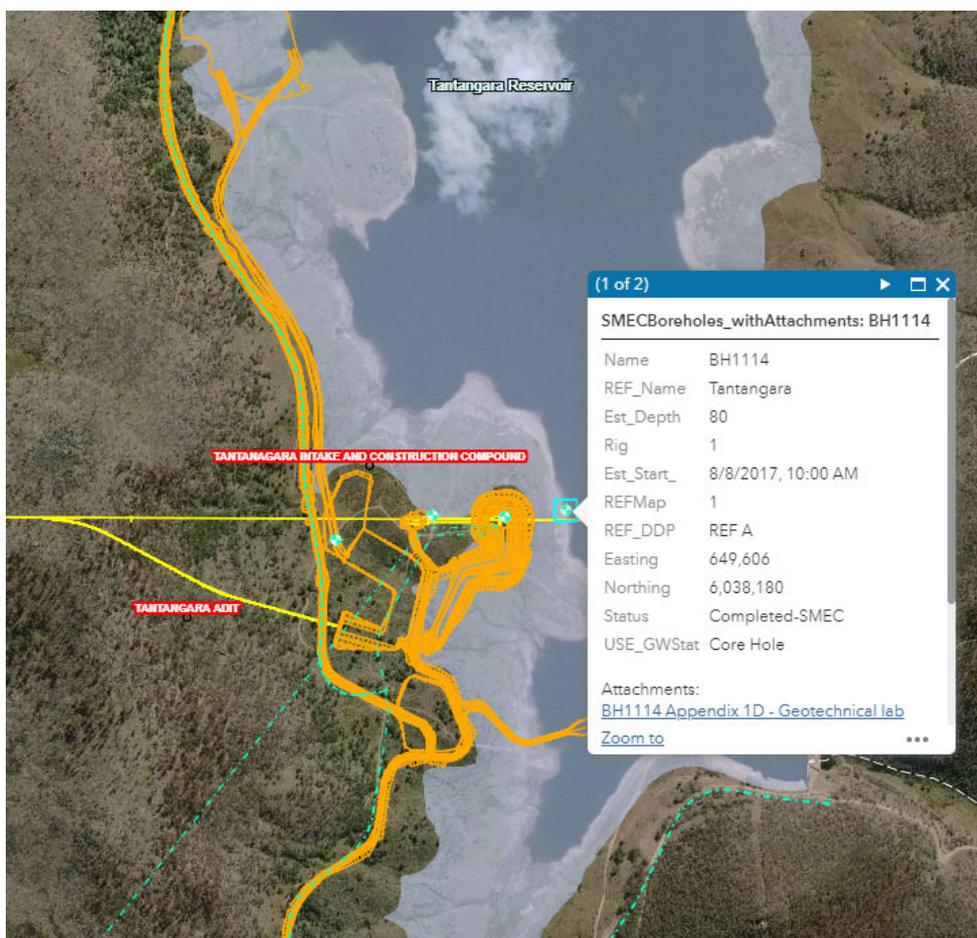
Figure 4.2 Tantangara GIP borehole location (BH1114)

An extract from the drill hole engineering log undertaken near the Tantangara intake location (BH1114) is provided in Figure 4.1. A map is also provided to show the location in Figure 4.2.

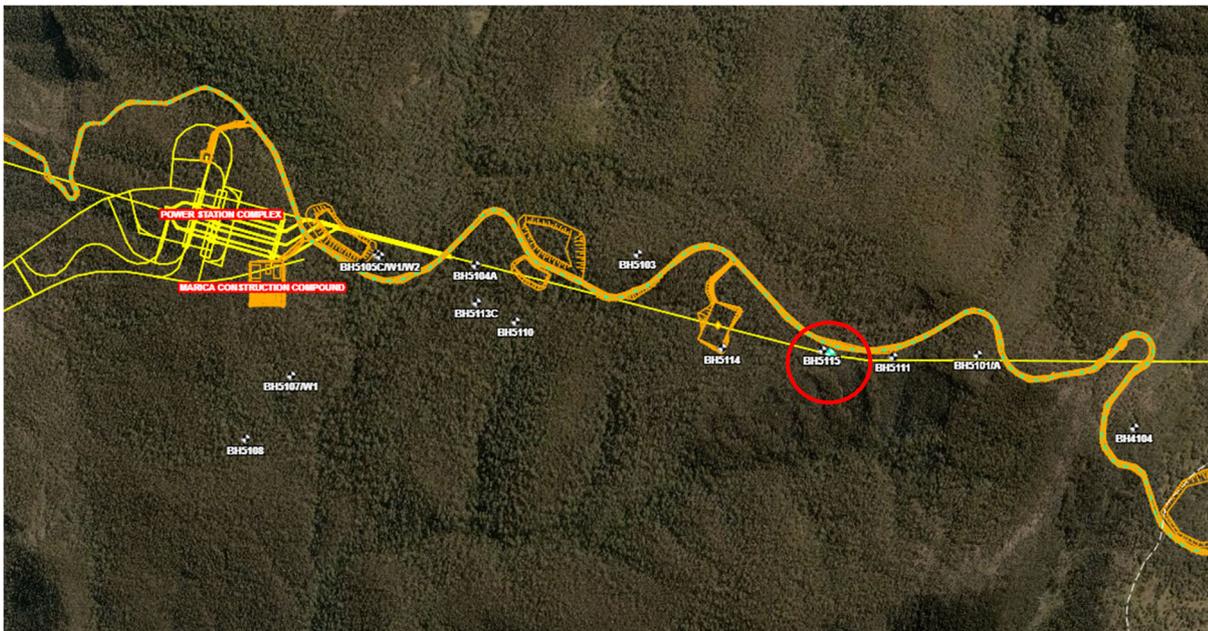
Figure 4.4 Marica GIP borehole location (BH5102)

Marica has been a key focus of the GIP as the area comprises large excavations, notably the upstream surge tank, inclined pressure shaft and underground power station cavern. As an example of the type of soil material at this location, the drill hole log for BH5102 is provided in Figure 4.3. The location of BH5102 is provided in Figure 4.4.

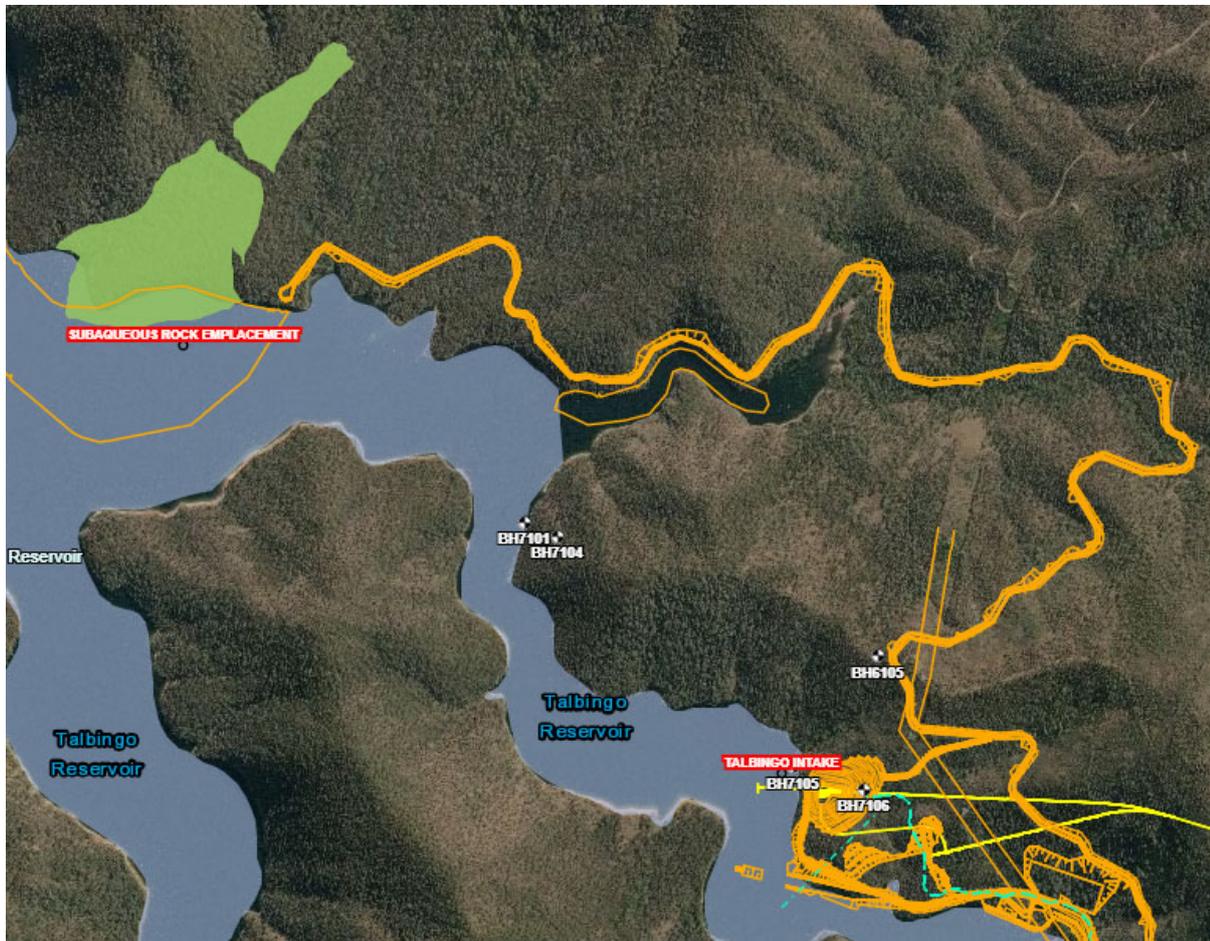
Figure 4.5 Talbingo GIP borehole locations

Numerous drill holes have been executed in the Talbingo area of the Project to inform the design of the Talbingo intake. Currently, no geotechnical investigations have been undertaken at the Ravine Bay emplacement area. These investigations will form part of the activities carried out once approved, as described in the EIS, to inform the detailed design process. See Figure 4.5 providing drill hole locations for reference below.

Based on the geotechnical investigations (borehole drilling and seismic refraction lines) at the nearby Talbingo intake and the Feasibility Study intake site (BH7101, BH7104, BH7105, BH7106 and BH6105), conditions at the Ravine Bay emplacement area can be inferred as follows:

- The bedrock is the Ravine Beds East formation, a succession of shale, slate, sandstone, gritty sandstone and conglomerate.
- Geotechnical strength is expected to have shallow weathering of the bedrock in the initial 2-3 m and low to medium strength. Below this the rock is generally fresh and has high to very high strength.
