# Proposed Development – 2 to 6 Conway Avenue, 15 & 15A Fernleigh Avenue, & 38 to 40 Carlisle Street, Rose Bay

## Preliminary Assessment of Potential Geotechnical Impacts on Neighbouring Properties

**Proposed Development – 2 to 6 Conway Avenue, 15 & 15A  
Fernleigh Avenue, and 38 to 40 Carlisle Street, Rose Bay**  
*Preliminary Assessment of Potential Geotechnical Impacts on  
Neighbouring Properties*

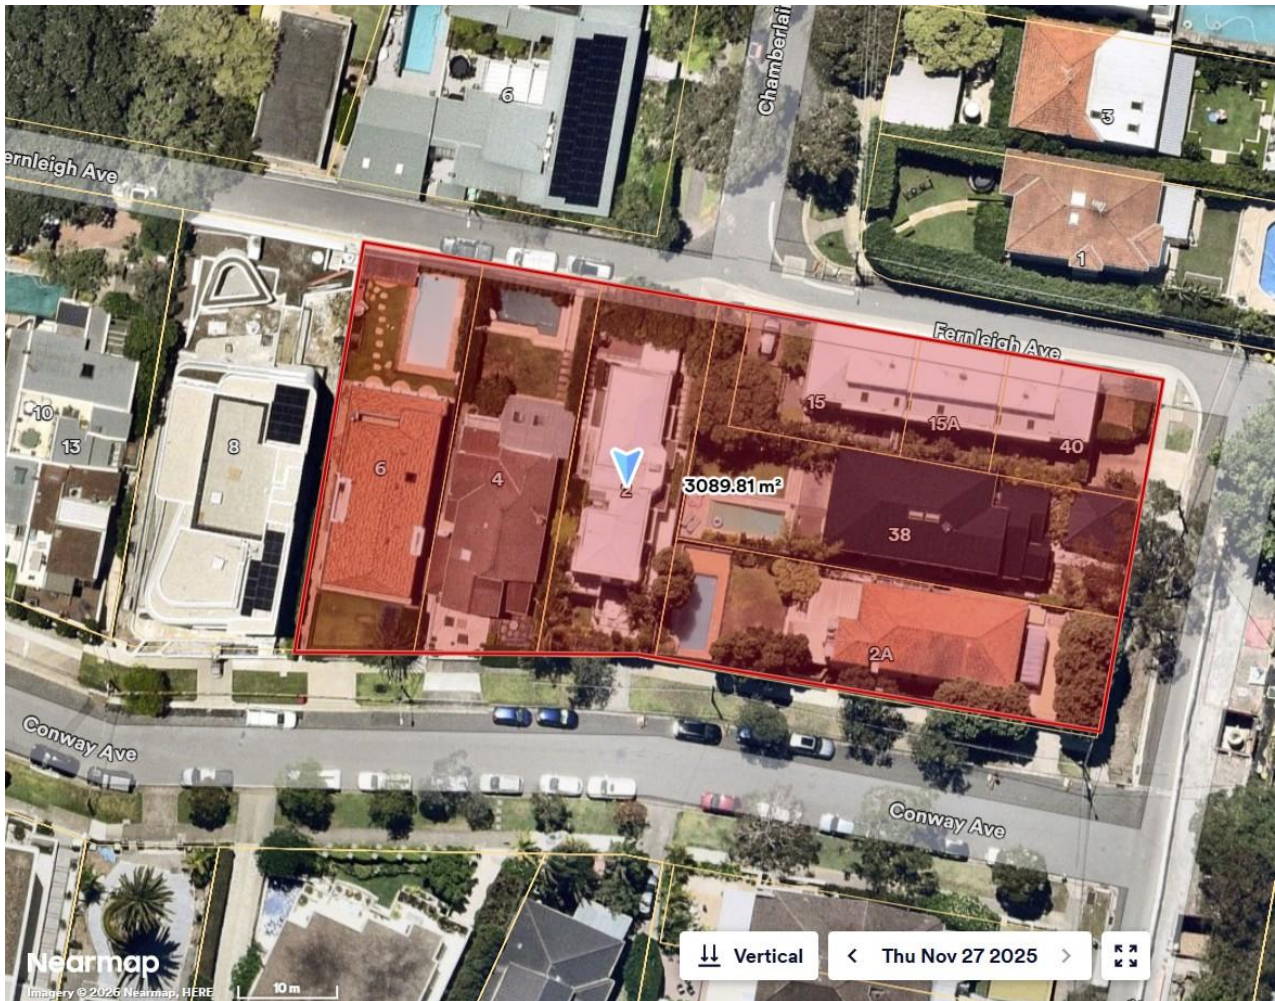
Plate 2-1: Site Location Showing the Proposed Development

The site is located at 2 to 6 Conway Avenue, 15 & 15A Fernleigh Avenue, and 38 to 40 Carlisle Street, in Rose Bay, in the eastern suburbs of Sydney. Plate 2-1 shows a recent aerial photo of the site, showing it to be currently occupied by five detached residential dwellings and a small townhouse development.

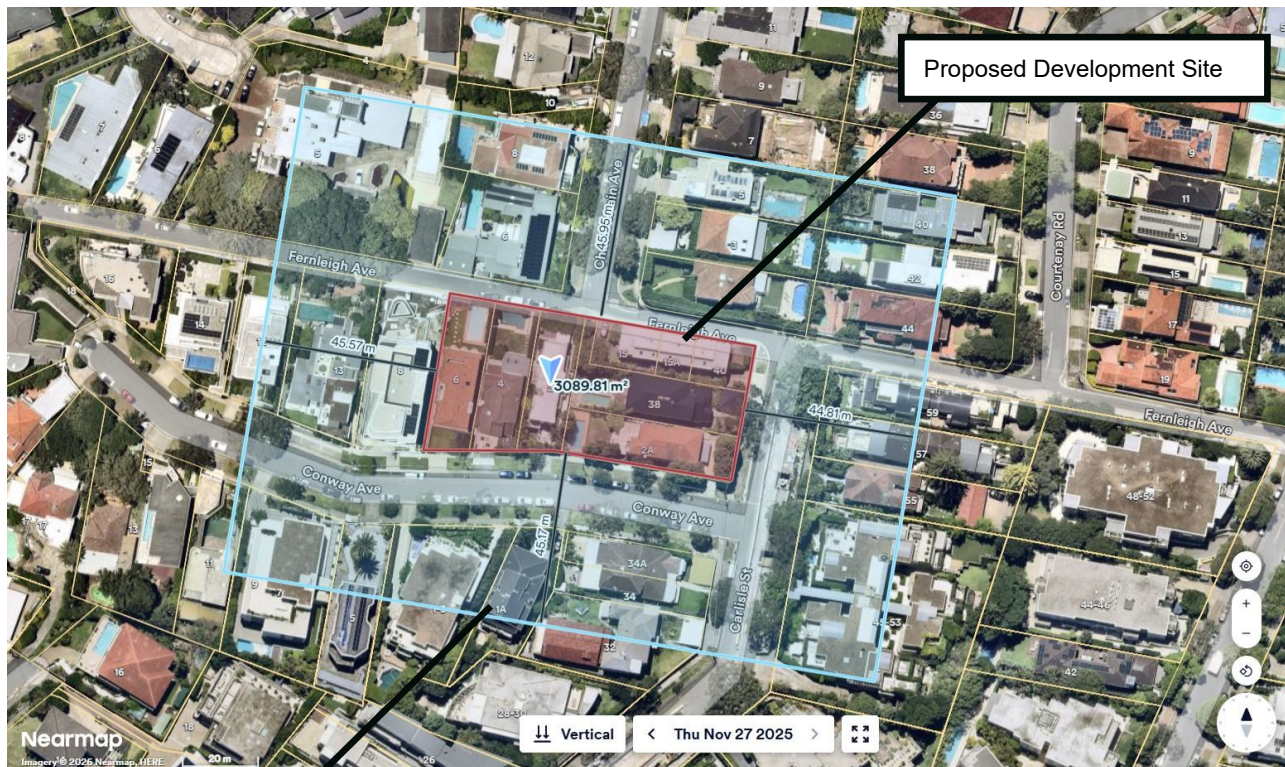
Approx. Area Impacted by  
Groundwater Drawdown During  
Dewatering (assuming ~45m  
impact radius)

Plate 4-1: Aerial Photo Showing the Approximate Area That will be Impacted by Groundwater Drawdown During Dewatering

- Based on our own assessment of potential groundwater drawdown (no numerical modelling has been provided by the proponent), it is estimated that drawdown of the groundwater table will not just be limited to the site, but exceeds 0.3m of drawdown extending between 15m and 35m away from the excavation boundaries (and therefore exceeding the GHD and Council DCP Amendment 30 recommended value of 0.3m of drawdown up to ~35m away from the site boundaries). Therefore, the area impacted by groundwater drawdown exceeding the GHD recommendation is shown in the aerial photo in Plate 4-1 below, and impacts between 20 and 25 properties.

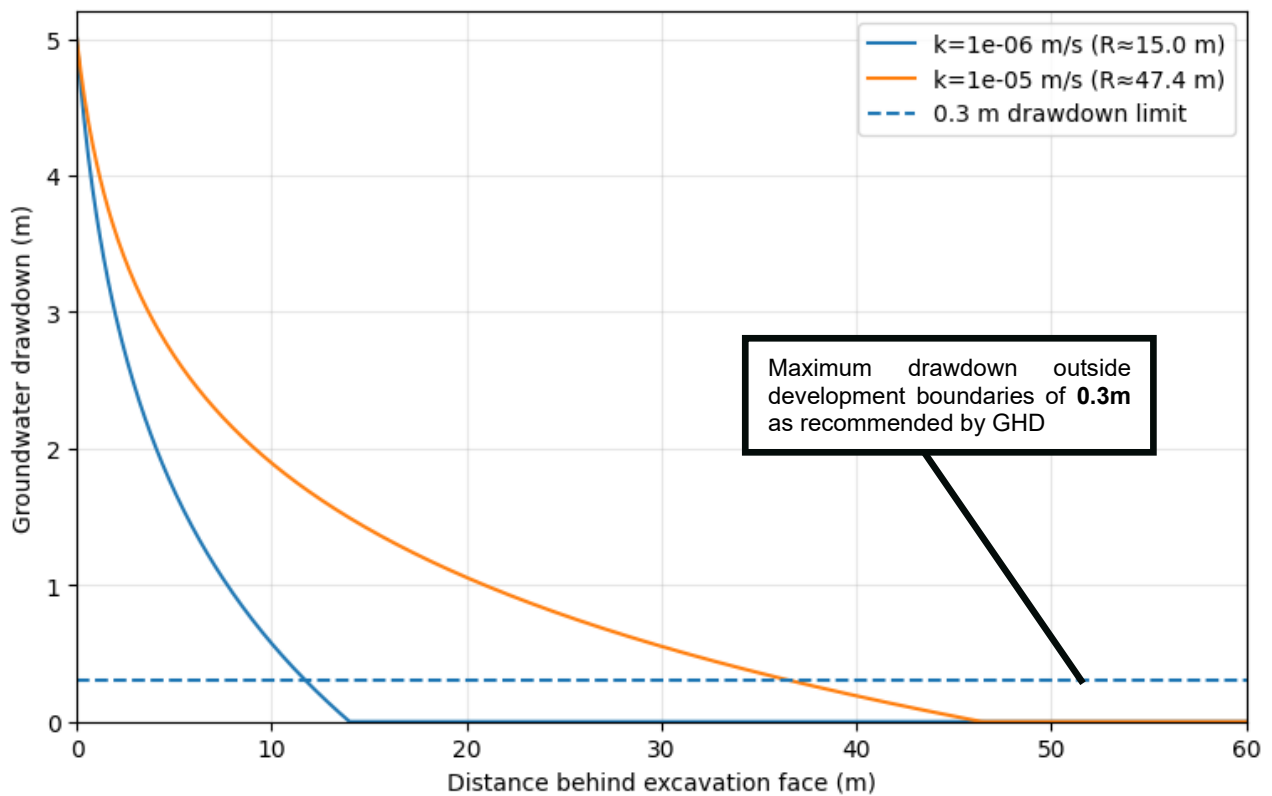
Plate 4-2: Graphical Representation of the Depth of Expected Groundwater Drawdown at Distances Extending From the Excavation Boundary (not based on numerical modelling, as this has not been provided by the proponent)

- There are existing structures within 5m to 10m of the proposed excavation, and our estimate is that drawdown of the water table could be greater than 2m depth at this set back distance. The GHD report commissioned by Woollahra Municipal Council states that such drawdown can cause settlement and damage to properties, and therefore recommended that **a limit of 0.3m of groundwater drawdown outside the development boundary** be permissible. Given that we estimate that groundwater drawdown will be greater than this affecting between 20 and 25 neighbouring properties, it is assessed that the proposed development would not comply with Council advice under these conditions.

- Plate 4-2 below is a graph prepared by us based on our own assessment showing the potential groundwater drawdown at set-back distances behind the excavation shoring wall. It should be noted that this is our preliminary estimate, as no numerical modelling has been provided by the proponent.

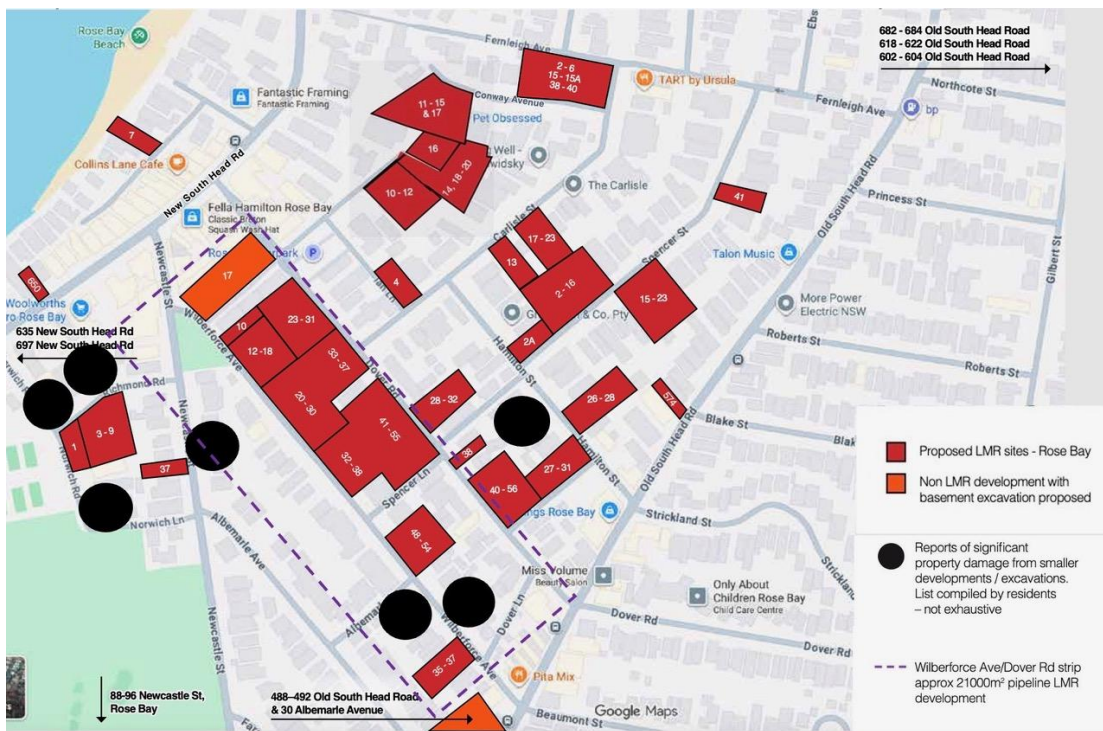
Plate 5-1 – Indicative markup provided by the client showing the development site (yellow), proposed LMR development sites (red), and known properties that have experience structural damage due to adjacent developments.

- Numerous instances in Double Bay and Rose Bay of structural cracking and damage to existing houses and apartments which are located near or adjacent to building sites where deep excavations with dewatering are being undertaken. Specific instances where structural damage to neighbouring properties that have been attributed to shoring installation (both from vibrations due to installation of sheet piling and over-flighting for bored piles), excavation and dewatering works in Rose Bay are shown in Plate 5-1 and include:
