# Proposed Development – 2 to 6 Conway Avenue, 15 & 15A Fernleigh Avenue, & 38 to 40 Carlisle Street, Rose Bay

## Preliminary Assessment of Potential Geotechnical Impacts on Neighbouring Properties

**Proposed Development – 2 to 6 Conway Avenue, 15 & 15A  
Fernleigh Avenue, and 38 to 40 Carlisle Street, Rose Bay**  
*Preliminary Assessment of Potential Geotechnical Impacts on  
Neighbouring Properties*

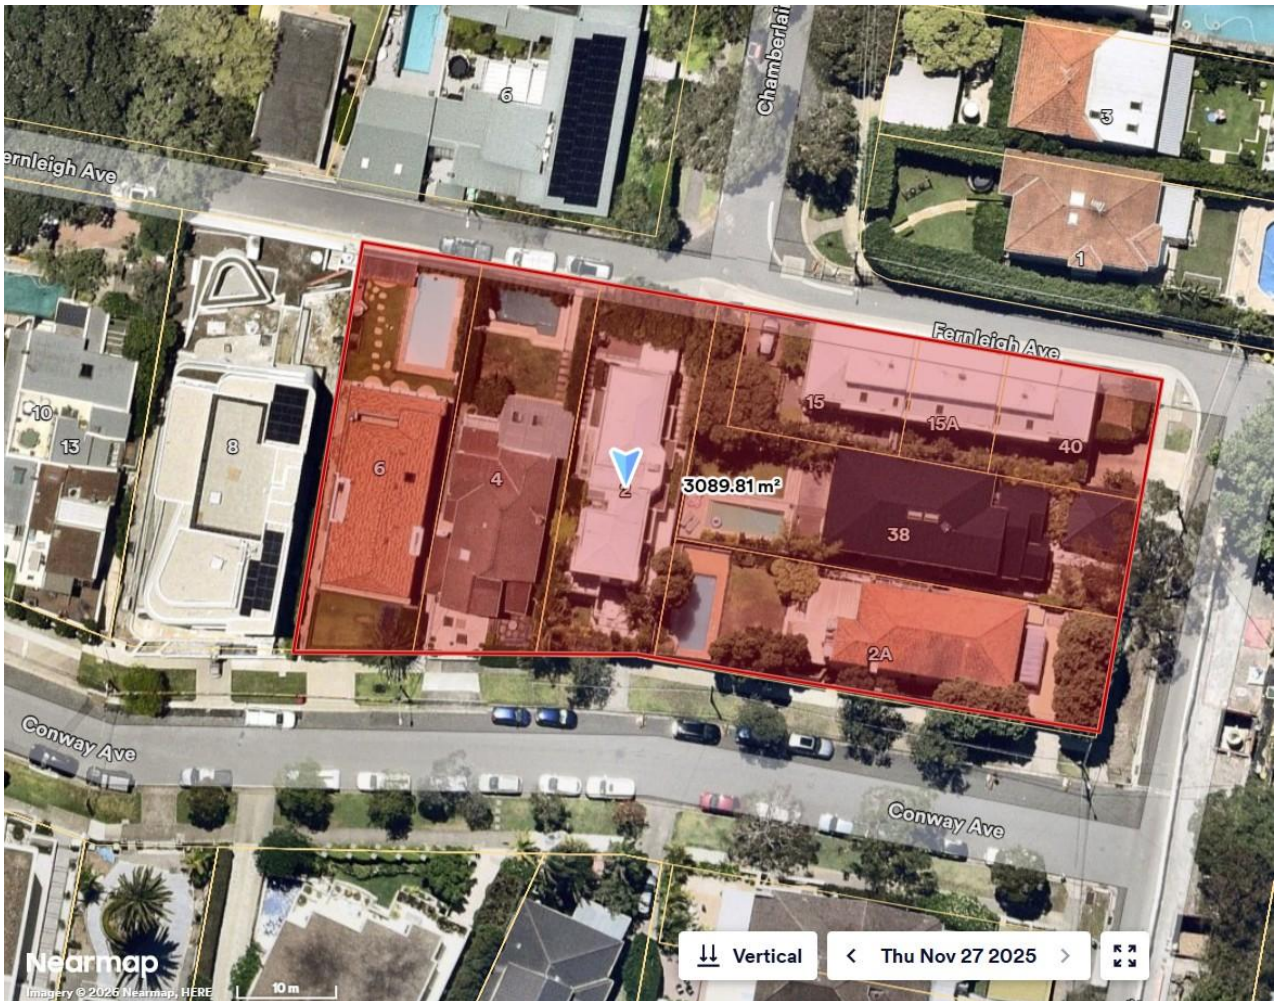
Plate 2-1: Site Location Showing the Proposed Development

The site is located at 2 to 6 Conway Avenue, 15 & 15A Fernleigh Avenue, and 38 to 40 Carlisle Street, in Rose Bay, in the eastern suburbs of Sydney. Plate 2-1 shows a recent aerial photo of the site, showing it to be currently occupied by five detached residential dwellings and a small townhouse development.

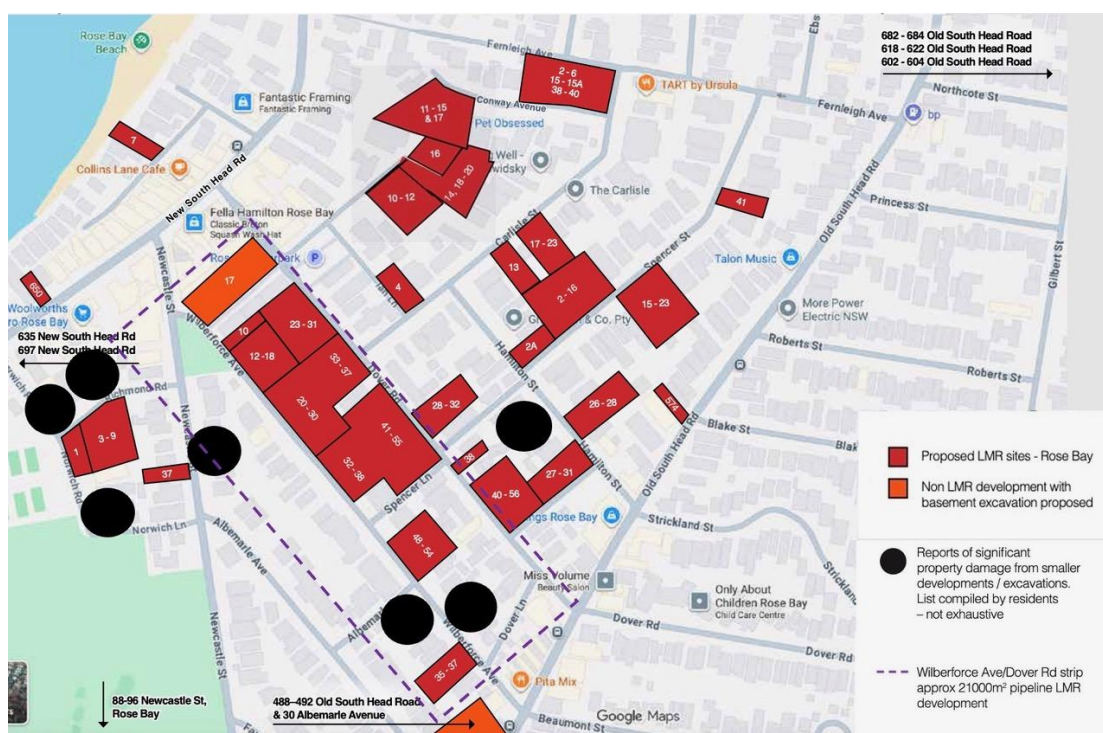
Plate 5-1 – Indicative markup provided by the client showing the development site (yellow), proposed LMR development sites (red), and known properties that have experience structural damage due to adjacent developments.

- Numerous instances in Double Bay and Rose Bay of structural cracking and damage to existing houses and apartments which are located near or adjacent to building sites where deep excavations with dewatering are being undertaken. Specific instances where structural damage to neighbouring properties that have been attributed to shoring installation (both from vibrations due to installation of sheet piling and over-flighting for bored piles), excavation and dewatering works in Rose Bay are shown in Plate 5-1 and include:

- Forest Road (Double Bay) – a room of the neighbouring house was structurally damaged and had to be re-built. Another property on this street suffered where plumbing sank 1.4m, detaching itself from the house.

- Glendon Road (Double Bay) – 4 houses severely damaged. Family displaced for 18 months while the house was re-built
