**Submission:** Formal objection to the Cammeray Seniors Living development (SSD-96505456)

### Key facts – 27 Rosalind Street

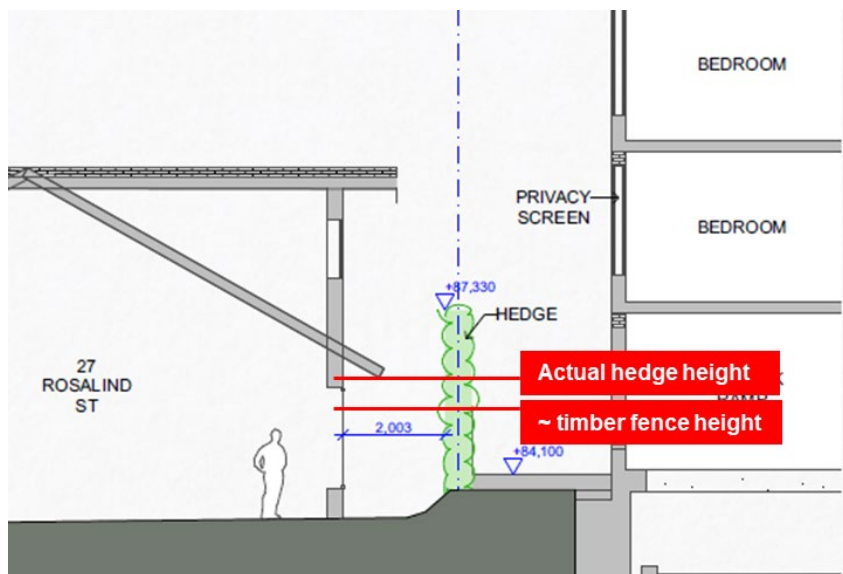
*Image 3: EIS flawed solar analysis, highlighting correct height of hedge and underlying timber fence*

The EIS also misrepresents the hedge’s height and disregards the fixed timber fence beneath it (~ 0.5 m lower). Based on the section drawings, the hedge height assumed appears overstated by more than 75% when compared with the underlying timber fence. See Images 4 and 5 for the current height of the hedge and the underlying timber fence. The hedge does not extend almost to the bottom of the upper-level windows, as depicted in Image 3.

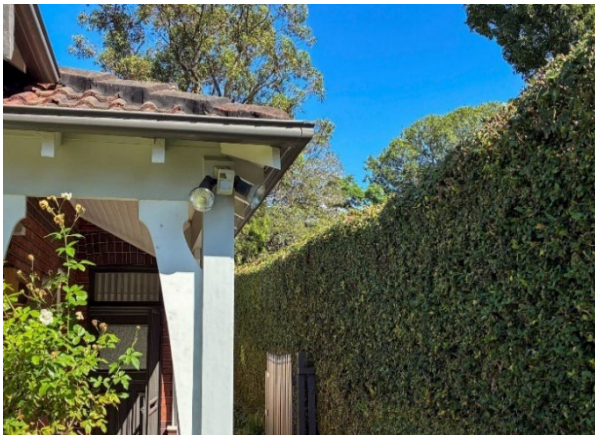
*Image 4: Hedge at maximum height*

The hedge is routinely cut back in winter to maximise sunlight and allowed to grow higher in summer for shade. It was at its maximum height when the solar assessment was prepared. It also sits on a failing retaining wall that requires replacement and is not addressed in the EIS, further undermining the assessment’s reliability.

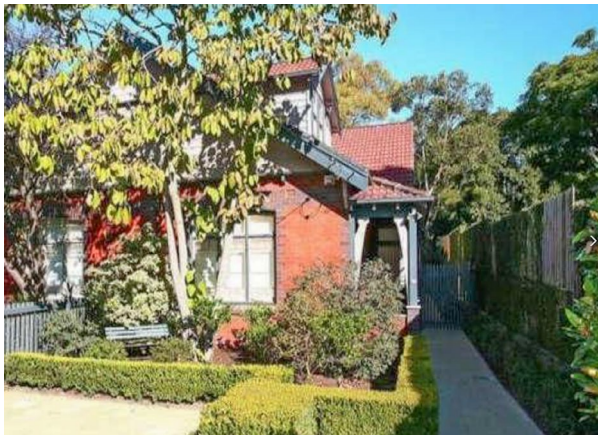
*Image 5: Underlying timber fence without hedge*

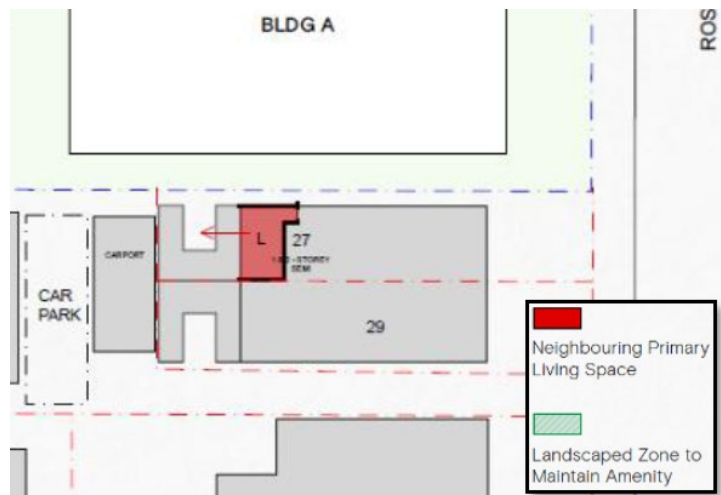
*Image 6: EIS assessment of neighbouring primary living space and landscape zones*

Image 6 illustrates the EIS’s limited identification of living spaces and does not show the proposed landscaped zone along the eastern boundary referenced elsewhere in the EIS documentation.

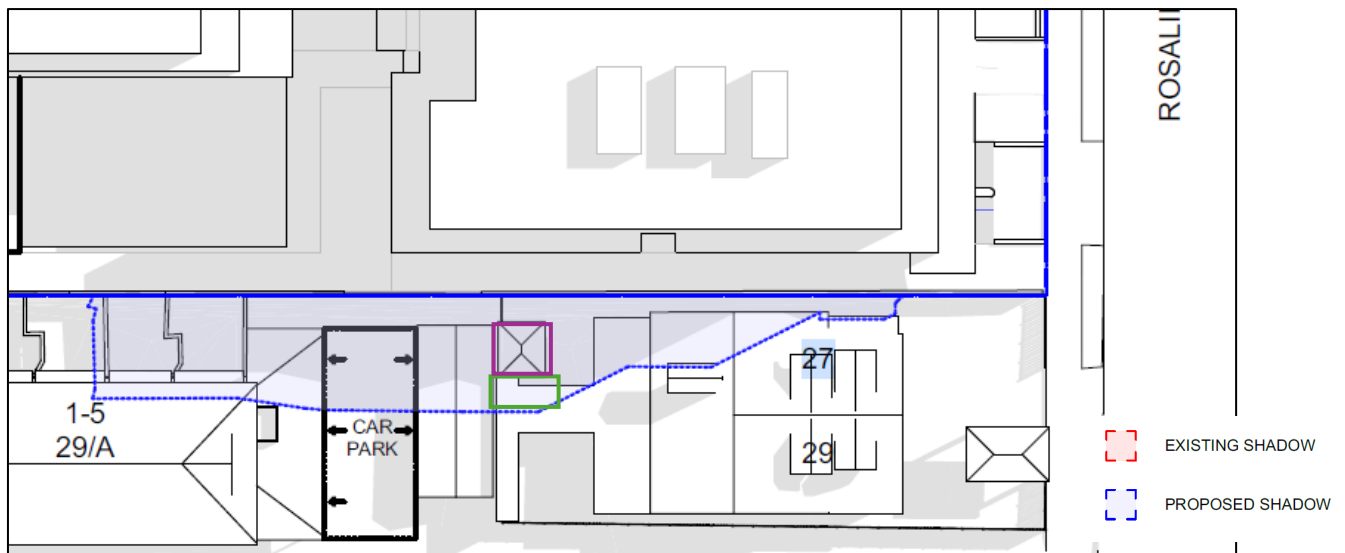
*Image 8: Shadow diagrams 1/2 (Appendix A, EIS), showing assessed solar impact on 27R at 1 pm*

Observations on Image 8:

- The image does not include a pink dashed line on my property to denote existing shadow. On this basis, it appears the grey shading represents the proponent's assessment of existing shadow extent.
- The structure shown in purple is an outdoor cabana or sunroom. It is a well-used private outdoor space that currently receives direct sunlight until late afternoon.
- The EIS appears to overstate built structures within my rear courtyard along the eastern boundary, as marked by the green rectangle. This area is garden space, not built form.

Images 9, 10 and 11 are real photographs of my home taken under comparable solar conditions as the EIS shadow image 8 below. They show that existing shadowing on my home is materially less than represented in the EIS. If modelled at the height of the underlying timber fence (versus the hedge in place in this photos), existing shadow would be reduced further by up to a 1 m. These time-matched photographs accurately depict the extent of existing sunlight reaching the house and courtyard and demonstrate that the EIS fundamentally overstates existing shadow conditions and understates the additional shadow impacts that would result from Building A.

When compared with the proposed shadow extent shown in Image 8 from the EIS, these photographs illustrate that the development would place all west-facing windows into complete shadow before 1 pm, well before the times currently experienced. This would result in a substantial and unjustified loss of solar access post-development.

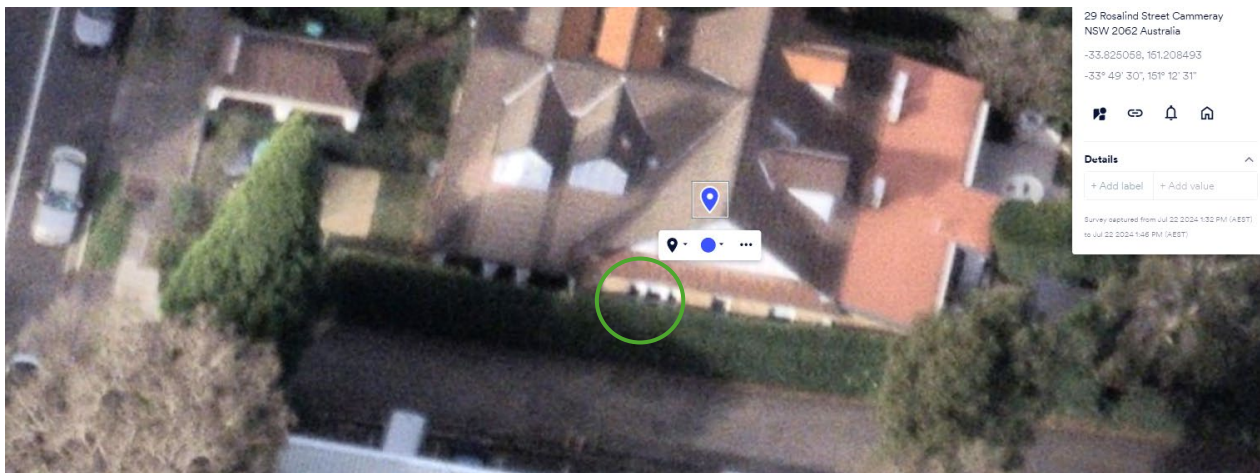
*Image 9: Aerial panorama photograph, 22 July at 1:46 pm (shadow conditions are effectively equivalent to those on 21 June at 1:00 pm, with the shadow length an immaterial ~1% longer in this image)*

- **Both house levels currently receive direct sunlight.** The upper level is sunlit, as is the lower level from the front door through to the rear, including the living area identified in the EIS as a “secondary” space (shown by the green circle). See Image 11 for sunlight conditions in the rear courtyard.

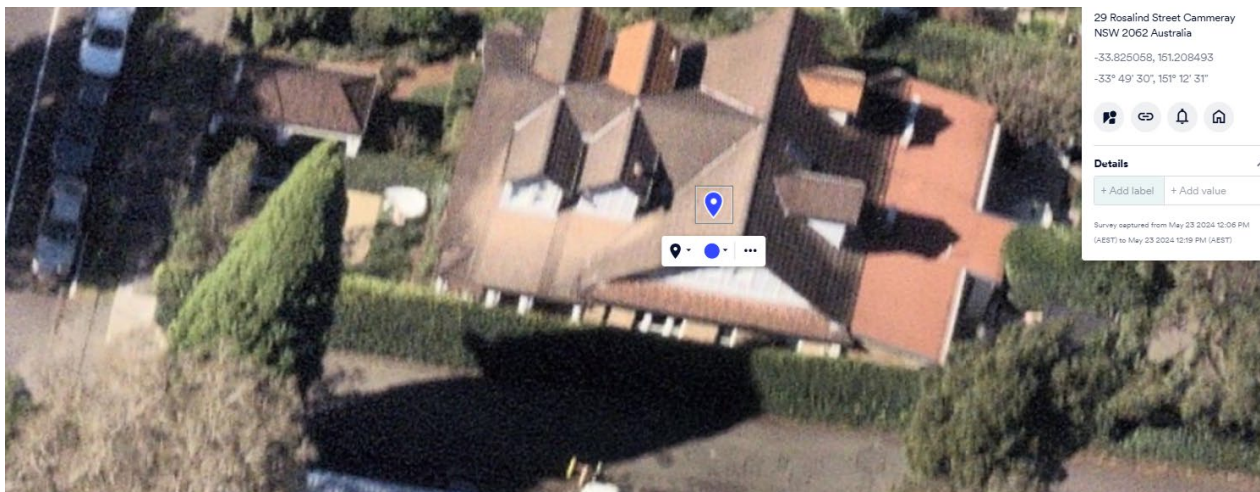
*Image 10: Aerial panorama photograph showing existing solar conditions, 23 May at 12:19 pm*

- The image above further confirms that the entire home, including both upper and lower levels, currently receive direct sunlight.

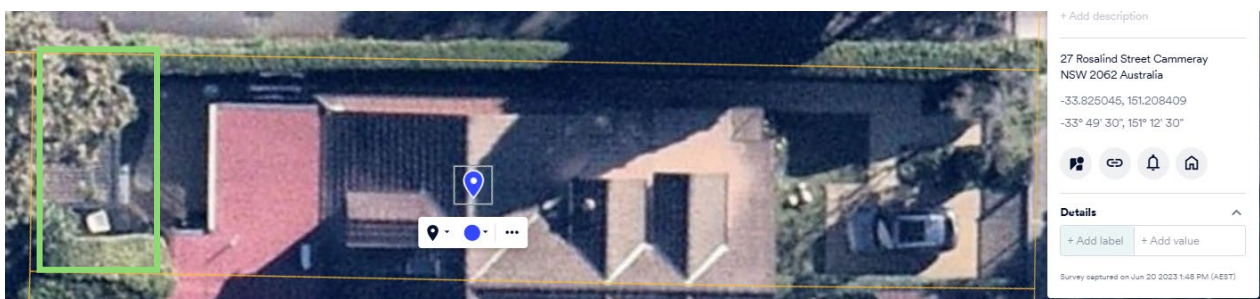
*Image 11: Aerial photograph showing existing solar conditions, 20 June at 1:48 pm (48 mins later than EIS)*

- The image above, taken almost an hour later than the EIS solar assessment, demonstrates that existing solar access is materially greater than represented in the EIS, with more than 50% of the rear courtyard remaining in direct sunlight.

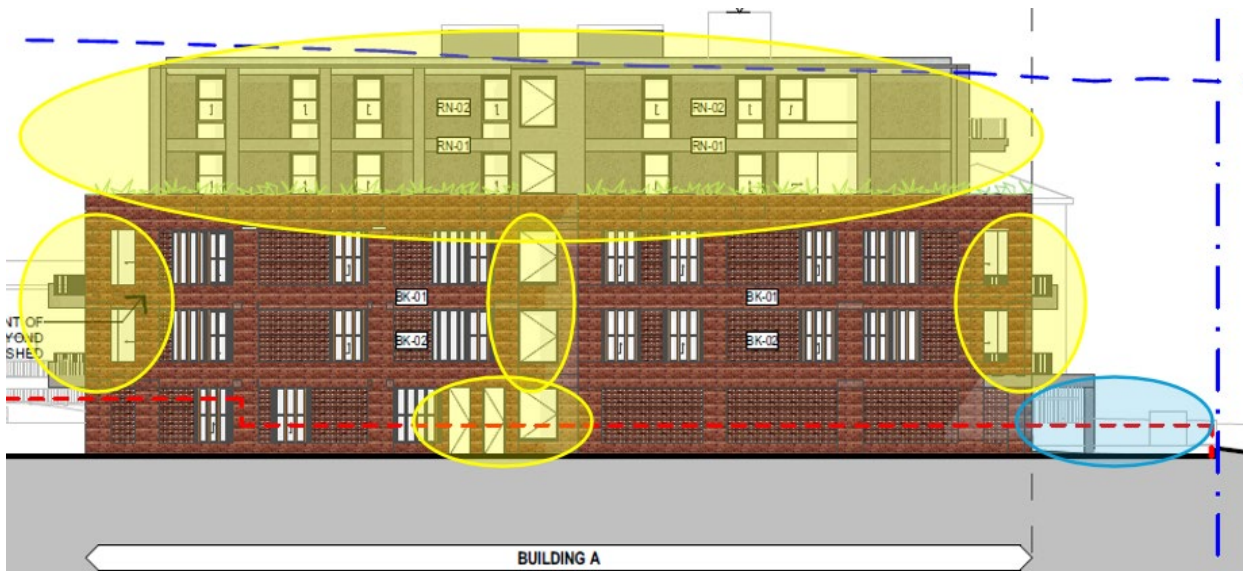
*Image 12: EIS image outlining privacy measures, yellow highlighting areas where no measures provided*

In Image 12 below, the areas highlighted in yellow identify locations where no privacy measures are proposed, further demonstrating the lack of effective mitigation to protect my privacy. The area marked in blue identifies the car park entry, which also requires appropriate acoustic treatment and light spill mitigation to address impacts on my home.

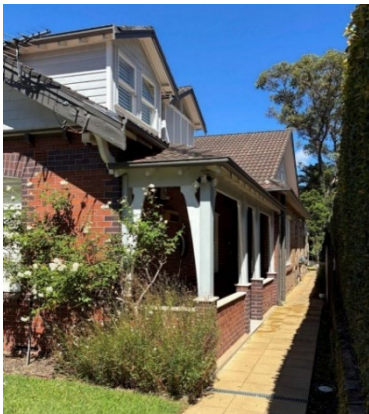
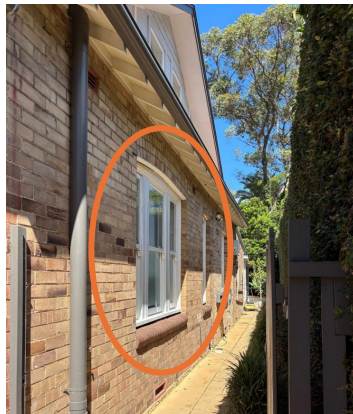
**Side of 27 Rosalind Street (eastern boundary) – 22 March 1.30 pm**

- The entire eastern side of the house, at both lower and upper levels, is receiving full direct sunlight, despite the hedge being at a relatively high position.
- The window circled in red identifies the room described in the EIS as a secondary living space, which is clearly shown to receive direct sunlight under existing conditions.

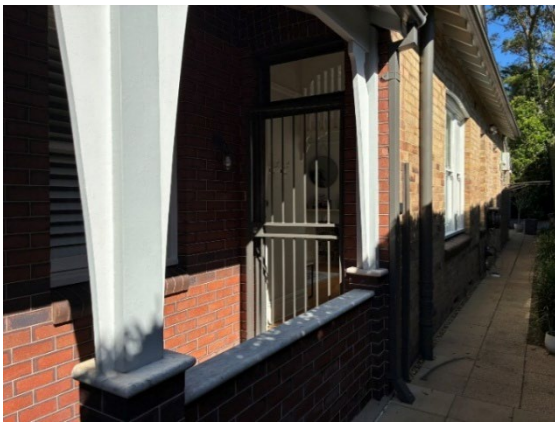
**Side of 27 Rosalind Street (eastern boundary) – 22 March 3.30 pm**

- The eastern façade of the house continues to receive direct sunlight at 3.30 pm, from windowsill height upwards.
- Under the proposed development, this façade would be in full shadow at this time.

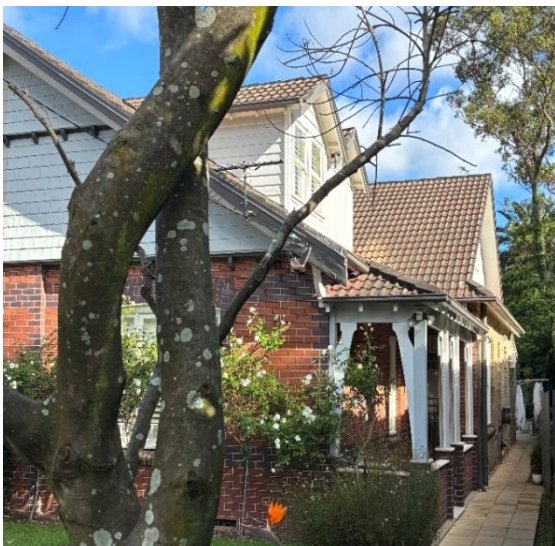
**Side of 27 Rosalind Street (eastern boundary) – 23 March 4.30 pm**

- Upper level remains in full sun; north façade is still partly sunlit.
- Under the proposal, this would be in full shadow.
- Western façade still enjoying sunlight including front balcony
- Under the proposal, northern solar access would also reduce because Building A extends further north than my house

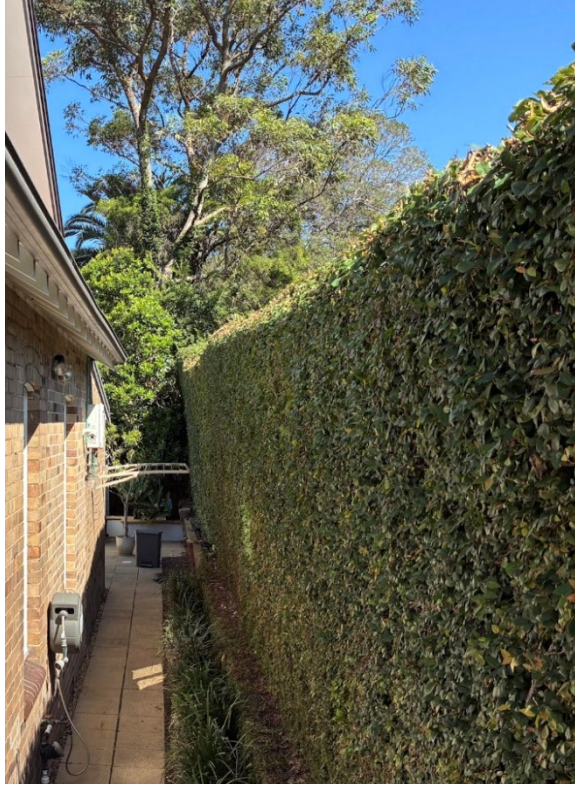
**Rear of 27 Rosalind Street – eastern boundary**

- The hedge is located above the retaining wall on the developer’s land. The structure comprises a brick base, topped with a timber fence, with the hedge growing above.
- The ongoing lean/movement of this retaining wall/fence/hedge structure is visible along the eastern boundary.

The photographs below document the condition of the eastern boundary between 27 Rosalind Street and the development site at 19–23 Rosalind Street. They show a failing retaining wall located on the development site, retaining higher ground, and temporary propping works constructed on my land to counteract its instability. The images illustrate progressive movement, cracking, and the inadequacy of the existing structures, particularly in the context of proposed deep basement excavation.

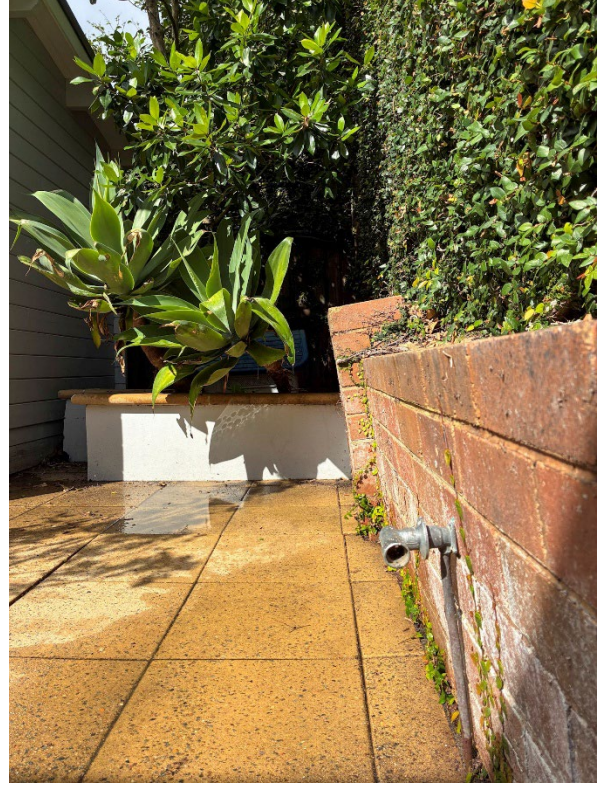
**Rear of 27 Rosalind Street – sub-wall supporting eastern boundary**

- A brick “sub-wall” has been constructed on my land, extending into Lot 29A, to prop the failing retaining wall on the development site.
- The sub-wall is itself leaning, consistent with ongoing pressure from the retaining wall behind.
- Cracking, displacement, and deterioration are visible along the length of the sub-wall.

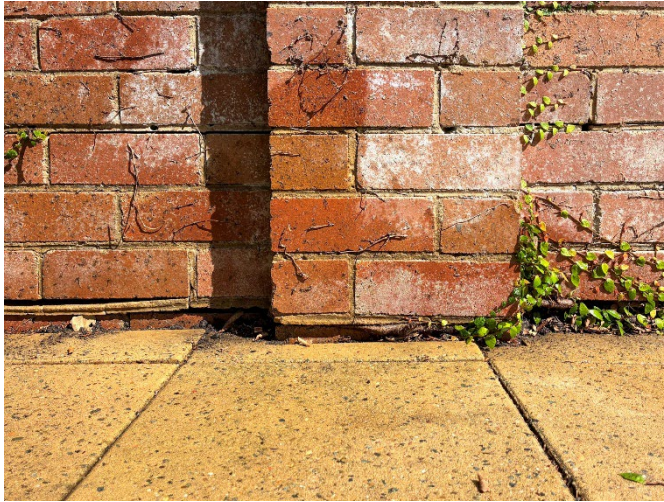
**Brick sub-wall at the rear of 27 Rosalind Street (eastern boundary), supporting the developer's retaining wall:**

- The brick sub-wall exhibits visible cracking and leaning, consistent with pressure from the failing retaining wall behind it.
- Brick loss, root penetration, and general deterioration are evident along the length of the wall, indicating ongoing instability.

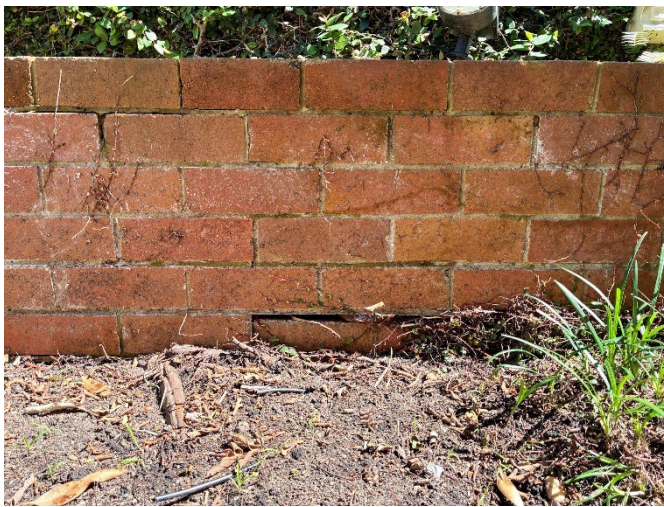
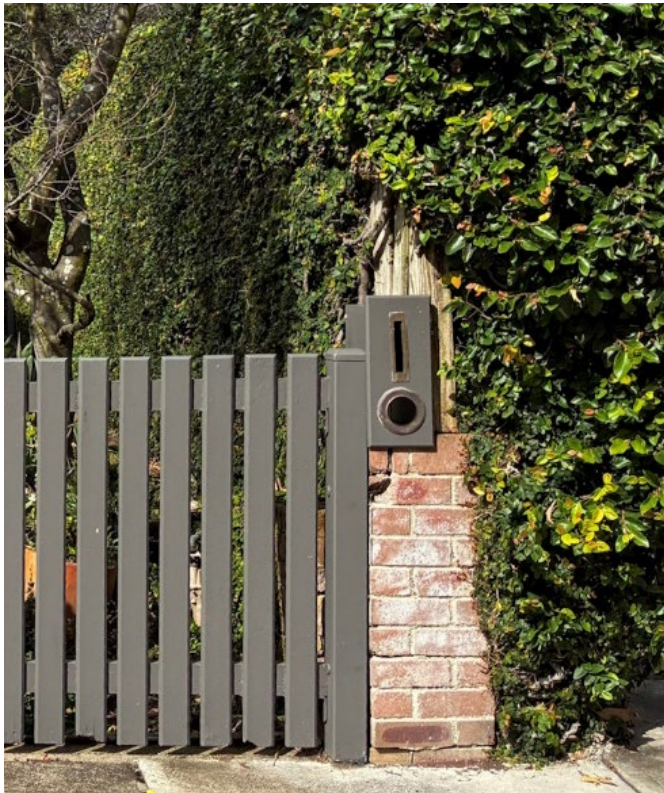
**Retaining wall on eastern boundary, view from Rosalind Street:**

- View of the retaining wall from Rosalind Street. The developer's survey identifies this wall as being on the development site.
- Visible cracking, displacement, and missing bricks are evident. The wall retains the higher ground level of 19-23 Rosalind Street.
