Cadia Community Sustainability Network (CCSN) Comments/Objections To Newmont/Cadia Valley Operations (CVO) Modification 15 Tailings Storage Facility Embankment Buttressing

1 Embankment Buttressing

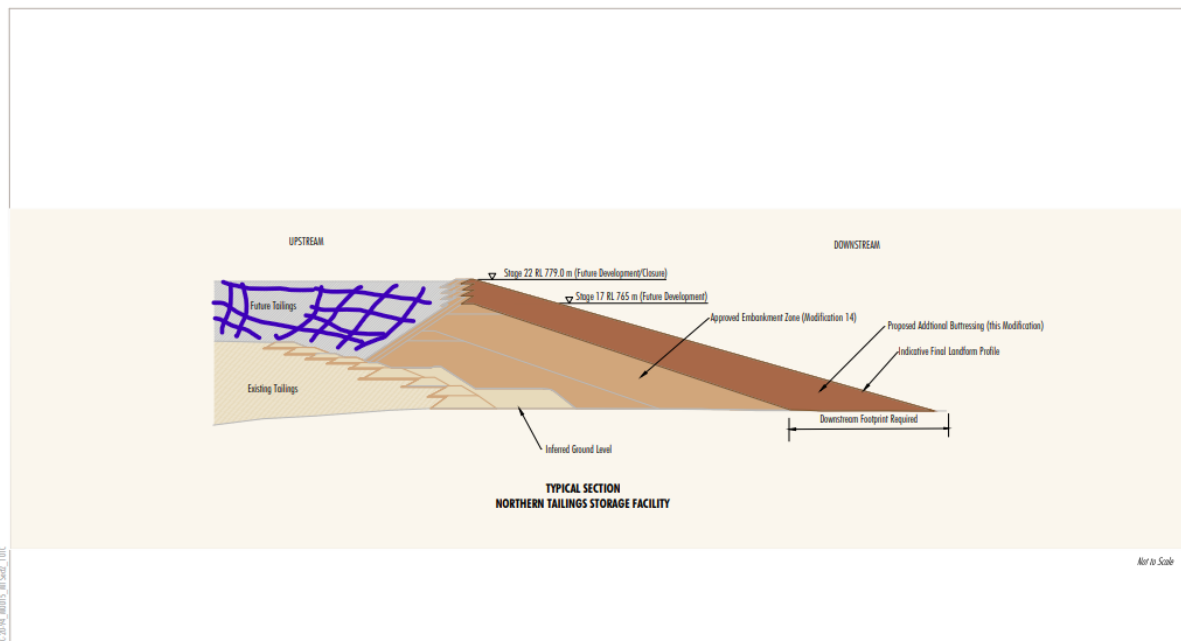
Newmont
CADIA
CADIA VALLEY OPERATIONS
Typical Cross Section through the
Northern Tailings Storage Facility
Main Embankment
Figure 2-1b

Changing the tailings dam construction from upstream to centreline or downstream will result in a significant increase in storage capacity (blue cross hatched area). The dam wall will effectively be built in a line upwards rather than building over the current tailings dam. The Advisian model (Appendix D – Groundwater Impact Assessment) for the NTSF and STSF revises the cell matrix used to model the tailings dam footprints and identifies an increase in the tailings dam footprint area by 200 modelled cells, approximately 20% (Figure 5-2).

Source: After CHPP (2023), ATC Williams (2023)

Descriptions that buttressing the outer slopes of both the NTSF and STSF and moving to a centreline or downstream lift has no change in the volume of tailings material stored or the footprint of the stored tailings is false. The assertion that all tailings deposition would remain within existing Mine License (ML) is totally misleading. The notice of exhibition for the Mod is deliberately intended to mislead and downplay the significance of Mod 15.

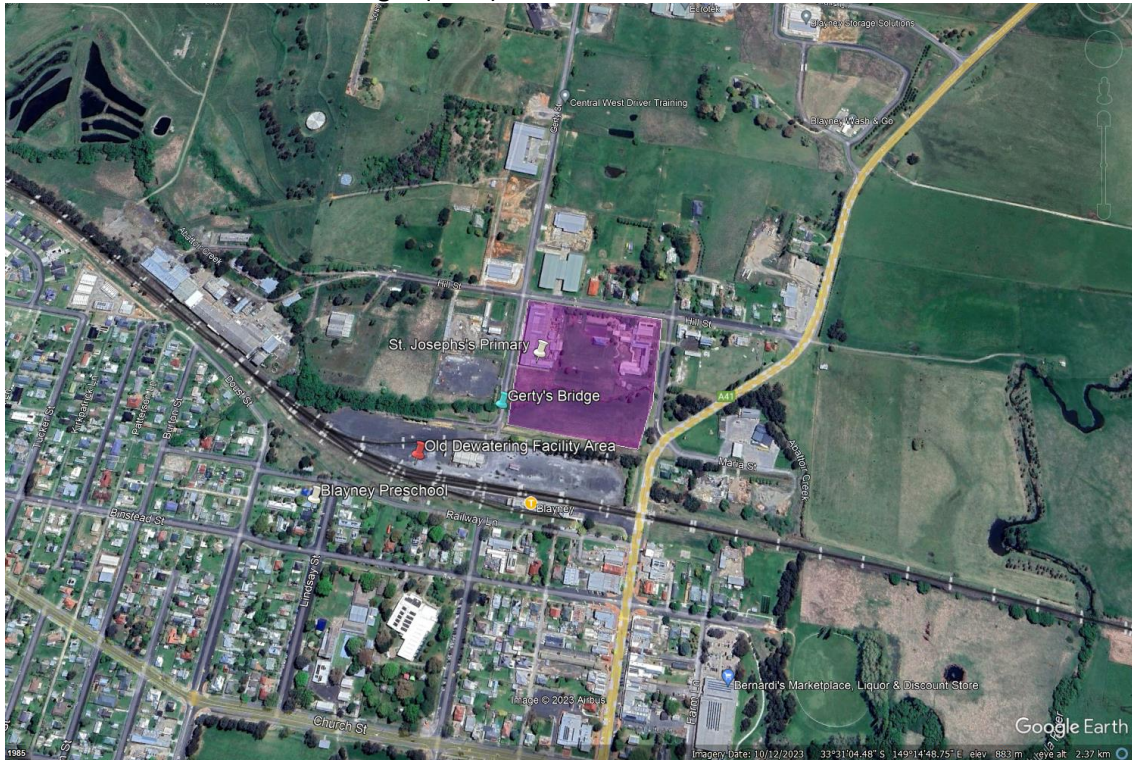
Source – Assoc. Prof Dr. Ian Wright (UWS) and the CCSN

12 August	14 August	Australian Drinking Water Guidelines (Health)	12 August Exceedance of ADWG	ANZECC (River Ecosystem Guidelines) 95% protection	12 August Exceedance of ANZECC
Arsenic	8470 µg/L (=8.47 mg/L)	2 µg/L (=0.002 mg/L)	<10 µg/L	X 847 times	<24 µg/L (but depends on form of As)	X 352 times
Copper	20600 µg/L (=20.6 mg/L)	3 µg/L (=0.003 mg/L)	<2000 µg/L	X 10 times	<1.4 µg/L	X 14714 times
Lead	1520 µg/L (=1.52 mg/L)	<1 µg/L (= <0.001 mg/L)	<10 µg/L	X 152 times	<3.4 µg/L	X 447 times
Nickel	1200 µg/L (=1.2 mg/L)	2 µg/L (=0.002 mg/L)	<20 µg/L	X 60 times	<11 µg/L	X 109 times
Uranium	22 µg/L (=0.022 mg/L)	<1 µg/L (= < 0.001 mg/L)	<20 µg/L	by 10 %	No guideline	No guideline

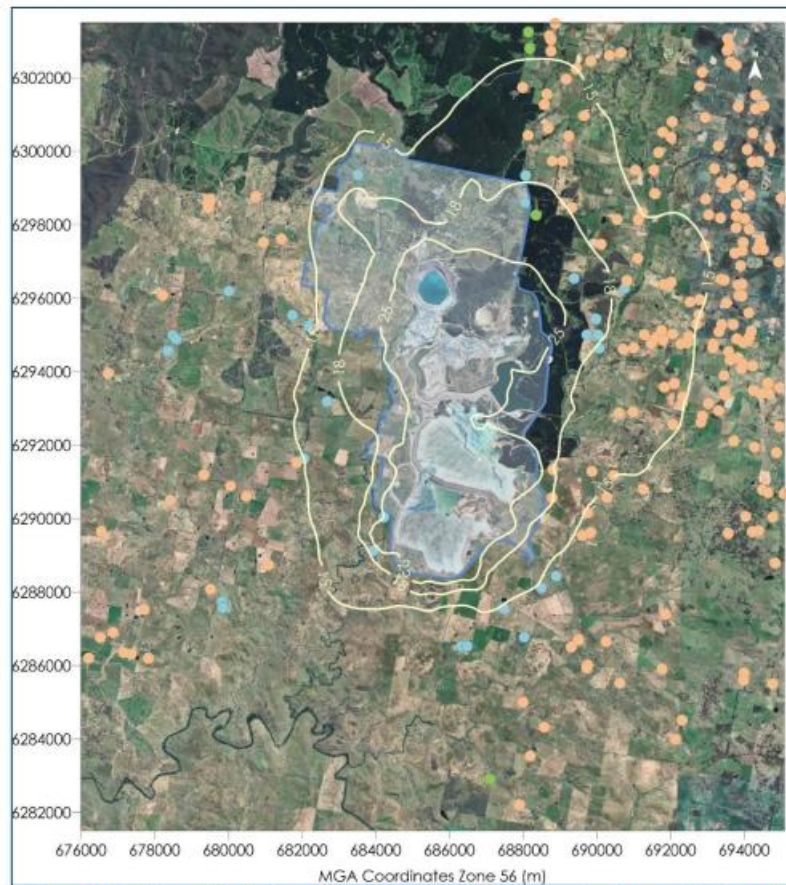
Figure F-6: Sensitivity analysis showing predicted annual average PM_{10} concentrations due to emissions from the Modification and other sources ($\mu\text{g}/\text{m}^3$)

On the basis a precautionary approach is adopted, 10-20% of the PM₁₀ is RCS and there are real concerns in regard to life time exposure to RCS around the CVO mine, refer to Todoroski PM₁₀ isopleth below.

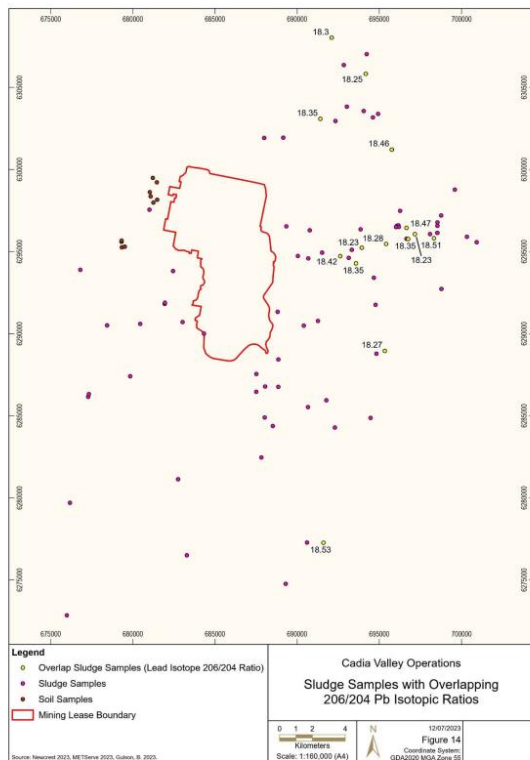
Figure 16. Sludge samples with 206/204 Pb isotopic ratios overlapping the 'Ore field' values.

In addition, we believe we have identified what appears to be a pattern of distribution:

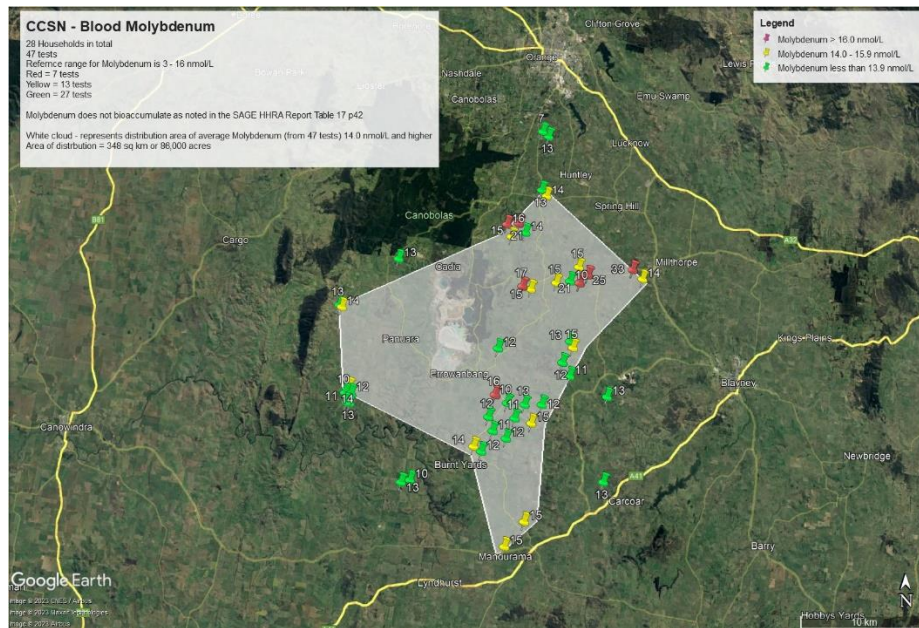
(Appendix D – the above map for clearer viewing)

Residents in the Cadia district undertook a study of blood contamination. The results of this study are summarised in Appendix - D - Section A Parliamentary Inquiry. It was noted as part of this work that there appeared to be a pattern of distribution. There follows a map of the distribution of Molybdenum levels in 47 blood samples (adults and children). We looked at the distribution of above reference range levels (>16 red pin) and close to reference range levels (14-15.9 yellow pin).

The red pin (33) to the east near Millthorpe is a 4-year-old child with a blood level of 33. CVO has a molybdenum plant.
