# Errors and Inadequacies

## SSD-82899468, 1-5 Nelson Rd Lindfield

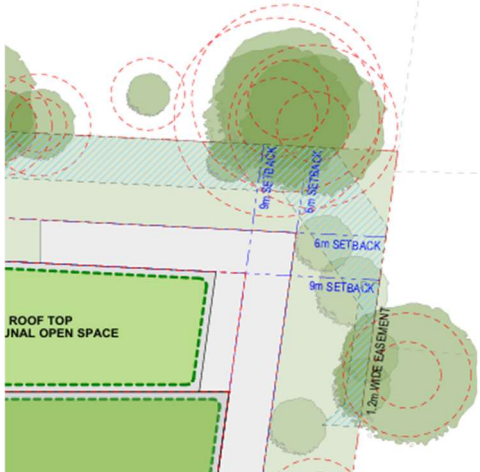
Doc Ref	ID	Error / Inadequacies	Details
	9.2	North-east corner waterway drawn incorrectly	<p>The location of the waterway is not drawn accurately (Diagram 102). As proposed, the building is located partially within the waterway at the north-east corner. Note also that there is a significant drop in height in this area, meaning that the basement levels (ref drawing numbers DA300, DA301 and DA302) would be flooded during construction. Damming and bypass pumping during construction and potentially relocation of the waterway post-construction would be required and has not been considered or detailed.</p>

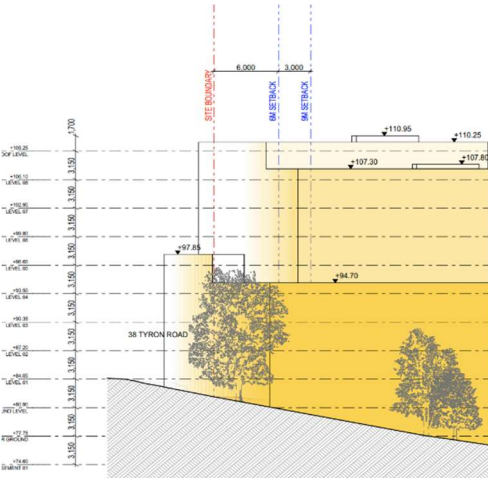
Doc Ref	ID	Error / Inadequacies	Details
	9.3	Building outside boundary	<p>The elevation drawing appears misleading as the building footprint is shown beyond the site boundary. This makes the indicated setbacks difficult to interpret and renders the elevation irrelevant for compliance assessment (DA 201)</p>

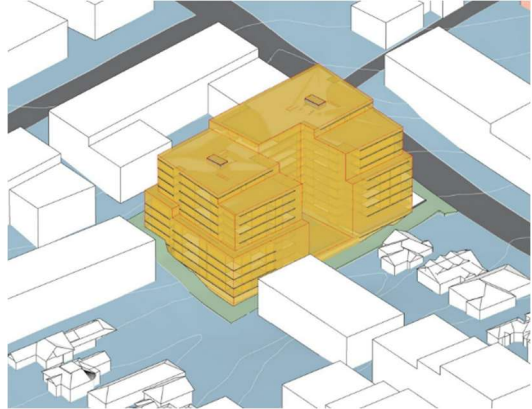
9.17	Inaccurate Eye of the Sun and height limit Diagrams	<p>The diagrams did not reflect the true surrounds of the neighbouring buildings. The model replaces current single and double-storey dwellings with apartment style buildings hence underrepresenting the severity of overshadowing in reality. This undermines transparency and makes it difficult for the assessment authority and residents to understand the true impact (DA402, DA403 and DA404).</p>

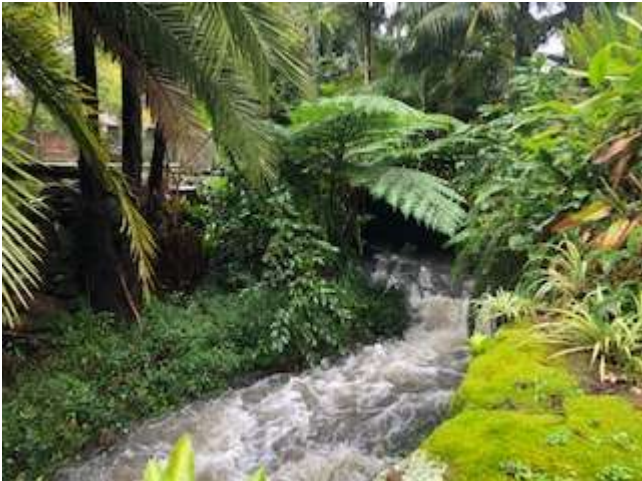
12.5	Incorrect assessment of watercourse by omitting watercourse running through the site	<p>Section 2.3 cites the nearest surface water feature to be “Gordon Creek, located approximately 280m southeast of the site”. It also states the groundwater flow direction is “Inferred to be in a southeast direction, towards Gordon Creek (approximately 290m to the southeast”. (p.6)</p> <p>The nearest watercourse is actually <u>within the site</u>, running through number 5 Nelson Road in an easterly direction. It is a spring-fed, surface water feature that captures both groundwater and surface runoff. Below is a photo, with 5 Nelson Rd dwelling in the background. The assessment of water flow is therefore likely to be invalid and affects the impact on existing on-site riparian zones and proposals for basement excavations.</p>

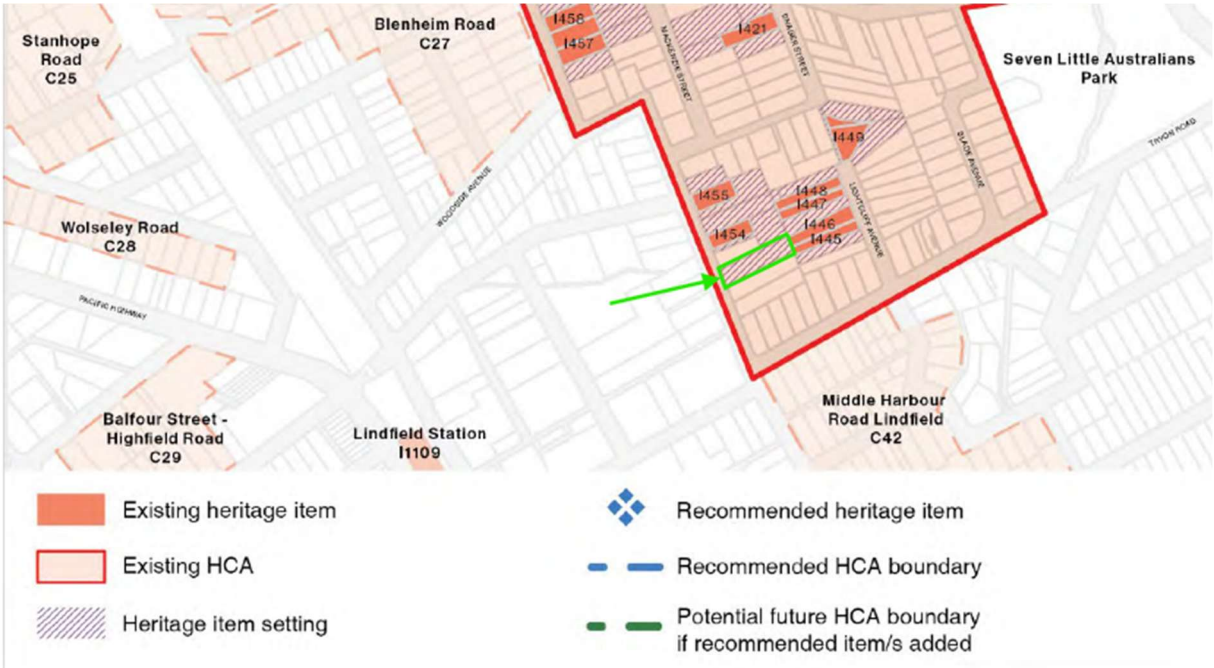
16.8	Inadequate Historical Overview – 5 Nelson Rd	<p>The information provided for 5 Nelson Rd in Section 3.5 (Historical Overview) is substantially deficient compared to 1 and 3 Nelson Rd.</p> <p>Section 3.6 fails to acknowledge that 9 Nelson Rd along with several other adjacent properties to the SSDA site, are identified as Heritage Items and 5 Nelson Rd is identified as a “Heritage Item Setting. (<a href="#">C22 Crown Blocks Conservation Area.pdf</a> p.38). The screenshot below is an excerpt of page 38 of the C22 Crown Blocks Conservation Area document. The green arrow and box below outline the property boundary of 5 Nelson Rd. Whether this property should be allowed to be removed requires clarification.</p>

<p>The map shows a street grid with various heritage items and settings. A red outline highlights the existing HCA boundary. A green arrow points to a potential future HCA boundary for 5 Nelson Rd. The legend includes:</p> <ul style="list-style-type: none"> <li>Existing heritage item (orange square)</li> <li>Existing HCA (red outline)</li> <li>Heritage item setting (hatched square)</li> <li>Recommended heritage item (blue diamond)</li> <li>Recommended HCA boundary (blue line)</li> <li>Potential future HCA boundary if recommended item/s added (green line)</li> </ul>

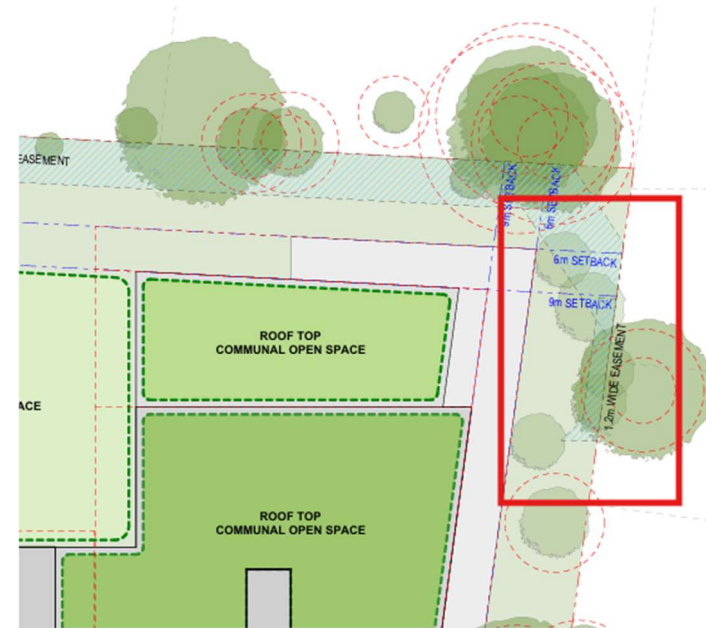
A second easement (/discharge) is detailed in architectural drawing DA102 near the northeast corner of the proposed site – see screenshot below - but does not appear to be from the detention pit. Details of what is collected and discharged from this second discharge site has not been detailed and could lead to uncontrolled downstream flooding.

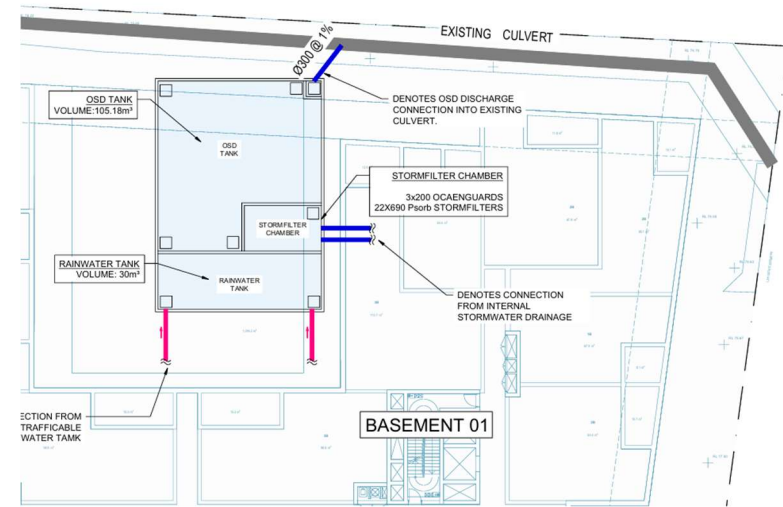
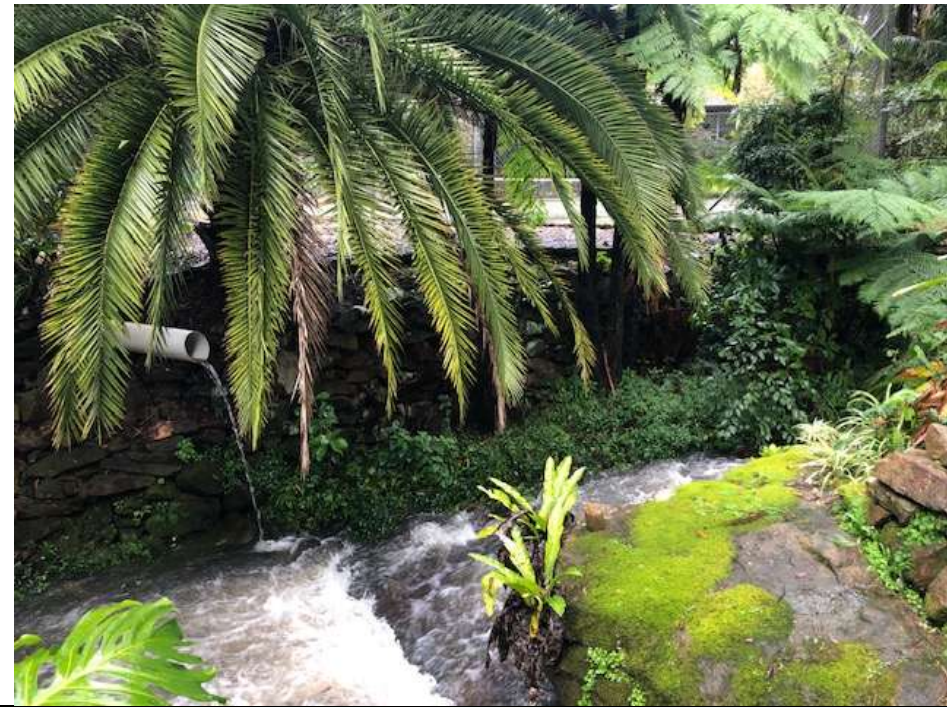
Drawing S01-SW302 from SGC (screenshot below) acknowledges the easement but does not include details of what it will be used for. A photo of this second existing 300mm diameter outlet is also shown below.
