# REMEDIAL ACTION PLAN

**Lots 14 and 15 Section L DP 8993**  
**No. 7 James Street**  
**Argenton**

for  
**Alesco Senior College**  
**C/o: Untapped Planning**

Ref: 2019233

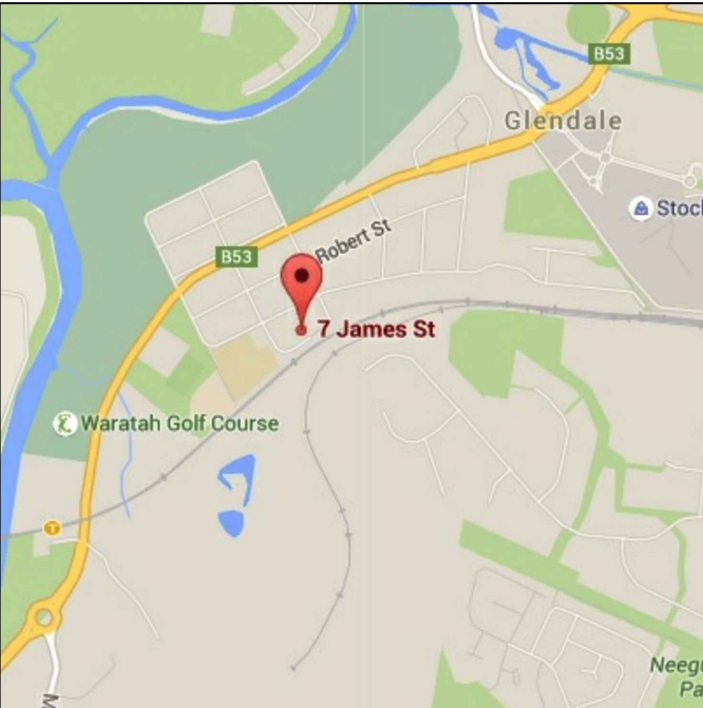
SCALE  
NOT TO SCALE  
DRAWING No.  
2019233-SIT-01  
REVISION  
0

LEGEND:  
BH1/TP1 - APPROXIMATE BOREHOLE/TESTPIT LOCATION

TITLE  
SITE PLAN  
LOTS 14 & 15 SECTION L DP 8993  
No. 7 JAMES STREET  
ARGENTON

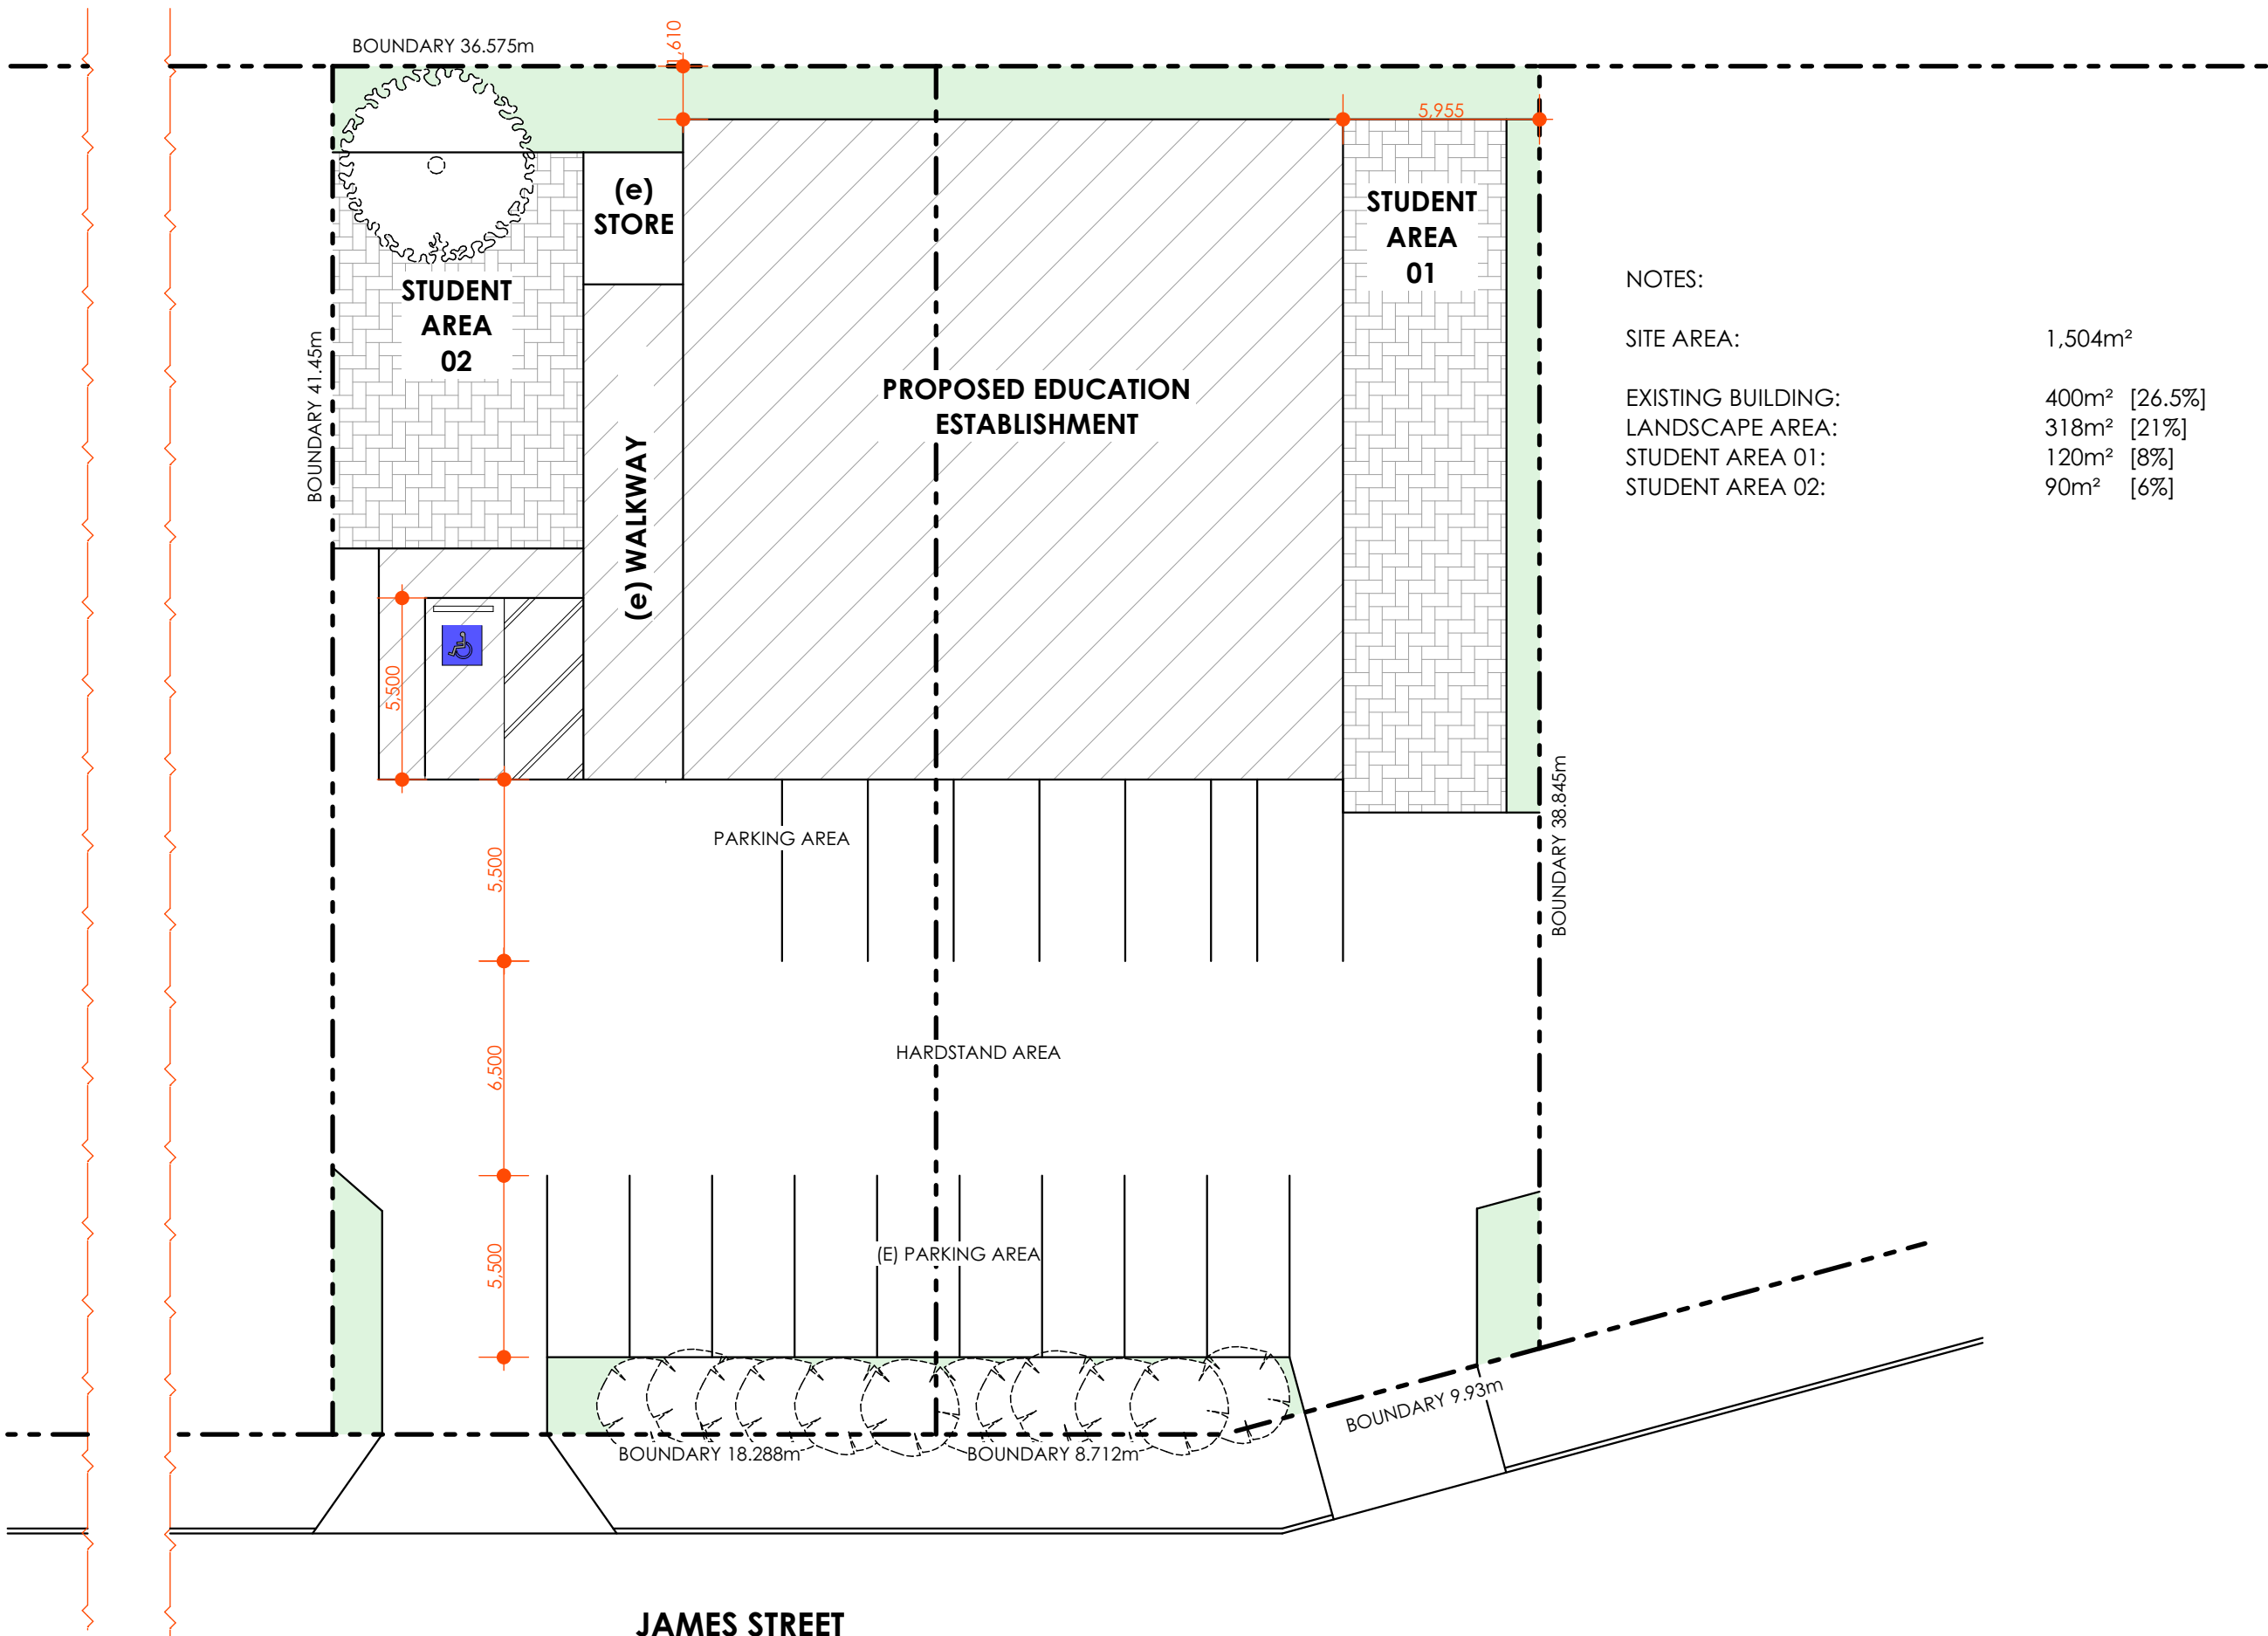
A-01

Site Plan

Client	UNTAPPED PLANNING	Sheet:	
Drawn By:	DMc	Issue Date:	24/10/2018
Scale:	1:200		
Drawing Title:	SITE PLAN	Project No:	2018-150
		Revision No:	C
