Re: Foxground and Berry Bypass - The Roads and Maritime Services (RMS) is seeking approval under Part 3A of the *Environmental Planning and Assessment Act 1979* to upgrade 11.6 kilometres of the Princes Highway between Toolijooa Road north of Foxground and Schofields Lane south of Berry.

As owners of the 'Glenvale' property (CH12250 to CH 13750) which is impacted by the upgrade we wish to lodge our submission to the NSW Department of Planning and Infrastructure so that our concerns can be considered.

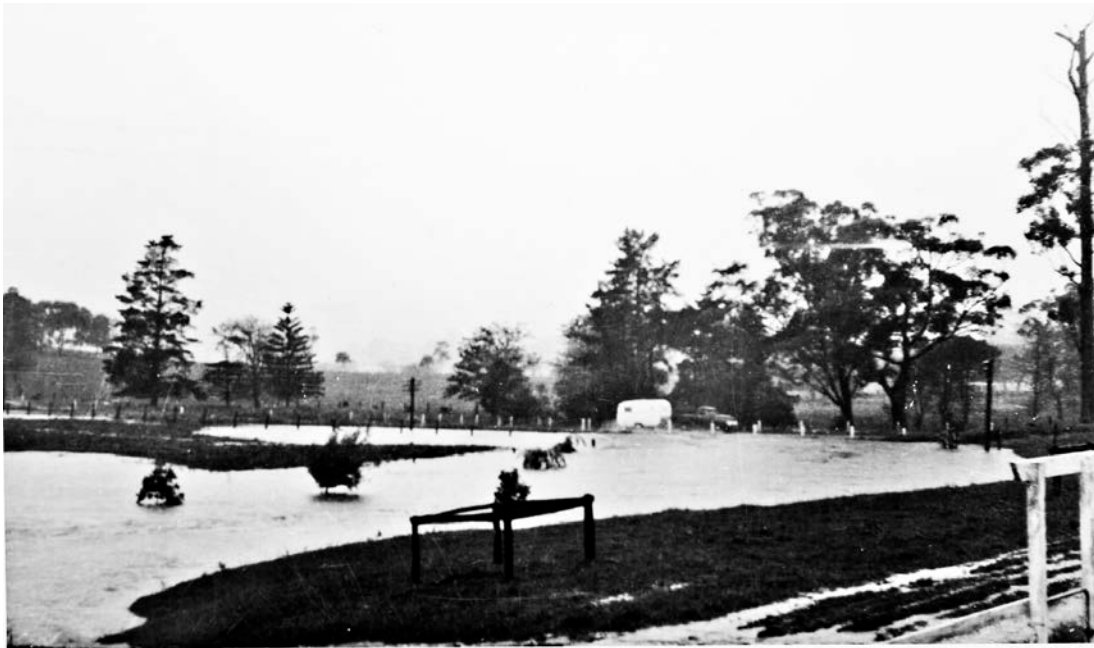
Below is a family photo which shows water overtopping the highway in 1959.

Our family has owned the property since 1950 and as you can see from the following family photos, the present highway has been overtopped by flooding from the creek at 'Glenvale' on many occasions during that time (some 60 years) at CH 12800. Our discussions with RMS office staff suggest to us that they are unaware of this and in the EA there is no mention of the overtopping which occurs regularly at this point. We have been advised to include these photos in our submission to show that this does occur.

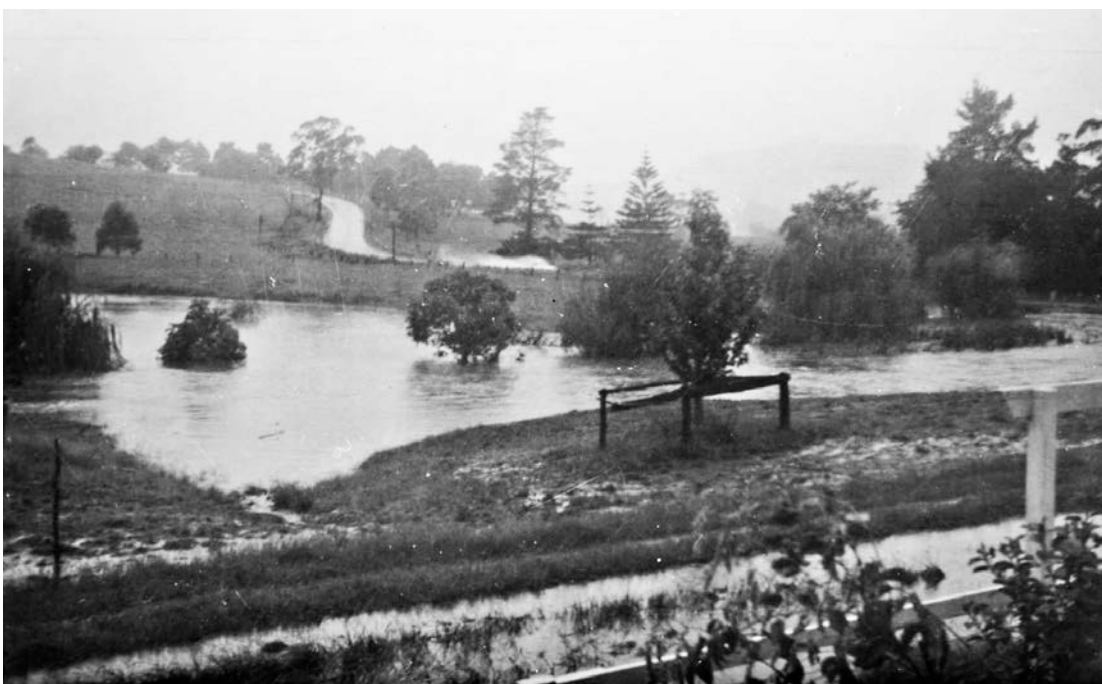
And again in another family photo of flooding at 'Glenvale' dated 1963.

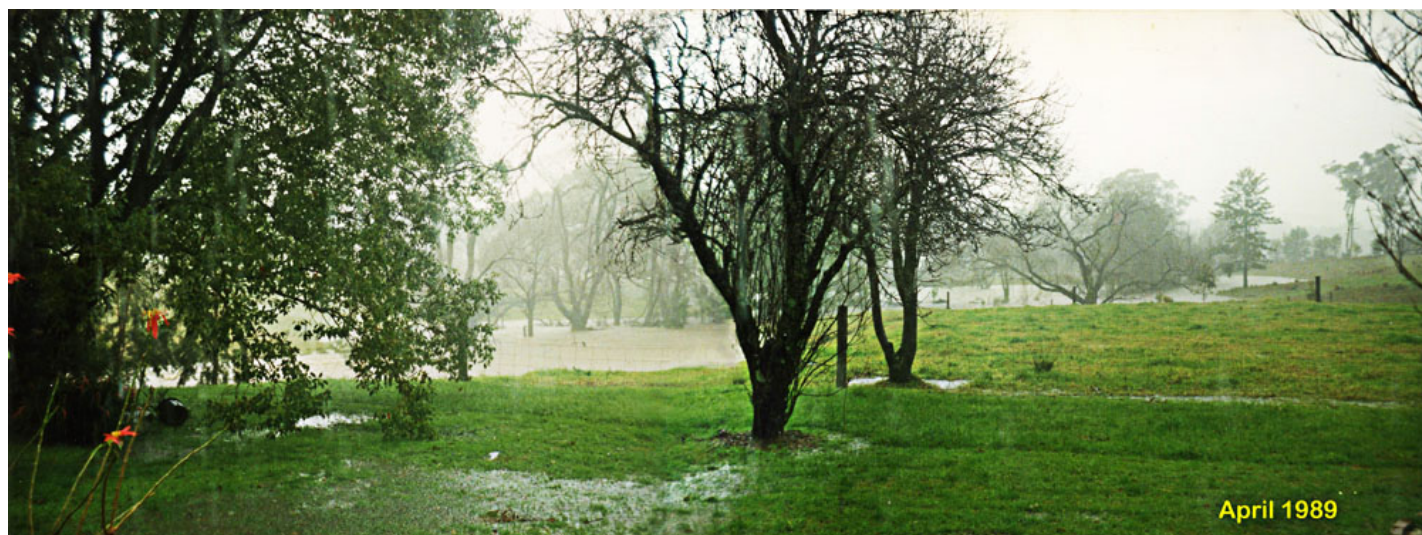
Pictured below - flooding of the creek looking towards existing highway from front verandah of heritage residence at 'Glenvale

The 21st March 2011 the present culvert's capacity was exceeded and the flood level overtopped the Princes Highway and came to the bottom of the Armco railing which is 300mm above the road surface. The flooding occurred for a 40 metre length along the highway above the culvert, but it is beyond our capability to calculate the volume of water that exceeded the culvert's capacity.

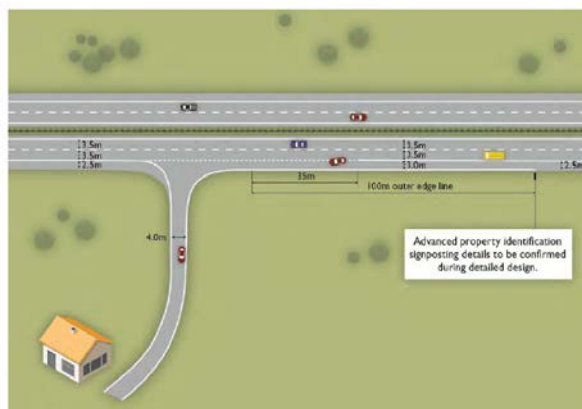
Figure 4-15 Typical rural property access (lengths shown are indicative only)

1. Emergency Fire brigade in the event of bush fire
 2. the maintenance crews servicing the Eastern Gas pipeline
- The access to 'Glenvale' (as illustrated in the diagram below from Pg 83 in Chapter 4) shows positive changes such as the increased radius of entry into the property, extra sight distance, level gradient of road surface and extra shoulder width (acting as a deceleration lane). Hopefully these changes will outweigh concerns relating to turning left straight into oncoming traffic flows travelling at 100kph (or more) without a designated acceleration lane. Hopefully driver courtesy will prevail to ensure our safety.

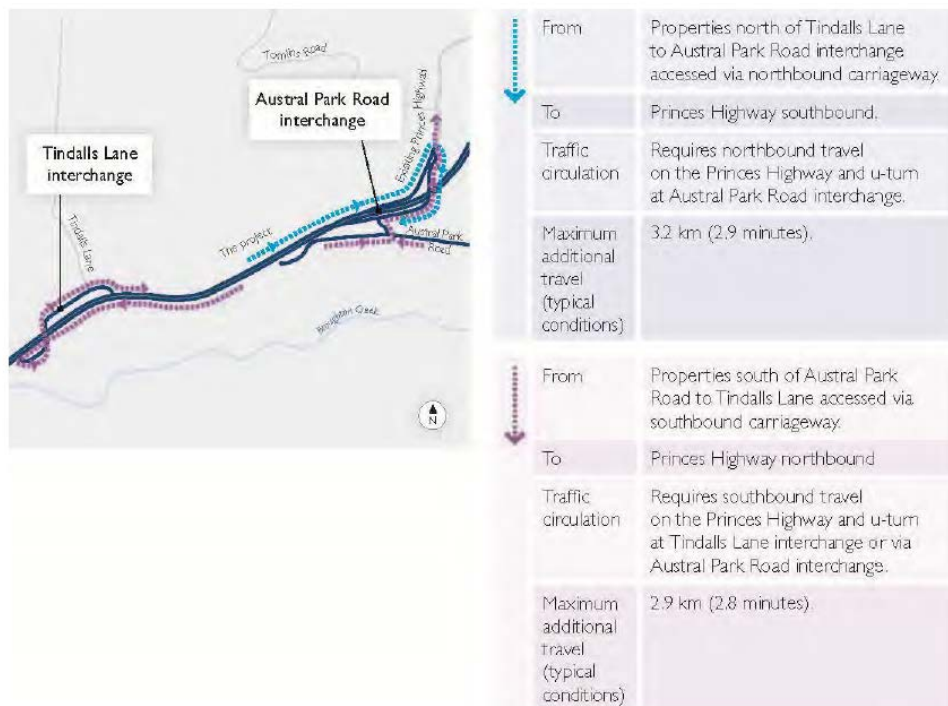
Figure 7.6: Access constraints - Tindalls Lane to Austral Park Road

(Source: AECOM, based on data from Gabites Porter Consultants sub-area TRACKS model)

- An added concern is for parents dropping off/picking up children at the bus pick up bay in Tindalls Lane because the extra travel distance and time involved and the added stress this may cause.
