Ku-ring-gai Council: heritage comments on Lindfield Learning Village Stages 2 and 3

Heritage impact external

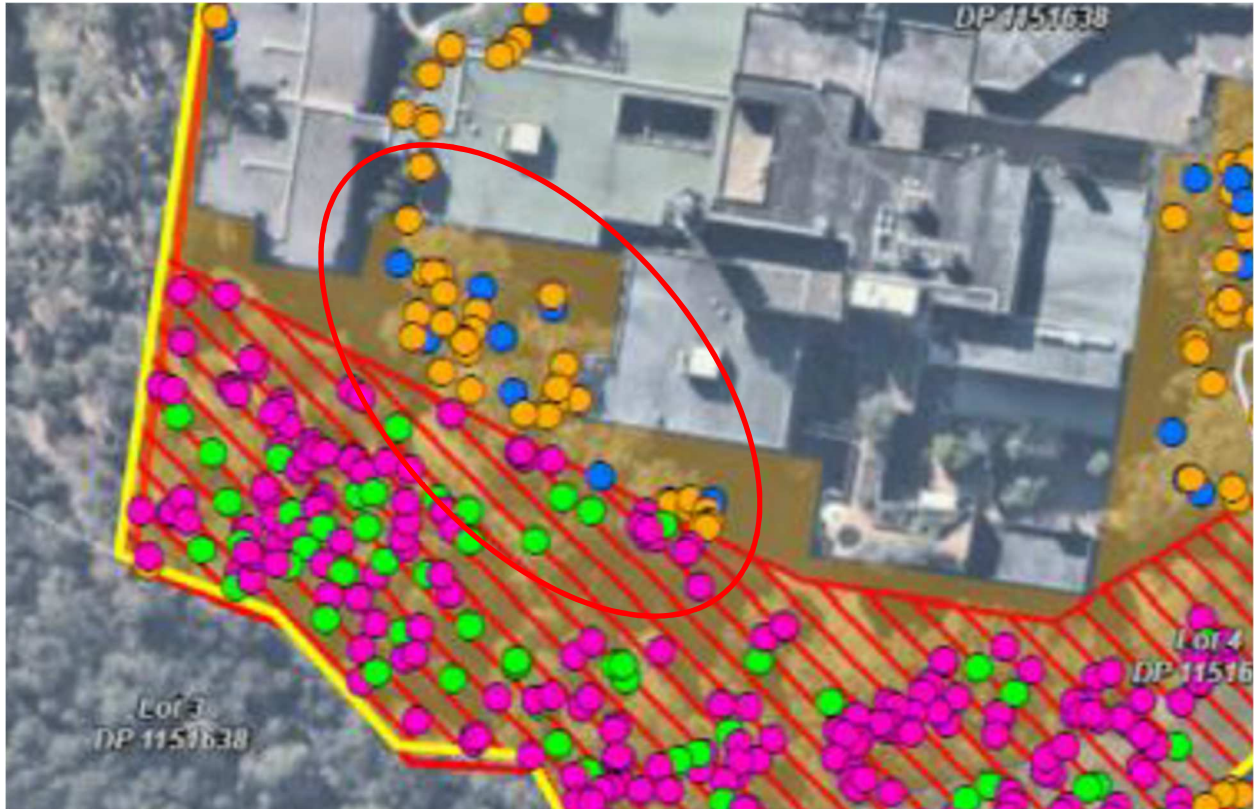
Figure 1: Proposed tree removal plan. Yellow and pink trees to be removed. (Source: Kleinfelder Landscape Management Plan August 2018)

It is noted that although the majority of the trees within the immediate context of the school would be removed. The plan below shows that some of the largest trees on the site would be retained. This includes some trees in close proximity to the building.”

Figure 2 Proposed tree removal plan showing area for IPA – Parkland (Stage 1 Assessment of Heritage Impact, Urbis, 2018) lists the following tree numbers for removal and retention:

This assessment lacks an analysis of where these trees are sited and the localised impact of their loss as opposed to a numerical assessment of the total loss of trees for the total site. The clearance of the inner ring closest to the building has already been severe.

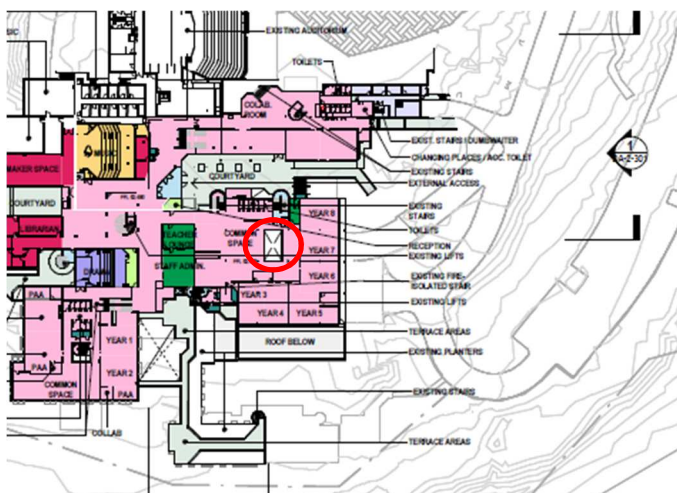
Figure 2: Level 4, proposed are of slab to be removed circled in red

The partial demolition of the slab on level 4 and above the former library to improve light penetration will result in the minimal loss of original fabric. The “horizontal window” or glass flooring is the preferred option for the treatment of the new opening.

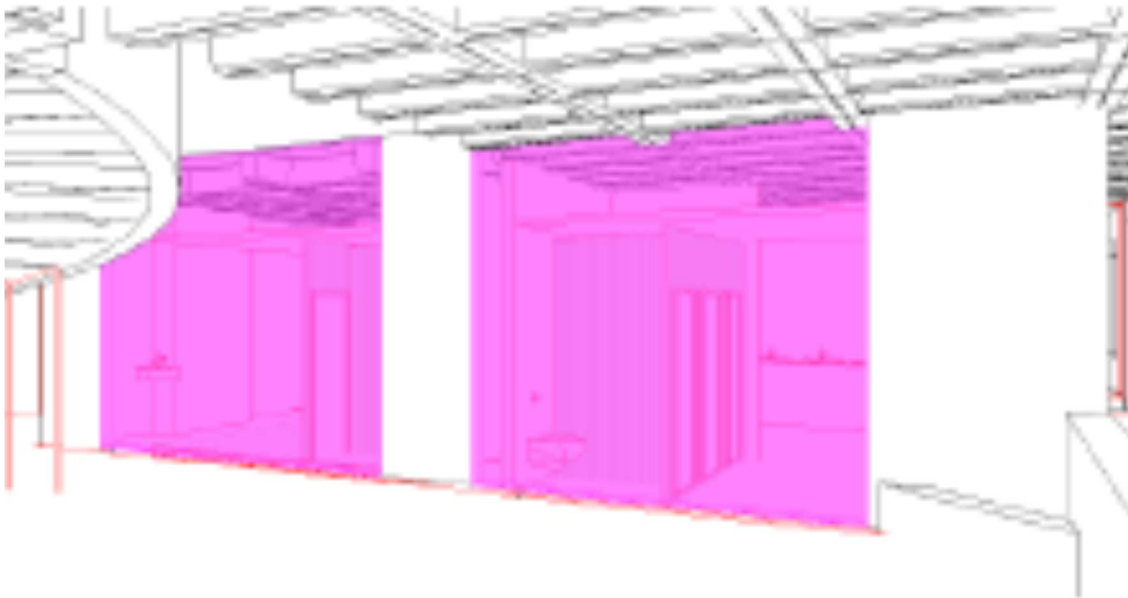
Figure 3: section of concrete wall to be removed (Source: Lacoste Stevenson)

facility. The unnecessary and seemingly optional removal of this wall so close to such a significant element being the spiral staircase cannot be supported. Alternative solutions to provide light should be explored and the wall retained. A secondary option would be the use of a high-light window which will allow light but keep most of the wall intact as opposed to such an excessive and generous opening.

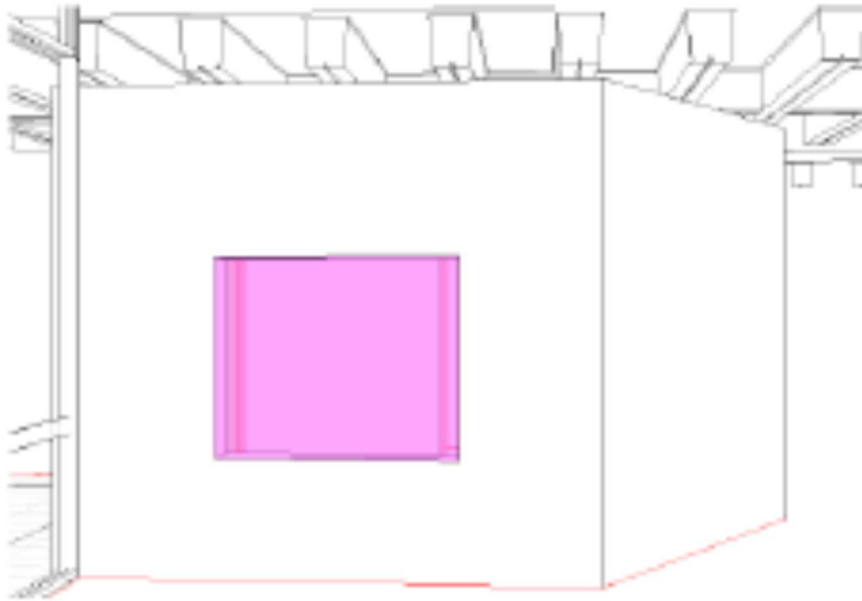
Figure 4: section of concrete wall to be removed (Source: Lacoste Stevenson)

The removal of highly significant fabric for essential needs where suitable alternatives cannot be found is unfortunate but can be accepted in the greater scheme. To create a reception area at the Level 4 main entry is considered as essential. Of the options option 3 has the least impact and is supported.
