Epping to Thornleigh Third Track

**Submission by John R Marcer BE(Civil 1967) MEngSc(Construction 1970)
MIEAust CPEng(1989- 2008)
(Principal Design Engineer Bridges, FreightRail 1990 – 1995
Safety and Standards, CityRail through to RIC 1995 to 2003
AS 5100 Bridge design, NSW railway representative on 4 subcommittees
and later on main committee 1997-2005)**

Executive Summary

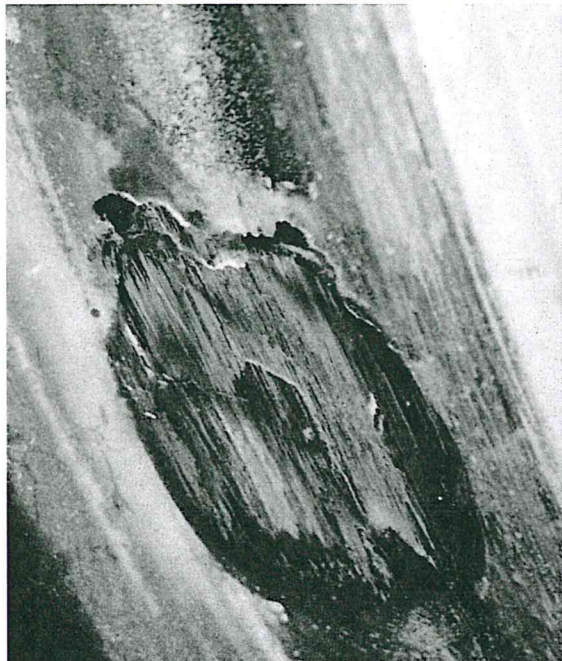
Figure 1 Wheel Flat close to 100 mm – Class 4 skidded wheel

Wheel flats are the most commonly thought of wheel defect. See Figure 1 showing class 4 skidded wheel. This is because they are very audible, with a regular annoying impact on every revolution, and are easily measured. Because wheel flats are so easily identified they are removed from service in relatively quick time. These and other defects concentrated at one point on the wheel circumference are the most significant defects on conventional tread braked vehicles.
