ARMIDALE REGIONAL LANDFILL

Hydro-Geotechnical Assessment

Armidale Dumaresq Council Landfill Facility Hydro-Geotechnical Assessment

Report Number 20969.13861

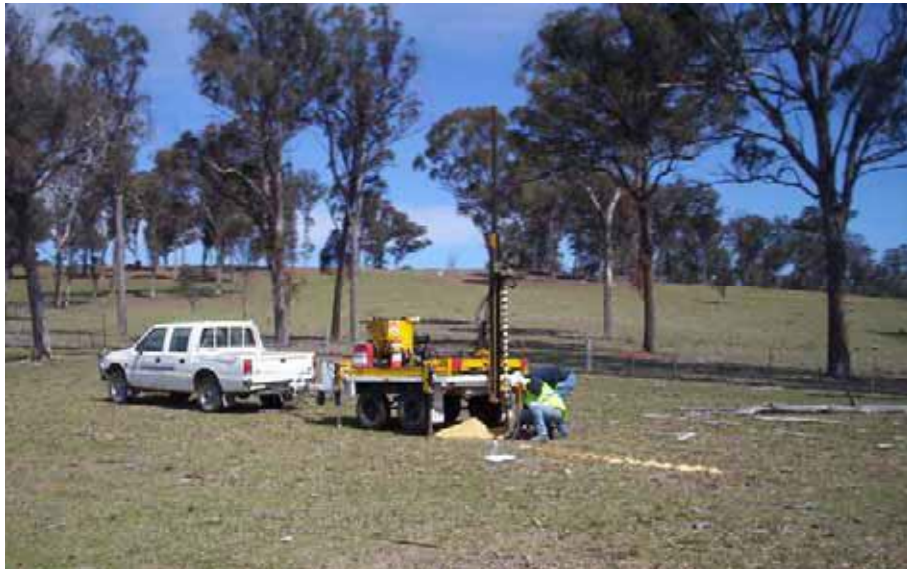
Plate 1. The E.A. Systems light drill rig at Bore Hole 1.

The bore holes were dug using a light, trailer mounted drill rig (Plate 1). Most holes were drilled to a depth of approximately four metres, or until refusal. Several deeper pilot holes were drilled to a depth of 5.5 metres.

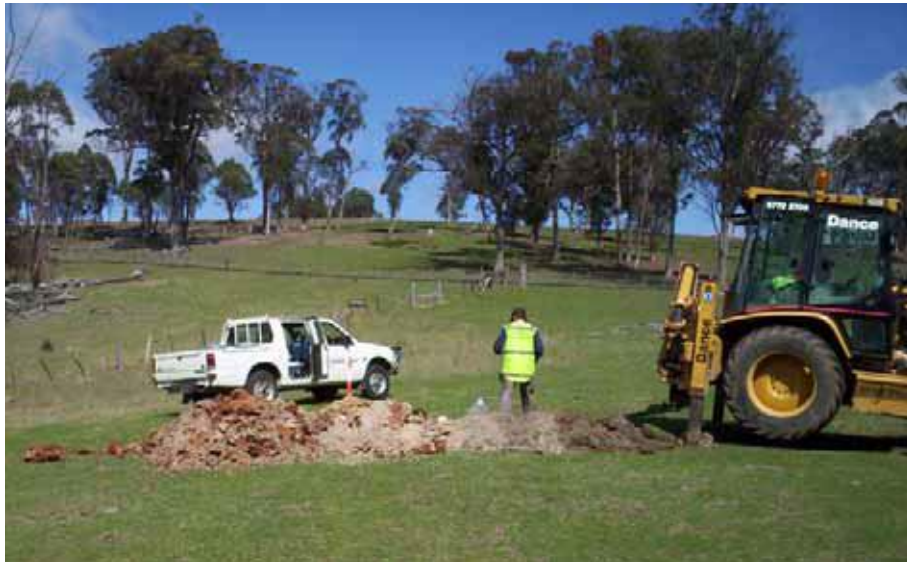
Plate 2. Pit excavation with a backhoe at Test Pit 2

The nine test pits were excavated with a backhoe to a depth of approximately 1.5 metres (Plate 2). The pits were excavated to allow the collection of bulk samples and to gain a greater understanding of the soil profile.

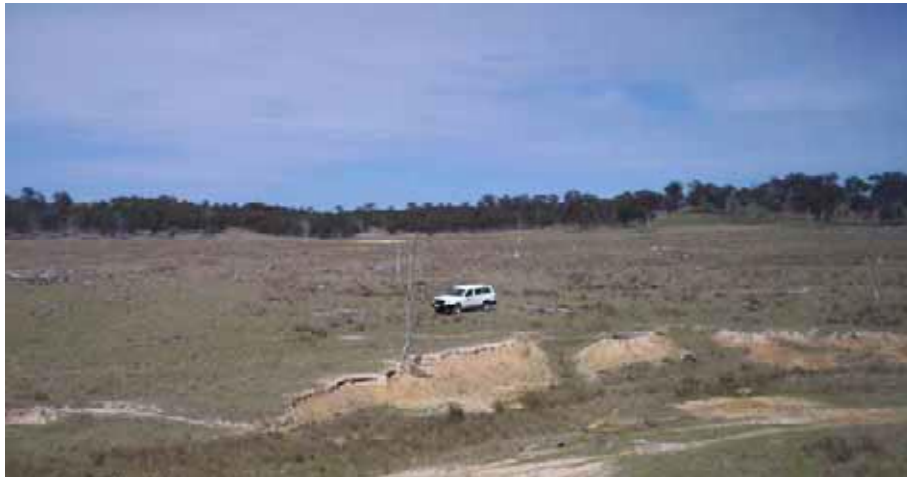
Plate 3. The 'flats' running down to the creek line (photo taken from across the main drainage line looking south up towards the proposed landfill).

The site can be broadly broken down into four areas based on the EM survey, landform and soil profiles; the 'flats' running out to the creek line (Plate 3), the toe of the slope, the wooded midslope (Plate 4) and the rocky crests of the hill (Plate 5). Figure 4 shows the delineation of each of these areas and how they relate to site topography and the location of the bore holes and test pits. With the exception of the hill crest where the profile was generally shallower and contained more rock and bedrock outcrops, the soils were relatively uniform across the site.

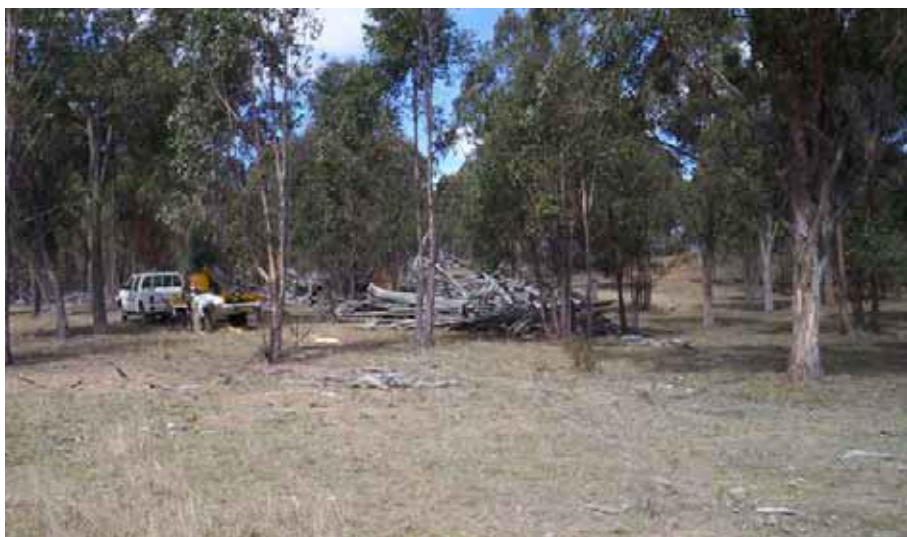
Plate 4. Typical area of the wooded midslope area.

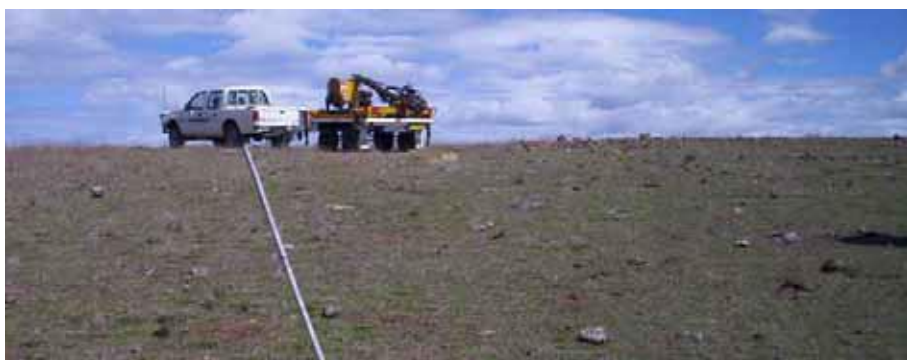
Plate 5. Typical hill crest (near Bore Hole 13).

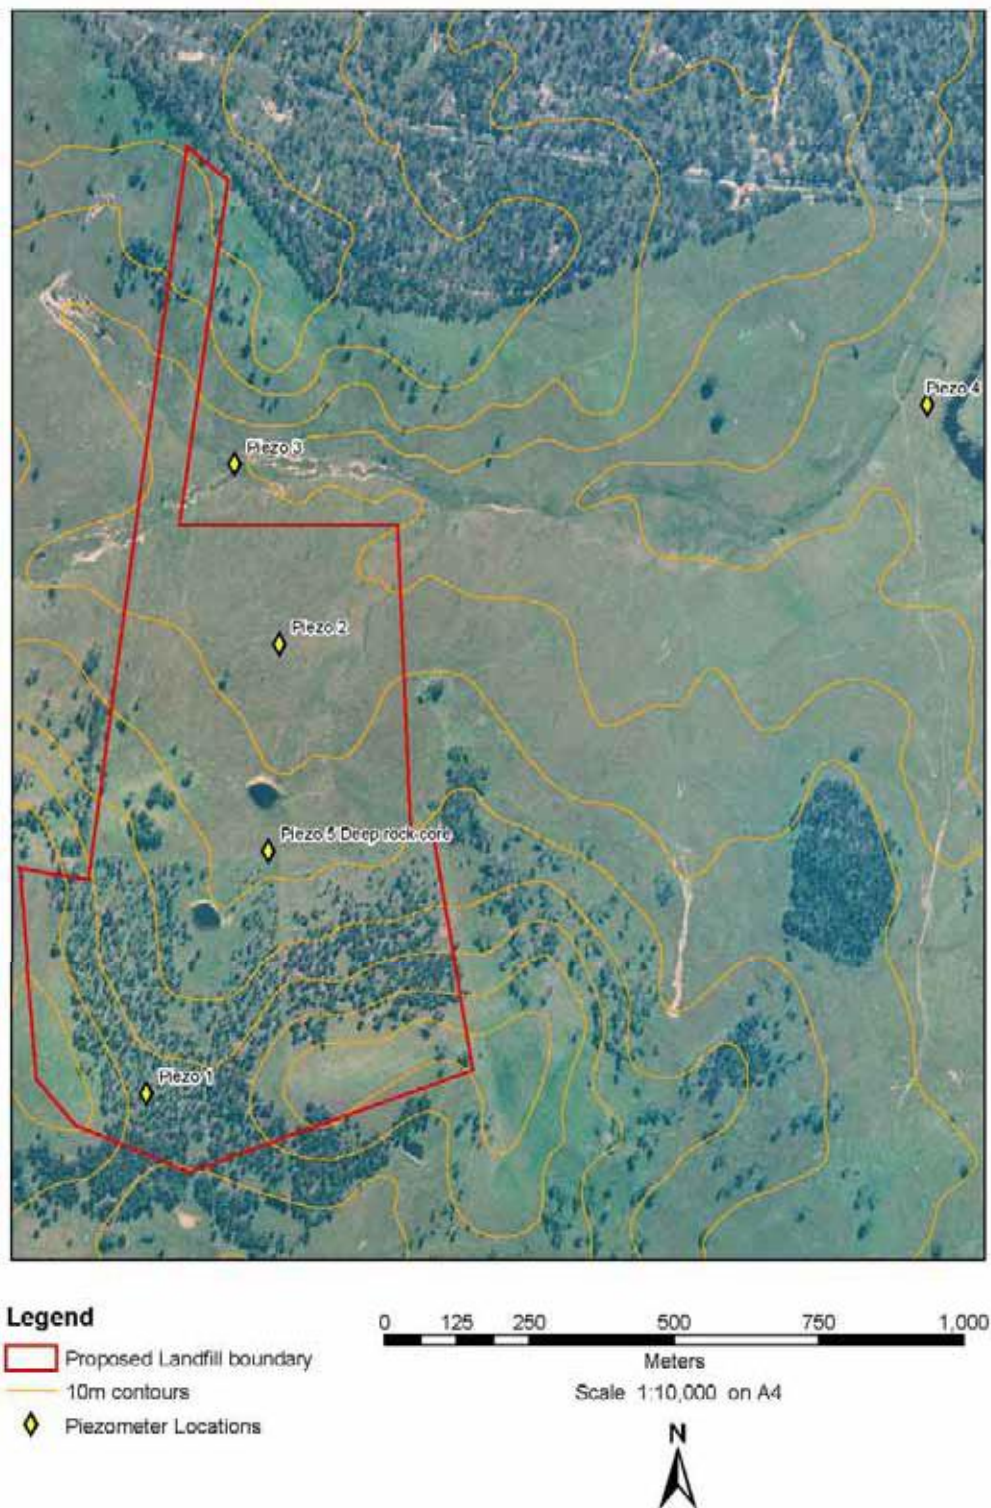
Figure 6. Piezometer locations

Four piezometers were installed on the site on the 13th October 2005 (Figure 6 and Table 3). Piezometers one, two and three were installed with interception screens ranging from depths of 0.35 to 2.0 metres. The screen depth indicated the depth at which shallow groundwater was most likely to move through the gravel layers, and also the layers that were most likely to be impacted by the proposed landfill site. Piezometer one was placed on the ridge at the southern end of the site to provide an indication of unaffected groundwater as it enters the site. Piezometer two is located on the flats at the lower end of the proposed site and will indicate the quality of groundwater leaving the proposed site. Piezometer three is located beside the gully north of the proposed site and will provide background data on any unaffected groundwater moving along the natural drainage line that enters the Gara River. Piezometer four was placed adjacent to the Gara River with screen at a depth of 1.1 to 2.6 metres. Piezometer four will provide an indication of any groundwater entering the potentially sensitive receptor of the Gara River.

A vertical, deep diamond drill core was drilled to a depth of 26 metres in the location shown in Figure 6 (Piezo 5 Deep Rock Core). The drill core from five to 26 metres was collected and logged by Associate Professor Paul Ashley (Department of Earth Sciences, University of New England). The top five metres of the profile was discarded as recovery of the weathered material was poor.
