Proposed Residential Subdivision at Lot 112 DP1073791 Lyons Road, North Bonville

Preliminary Groundwater Assessment

301015-01381 – 301015-01381-SS-REP-0001

17 May 2010

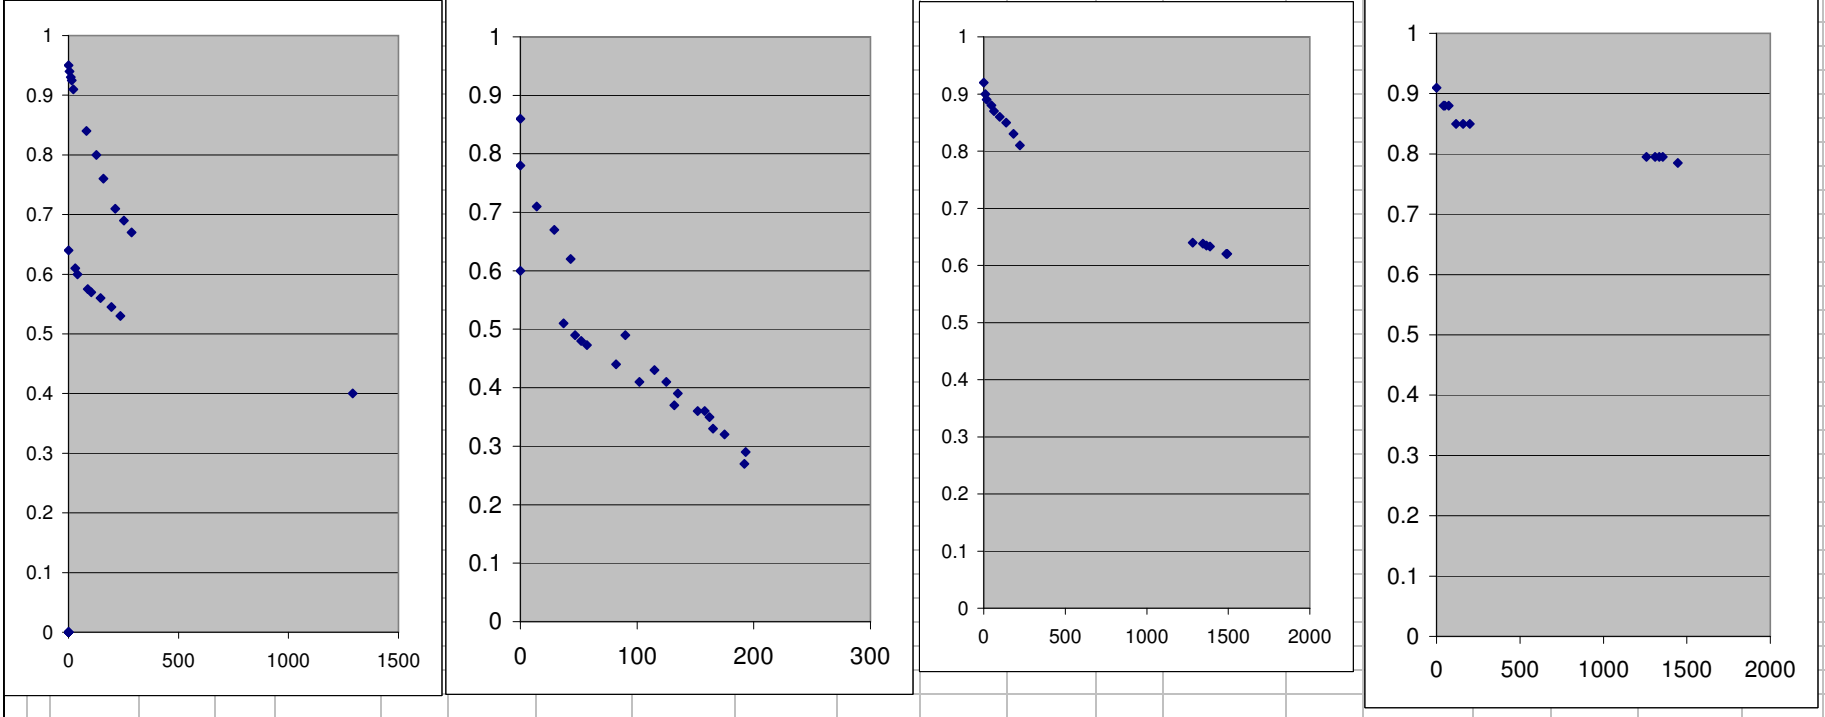
MW1					MW2					MW3					MW4				
Depth =	1.13		L=	1.13	Depth =	1.07		L=	1.07	Depth =	1.05		L=	1.05	Depth =	1.06		L=	1.06
Date	Time	Water Level	Elapsed Time (min)	Height h (m)	Date	Time	Water Level (m bal)	Elapsed Time (min)	Height h (m)	Date	Time	Water Level	Elapsed Time (min)	Height h (m)	Date	Time	Water Level (m)	Elapsed Time (min)	Height h (m)
14-Sep-09	11:38:00	0.18		0.95	14-Sep-09	12:52:00	0.21		0.86	14-Sep-09					14-Sep-09

(t1, h1)	=	252.0	0.69	(t1, h1)	=	0.86	(t1, h1)	=	222.0	0.81	(t1, h1)	=	1335.0	0.80	
(t2, h2)	=	287.0	0.67	(t2, h2)	=	43.0	0.62	(t2, h2)	=	1281.0	0.64	(t2, h2)	=	1446.0	0.79
C		0.168		C		1.356		C		0.923		C		0.042	
Hydraulic Conductivity, k			1.4E-07	Hydraulic Conductivity, k			9.6E-07	Hydraulic Conductivity, k			2.7E-08	Hydraulic Conductivity, k			1.2E-08
