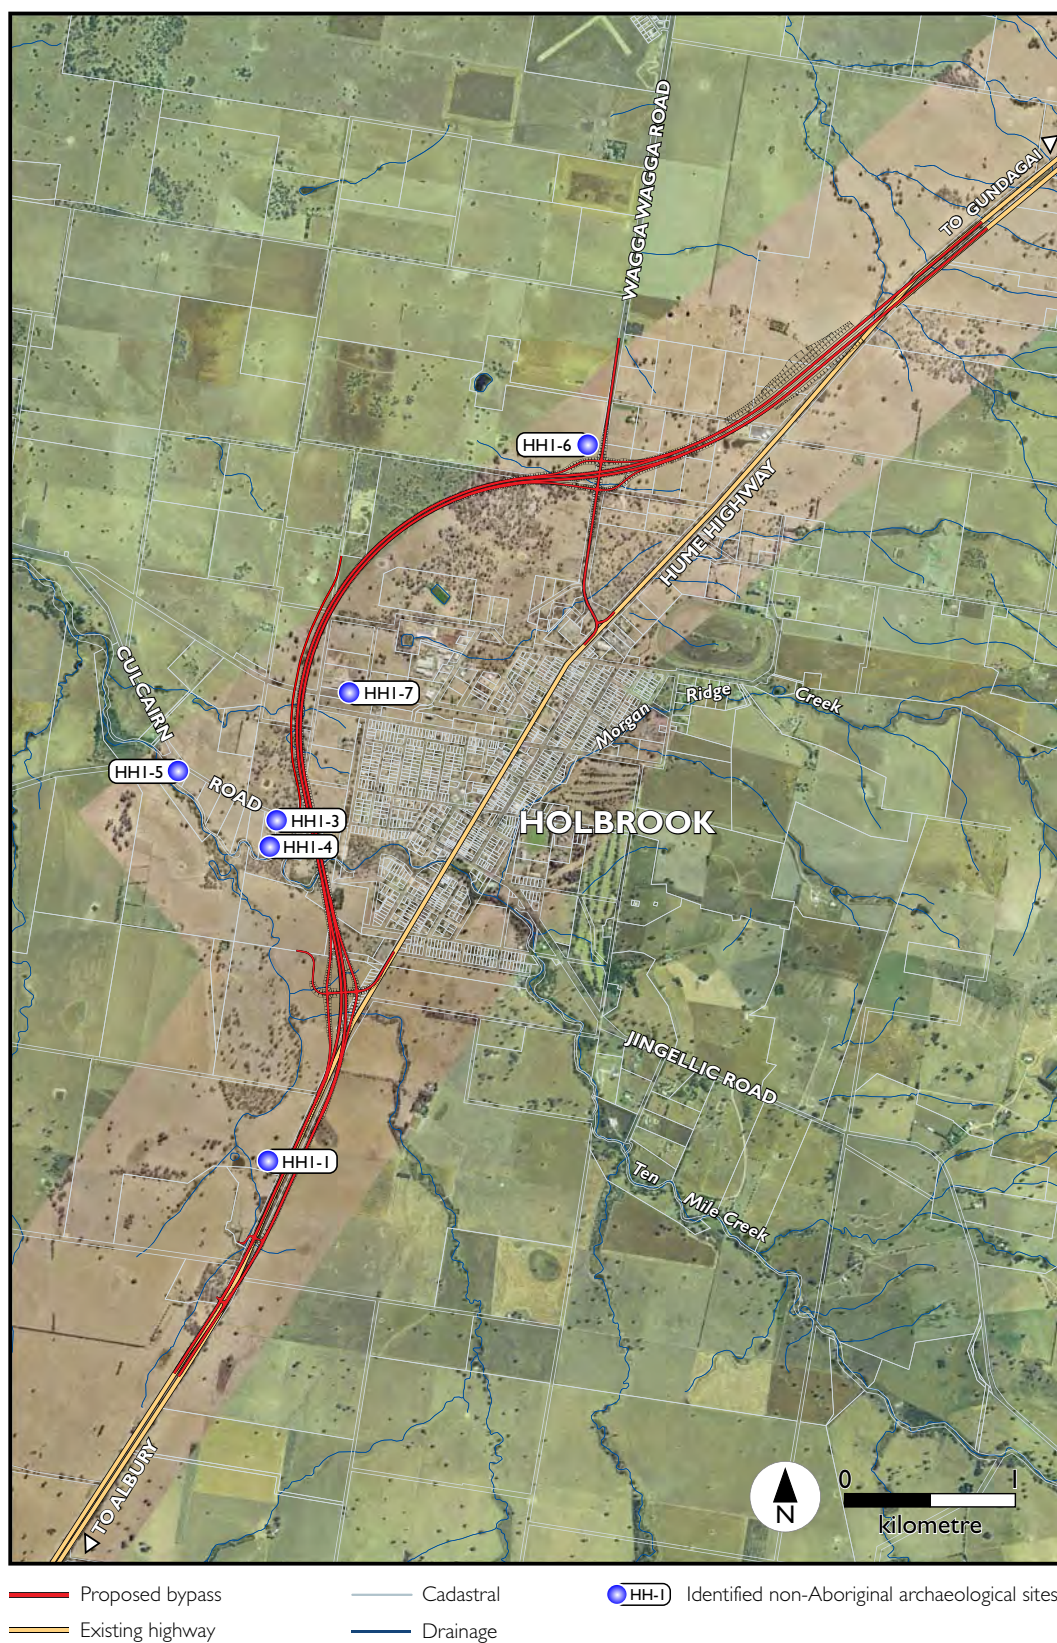
Figure 10-5 Location of identified non-Aboriginal heritage sites/items in the assessment area
