2.0 Assessment of Archaeological Potential

2.1 Historical Summary

2.1.1 Bennelong Point

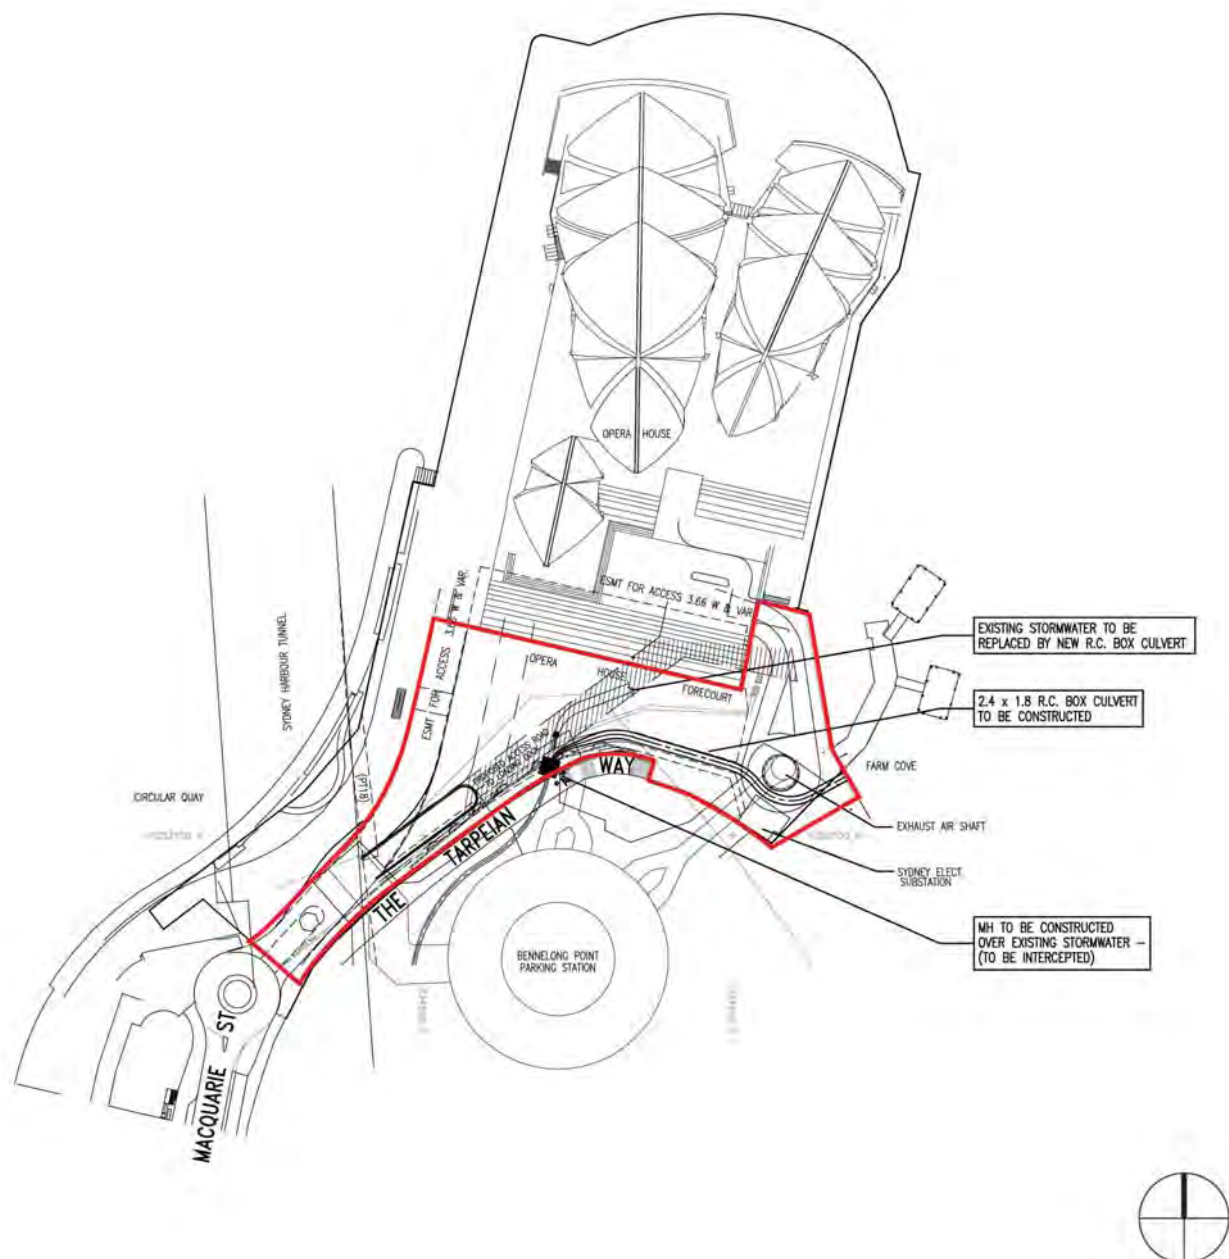
Figure 1.2 Plan of the Sydney Opera House site with the study area outlined. (Base plan courtesy of SOHT)
