Maritime Design Report

Barangaroo Headland Park Maritime Works, Concept Design Report

Author	Peter Masters	
Checker	Greg Riordan	
Approver	Peter Masters	
Report No	1 Rev 2	
Date	9 September 2010

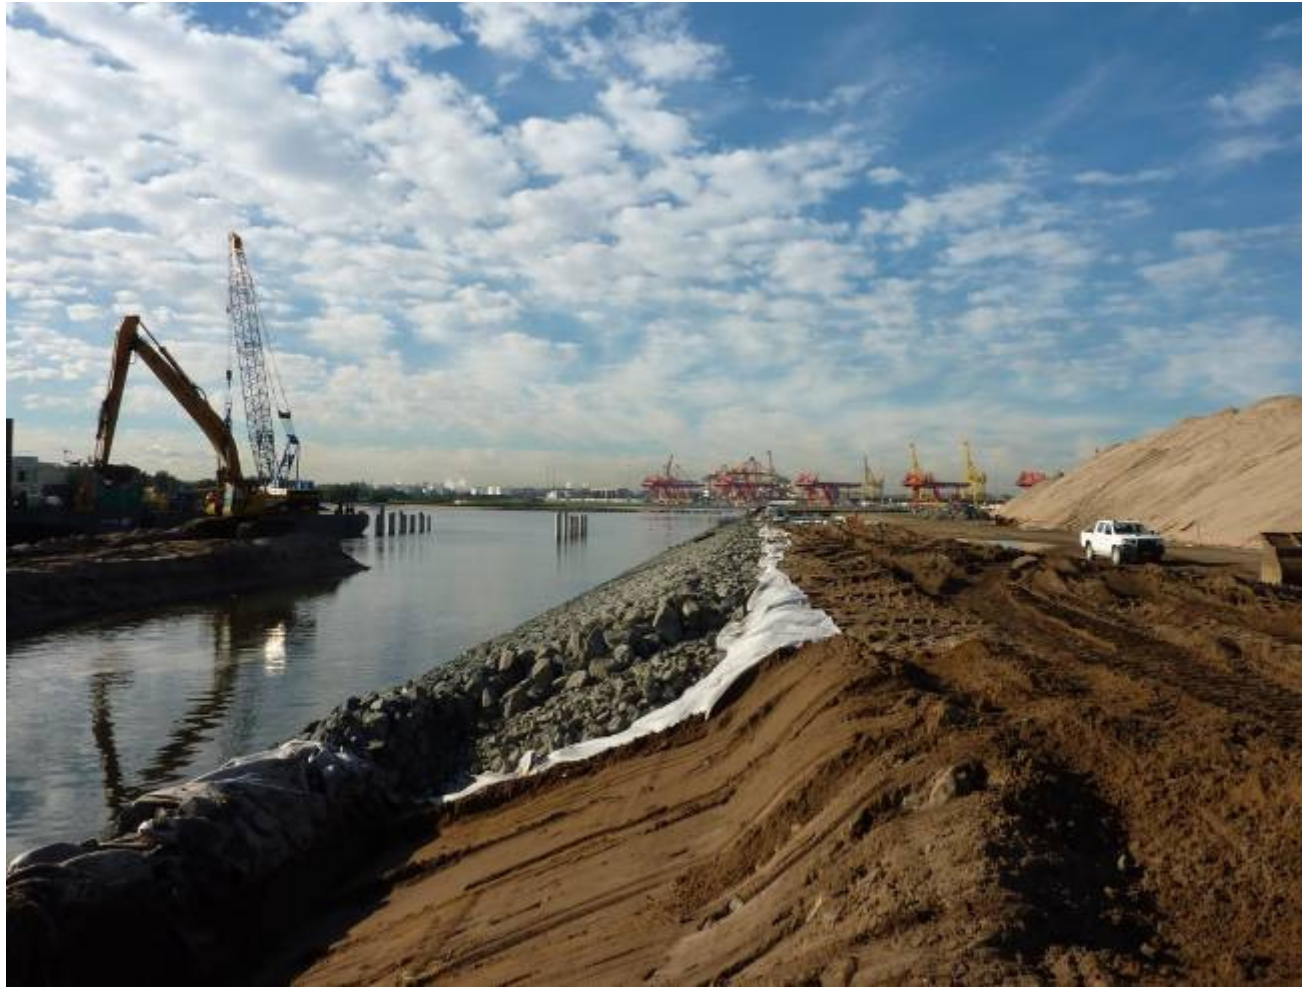
Photo 1: Rock Armour: Large Rock Armour Rocks over geotextile protection layer over geotextile on embankment.

A number of structure types were examined for the section below low water including diaphragm walls, contiguous pile walls, secant pile walls, CFA pile with jet grout between, gravity walls such as counterforts, caissons, jet grout, however an embankment with rock ballast (amour, rip rap) facing solution was chosen as it was the most cost effective and could be placed in the wet if required. Refer Photo 1 and Concept Design Sections on SK02 and SK03 for details

The thickness of rock armour has been increased to 900mm in the base areas and 1400 thick on the slope to allow for placement under water. This will be revisited at detail design with the view of reducing it, however at this stage it provides a good contingency

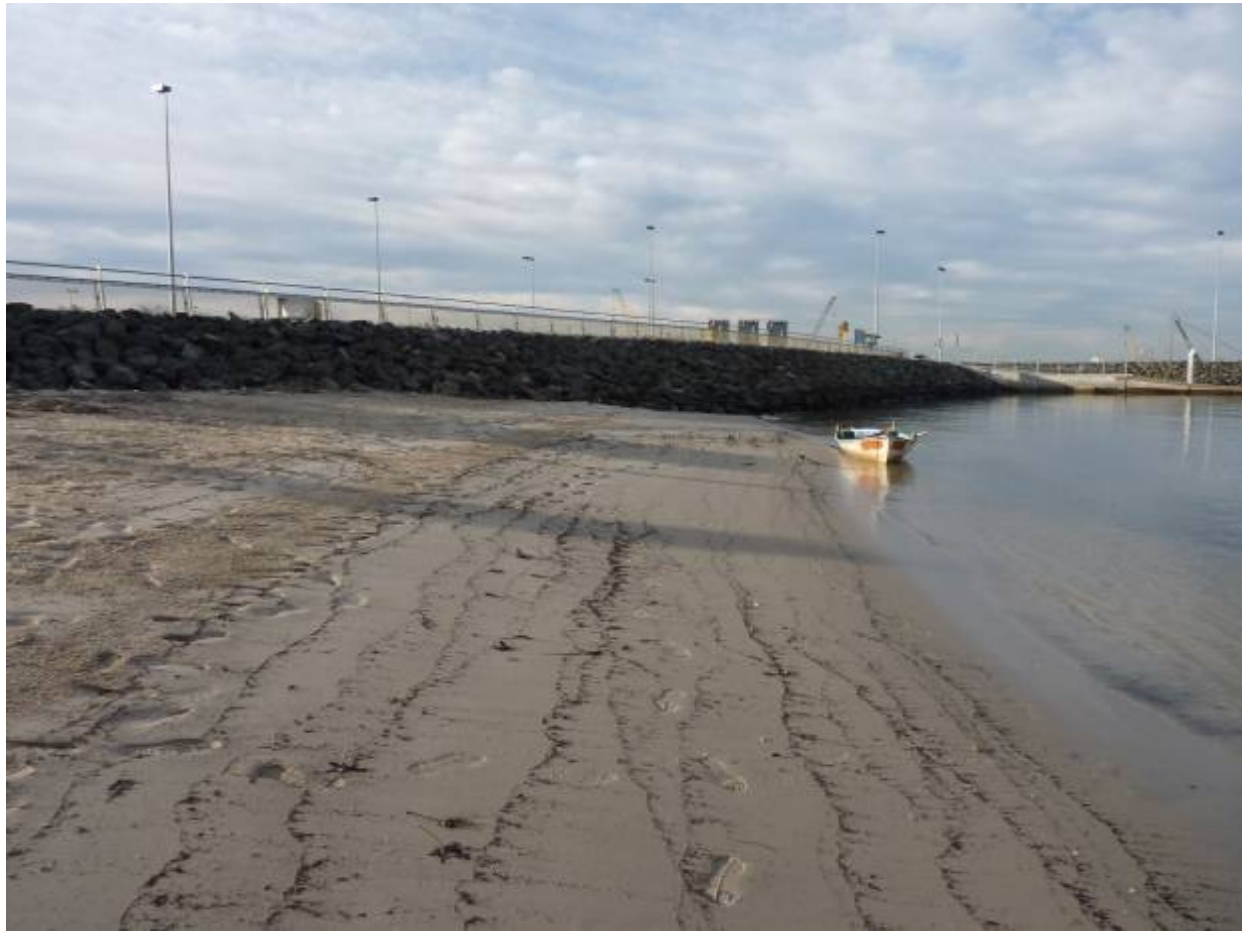
Photo 2: Beach with 1 in 10 natural slope

Typical beach slopes are 1 in 20 for fine grain sands i.e. 0.3mm diameter to 1 in 10 for coarse grain sands .Please refer to Photos 2 and 3.

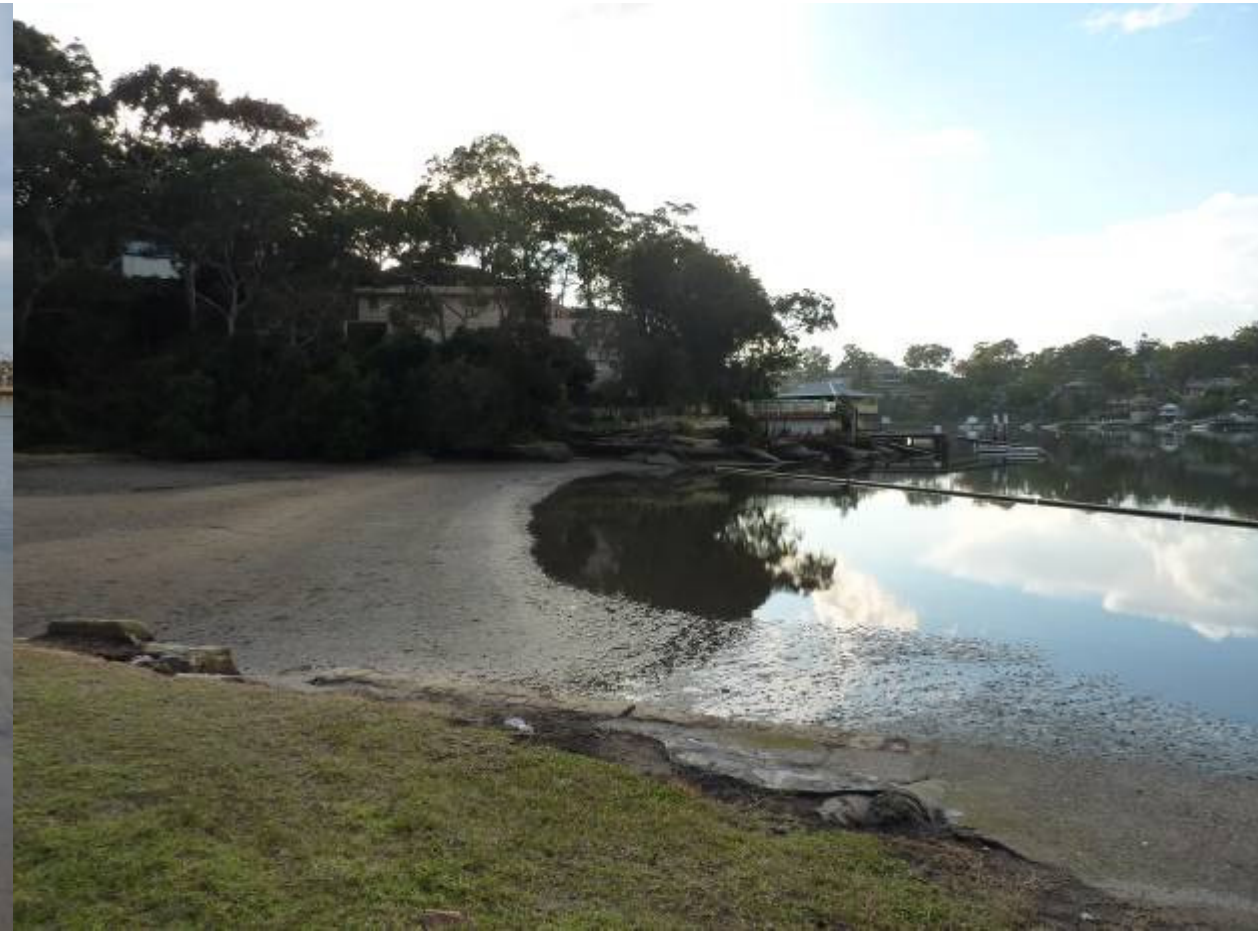
Photo 3: Beach with 1 in 20 slope

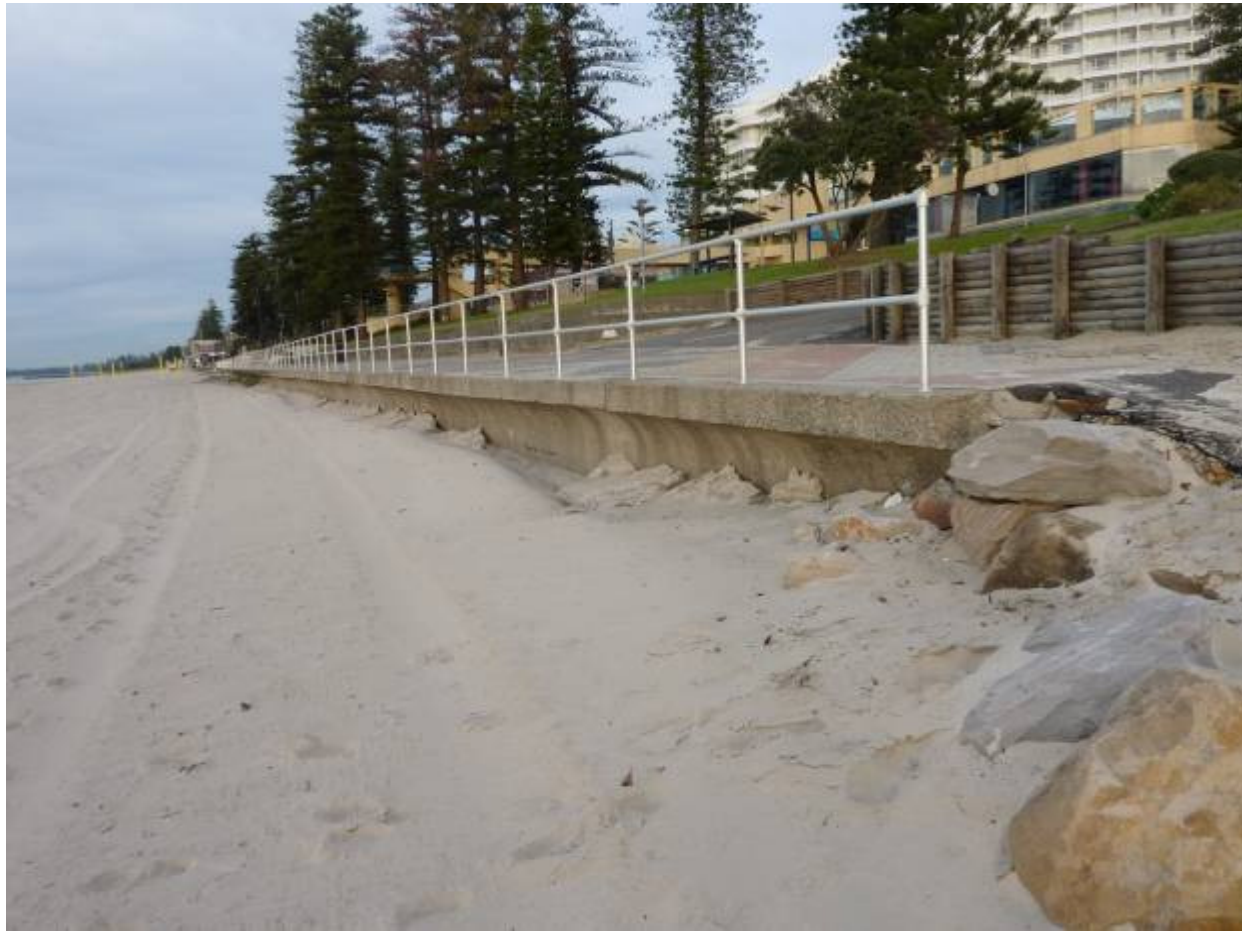
Photo 4: Wall at back of beach to contain sand

The upper beach edge interface with the general area will require some sort of small retaining wall to stop wave wash out erosion, wind drift of sand up the beach on to the general area and contamination of sand by general fill. An embankment will often not work in this area. The sandstone from the existing wall could be used to form this wall. Such walls are generally 600mm to 900mm high. Please see attached photos from local sites Photos 4 and 5.

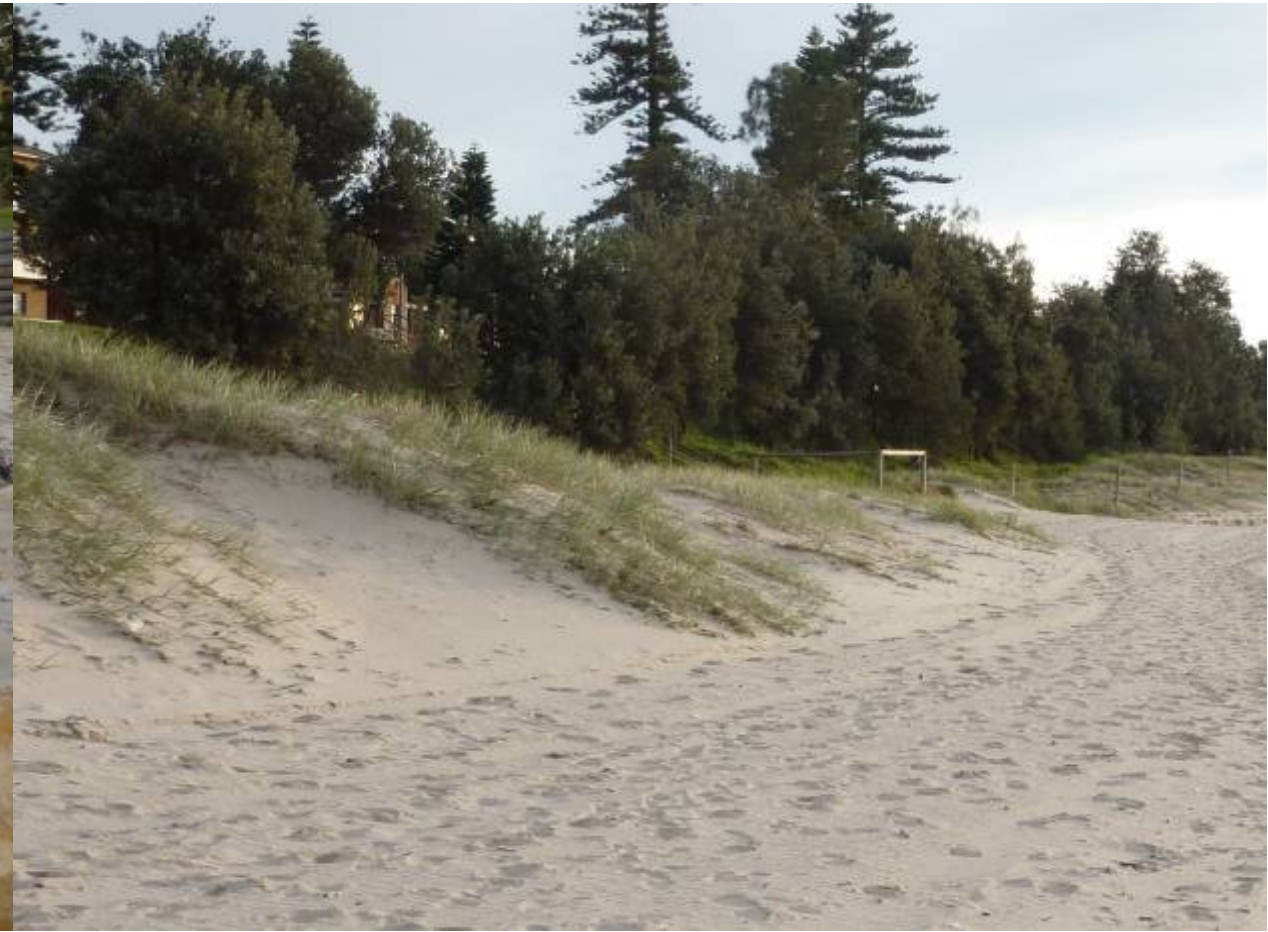
Photo 5: Erosion on beach with no back wall

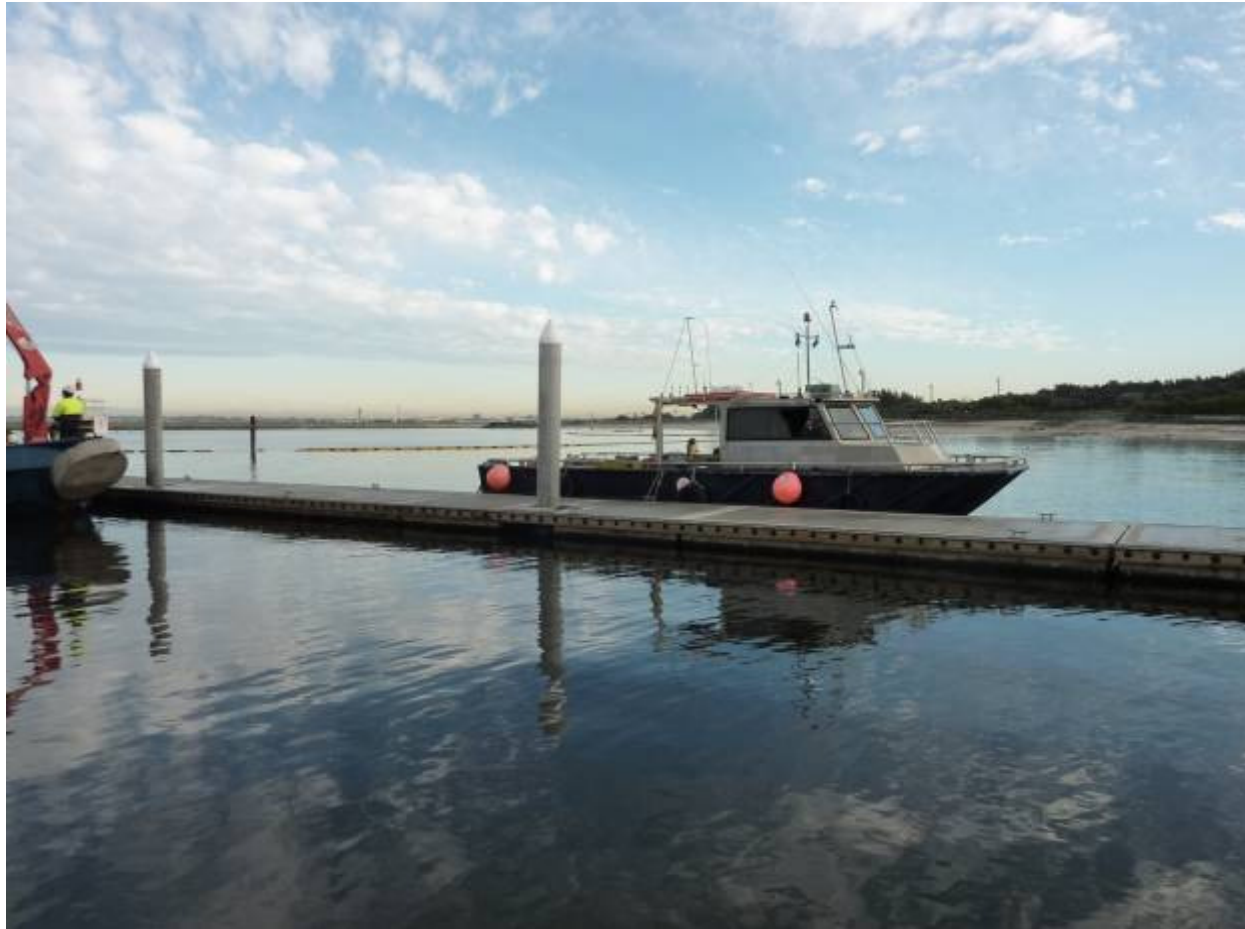
Photo 6: Pontoon for small craft such as water taxi.

It is proposed to use a proprietary brand pontoon as used in Darling Harbour and Port Botany Boat Ramp. The prime function of the pontoon is to provide drop off access for water taxis. It is not a mooring point for pleasure craft.

Please refer to Photos 6 and 7 for typical pontoons.

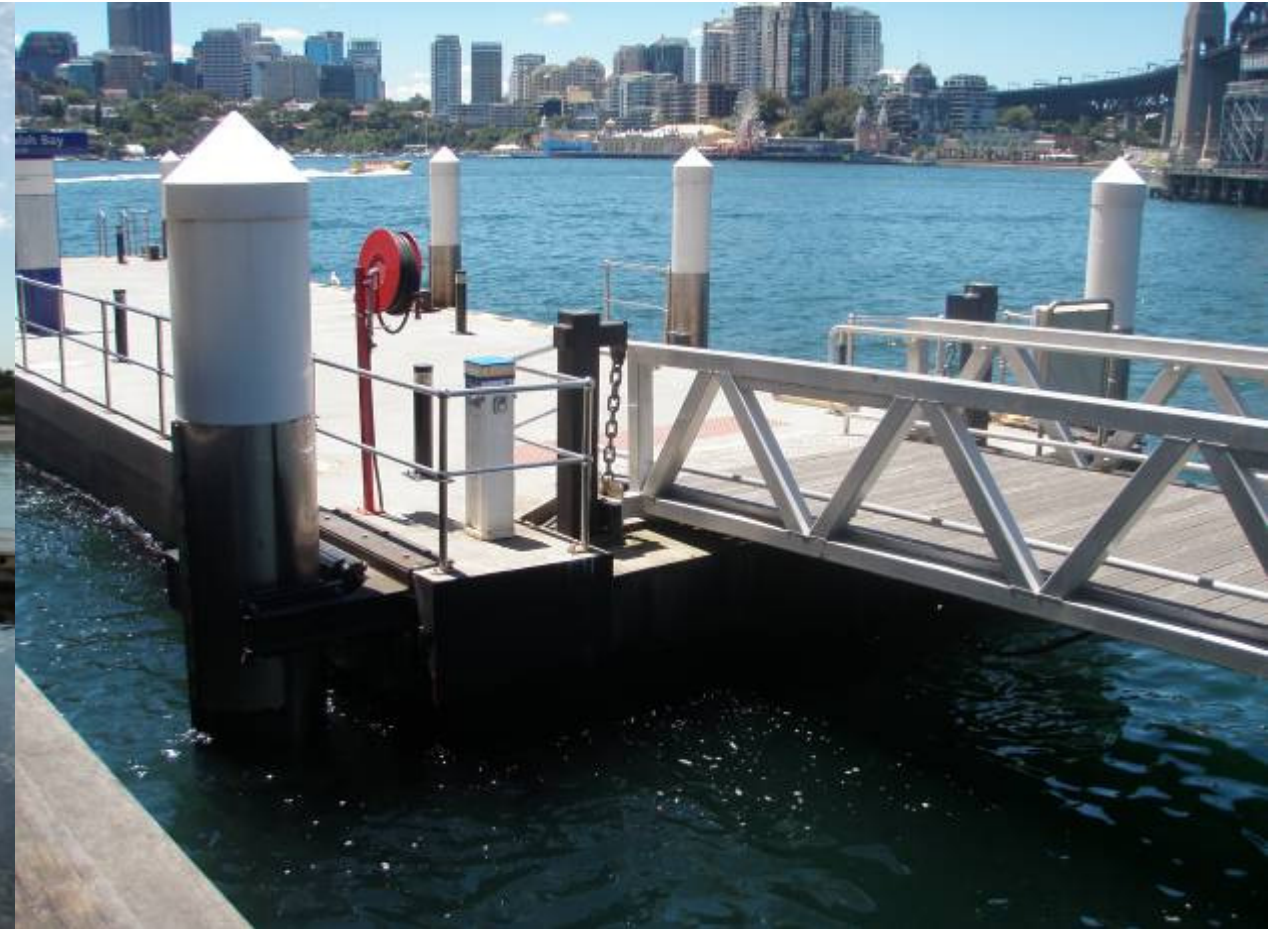
Photo 7: Pontoon for larger vessels such as small ferries

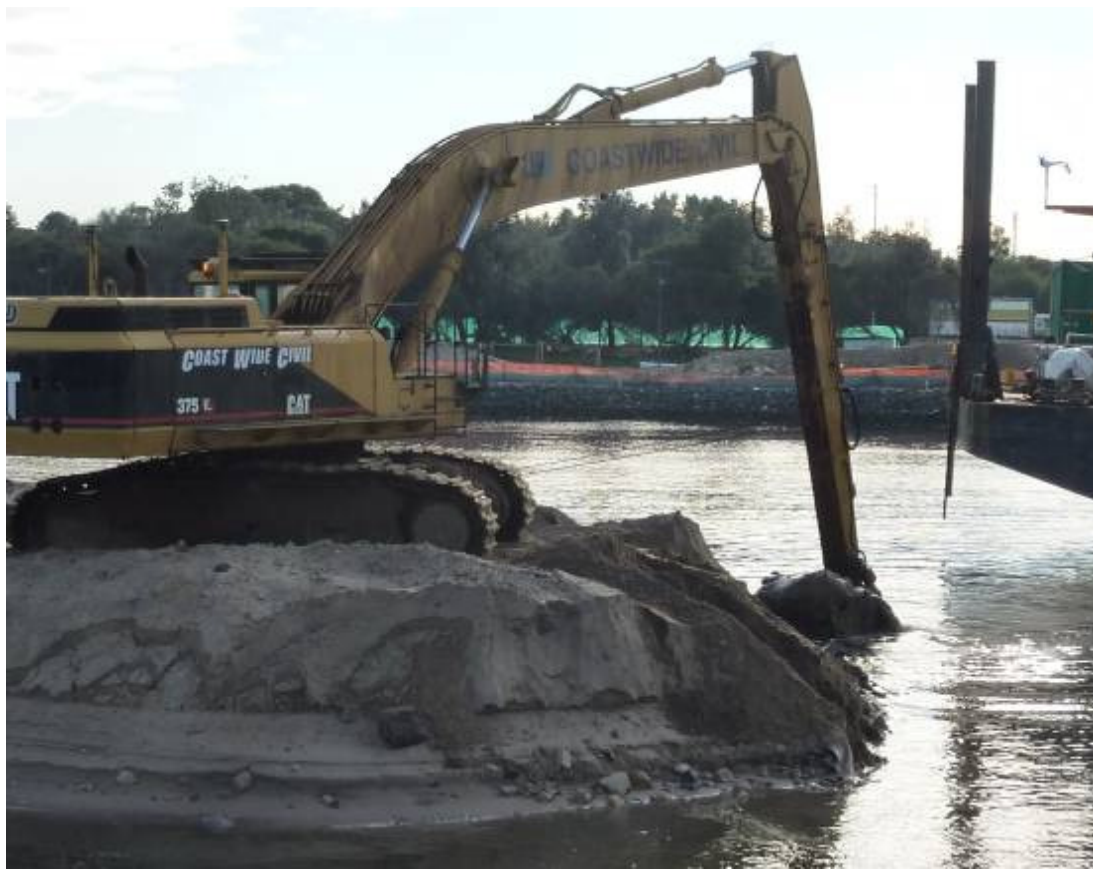
Photo 8 75 Tonne Excavator carrying out wet excavation

The other alternative to dry excavation is full wet exaction and structure placement. Please refer to Photo 8 for typical wet excavation. This work usually involves the use of large long reach excavators. The excavation progresses back with excavation carried out flowed by placement of geofabric and rock armour. The geofabric often has to be placed by divers. A reasonable allowance has to be made for placement in the wet as the work area cannot be seen.

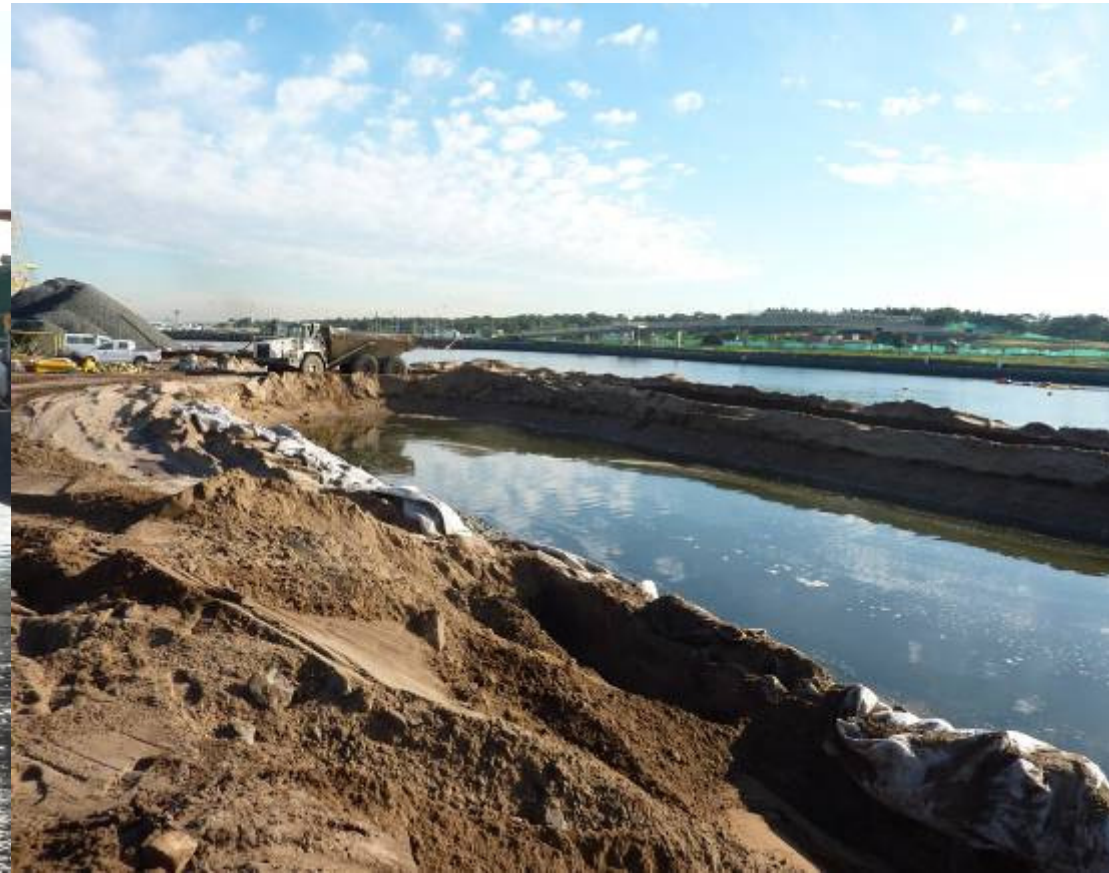
Photo 9 Typical bunded area for local dewatering

The alternatives to full dry excavation are local dry excavation whereby a local area is bunded off and local dewatering is carried out. This type of construction methodology may be employed by contactors for the shoreline edge structure where work will be visible and appearance of finished work is important. Please refer to Photos 9 and 10 for typical bunding arrangement.

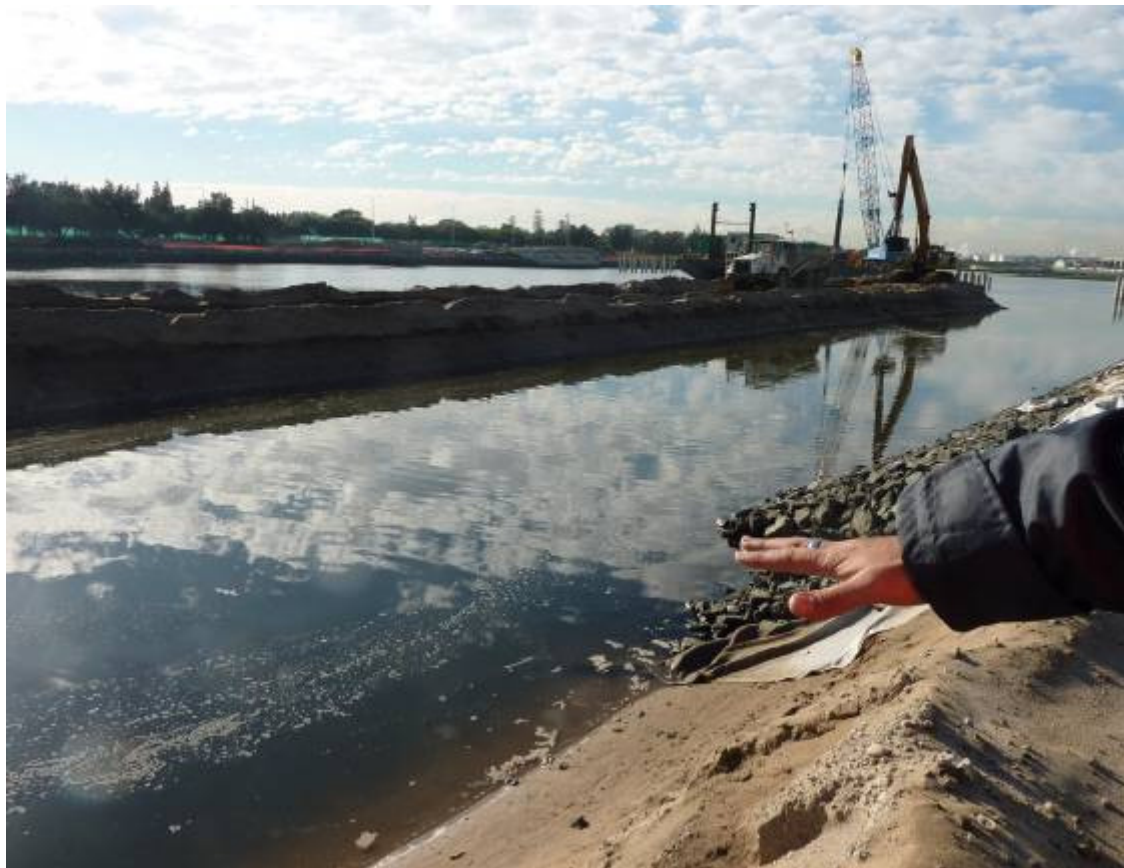
Photo 10 Bunded area after breakthrough

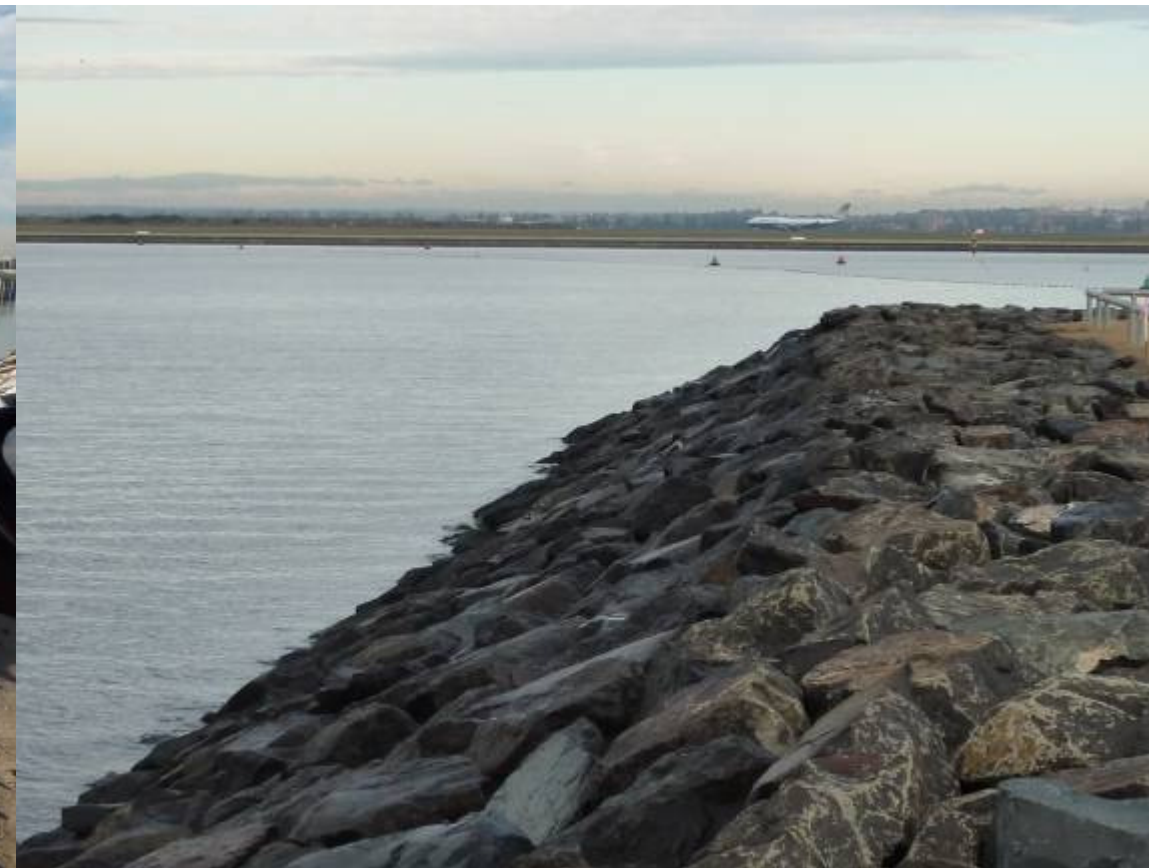
Photo 11: Relatively flat finished rock face achieved by the back of bucket of a large excavator.

Marine work of this nature is carried out in dry conditions where ever possible. Dry excavation is quicker, allows for the employment of a variety of plant, and provides good material handling outcomes. Finished levels and surface finishes are better as contractors and operators are able to physically see their work area. Large excavators are usually used to carry out the excavation as they hold large volumes, are accurate, can be guided by GPS and laser systems and can be used for a variety of tasks from excavation to trimming and rock placement. The back of the bucket can be used to forcefully bed armour down to achieve a relatively flat finished surface refer photo 11. Where the excavation extends below the water table, it is common to dewater using a sump and pumps.

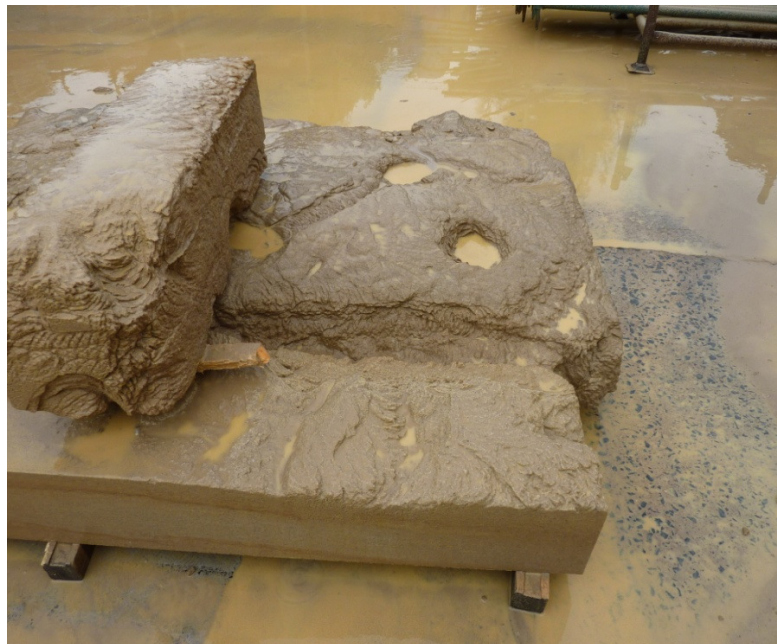
Photo 12 Water Blasted Sandstone

A trial of water blasting of sandstone shoreline blocks to achieve a natural effect was carried out on 2nd September 2010 at the Government Stone Masons yard at 92 Burrows Road, Alexandria. The effect achieved was similar to that of natural stone. Currently it is proposed to carry out the water blasting of the sandstone once the rock has been placed in its final position.

Please see Photo 12 below which shows the effect of the water blasting. It should be noted that the runoff from the water blasting should be natural local material and as such there should be no chemical impact from the water blasting activities. With regards to the silt in the runoff from the water blasting, although the exact details are not yet developed, the silt will be controlled during construction by a number of methods. For those areas of work carried out before the caissons are removed, the caissons will control any silt. For those areas of work which are carried out outside the caissons or after the caissons are removed, a turbidity curtain or similar will be used to control the silt and turbidity. Please refer to 'Soil and Water Report to support the Environmental Assessment for Headland Park Barangaroo, Barangaroo Delivery Authority, September 2010' by WSP Environment and Energy section 3.5.2 Potential Impacts, Park Foreshore.
