## **Graythwaite, Union Street, North Sydney**

Section 75W Modification  
(MP10\_0150)

Proposed modifications to approved new works  
and other minor works

### Statement of Heritage Impact

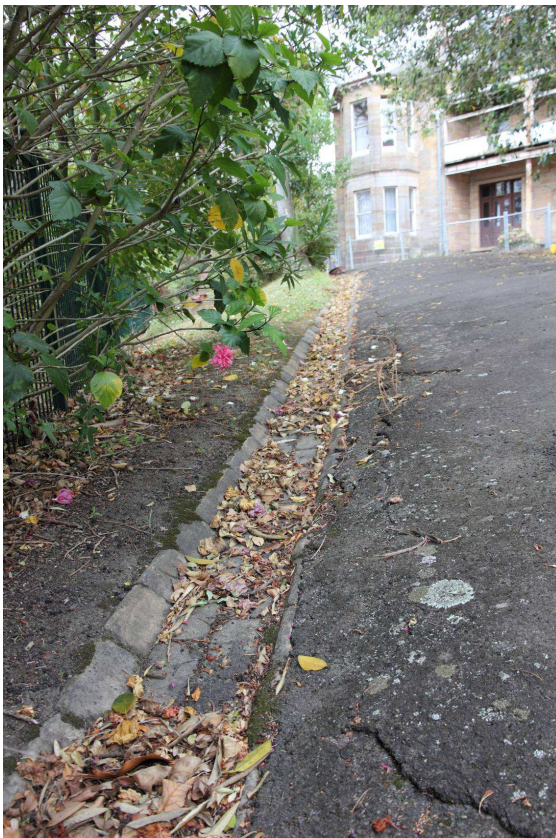
Figure 3 Remnant 1890s brick drain along the upper driveway.  
Source: Tanner Kibble Denton Architects, 2013.

The proposed kerb is designed to reflect the design and character of the remnant 1890s historic brick drain which remains along the upper section of the driveway (see Figure 3). The proposed new kerb will not alter the width of the original driveway and will enhance the understanding of its original design. Impacts associated with the works include the removal of the historic kerbing which is unable to sufficiently handle rainwater runoff. Mitigating measures include the archival recording of the brickwork prior to its removal and its interpretation in the design of the new brick kerbing.

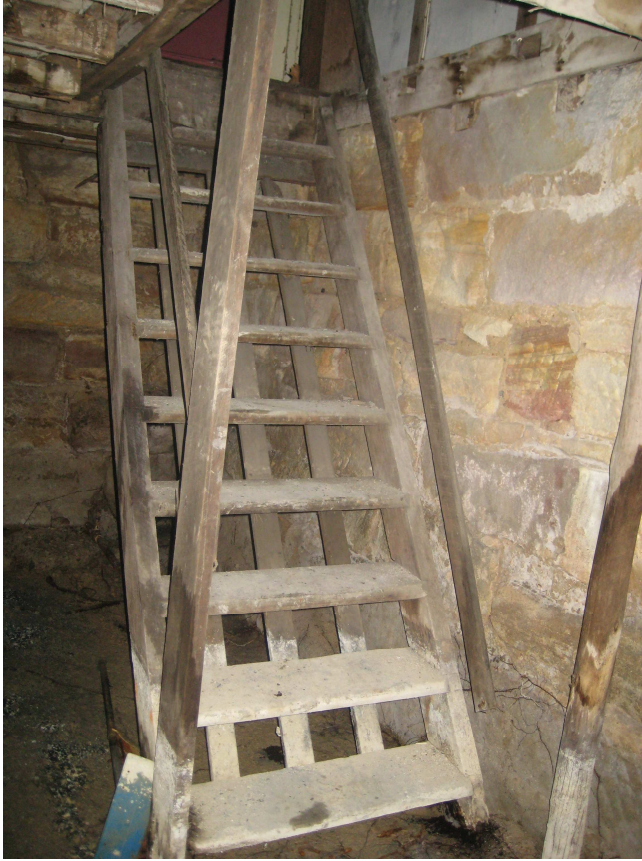
Figure 4 Non-original timber-framed basement stairs proposed to be replaced.  
Source: Tanner Architects, 2010.

The proposed additional works to the basement consist of the replacement of the existing timber-framed stairs leading to the basement from the ground floor (Figure 4), with steel access stairs. The replacement of the stairs and its enclosure within a fire-rated lobby is necessary to achieve compliance to provide fire separation between ground and basement levels.

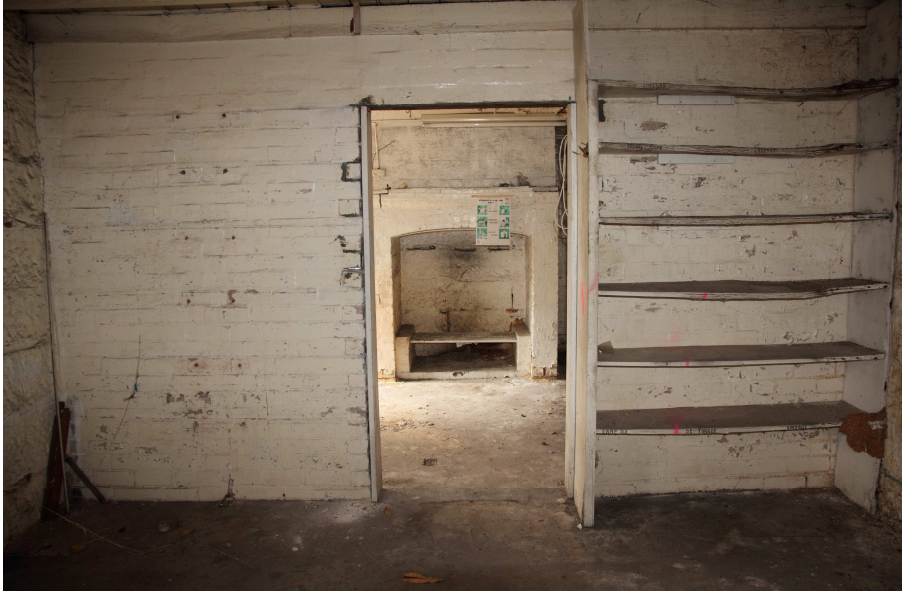
Figure 5 The existing opening between rooms G19a and G19b which is proposed to be widened.  
Source: TKD Architects, 2013.

The proposed partial demolition of the brick wall in the Stables Building consists of widening the current opening between the two rooms (see Figure 5). Wall nibs will remain at either end of the enlarged opening. The wall divided the building into two rooms, a groomsman's room and a coach house/stable. The date of its construction is unlikely to be from the original period of construction, most likely constructed c1880s, at the same time as the brick chimney and fireplace. Although not original, it is an indicator of the early functioning of the building.

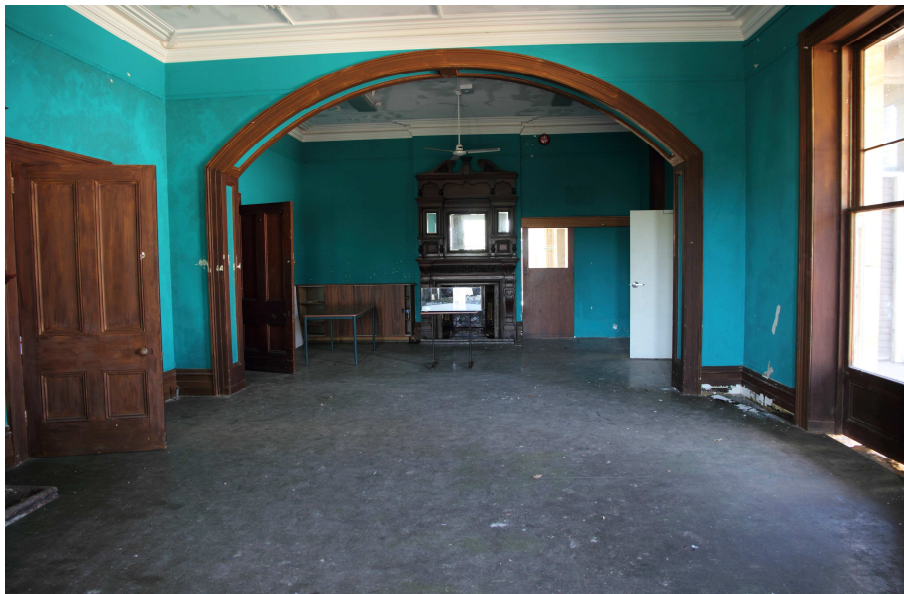
Figure 6      Semi-circular arched opening which currently divides G6 Reception Room, proposed to house the new bi-fold doors.

The proposed timber bi-fold doors in Room G6 allow for a more flexible use of the room. Presently divided into two spaces by the original semi-circular arched opening (see Figure 6), the doors will allow the two spaces to function independently.

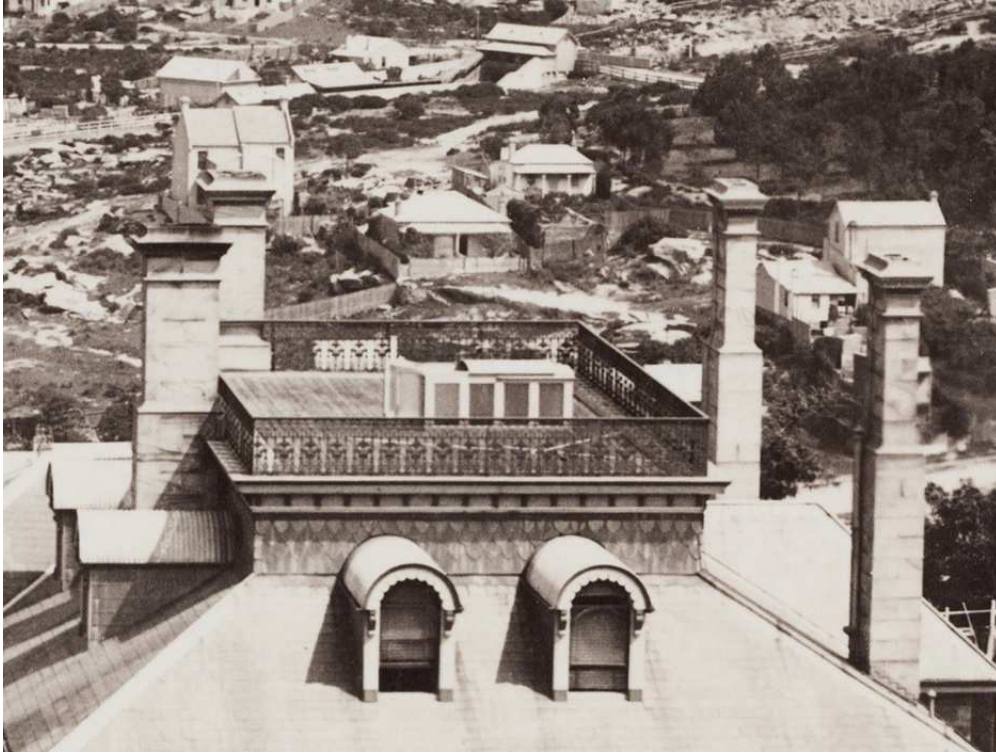
Figure 7      c1900 photo of the Widow's Walk on the roof of Graythwaite House.  
Source: Mitchell Library

Impacts associated with these works include the minor removal of original fabric, namely timber flooring and framing (the present ceilings are not original). The removal of fabric is minor in extent and will not result in adverse impacts on Graythwaite overall. A substantial positive benefit of the work is the reinstatement of the Widow's Walk as a functioning feature of the building (see Figure 7).

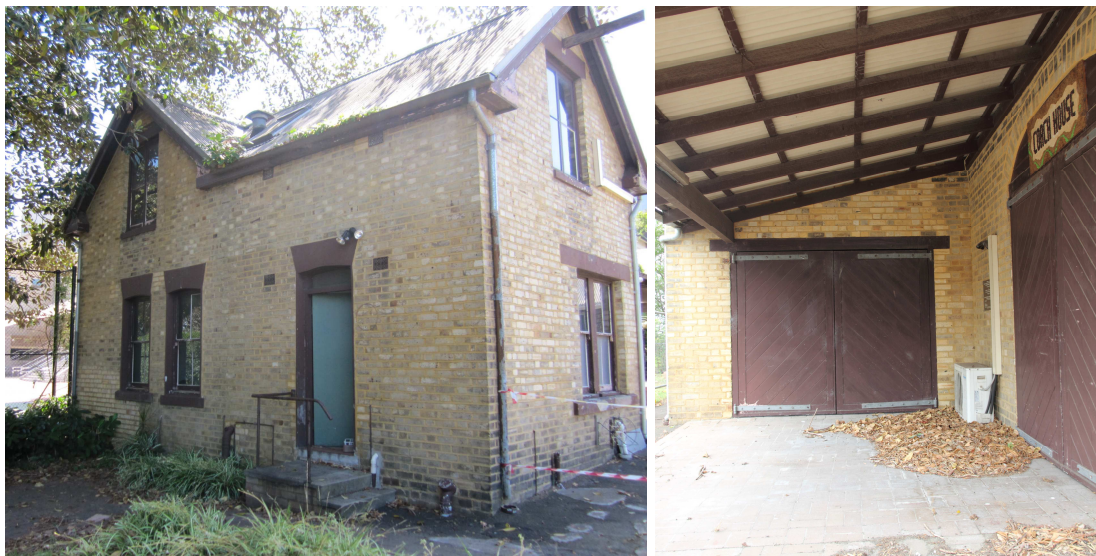
Figure 8 The Coach House's non-original steps and doorway on the western elevation of the building and the c1970s timber ledged and braced door in the verandah; both of which are proposed to be removed and replaced as part of the Stage 1 Works.  
Source: TKD Architects 2010 and 2013.

The external modifications to the Coach House consist of the demolition of the non-original entry steps and the removal of the non-original doorway opening (Figure 8) to be in-filled with brick and replaced with a window. As the fabric affected is not original, the works will not have an adverse impact on the significance of the building.

A new timber framed glazed door is proposed to replace the current, c1970s, timber ledged and braced door (Figure 8), so as to provide accessible entry to the building. The proposed new design is sympathetic to the structure and will more clearly articulate the main entrance. The impact on the exterior presentation of the building will be negligible, and there will be no physical impact on significant fabric.

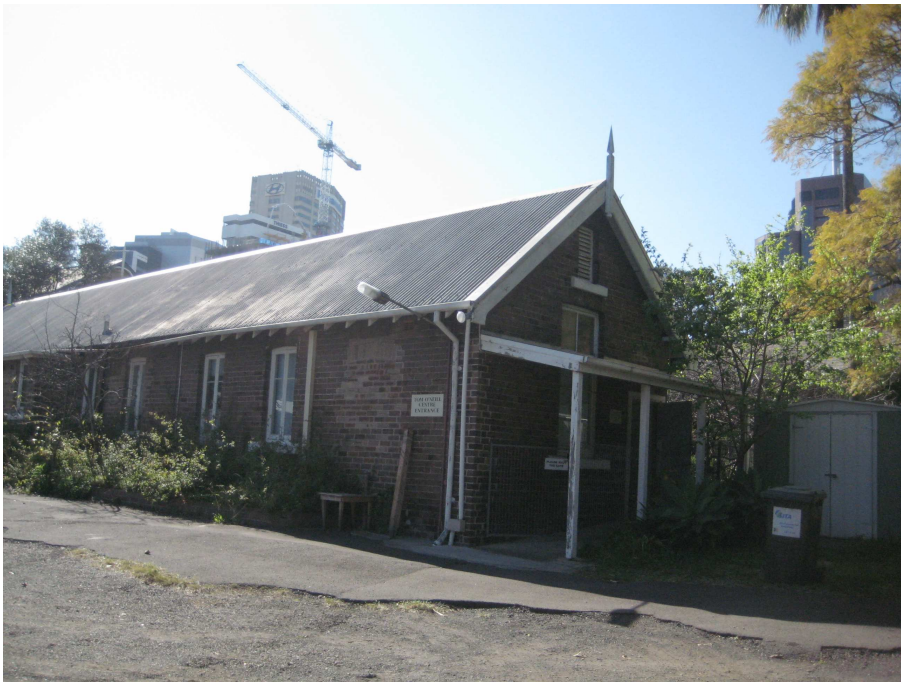
Figure 9 The c1950s or 60s skillion-roofed verandah and subsequent entry opening, proposed to be removed.

The proposed minor external modifications to the exterior of the Tom O'Neill Centre involve the demolition of the southern verandah and brick in-fill the entry on the southern elevation. The skillion-roofed verandah and subsequent entry opening are not original features, probably added c1950s or 60s (Figure 9). There are no adverse impacts associated with these works; removal of later accretions will return the building largely to its original form. It is noted that demolition of the building is approved as part of Stage 3 works for the site.

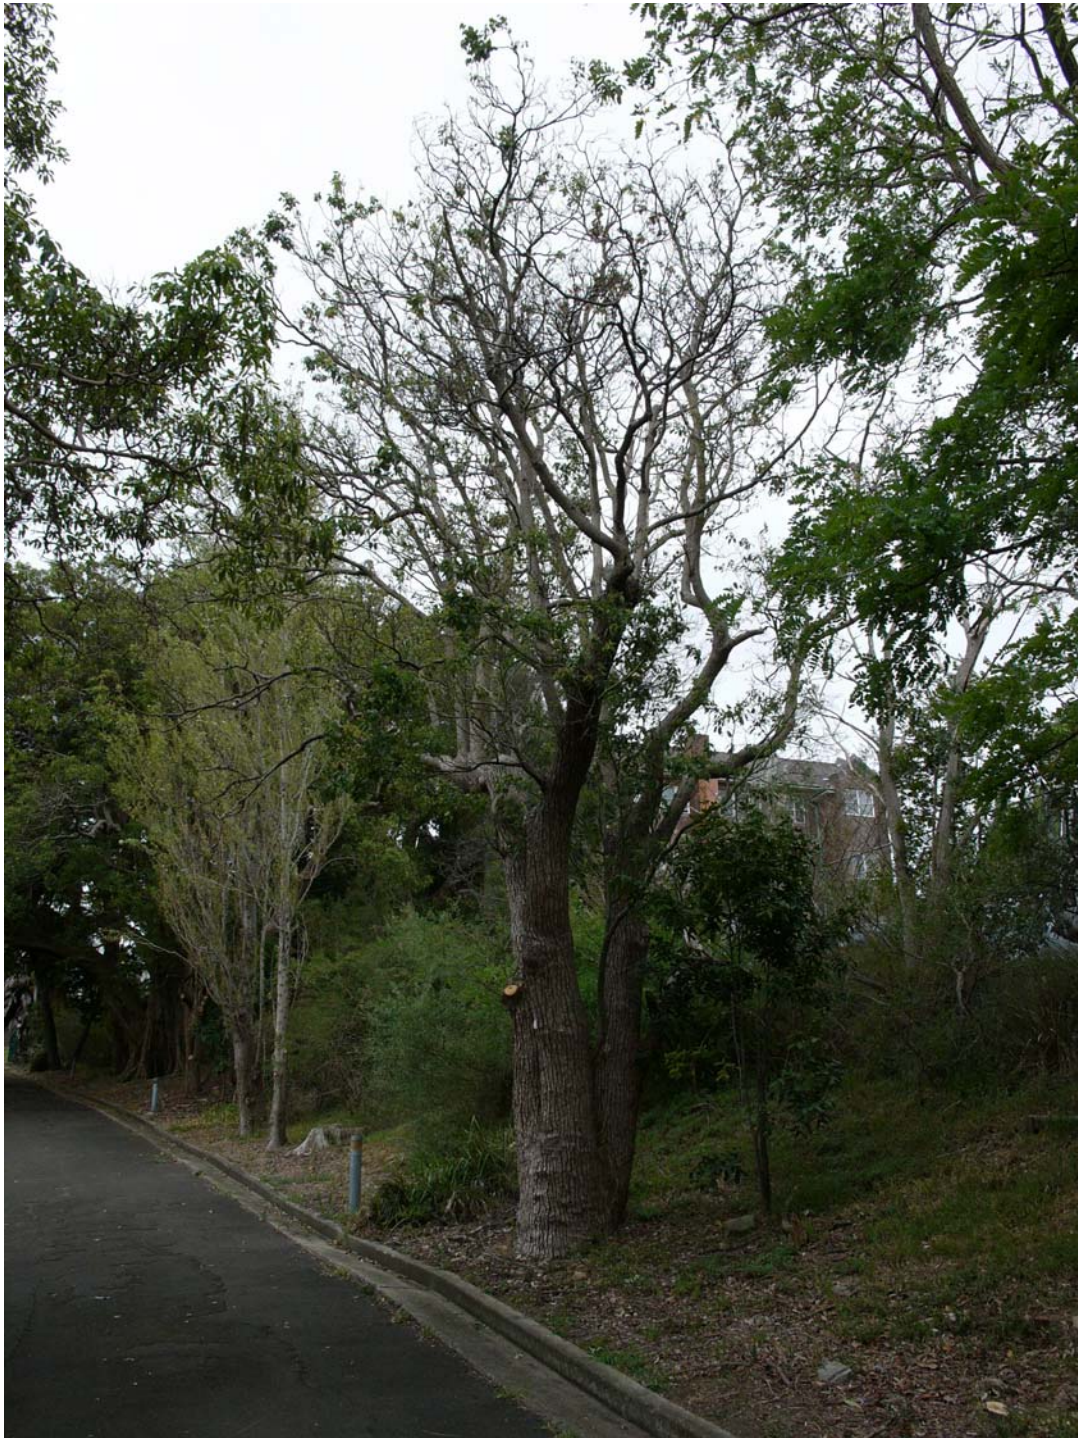
Plate 1 – T34 (Camphor Laurel) showing poor health and condition with extensive defoliation and dieback due to constant foraging by Possums and general decline. Note the localised uplifting of the adjacent kerb, gutter and asphalt adjacent the trunk.

In the instance of T18, T30 & T34, all of these Camphor Laurels are in poor condition, having been previously lopped and being extensively defoliated by Possum foraging (refer to Plates 1 & 2 as examples of their present condition). An extract of Appendix 4 of my report (Tree Health and Condition Schedule) is attached for reference purposes. This has been updated to reflect the present health and condition of the trees.

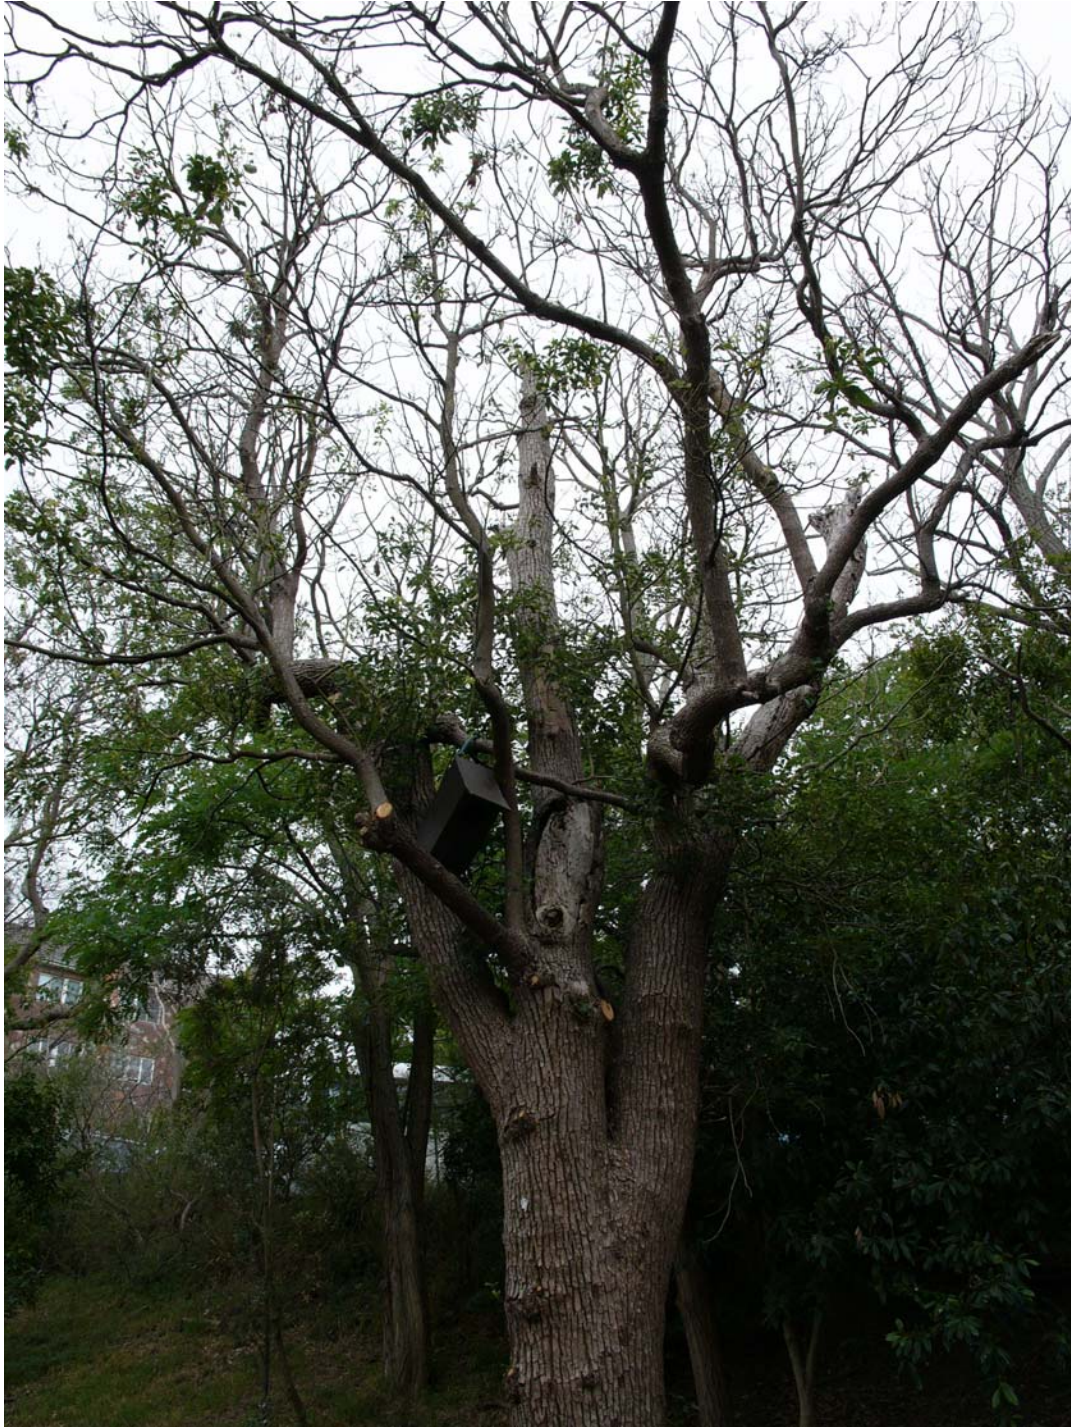
Plate 2 – T30 (Camphor Laurel) similarly showing poor health and condition with extensive defoliation and dieback due to constant foraging by Possums and general decline. This tree also exhibits extensive decay in all main primary limbs.
