# **Rehabilitation Strategy**

**Document No. 710-005-EN-STR-0002**

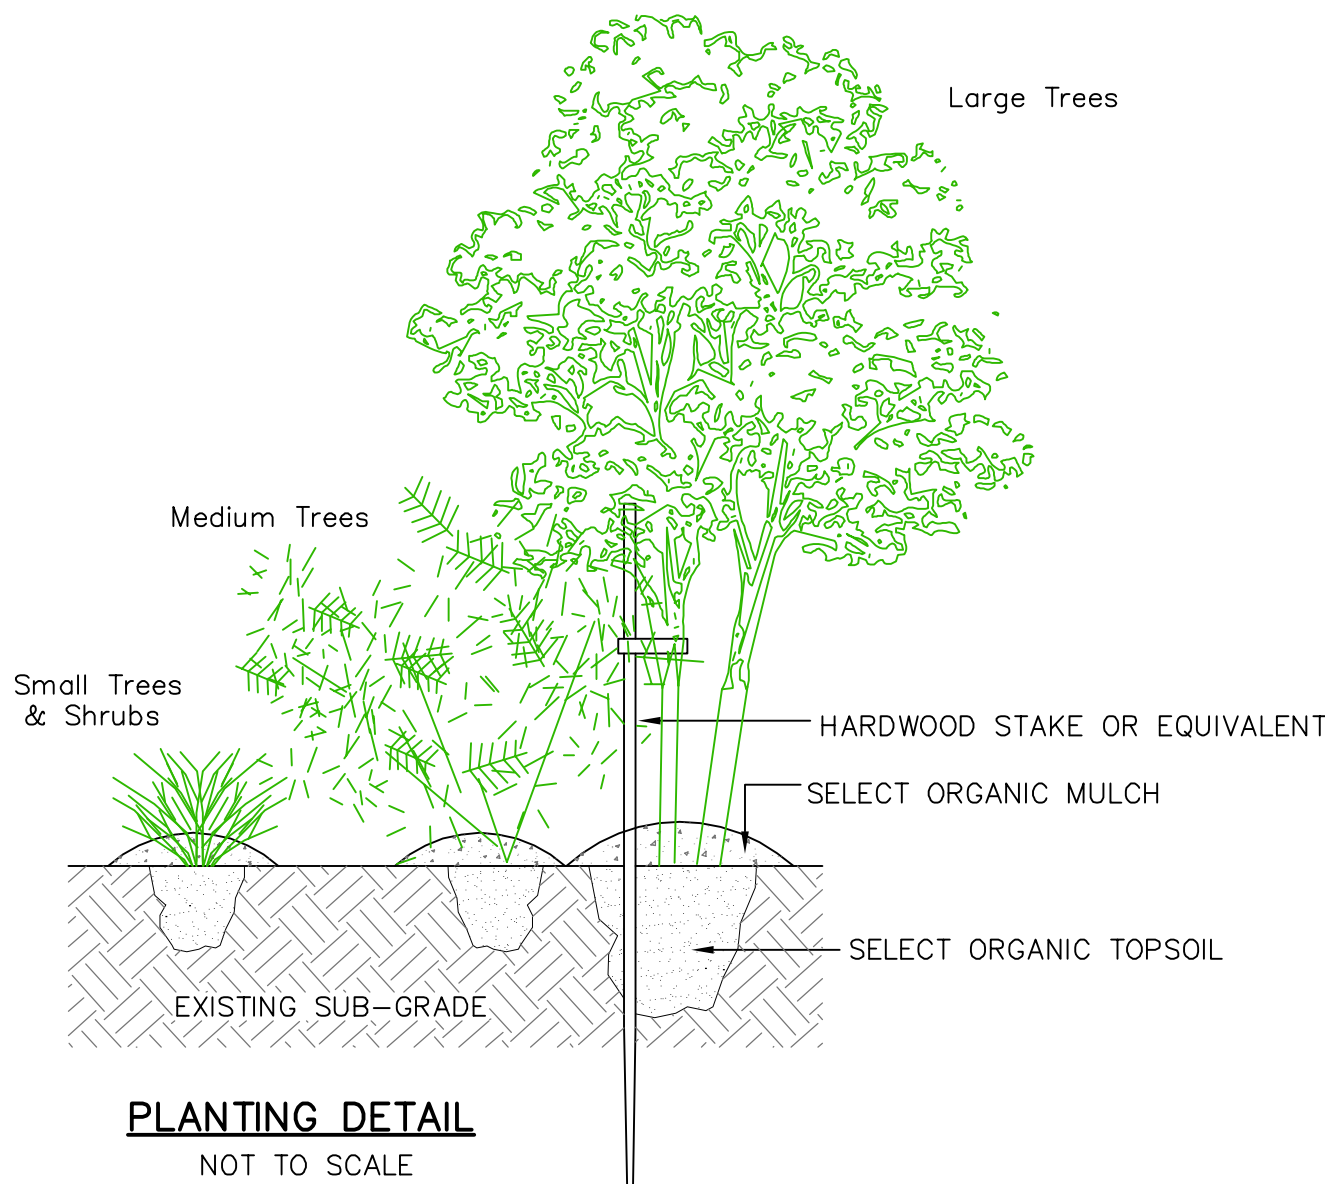
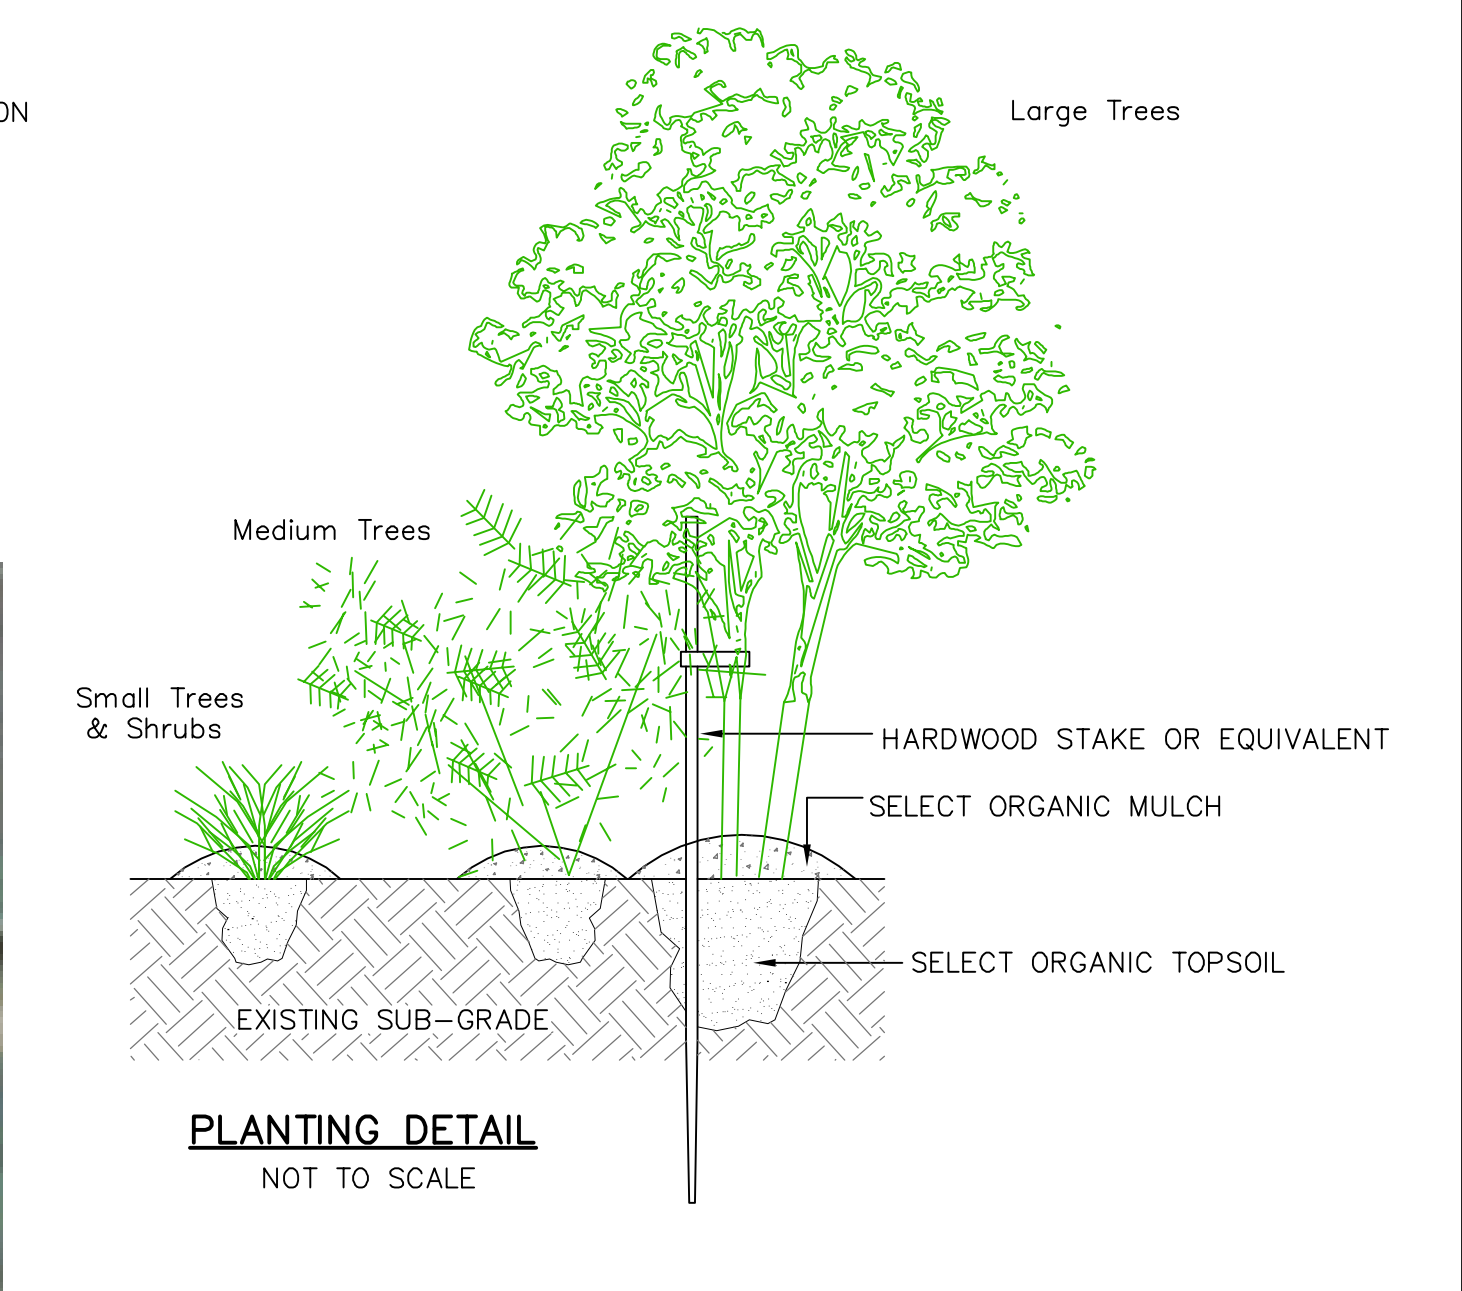
CADIA VALLEY OPERATIONS – SEALINK CONCENTRATE FILTRATION & HANDLING FACILITY – NEWBRIDGE ROAD – BLAYNEY  
FIGURE 2 – PROPOSED LANDSCAPING PLAN

DENOTES PROPOSED EARTH MOUND 3m HIGH AS ADDITIONAL NOISE & VISUAL SCREEN

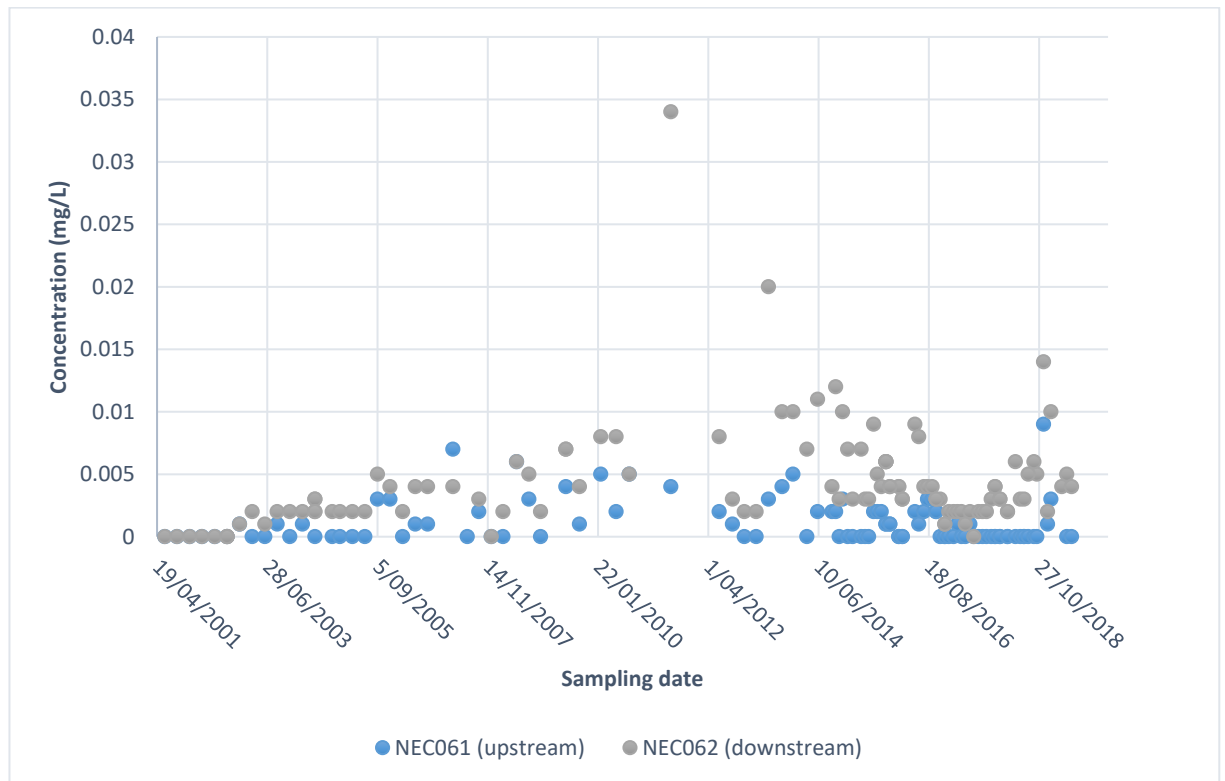
**Chart 1 Concentrations of copper in Abattoir Creek surface water between June 2011 and June 2019**

With the removal of source material from the site to prevent further offsite migration, and removal of locally impacted shallow sediment in Abattoir Creek it is considered copper concentrations will be further reduced in surface water. As such, remedial strategies to address dissolved copper in surface water within Abattoir Creek or the drainage channel are not considered to be required. However, surface water will be assessed as part of the validation program.

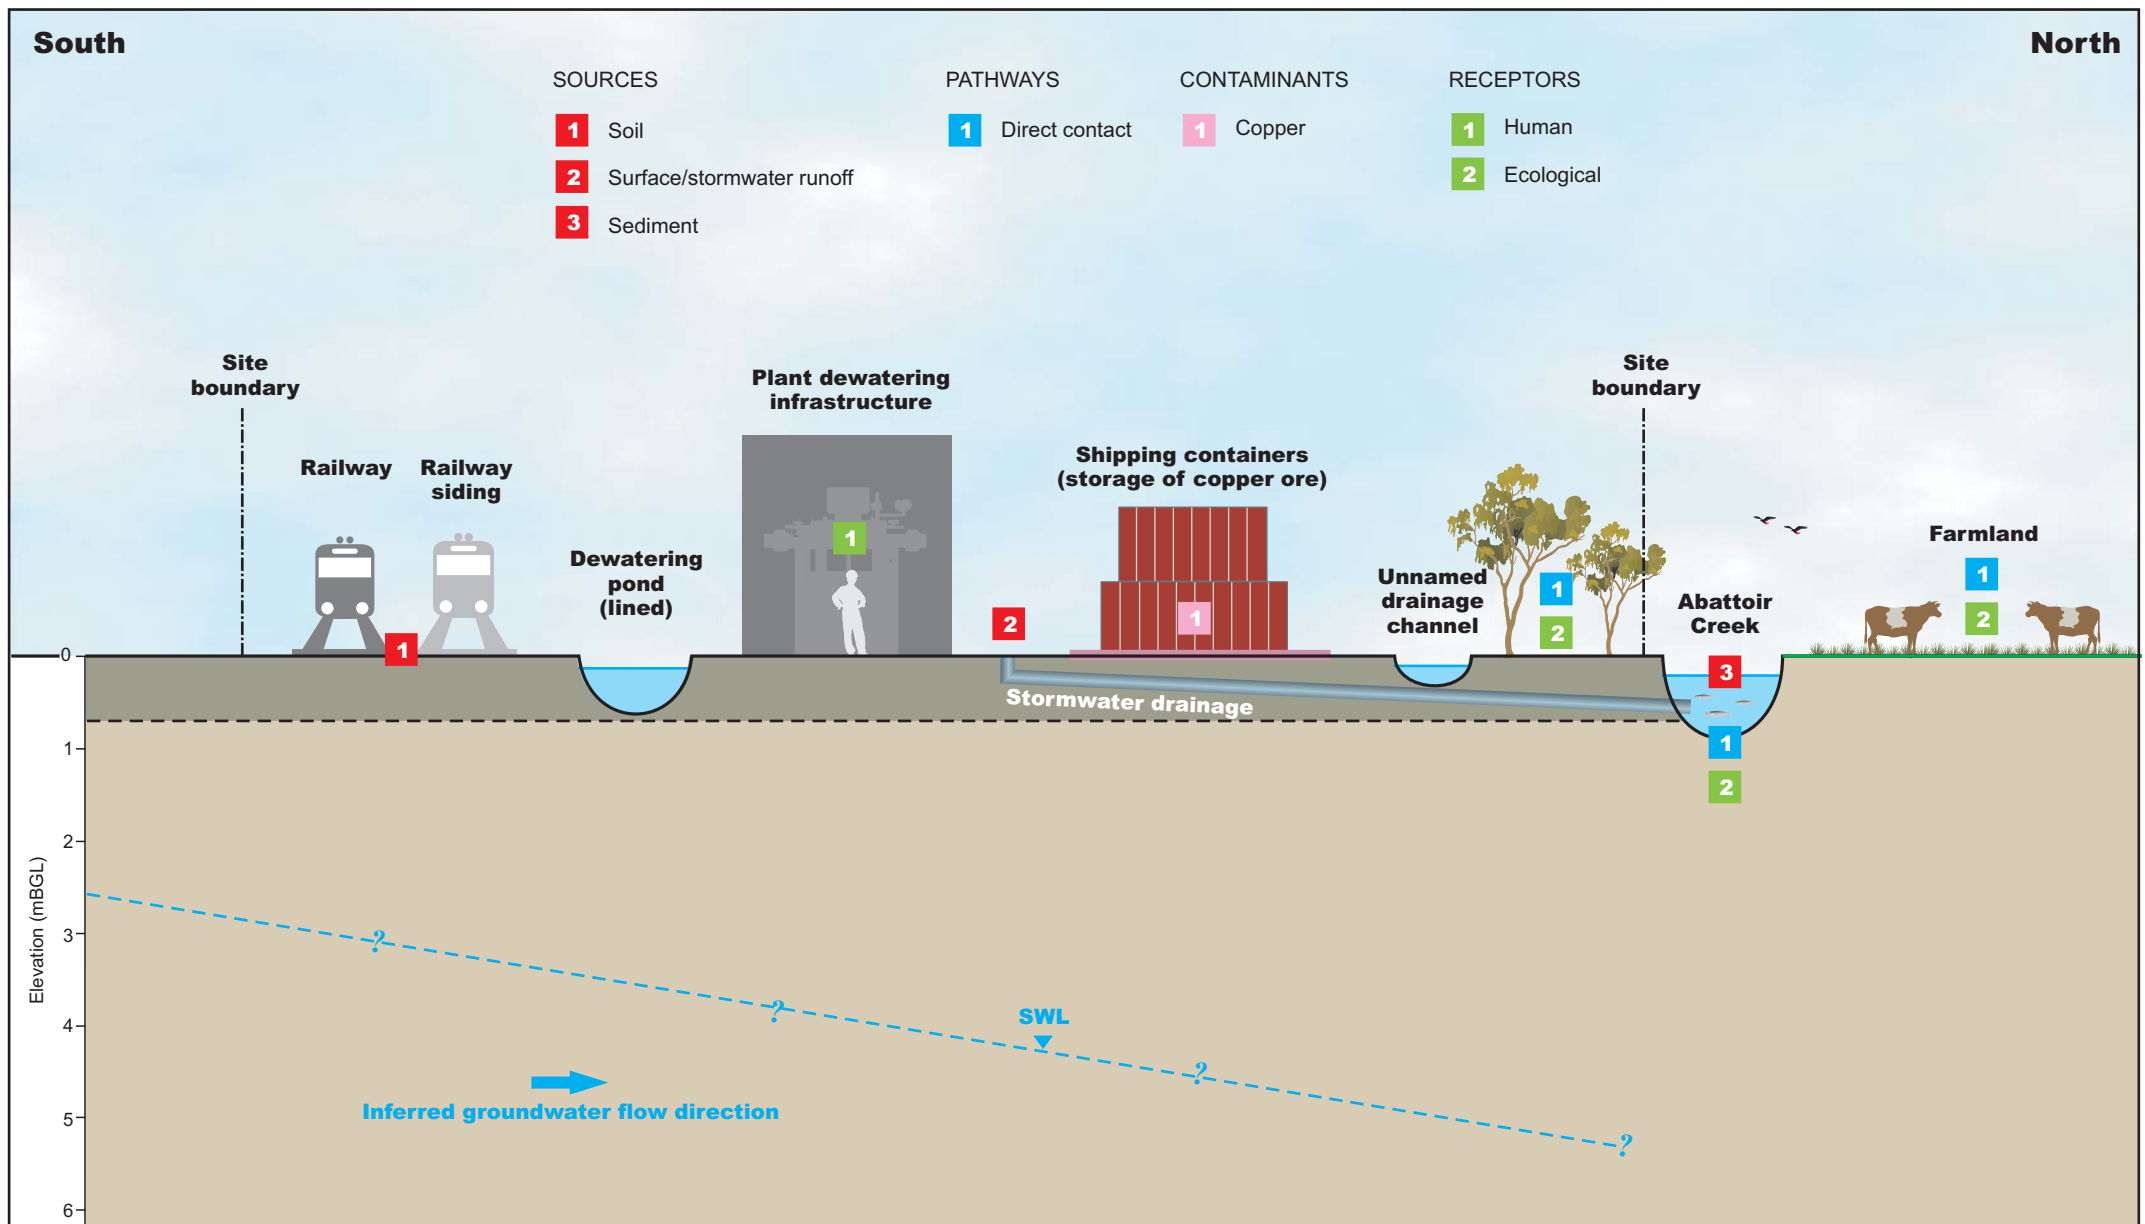
**Figure 7**

Conceptual diagram  
only - not to scale

The conceptual site model (CSM) is a qualitative analysis tool that defines the contamination sources, transport mechanisms, exposure pathways and receptors considered. The CSM has been developed based on GHD's understanding of the site setting, including geology, hydrogeology and surrounding land use in order to identify potentially significant source-pathway-receptor (SPR) linkages in respect of risks to human health and the environment. The potential sources, receptors and pathways are summarised in the sections below, and presented schematically in Appendix A.

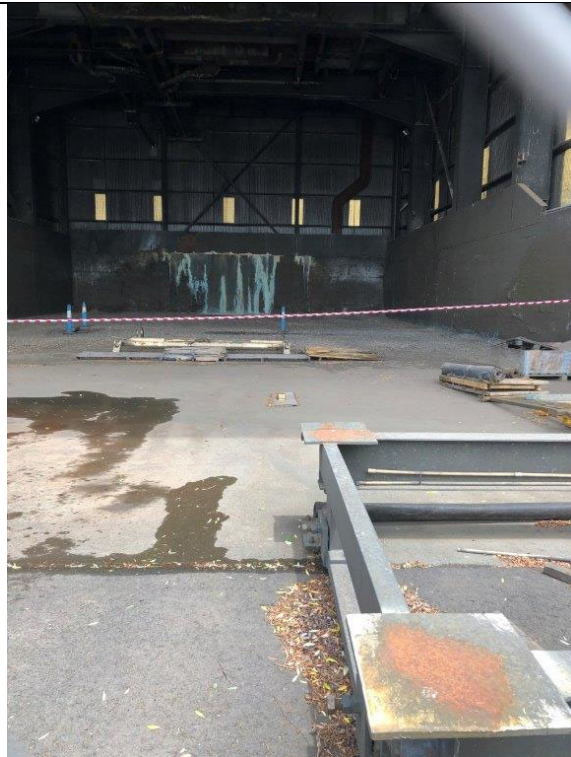
Photograph 3 Copper staining visible on internal surfaces of site buildings

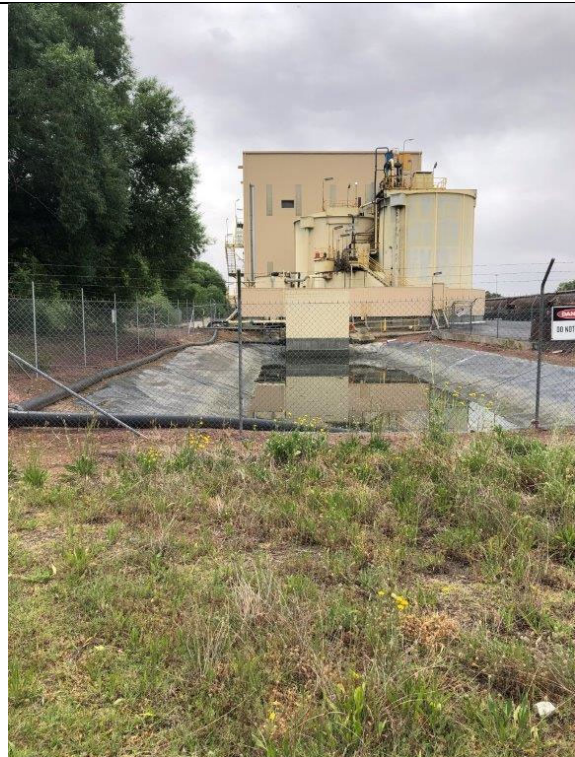
Photograph 4 Dewatering pond to the west of site buildings

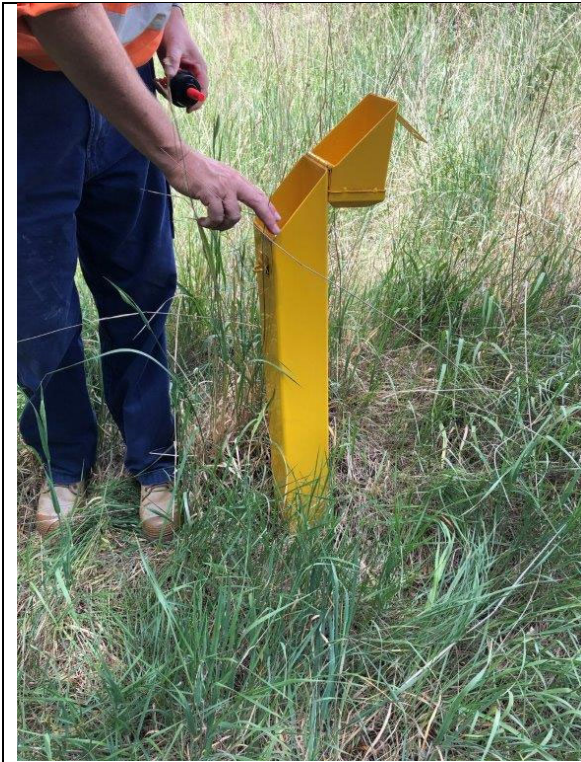
Photograph 5 Example of groundwater monitoring wells at the site

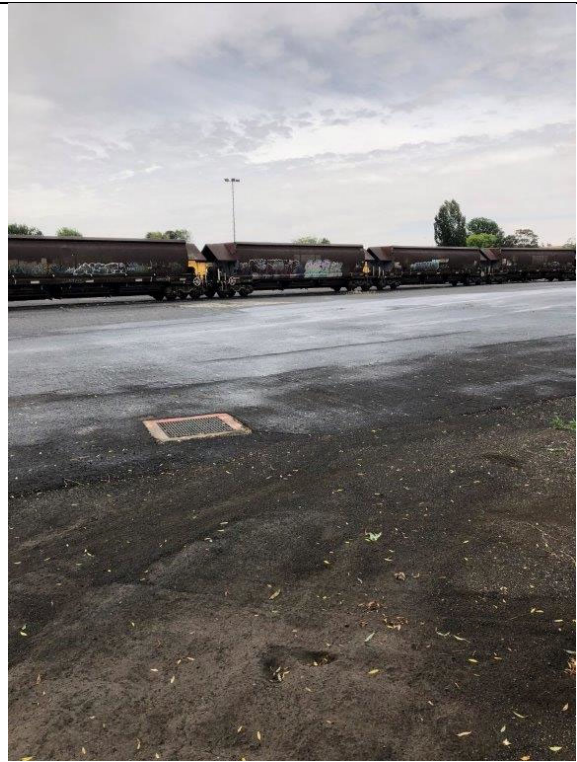
Photograph 6 Stormwater drain observed at the site

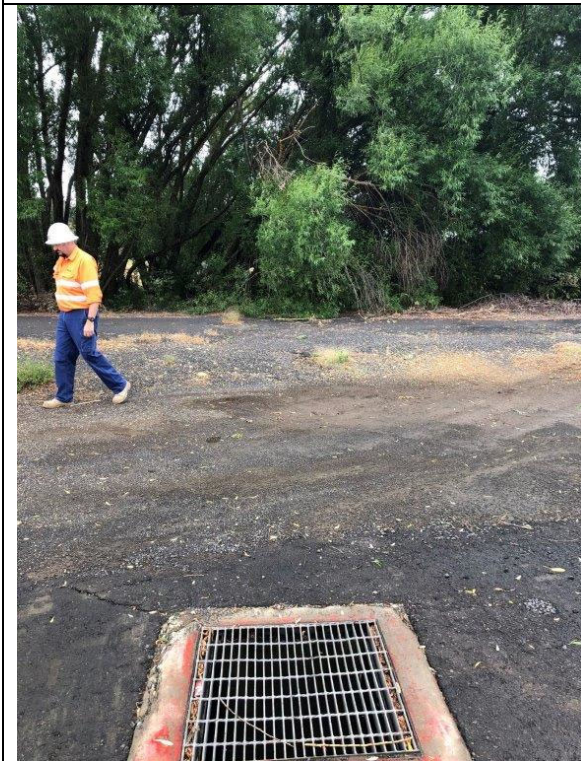
Photograph 7 Proximity of stormwater drain to Abattoir Creek

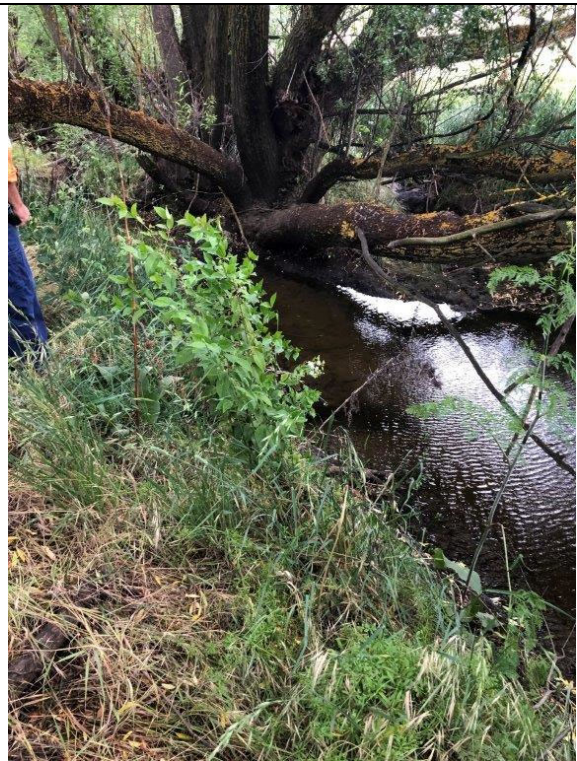
Photograph 8 Abattoir Creek showing vegetation and location of stormwater outlet

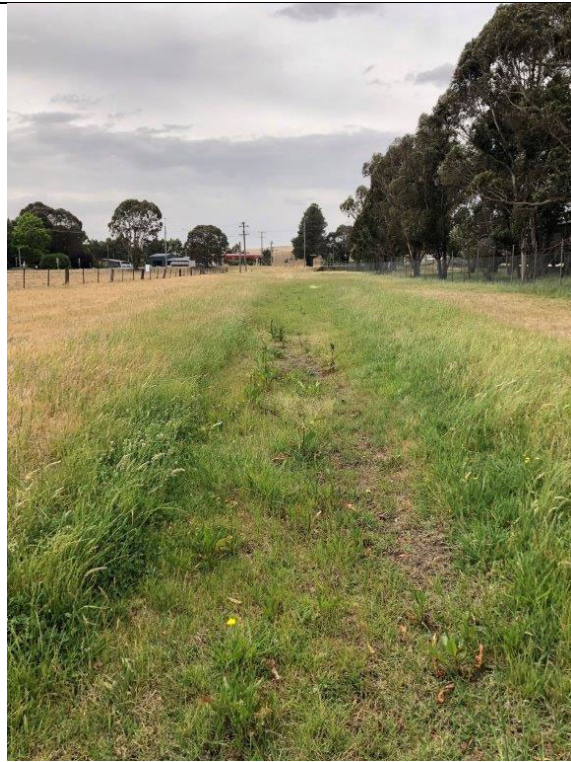
Photograph 9 Unnamed drainage channel (the channel) offsite
