# Dewatering Management Plan

**Qantas Flight Training Centre**

**297 King Street and 65 Kent Road**

**Mascot NSW**

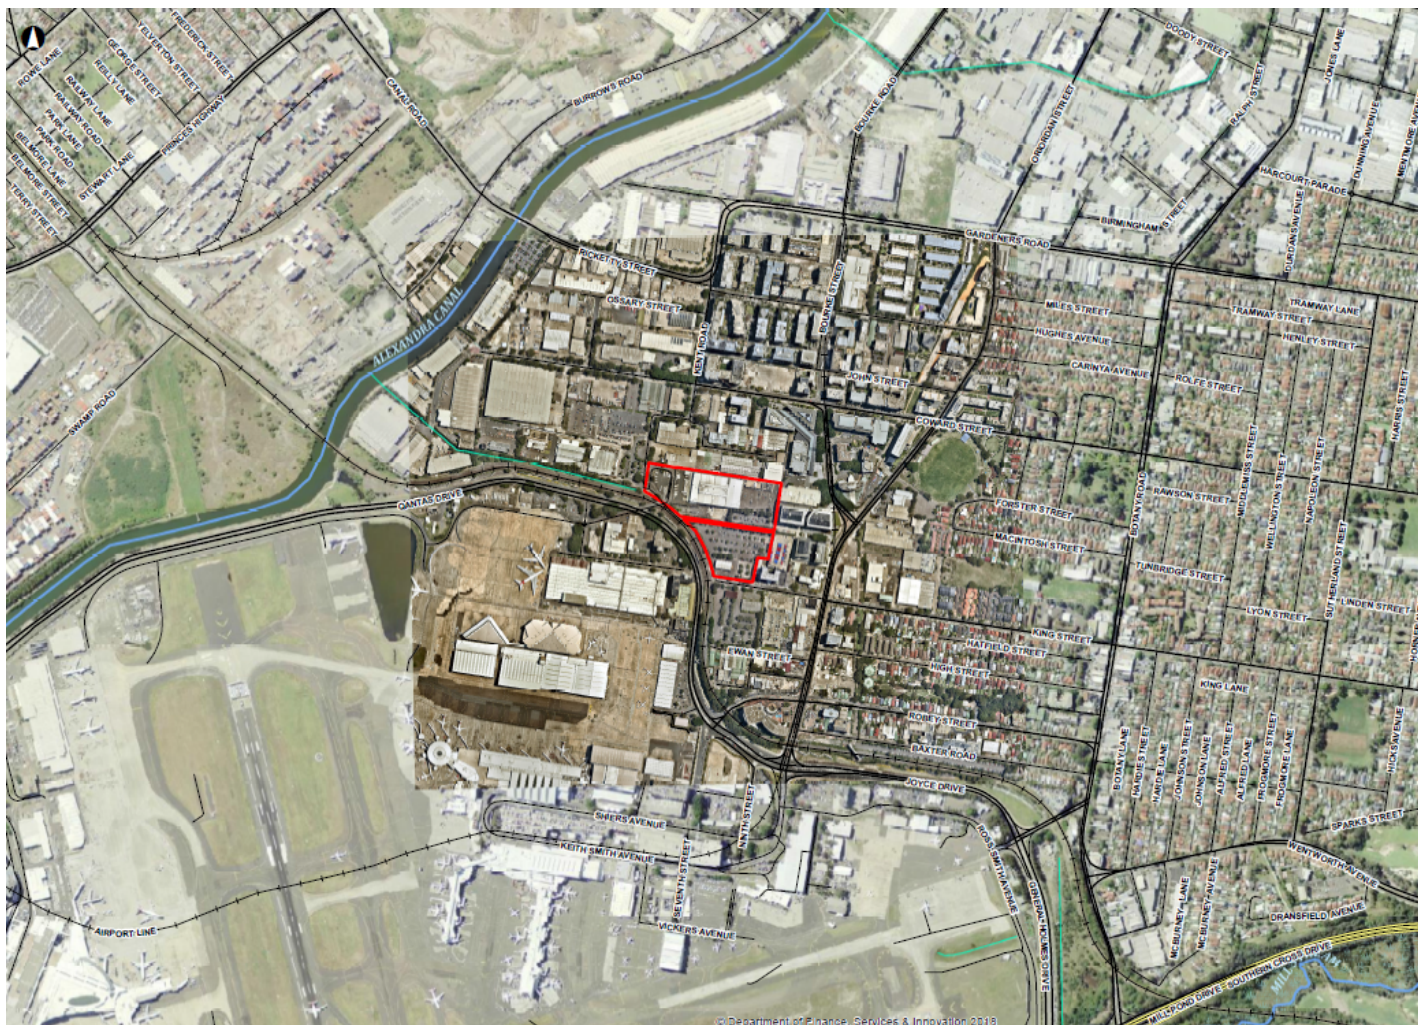
Figure 1  
Site Location

Site location  
297 King St & 65 Kent Rd, Mascot NSW

Figure 1, **Appendix A**, identifies the site location and surrounding features, and Figure 2, **Appendix A** details the proposed development site layout. The site details are summarised in Table 1-1 below.

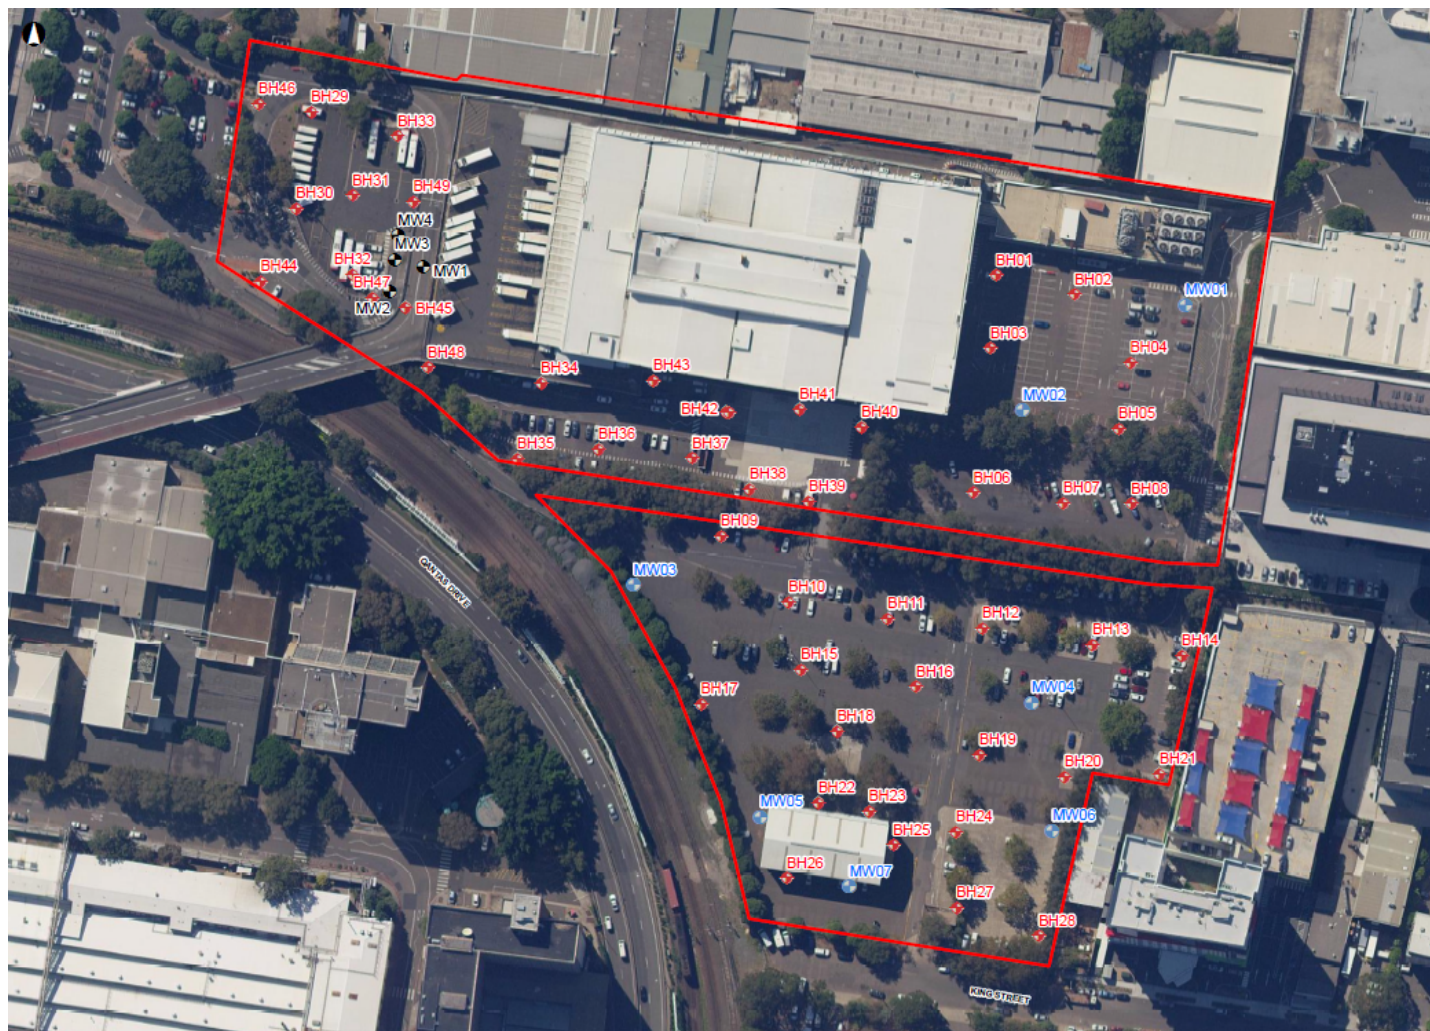
Arcadis Groundwater  
Monitoring Well Locations

A total of 15 groundwater monitoring wells have been installed and monitored across the site. In addition, 24 Cone Penetrometer Test (CPT) have been completed which have interpreted groundwater water table levels. Locations are provided on Figures 3 & 4, **Appendix A**.

Collection and analysis of groundwater samples from 11 onsite monitoring wells has been completed by Arcadis (2019). The locations of groundwater monitoring wells are presented in Figure 3 & 4, **Appendix A**. Copies of the result summary tables are provided in **Appendix C**.

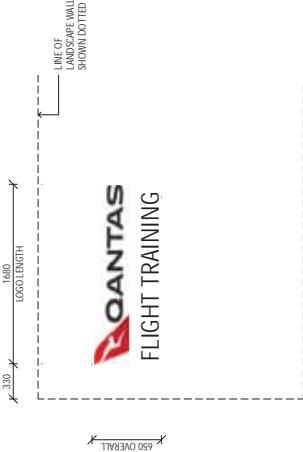
01 DETAIL ELEVATION - F-SN-OF-01 - NORTH ROAD  
1:25

EXTERNAL BUILDING IDENTIFICATION SIGN  
- EXTERNAL ILLUMINATION

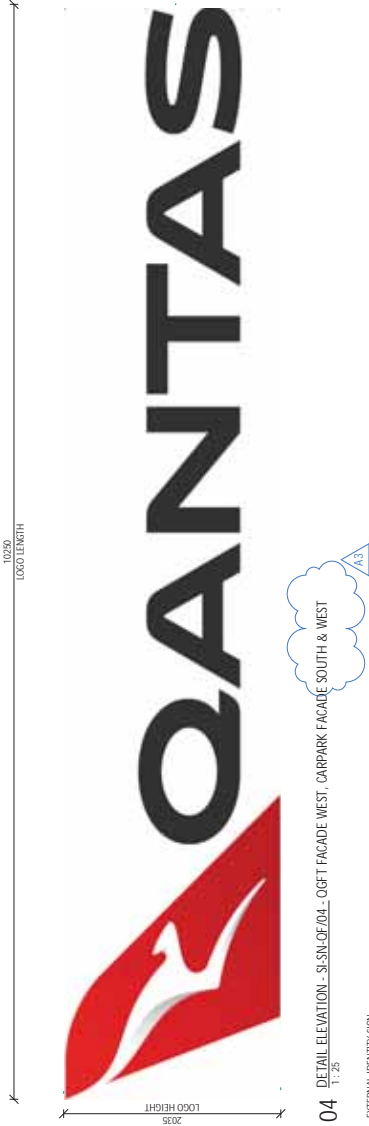
04 DETAIL ELEVATION - SI-SN-OF-004 - QGFT FACADE WEST, CARPARK FACADE SOUTH & WEST  
1:25

EXTERNAL IDENTITY SIGN  
- INTERNAL ILLUMINATION

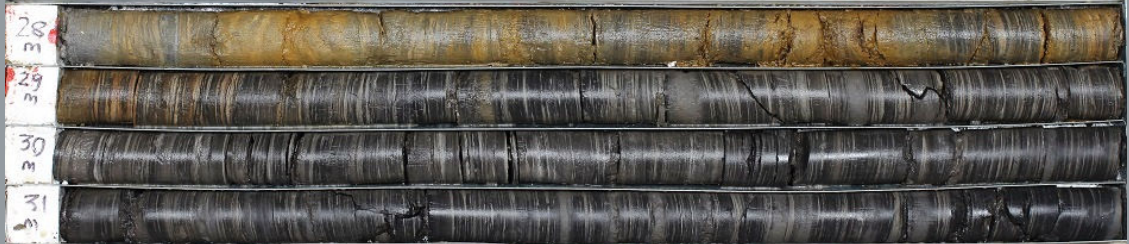
85777.15 MASCOT START 28.0m BH1 15-1-19

28.00 - 32.00m

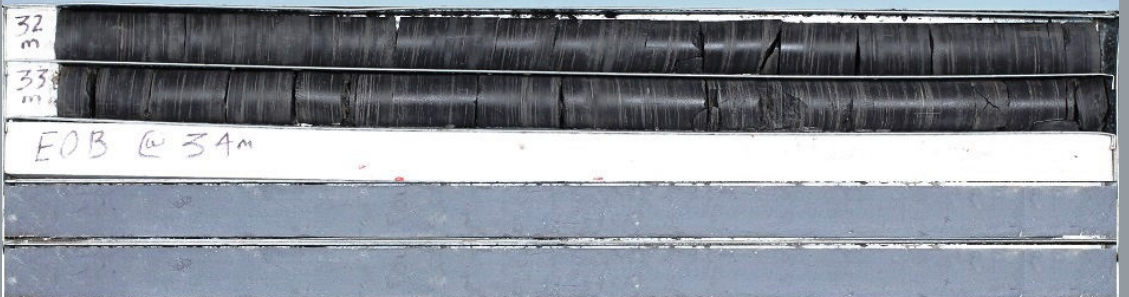
Project No: 85777.15  
BH ID: BH 1  
Depth: 32.00 - 34.00 m  
Core Box No.: 2

32.00 - 34.00m

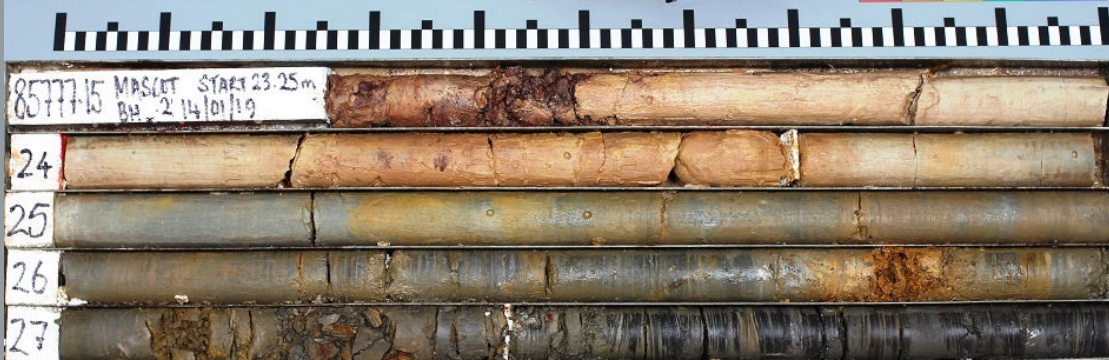
Project No: 85777-15  
BH ID: BH 2  
Depth: 23.25 - 28.00 m  
Core Box No.: 1

23.25 - 28.00m

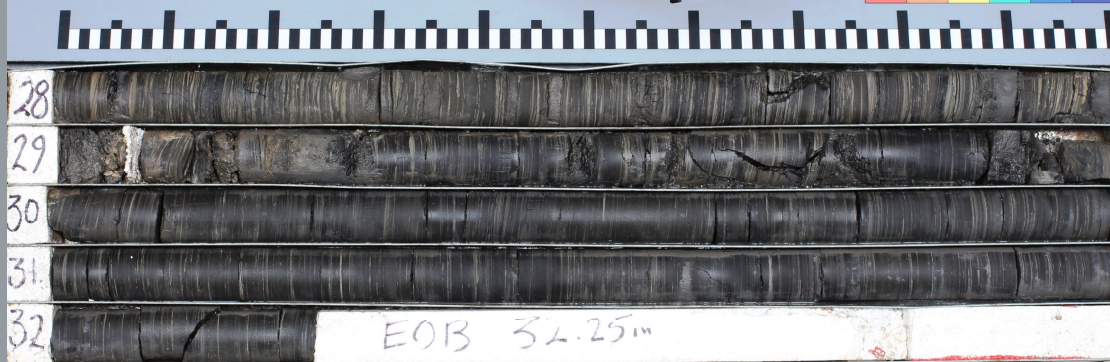
Project No: 85777-15  
BH ID: BH 2  
Depth: 28.00 - 32.25 m  
Core Box No.: 2

28.00 - 32.25m

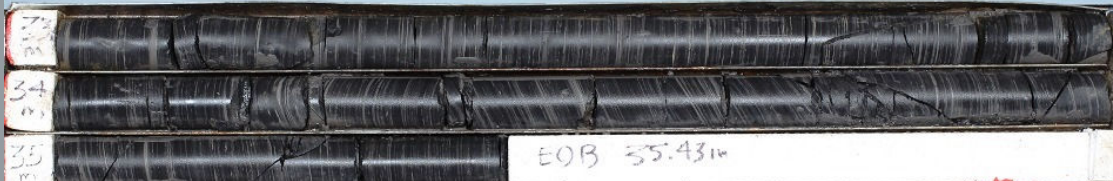
Project No: 85777-15  
BH ID: BH3  
Depth: 33.00 - 35.43m  
Core Box No.: 2

33.00 - 35.43m

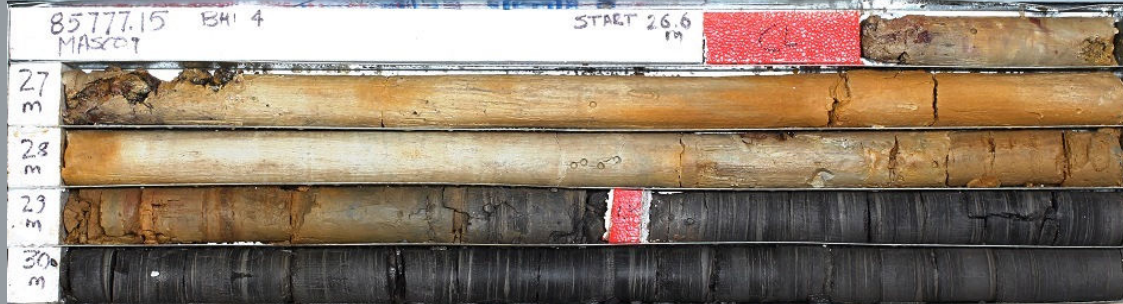
Project No: 85777.15  
BH ID: BH4  
Depth: 26.60 - 31.00 m  
Core Box No.: 1

26.60 - 31.00m

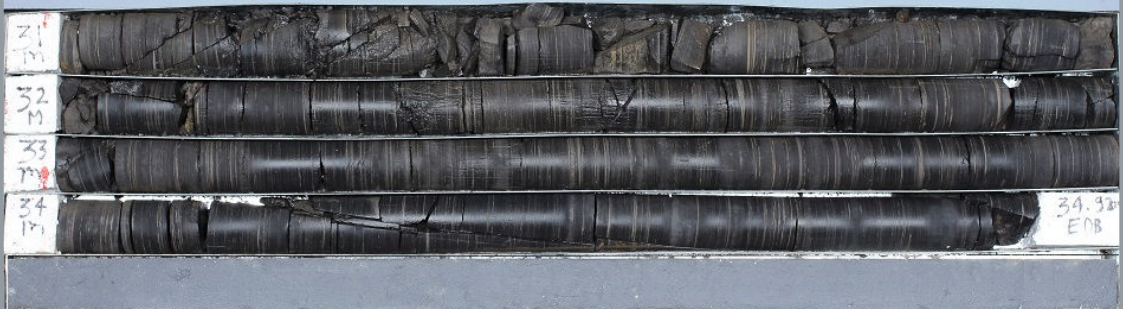
Project No: 85777.15  
BH ID: BH4  
Depth: 31.00 - 34.92 m  
Core Box No.: 2

31.00 - 32.92m

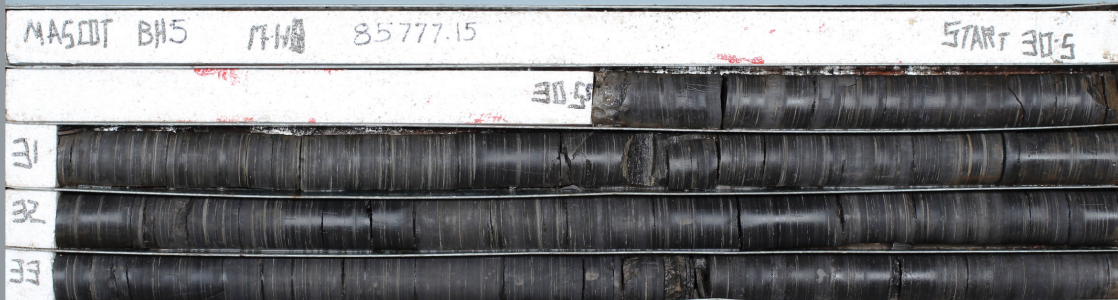
Project No: 85777.15  
BH ID: BH 5  
Depth: 30.55 - 34.00 m  
Core Box No.: 1

30.50 - 34.00m

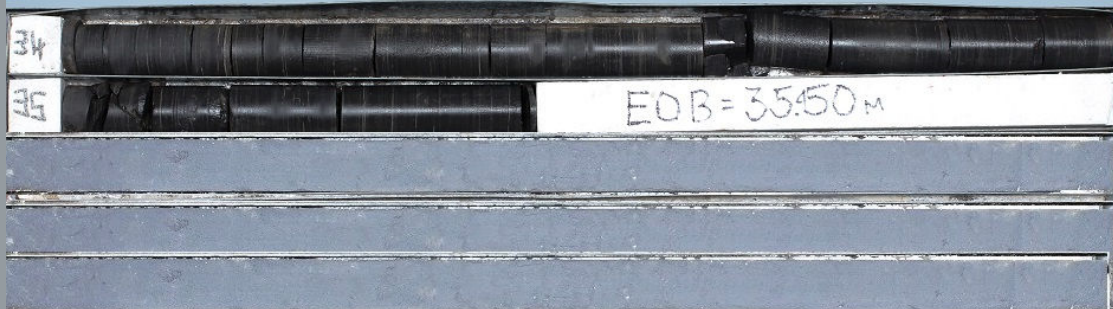
Project No: 85777.15  
BH ID: BH 5  
Depth: 34.00 - 35.45 m  
Core Box No.: 2

34.00 - 35.45m

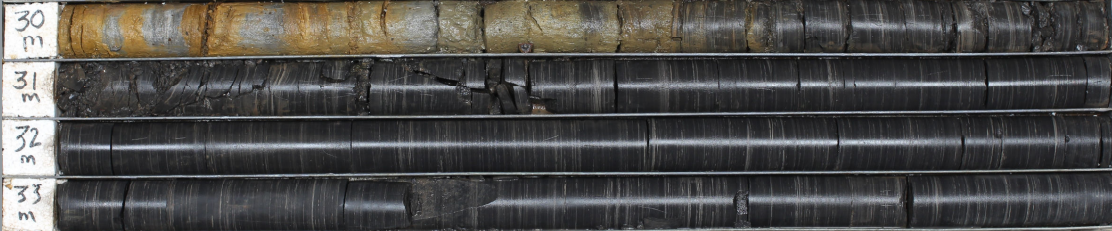
85777-15 MASCOT BH6 START 29.55 m  
24-1-2019

29.55 - 34.00 m

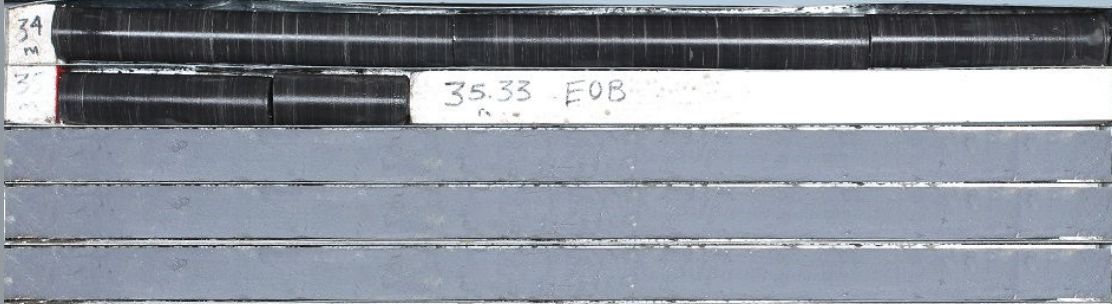
Depth: 34.00 - 35.33 m

Core Box No.: 2

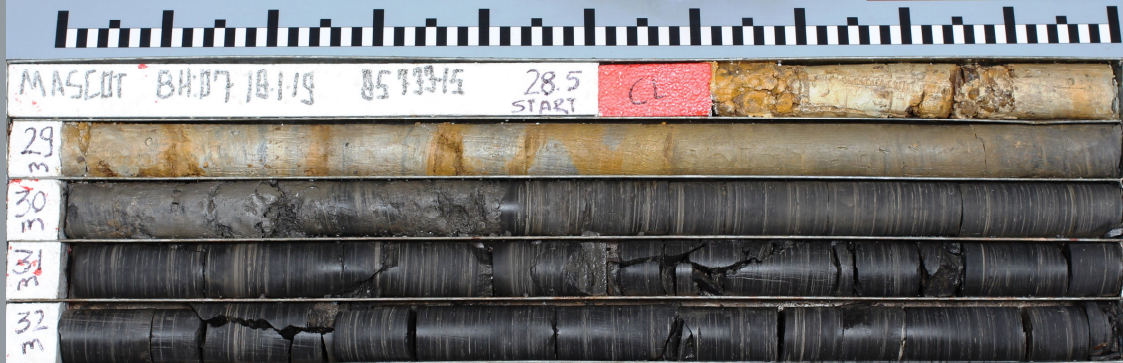
28.50 - 33.00m

Project No: 8577715  
BH ID: BH 7  
Depth: 28.50 - 33.00 m  
Core Box No.: 1

BORE: 7

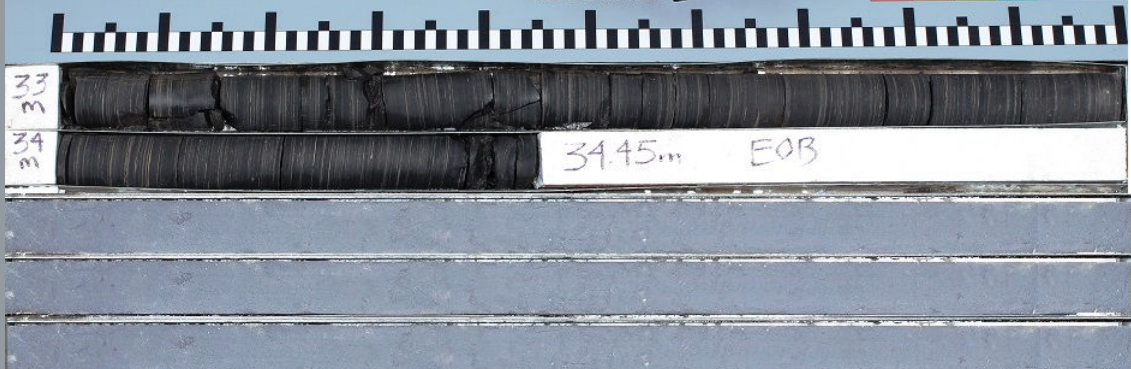
33.00 - 34.45m

Project No: 8577715  
BH ID: BH 7  
Depth: 33.00 - 34.45 m  
Core Box No.: 2

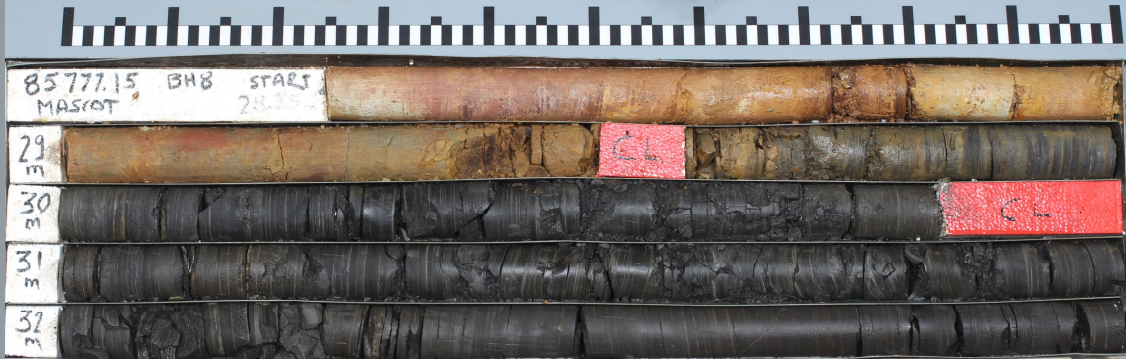
Project No: 85777-15  
BH ID: BH 8  
Depth: 28.25 - 33.00 m  
Core Box No.: 1

BORE: 8

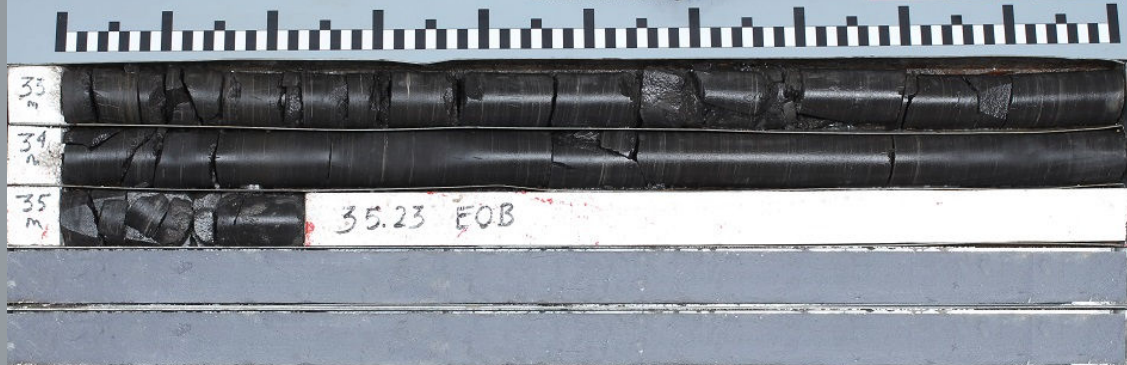
Project No: 85777-15  
BH ID: BH 8  
Depth: 33.00 - 35.23 m  
Core Box No.: 2

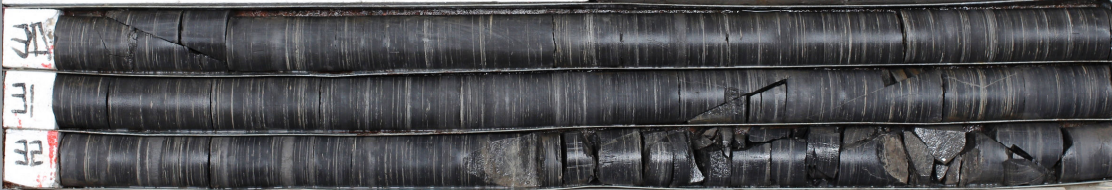
29.5 - 33.00 m

MASCOT 16-119 BH:9 85777-15 START 29.5

BORE: 9

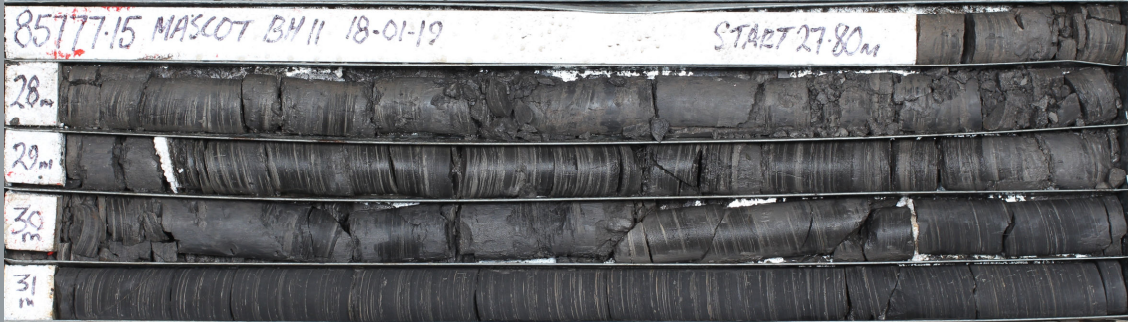
27.80 - 32.00m

Project No: 85777-15  
BH ID: BH 11  
Depth: 27.80 - 32.00 m  
Core Box No.: 1

BORE: 11

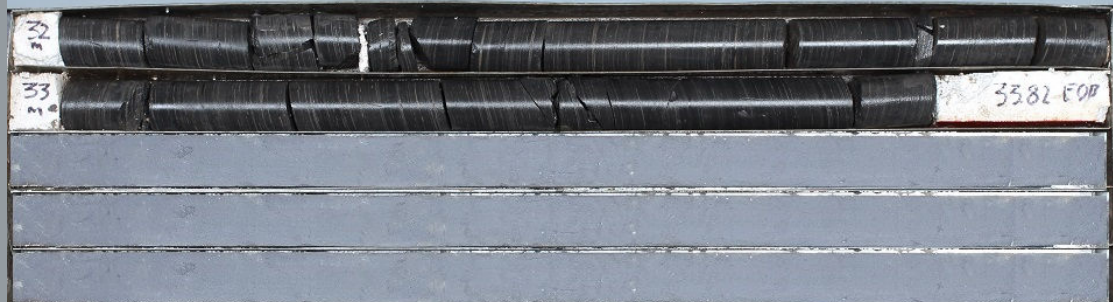
32.00 - 33.82m

Project No: 85777-15  
BH ID: BH 11  
Depth: 32.00 - 33.82 m  
Core Box No.: 2

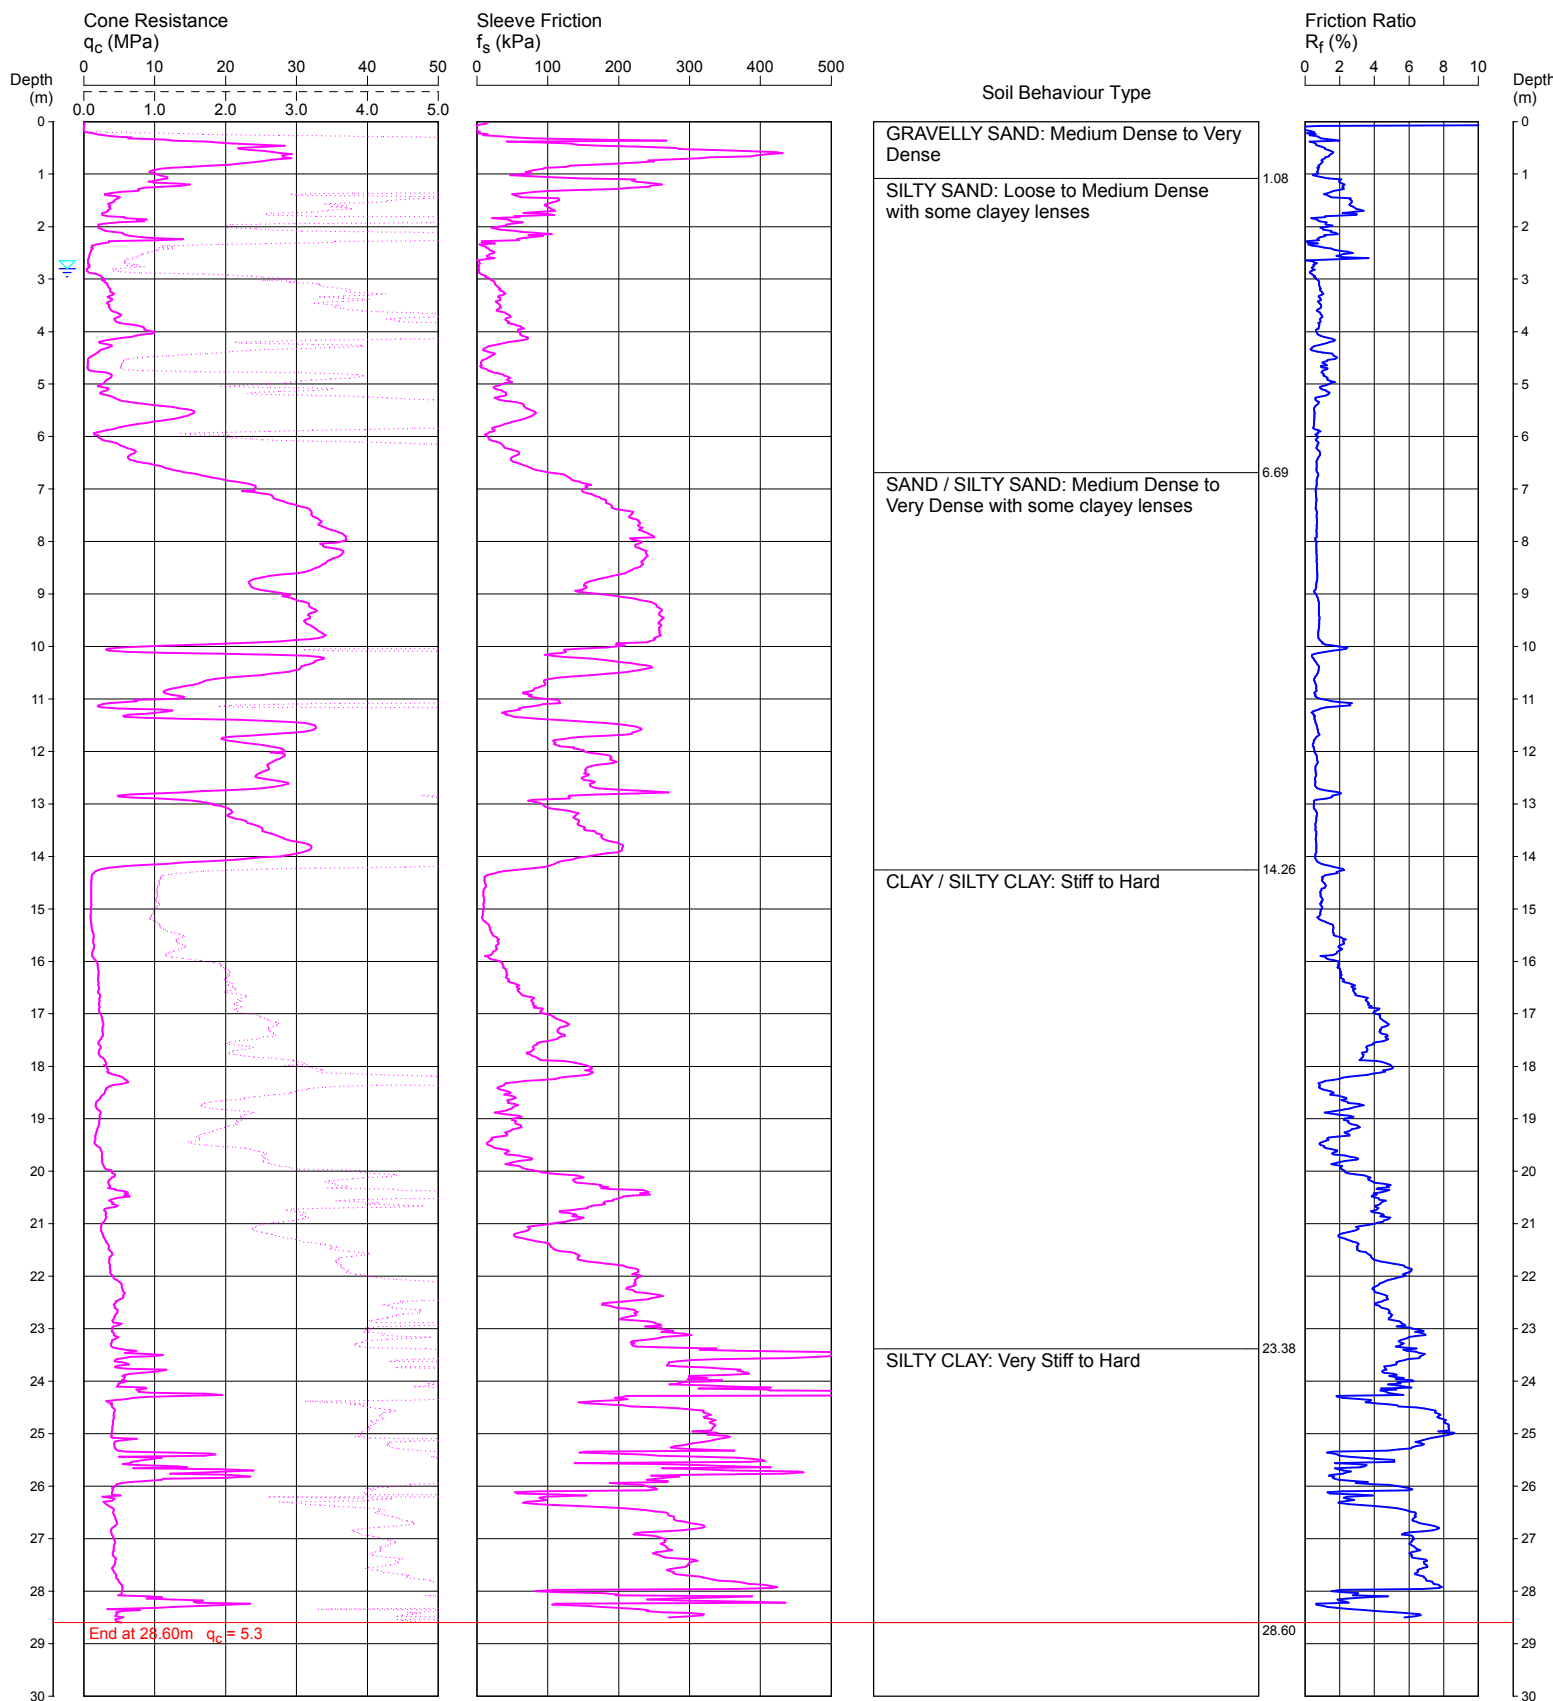
REMARKS: CONCRETE CORE TO 0.2 m DEPTH. TEST DISCONTINUED DUE TO EXCESSIVE CONE BENDING.  
HOLE COLLAPSE AT 0.5 m AFTER WITHDRAWAL OF RODS.

Water depth after test: 2.80m depth (assumed)

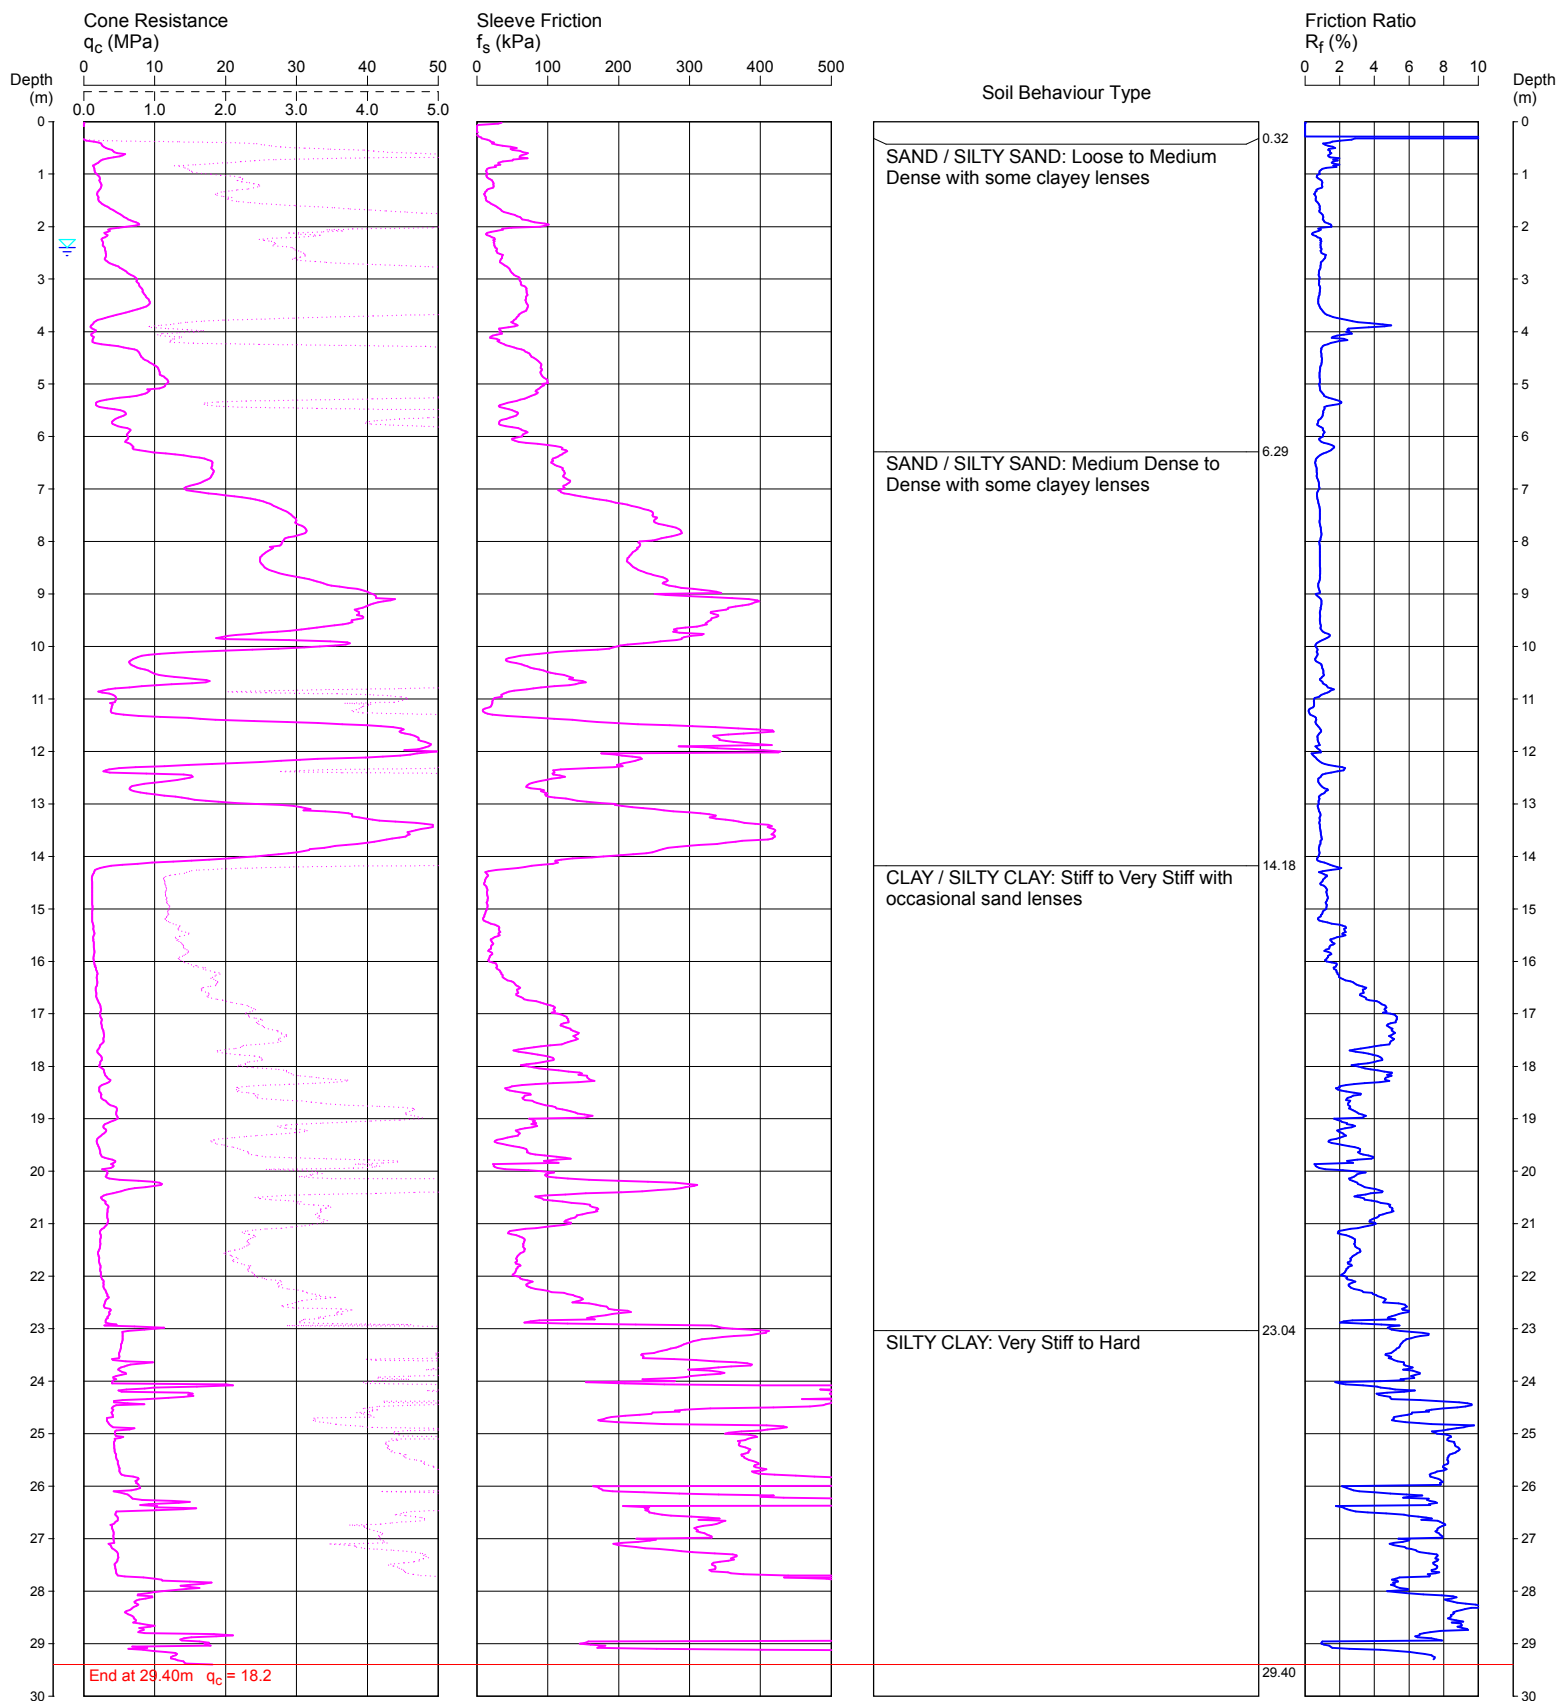
REMARKS: CONCRETE CORE TO 0.35 m DEPTH. TEST DISCONTINUED DUE TO EXCESSIVE CONE BENDING.  
GROUNDWATER OBSERVED AT 2.4 m AFTER WITHDRAWAL OF RODS.

Water depth after test: 2.40m depth (assumed)

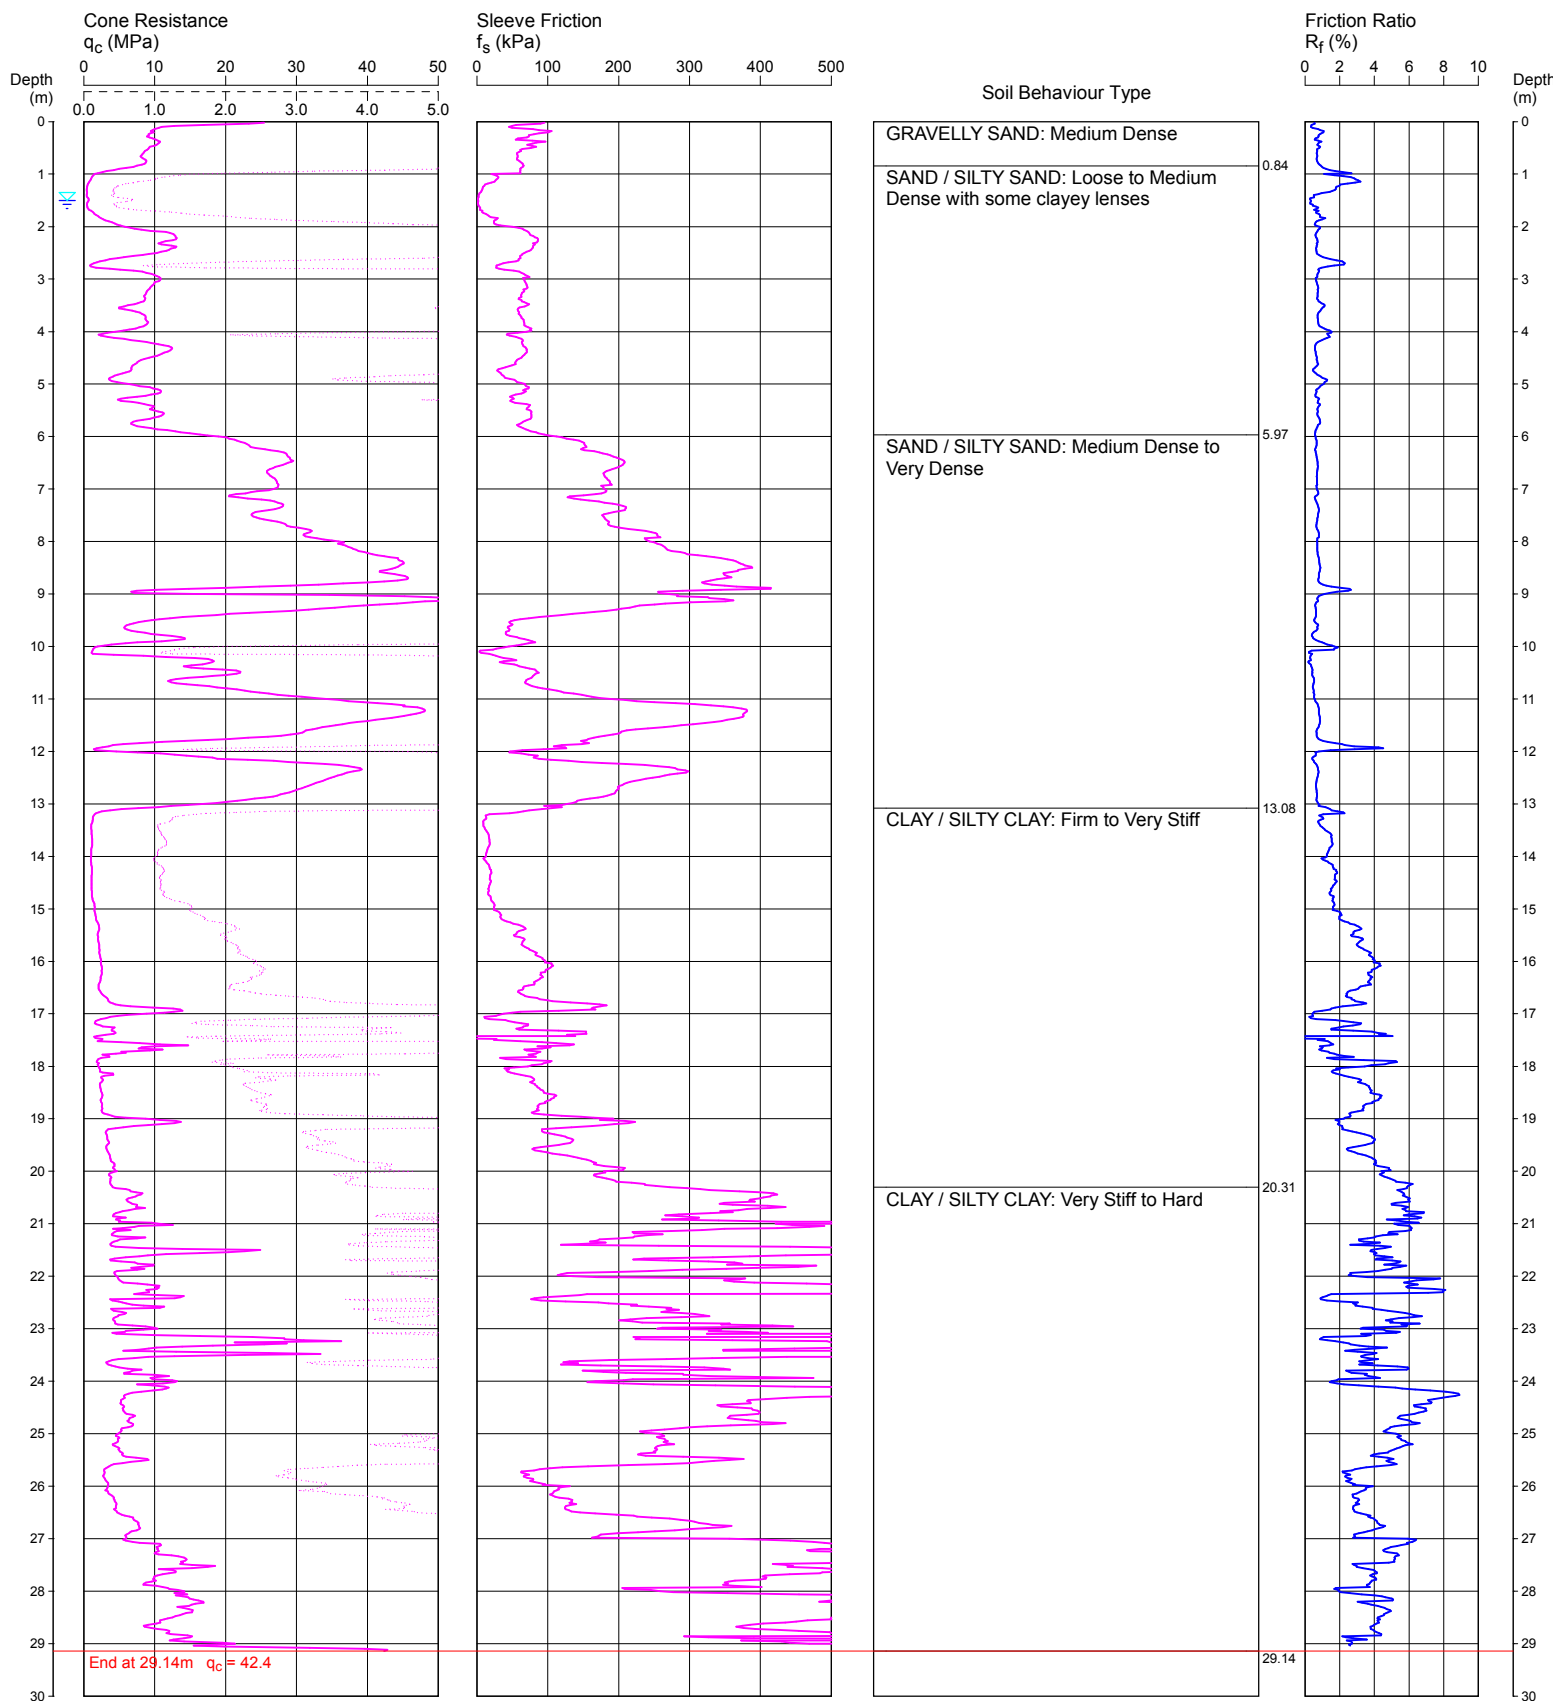
REMARKS: TEST DISCONTINUED DUE TO EXCESSIVE CONE BENDING.  
HOLE COLLAPSE AT 1.5 m AFTER WITHDRAWAL OF RODS.

Water depth after test: 1.50m depth (assumed)

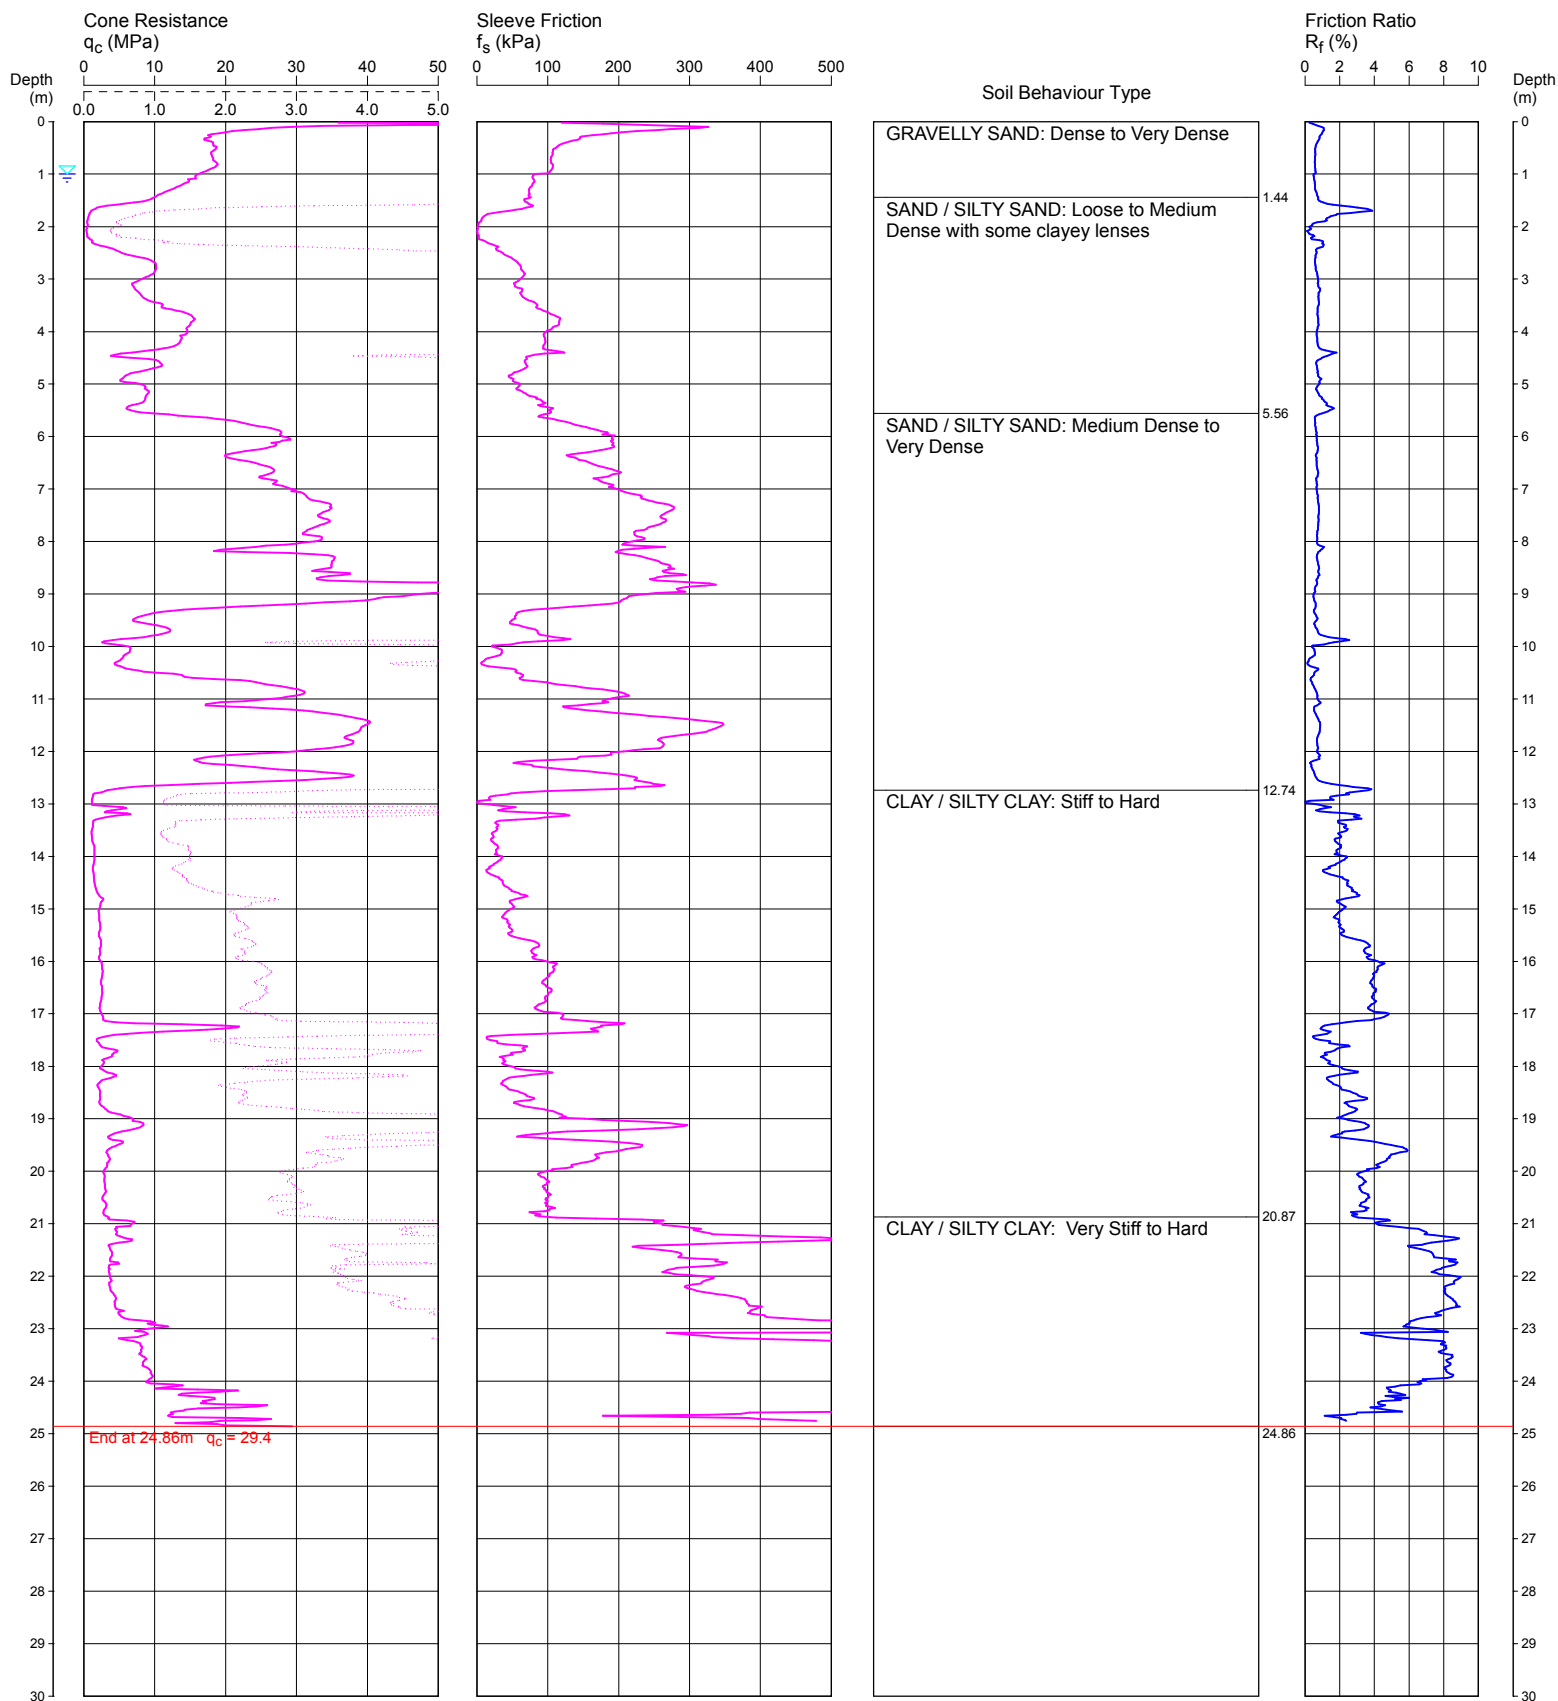
REMARKS: TEST DISCONTINUED DUE TO EXCESSIVE CONE BENDING.  
GROUNDWATER OBSERVED AT 1.0 m AFTER WITHDRAWAL OF RODS.

Water depth after test: 1.00m depth (assumed)
