# Dewatering Management Plan

**Qantas Flight Training Centre**

**297 King Street and 65 Kent Road**

**Mascot NSW**

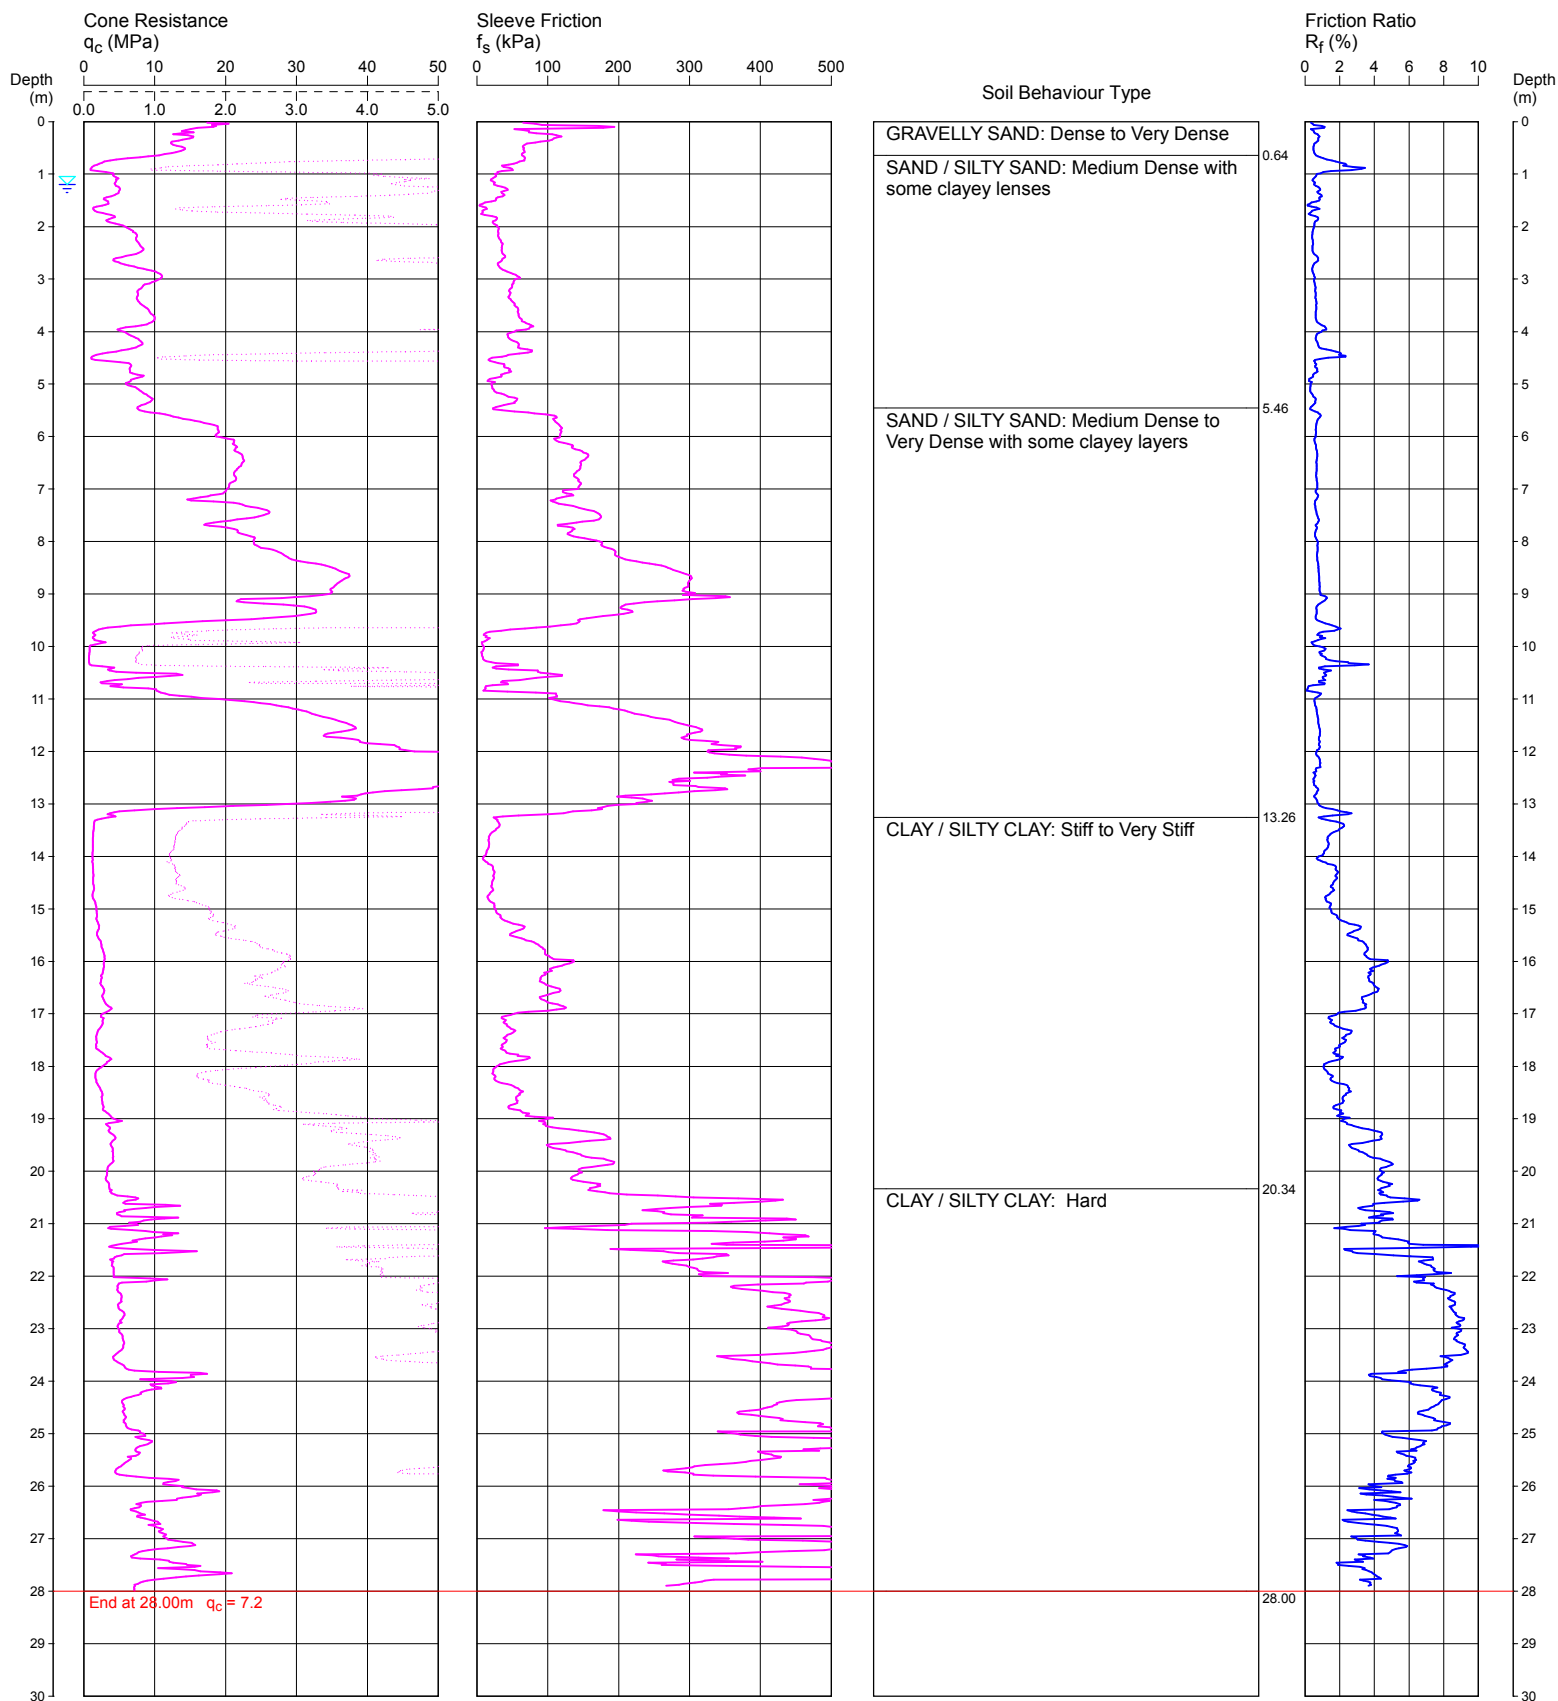
REMARKS: TEST DISCONTINUED DUE TO EXCESSIVE ROD BOWING.  
HOLE COLLAPSE AT 1.4 m AFTER WITHDRAWAL OF RODS.

Water depth after test: 1.20m depth (assumed)
