Fort Street Public School Hazardous Materials Management Plan (HMMP)

SSD 10340

Prepared by JBS&G Australia Pty Ltd

For School Infrastructure NSW

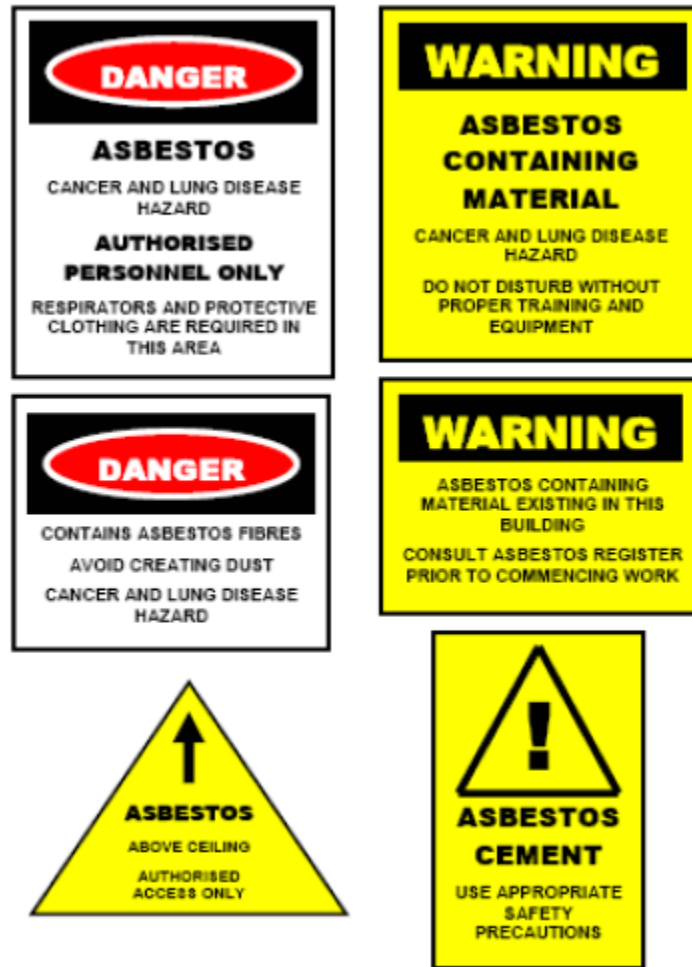
In-situ non-friable ACM must be labelled with asbestos warning signs in accordance with Australian Standard AS1319 *Safety Signs for the Occupational Environment*. Examples of typical warning signs are shown below.

In addition to this, asbestos warning signs should be installed at all entrances to the structure to inform personnel of the presence of ACM. In the event that all occurrences of ACM cannot be labelled, a 'permit to work' system must be implemented to ensure occurrences of ACM are identified to any site personnel prior to commencing works.

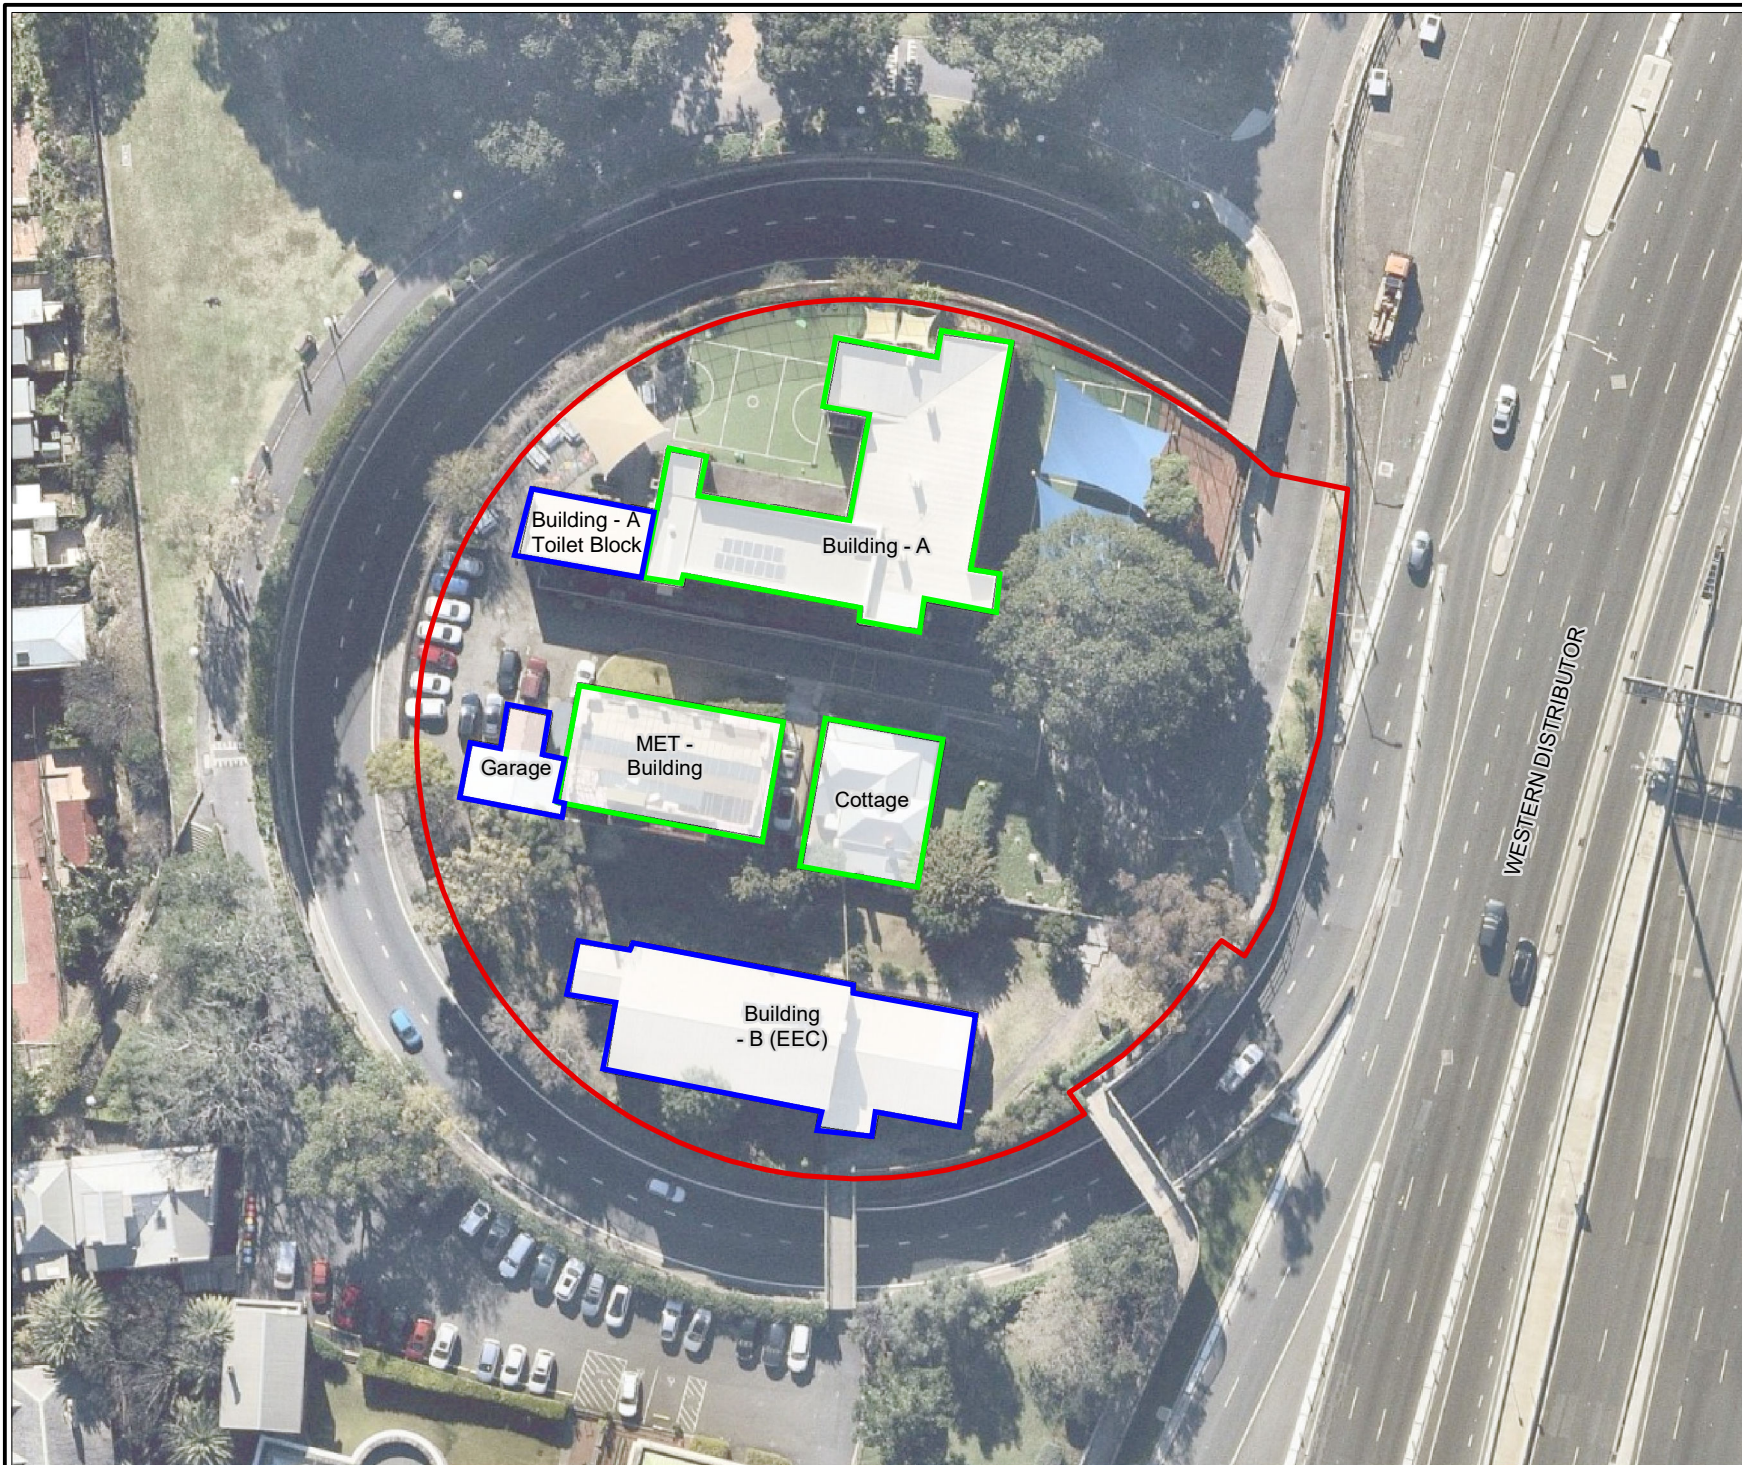
- ▬ Approximate Site Boundary
- ▬ Structure to be Demolished
- ▬ Structure to be Retained/Refurbished

JBS&G Australia Pty Ltd (JBS&G) was engaged by School Infrastructure NSW (SINSW, the client), care of Johnstaff Projects Pty Ltd (Johnstaff) to prepare a Hazardous Materials Management Plan (HMMP) for Fort Street Public School (FSPS), located at Observatory Hill, Upper Fort Street, Millers Point, NSW (the site). The site is legally identified as Lot 2 of DP 732592, Lot 3 of DP 732592, Lot 4 of DP 732592, Lot 106 of DP 748340, Lot 107 of DP 748340, Lot 108 of DP 748340, Lot 9 of DP 732592, and Lot 5 of DP 258013, as shown on **Figure 1** and **Figure 2**, and covers an area of approximately 5,600 m².
