APPENDIX 'C'

LABORATORY TEST CERTIFICATES

Quality of Materials Report

Client :	WOOD & GRIEVE ENGINEERS	Report Number:	GE18-144.1/1
Address :		Report Date :	15/08/2018
Project Name :	GEOTECHNICAL INVESTIGATION	Order Number :	
Project Number :	GE18/144	Test Method :	AS1289.3.6.1
Location:	TWEED VALLEY HOSPITAL, CUDGEN ROAD , KINGSCLIFF	Page 1 of 1

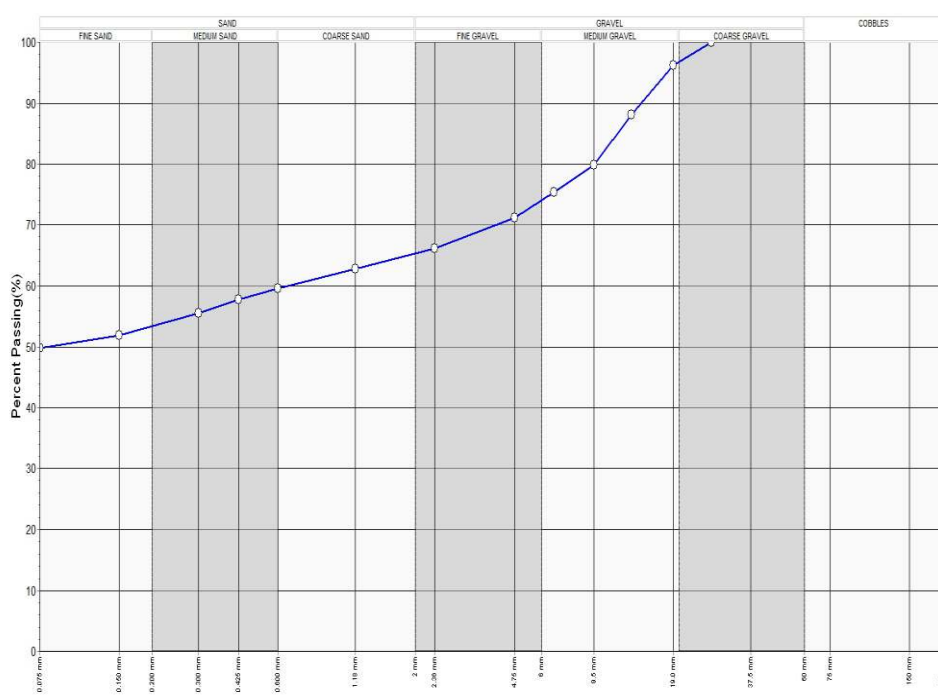
AS Sieve Size(mm)	Percent Passing	Specification Limits

Sample Number :	245179	SAMPLE LOCATION	
Sampling Method :	-	BH 3	
Sampled By :	LEIGH BEXLEY	1.5 - 2.5	
Date Sampled :	3/08/2018	DISTURBED	
Date Tested :	13/08/2018	SAMPLE	
Material Type :	DISTURBED SAMPLE	Test Number :	
Material Source :	INSITU	Lot Number :	
Remarks :		Specification Number :

100			
75.0			
63.0			
53.0			
37.5			
26.5	100		
19.0	96		
16.0			
13.2	88		
9.5	80		
6.7	75		
4.75	71		
2.36	66		
1.18	63		
0.600	60		
0.425	58		
0.300	56		
0.150	52		
0.075	50

Test Method	Results		
Liquid Limit (%) :		AS1289.3.1.2	47	Shrinkage Comments :	cracking and curling
Plastic Limit (%) :		AS1289.3.2.1	33	Mould Length (mm) :	250.4
Plasticity Index (%) :		AS1289.3.3.1	14	Sample History	
Linear Shrinkage (%) :		AS1289.3.4.1	8.5		
Soil Description :

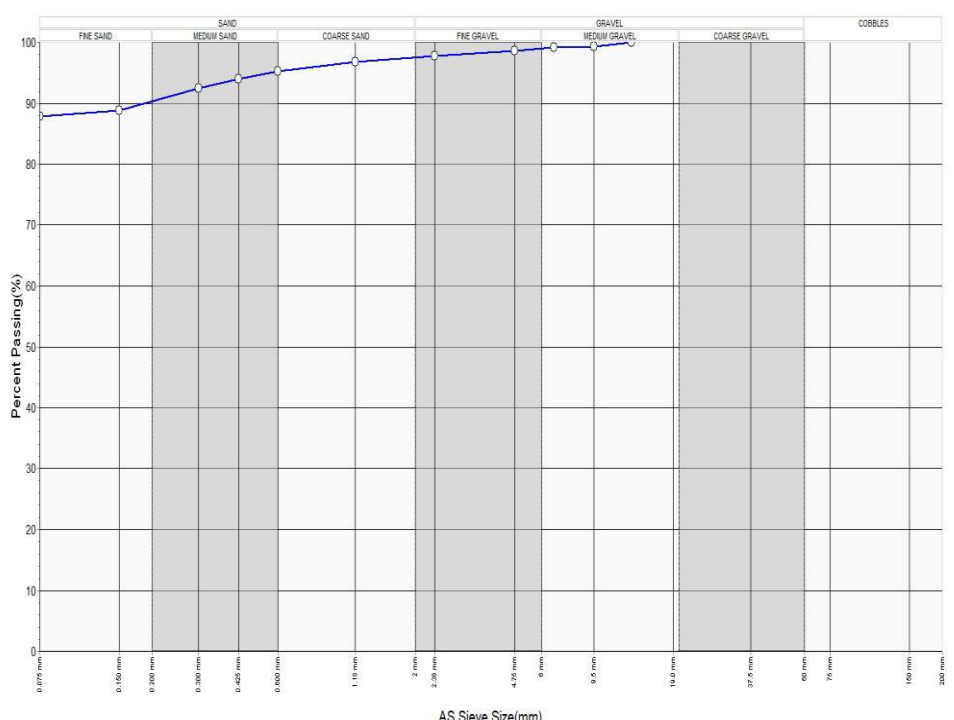
AS Sieve Size(mm)	Percent Passing	Specification Limits

Sample Number :	245181	SAMPLE LOCATION BH 7 0.1 - 0.5 DISTURBED SAMPLE	
Sampling Method :	-		
Sampled By :	LEIGH BEXLEY		
Date Sampled :	3/08/2018		
Date Tested :	13/08/2018		
Material Type :	DISTURBED	Test Number :	
Material Source :	INSITU	Lot Number :	
Remarks :		Specification Number :

100			
75.0			
63.0			
53.0			
37.5			
26.5			
19.0			
16.0			
13.2	100		
9.5	99		
6.7	99		
4.75	99		
2.36	98		
1.18	97		
0.600	95		
0.425	94		
0.300	92		
0.150	89		
0.075	88

Test Method	Results		
Liquid Limit (%) :		AS1289.3.1.2	42	Shrinkage Comments :	cracking and curling
Plastic Limit (%) :		AS1289.3.2.1	27	Mould Length (mm) :	250.1
Plasticity Index (%) :		AS1289.3.3.1	15	Sample History	
Linear Shrinkage (%) :		AS1289.3.4.1	10		
Soil Description :

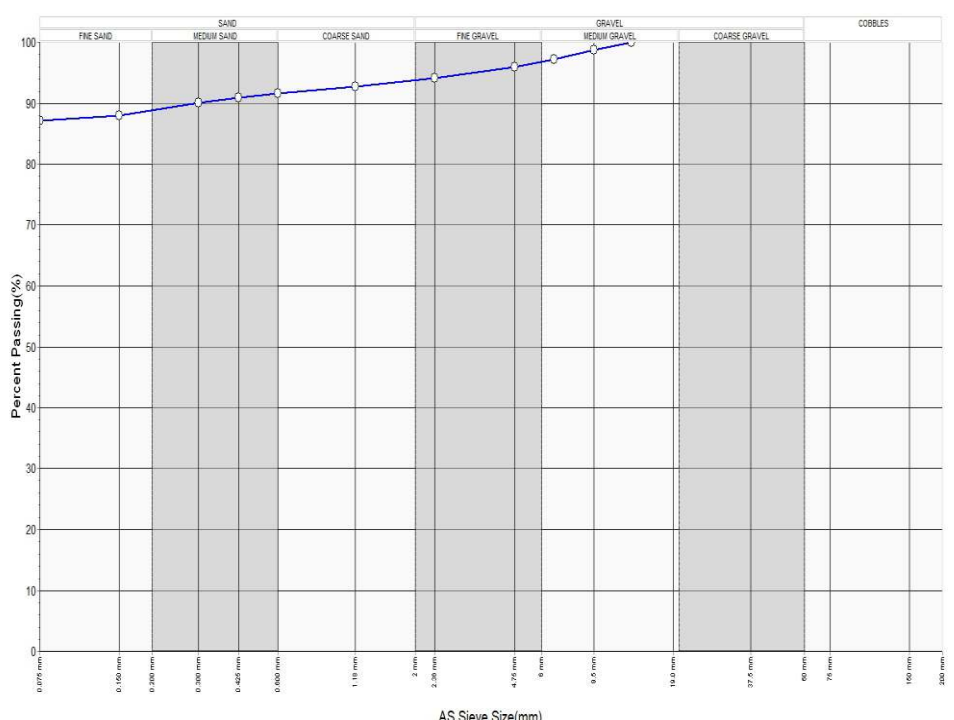
AS Sieve Size(mm)	Percent Passing	Specification Limits

Sample Number :	245183	SAMPLE LOCATION BH 10 1.0 - 1.5 BULK SAMPLE	
Sampling Method :	-		
Sampled By :	LEIGH BEXLEY		
Date Sampled :	3/08/2018		
Date Tested :	13/08/2018		
Material Type :	BULK SAMPLE	Test Number :	
Material Source :	INSITU	Lot Number :	
Remarks :		Specification Number :

100			
75.0			
63.0			
53.0			
37.5			
26.5			
19.0			
16.0			
13.2	100		
9.5	99		
6.7	97		
4.75	96		
2.36	94		
1.18	93		
0.600	92		
0.425	91		
0.300	90		
0.150	88		
0.075	87

Test Method	Results		
Liquid Limit (%) :		AS1289.3.1.2	46	Shrinkage Comments :	cracking and curling
Plastic Limit (%) :		AS1289.3.2.1	29	Mould Length (mm) :	250.1
Plasticity Index (%) :		AS1289.3.3.1	17	Sample History	
Linear Shrinkage (%) :		AS1289.3.4.1	12		
Soil Description :

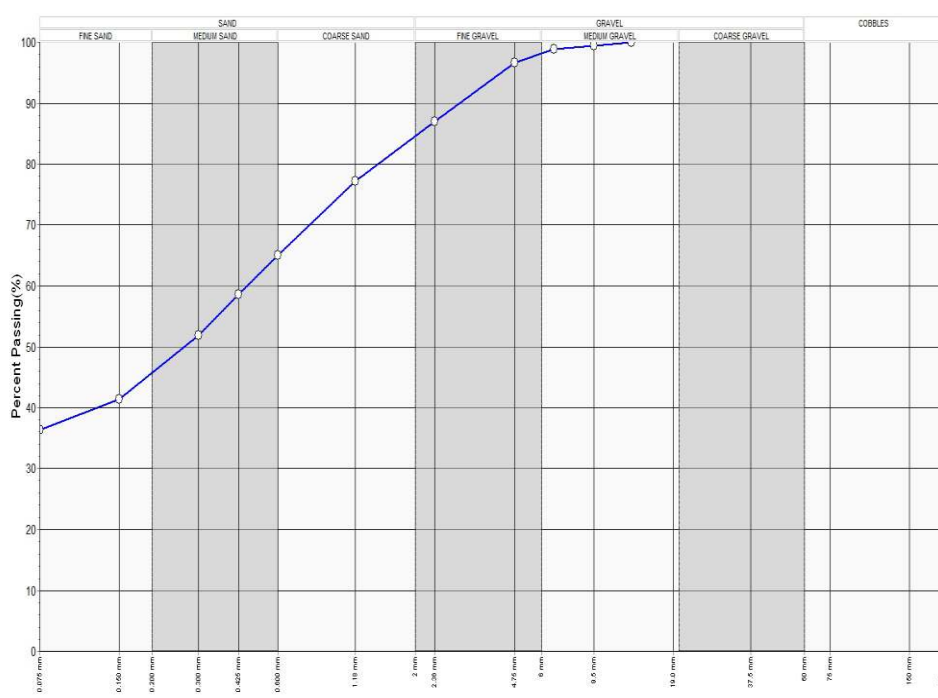
AS Sieve Size(mm)	Percent Passing	Specification Limits

Sample Number :	245185	SAMPLE LOCATION BH 17 0.3 - 1.0 BULK SAMPLE	
Sampling Method :	-		
Sampled By :	LEIGH BEXLEY		
Date Sampled :	3/08/2018		
Date Tested :	13/08/2018		
Material Type :	BULK SAMPLE	Test Number :	
Material Source :	INSITU	Lot Number :	
Remarks :		Specification Number :

100			
75.0			
63.0			
53.0			
37.5			
26.5			
19.0			
16.0			
13.2	100		
9.5	99		
6.7	99		
4.75	97		
2.36	87		
1.18	77		
0.600	65		
0.425	59		
0.300	52		
0.150	41		
0.075	36

Test Method	Results		
Liquid Limit (%) :		AS1289.3.1.2	40	Shrinkage Comments :	cracking and curling
Plastic Limit (%) :		AS1289.3.2.1	32	Mould Length (mm) :	250.4
Plasticity Index (%) :		AS1289.3.3.1	8	Sample History	
Linear Shrinkage (%) :		AS1289.3.4.1	5.5		
Soil Description :

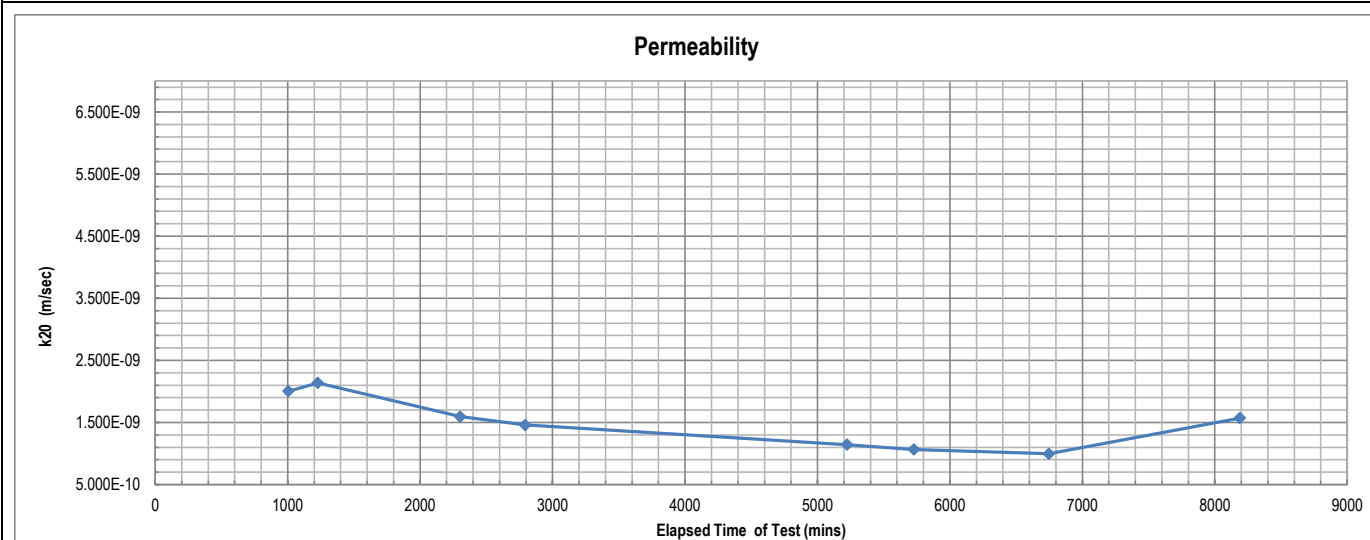
Compaction Method	AS1289.5.1.1 - Standard Compaction		
Maximum Dry Density (t/m ³)	1.31	Hydraulic Gradient	9.4
Optimum Moisture Content (%)	31.5	Surcharge (kPa)	3.0
Placement Moisture Content (%)	31.4	Head Pressure Applied (kPa)	10.79
Moisture Ratio (%)	99.5	Water Type	Deaerated
Placement Wet Density (t/m ³)	1.69	Percentage Material Retained/Sieve Size (mm)	0 % /9.5 mm
Density Ratio (%)	98.2	Sample Height and Diameter (mm)	116.63 / 101.14 mm

PERMEABILITY $k_{(20)} = 1.6 \times 10^{-09}$ (m/sec)

Remarks: The above specimen was remoulded at 98% Standard Dry Density and at Optimum Moisture Content as advised by the client

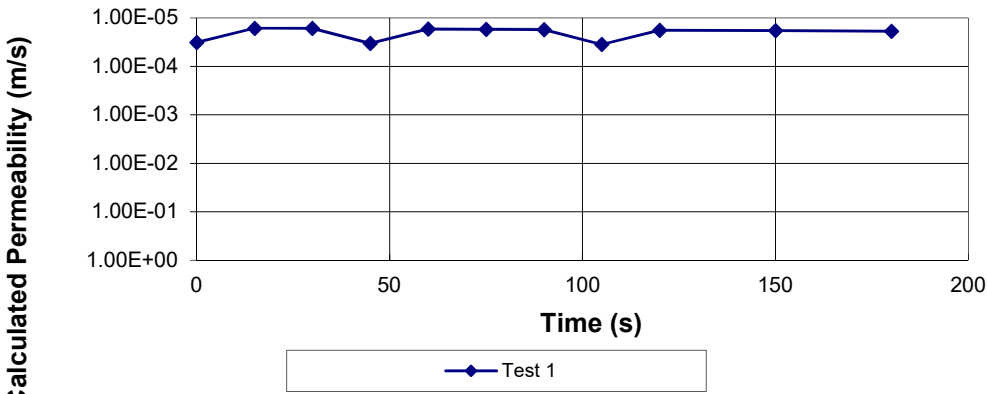
Permeability Test

Project	Tweed Valley Hospital		
Project Number	Test 3	Date	24/10/2018
Test Location	BH23	Tester	CL

Permeability (m/s)	2.2E-05
mm/hr	77.6
