Report on
Preliminary Geotechnical Investigation

Cricket NSW Cricket Centre
Wilson Park, Newington Road
Sydney Olympic Park

Prepared for
Cox Architecture Pty Ltd

Project 86694.02
September 2019

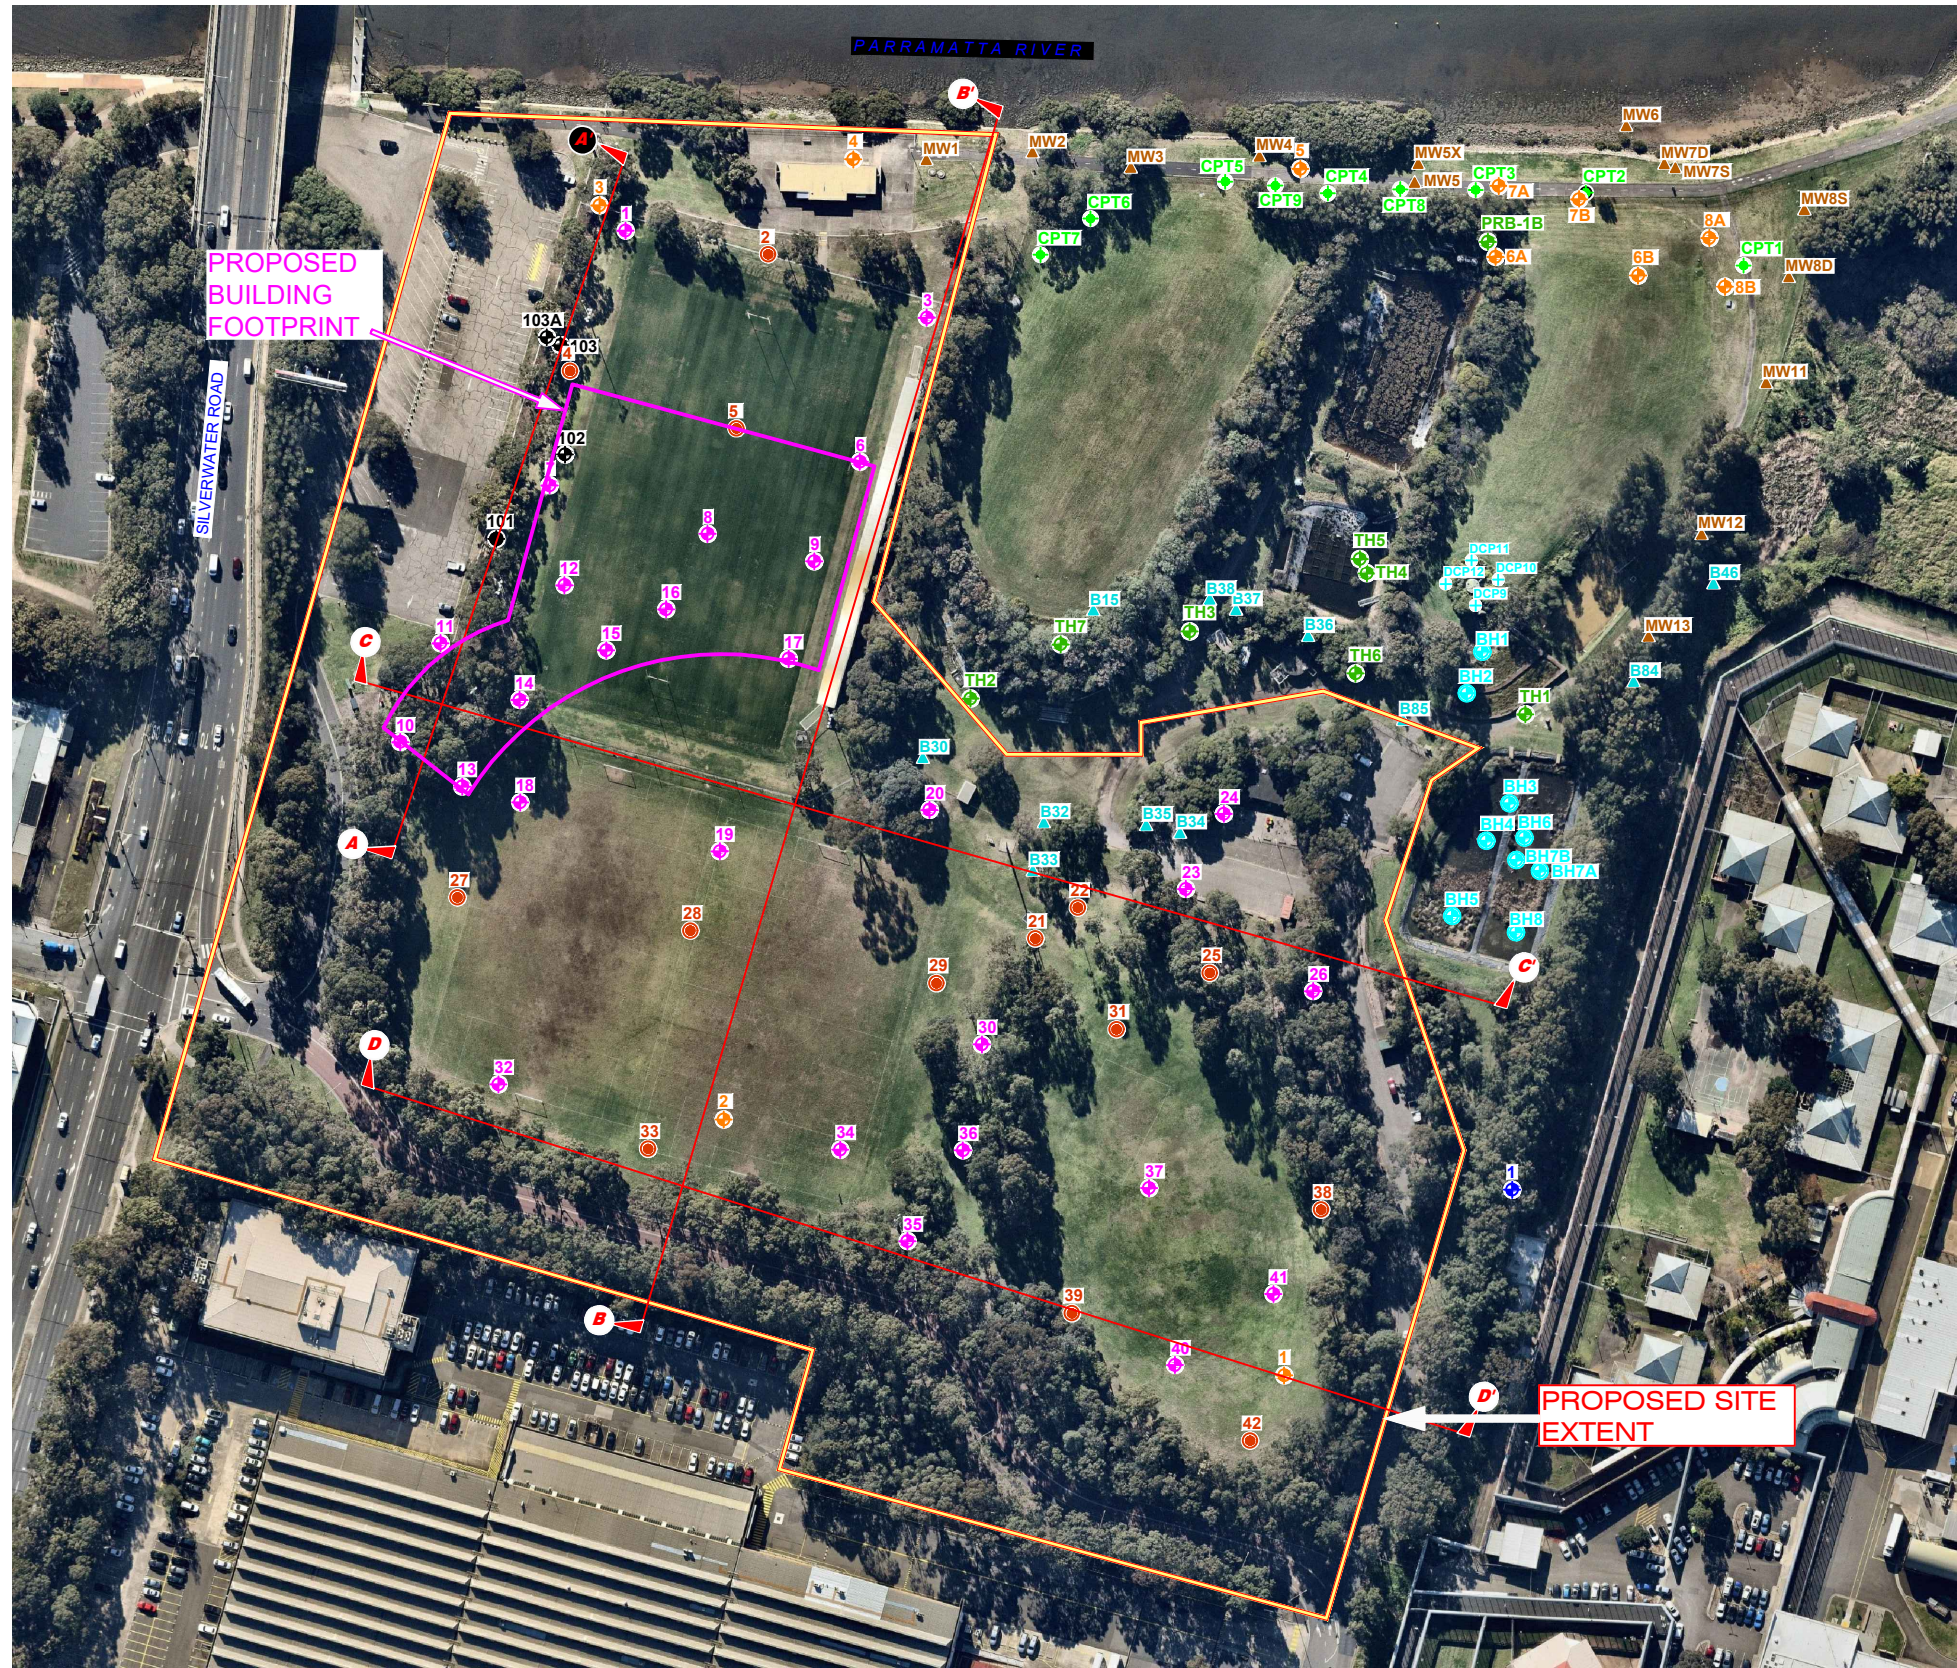
NOTE:
1: Base image from Nearmap.com
(Dated 1.7.2019)
2: Test locations are approximate only and have been
estimated based on historical drawings with reference to
existing features.

The approximate locations of all tests referenced above are shown on Drawing 1 of Appendix B. It is noted that the test locations are approximate only and have been estimated based on historical drawings with reference to existing site features.

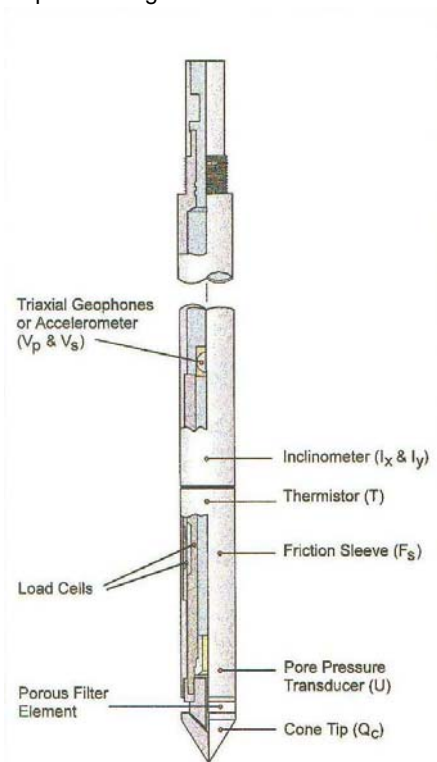
Figure 1: Cone Diagram

- Cone tip resistance q_c
- Sleeve friction f_s
- Inclination (from vertical) i
- Depth below ground z

The inclinometer in the cone enables the verticality of the test to be confirmed and, if required, the vertical depth can be corrected.

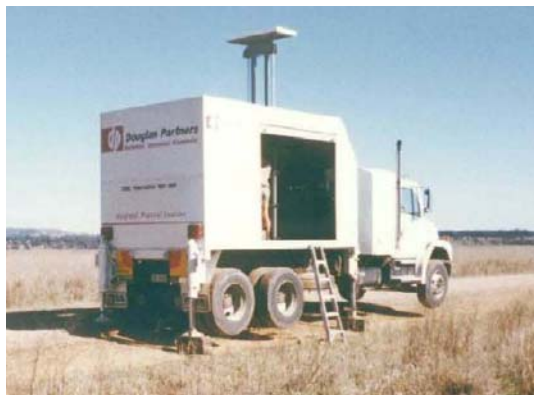
Figure 2: Purpose built CPT rig

The cone is thrust into the ground at a steady rate of about 20 mm/sec, usually using the hydraulic rams of a purpose built CPT rig, or a drilling rig. The testing is carried out in accordance with the Australian Standard AS1289 Test 6.5.1.

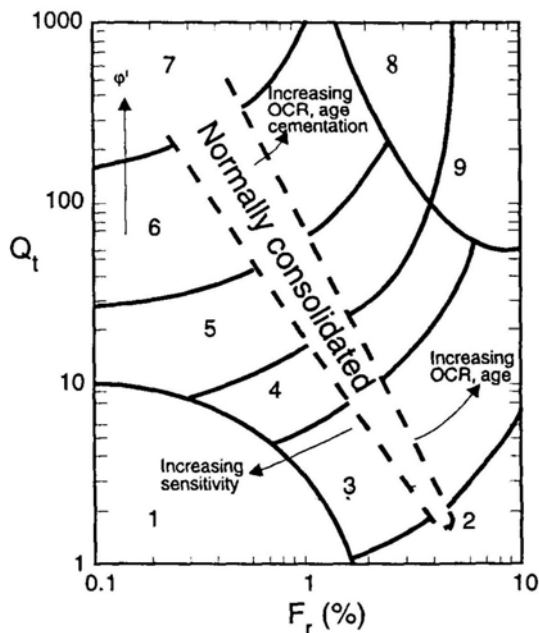
Figure 3: Soil Classification Chart

The CPT parameters can be used to infer the Soil Behaviour Type (SBT), based on normalised values of cone resistance (Q_t) and friction ratio (Fr). These are used in conjunction with soil classification charts, such as the one below (after Robertson 1990)

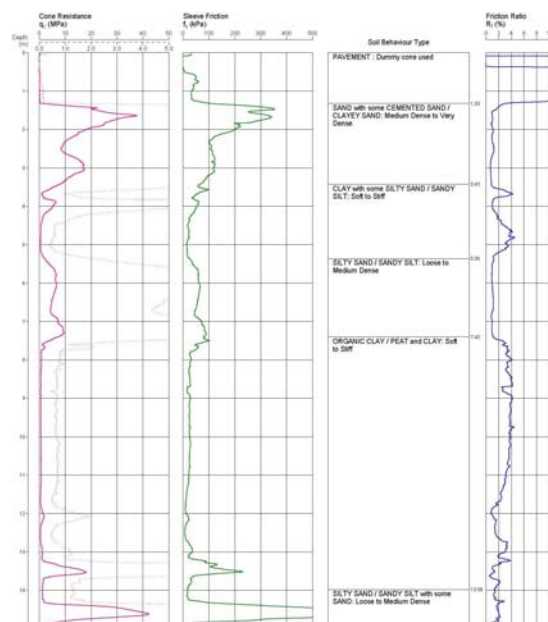
Figure 4: Sample Cone Plot

DP's in-house CPT software provides computer aided interpretation of soil strata, generating soil descriptions and strengths for each layer. The software can also produce plots of estimated soil parameters, including modulus, friction angle, relative density, shear strength and over consolidation ratio.

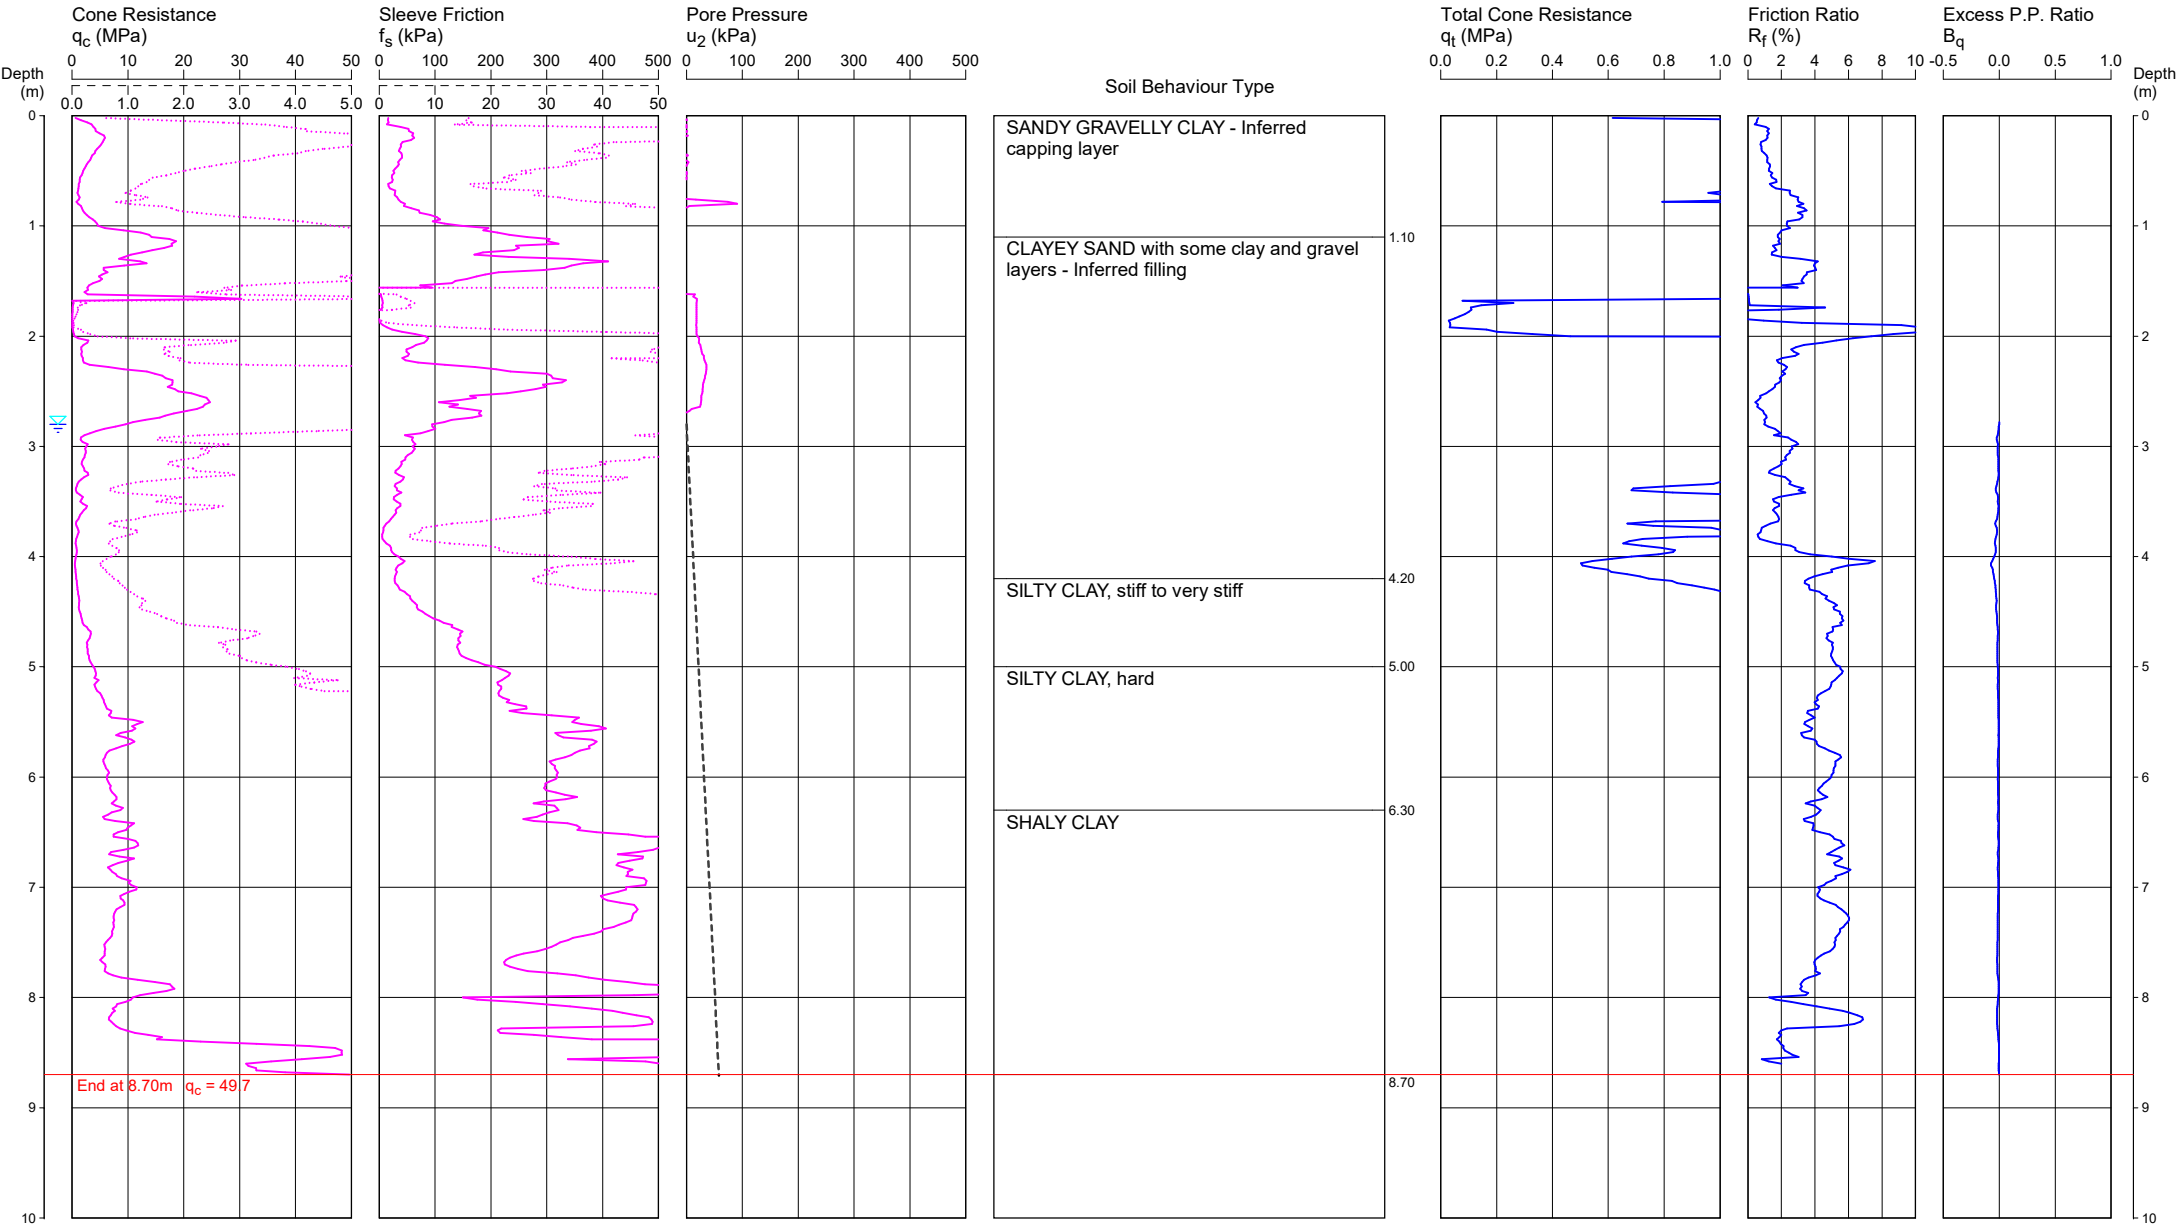
REMARKS: DUMMY CONE FROM 1.66 TO 2.0 m DEPTH TO PENETRATE FILLING. TEST DISCONTINUED DUE TO EXCESSIVE CONE BENDING AT NEAR REFUSAL.

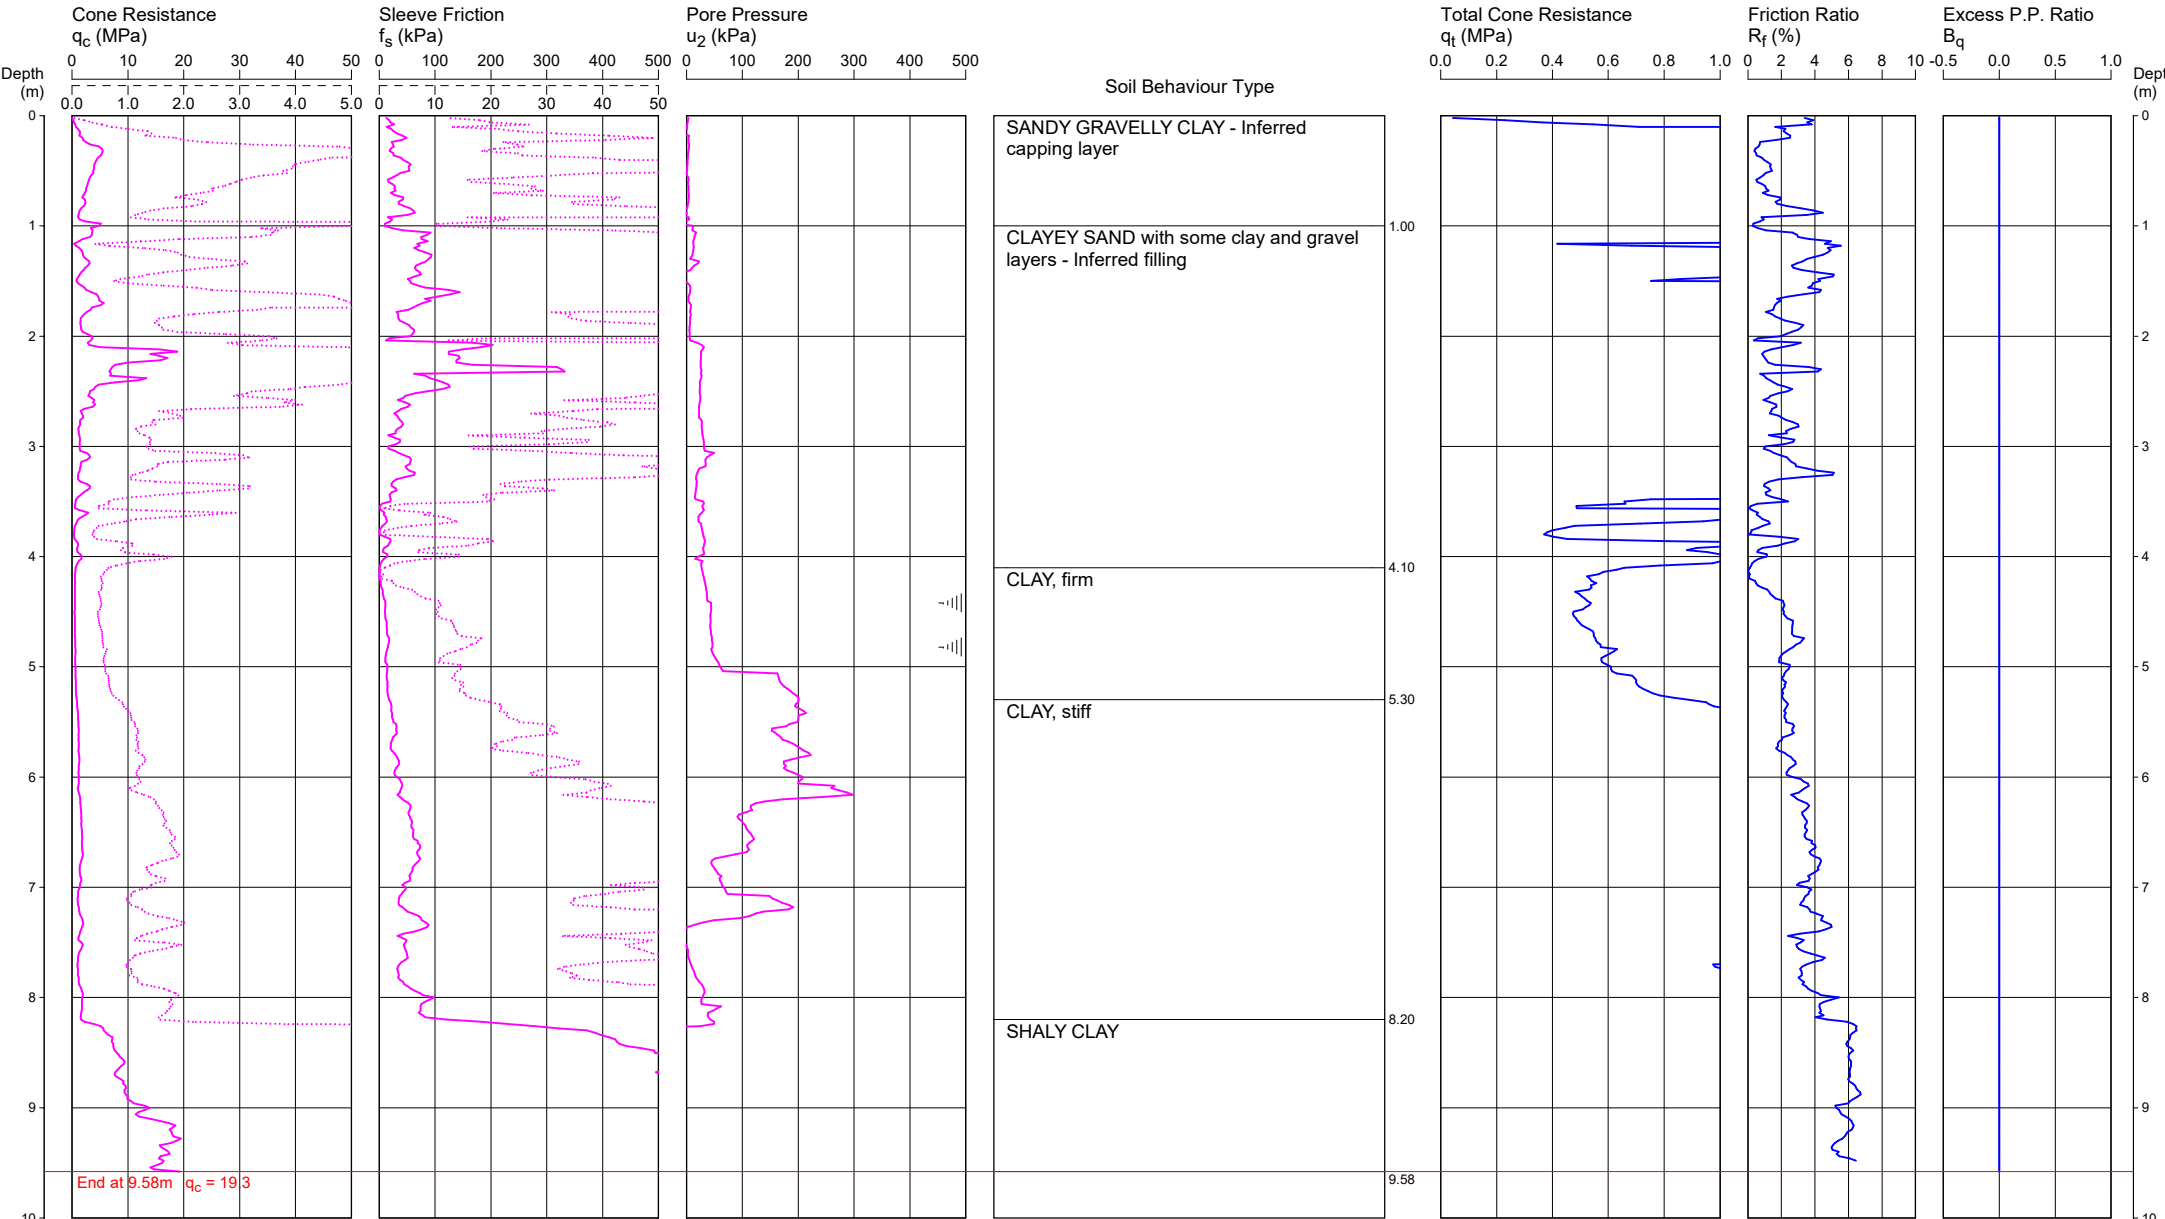
REMARKS: HAND AUGER TO 0.2 m DEPTH.
TEST DISCONTINUED DUE TO EXCESSIVE CONE BENDING AT NEAR
REFUSAL.HOLE COLLAPSE AT 3.5 m AFTER WITHDRAWAL OF RODS.

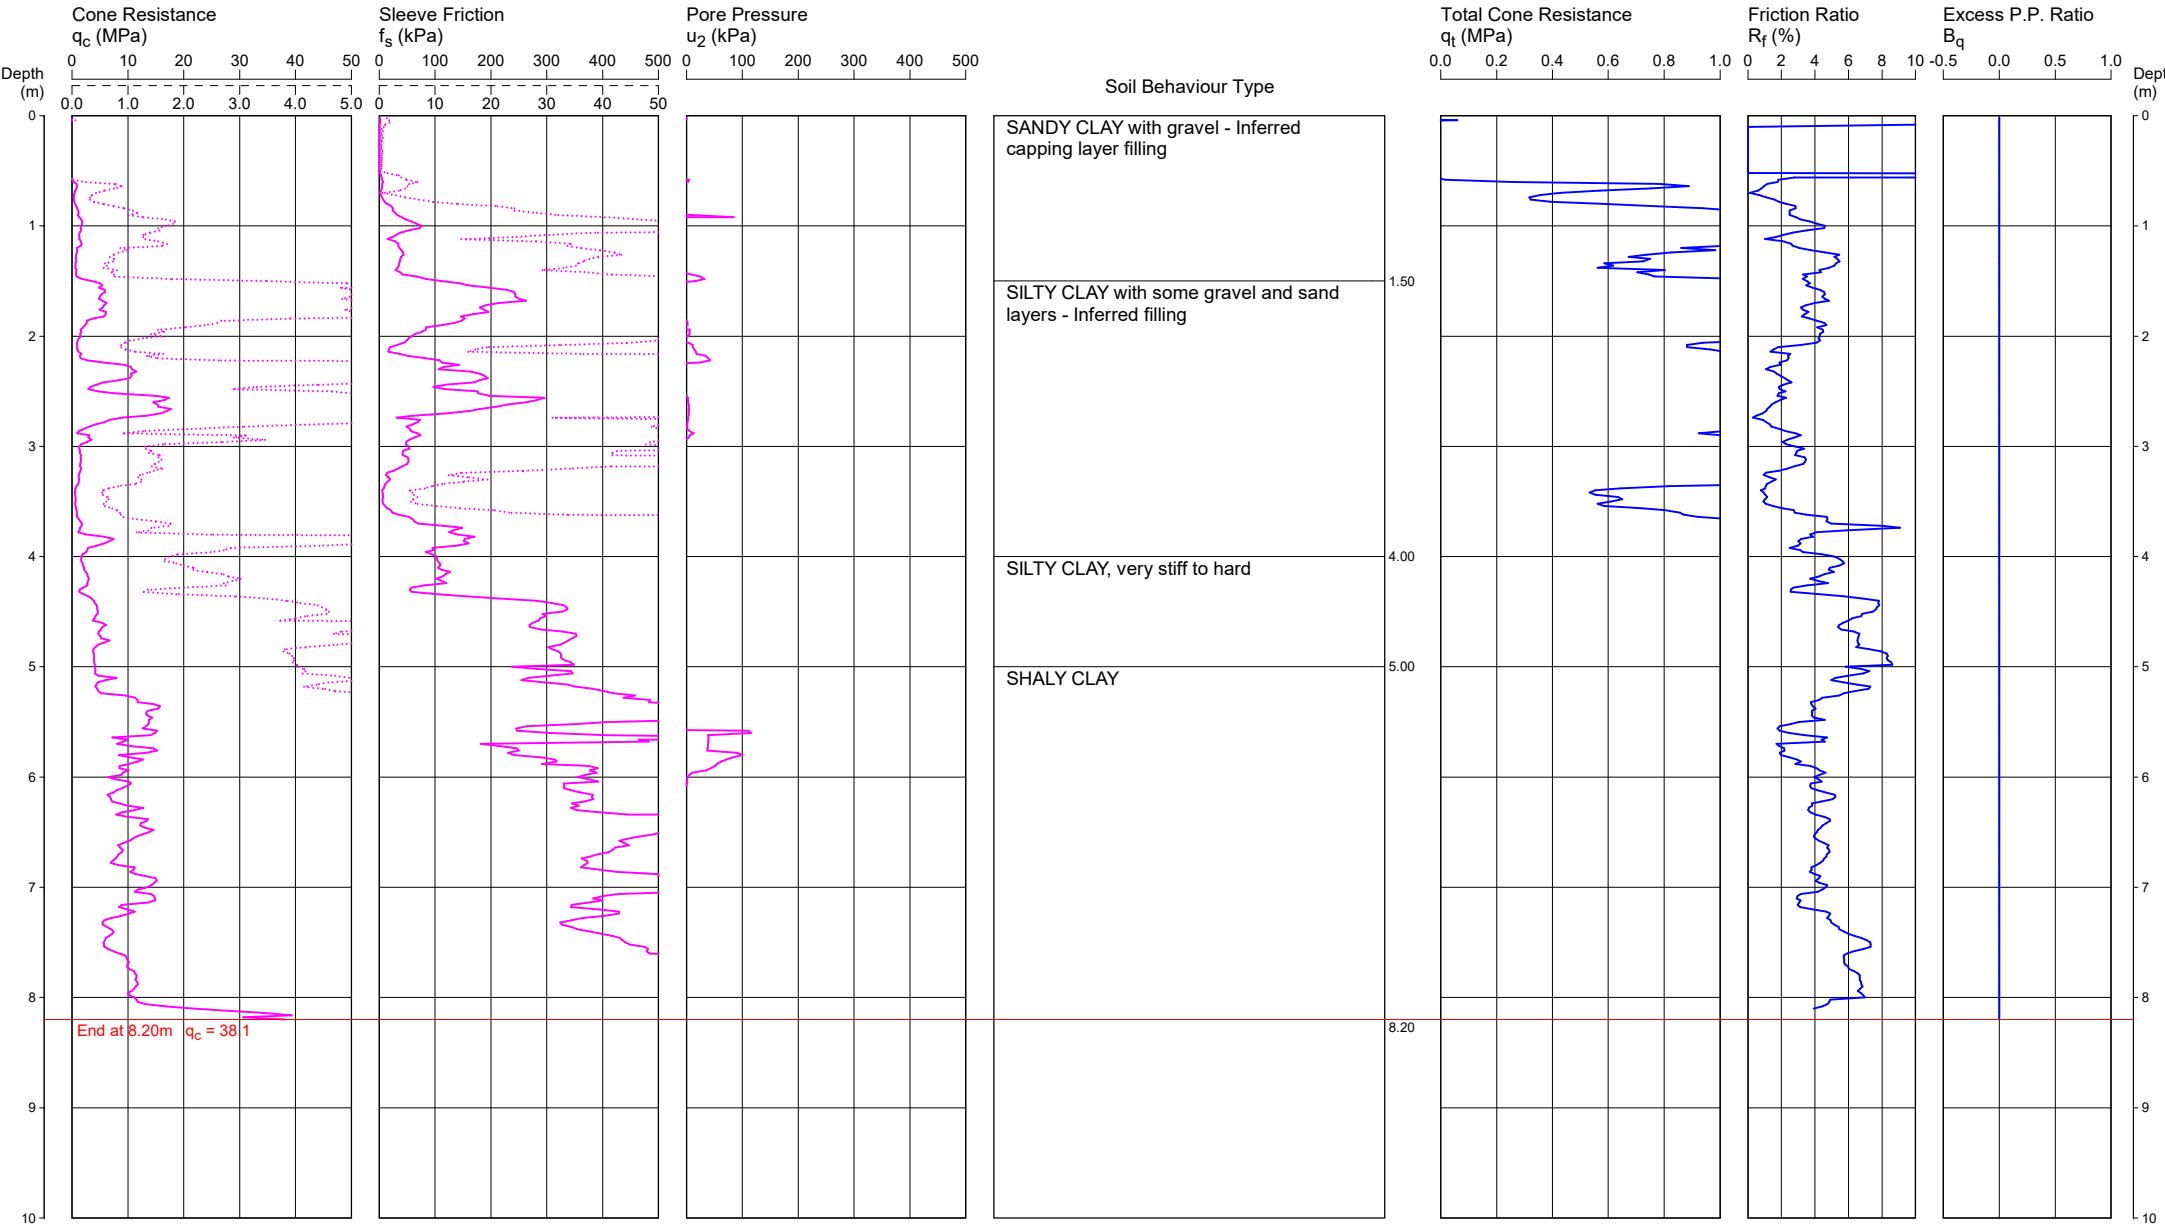
REMARKS: HAND AUGER TO 0.65 m DEPTH.
TEST DISCONTINUED DUE TO CONE TIP REFUSAL.

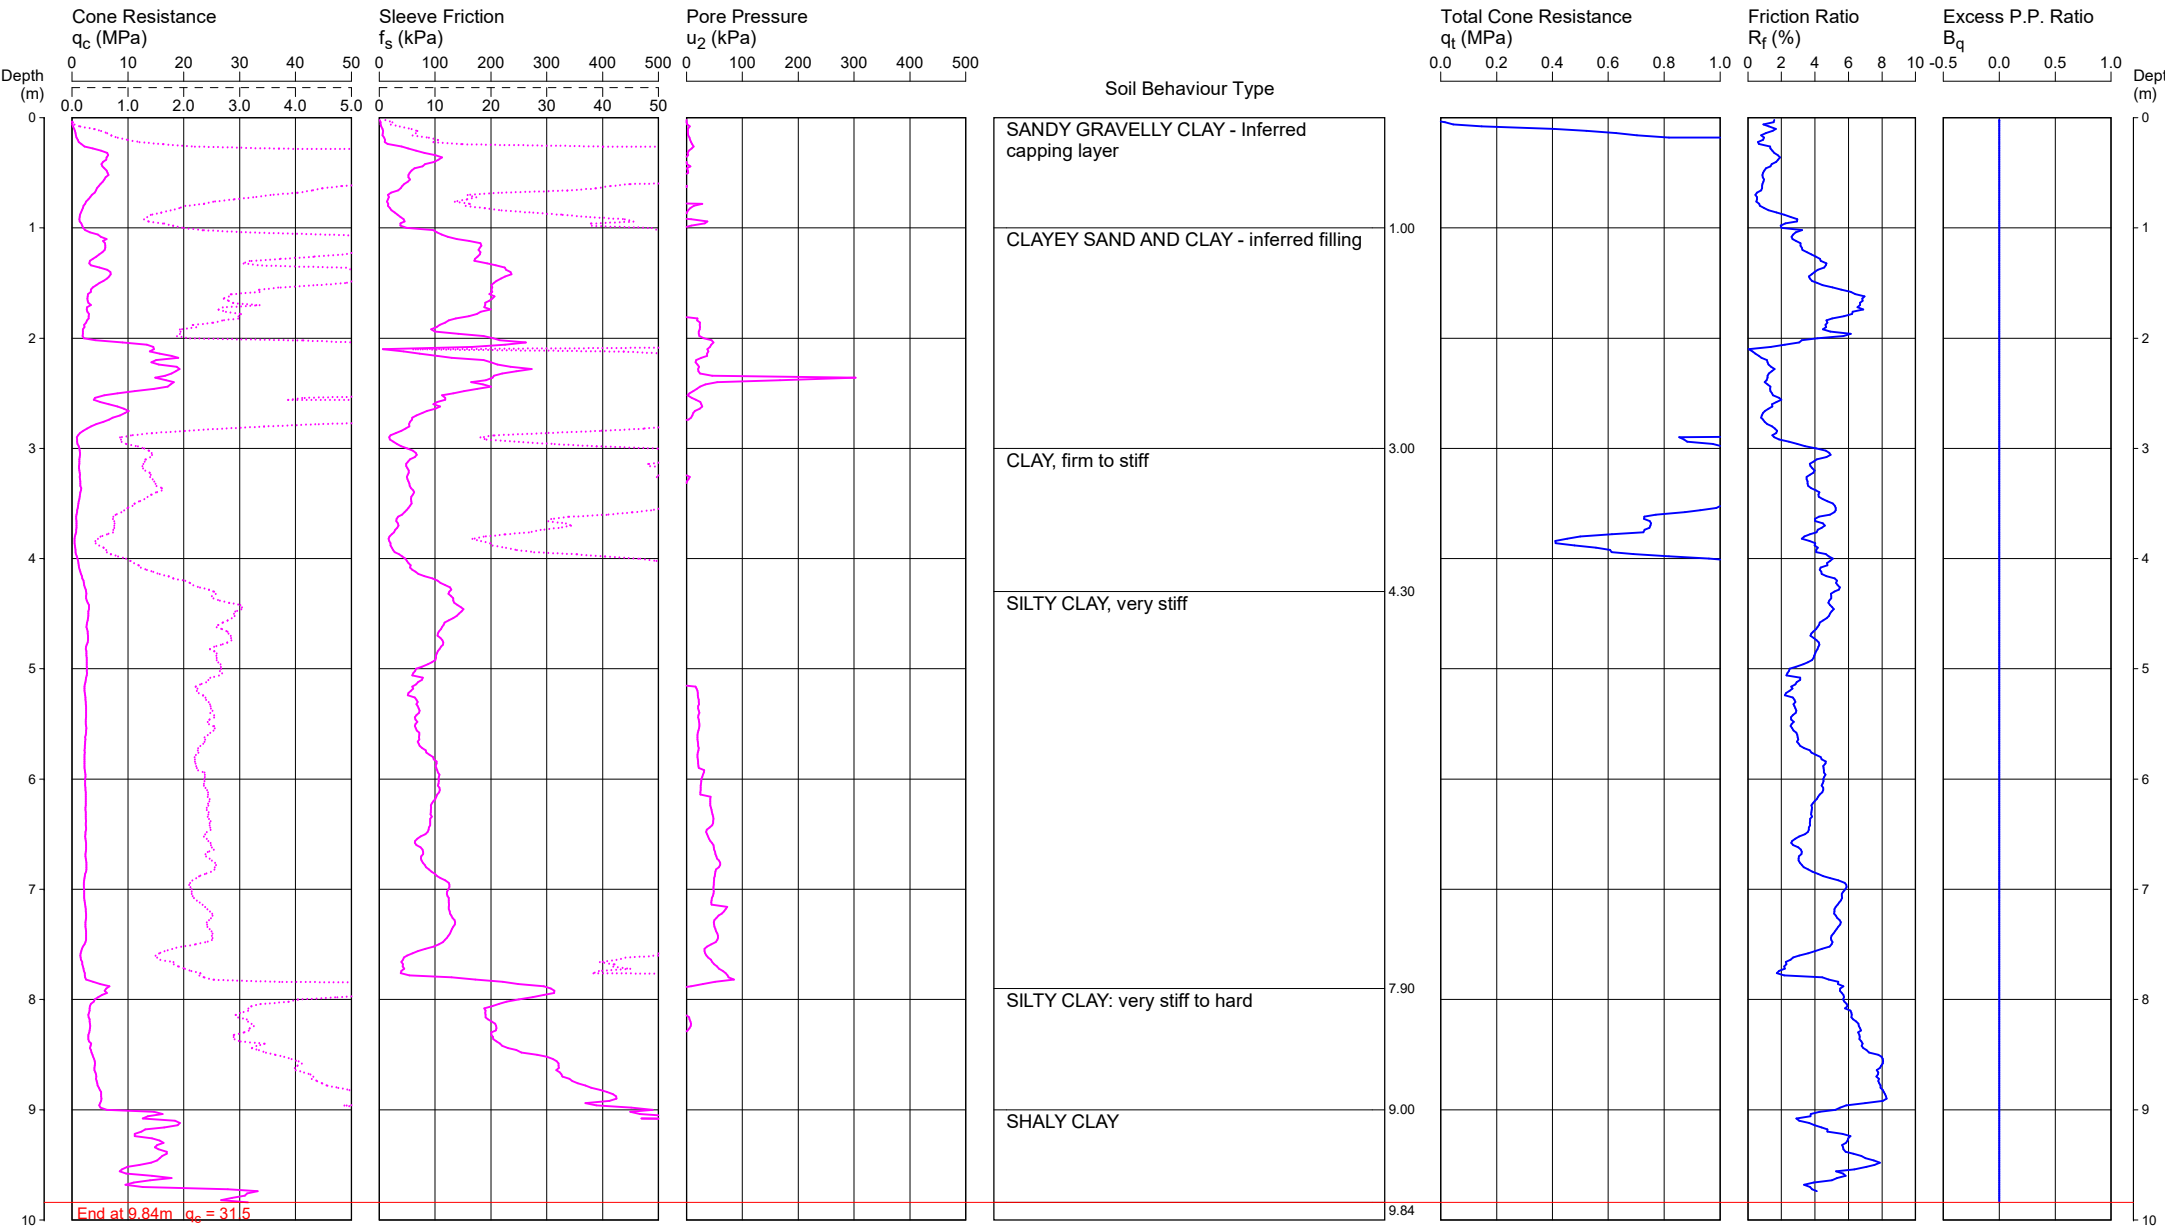
REMARKS: HAND AUGER TO 0.2 m DEPTH. TEST DISCONTINUED DUE TO CONE TIP REFUSAL.
HOLE COLLAPSE AT 2.1 m AFTER WITHDRAWAL OF RODS.

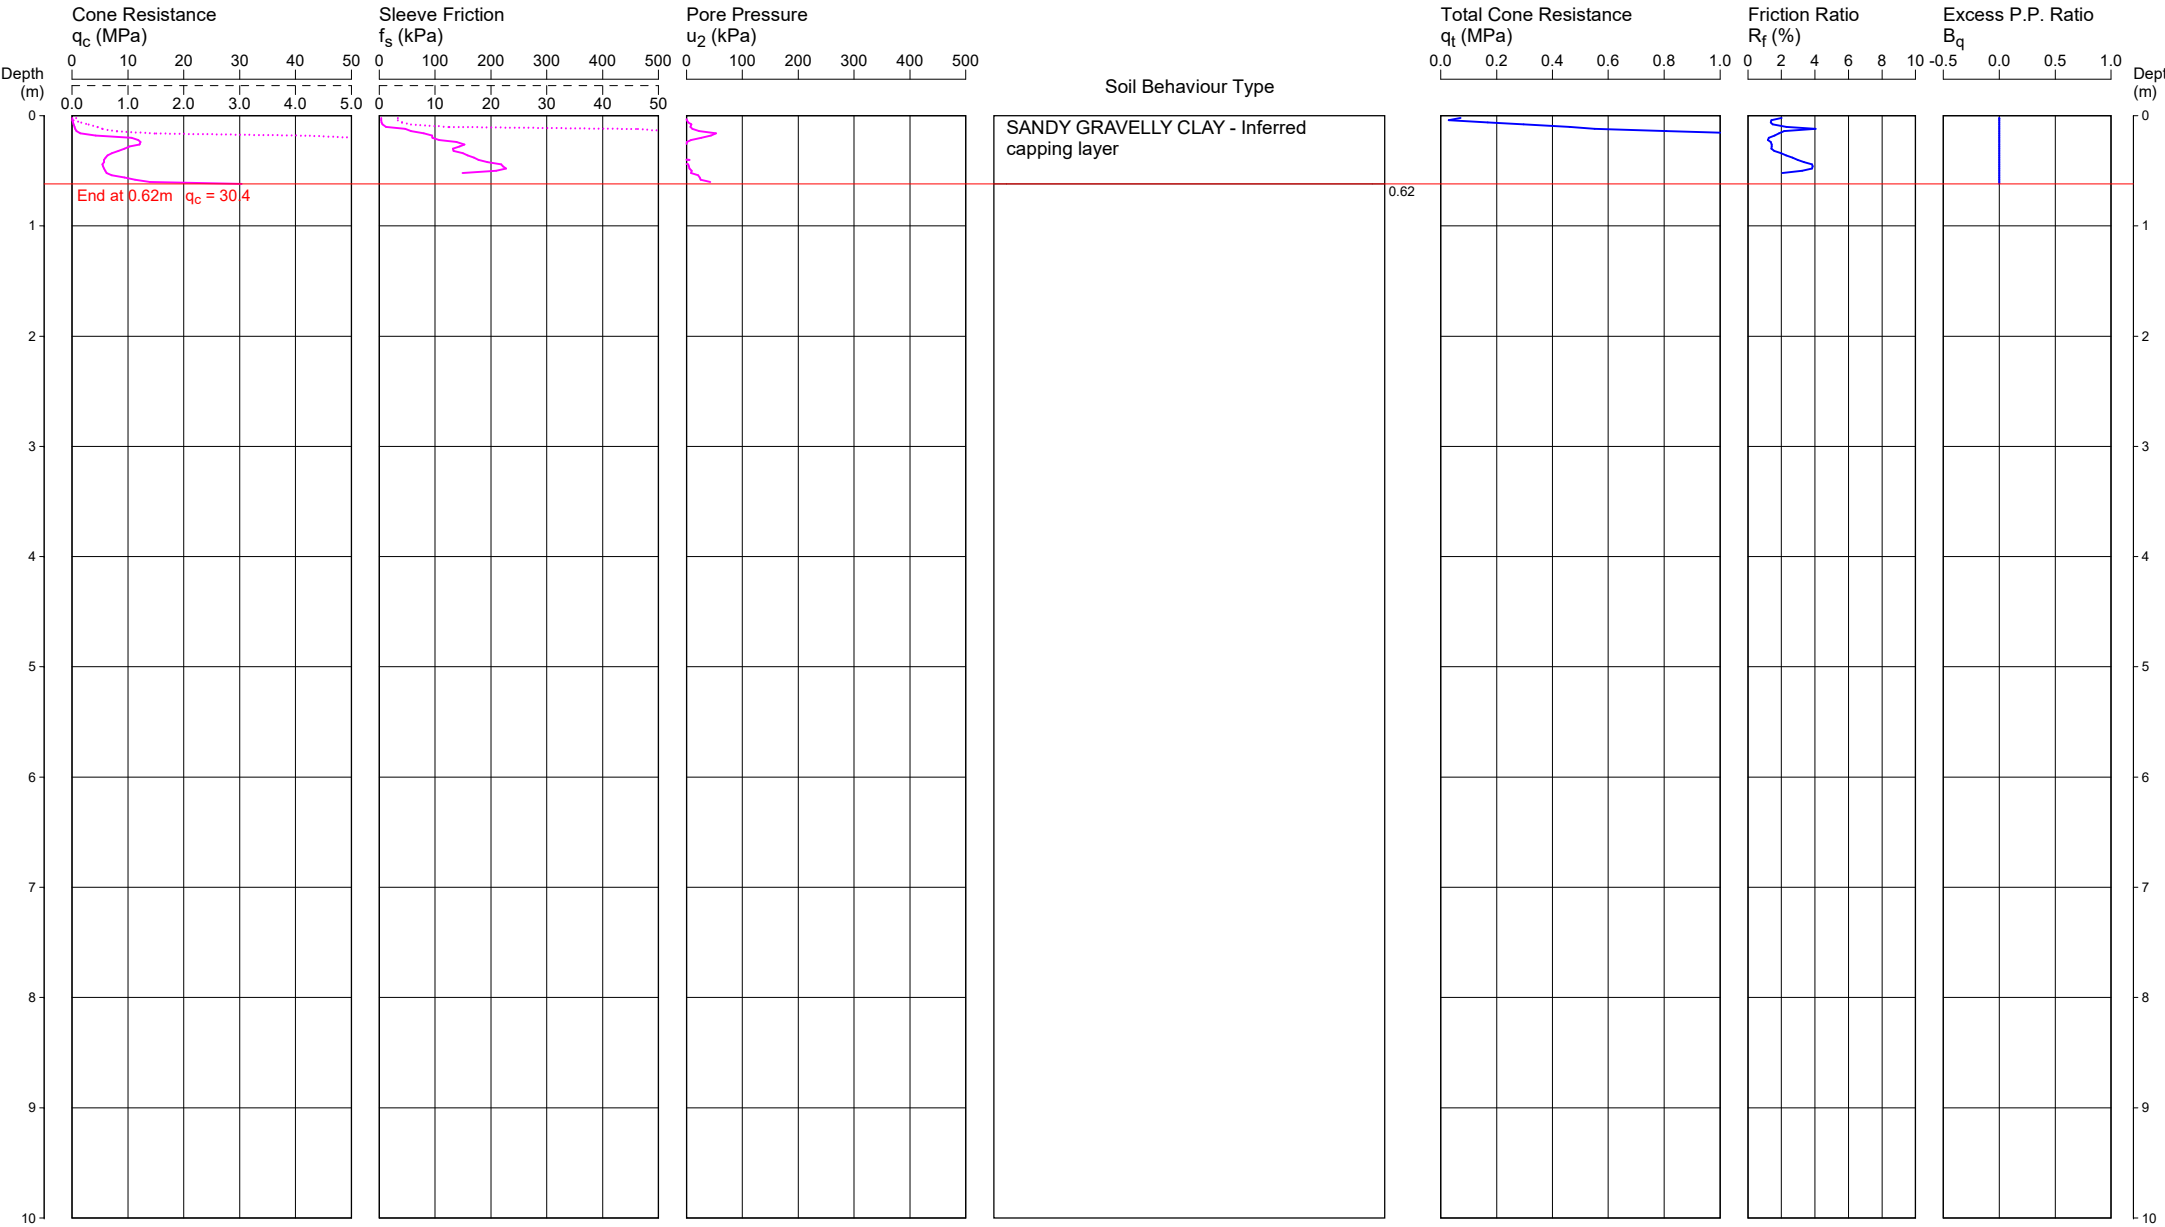
REMARKS: HAND AUGER TO 0.2 m. DUMMY CONE FROM 0.62 TO 0.62 m DEPTH TO PENETRATE FILLING. TEST DISCONTINUED DUE TO DUMMY CONE REFUSAL ON OBSTRUCTION.

Obstructions such as large rock and concrete may be encountered in the fill. As such, some allowance for dealing with these should be made. If driven piles are used, and pre-drilling is not permitted due to contamination issues, then a 'flexible' pile configuration that can accommodate some repositioning of piles is recommended. It is noted that obstructions were encountered in test location 10 and 14.

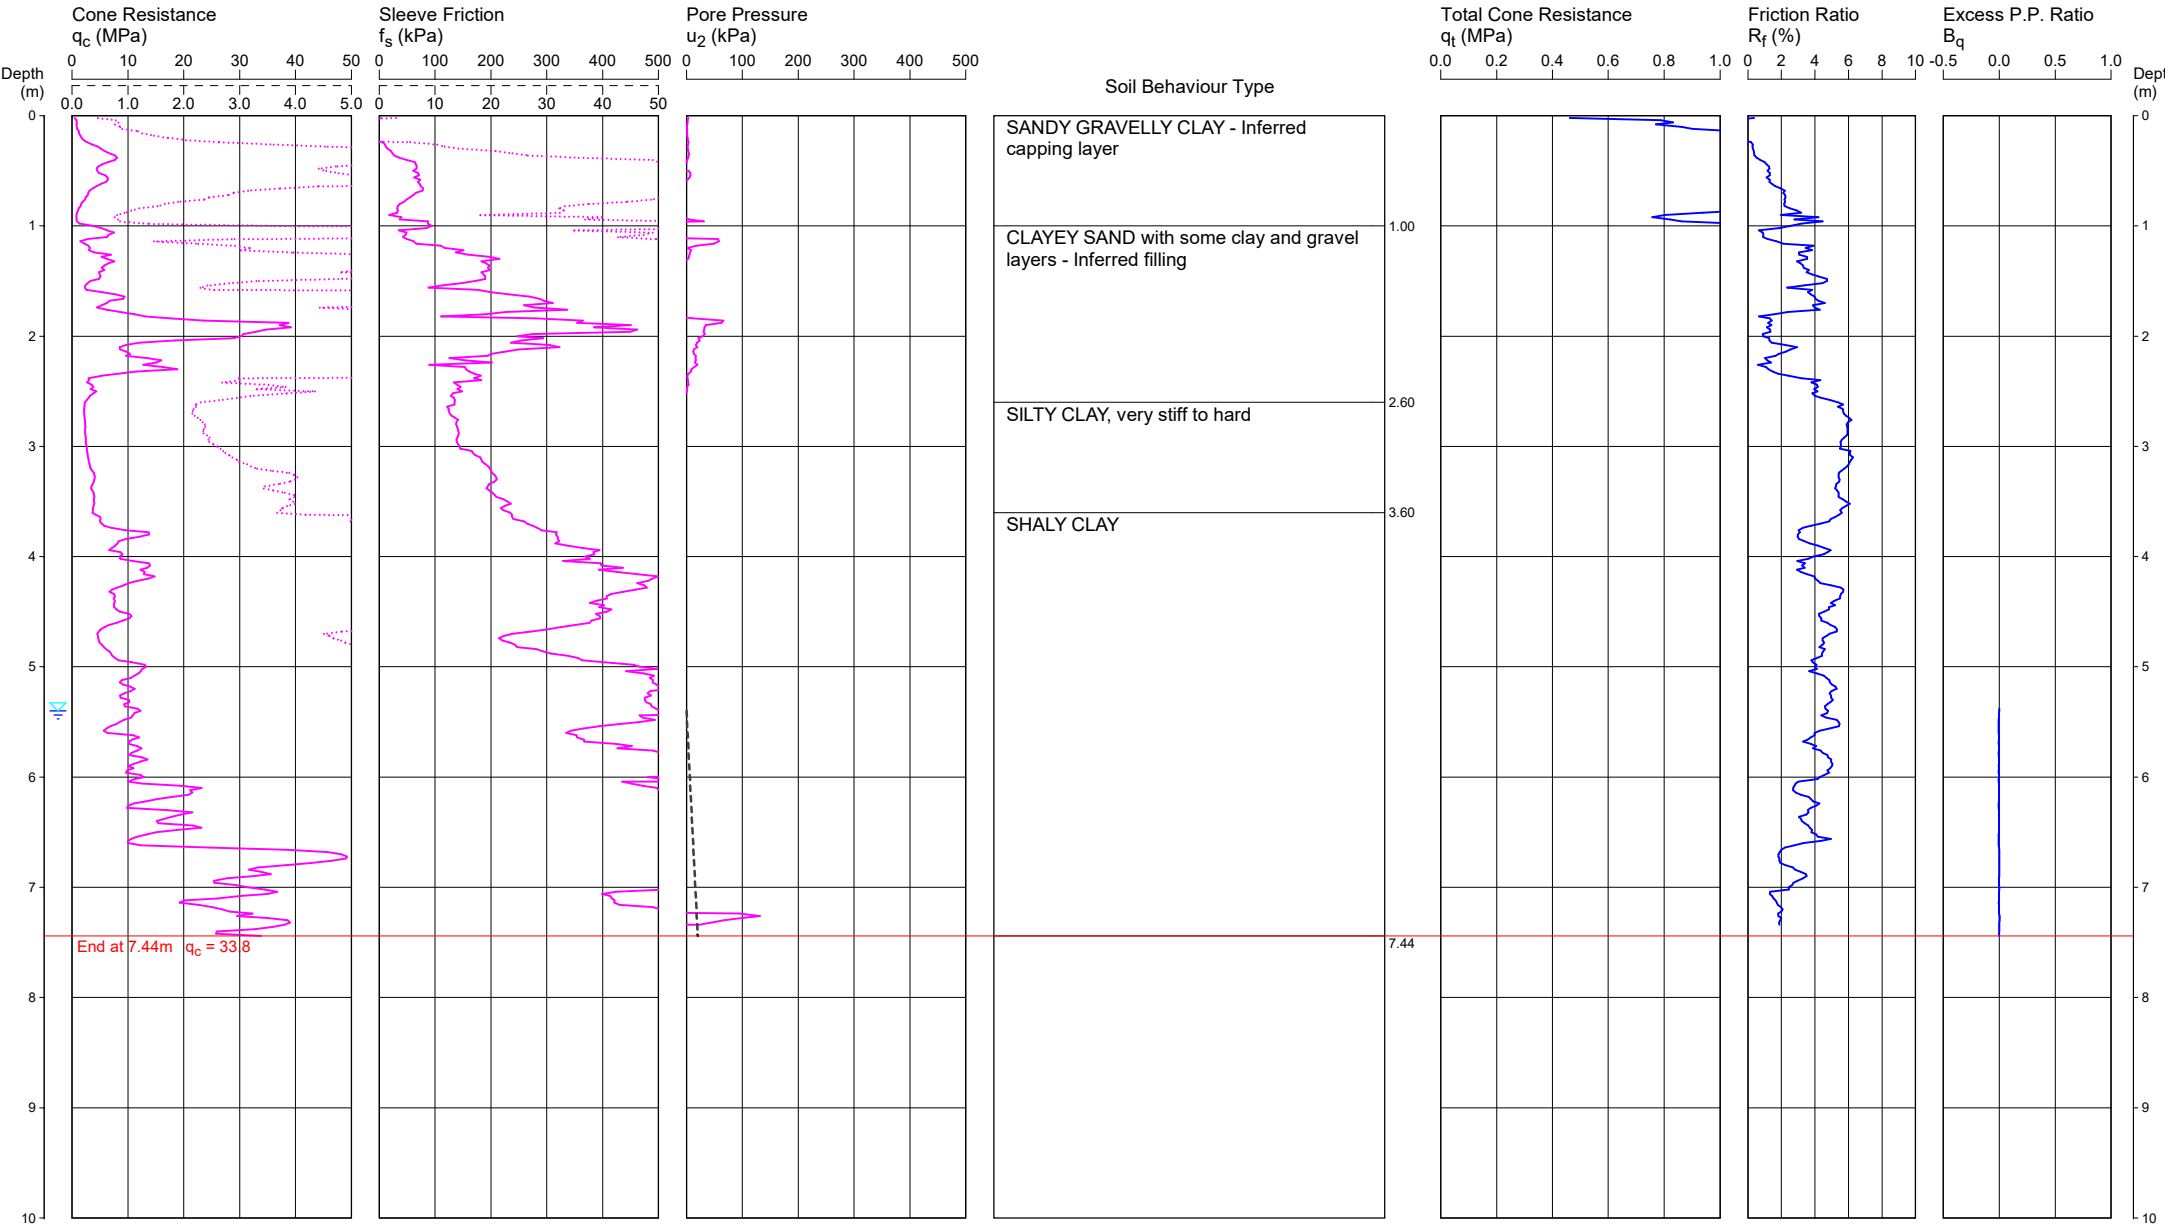
REMARKS: HAND AUGER TO 0.2 m DEPTH.
TEST DISCONTINUED DUE TO EXCESSIVE CONE BENDING
AT NEAR REFUSAL.

Water depth after test: 5.4 m
