Report on
Preliminary Geotechnical Investigation

Cricket NSW Cricket Centre
Wilson Park, Newington Road
Sydney Olympic Park

Prepared for
Cox Architecture Pty Ltd

Project 86694.02
September 2019

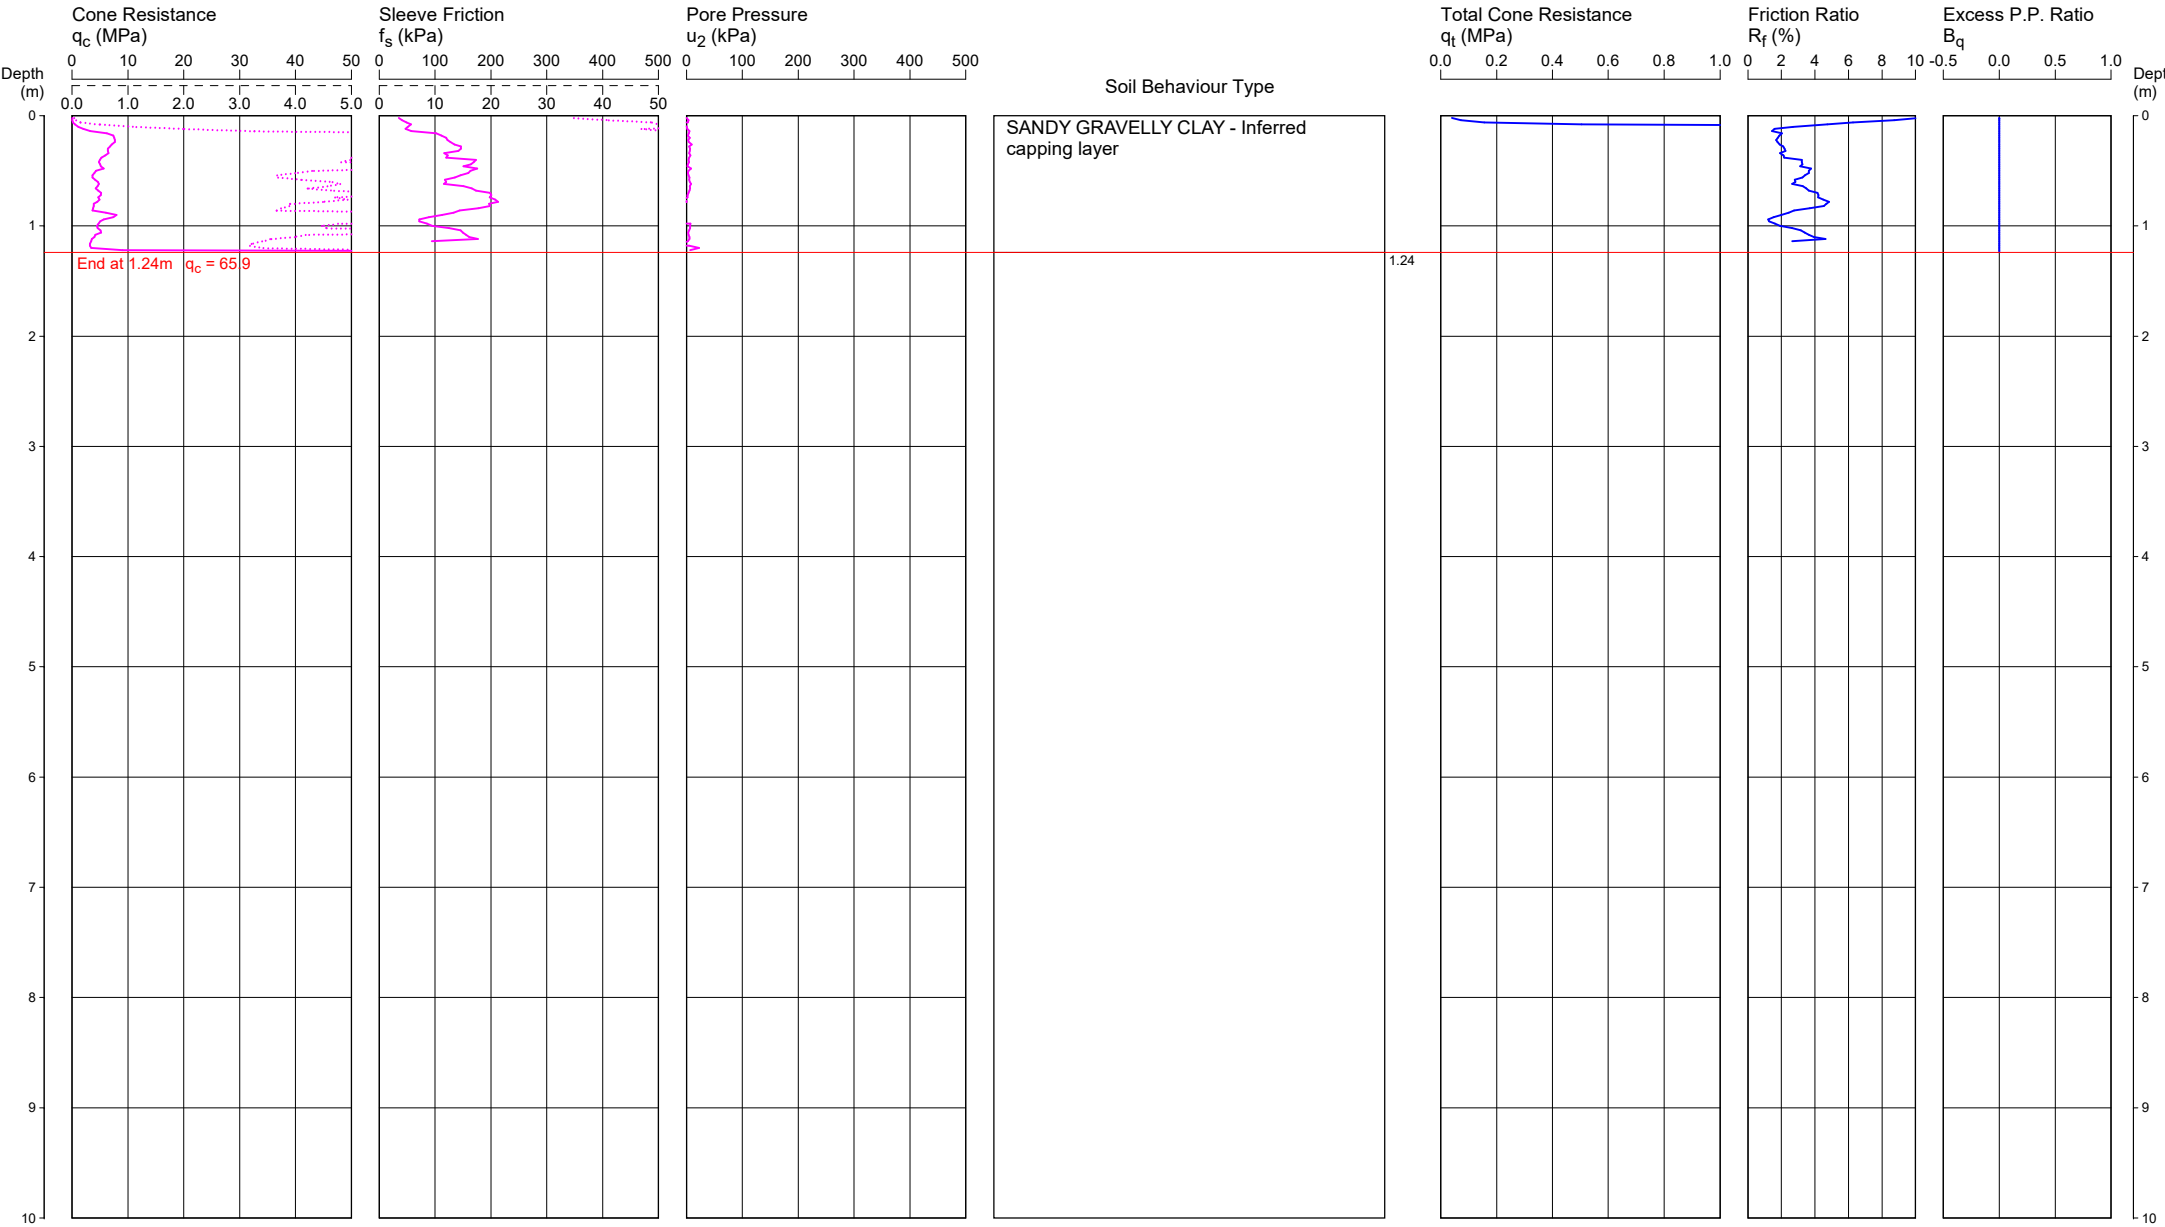
REMARKS: HAND AUGER TO 0.2 m DEPTH.
TEST DISCONTINUED DUE TO CONE TIP REFUSAL ON
OBSTRUCTION.

Obstructions such as large rock and concrete may be encountered in the fill. As such, some allowance for dealing with these should be made. If driven piles are used, and pre-drilling is not permitted due to contamination issues, then a 'flexible' pile configuration that can accommodate some repositioning of piles is recommended. It is noted that obstructions were encountered in test location 10 and 14.

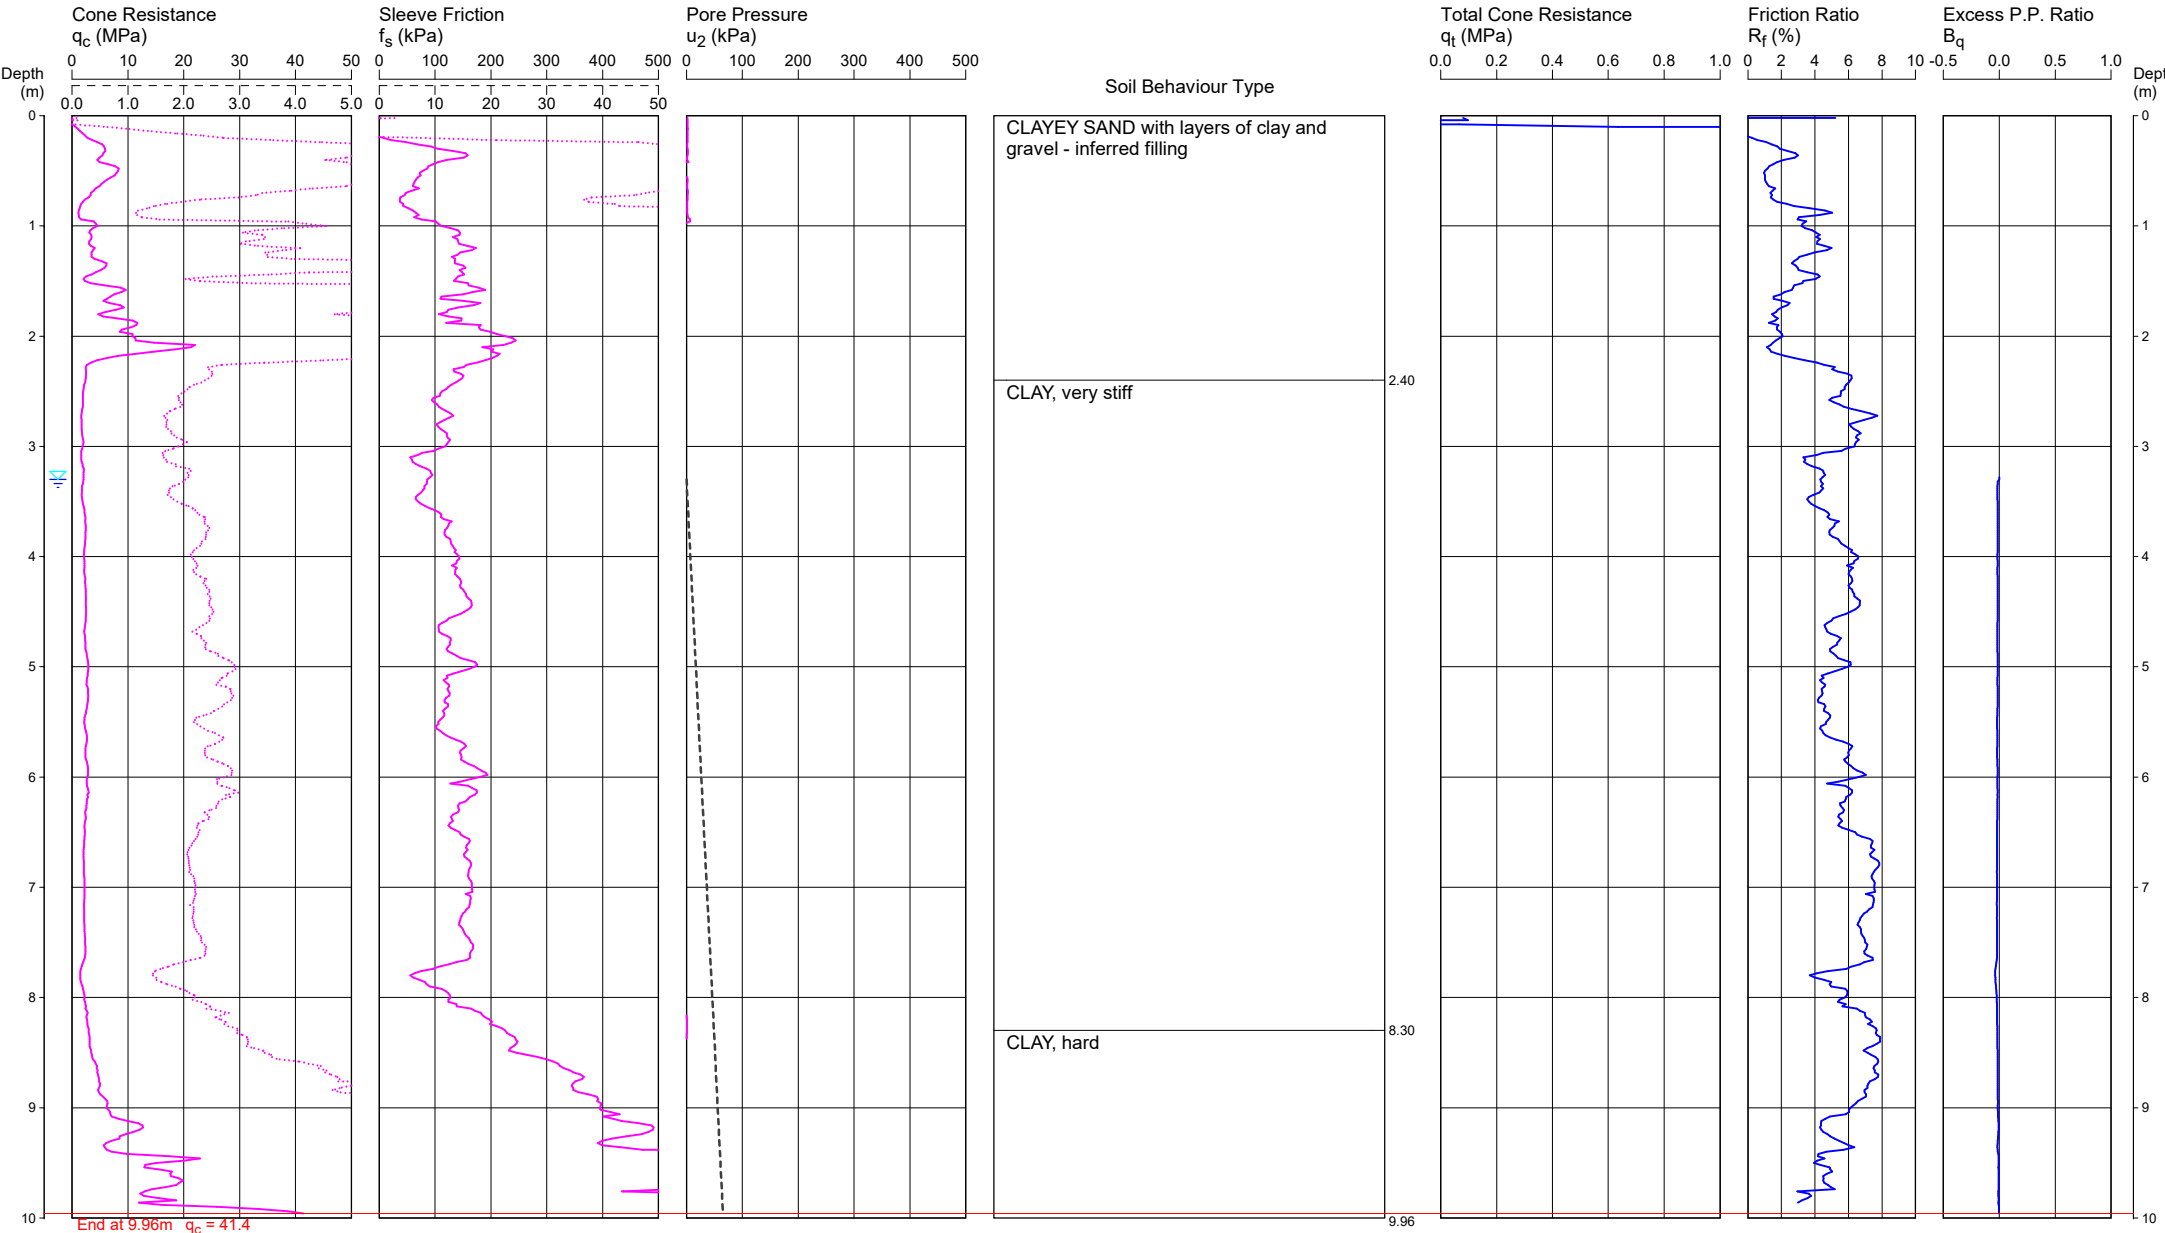
REMARKS: HAND AUGER TO 0.2 m DEPTH.
TEST DISCONTINUED DUE TO CONE TIP REFUSAL.

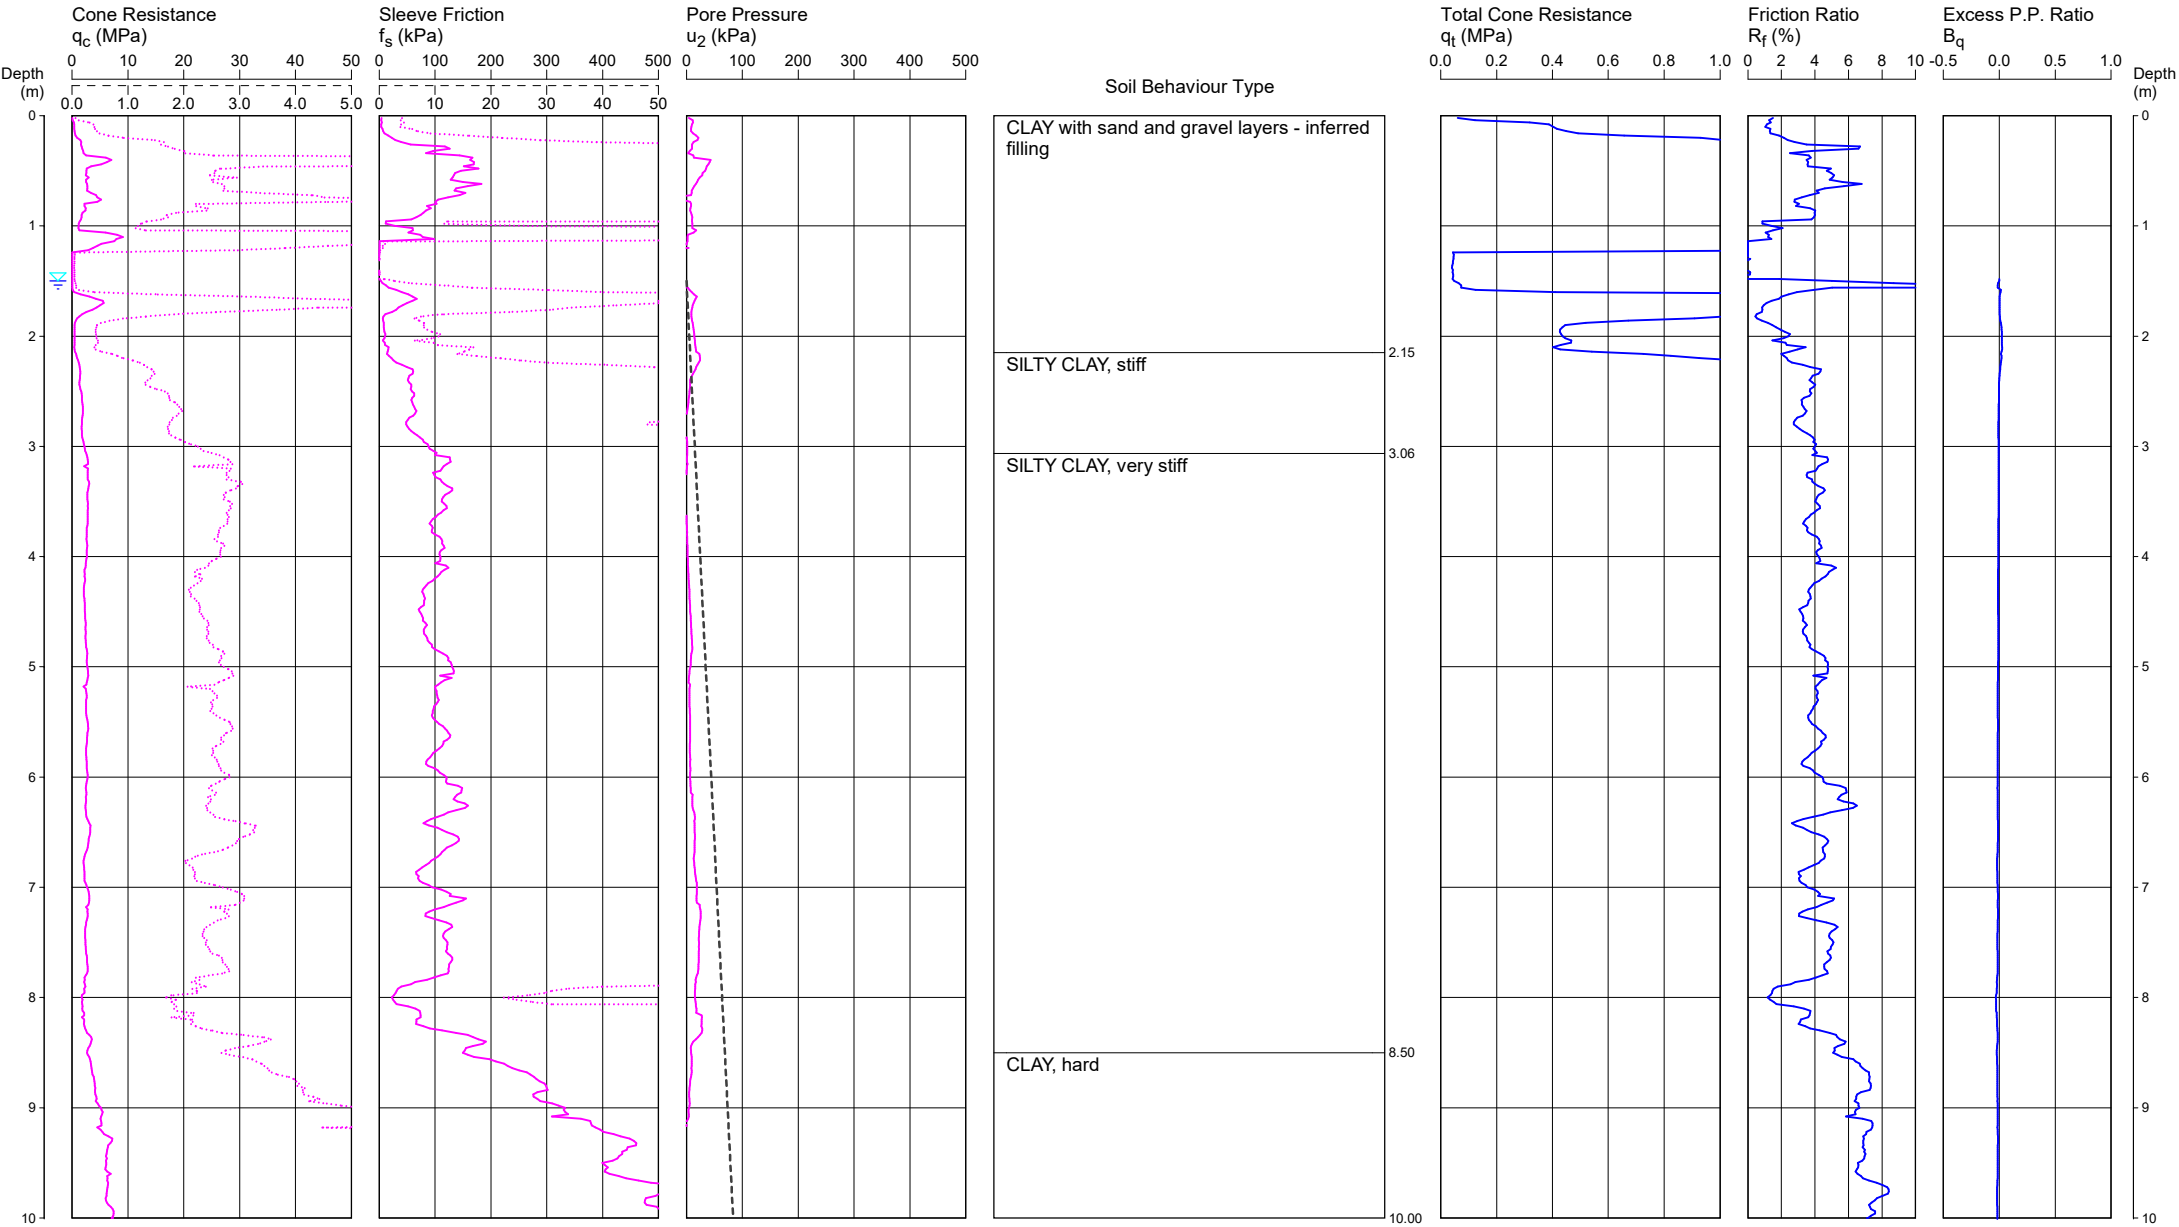
REMARKS: HAND AUGER TO 0.2 m. DUMMY CONE FROM 1.22 TO 1.6 m DEPTH TO PENETRATE FILLING. TEST DISCONTINUED DUE TO CONE TIP REFUSAL.

Water depth after test: 1.5 m

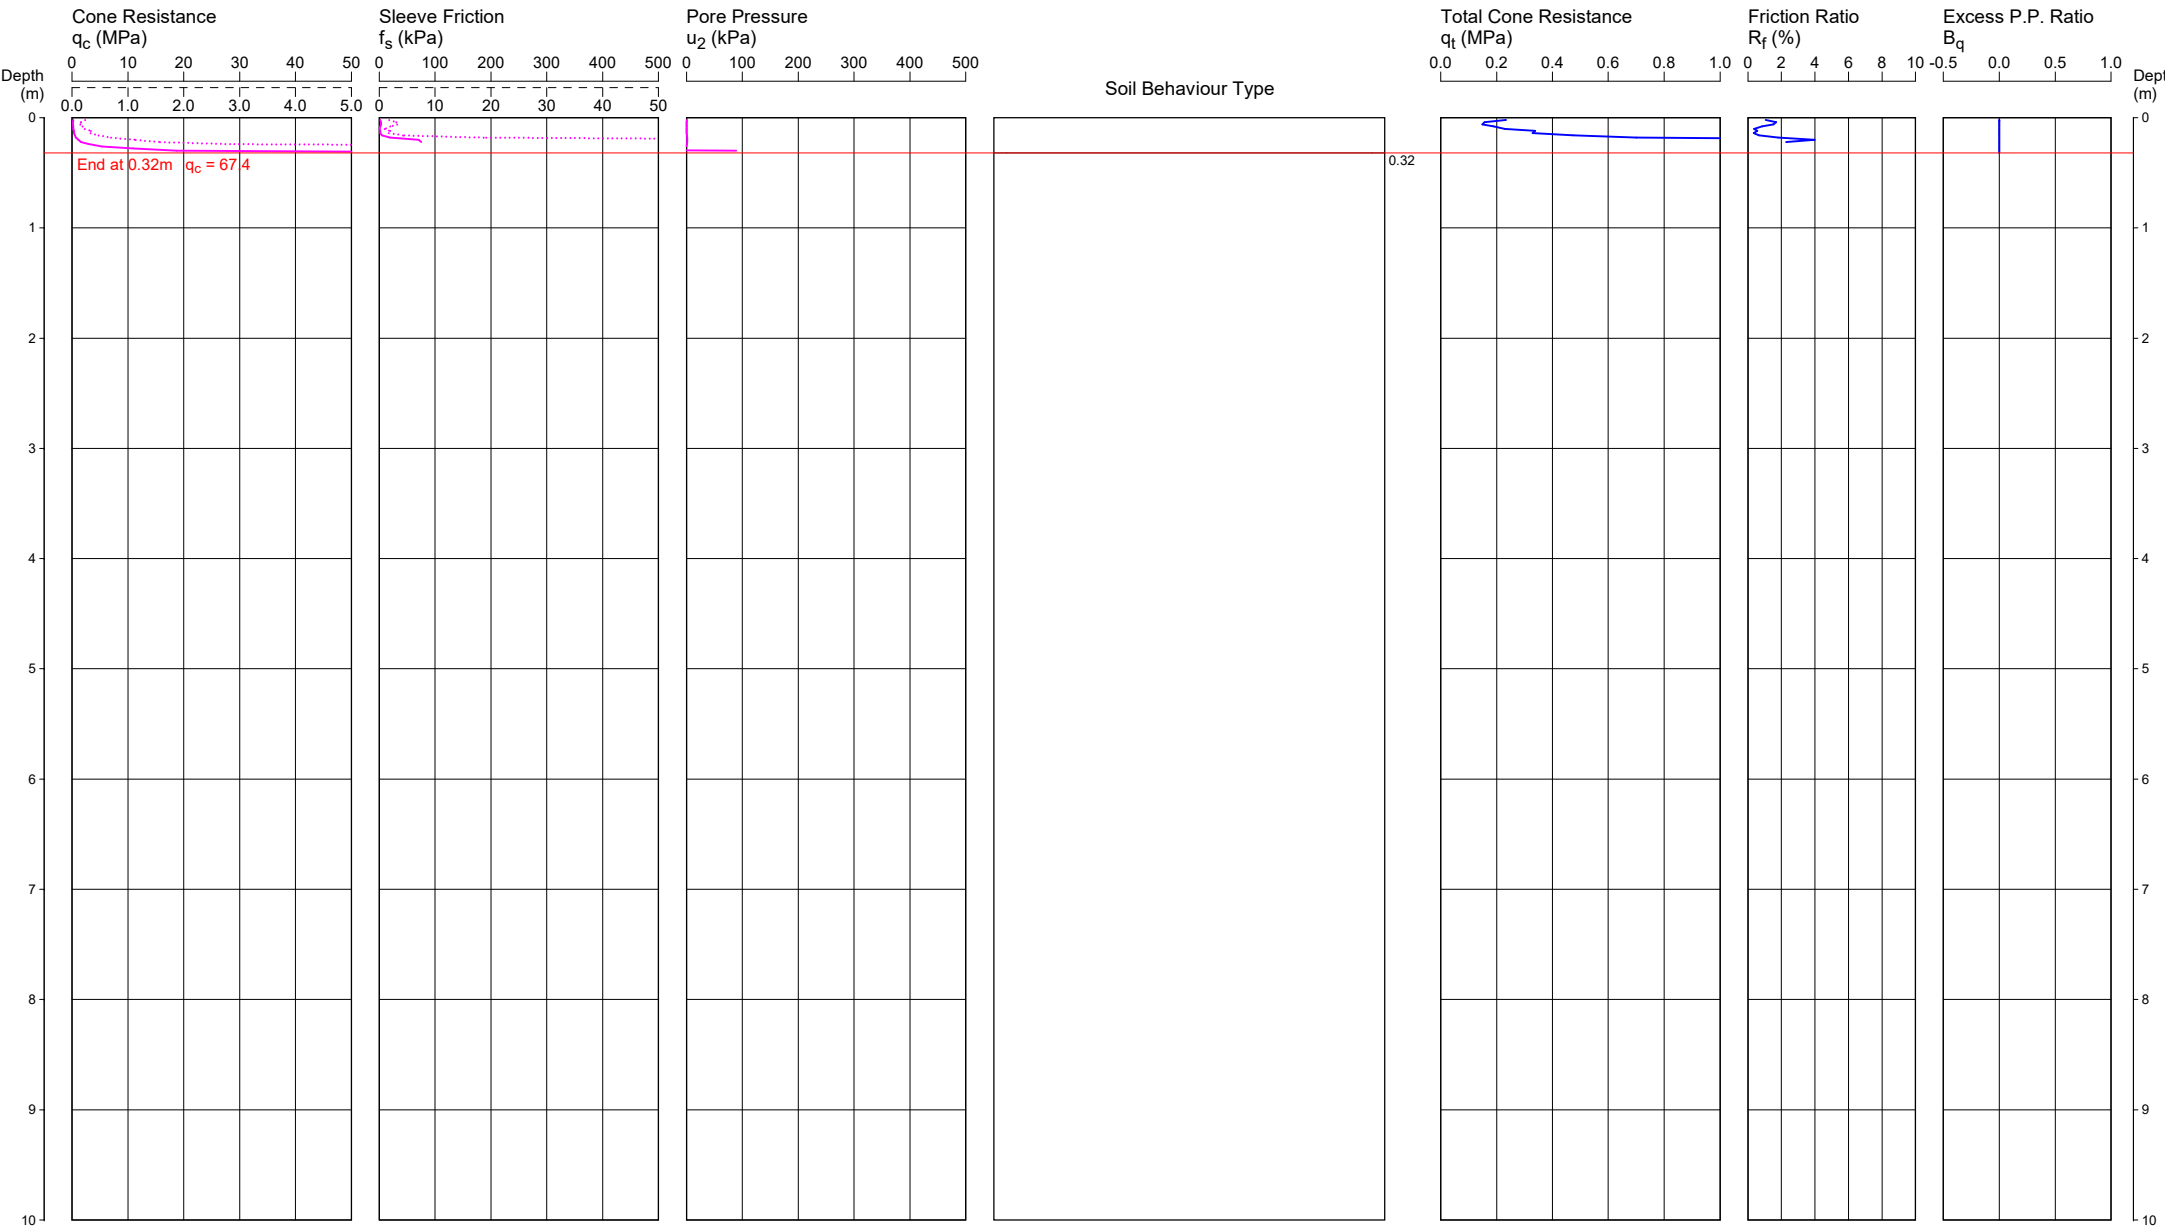
REMARKS: HAND AUGER TO 0.2 m. DUMMY CONE FROM 0.32 TO 0.5 m DEPTH TO PENETRATE FILLING.
TEST DISCONTINUED DUE TO DUMMY CONE REFUSAL ON OBSTRUCTION.

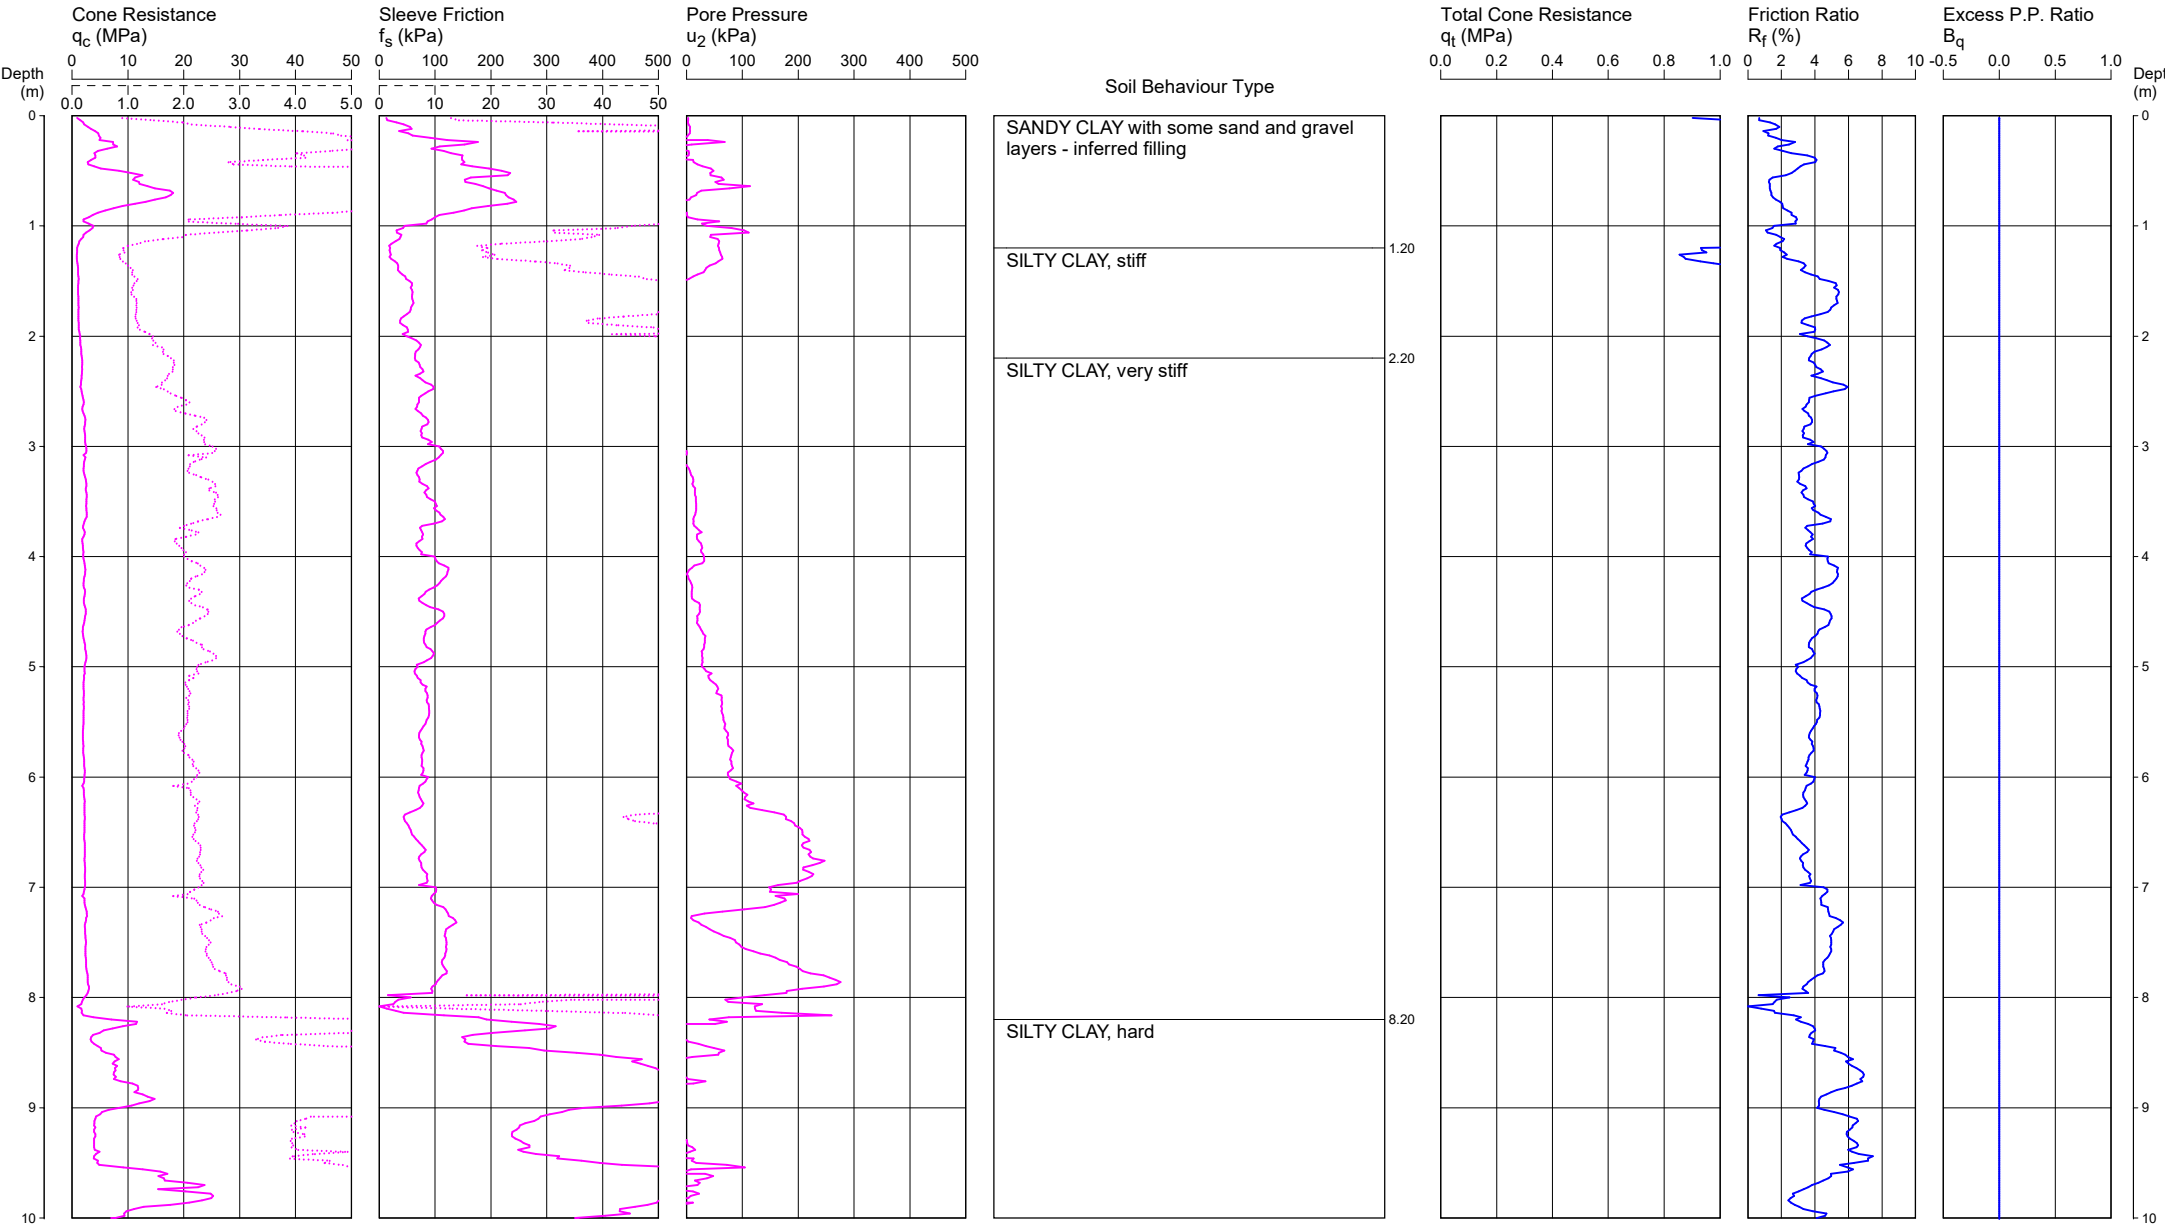
REMARKS: HAND AUGER TO 0.2 m. TEST DISCONTINUED DUE TO CONE TIP REFUSAL.
HOLE COLLAPSE AT 1.0 m AFTER WITHDRAWAL OF RODS.

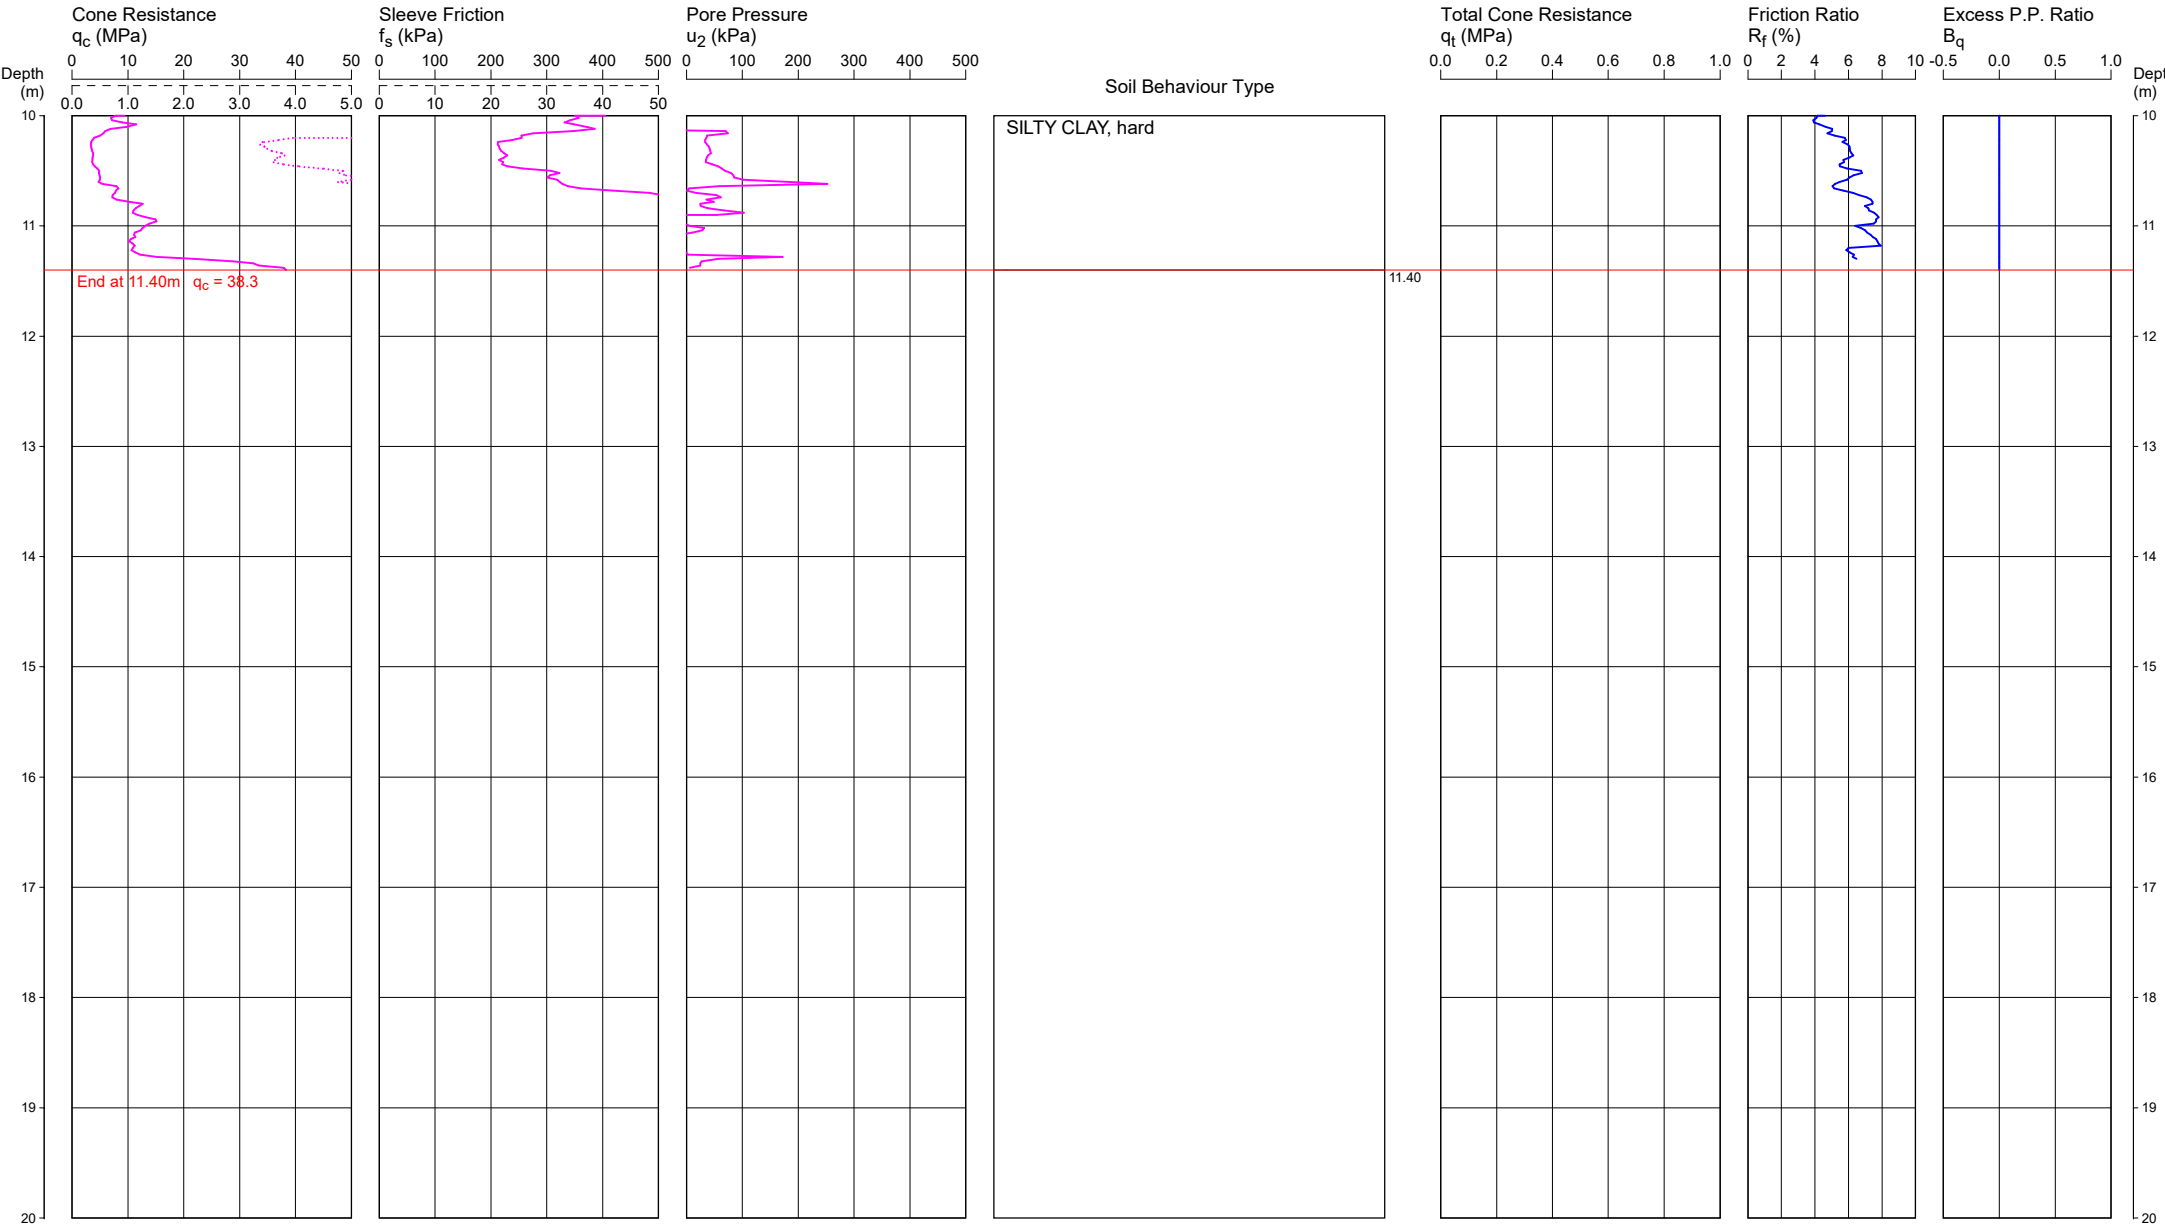
REMARKS: HAND AUGER TO 0.2 m. TEST DISCONTINUED DUE TO CONE TIP REFUSAL.
HOLE COLLAPSE AT 1.0 m AFTER WITHDRAWAL OF RODS.

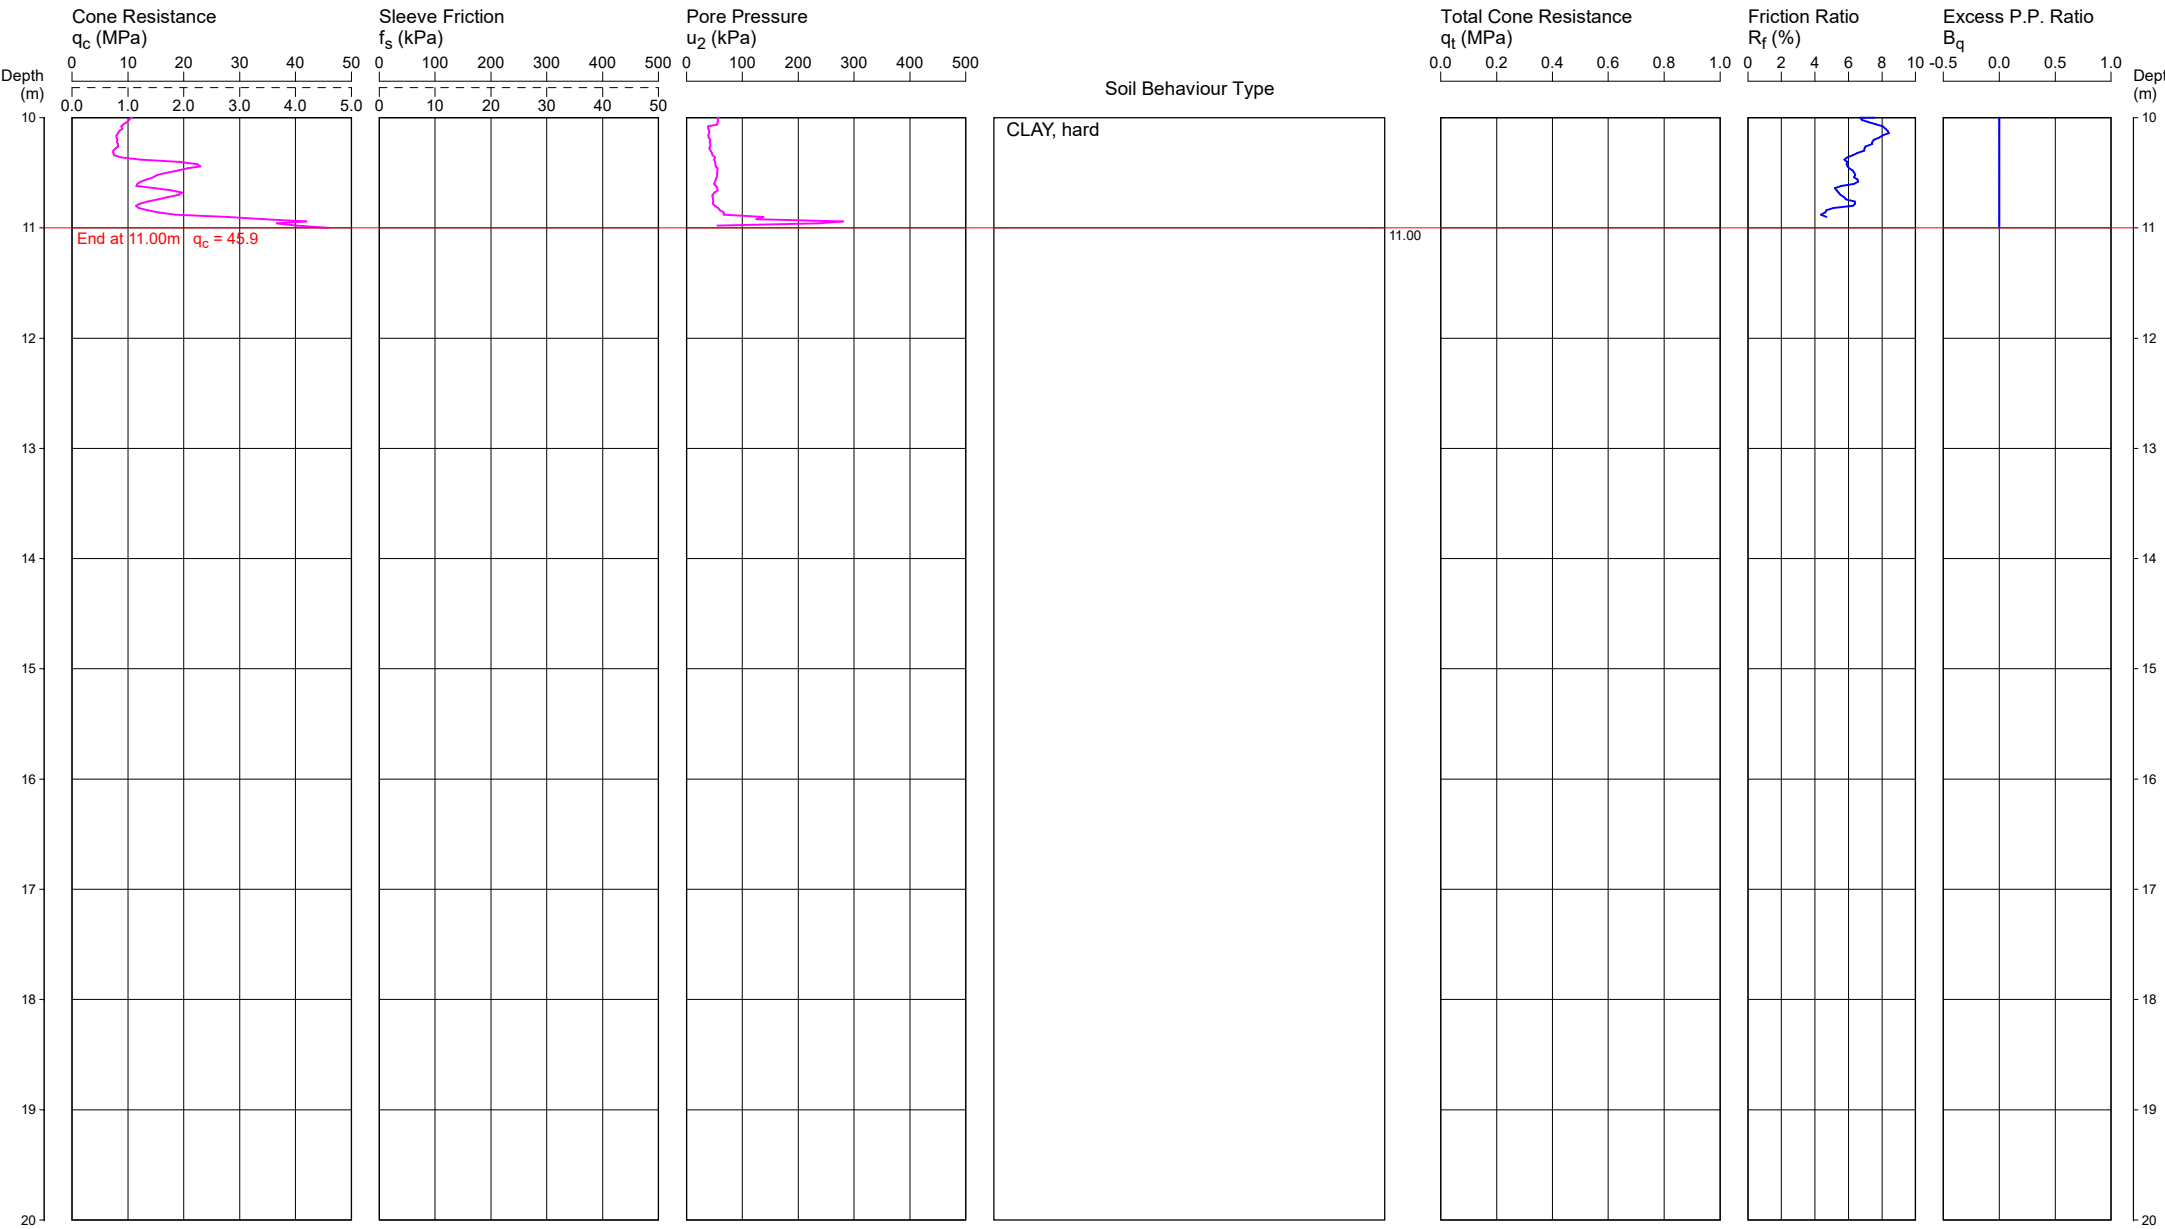
REMARKS: DUMMY CONE FROM 0.00 TO 0.30 m & 0.8 TO 1.4 DEPTH TO PENETRATE FILLING.
TEST DISCONTINUED DUE TO CONE TIP REFUSAL.
HOLE COLLAPSE AT 2.2 m AFTER WITHDRAWAL OF RODS.

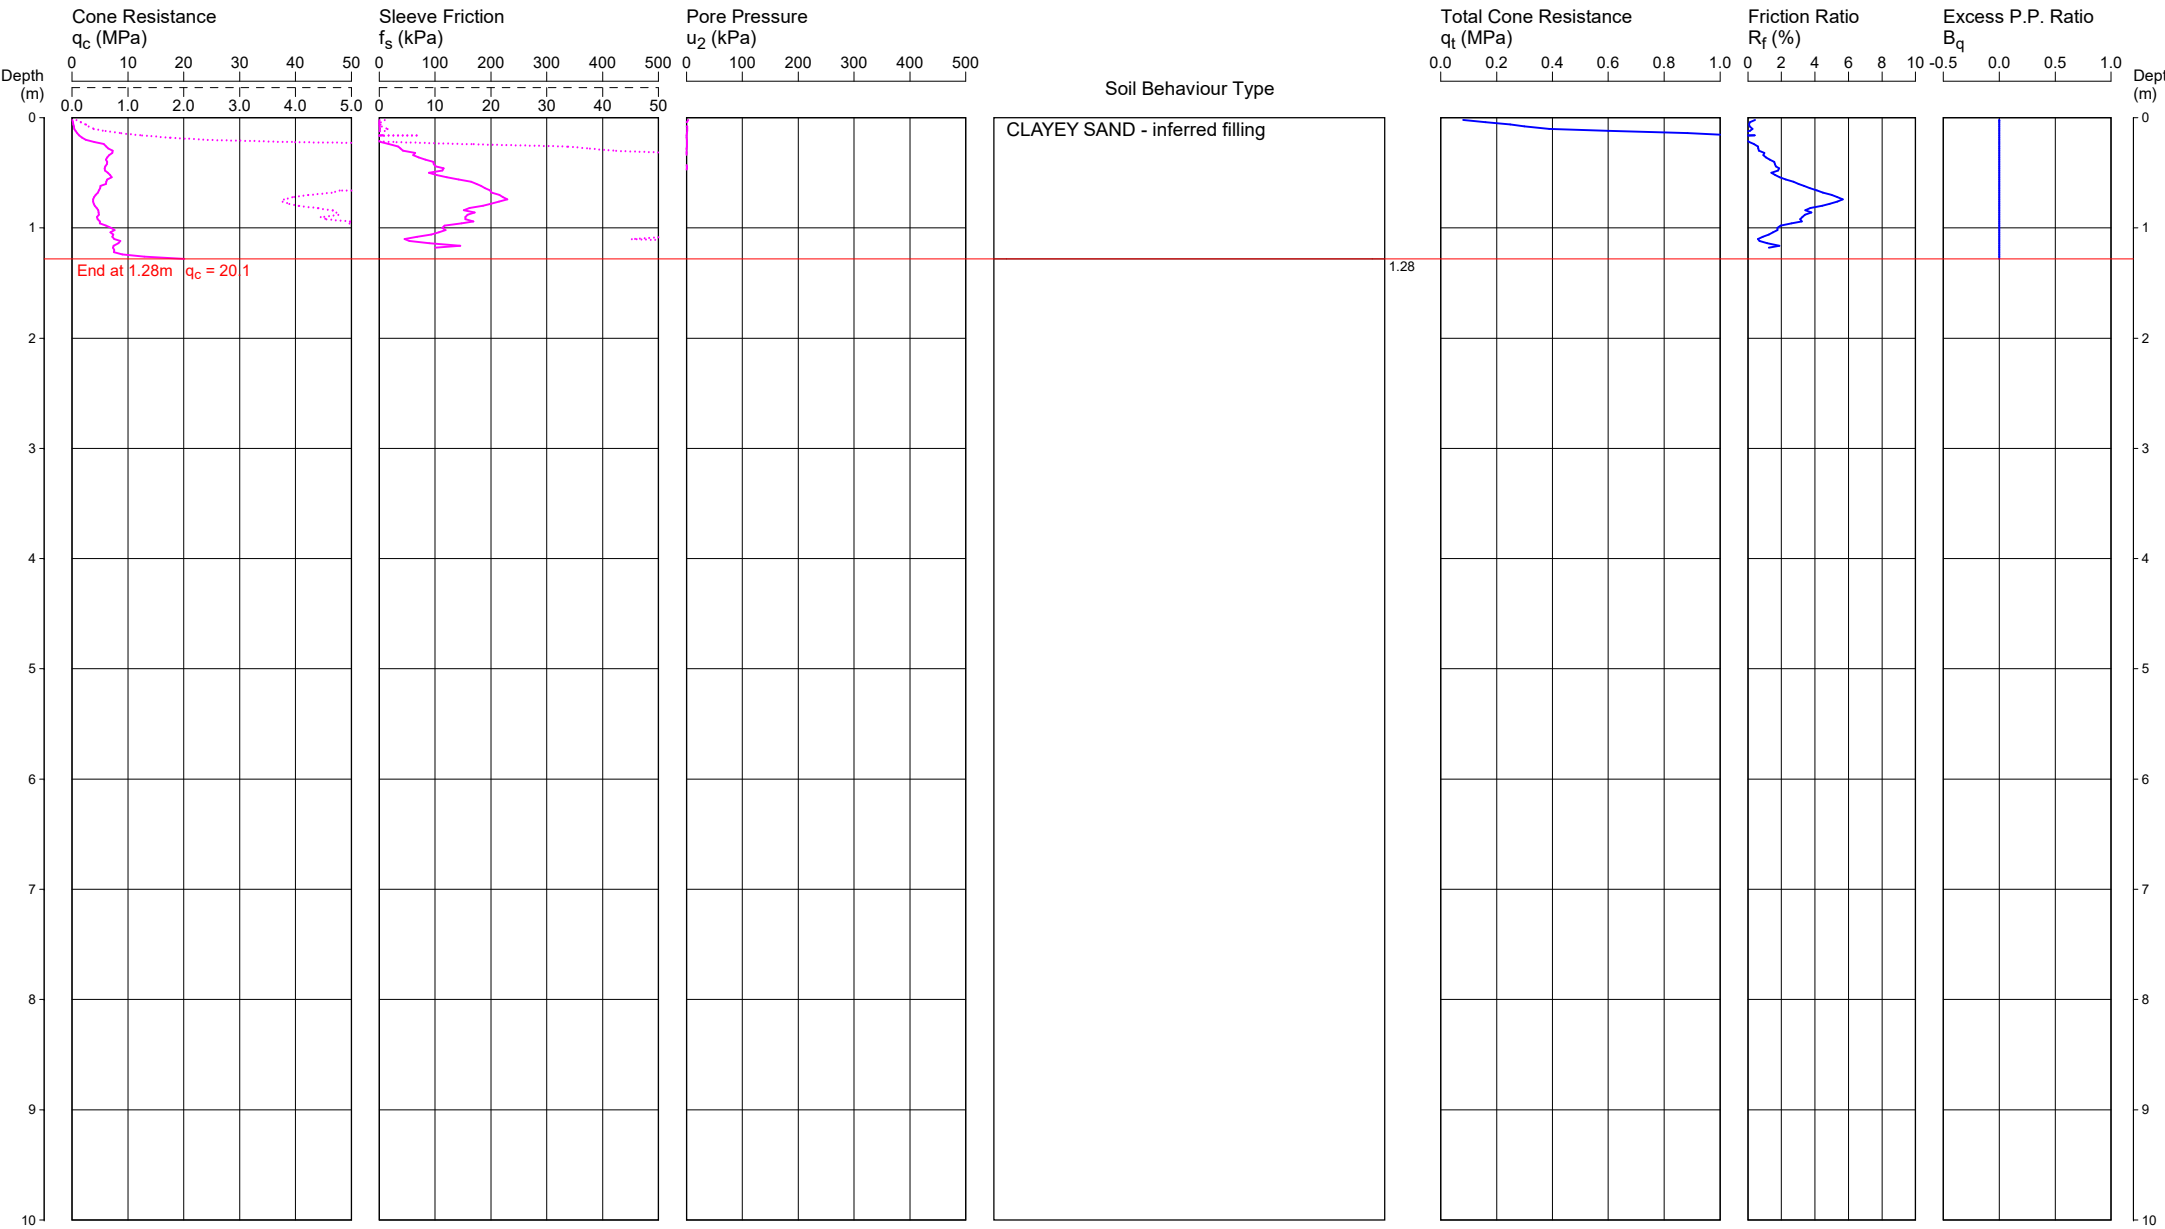
REMARKS: HAND AUGER TO 0.3 m. DUMMY CONE FROM 1.28 TO 1.3 m DEPTH TO PENETRATE FILLING. TEST DISCONTINUED DUE TO DUMMY CONE REFUSAL ON OBSTRUCTION.
