Report on
Preliminary Geotechnical Investigation

Cricket NSW Cricket Centre
Wilson Park, Newington Road
Sydney Olympic Park

Prepared for
Cox Architecture Pty Ltd

Project 86694.02
September 2019

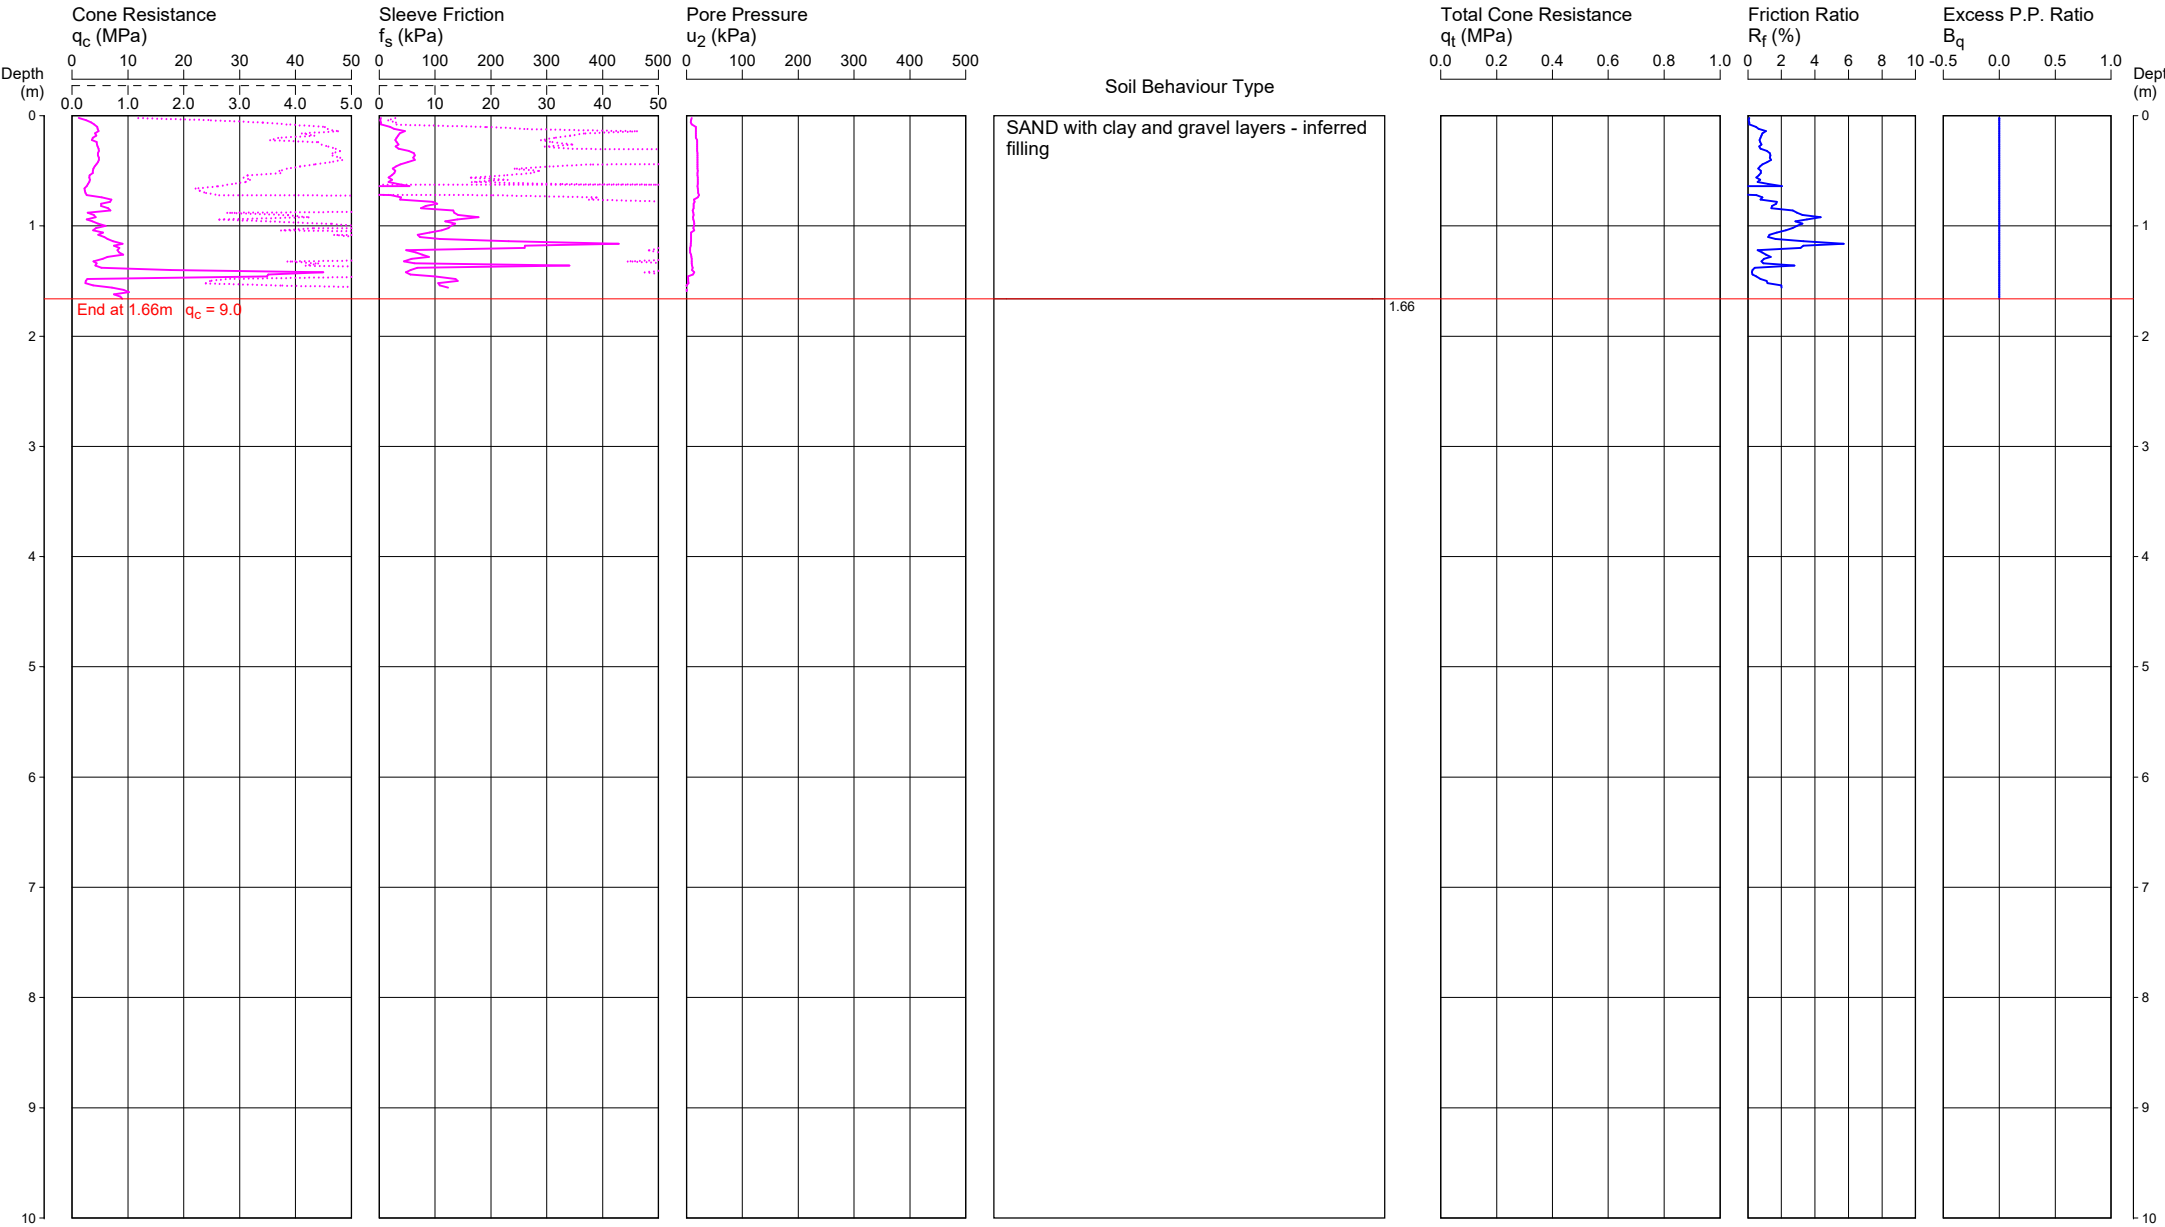
REMARKS: HAND AUGER TO 0.2 m. DUMMY CONE FROM 1.46 TO 1.8 m DEPTH TO PENETRATE FILLING. TEST DISCONTINUED DUE TO EXCESSIVE CONE BENDING IN THE DUMMY HOLE.

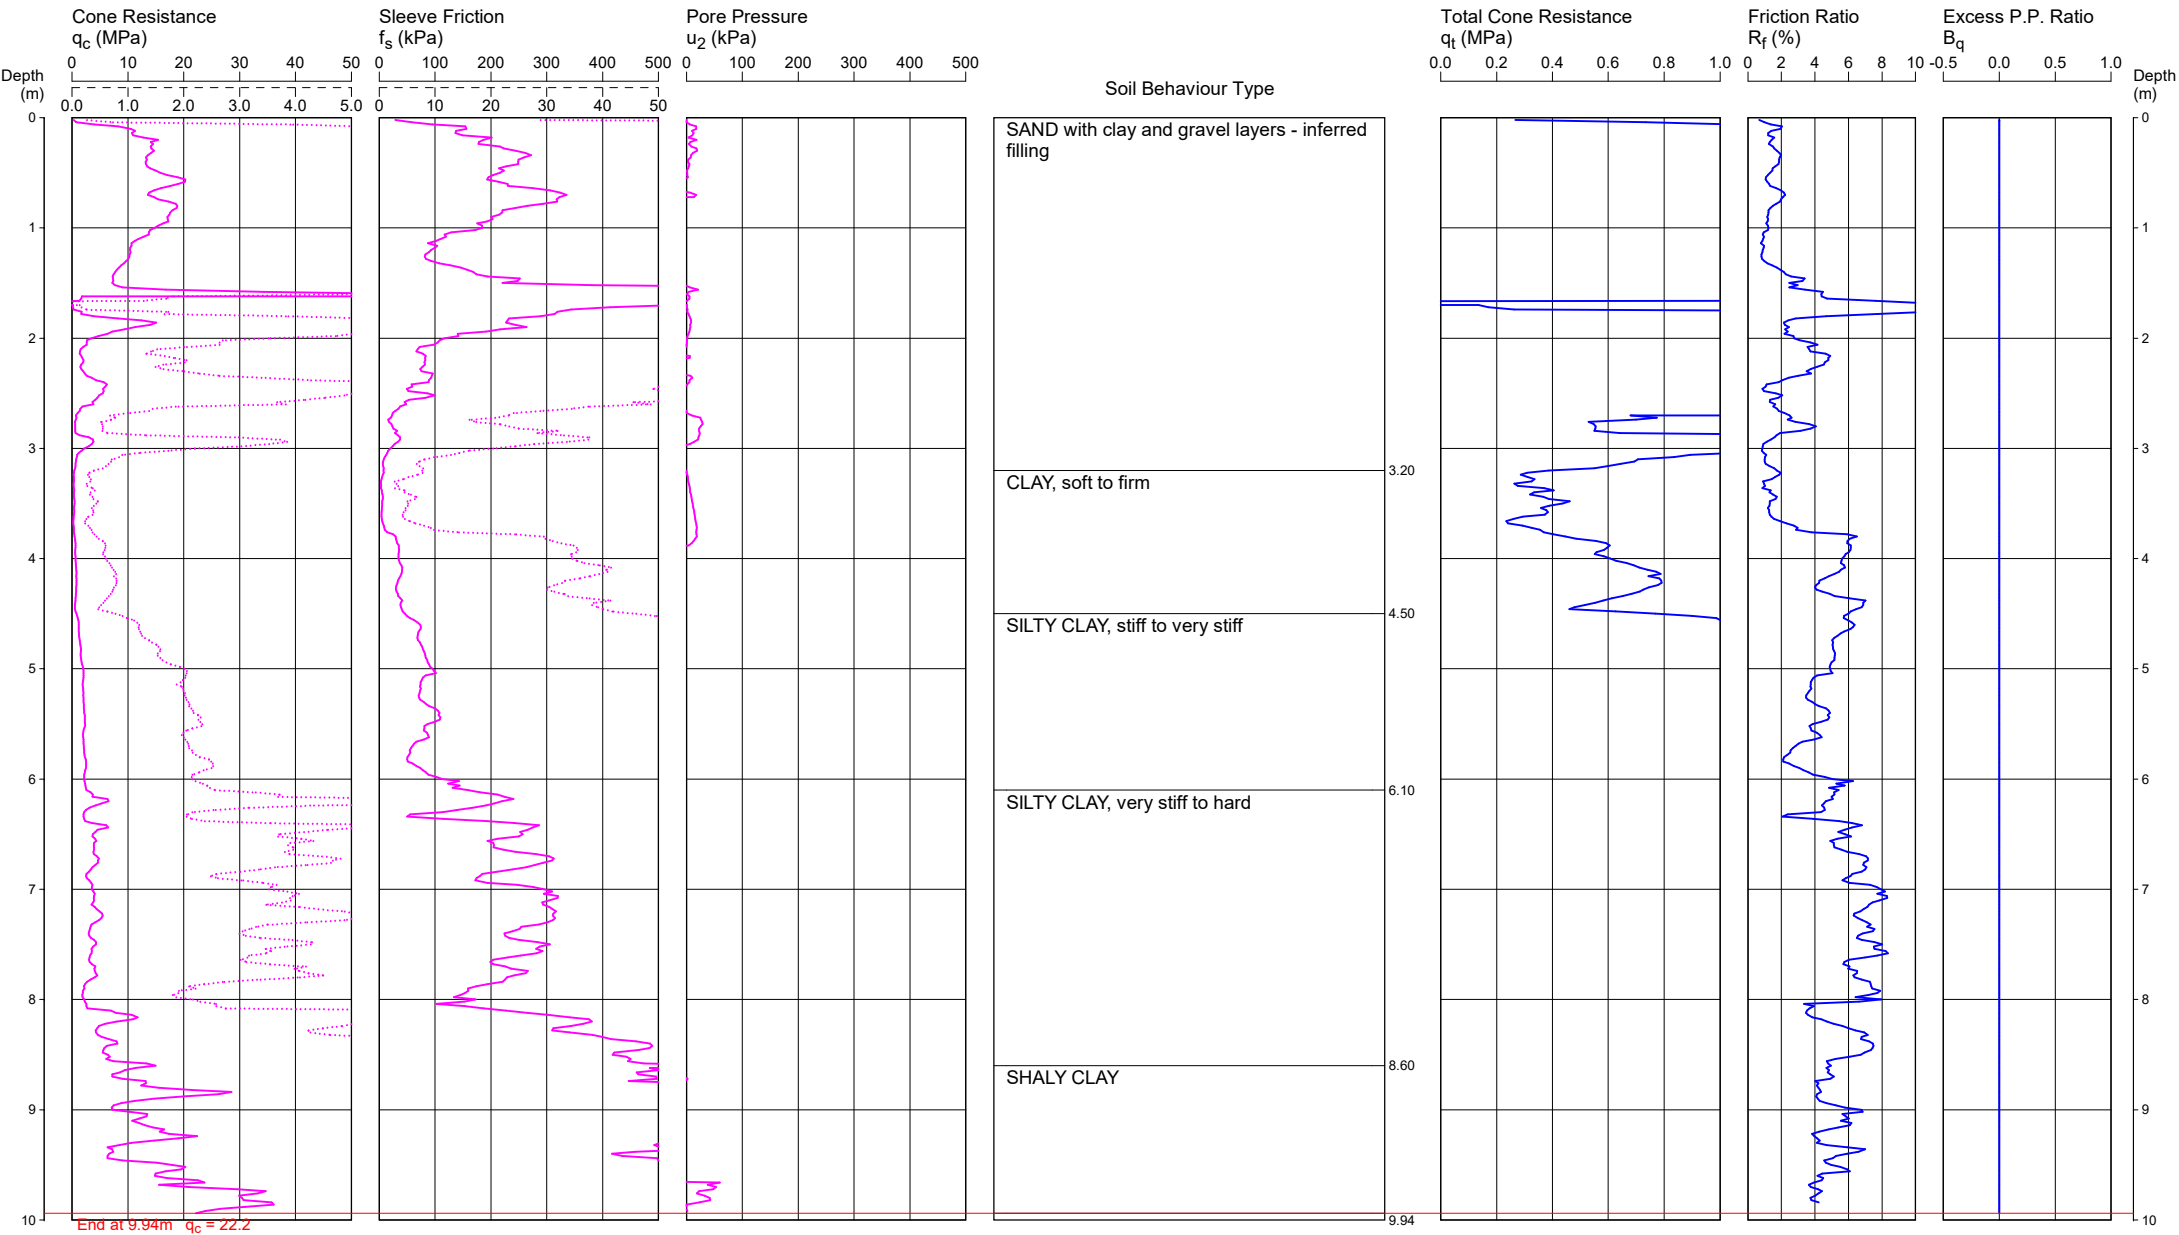
REMARKS: HAND AUGER TO 0.2 m. DUMMY CONE FROM 1.6 TO 1.9 m DEPTH TO PENETRATE FILLING.
TEST DISCONTINUED DUE TO CONE TIP REFUSAL.
HOLE COLLAPSE AT 0.0 m AFTER WITHDRAWAL OF RODS.

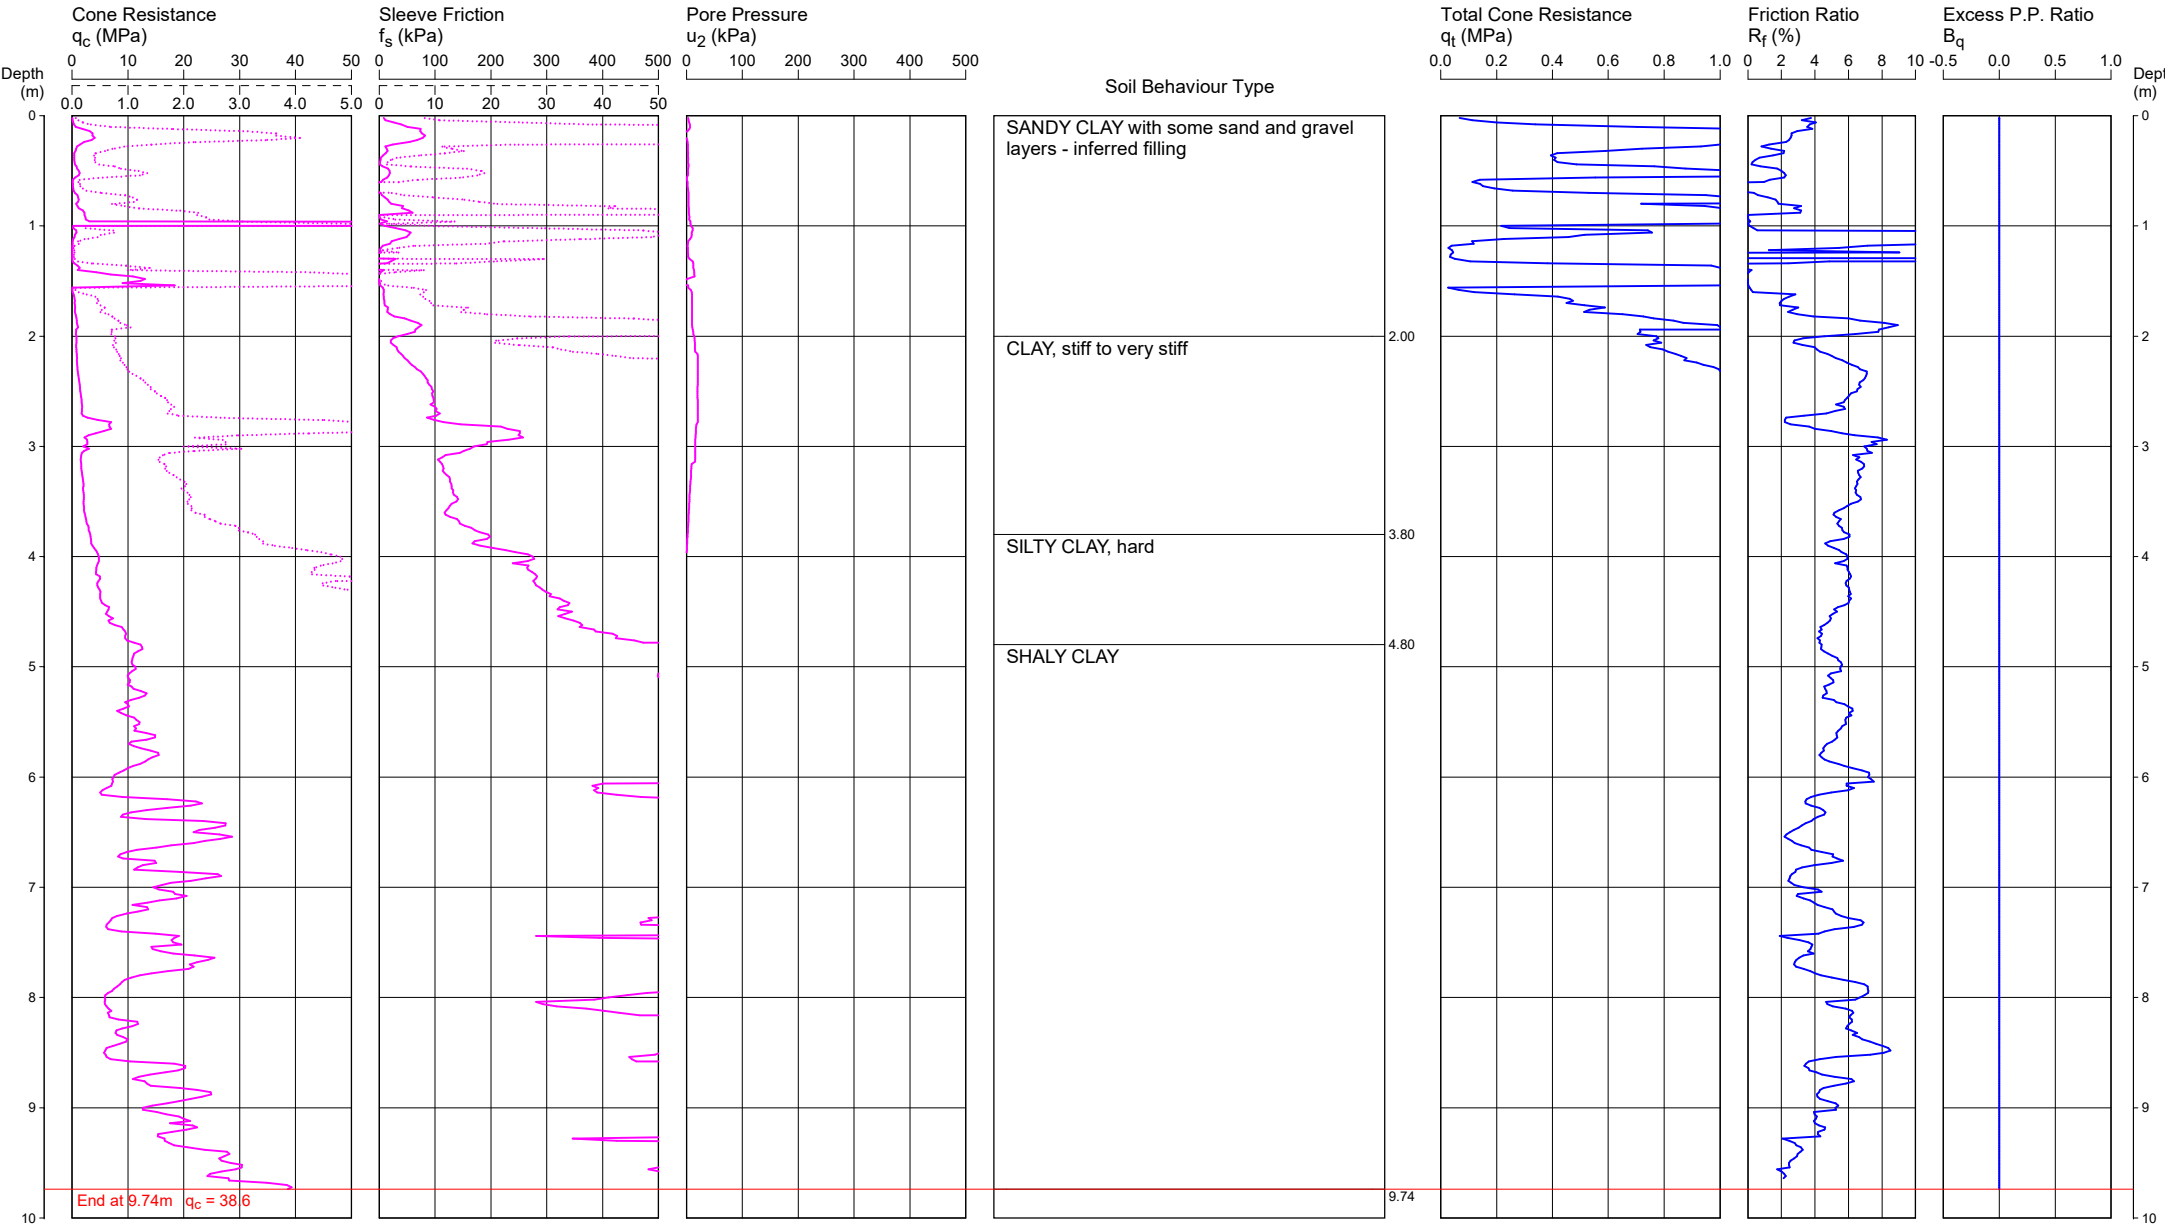
REMARKS: HAND AUGER TO 0.2 m. DUMMY CONE FROM 0.98 TO 1.4 & 1.54 TO 2.0 m DEPTH TO PENETRATE FILLING. TEST DISCONTINUED DUE TO EXCESSIVE CONE BENDING AT NEAR REFUSAL. HOLE COLLAPSE AT 1.8 m AFTER WITHDRAWAL OF RODS.

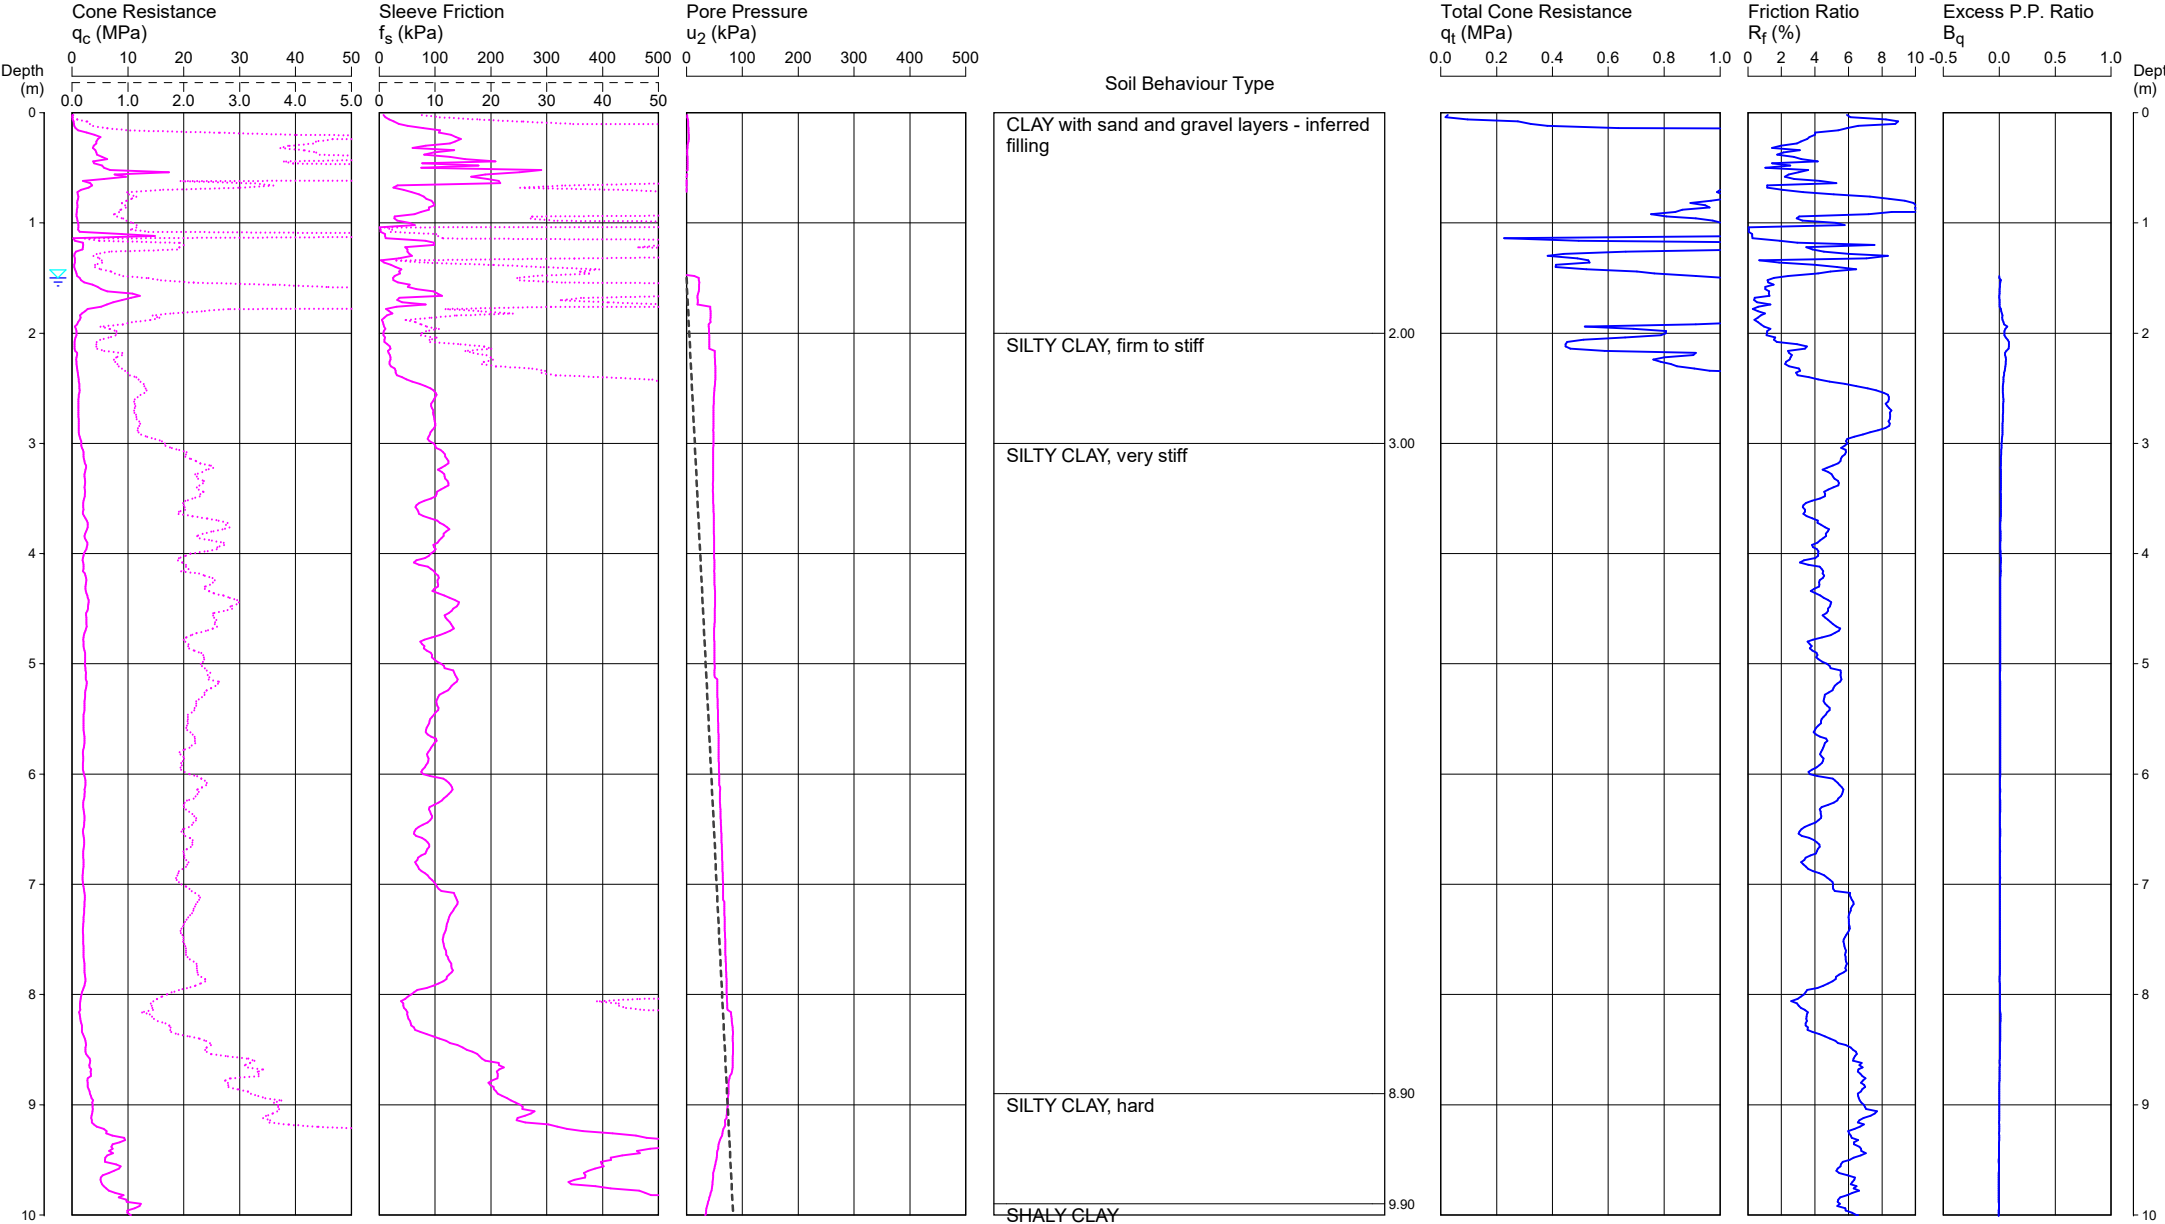
REMARKS: HAND AUGER TO 0.2 m. DUMMY CONE FROM 1.12 TO 1.50 m DEPTH TO PENETRATE FILLING.
TEST DISCONTINUED DUE TO EXCESSIVE CONE BENDING AT NEAR REFUSAL.

Water depth after test: 1.5 m

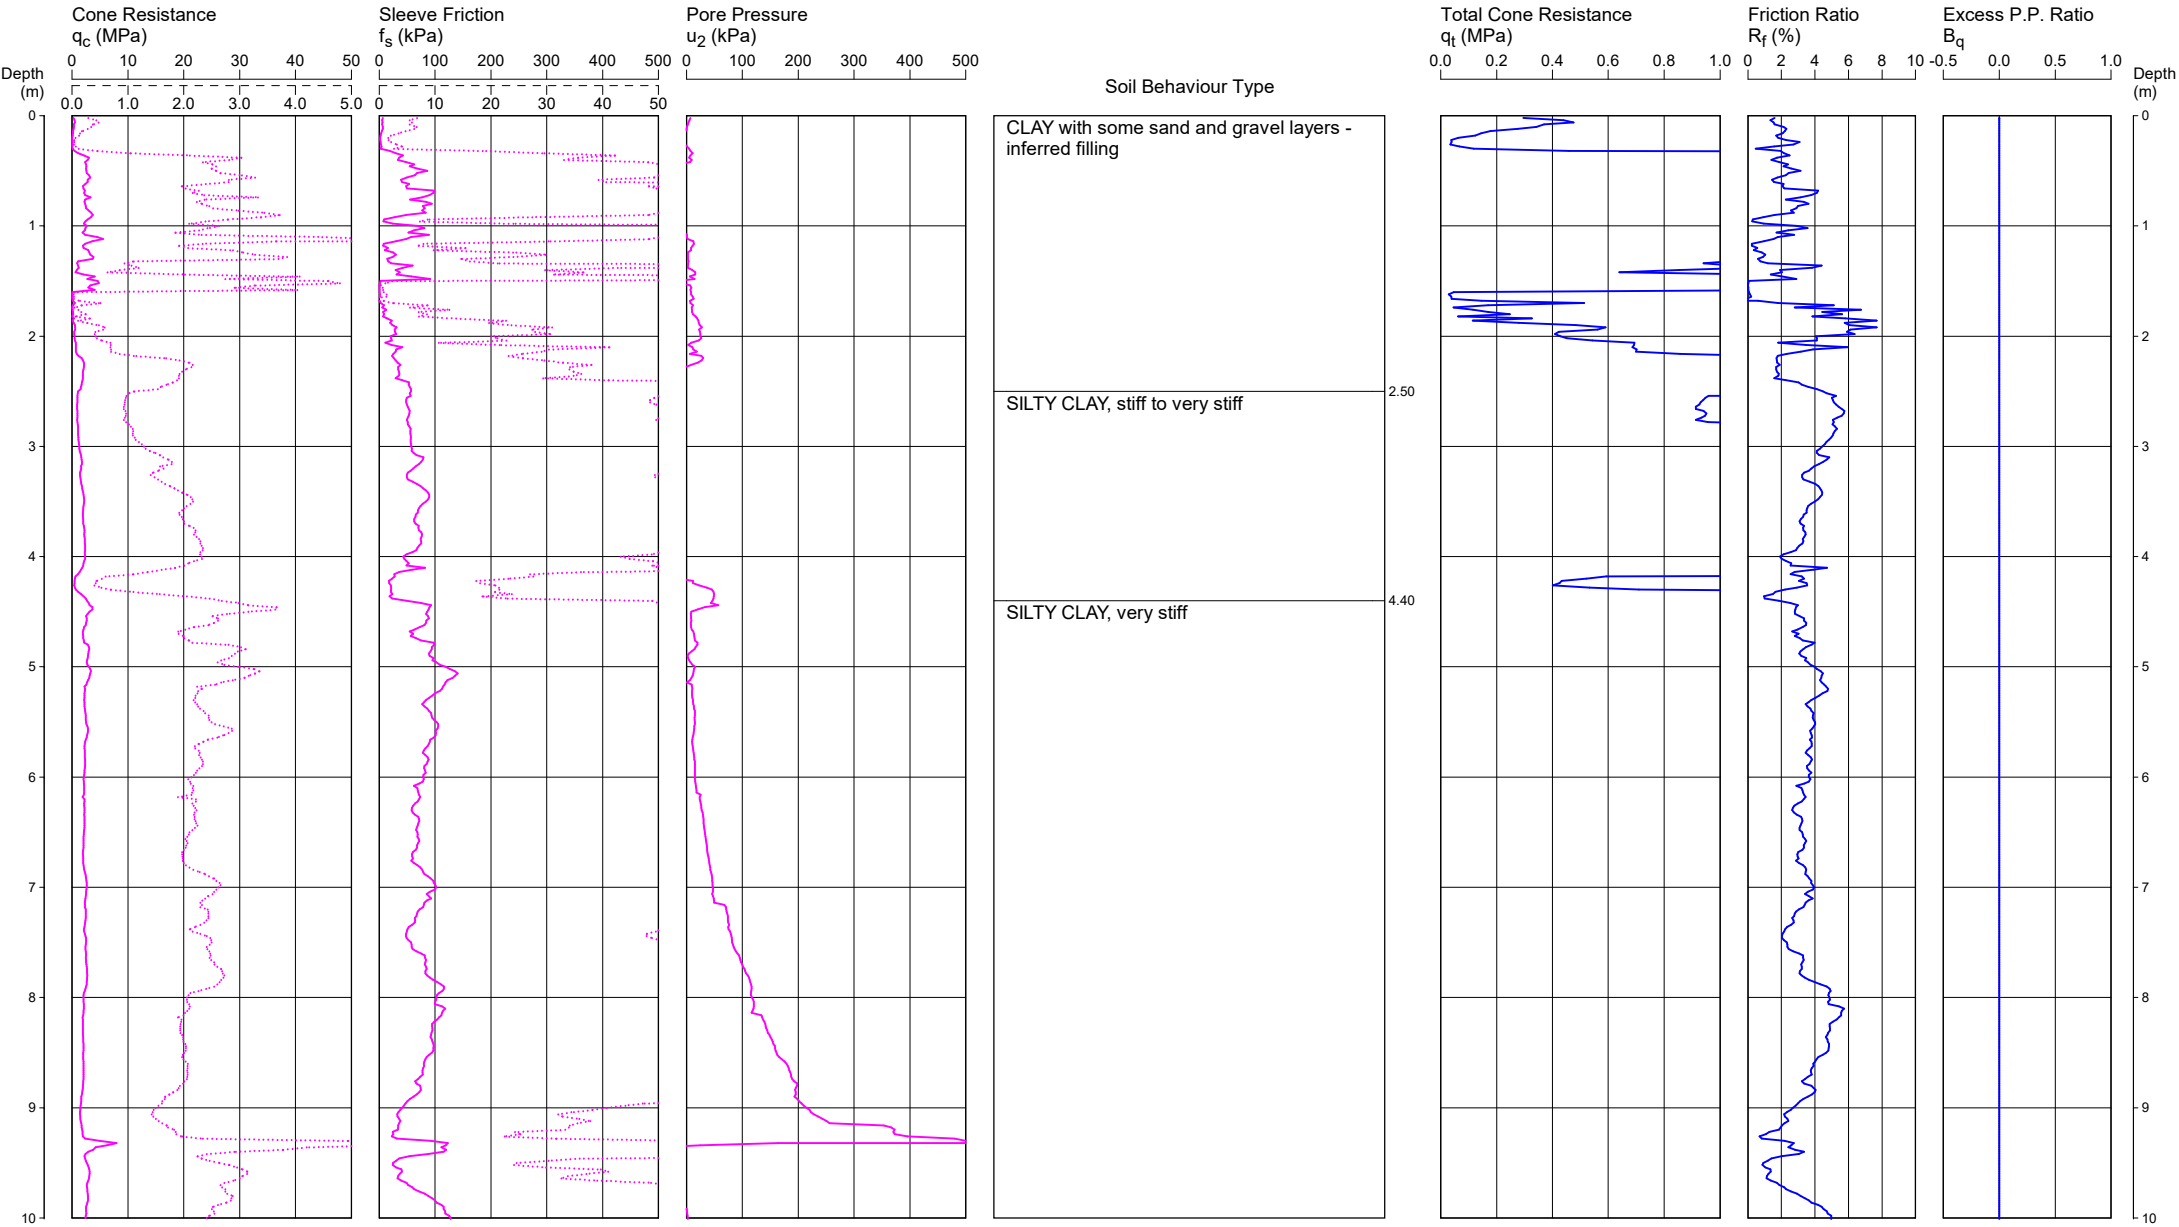
REMARKS: HAND AUGER TO 0.2 m. DUMMY CONE FROM 1.58 TO 2.20 m DEPTH TO PENETRATE FILLING. TEST DISCONTINUED DUE TO EXCESSIVE CONE BENDING AT NEAR REFUSAL. HOLE COLLAPSE AT 1.3 m AFTER WITHDRAWAL OF RODS.

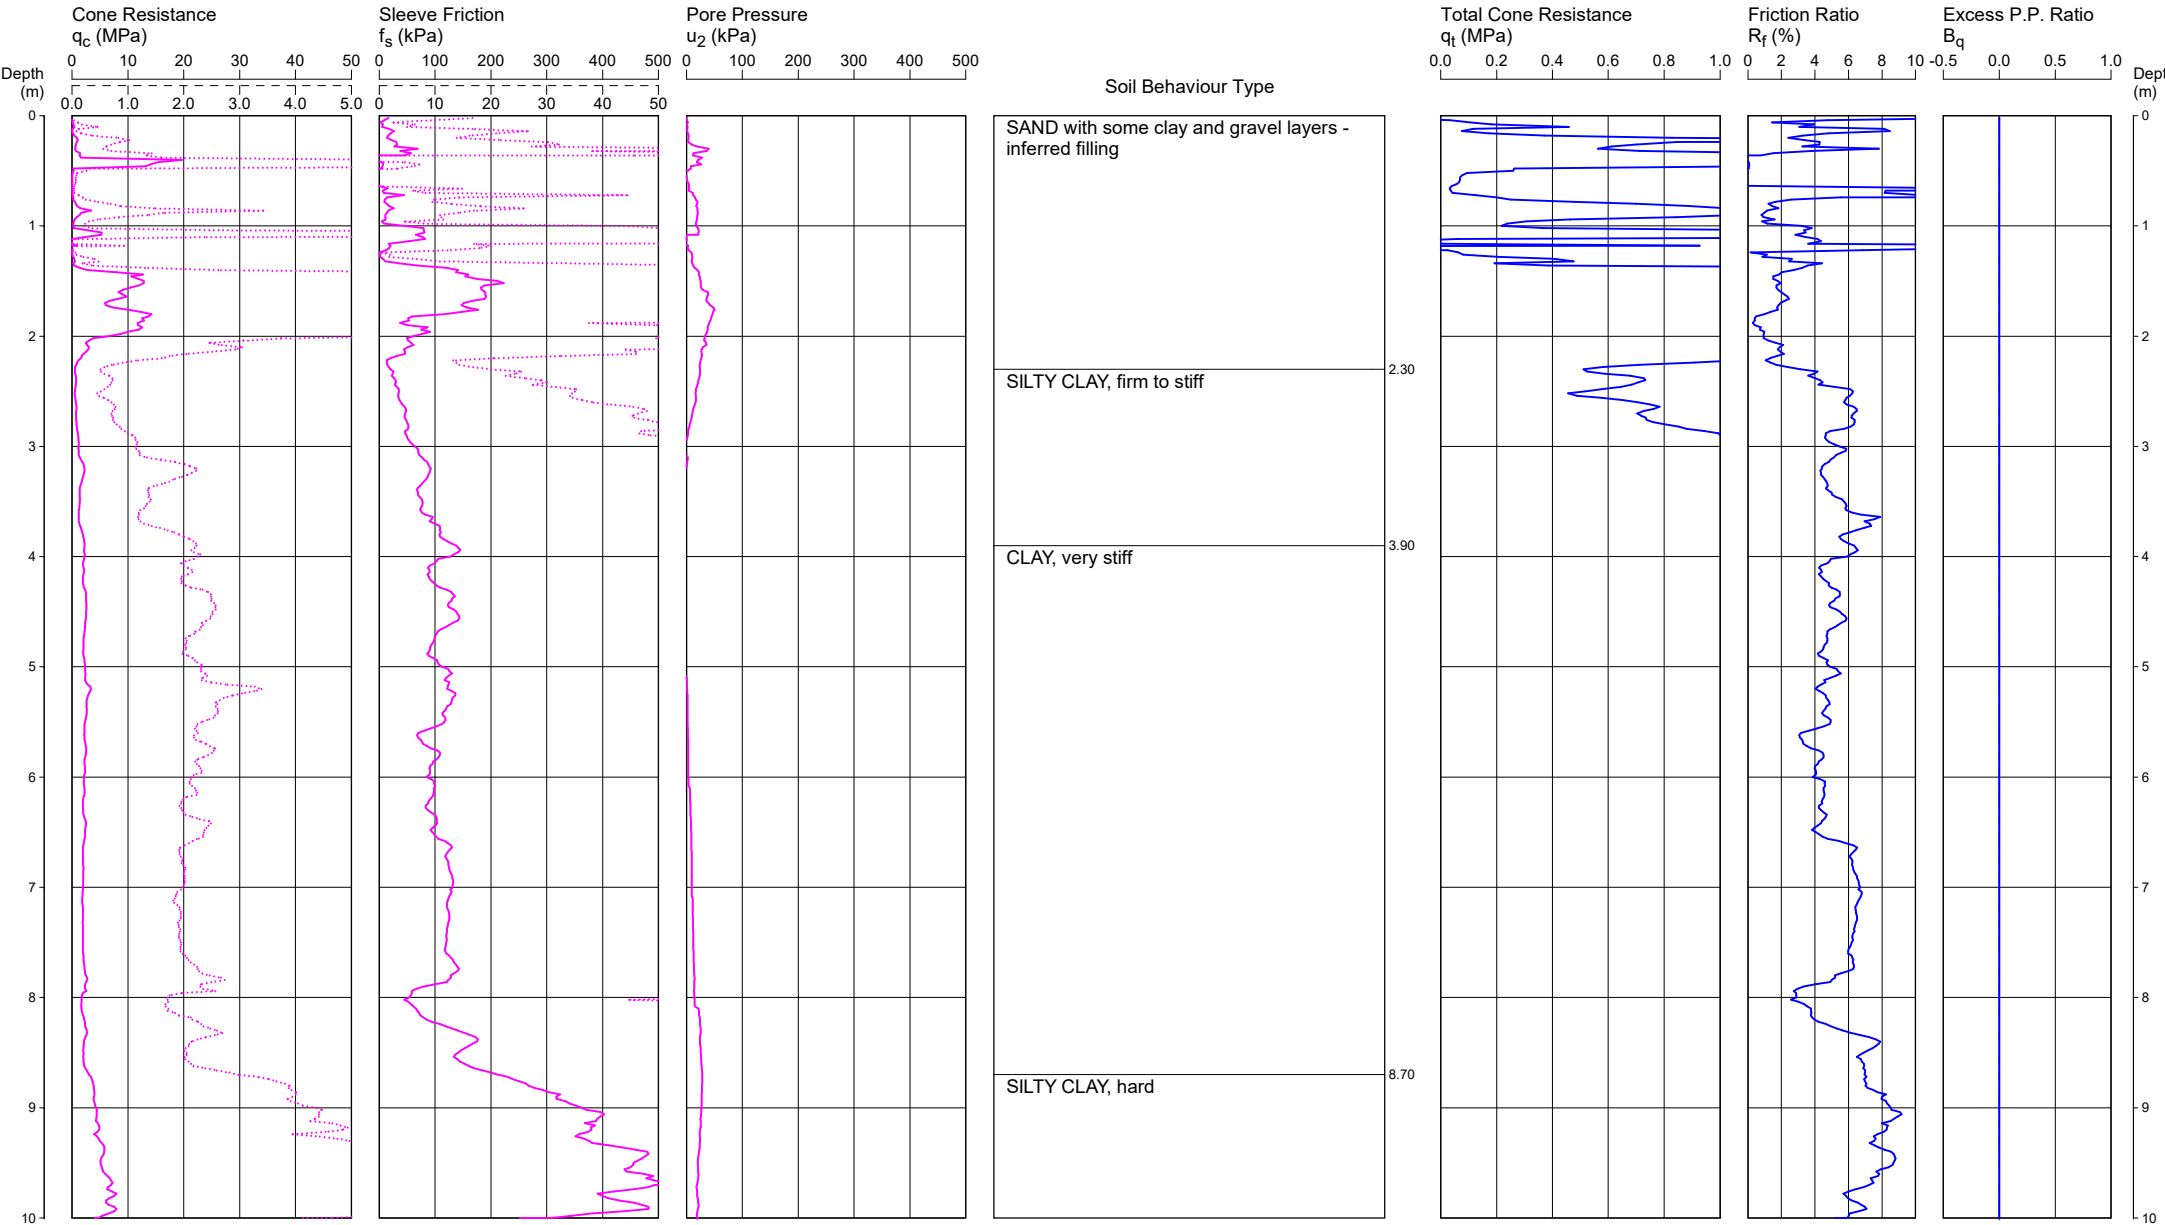
REMARKS: HAND AUGER TO 0.2 m. DUMMY CONE FROM 0.46 TO 0.8 m DEPTH TO PENETRATE FILLING.
TEST DISCONTINUED DUE TO CONE TIP REFUSAL.

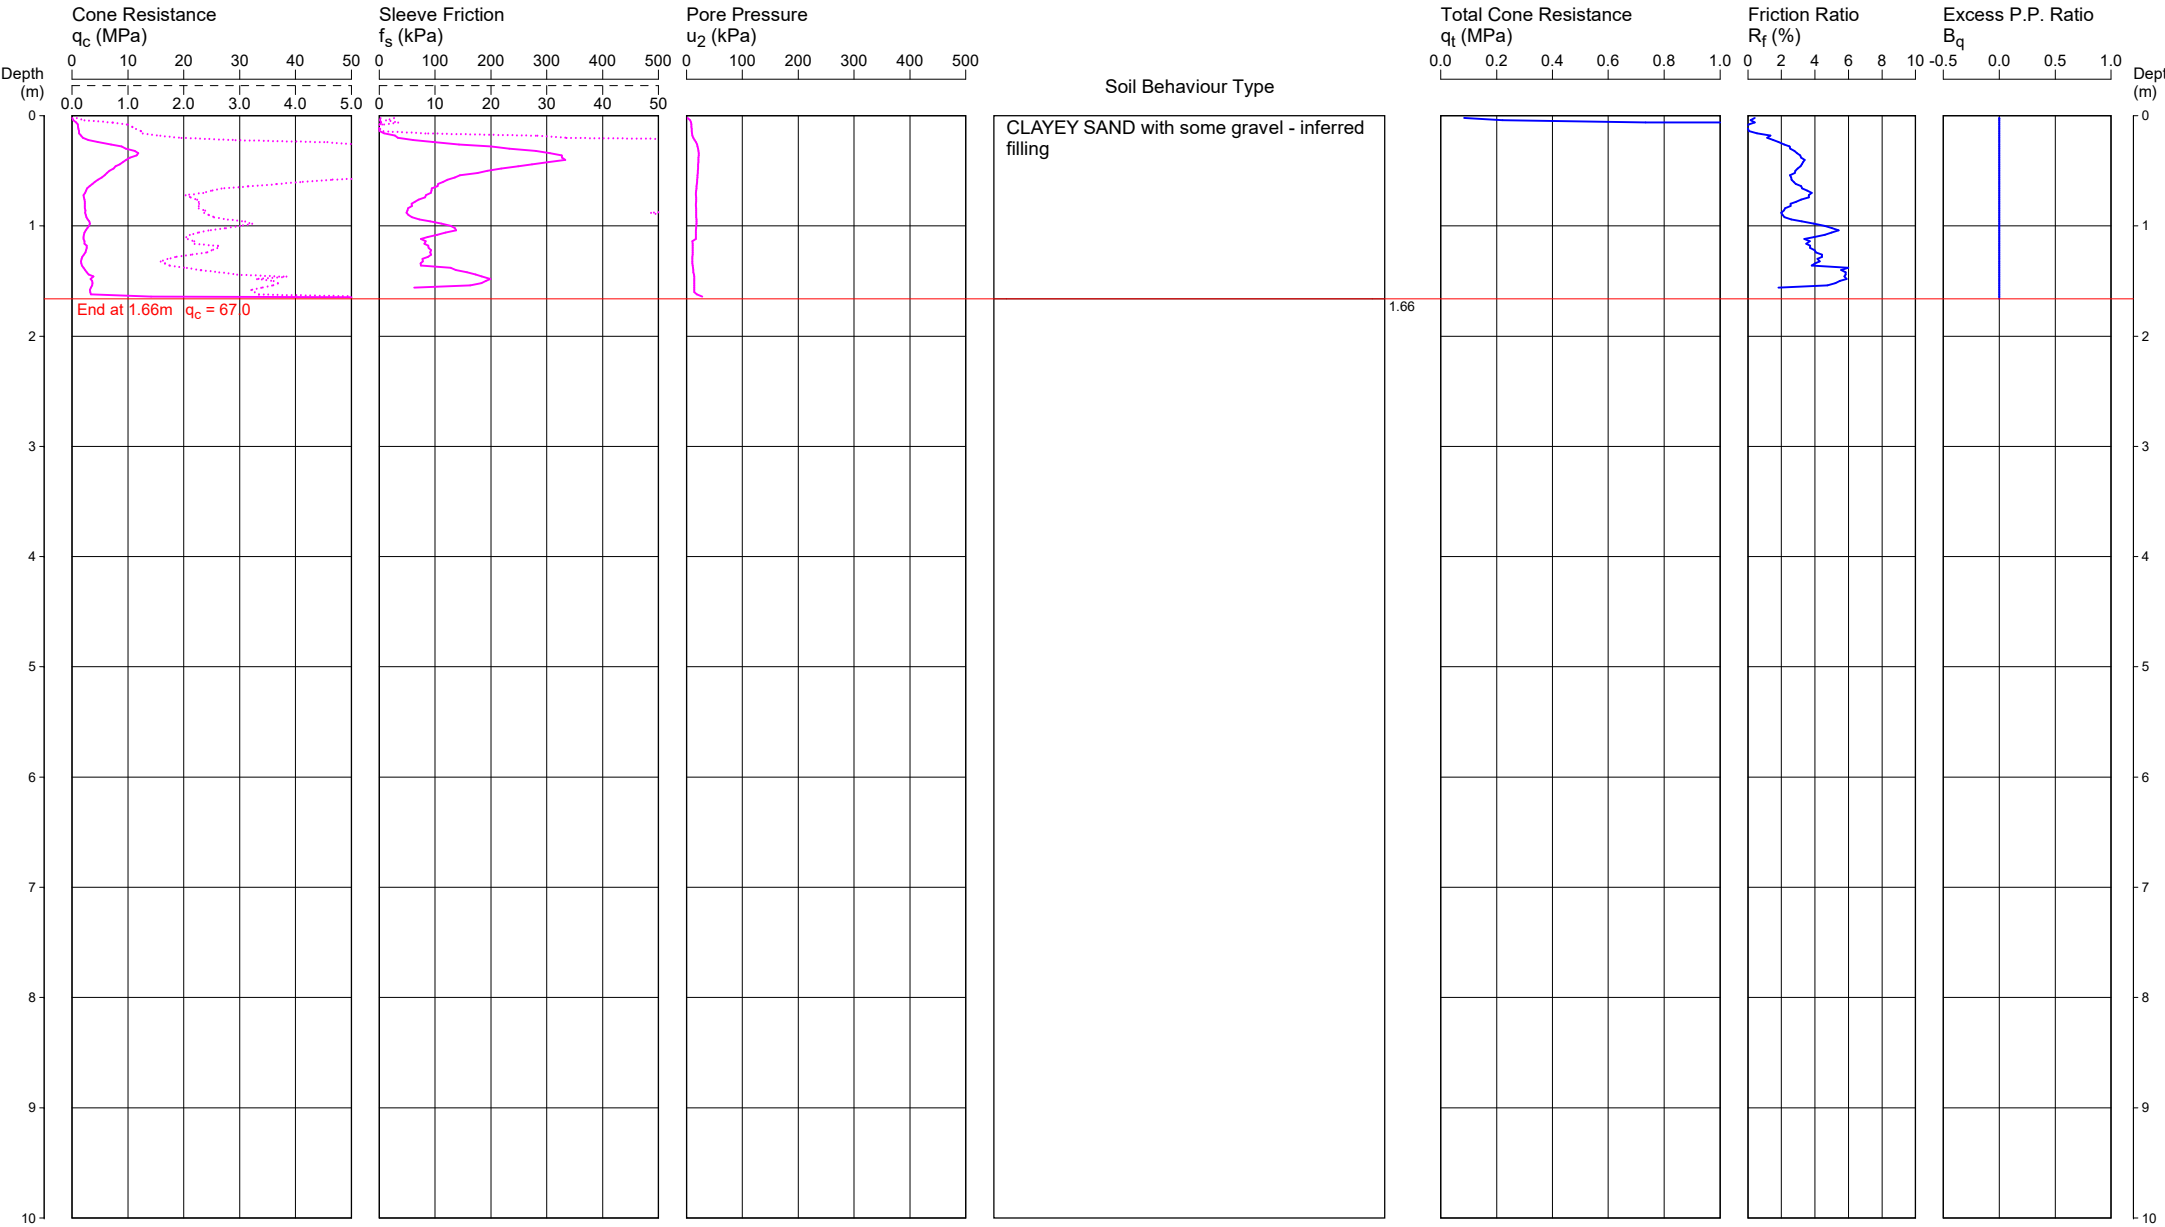
REMARKS: HAND AUGER TO 0.2 m. DUMMY CONE FROM 1.66 TO 1.66 m DEPTH TO PENETRATE FILLING.
TEST DISCONTINUED DUE TO DUMMY CONE REFUSAL ON OBSTRUCTION.
HOLE COLLAPSE AT 1.0 m AFTER WITHDRAWAL OF RODS.

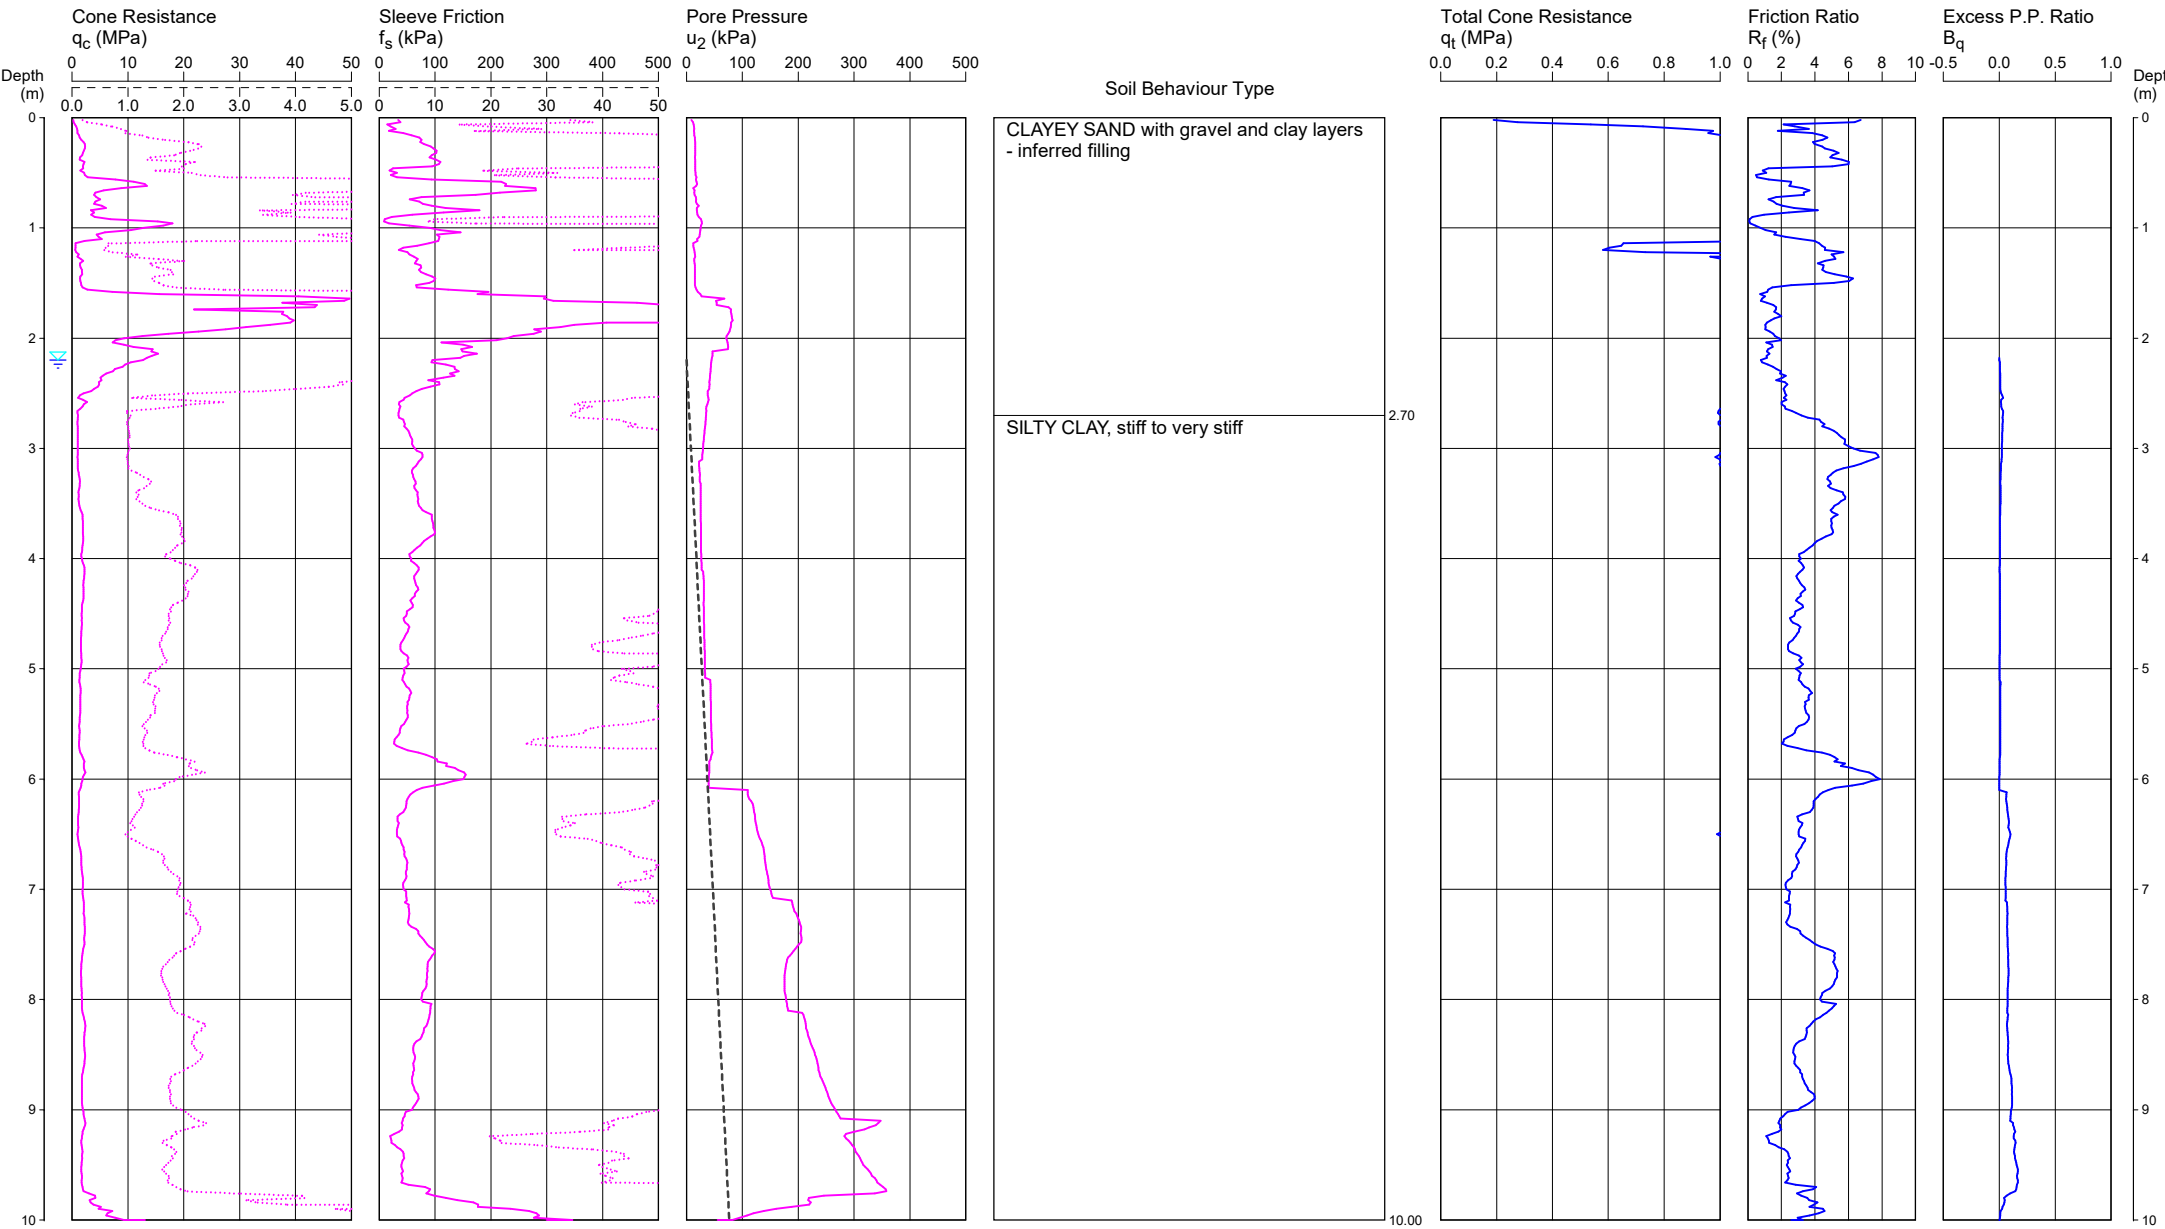
REMARKS: HAND AUGER TO 0.2 m.
TEST DISCONTINUED DUE TO EXCESSIVE CONE BENDING AT
NEAR REFUSAL.

Water depth after test: 2.2 m
